Description of Chronostratigraphic Units Preserved as Channel Deposits and Geomorphic Processes Following a Basin-Scale Disturbance by a Wildfire in Colorado

Open-File Report 2017–1090

U.S. Department of the Interior
U.S. Geological Survey

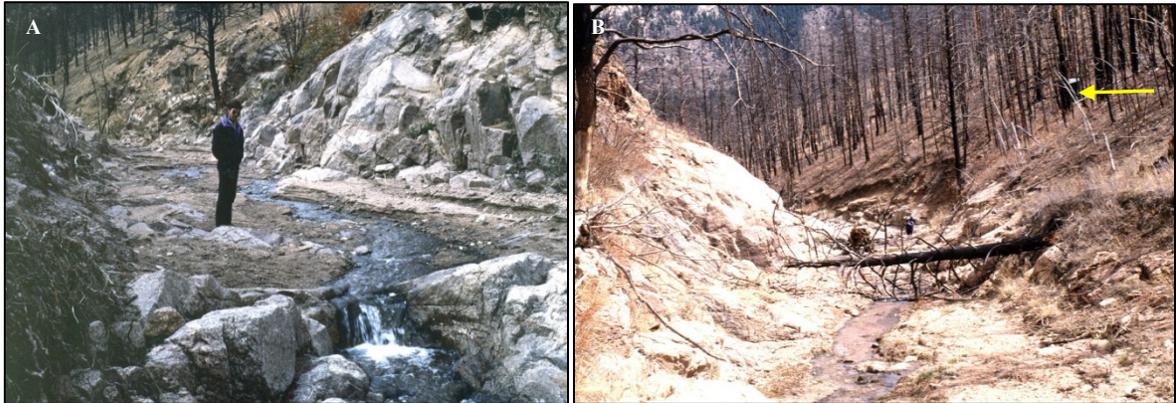
Figure 56. Spring Creek gage site, 1996–2001. A, November 6, 1996. View is looking upstream. G. O’Neil (about 1.7 meters [m] tall) is standing at the future location of the streamgage that was operational in April 1997. The site is about 20 m upstream from XS1450, which is also within the narrow (about 10 m wide) bedrock reach. The extreme flood (about 510 cubic meters per second) was on July 12, 1996. B, April 6, 2001. View is looking downstream at the gage site just beyond the fallen tree where D. Martin (about 1.7 m tall) is standing. The bed and banks through this reach are bedrock. The yellow arrow points to the gage house.

Cross section 1450 was measured at the upstream end of a narrow, bedrock-dominated reach of Spring Creek extending from 1,240 m to 1,470 m upstream from the confluence of Spring Creek with the South Platte River (fig. 56). Sediment was not preserved within this part of the bedrock reach from May 1998 through June 2014. Deposition during the extreme flood on July 12, 1996, (about $510 \text{ m}^3/\text{s}$) was minimal, as shown in the photograph in figure 56, which was taken 4 months after the flood. The first cross-section survey was on May 3, 1998, after seven major floods in 1997 that ranged from 1.15 to $140\text{--}180 \text{ m}^3/\text{s}$.

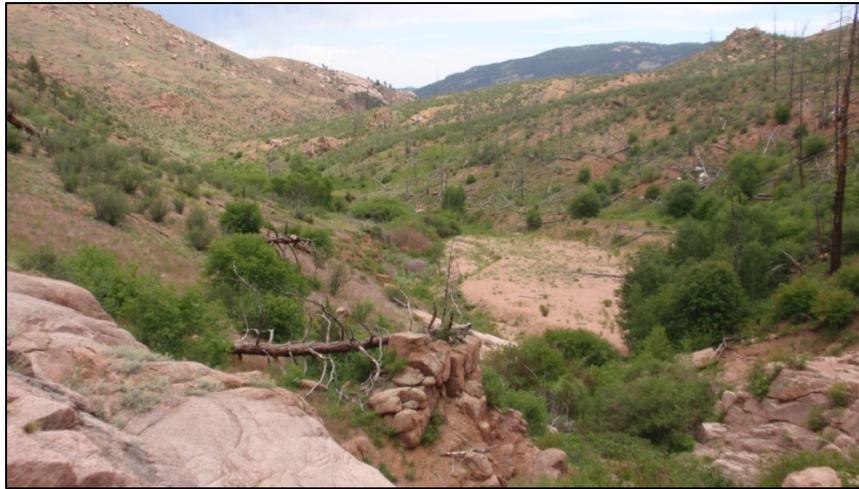
Figure 58. Photograph of the Spring Creek channel that includes the location of cross section 4850 (XS4850), 2014. Photograph was taken on June 22, 2014, looking downstream from the top of a bedrock outcrop. This nearly vertical bedrock outcrop extends across the channel (about 20 meters upstream from XS4850) and forms a waterfall when Spring Creek is flowing. The nearly flat surface composed of bare sand and gravel seen in this photograph begins at the base of the bedrock outcrop. Most of the burned trees that were once upright have fallen down.

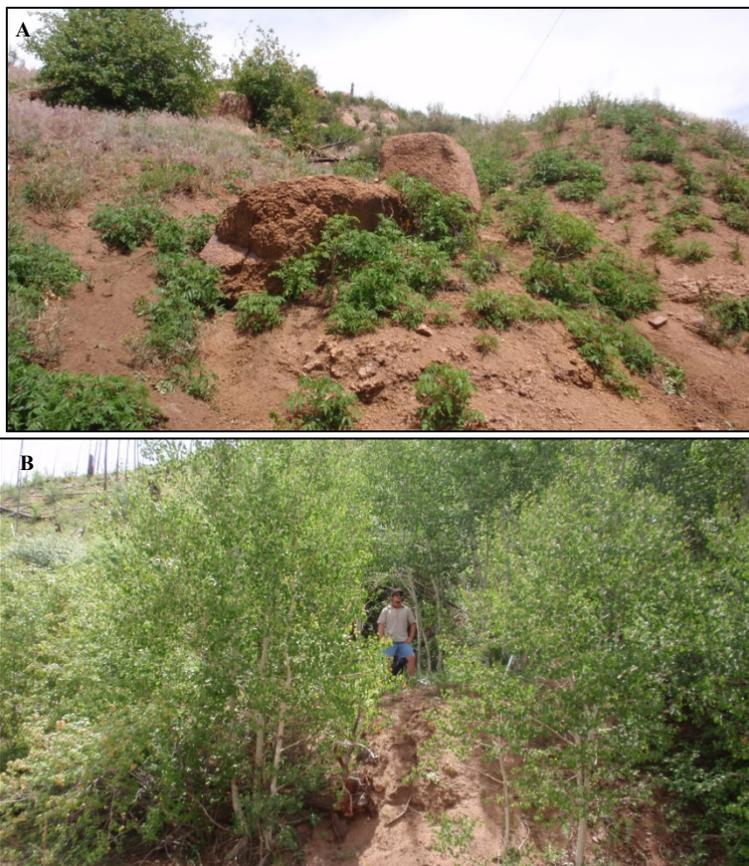
Figure 59. Photographs of the two ends of cross section 4850 (XS4850), 2014. *A*, View shows the area around the zero reference pin on June 22, 2014. The zero pin is located at the base of the bedrock outcrop to the left center of the photograph. *B*, View shows the location of the right bank reference pin. The reference pin is near the left foot of J. Smith (about 1.6 meters tall).

Cross section 4850 was measured in the most upstream location of all the cross sections (fig. 1B, 58, 59) and was selected to monitor the depletion of the original sediment deposited by the extreme flood on July 12, 1996, (about $510 \text{ m}^3/\text{s}$) in the headwater of Spring Creek. It is located about 3,400 m upstream from the streamgage site (near XS1450). The first survey was on July 18, 1998, and this cross section was not resurveyed as frequently as the other cross sections downstream (only 7 times). Thus, the initial profile also includes the deposition from seven major floods in 1997 and one major flood in 1998 as a single chronostratigraphic unit. The discharges of these eight major floods ranged from 1.15 to 140–180 m^3/s at the gage downstream.
