Erosion and Deposition
Produced by the Flood
Of December 1964
On Coffee Creek
Trinity County, California

GEOLOGICAL SURVEY PROFESSIONAL PAPER 422-K

By JOHN H. STEWART *and* VALMORE C. LaMARCHE, JR.

PHYSIOGRAPHIC AND HYDRAULIC STUDIES OF RIVERS

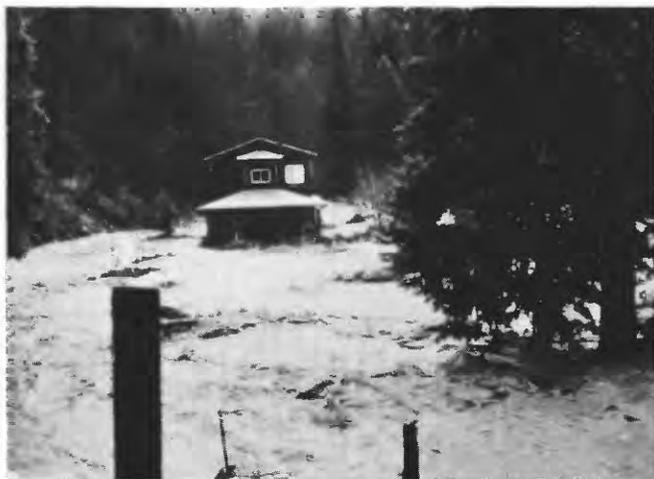
FIGURE 3.—Mad Meadows (mile 4.3) during flood, looking downstream. House in picture is at locality 11, plate 1 and figure 7. Picture taken during mid-morning, December 23, 1964, about 10 hours after crest of flood. Water is down 2–3 feet from crest. Photograph by Roger Wiborg.

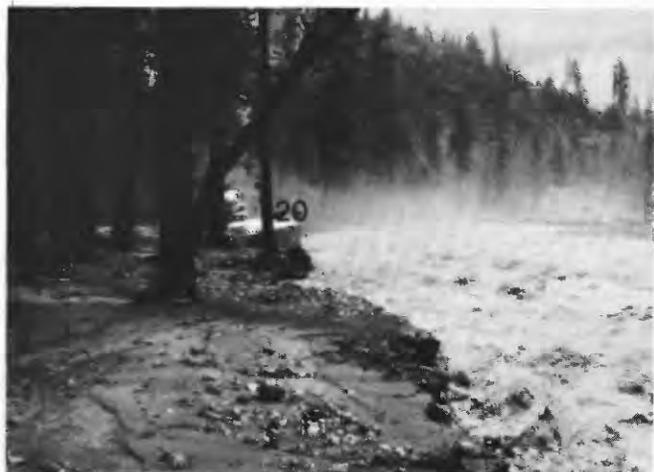
FIGURE 4.—Near Coffee Creek Campground (mile 2.1) during flood, looking downstream. Picture taken about mid-morning, December 23, 1964, about 10 hours after crest of flood. Water down several feet from crest. View is southeast toward locality 20 (also loc. 20, pl. 1). Flood waters on right side of photograph have cut deeply both laterally and vertically into former land area. About 10 feet of bank erosion occurred after photograph was taken. East side of section F–F' (pl. 2) is near location of truck. Photograph by Roger Wiborg.

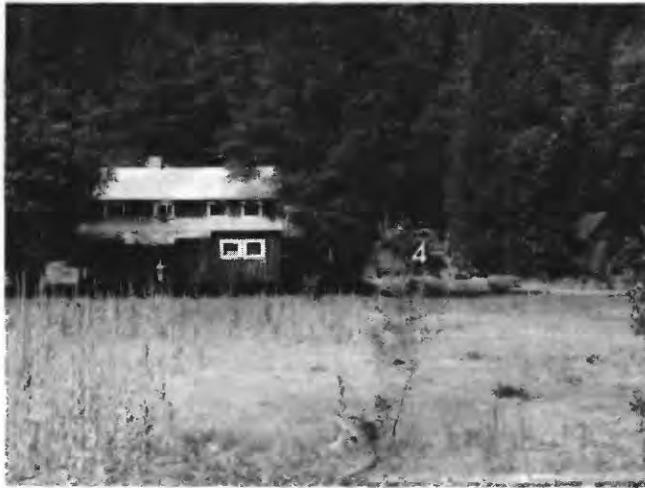
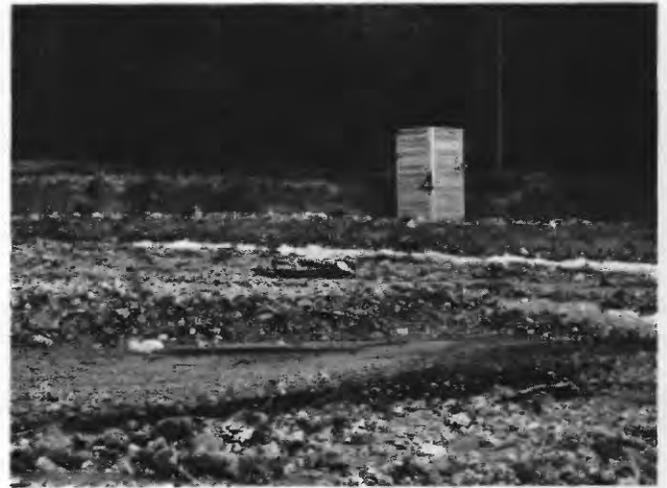
FIGURE 5.—Preflood and postflood photographs taken from approximately same position looking north-northeast at The Cedars (mile 5.0 to 5.1). Cabin (4) is the same in both photographs (also loc. 4, pl. 1). A, Photograph taken during late 1950's or early 1960's. Area looked virtually like this immediately prior to December 1964 flood. Picture supplied by J. Guggenmos. B, Photograph taken in May 1965; cabin has toppled off cutbank since the flood. Cutbank is an alluvial material derived from granitic rock; note dark soil below pre flood surface at top of cutbank. All material in foreground up to cutbank was deposited by flood, after erosion of pre flood terrane.

The most spectacular erosion, however, was of colluvial and alluvial fan deposits along the sides of the valley. In the upper 2.4 miles studied, these deposits consist of easily eroded unconsolidated sand derived from granitic rock. Large amounts of this sand were washed away by the flood between mile 4.9 and 5.3 (left-hand part of sections *A-A'* and *B-B'*, pl. 2; figs. 5, 6),

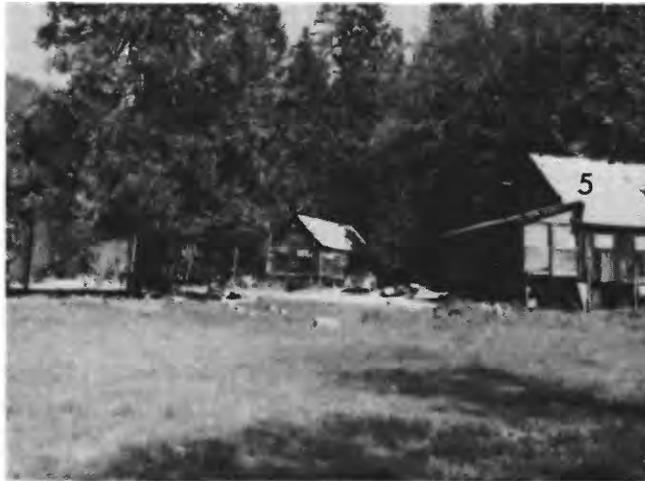
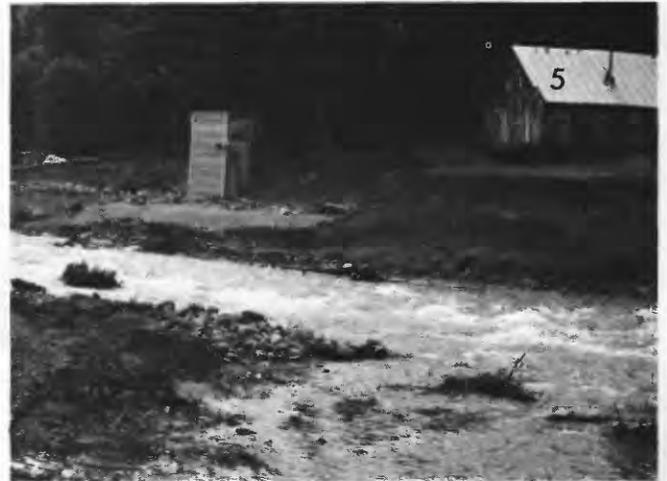
FIGURE 6.—Preflood and postflood photographs taken from approximately same position looking upstream north-northwest at The Cedars (mile 5.0 to 5.1). House (5) is the same in both photographs (also loc. 5, pl. 1). A, Photograph taken during late 1950's or early 1960's. Area looked virtually like this immediately prior to December 1964 flood. Picture supplied by J. Guggenmos. B, Photograph taken in May 1965; cabin, beyond house, has toppled off cutbank since flood. This cabin is also shown in figure 5. Cutbank is in alluvial material derived from granitic rock. Note soil developed below pre flood surface.

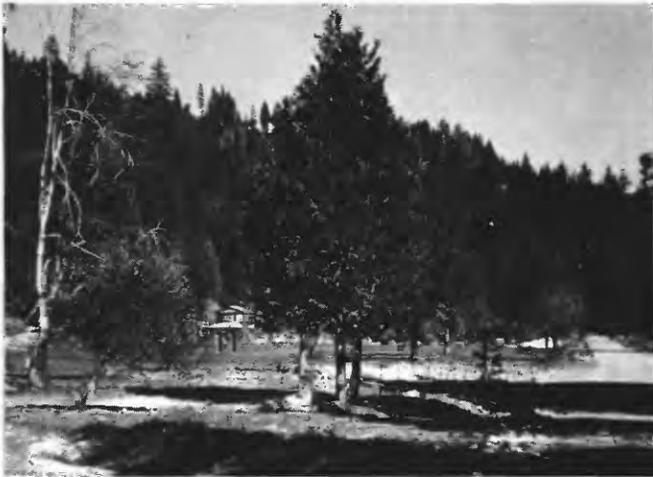
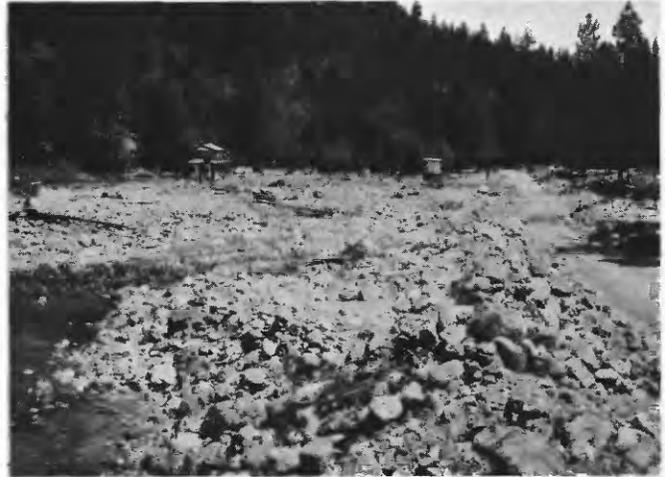
FIGURE 7.—Preflood and postflood photographs taken from approximately same position looking east at Mad Meadows (mile 4.3). House (11) is the same in both photographs (also loc. 11, pl. 1), and is also shown on figure 3. A, Photograph taken during late 1950's or early 1960's. Area looked virtually like this immediately prior to December 1964 flood. Irrigation ditch in foreground. Picture taken by A. D. Rankin. B, Photograph taken in May 1965. Road has been rebuilt since flood. This area lies 500-600 feet north of the preflood stream channel.

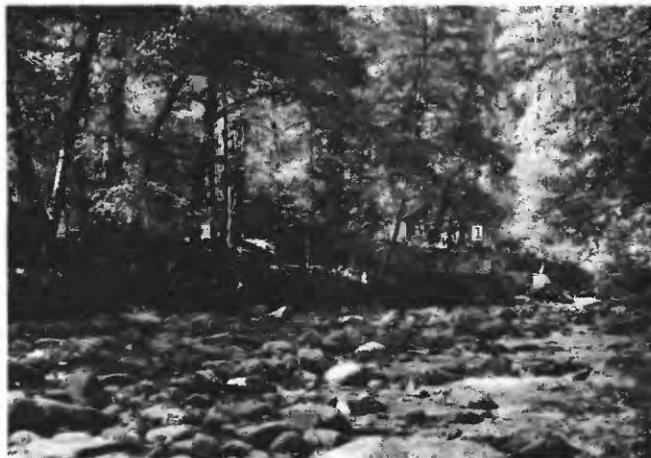
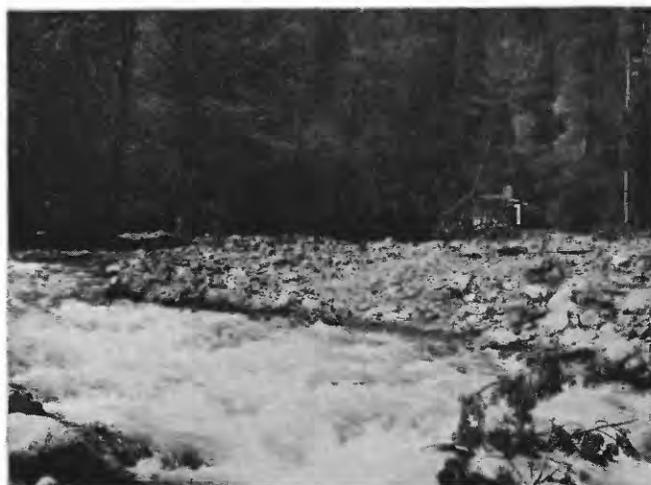
FIGURE 10.—Pre-flood and post-flood photographs taken from approximately the same position near mile 5.3; upstream view (north). House (1) is the same in both photographs (also loc. 1, pl. 1). Comparison of A and B indicates that 5 feet or more of deposition occurred during flood in the pre-flood channel. A, Photograph taken during the 1950's. According to residents, the stream channel looked approximately like this immediately prior to December 1964 flood. Picture supplied by J. H. Jessup. B, Photograph taken in May 1965. The stream channel here is not the same as that shown on plate 1 as a natural diversion has caused a shift in the stream channel between the date (April 24, 1965) the photographs used in preparing plate 1 were taken and the date of this photograph.

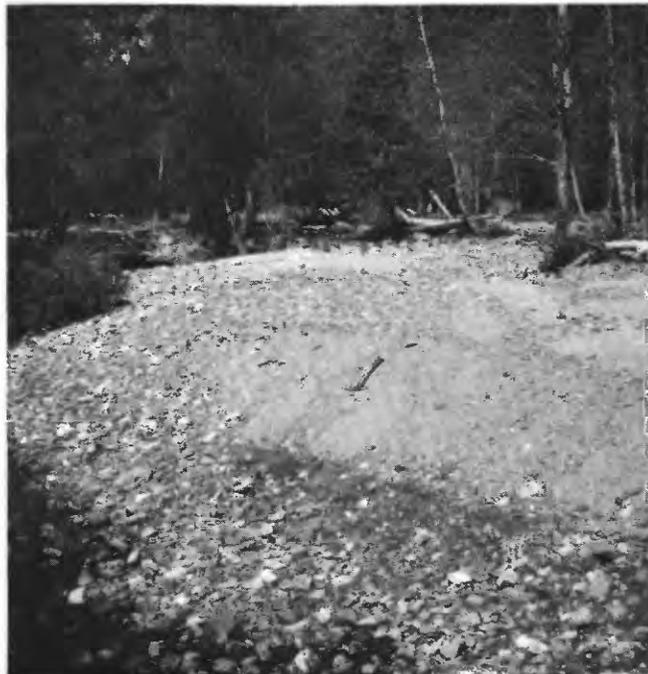
FIGURE 13.—Flat-topped bar formed during flood and composed of sand and fine gravel. View east-northeast from locality 31 near mile 0.3. Dark area in lower left corner is grass-covered pre-flood surface that elsewhere in the area photographed lies 2-3 feet below the new gravel. Scale indicated by pick in center of photograph.

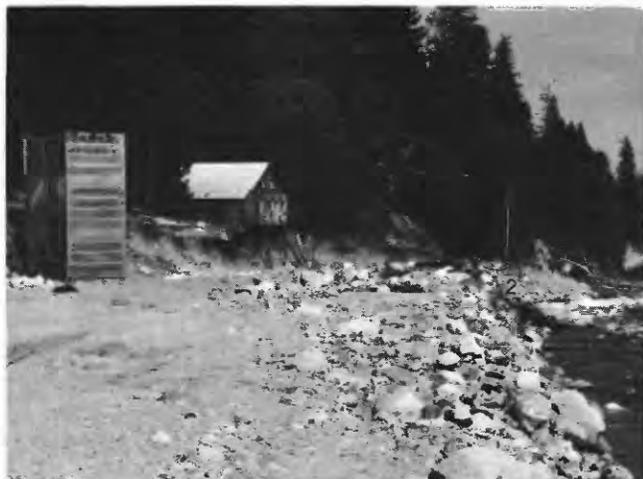
FIGURE 15.—Natural levee at The Cedars (mile 5.0) formed in flood. Large boulders occur at surface of levee, and levee slopes gently to left away from stream channel. View is downstream toward southeast. Detailed photograph (fig. 17) of levee deposit taken at locality 2 (also loc. 2, pl. 1).

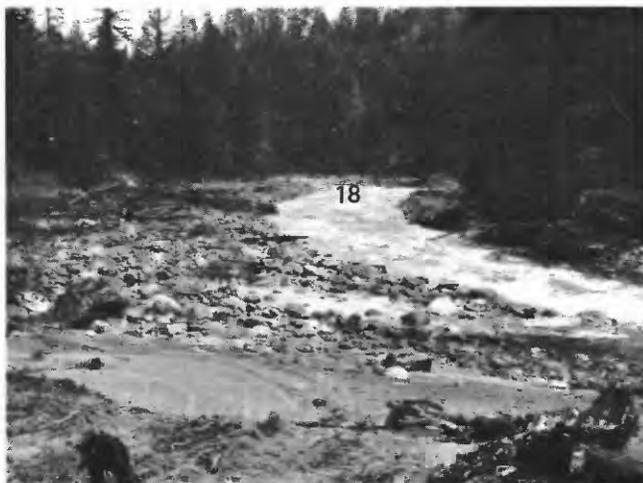
FIGURE 16.—Natural levees formed in the flood, near mile 3.1, looking southeastward. Stream is confined by the levees in this reach. The natural levees slope gently away from the stream. Locality 18 shown on plate 1.

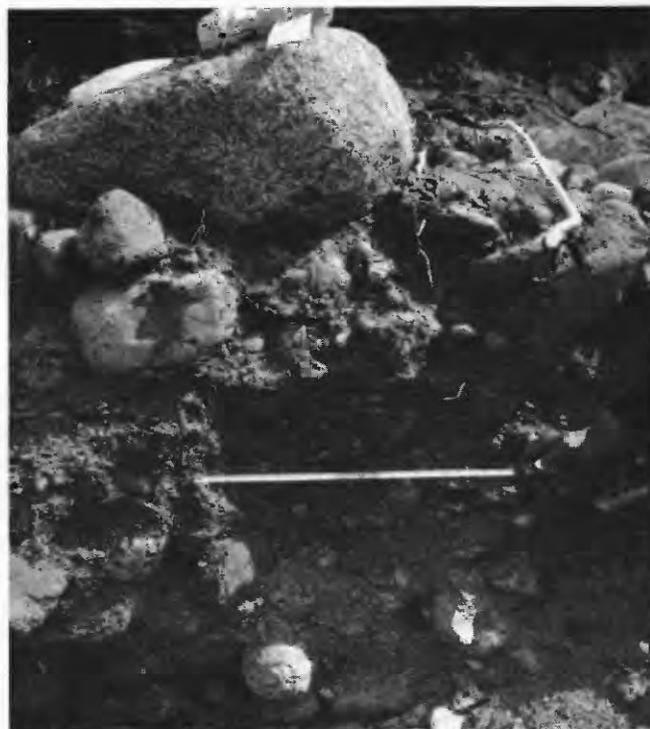
FIGURE 17.—Sandy gravel in natural levee at The Cedars (mile 5.0; loc. 2, pl. 1, fig. 15). Length of scale is 2 feet. Plant debris in deposit was transported during flood.

The natural levees are composed of poorly sorted gravel (sample at loc. 2, fig. 12; fig. 17) and have a fairly high content of sand. The surfaces of the levees, however, are composed mainly of coarse gravel with little, if any, sand. The gravel at the surface appears coarser than that within the deposit, but this difference cannot be conclusively demonstrated. The natural levees on the outside of the bends in the stream are composed
