# Botanical Evidence of Floods and Flood-Plain Deposition

GEOLOGICAL SURVEY PROFESSIONAL PAPER 485-A

By ROBERT S. SIGAFOOS

*A description of botanical methods used to determine  
dates and occurrences of floods and deposition of  
sediment on modern flood plains*

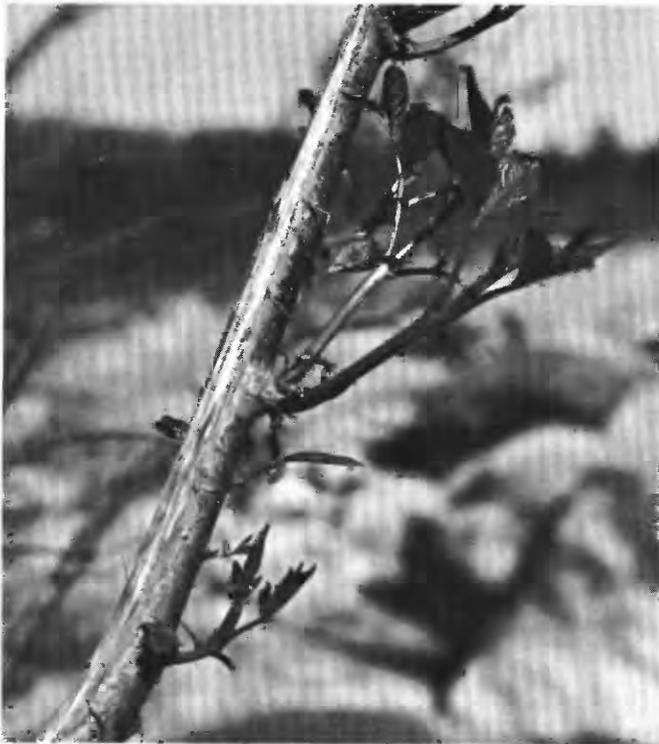
FIGURE 2.—Sprouts that started to grow from ash stem after flood of May 1, 1958, damaged first growth of 1958 growing season. Photograph taken in vicinity of Chain Bridge, Washington, D.C., May 22, 1958.

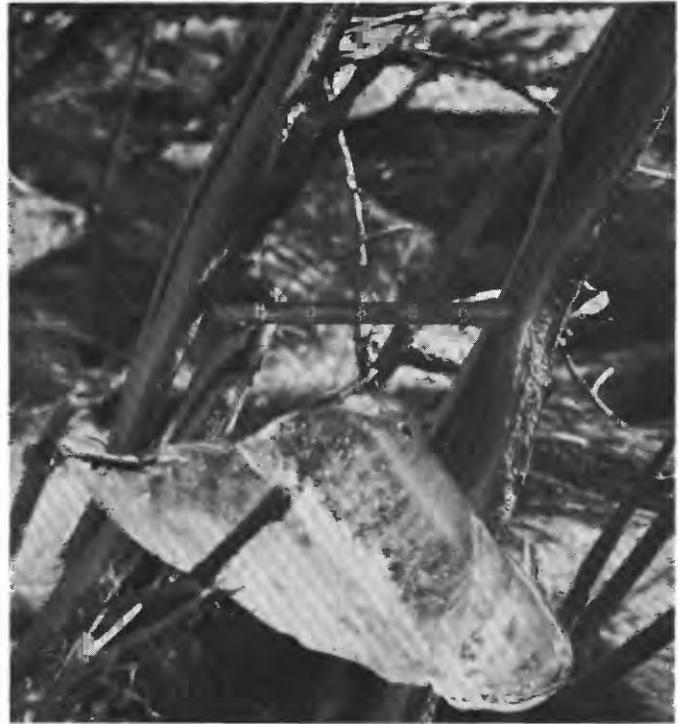
FIGURE 4.—Floating ice overriding flood plain scars trees. Ice fragment lodged in small ash tree that shows light-colored wood exposed by ice abrasion on January 15, 1958.

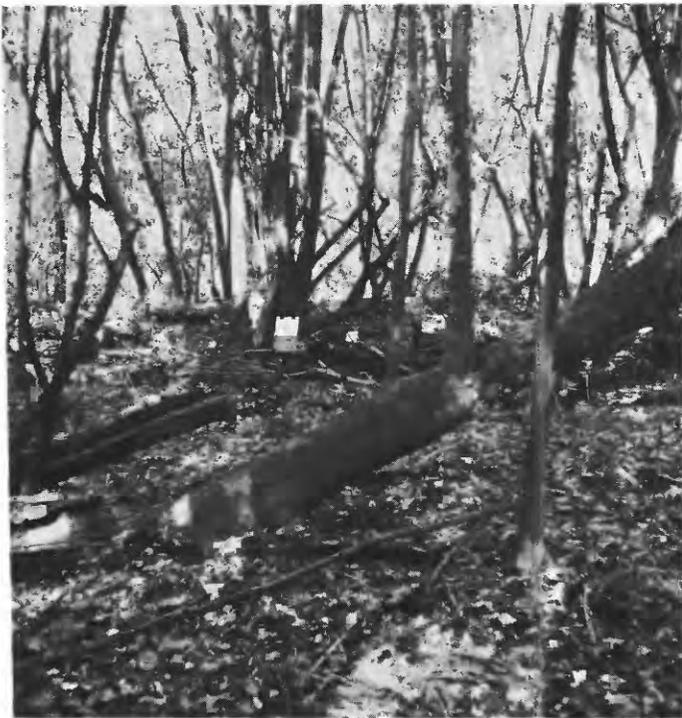
FIGURE 3.—View of flood-plain forest showing poor form and sprout origin of trees.

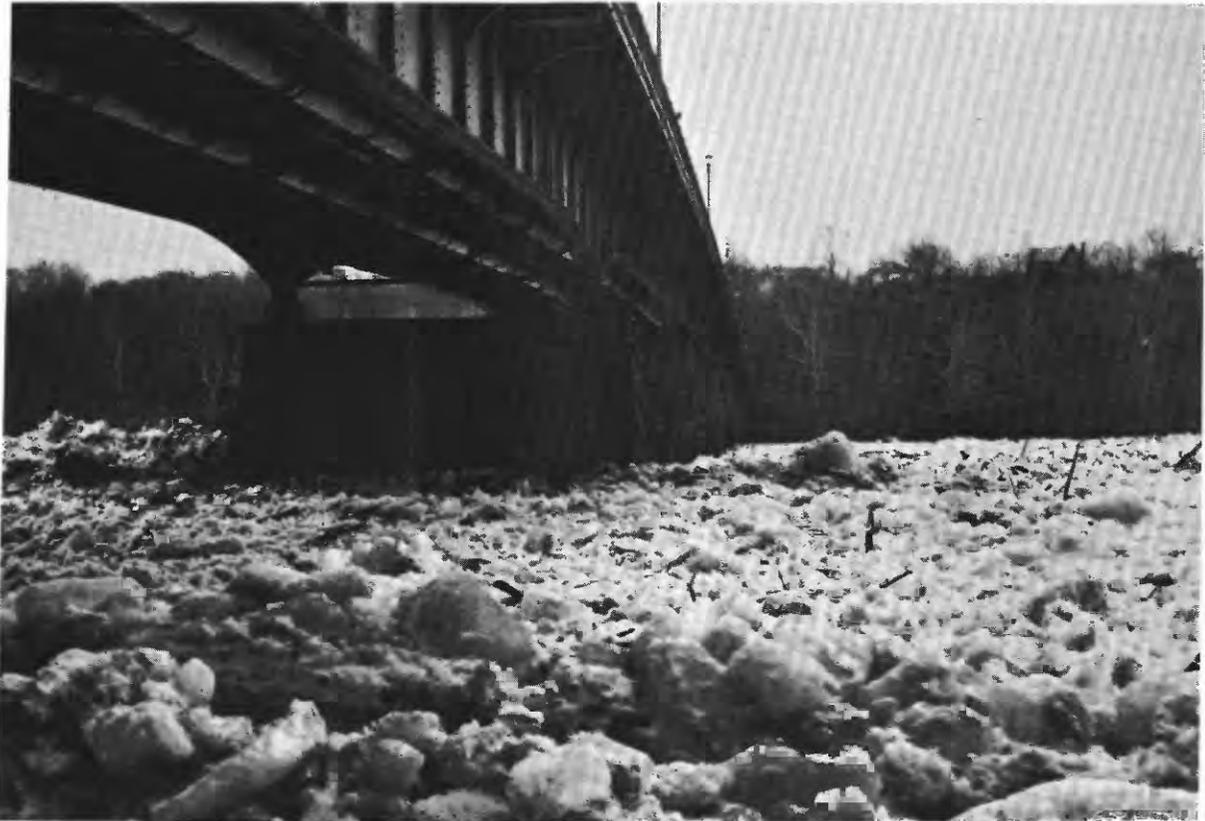
FIGURE 5.—Ice jam on Potomac River at Chain Bridge, Washington, D.C., February 16, 1948. The Washington Post photograph.

Severe floods such as the ones that crested on March 19, 1936, and October 17, 1942, and the ice jam that occurred on February 16, 1948, (figs. 5, 6) inflict great damage to a large number of trees. Most of the trees in the paths of these floods or of the ice jam were bent over or partly uprooted, and the crowns were heavily pruned. As long as 25 years after such an event, the trunks of trees are still bent and inclined in a downstream direction and have scars on the upstream side.

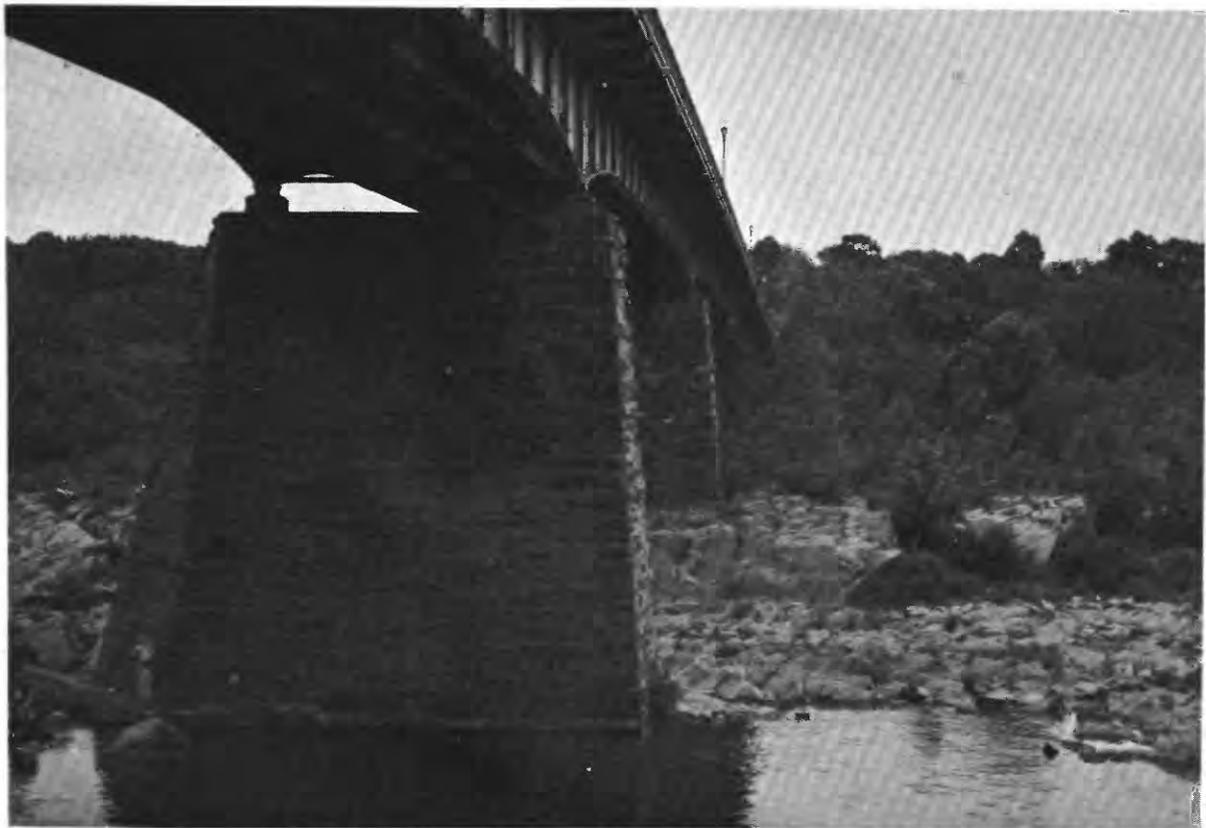
FIGURE 6.—Low flow on Potomac River at Chain Bridge, Washington, D.C., July 1956.

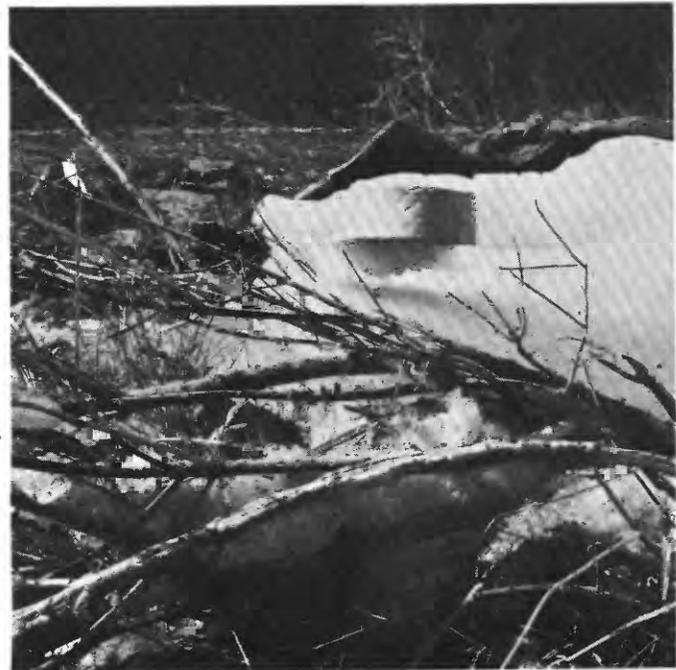
FIGURE 9.—Fragments of ice deposited on flood plain of Potomac River on January 15, 1958, in area where tree in figure 8 was collected. The lightly shaded parts of the stems are bare wood and are on the upstream side of the stems.

1958 (fig. 9). Subsequent observations in this area suggest that some stems of trees similarly damaged in 1958 have died, whereas many others have survived. Indeed, sections of a number of trees collected in late August 1960 show two rings outside a scar that is attributed to the 1958 ice jam.

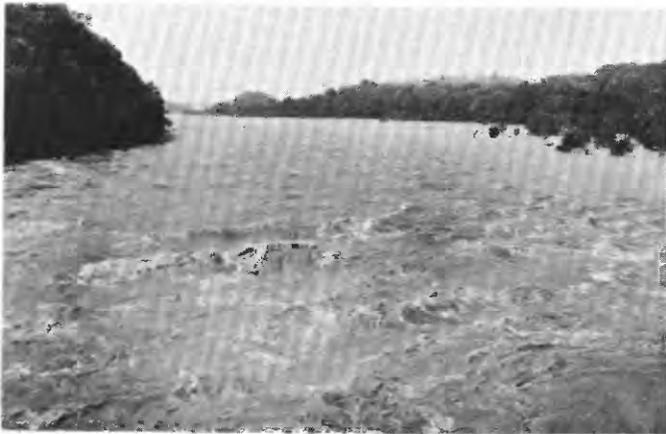
FIGURE 11.—Potomac River on August 20, 1955. View is in upstream direction from Chain Bridge. Flood peak discharge was 216,000 cfs at 2:30 p.m. Maximum depth of the water here above low flow is about 35 feet. Photograph by Abbie Rowe, National Park Service.

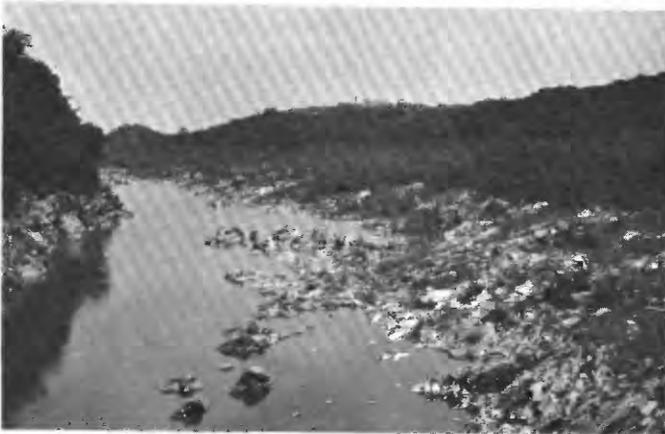
FIGURE 12.—Potomac River, viewed in upstream direction from Chain Bridge, at low flow, June 1956. Two fishermen can be seen standing on a rock to the left of center. This point is just upstream from the large waves in the center of figure 11.

The physical effects upon trees of floods of high magnitude that occur less often than once every 2 years, on the average, and evidence of flood damage have been inferred only from the form of trees growing on surfaces known to have experienced these severe floods (fig. 11, 12). Floods of high magnitude have not occurred since this study began.

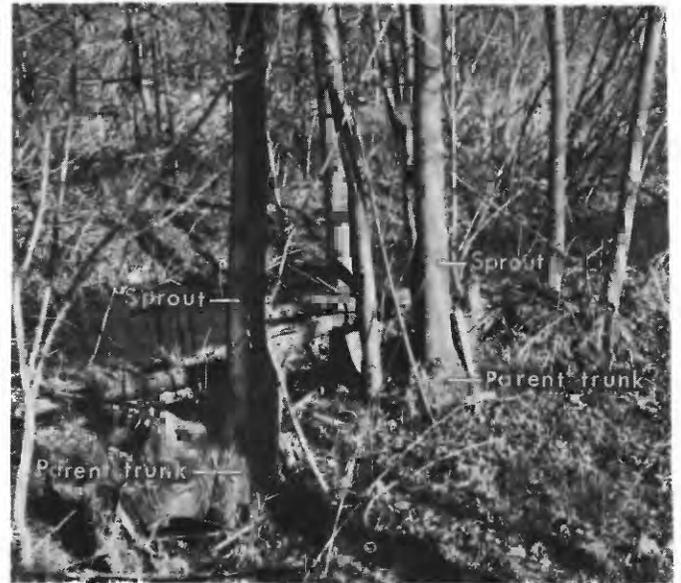
FIGURE 13.—Sprouts from stump cut off by an ice jam on February 16, 1948.

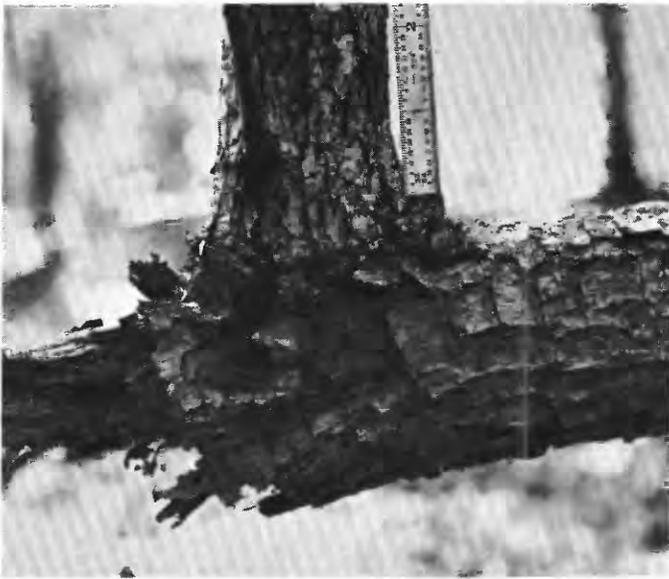
FIGURE 14.—Vertical sprout growing from inclined trunk, showing stub of rotten wood at end of parent trunk that was felled by 1948 ice jam. Difference in texture of bark of sprout and of trunk and line between them are apparent. Downstream is to the left.

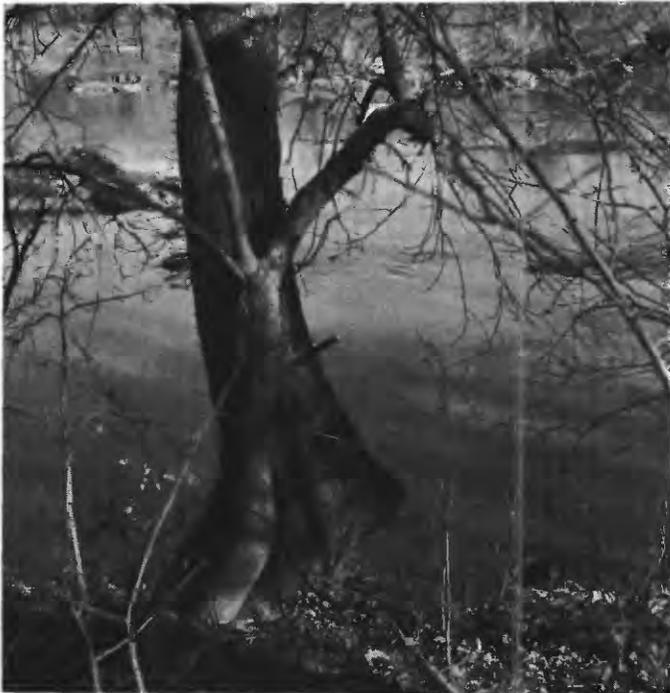
FIGURE 15.—Trunk of tree that has sharp angle near its base suggesting origin as a sprout from the part inclined in a downstream direction to the right. Trunk above angle started to grow in 1861.

The bark of the older inclined trunk is rougher, the scales or plates are larger, and ridges and grooves are deeper than are those of the sprout. The inclined trunk looks more mature than the sprout, and the two invariably have a visible line of demarcation between them. The L-shaped form and differences in texture of the bark persist for a long period of time (fig. 15).

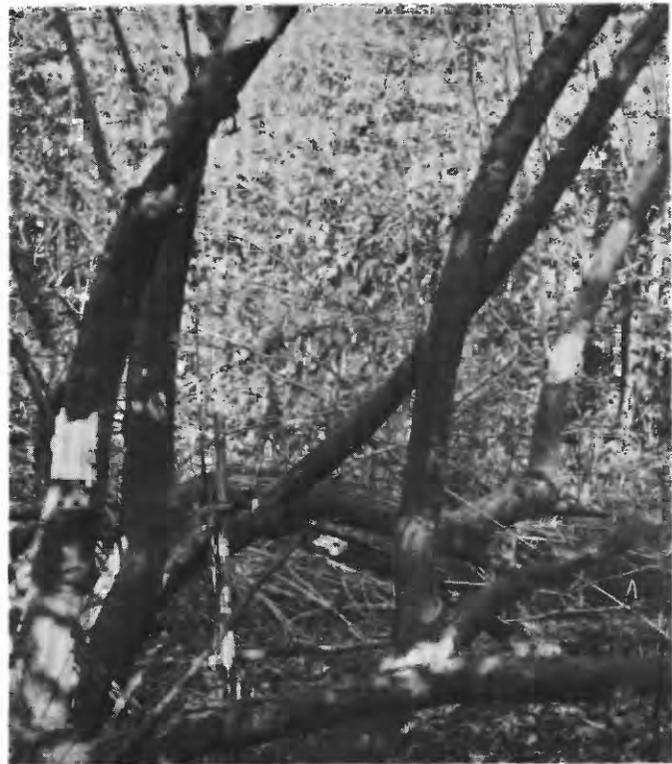
FIGURE 16.—Ash sprouts of four ages growing from a stump, to the left out of the photograph, on the Potomac River flood plain near Chain Bridge. The smallest sprouts, in upper half of photograph, are nearly vertical and started to grow in 1956. Second-age sprouts, shown forming a gentle arc and inclined to the right at about 70° from the horizontal, started to grow in 1948. The third-age sprout, the short segment in lower third of photograph, is inclined to the right at about 25° from the horizontal and is growing from a convex split trunk; this sprout started to grow in 1943. The oldest sprouts are a pair that started to grow in 1930.

Damage from several floods can be seen in the sequential composition of occasional trees: sprouts arising from older, inclined sprouts which in turn arise from the inclined parent trunk (fig. 16). The history of the ash tree illustrated in figure 16 is shown

Evidence that the 1929 floods damaged this tree is somewhat questionable; however, the evidence of subsequent floods is more reasonable. The sprouts that started to grow in 1930 were, by the autumn of 1942, small trees having trunks about 5 inches in diameter. On October 17, 1942, the second highest flood of record crested and bent the tree in a downstream direction.

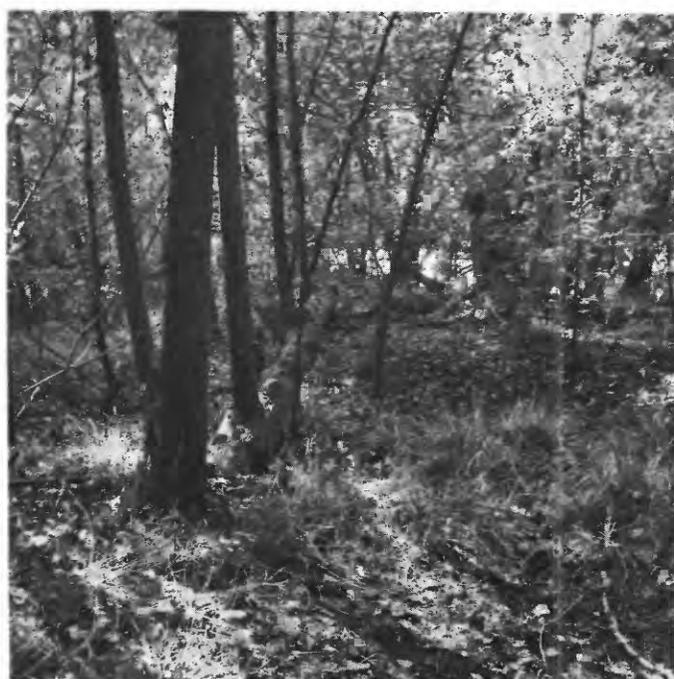
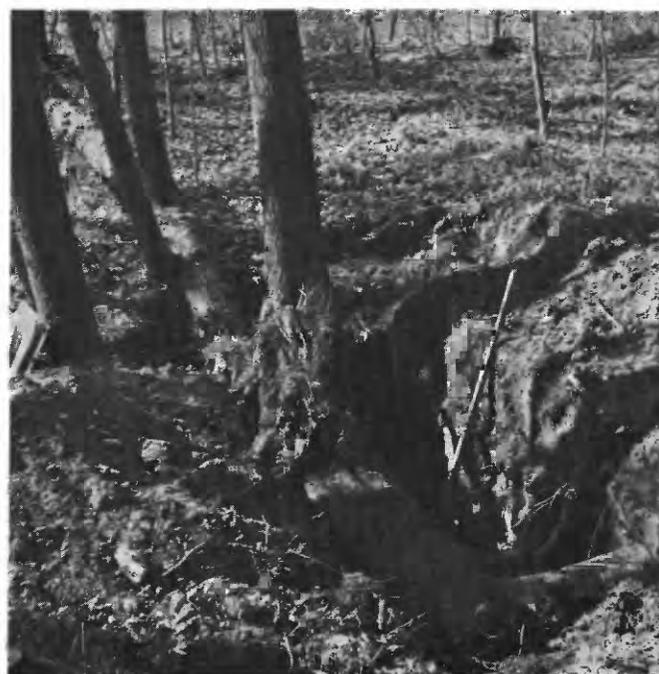
FIGURE 18.—Diagram showing forms of tree bases postulated as result of different rates of deposition. *A*, Flared base suggests recent and heavy deposition; *B*, inverted cone-shaped base suggests early and repeated deposition.

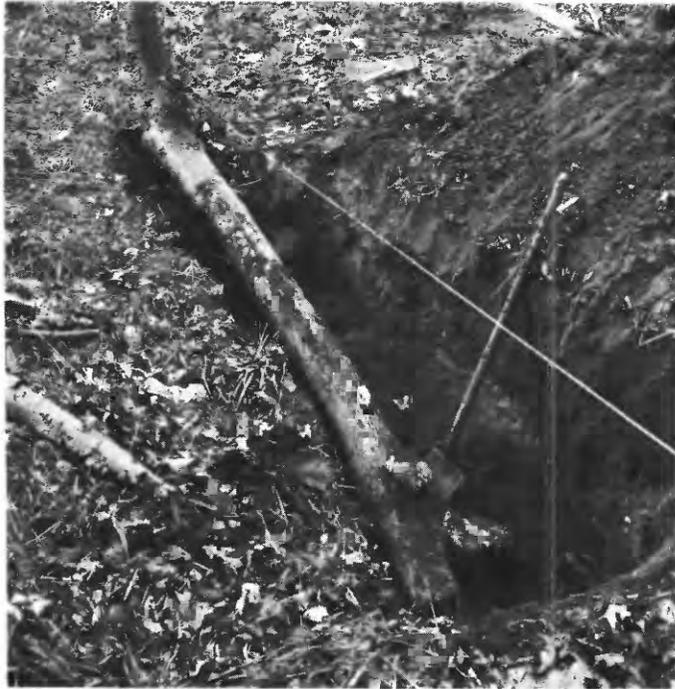
FIGURE 20.—Ash tree, showing inclined buried trunk and nearly vertical sprout. Buried dead basal sprout is barely visible to the left of the shovel. White line is horizontal, and shovel is 4½ feet long.

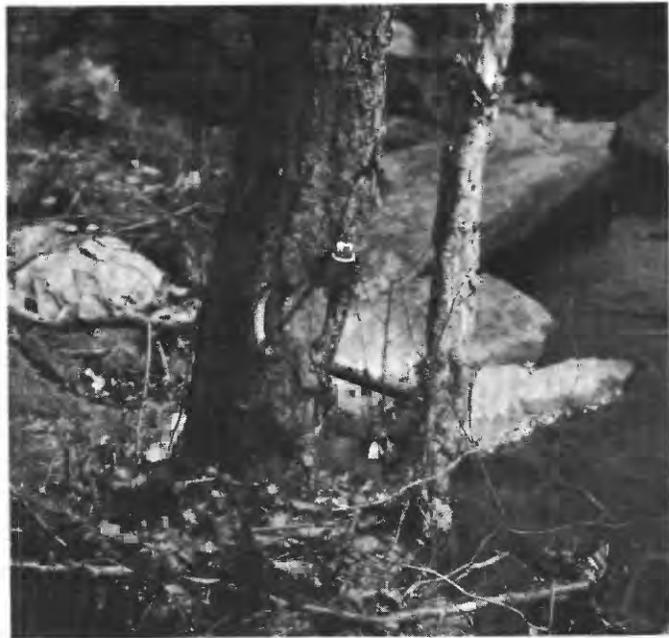
FIGURE 24.—Scar on channel side of river birch on Difficult Run, Va. Scar was formed before 1959 growing season and abraded again before the 1961 growing season.

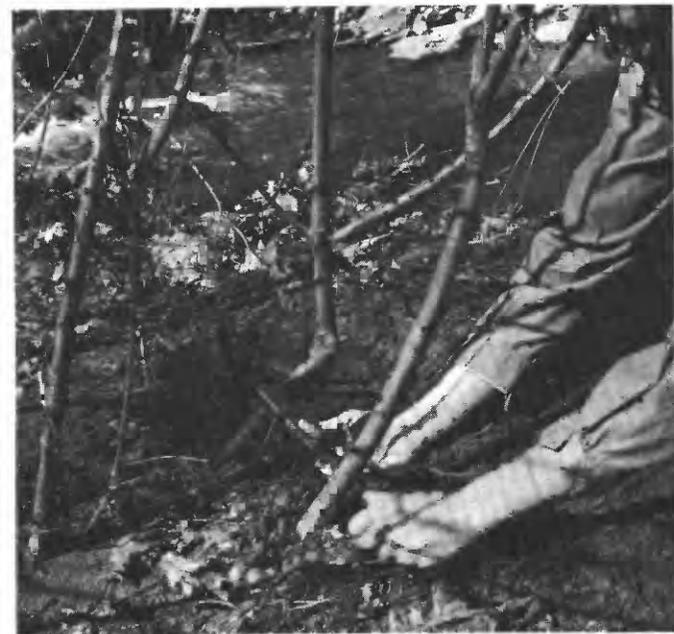
FIGURE 25.—Alder sprout growing from parent stem knocked over in 1956 along Scott Run, Va. Intense cloudburst flood occurred in the area on July 21. Parent stem was subsequently buried.

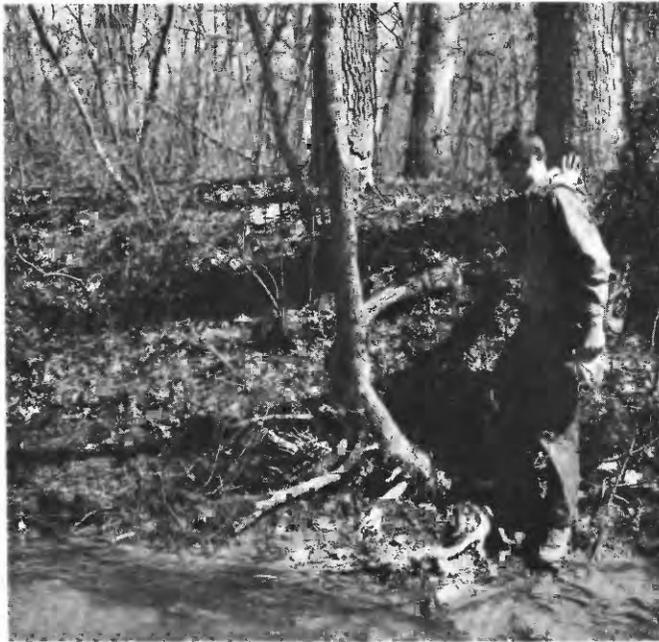
FIGURE 26.—Ash sprout growing from inclined trunk that was knocked over by flood prior to 1928 growing season along Scott Run, Va.

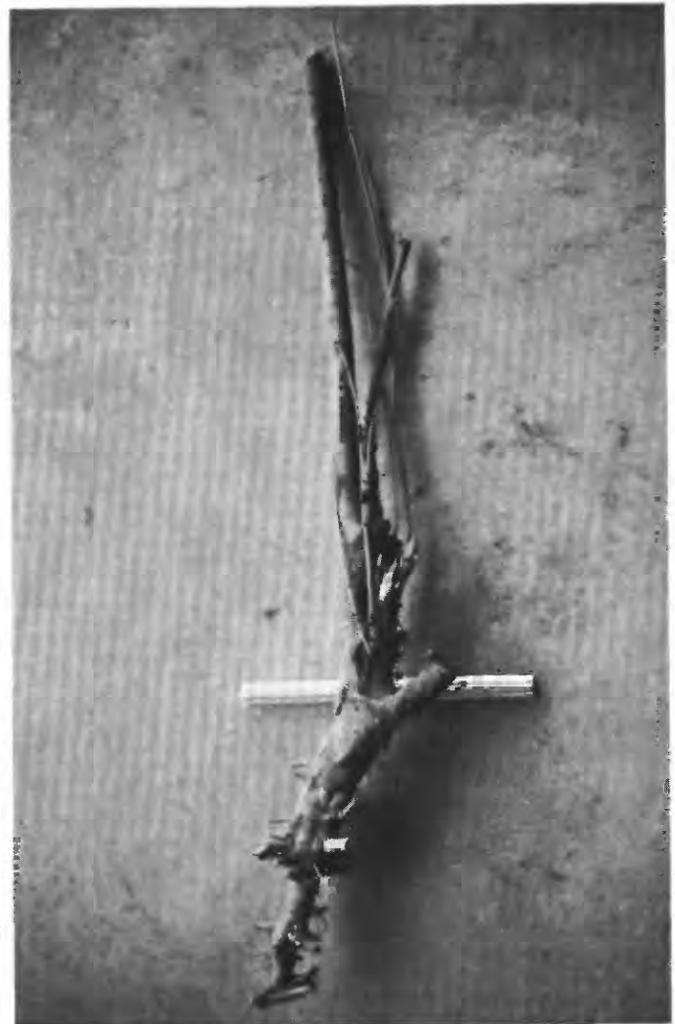
FIGURE 27.—Ash tree collected from flood plain of Tripps Run, Fairfax County, Va., showing the form of trees damaged by floods. Scale is 1 foot long and at 1962 ground level.

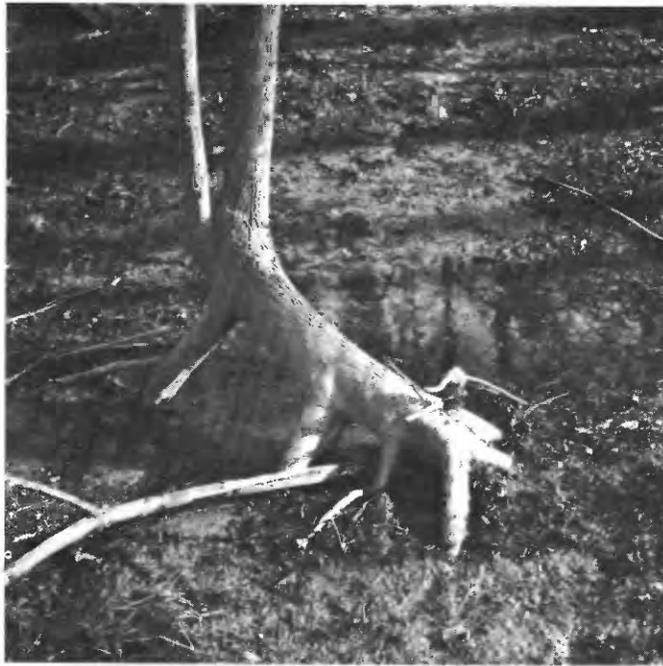
FIGURE 29.—Ash tree, on flood plain, that was knocked over by one flood, partly buried by another, and exposed by a third.

The analysis of the form and the wood structure in the trunk of another tree (fig. 29) is presented as another example of the reconstruction of at least a general history of floods and sedimentation. This tree also grows on the Potomac River flood plain, about 2 miles downstream from Great Falls. The inclined trunk and vertical sprouts show that the tree was knocked over. The roots growing from the fallen trunk show also that the trunk was buried; a small basal sprout, however, attests that the tree was buried during a flood later than the one that felled the tree. Subsequent erosion is confirmed by the exposed roots. The tree was knocked over after the 1942 growing season, probably during the flood of October 17, which was the second highest flood of record. The year of burial cannot be determined from the cores that were taken because some rings cannot be identified; however,

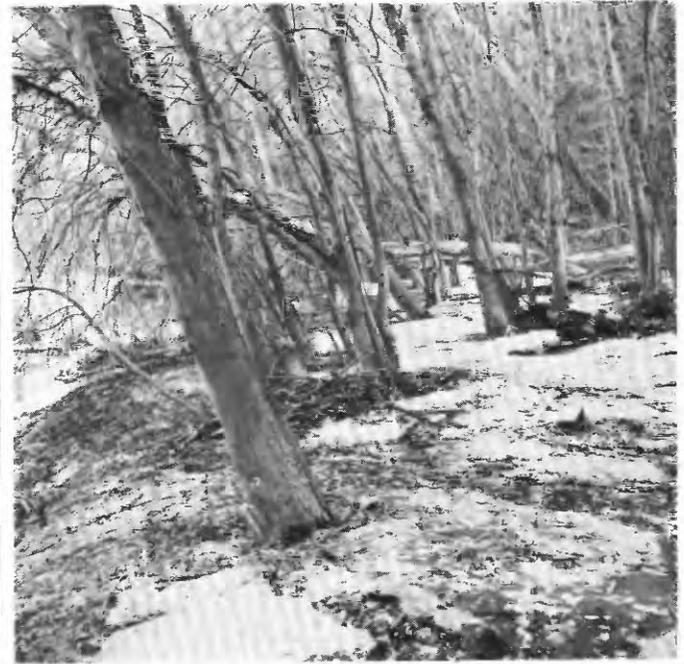
FIGURE 30.—Mature silver maple trees on low bank that was flooded at least 60 times between 1931 and 1960. Flow at time of photograph, February 18, 1963, was about 5,000 cfs. Average annual discharge is 11,000 cfs. The 2-year flood is about 10 feet deep at this section.

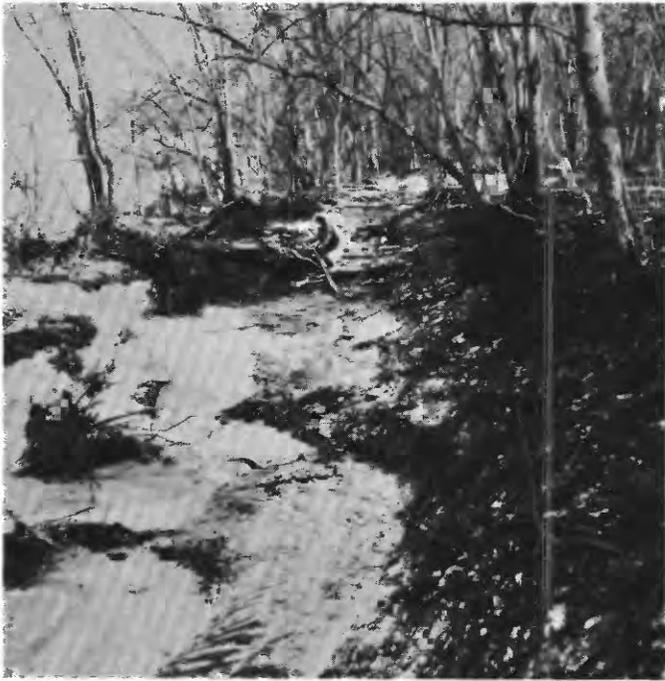
FIGURE 32.—Cut bank of Potomac River showing newly exposed roots and recently fallen trees. Two-year flood just reaches top of the bank. Area is almost 200 yards upstream from area in figure 30.
