# MAINE COASTAL STORM AND FLOOD OF FEBRUARY 2, 1976

GEOLOGICAL SURVEY PROFESSIONAL PAPER 1087

By R. A. MORRILL, U.S. Geological Survey, and E. H. CHIN and W. S. RICHARDSON,  
National Weather Service, National Oceanic and Atmospheric Administration

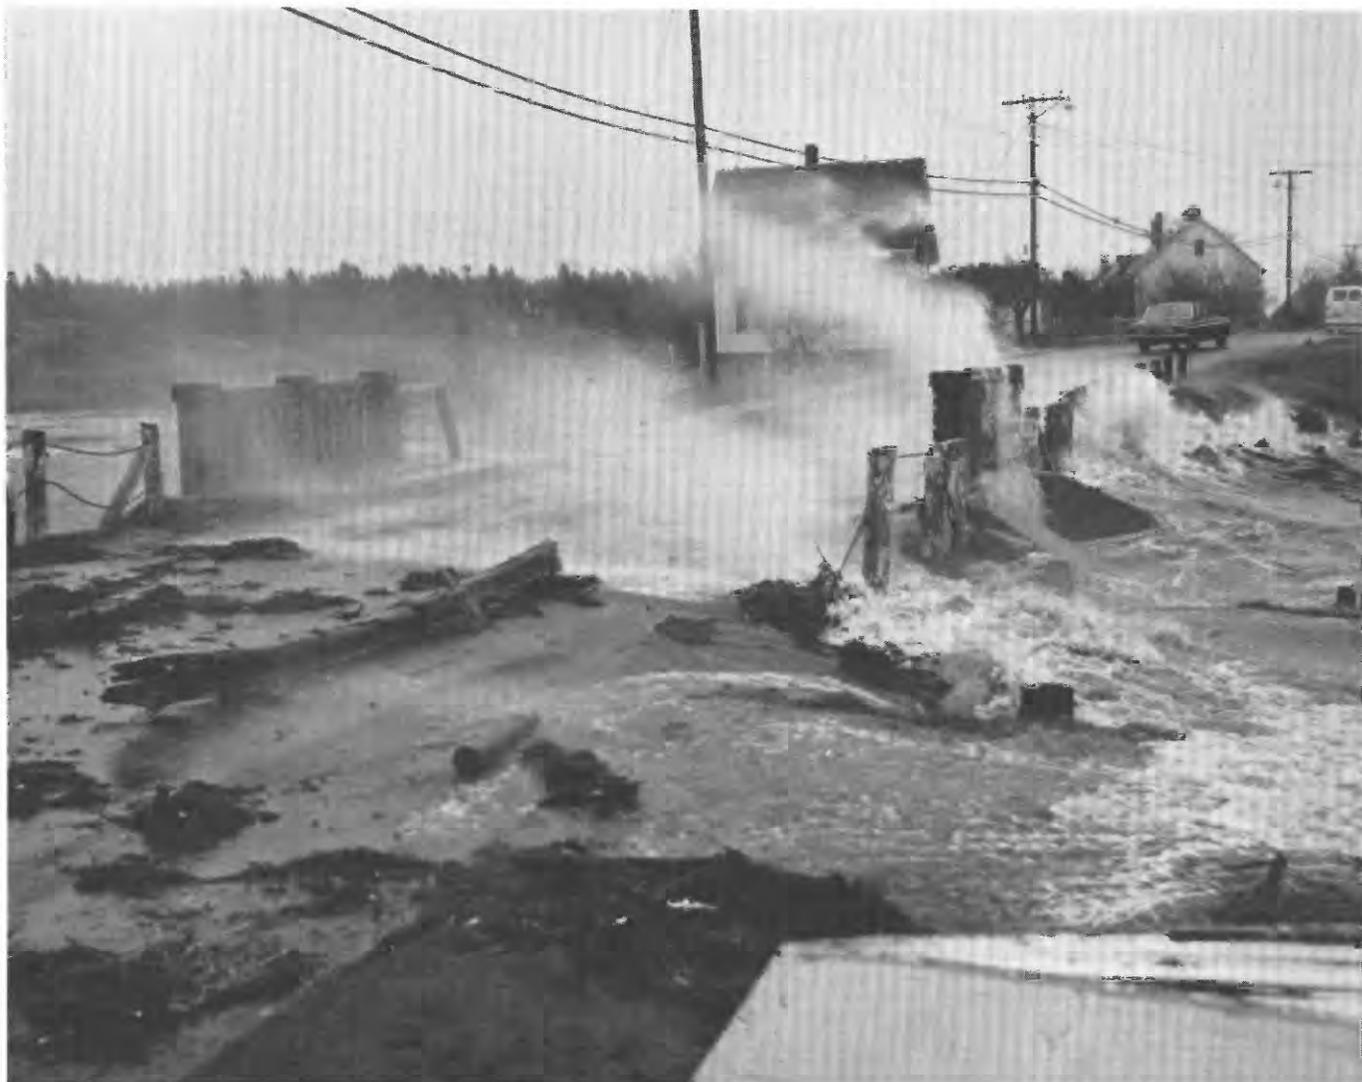
FIGURE 6.—The storm downeast, West Jonesport, Maine. This photograph (Bangor Daily News, 1976) is typical of the effects of the wind and wave action associated with the storm. This location is in Washington County where a small stream normally flowing from left to right empties into a tidal estuary. Photograph courtesy Bangor Daily News.

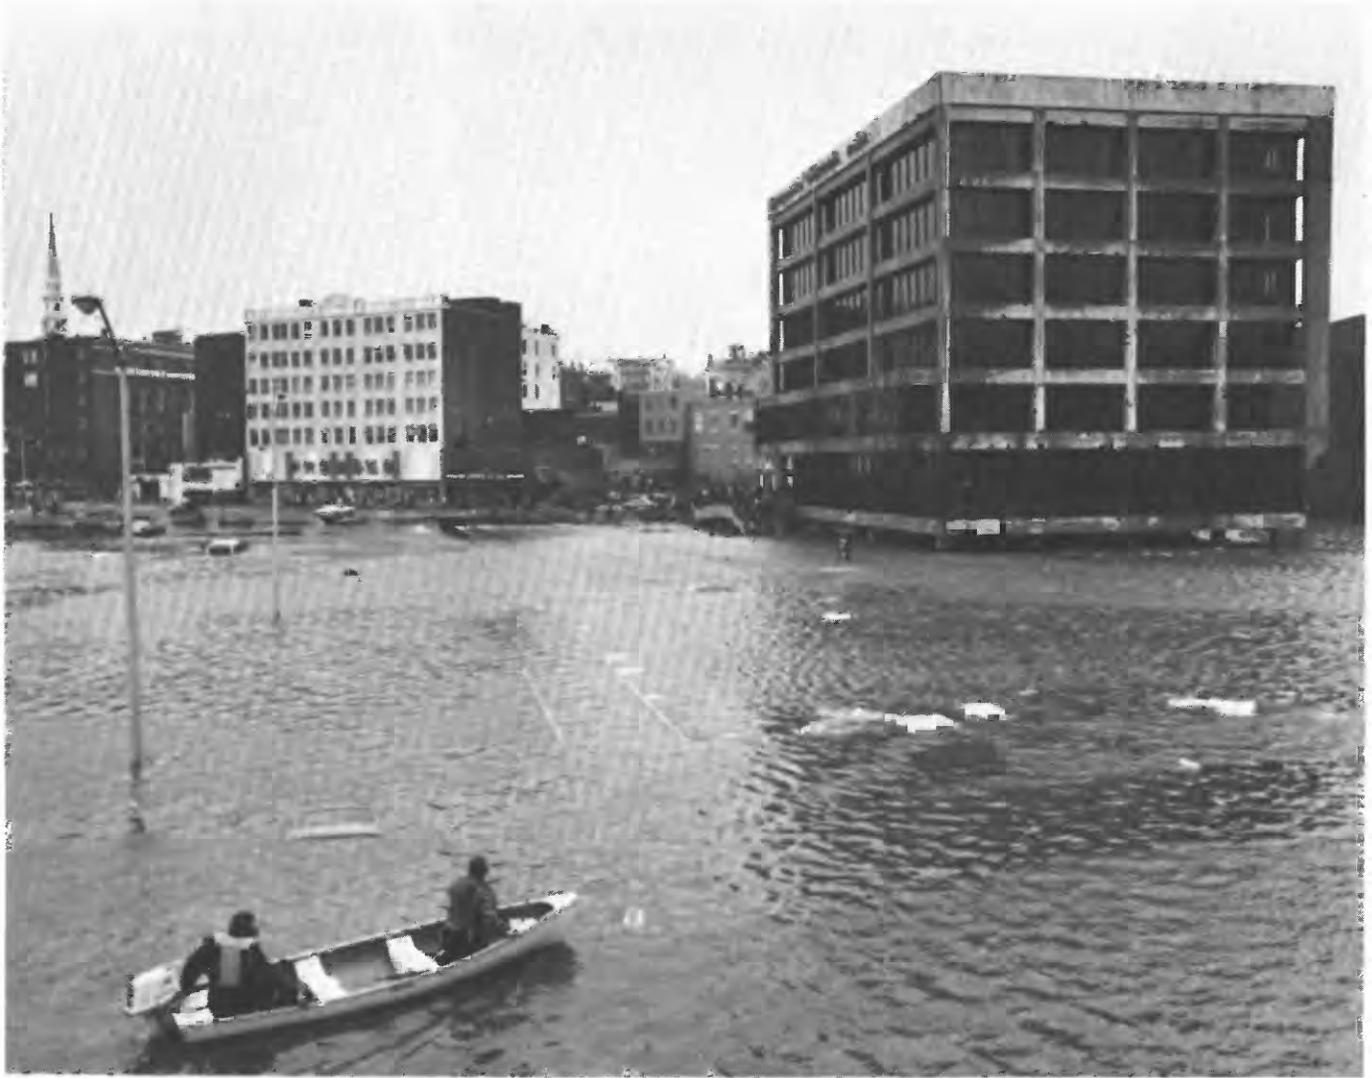
FIGURE 8.—Floodwaters at highest point, Kenduskeag Plaza, Bangor, Maine. This photograph (Bangor Daily News, 1976) shows the depth and area of the downtown flood. The normal channel of the Kenduskeag is between the two light posts on the left, and footbridge guardrails are shown inundated near the center of the photograph. The normal flow is from right to left. Photograph courtesy of Bangor Daily News.

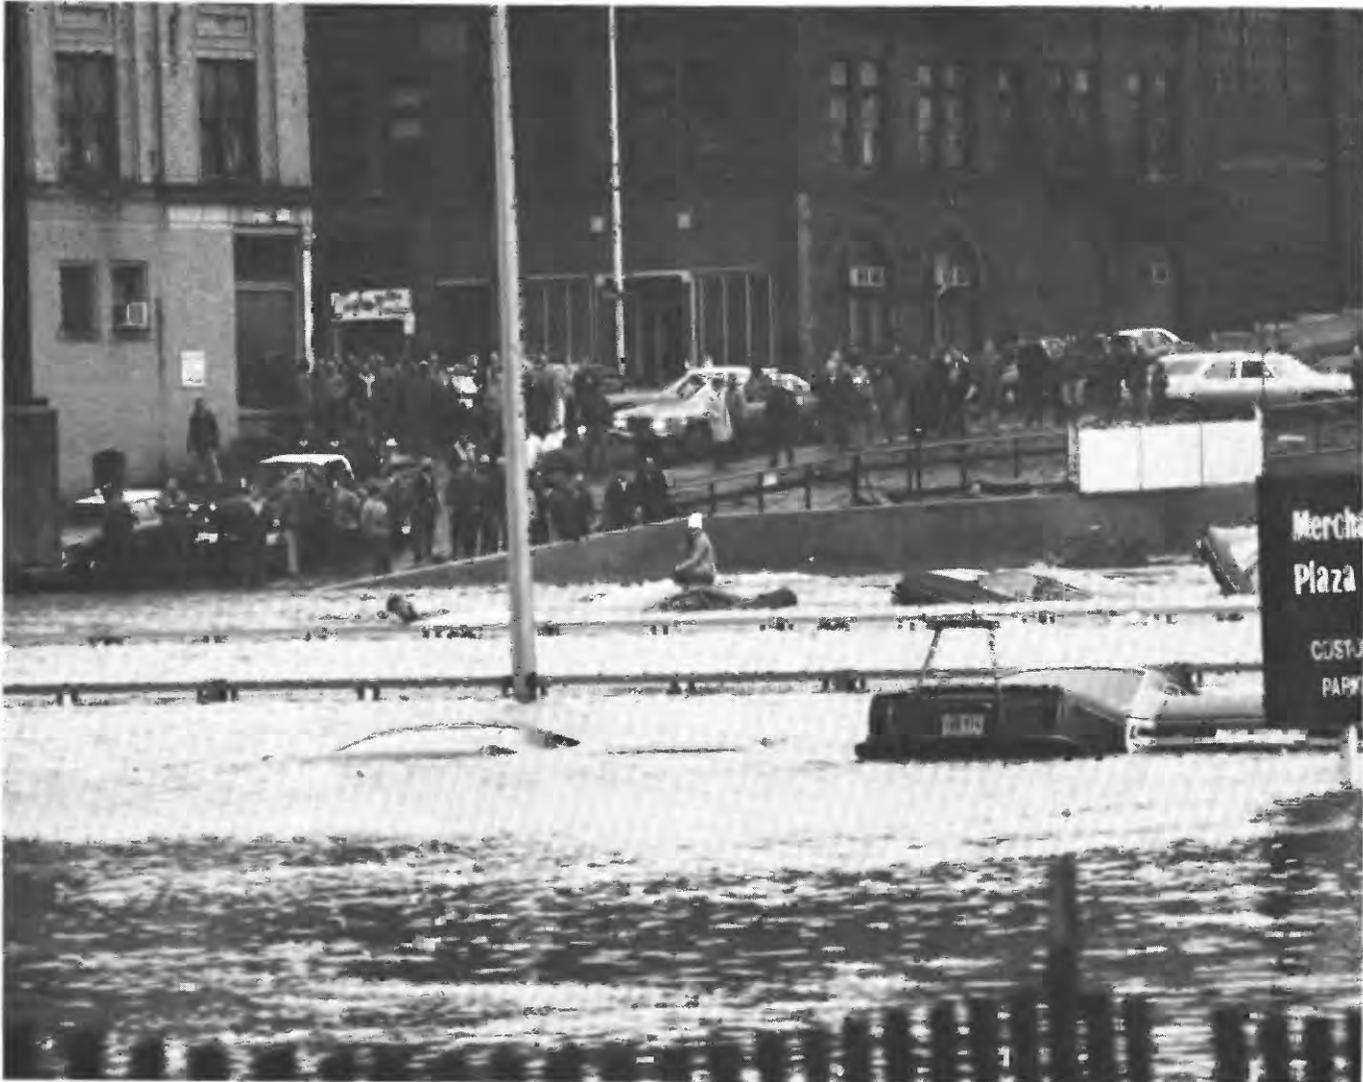
FIGURE 9.—Strong currents hampering rescue attempts, Kenduskeag Plaza, Bangor, Maine (Bangor Daily News, 1976). In the center of this photograph, a young woman stranded in her car is being rescued. At this location Kenduskeag Stream is channelized between parking areas on both banks. The stream normally flows between the guardrails in a left-to-right direction. Photograph courtesy of Bangor Daily News.

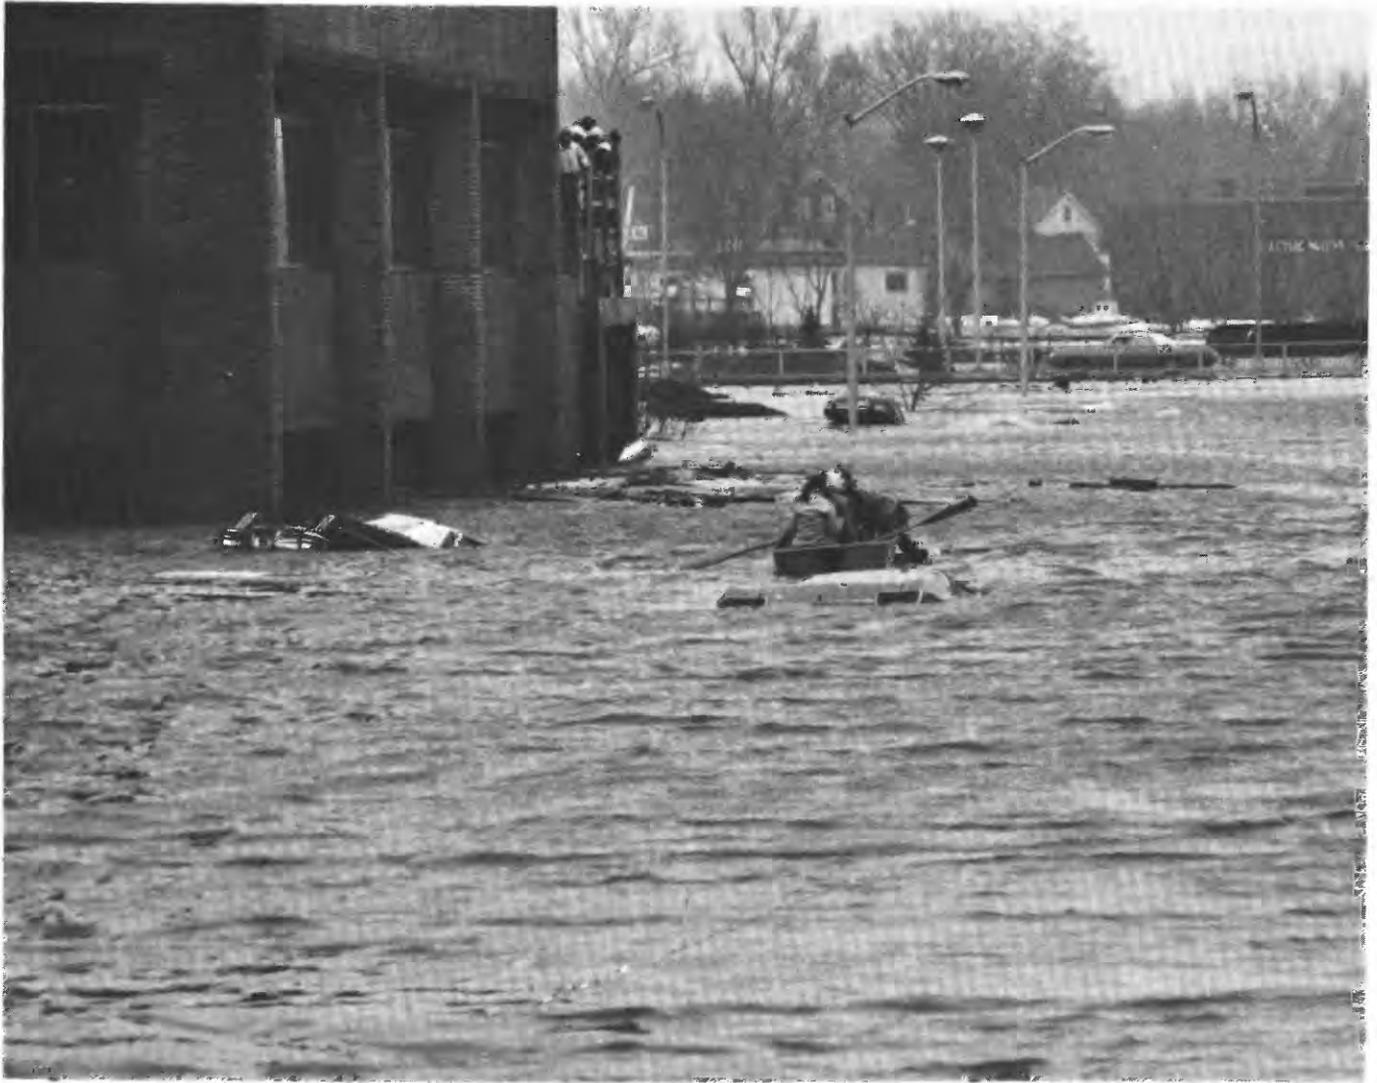
FIGURE 10.—Motorist rescued by boat from strong flood currents, Kenduskeag Plaza, Bangor, Maine. This photograph (Bangor Daily News, 1976) shows the flooding of the parking area near the Merrill Trust Company building. The normal stream channel is in the foreground with flow from left to right. Photograph courtesy of Bangor Daily News.
