Mass Movement in Two Selected Areas of Western Washington County, Pennsylvania

GEOLOGICAL SURVEY PROFESSIONAL PAPER 1170-B

*Landsliding and its relation to geology and an
analysis of various interpretive elements
in a region of the Allegheny Plateau
subject to landslides*

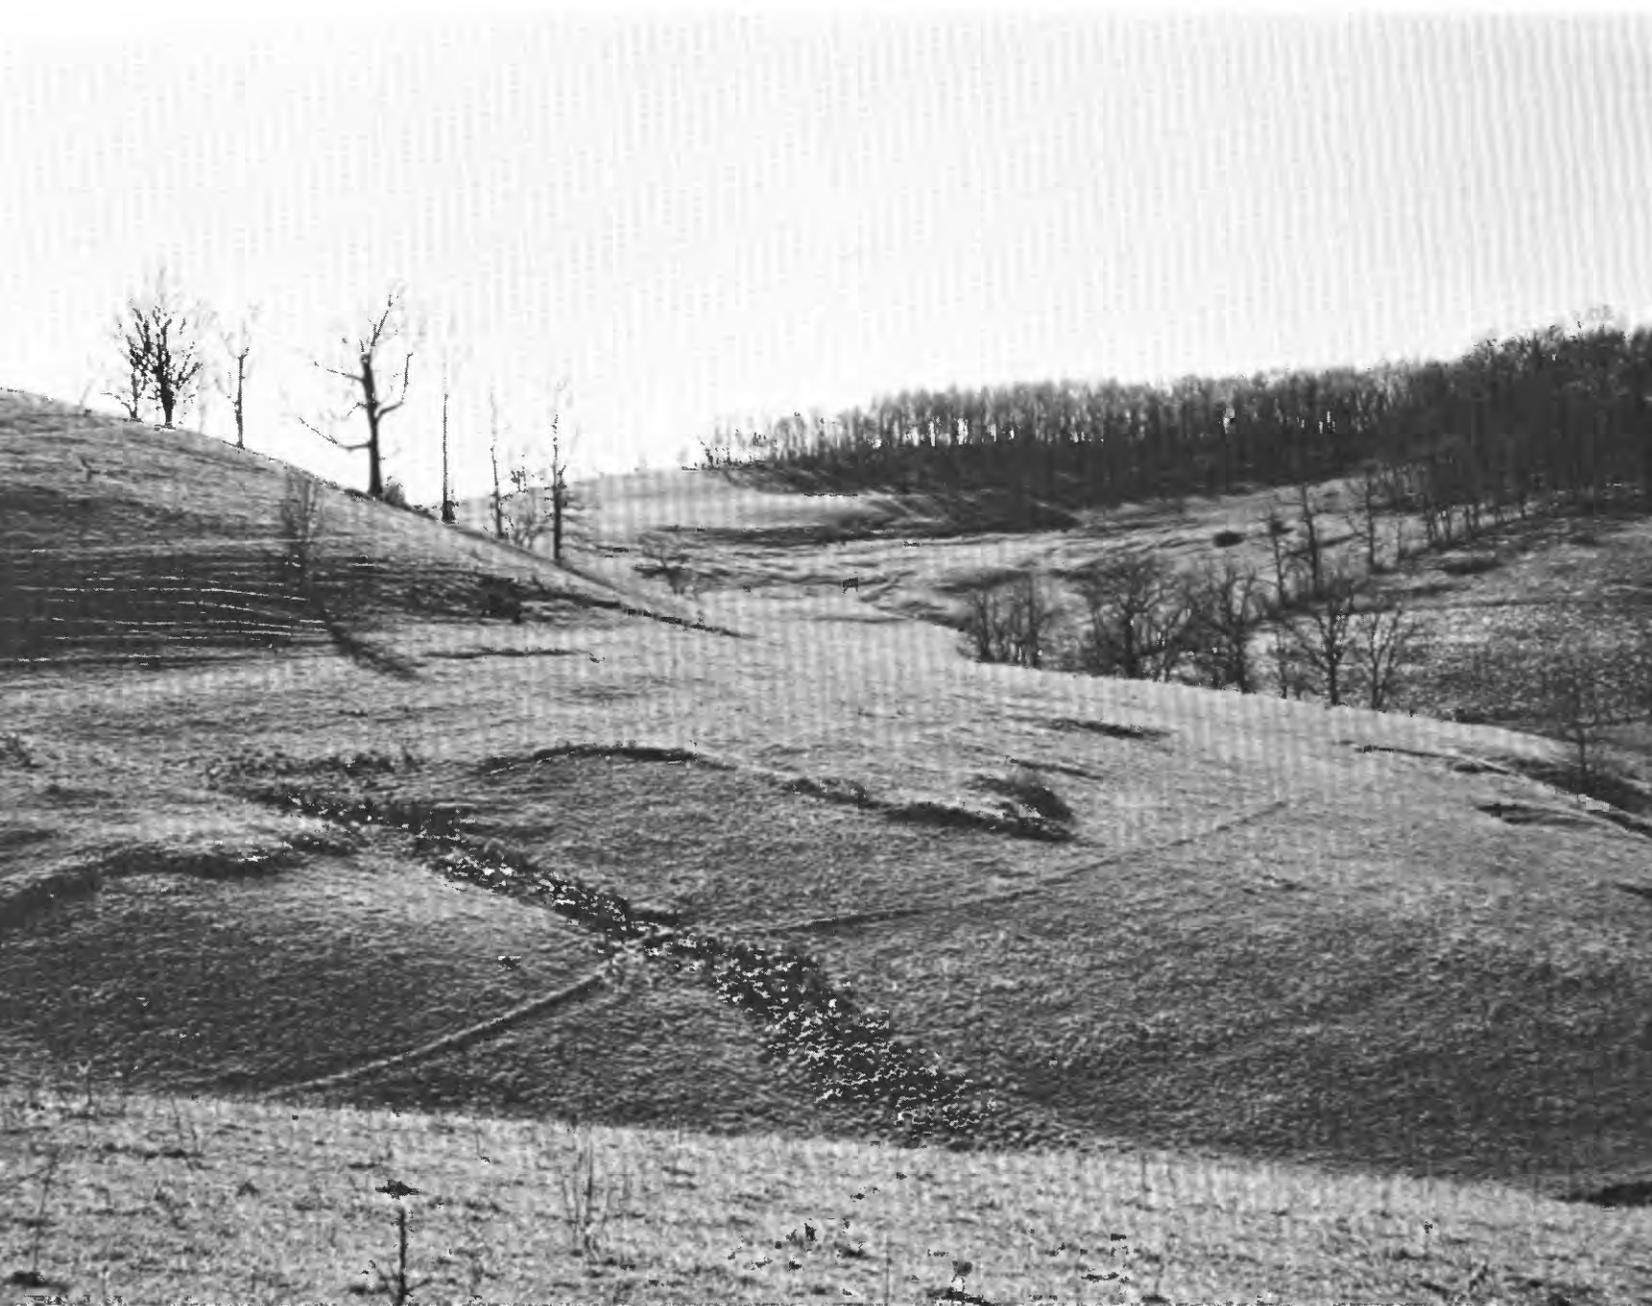
Recent earthflows along concave-convex east- to north-facing slopes west of Prosperity, Pa.

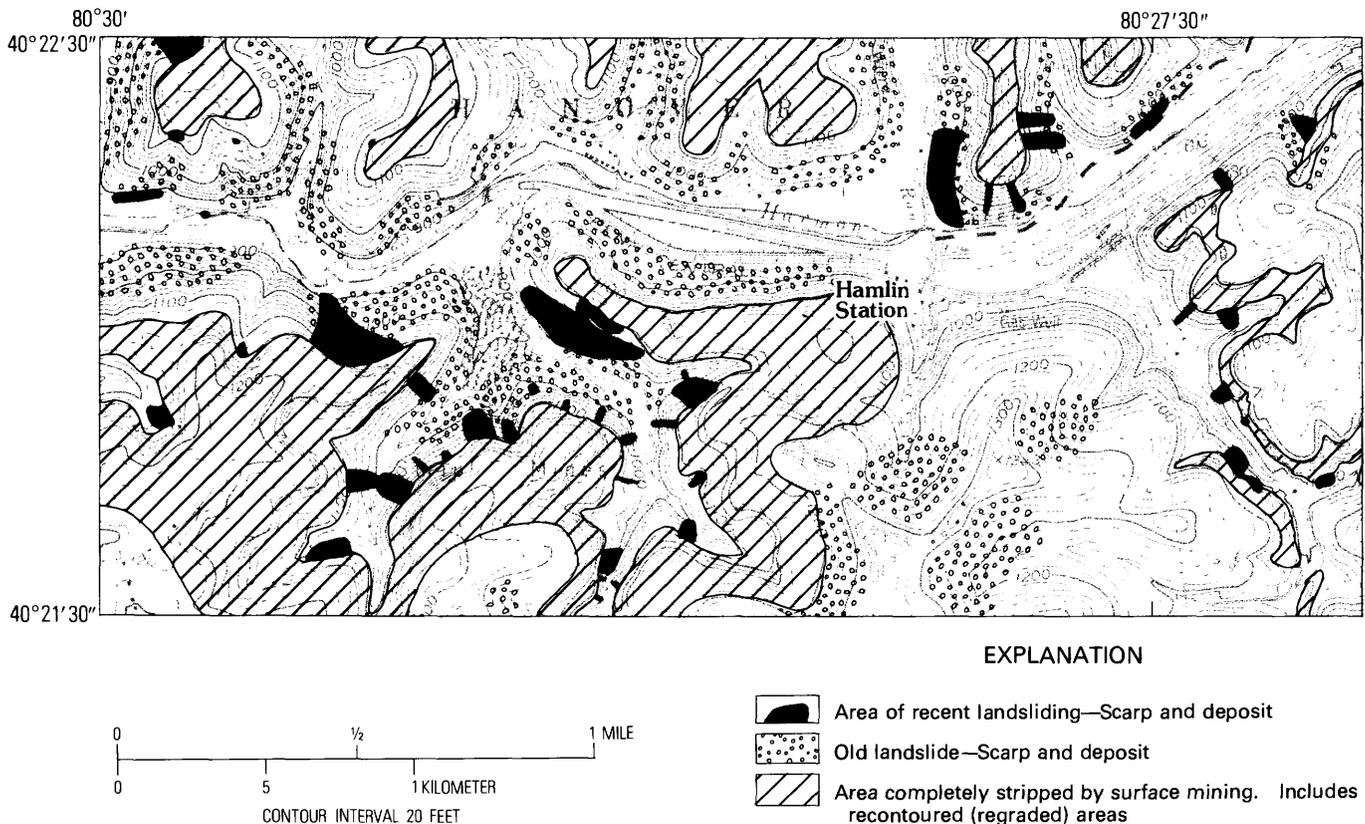
FIGURE 2.—Landslide map of that part of the Harmon Creek area in the Avella 7½-minute Quadrangle, Washington County, Pa.

Figures 2 and 9 show recent and old landslides. In addition to currently active slides, the term "recent" includes those slides that are believed to have been active within the past century. Recent landslides may be shown as discrete individual bodies, but, in some places, a large number of closely spaced (and overlapping) slides are mapped as one unit.

The Conemaugh Group is poorly exposed along Harmon Creek and its tributaries. Rocks of the Conemaugh Group include poorly bedded variegated gray, tan, green, to maroon mudstone interlayered with claystone, shale, siltstone, sandstone, and minor limestone. The red mudstone units, commonly containing claystone interbeds, are of varying thickness and highly susceptible to landsliding where weathered. Red mudstones correlative with the "Pittsburgh red beds" of the Glenshaw Formation (Pomeroy and Davies, 1975; Pomeroy, 1977a) underlie the lowest slopes of Harmon Creek and its tributaries in the western part of the area shown in figure 2. Red mudstones identifiable in stratigraphic position with the "Clarksburg red beds" of the Casselman Formation (Pomeroy and Davies, 1975; Pomeroy, 1977a) occupy slopes in the central and eastern parts of the area shown in figure 2.

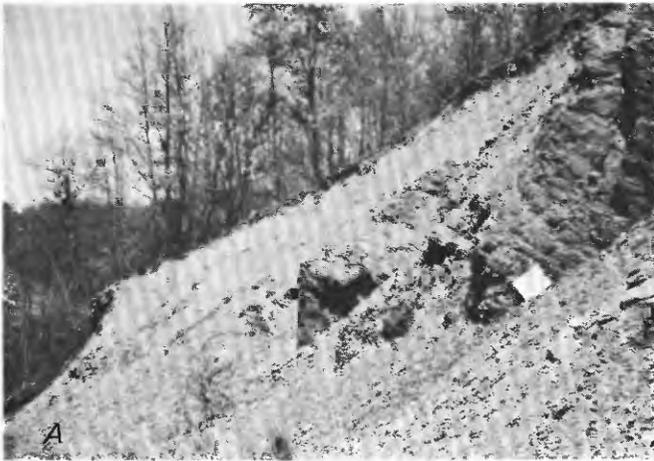
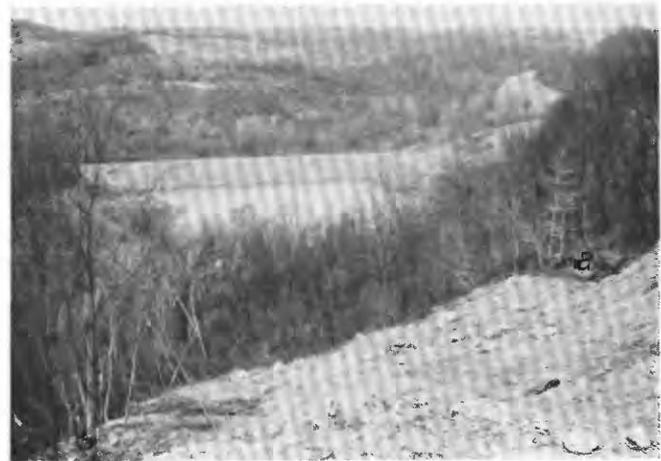
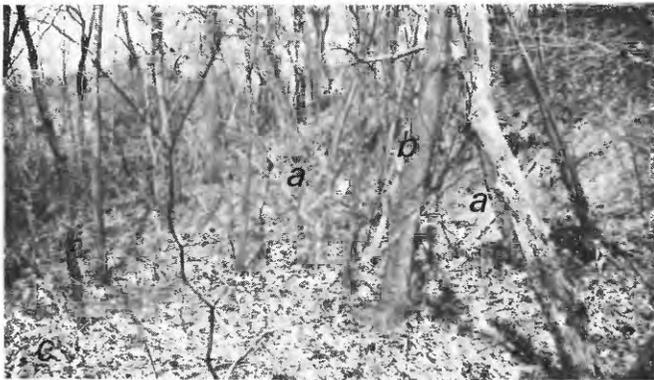
FIGURE 3—A, Old landslide remnant of slumped bedrock. B, Old slump bench adjacent to spoil flow; note flattening of slope (a). C, Reactivated part of old slump bench; note head scarp (a) and tilting of trees (b) produced by slumping.

Bedding of outcrops on some slopes (fig. 3A) is tilted back toward the slope at an angle much steeper than the regional subhorizontal dip. Local exposures that have steeply dipping beds are interpreted to be ancient rotational slump blocks. Other indicators of ancient landslides include hummocky ground surfaces and less obvious narrow terraced areas or benches along hillsides (fig. 3B). These geomorphic features represent colluvial materials from previous sliding episodes that are occasionally subject to reactivation (fig. 3C); some are not

apparent on the topographic map. Benched areas in forested land may be only a few meters wide (fig. 3B) and are commonly discontinuous. Thus, some cannot be identified on the aerial photographs.

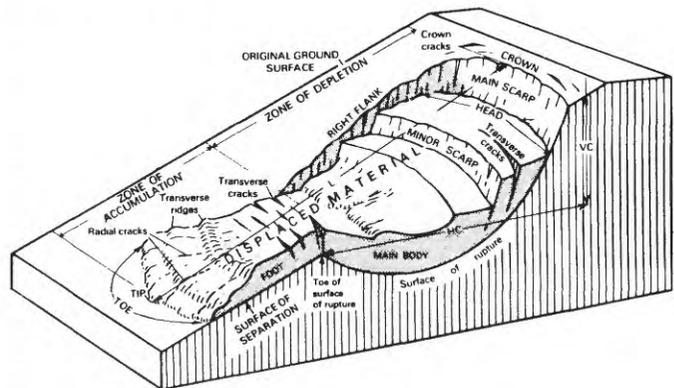
FIGURE 4.—Block diagram of slump-earthflow (from Varnes, 1978). HC, horizontal component; VC, vertical component; L, length. Note: A simple earthflow does not show slumping.

Small (less than 15 m wide) modern-day landslides, mostly slump-earthflows (fig. 4) take place in soils derived from red mudstone and claystone along slopes bordering Harmon Creek. These landslides combine the process of sliding and flow. The upper part slides downward by rotational slip (slump); the lower part moves as a viscous flow (earthflow). In the past, most slides were probably due to natural causes (precipitation and stream-bank undercutting) before the area was strip mined. Since the strip mining, most slides have originated as spoil-bank failures, slumps along hastily constructed access roads, and regraded spoil-bank areas (fig. 5) adjacent to steep slopes.

Earthflows and slump-earthflows (fig. 4), the dominant landslide types in the area (fig. 10), consist of soil and weathered rock that are rarely more than 3 m thick. Evidence of slumping is common in the head area. Earthflows are crescent-shaped, rectangular, or oval bodies often found along sloping pasture land and less often in forested areas. Earthflows range in size from a few meters to several tens of acres; most are less than a quarter of an acre. Scarps of earthflows may heal in less than 10 years, but the hummocky slopes indicate centuries of former slope movements. Sharpe (1938, p. 55) observed that many hills in eastern Ohio, West Virginia, and western Pennsylvania are "scarred by thousands of old earthflows, and almost the entire surface of certain slopes show the typical scarps and hummocks of former movements."

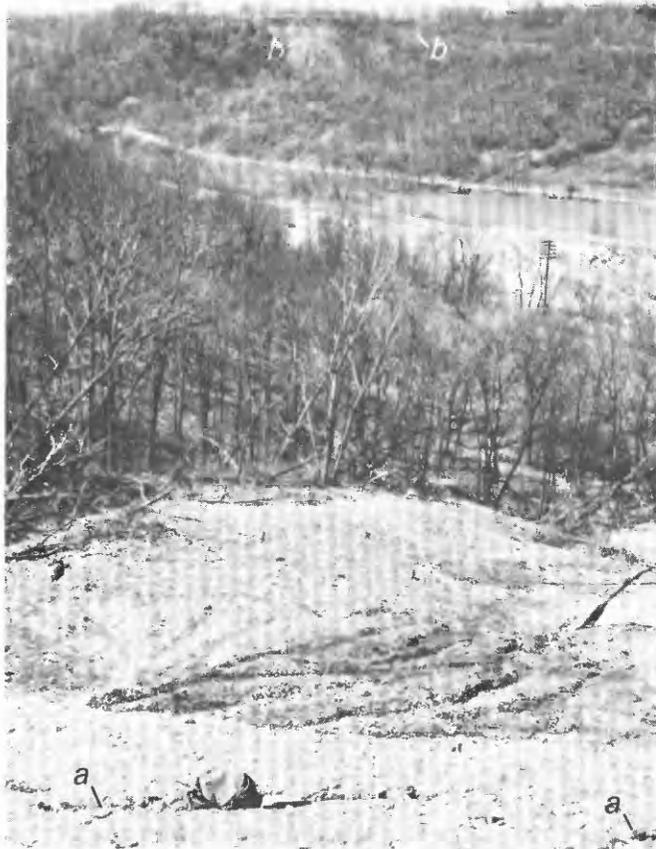
FIGURE 5.—Slides originating from regraded spoil-bank surface. Cracks (*a*) above head scarp indicate future retrogressive development. Slides in background (*b*) are similar to slide in foreground.

was begun. Part of an obvious 200-m-wide old landslide (e) has been reactivated (fig. 5, foreground) by post-1975 surface mining. Planar slope (f) shows small recent slump-earthflows in red mudstone colluvium above the road. The dissected slope is wet where seeps appear at the slight break in slope (g).

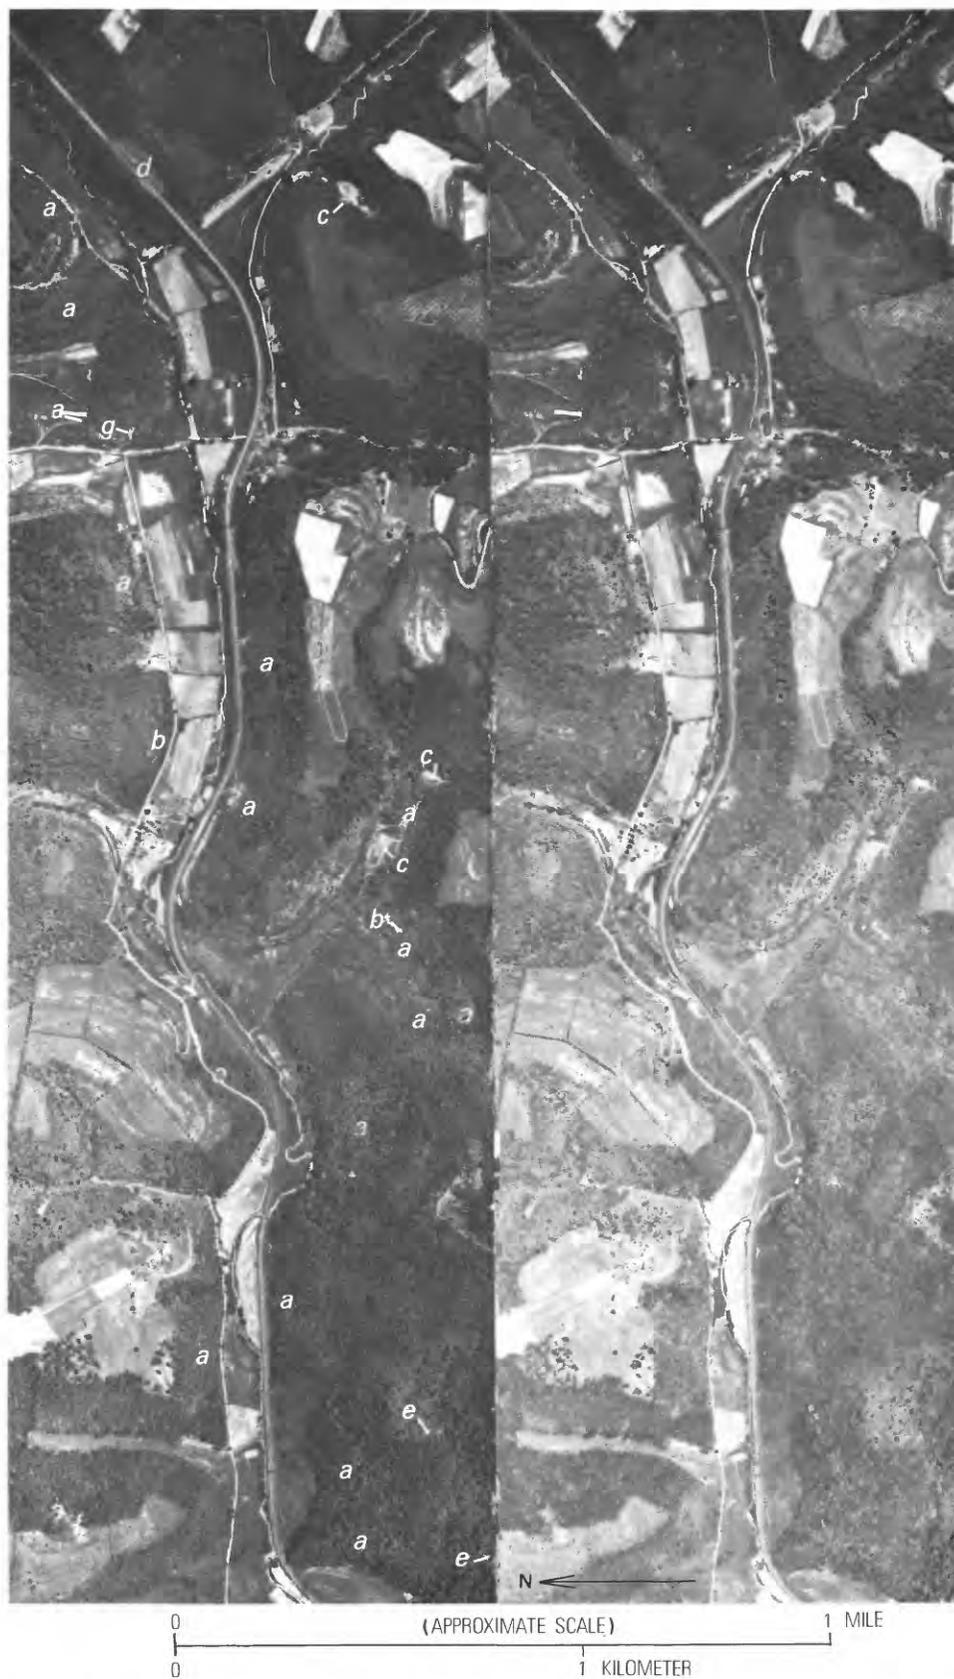
FIGURE 6. —Stereoscopic pair of Harmon Creek valley, Washington County, Pa., 1939. Explanation of letters given in the text.

Areas marked *a* represent old landslides characterized by a hummocky surface and moderate grade on the lower slopes. A break in the topography commonly

marks the location of the head of an ancient slump-earthflow as revealed by the benching at an old landslide above the north-south road in the eastern part of the area shown in the figure. Some bowl-shaped slope surfaces are more diagnostic of old landslides than are lower slope surfaces, which may be masked by dense vegetation. Planar to convex old landslides (*b*), where small narrow terraces or benches are present on at least three distinct levels on each slide, had not been identified before the field examination.

Coal refuse dumps (*c*) are composed of waste from local deep-mining operations located near the hilltop. An interesting note is that, earlier in the century, mine waste was not dumped at the level of the mining activity but instead was transported to small dumps, which were generally stable.

The rockfall hazard (*d*) was present only in outcrop areas along man-cut slopes above the railroad. Rockfalls are produced by weathering and erosion, which affect mudstone and shale more readily than they do sandstone, siltstone, and limestone. Only a few years need elapse before unsupported ledges of the more resistant rocks break away by falling. Jointing is a significant factor.

Slides (*e*) were obviously caused by precipitation and took place in the 28–36 m interval below the Pittsburgh coal.

An earthflow (*f*) lies within an old landslide and involves approximately the same interval as that shown at *e*. Note the recent slide at *g* which can be seen on the 1952 photographs (*c* on fig. 7B).

Summary. Before extensive strip mining, this sparsely populated area was subject to landsliding in colluvium derived from red mudstones. Nearly all slides shown in this particular stereoscopic pair (fig. 6) are assumed to have been caused by precipitation. The lower halves of slides designated *e* and *f* are inferred to be underlain by red mudstone on the basis of a nearby measured section.

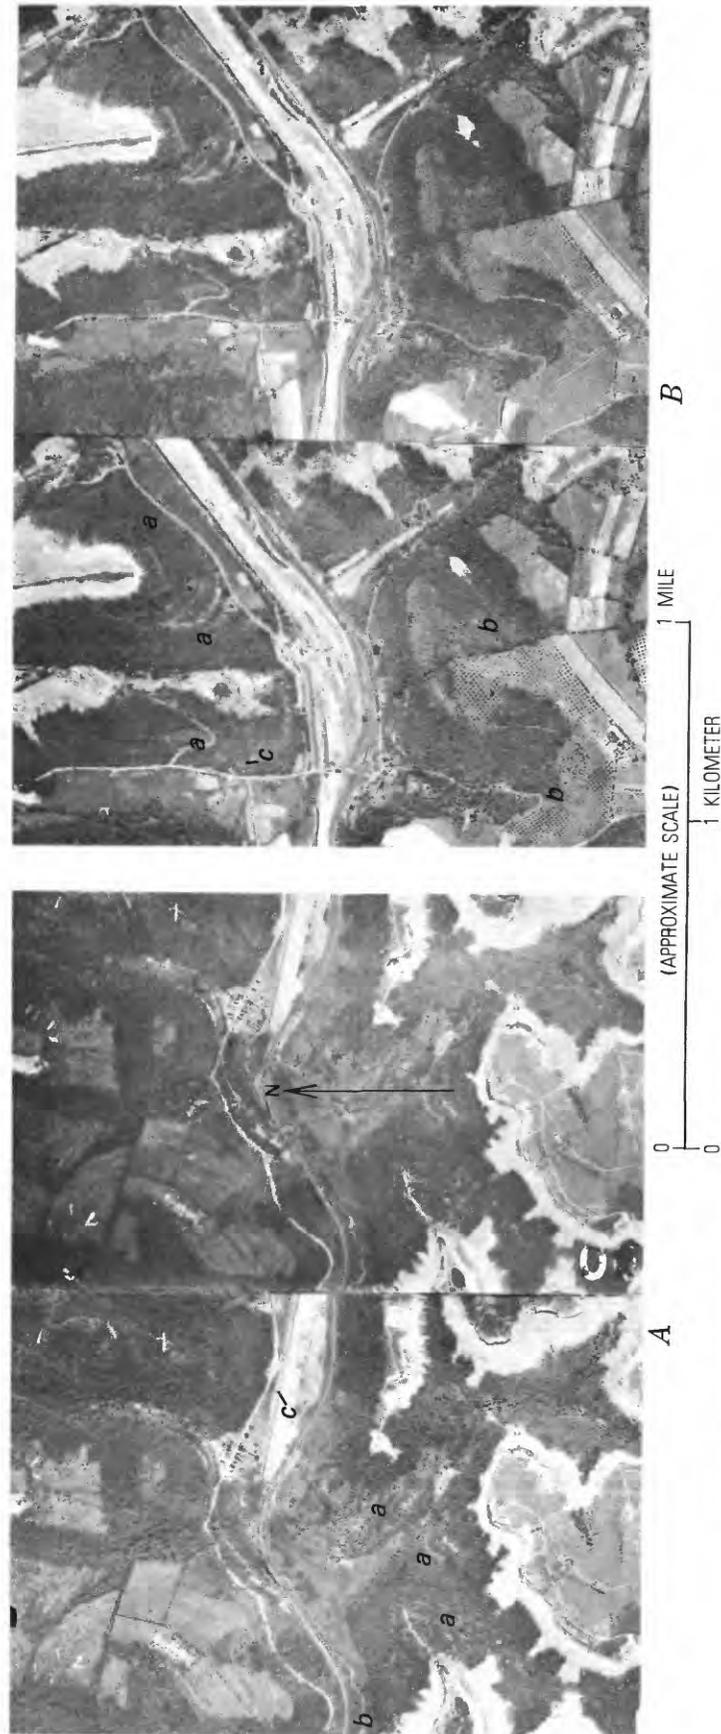
FIGURE 7.--Stereoscopic pairs, A and B, of Harmon Creek valley, Washington County, Pa., 1952. Explanation of letters given in text.

Strip mining was a radical change in land use. The obvious mine-waste slides shown on figure 7A rarely exceed 30 m in length and stop short of the hummocky less steep lower slopes (*a*) indicative of old landslides (1939 photographs), except in extensive slide area (*b*). The slides appear to be relatively shallow and reflect a failure of zones within the spoil material itself or at the spoil material-colluvium interface. The largest individual slide exceeds 6,000 m². Harmon Creek has been diverted by the emplacement of slag and mine waste (*c*).

Old landslide surfaces (*a*) shown on figure 7B can be seen on 1939 photographs. The surfaces of the probable old landslides (*b*) are underlain by unstable soil (U.S. Soil Conservation Service, 1974b) derived from the

Monongahela Group. A recent slide (c) was evident in the 1939 photographs (g on fig. 6). Vegetation has not covered this slide, probably because of the periodically renewed soil movement.

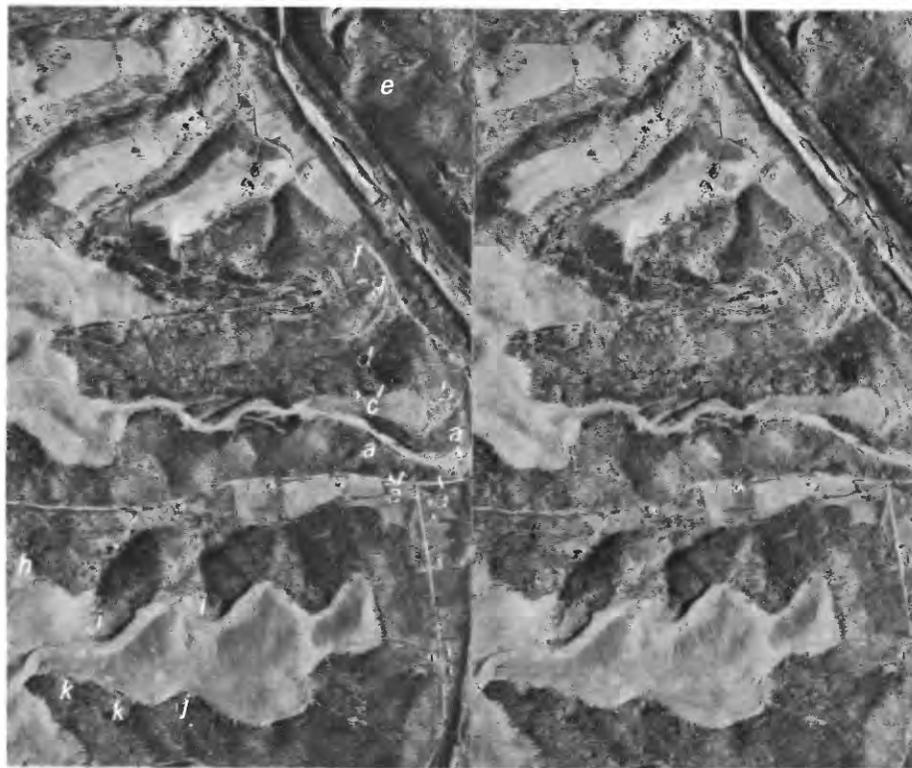
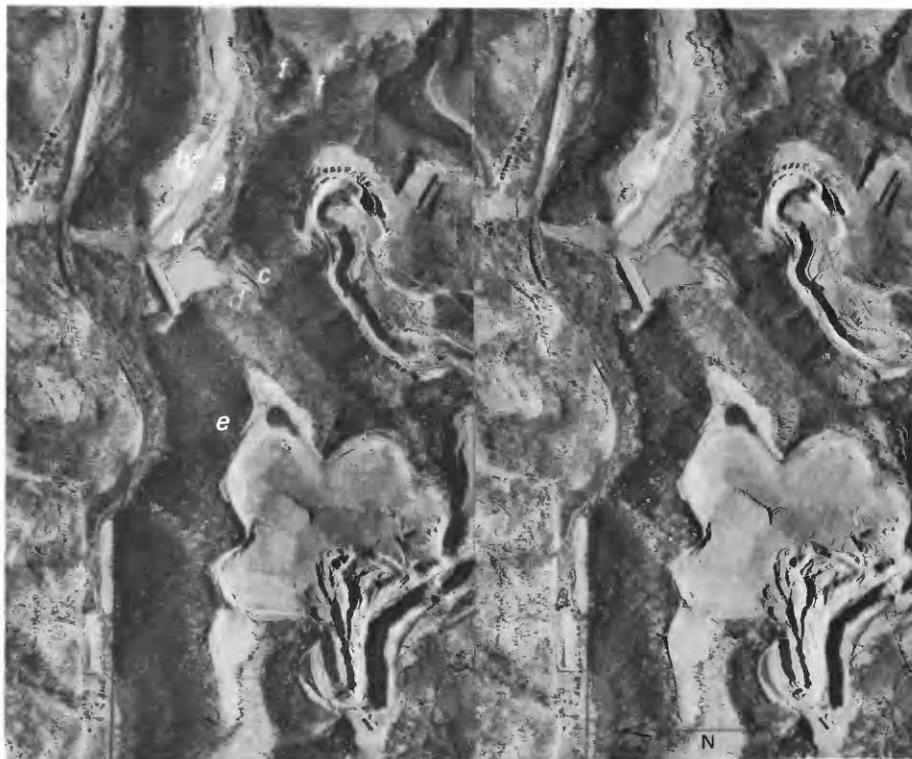
FIGURE 8. Stereoscopic pairs, A and B, of Harmon Creek valley, Washington County, Pa., 1975. Explanation of letters given in text.

In Figure 8A, an access road to the top of the hill traverses the slumped area seen on earlier photographs and has both directly and indirectly caused many new slides (a) in colluvium derived from red mudstones in the Casselman Formation. Obvious spoil-bank slides in 1952 are just faintly discernible 23 years later (b). The top of hill has been reclaimed (regraded), and spoil material has slumped (c) and flowed downslope. Bedrock ledges examined in the field are exposed by subsequent gully-ing halfway down the slope. Fresh scarps in red soil along the hummocky lower slope (d) adjacent to the slide have formed because of the additional weight of the transported material in addition to drainage changes diverting water to the hummocky area. This area is one of several old landslide areas where benching is more apparent on the 1939 photographs before surface mining

Obvious flow (h) along a planar slope below a regraded area shown in this 1975 photograph was grass covered in 1978, and the head scarp was still discernible. Areas (i) show well-defined flow movements originating from the edge of the regraded surface. An old surface (j), though not reactivated in 1975, showed a recent waste-rock flow when examined in the field in 1978. Slumping and flowage of regraded rock waste have taken place in area shown at k.

The major recent landslide at *a* on figure 8B took place after 1969, as determined by an analysis of 1969 photographs. The slide in colluvium, largely derived from red mudstone, was nearly 450 m wide, as seen in this photograph, but has since extended several tens of meters to the southeast. The terminus of the slide is outlined by a frontal margin of partially transported trees inclined in several directions; small ponds and cattail marshes are behind them. Sliding of the reclaimed (recontoured) surface (*b*) has taken place above the access road. The diversion of drainage caused by the road to the hummocky slope of the old landslide (figs. 6, 7A) has contributed to extensive reactivation downslope. Area (*c*) south of the newly constructed dam, was terraced after the landsliding that took place sometime after 1969. On earlier photographs (figs. 6, 7A), this convex slope showed natural benches indicative of earlier sliding. The hummocky lower slope of largely red mudstone colluvium at *d* was locally reactivated near the reservoir, partly because of tree removal. Most of the slides sharply defined on the 1952 photographs (fig. 7A)

are no longer discernible at *e*. New and enlarged failures at *f* took place after regrading.

We know that spoil-bank failures in the Harmon Creek area took place between 1939 and 1952 because 36 spoil-bank slides were identified on the 1952 aerial photographs. Between 1952 and 1969 only two of these slides were significantly enlarged, and no new slides took place. The 1975 photographs show extensive strip-mined areas that have been reclaimed by regrading the spoil to the approximate former configuration of the land surface. Only one spoil-bank failure had taken place during the 1969–1975 period, but 15 slides had formed along the edge of the restored surface. During or after reclamation, two large areas of sliding (*a* on fig. 8A, B) were caused by roadbuilding, which deflected drainage onto the sensitive slopes. Field inspection in early 1978 revealed one new massive slide in a recently stripped area (*e* on fig. 8A) and another slide in a regraded section (*j* on fig. 8A).

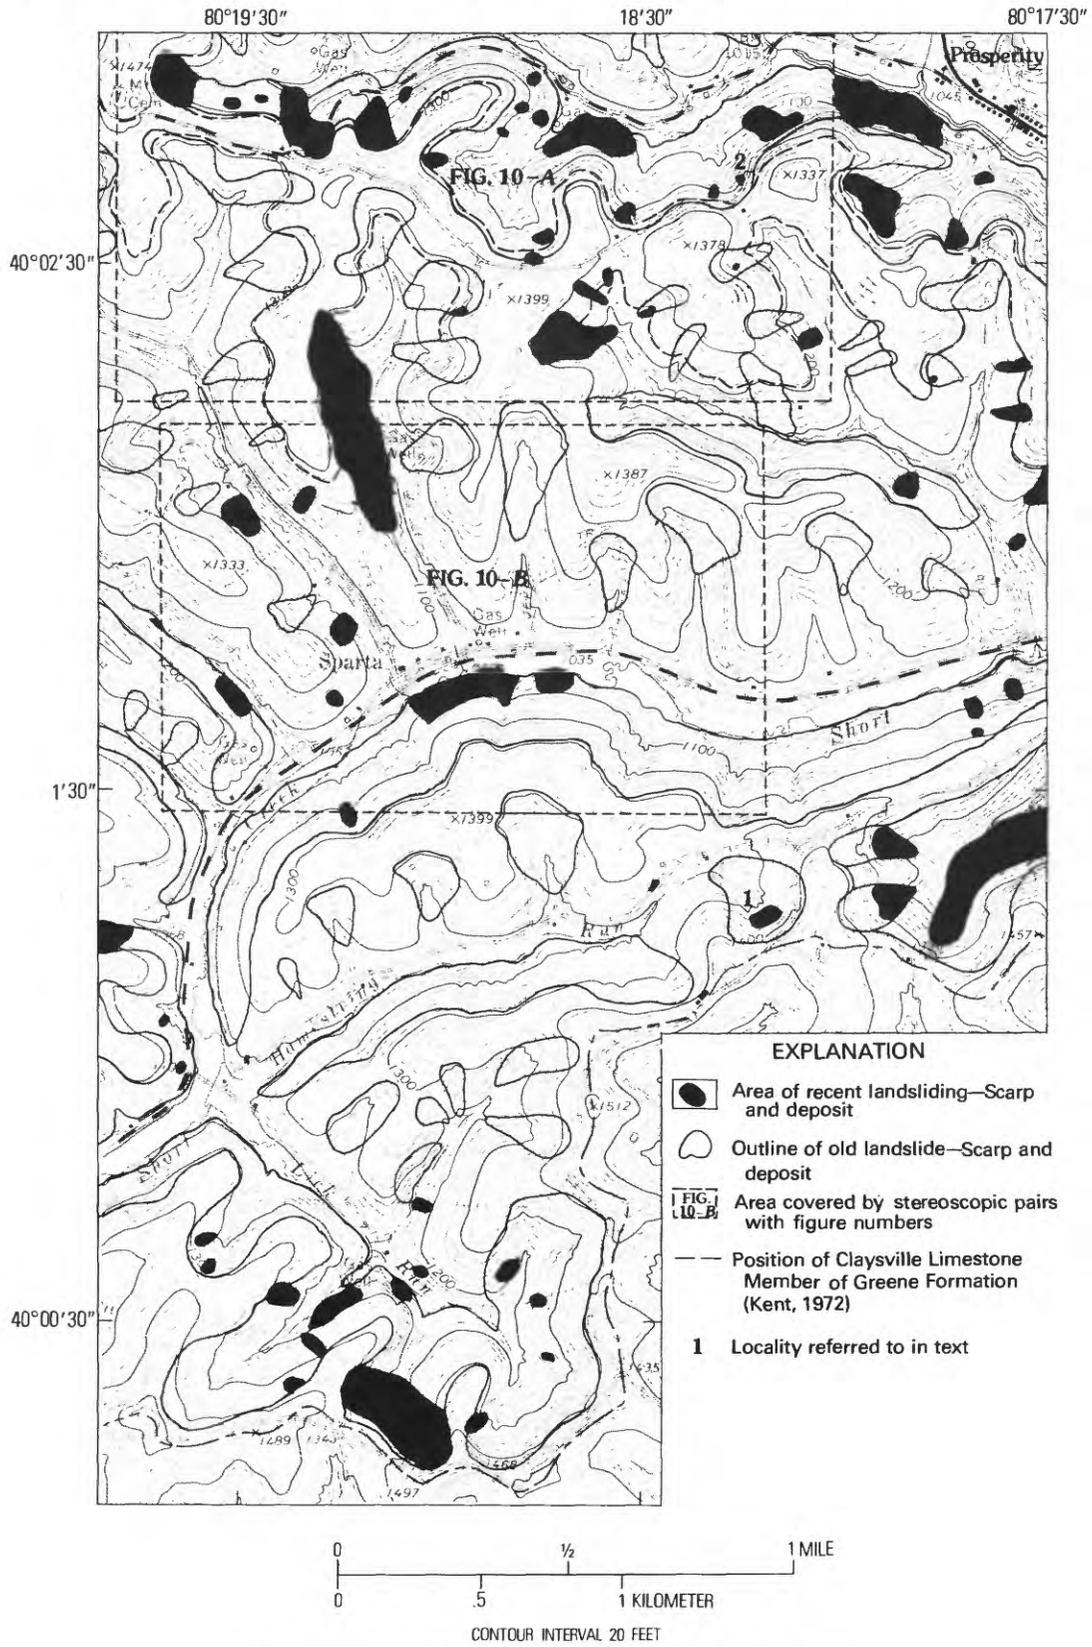
FIGURE 9.—Landslide map of part of the Short Creek area, Pa.

The Short Creek area lies within the Prosperity 7½-minute Quadrangle in southwestern Washington County and has an average relief of approximately 120 m. The village of Prosperity is in the extreme northeast corner of the area, nearly 15 km south of the city of Washington, Pa. Although the Prosperity 7½-minute Quadrangle has been geologically mapped and mass movement was clearly recognized by Kent (1972), landslides were not shown because their representation would have obscured the bedrock map units.

Both recent and old landslides have an affinity for concave slopes (longitudinally as well as laterally) (fig. 9, 10). Patton (1956) noted that recent earthflows were more common in coves or concave slopes than on other slope types. Both ground and surface water tend to concentrate along concave slopes. Unstable surface conditions are created where clayey soils that have at least a

At locality 2 (fig. 9), man's influence is apparent, as shown by the failure of roadfill in a concave-slope area. The area is part of an old landslide deposit, revealed by the hummocky and gullied forested surface seen in figure 14. Repeated attempts to stabilize the slope traversed by the paved road have failed. The author's observation indicated that surface water had not been diverted from this sensitive area.

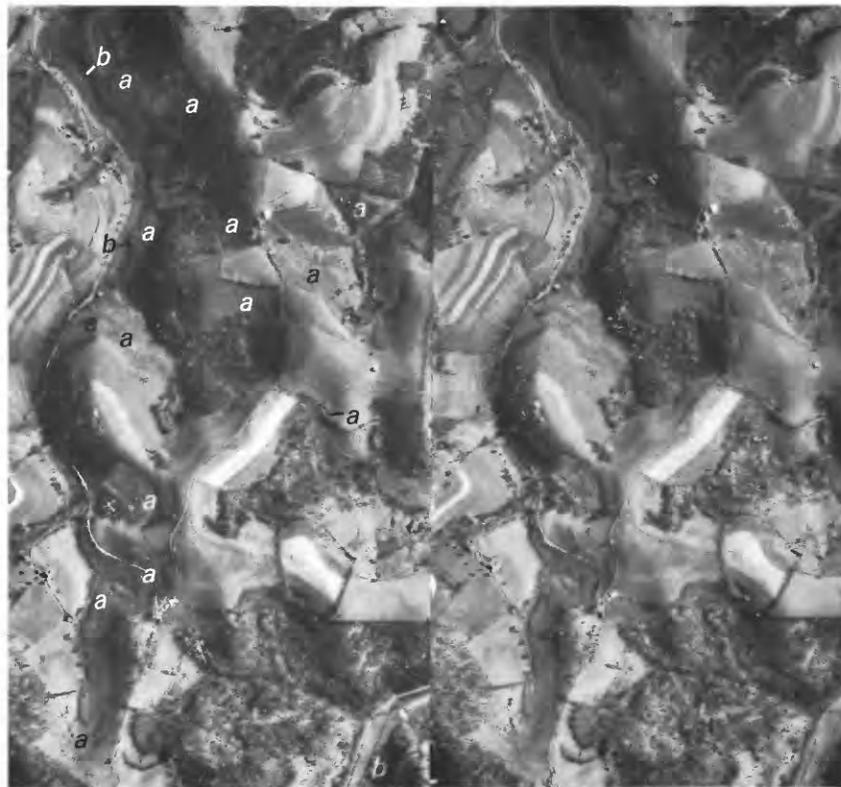
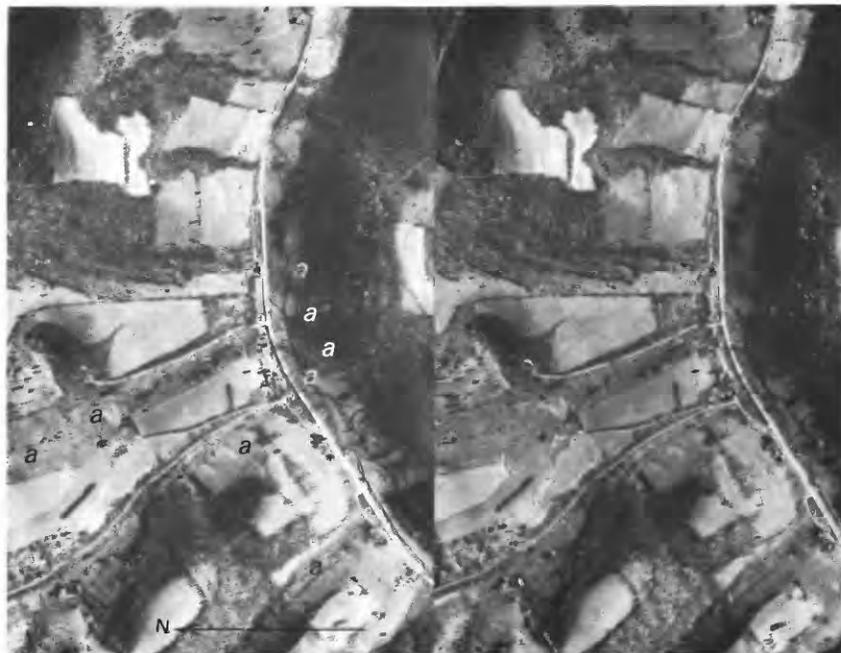
FIGURE 10.—Stereoscopic pairs of the Short Creek area, Washington County, Pa. A, Terrain west of Prosperity, Pa. Note the affinity of recent active earthflows (*a*) for concave north-west-north-northeast- and east-facing slopes. Note abrupt terminal margins (*b*) of old landslides. B, Short Creek Valley. Note the asymmetric valley formation. Many episodes of old to recent sliding have occurred along the steep north-facing slope bordering the east-trending Short Creek. Recently active earthflows (*a*) commonly show a strong preference for wetter north- to east-facing slopes. Note the recent slides on all configurations of slope surfaces. Note the frontal margins of old slides, especially along Short Creek.

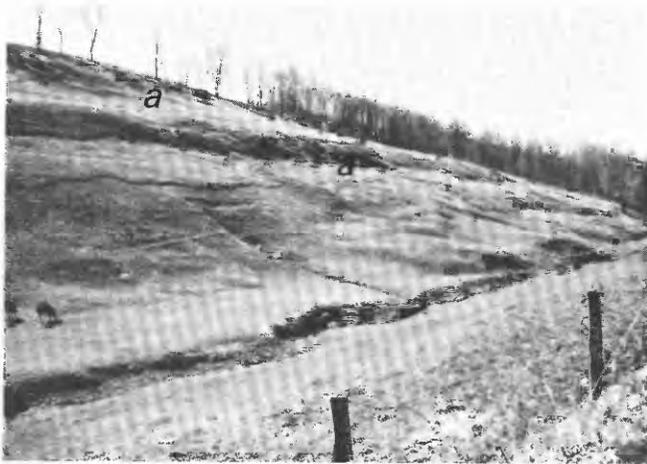
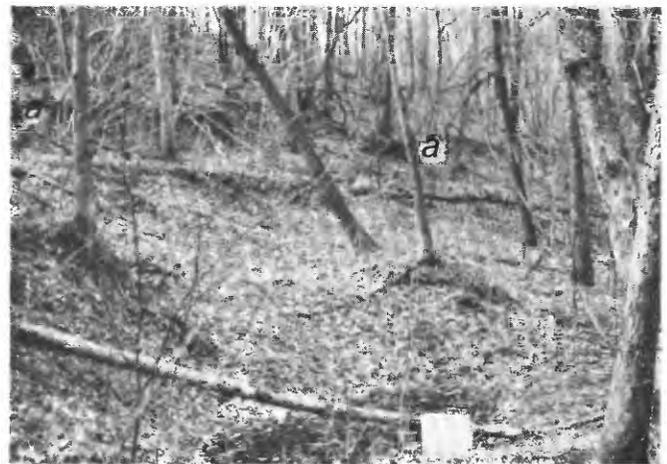
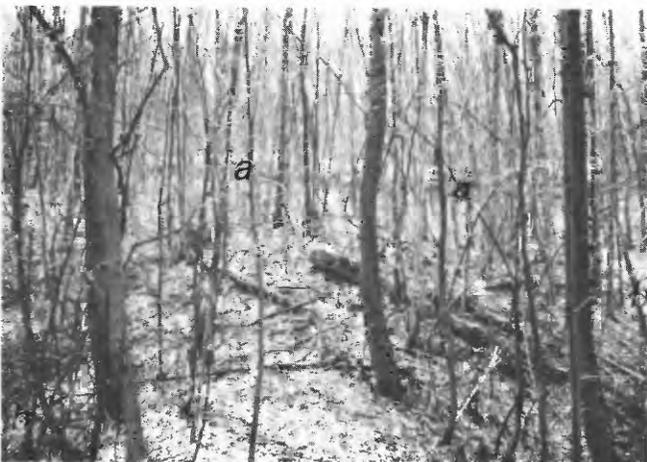
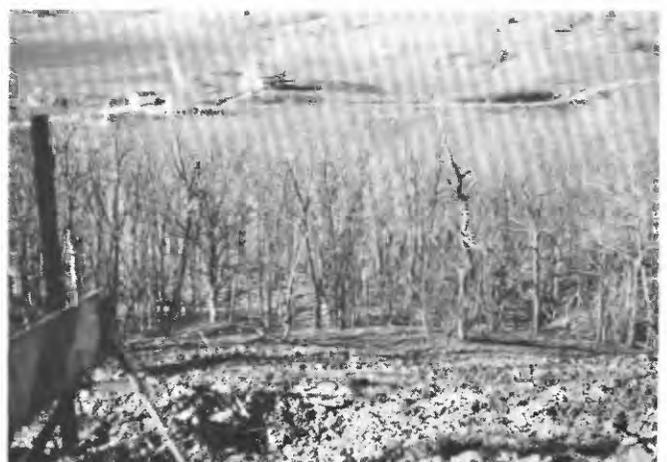
FIGURES 11-14:

11. Recent earthflows along planar northeast-facing slope		14
12. Head area of reactivated old slide		14
13. View from old slide surface up toward frontal lobe of recent slide		14

14. View down recent slide showing older hummocky surface lower on slope		14
