# **Seepage Study of McLeod Creek and East Canyon Creek near Park City, Summit County, Utah, 2004**

Scientific Investigations Report 2005-5164

**Prepared in Cooperation with the Snyderville Basin Water Reclamation District**

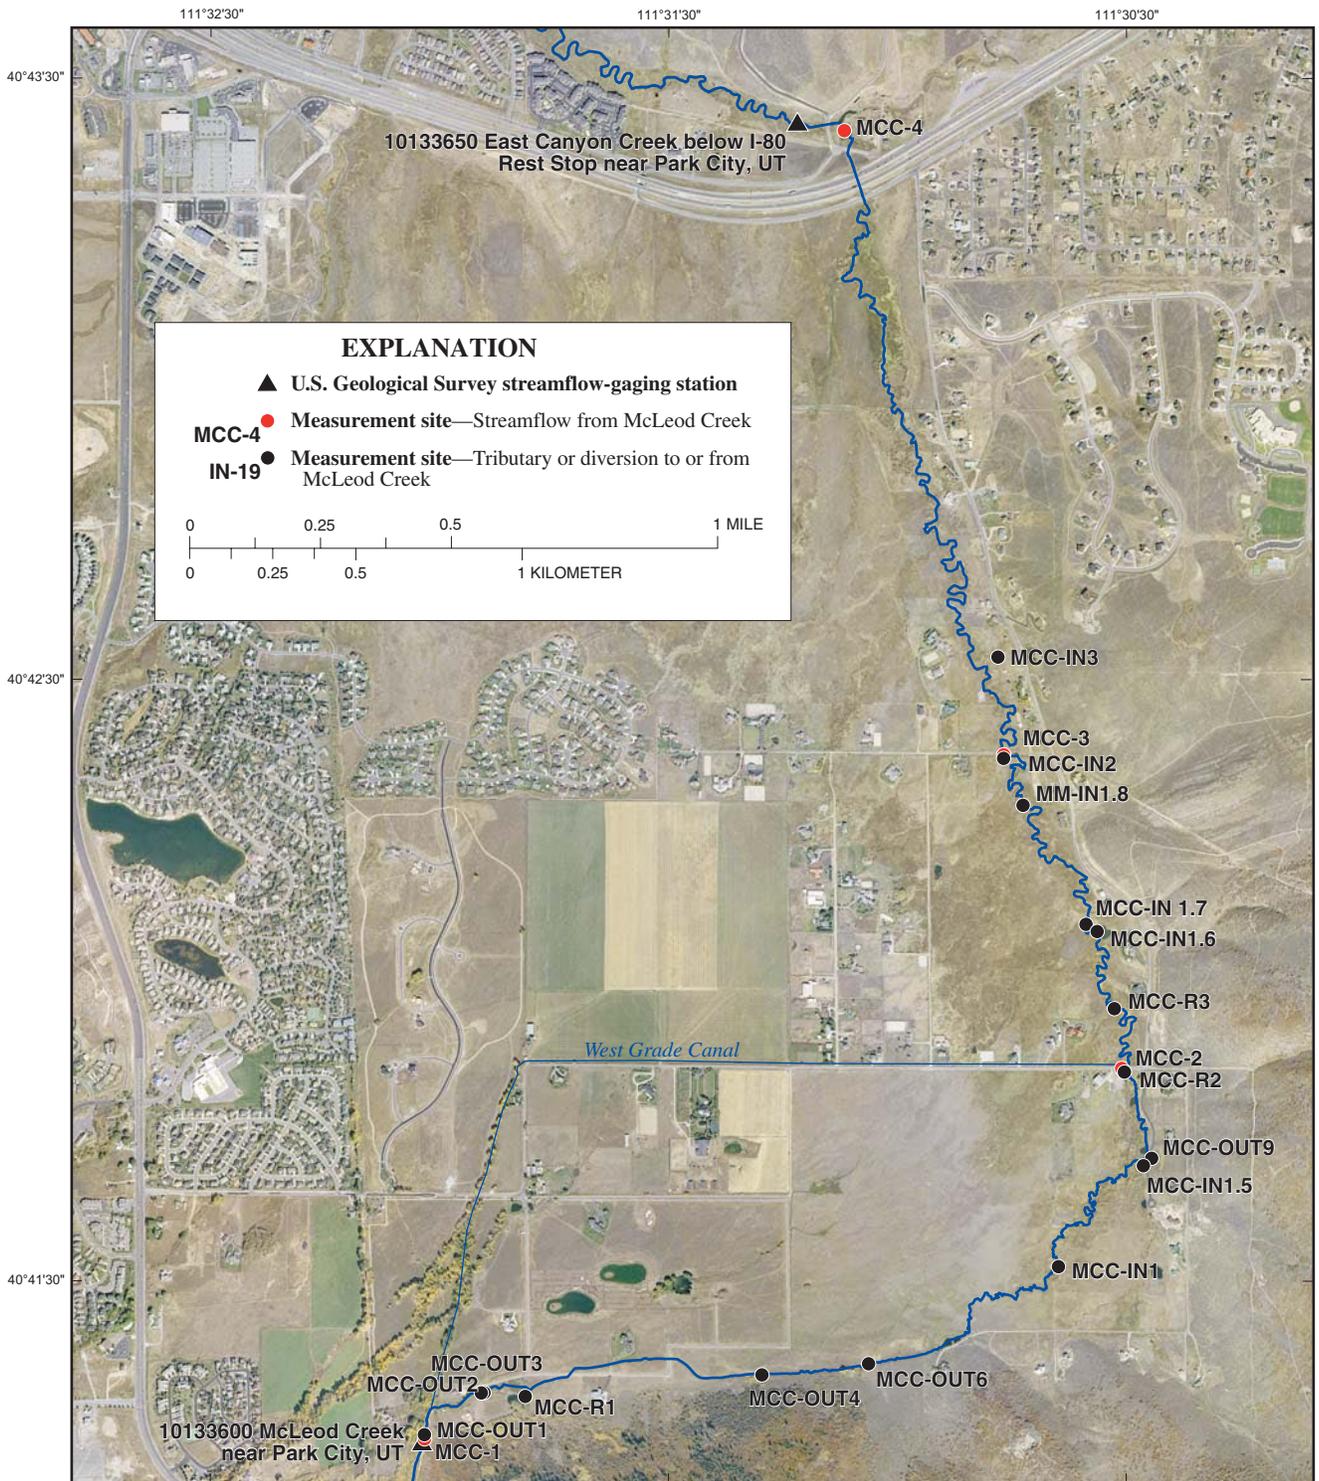
Figure 2. Location of the measurement sites along McLeod Creek near Park City, Utah.

Measurement sites along McLeod Creek are shown in figure 2. Sites along the creek were chosen at convenient measurement locations that were 1 to 2 mi apart. Inflow and

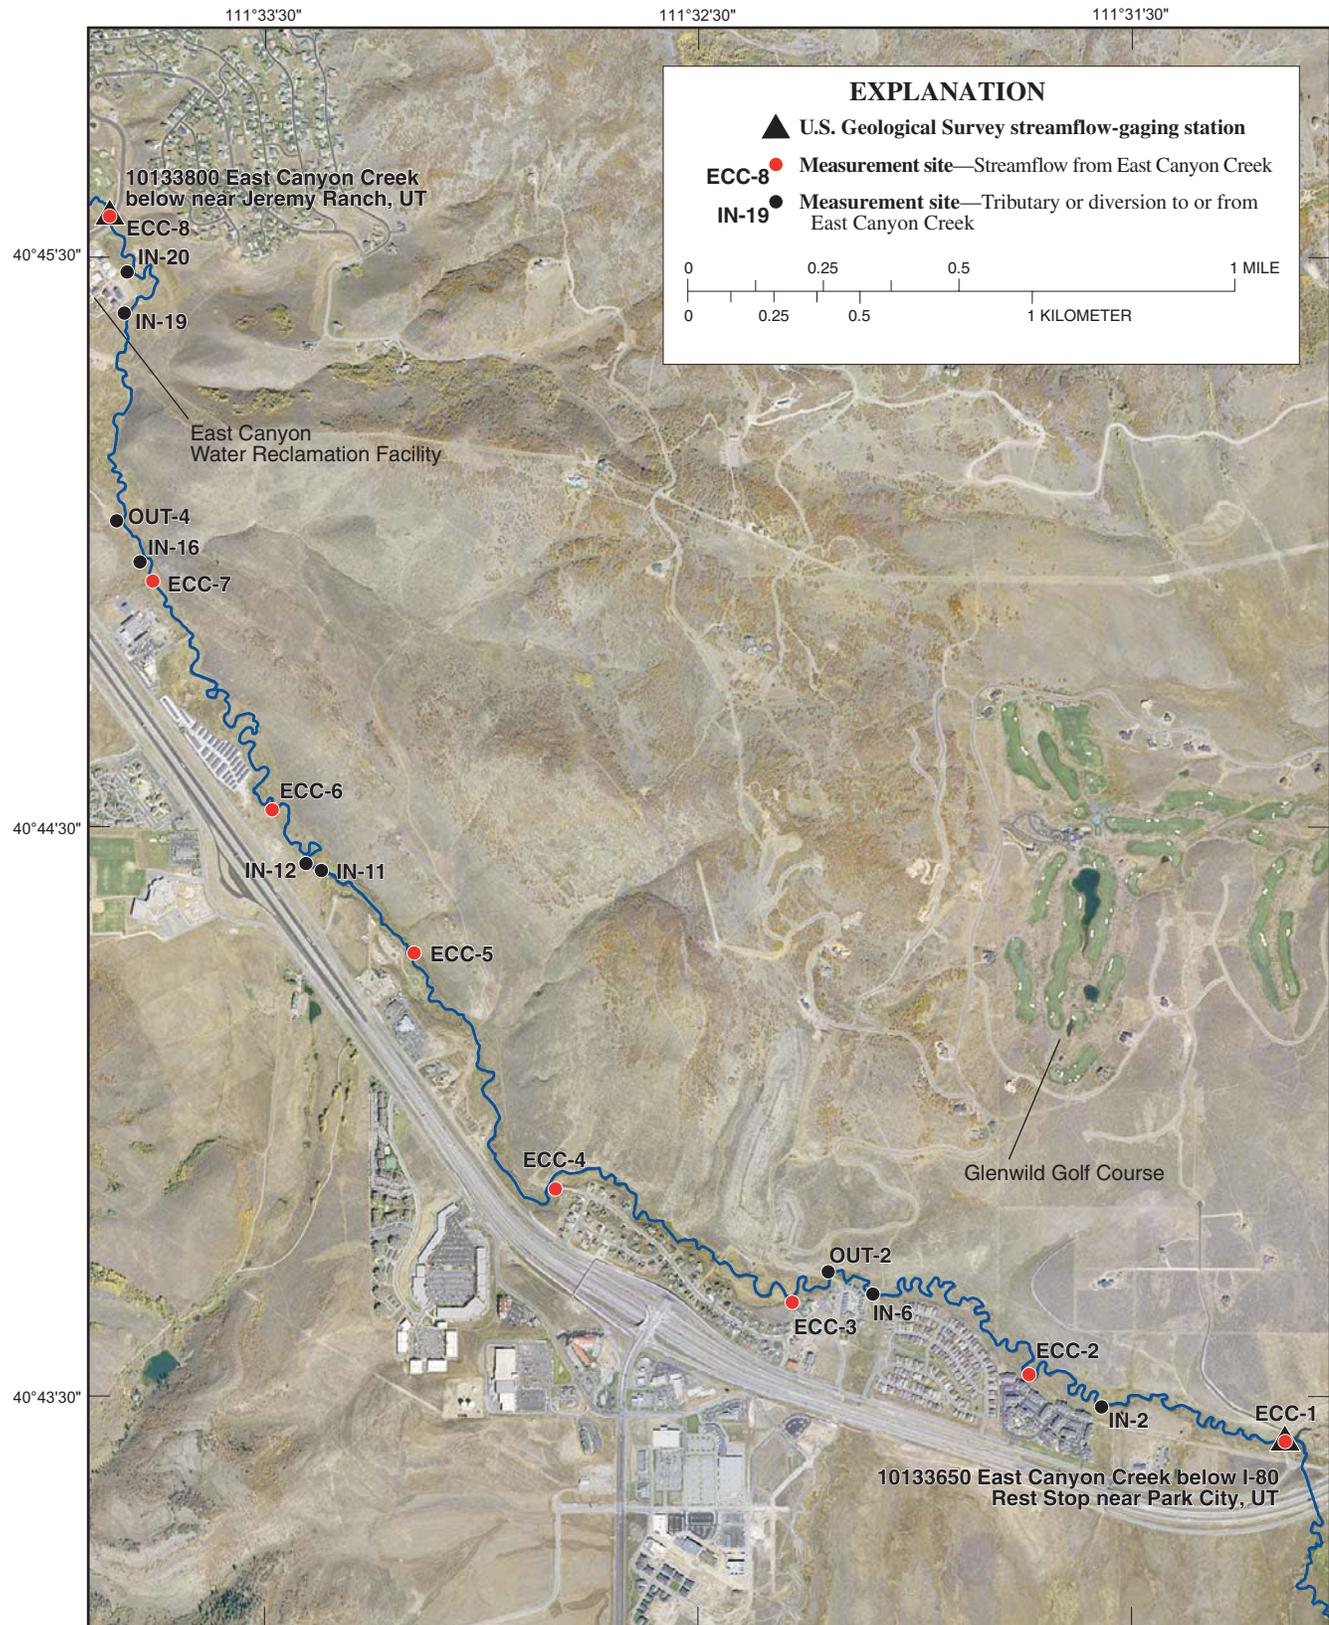
Figure 3. Location of the measurement sites along East Canyon Creek near Park City, Utah.

Four sets of measurements also were made along East Canyon Creek during the summer of 2004. These measurements were made on June 24, July 30, August 30, and October 1, 2004. Measurement sites along East Canyon Creek are shown in figure 3. These sites were chosen at convenient measuring locations approximately 1 mi apart. Inflows and diversions were measured or estimated wherever active flow was observed. For a selected set of seepage measurements, the date, time, discharge, specific conductance, water temperature, pH, and dissolved oxygen concentration from each measurement location are listed in table 4. OUT-2 is a pumping station that uses water from East Canyon Creek for irrigation of the Glenwild Golf Club. Discharge at this outflow was estimated for each set of measurements at 1.3 ft<sup>3</sup>/s (John O'Connell, oral commun., 2004). Station OUT-4 is a diversion to the Summit Water Distribution Company's water-treatment facility. Any water diverted to this facility during the summer of 2004 was immediately returned to East Canyon Creek (Van Martin, oral commun., 2004). Flow from the East Canyon Water Reclamation Facility enters East Canyon Creek at IN-20. Flow at this site was obtained from discharge records provided by the Snyderville Basin Water Reclamation District (Neil Jones, written commun., 2004).

Eight main channel measurement sites and nine tributary sites were selected to evaluate seepage gains and losses along

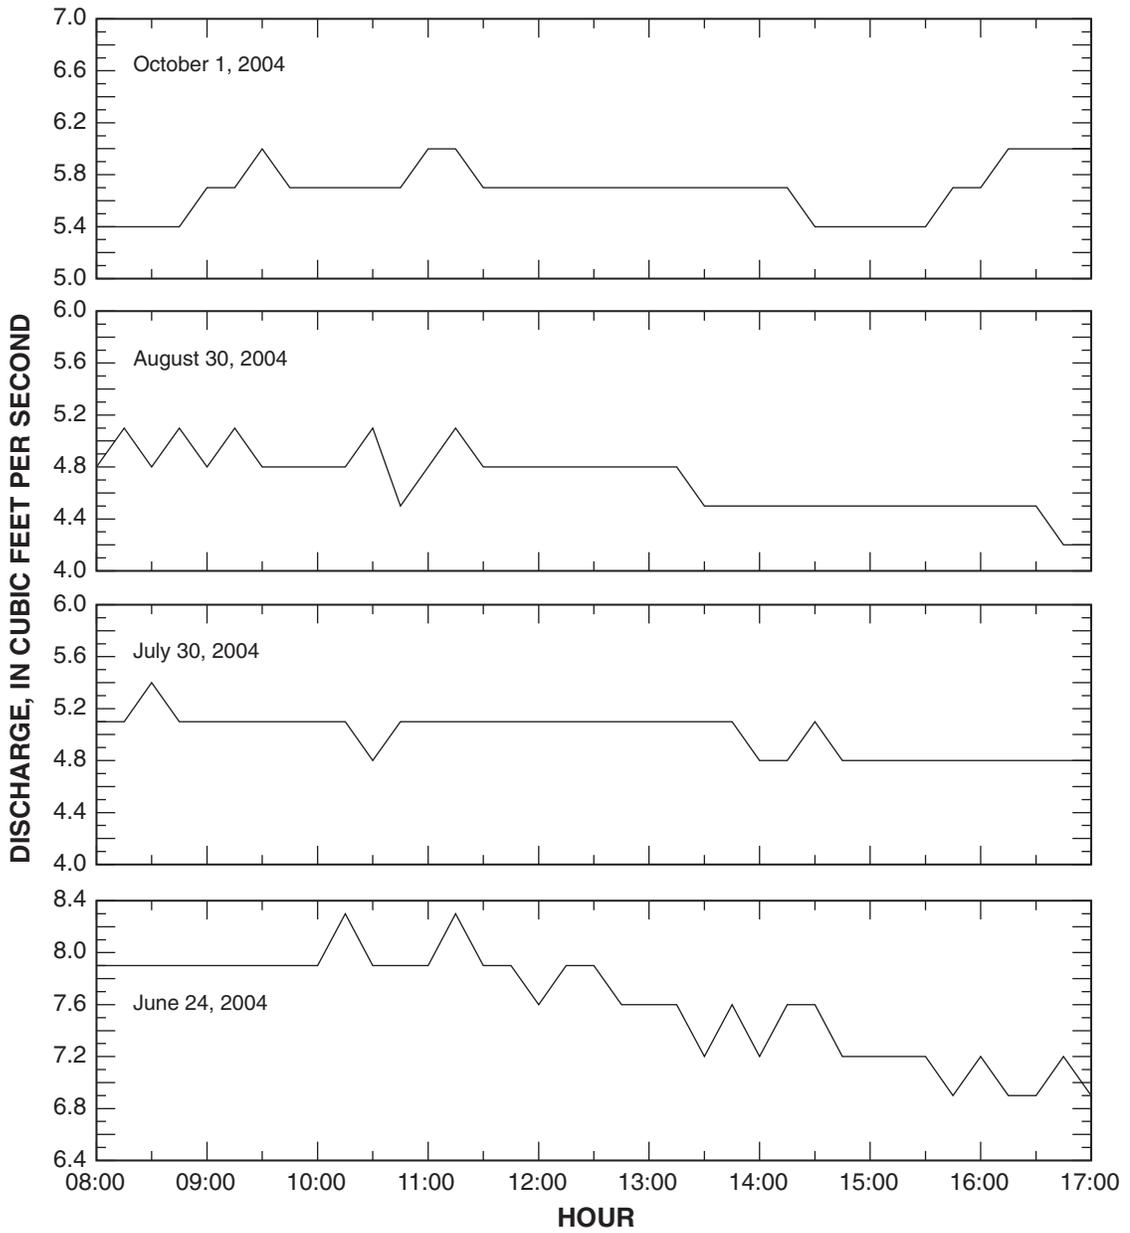
Figure 4. Discharge at U.S. Geological Survey streamflow-gaging station McLeod Creek near Park City, Utah.

I-80 Rest Stop near Park City, Utah (figs. 2, 3), and 10133800, East Canyon Creek near Jeremy Ranch, Utah (fig. 3). Discharge records from the three streamflow-gaging stations are shown in figures 4, 5, and 6, respectively. Because McLeod, Kimball, and East Canyon Creeks are in large part unregulated streams, small changes in discharge occurred during the course of most series of measurements. Recorded discharge at the beginning and end of the seepage measurements at each of the streamflow-gaging stations is shown in table 5. Changes in recorded discharge at the McLeod Creek near Park City gage ranged from -0.6 to 0.3 ft<sup>3</sup>/s. Changes in recorded discharge at the East Canyon Creek below I-80 Rest Stop near Park City gage ranged from -0.2 to -0.7 ft<sup>3</sup>/s. Changes in recorded discharge at the East Canyon Creek near Jeremy Ranch gage ranged from -3.1 to 0.2 ft<sup>3</sup>/s. The large change in discharge at the Jeremy Ranch site occurred on October 1, 2004. Only about 0.5 ft<sup>3</sup>/s of the -3.1 ft<sup>3</sup>/s change can be attributed to changing flow from the East Canyon Reclamation facility (Neil Jones, written commun., 2004). A -0.5 ft<sup>3</sup>/s change in discharge was recorded at the upstream station East Canyon Creek below I-80 Rest Stop on the same date (table 5). The other -2.1 ft<sup>3</sup>/s change observed at the downstream station may have been caused by the Glenwild Golf Club pump (OUT-2) turning on. The change in discharge at the Jeremy Ranch gaging station started at about 11:00 a.m. on October 1. The travel time from OUT-2 to Jeremy Ranch is unknown but is most likely on the order of a few hours. Therefore, it is likely

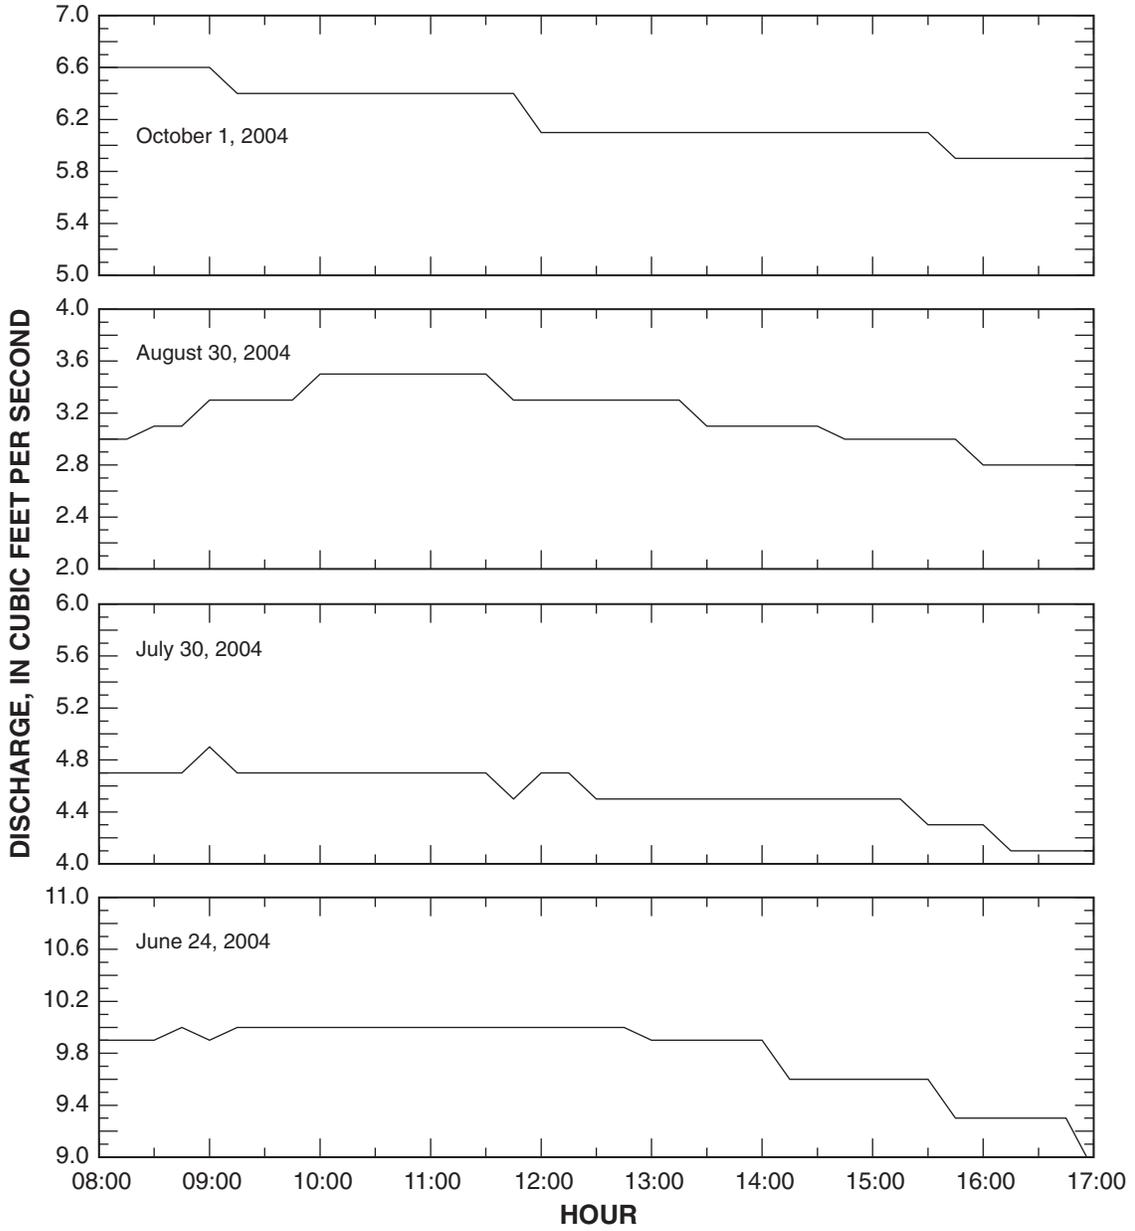
**Figure 5.** Discharge at U.S. Geological Survey streamflow-gaging station East Canyon Creek below I-80 Rest Stop near Park City, Utah.

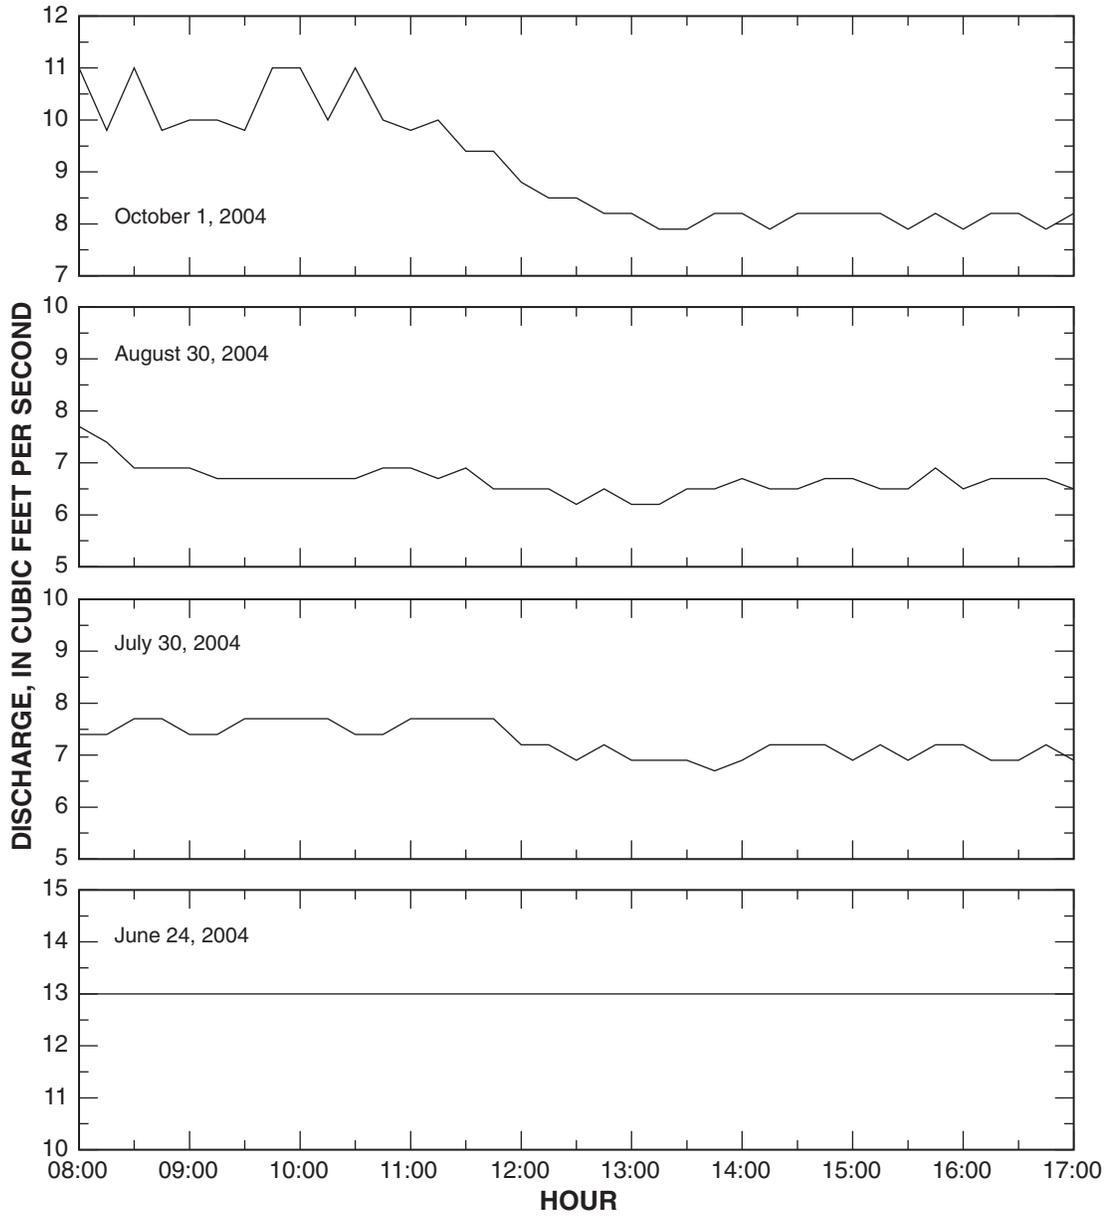
**Figure 6.** Discharge at U.S. Geological Survey streamflow-gaging station East Canyon Creek near Jeremy Ranch, Utah.

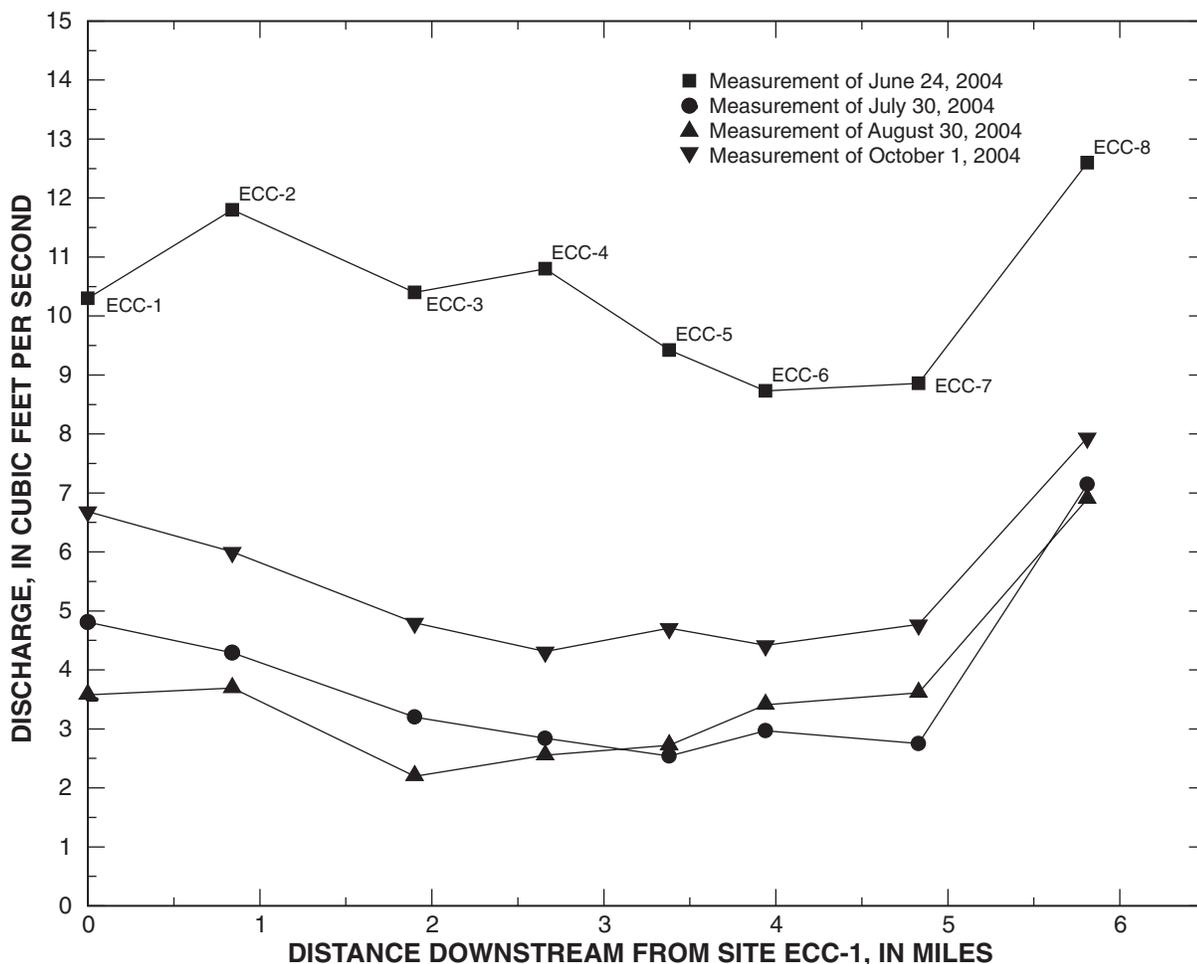
Figure 7. Discharge along East Canyon Creek near Park City, Utah.

A plot of the discharge measurements made along East Canyon Creek is shown in figure 7. This plot shows a fairly consistent pattern of discharge along the creek throughout the summer. The reaches with the greatest change in discharge are those that have the largest anthropogenic effects. Reach ECC-2 to ECC-3 shows a consistent loss in discharge. This is the result of an active diversion to the Glenwild Golf Club pump. Reach ECC-7 to ECC-8 shows a consistent gain caused by inflow from the East Canyon Water Reclamation Facility.

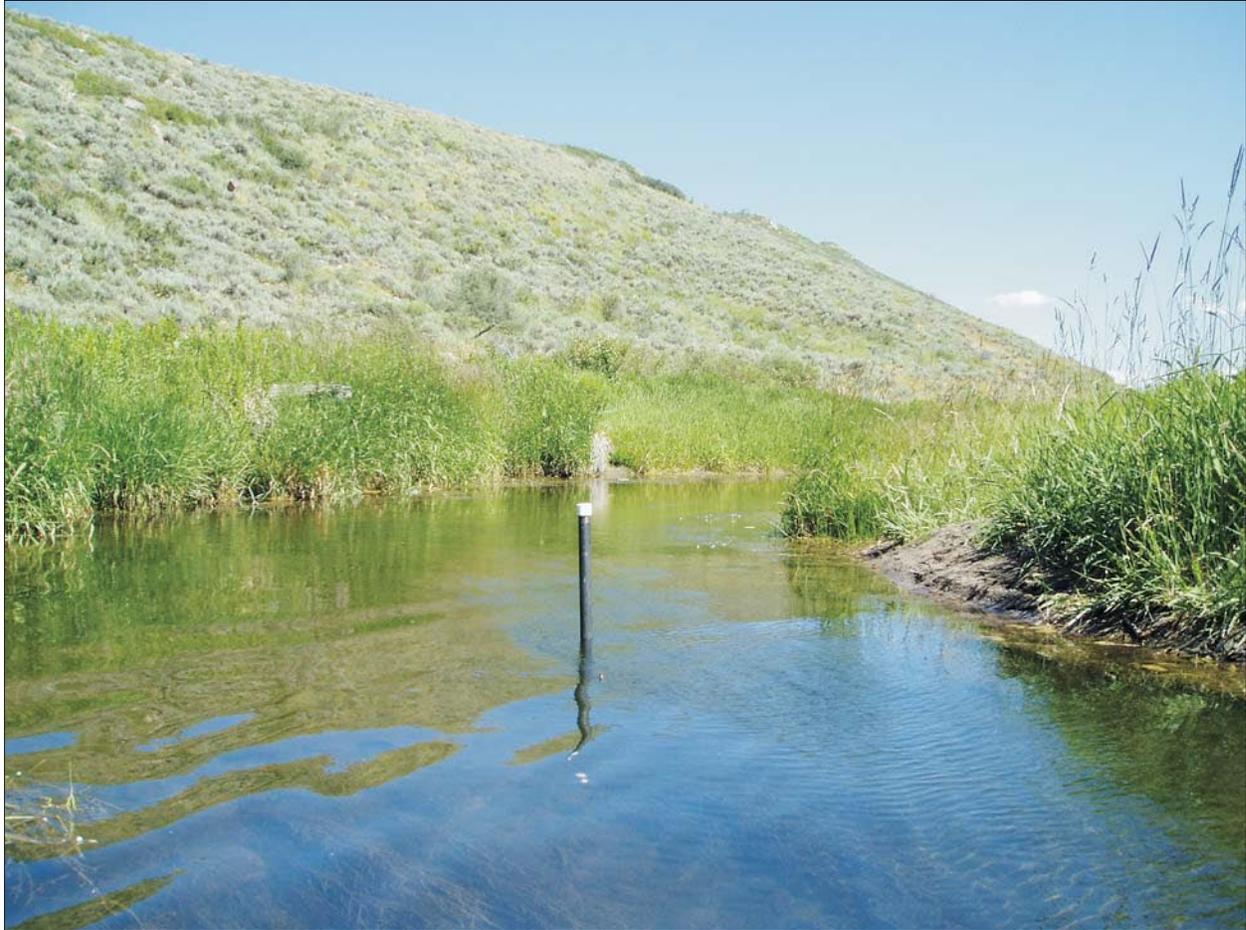
**Figure 8.** Streambed piezometer installed at site ECC-7, near Park City, Utah.

To determine if the study reach of East Canyon Creek is a gaining or losing reach, three shallow piezometers were installed in the creek bed to measure temperature fluctuations in the stream and in the streambed material. A well was installed at sites ECC-2, ECC-4, and ECC-7. The piezometers consisted of a 2-in. steel pipe that was flattened to a point on one end and driven approximately 1 to 2 ft into the streambed. The bottom of the pipe was perforated to allow water in the bed material to enter the well. Two Tidbit® temperature loggers were installed at each location. One was installed inside and at the bottom of the well while the other was attached to the outside of the pipe to record the surface-water temperature. A photo of a piezometer installation is shown in figure 8. Water-temperature data were collected from July 12 to October 29, 2004.

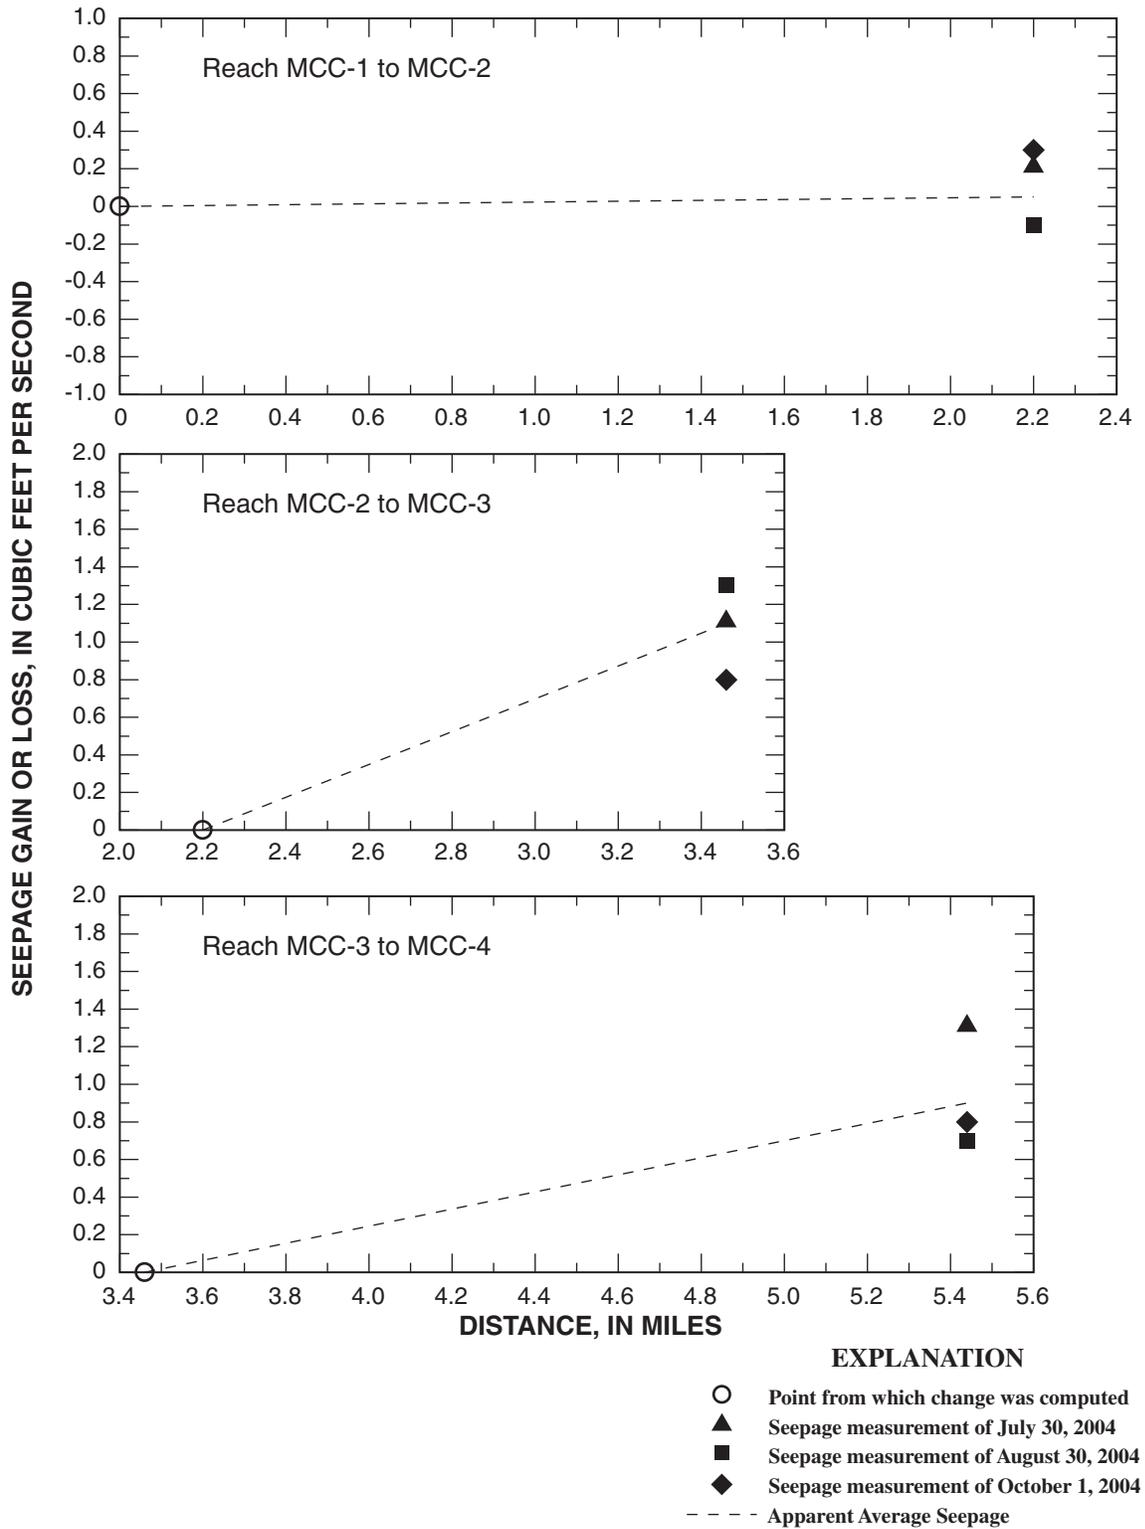
Figure 9. Measured and apparent average seepage gain for reaches of McLeod Creek near Park City, Utah.

as a percentage of the flow measured at site MCC-1. The measured seepage and the apparent average seepage are shown as a function of distance along the creek in figure 9.

Reach MCC-2 to MCC-3 showed a consistent net gain for all measurement dates (fig. 9). The net gain in discharge from site MCC-2 to MCC-3 on June 24, 2004, was  $5.2 \text{ ft}^3/\text{s}$ . A substantial part of this gain is irrigation return water from the West Grade Canal. The greatest seepage gains occurred during the measurements in July and August. MCC-R3 is a major irrigation return from water diverted at MCC-OUT1 (West Grade Canal). However, until the last measurement run of the study, it was believed that this return was located at MCC-R2. Therefore, MCC-R3 was not measured until October 1, 2004. Seepage gains reported in the reach from MCC-2 to MCC-3 include surface water that is returned from this diversion. It is likely, however, that most of the water diverted during the July and August measurements was consumed for irrigation, and the amount of water returned at MCC-R3 on July 30 and August 30, 2004, was small. For this reach the value measured on October 1, 2004,  $0.8 \text{ ft}^3/\text{s}$ , is the most representative of actual seepage. Seepage in this reach ranged from  $0.8$  to  $1.3 \text{ ft}^3/\text{s}$ . The apparent average gain was  $1.1 \text{ ft}^3/\text{s}$  or  $0.9 \text{ ft}^3/\text{s}/\text{mi}$  gain (table 8).

Reach MCC-3 to MCC-4 also showed a consistent seepage gain for all measurements (fig. 9). Seepage in this reach ranged from  $0.7$  to  $1.3 \text{ ft}^3/\text{s}$ . The difference in discharge between MCC-3 and MCC-4 measured on June 24, 2004, was  $1.3 \text{ ft}^3/\text{s}$ . This amount is similar to the seepage values measured later because there is only one very small surface-water inflow and no diversions in this reach. The apparent average gain for this reach was  $0.9 \text{ ft}^3/\text{s}$ , or  $0.5 \text{ ft}^3/\text{s}/\text{mi}$  gain (table 8).

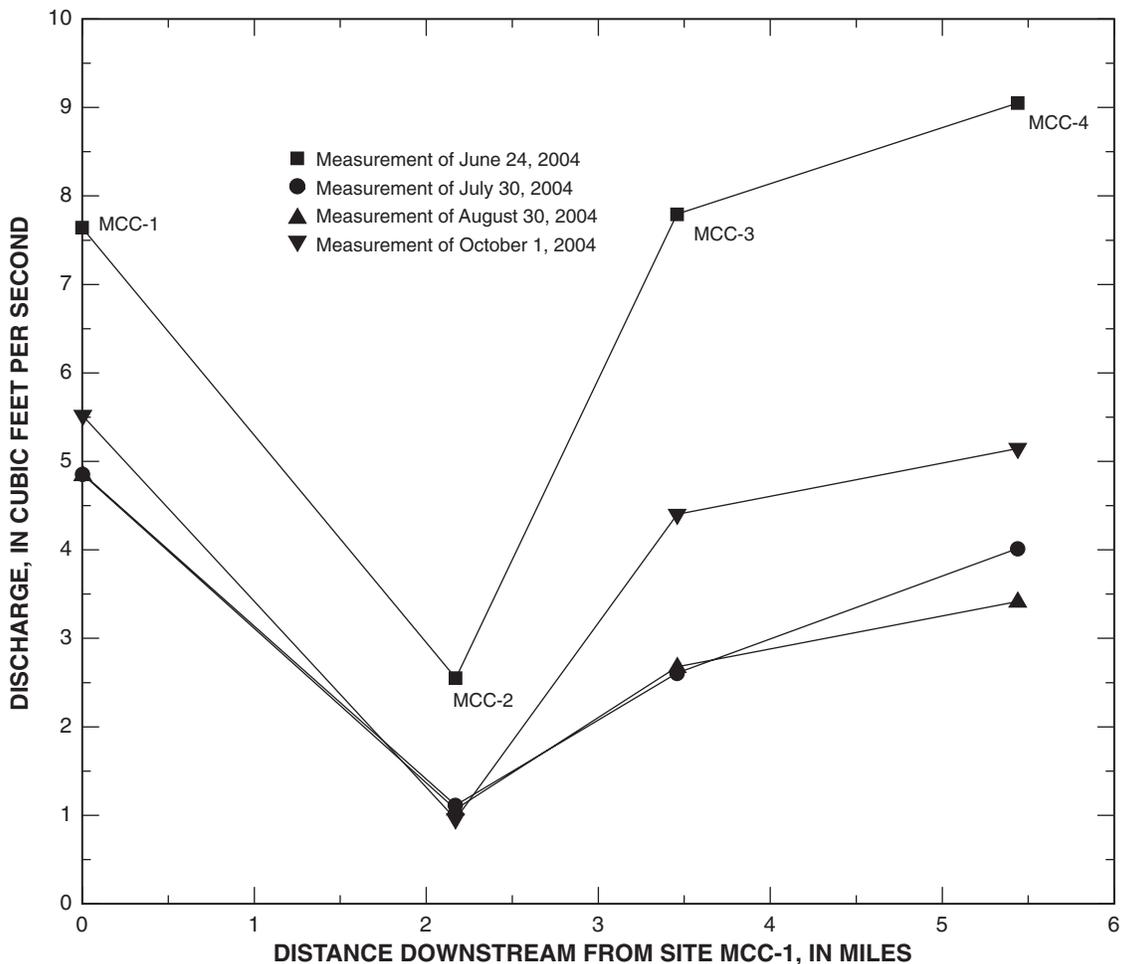
Figure 10. Discharge along McLeod Creek near Park City, Utah.

A graph of discharge measured at the stations along McLeod Creek is shown in figure 10. A consistent pattern of flow throughout the summer can be seen. From site MCC-1 to MCC-2 the creek consistently loses water. This reach contains the main water diversions. During the June 24, 2004, and October 1, 2004, measurements it appears that most of the water that is diverted from the upper section of McLeod Creek is returned downstream. This is because no irrigation was taking place at this time. During the July and August measurements, McLeod Creek gained water from site MCC-2 to MCC-3. However, the gains in this reach were less than the losses measured in the reach from site MCC-1 to MCC-2. From site MCC-3 to MCC-4 there was a consistent gain throughout the summer, with the largest gains occurring in June when conditions were wetter.

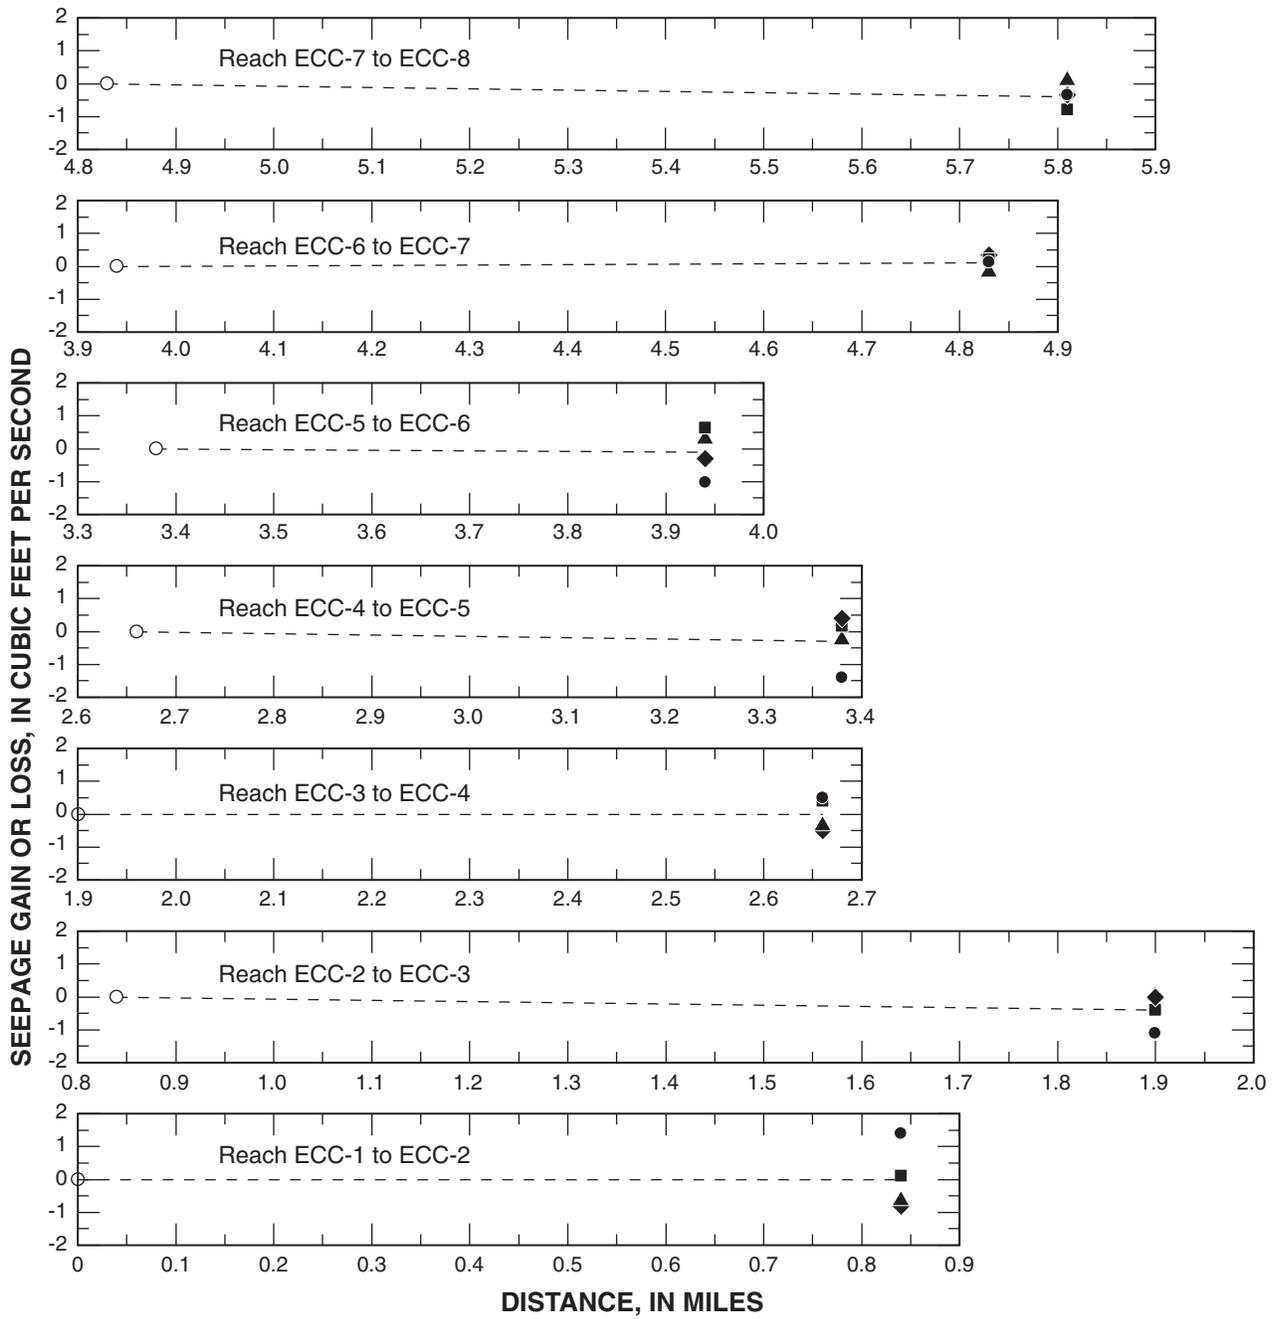
- EXPLANATION**
- Point from which change was computed
  - Seepage measurement of June 24, 2004
  - ▲ Seepage measurement of July 30, 2004
  - Seepage measurement of August 30, 2004
  - ◆ Seepage measurement of October 1, 2004
  - - - Apparent average seepage

**Figure 11.** Measured and apparent average seepage gain or loss for reaches of East Canyon Creek near Park City, Utah.

East Canyon Creek (fig. 3). The computed seepage and the apparent average seepage, calculated from measurements made on June 24, July 30, August 30, and October 1, 2004, along East Canyon Creek are reported in table 9. The total gain or loss also is shown as a percentage of the flow measured at site ECC-1.

No consistent seepage gain or loss was observed in the reach of East Canyon Creek from site ECC-1 to ECC-2 (fig. 11). Seepage in this reach ranged from -0.8 to 1.4 ft<sup>3</sup>/s. The apparent average seepage was 0.0 ft<sup>3</sup>/s (table 9). The 1.4 ft<sup>3</sup>/s gain was measured on June 24, 2004. This gain may have been caused by soils and the wetland areas surrounding East Canyon Creek draining after wetter conditions in the spring. The measurement made on August 30, 2004, was in the range of the discharge measurement error. The July and October measurements showed a measurable seepage loss for this reach of -0.7 and -0.8 ft<sup>3</sup>/s, respectively.

Seepage in the reach from site ECC-2 to ECC-3 consistently showed a minor loss (fig. 11) and ranged from -1.1 to 0.0 ft<sup>3</sup>/s (table 9). The -1.1 ft<sup>3</sup>/s loss was measured on June 24, 2004. The main diversion (OUT-2) to the Glenwild Golf Club pump is located in this reach of the creek. The seepage mea-

Seepage in the reach from site ECC-3 to ECC-4 ranged from  $-0.5$  to  $0.4 \text{ ft}^3/\text{s}$  (table 9). The seepage measured on June 24, 2004, was in the range of the discharge measurement error. No consistent seepage gain or loss was observed in this reach (fig. 11). The apparent average seepage was  $0.0 \text{ ft}^3/\text{s}$ .

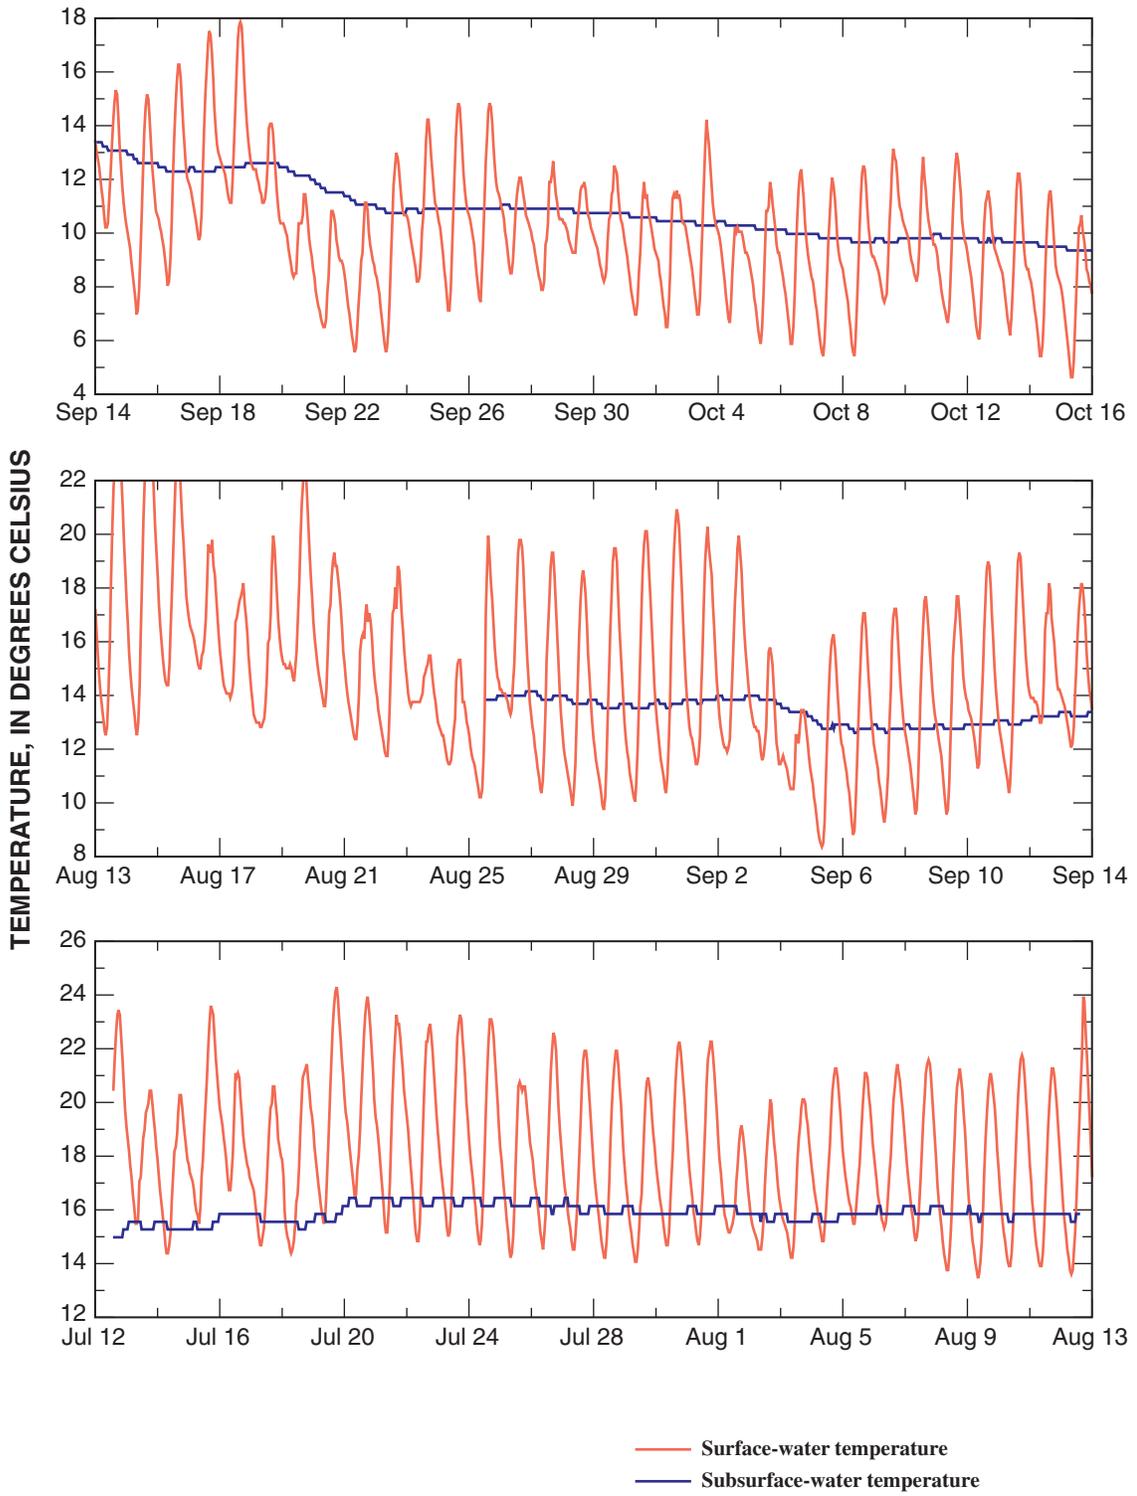
**Figure 12.** Water temperature and streambed piezometer temperature in East Canyon Creek at site ECC-2, near Park City, Utah.

sites ECC-1 to ECC-3 was -0.7, -0.3, and -0.8 ft<sup>3</sup>/s on July 30, August 30, and October 1, 2004, respectively (table 9). The diurnal variation in the piezometer data was less pronounced in September and October. Although it is not indicated by the seepage measurements made in October, this attenuation may be caused by a decrease in seepage loss in the immediate area around site ECC-2.

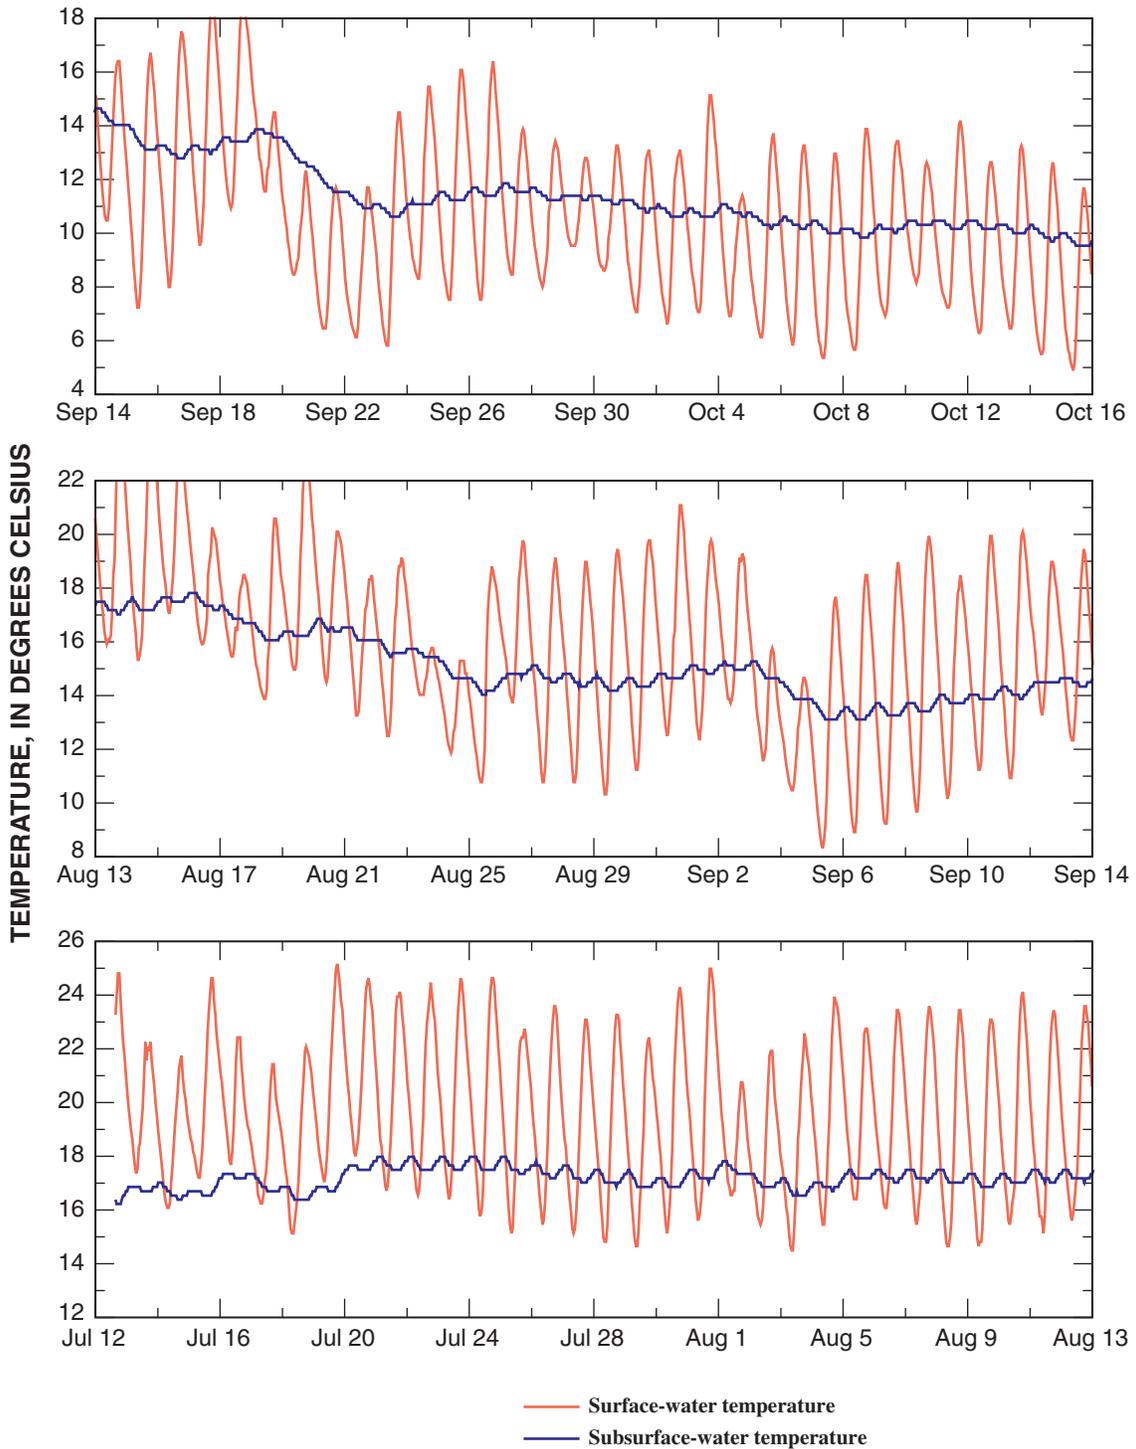
**Figure 13.** Water temperature and streambed piezometer temperature in East Canyon Creek at site ECC-4, near Park City, Utah.

A good relation between the surface and streambed water-temperature profiles appears to exist at site ECC-4. The peak daily water temperature occurs approximately 8 hours later in the piezometer than in the surface water. This is likely a result of the travel time of the water moving to the depth of the temperature sensor. Measured seepage from site ECC-3 to ECC-5 was -0.7, 0.6, and -0.1 ft<sup>3</sup>/s on July 30, August 30, and October 1, 2004, respectively. A diurnal fluctuation in the piezometer temperature data was observed throughout the summer at this location. The seepage gain measured on August 30, 2004, was not observed in the temperature data recorded at site ECC-4. This may have been caused by seepage gains that were occurring elsewhere between ECC-3 and ECC-5 on this date.
