# **Seepage Study of McLeod Creek and East Canyon Creek near Park City, Summit County, Utah, 2004**

Scientific Investigations Report 2005-5164

**Prepared in Cooperation with the Snyderville Basin Water Reclamation District**

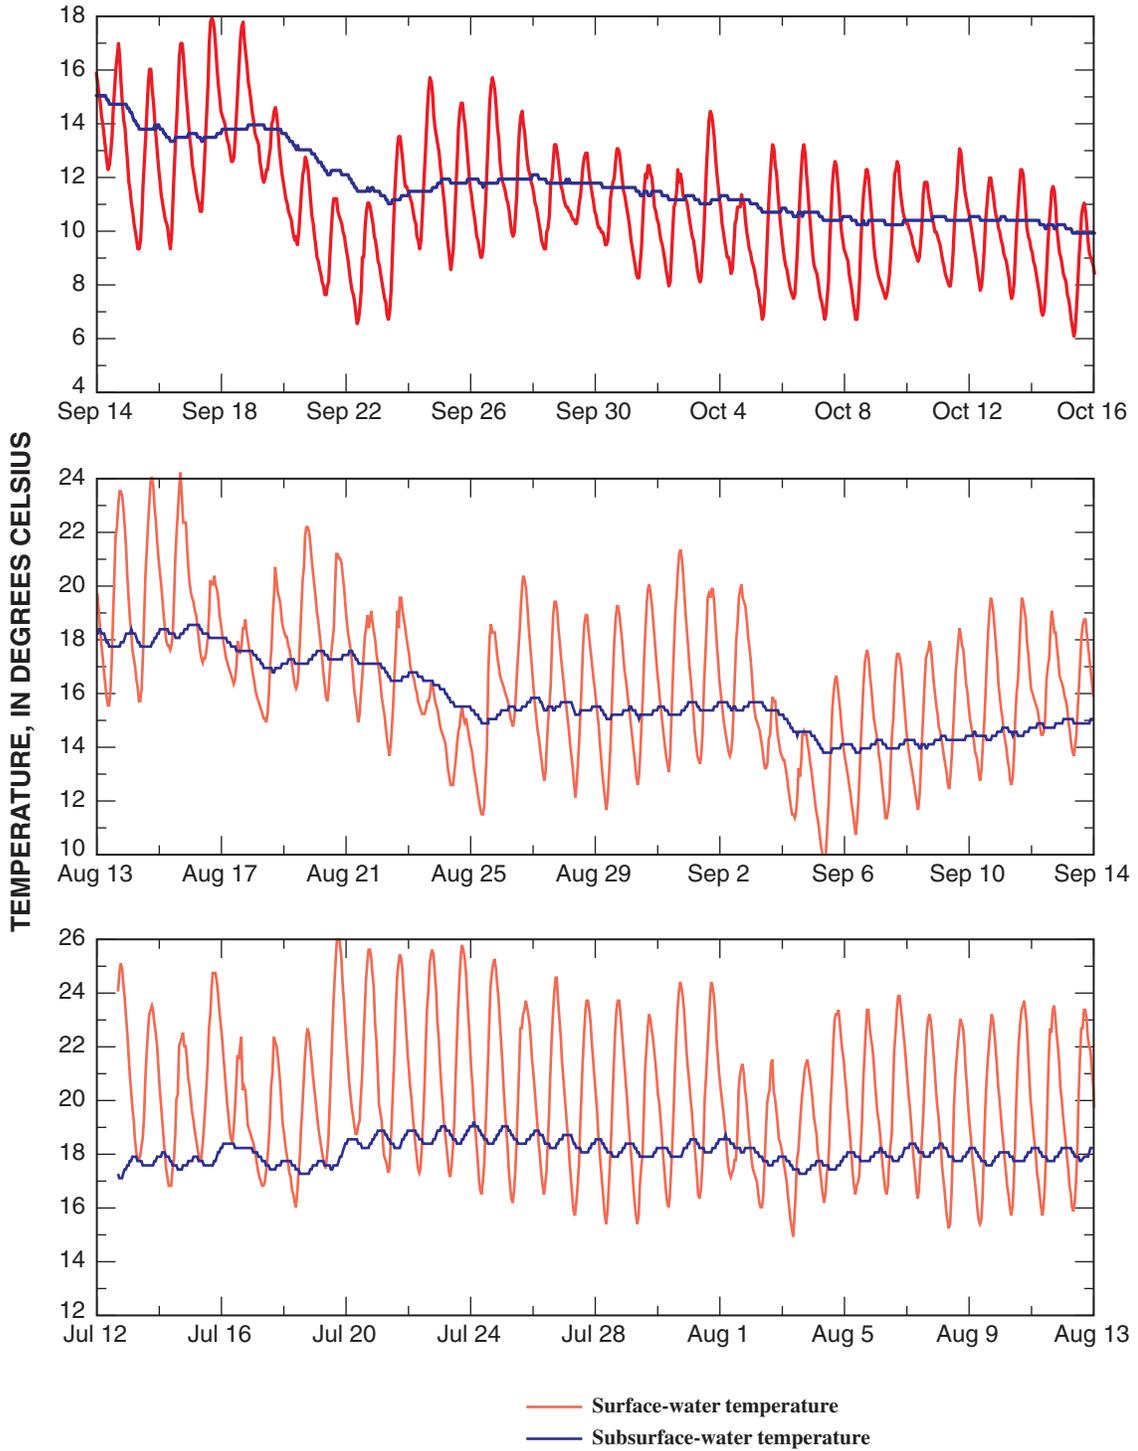
**Figure 14.** Water temperature and streambed piezometer temperature in East Canyon Creek at site ECC-7, near Park City, Utah.

A diurnal water-temperature fluctuation was seen in the piezometer installed at site ECC-7. This fluctuation appears to attenuate in September and October. This is consistent with a decrease in measured seepage that was observed between site ECC-6 and ECC-8. Measured seepage from site ECC-6 to ECC-8 was -0.1, -0.6, and 0.0 ft<sup>3</sup>/s on July 30, August 30, and October 1, 2004, respectively (table 9).
