# **Surface Water-Quality and Water-Quantity Data from Selected Urban Runoff-Monitoring Sites at the Rocky Mountain Arsenal, Commerce City, Colorado, Water Years 1988–2004**

Scientific Investigations Report 2005–5214

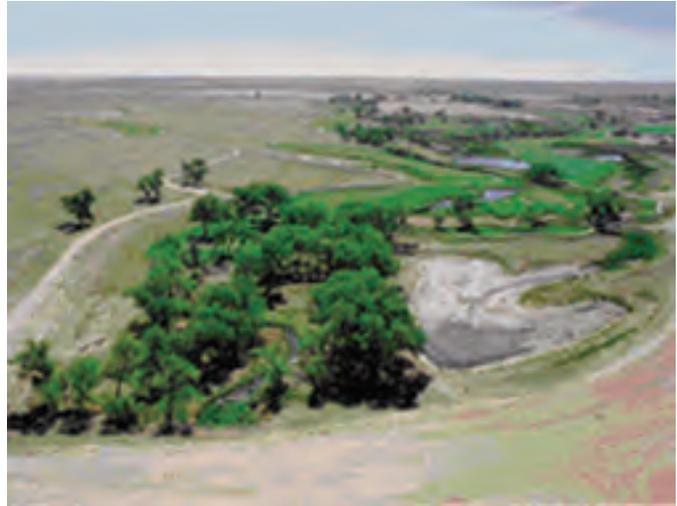
**Figure 8.** Aerial view of flood-detention ponds in a golf course along First Creek, near Commerce City, Colorado, 2003.

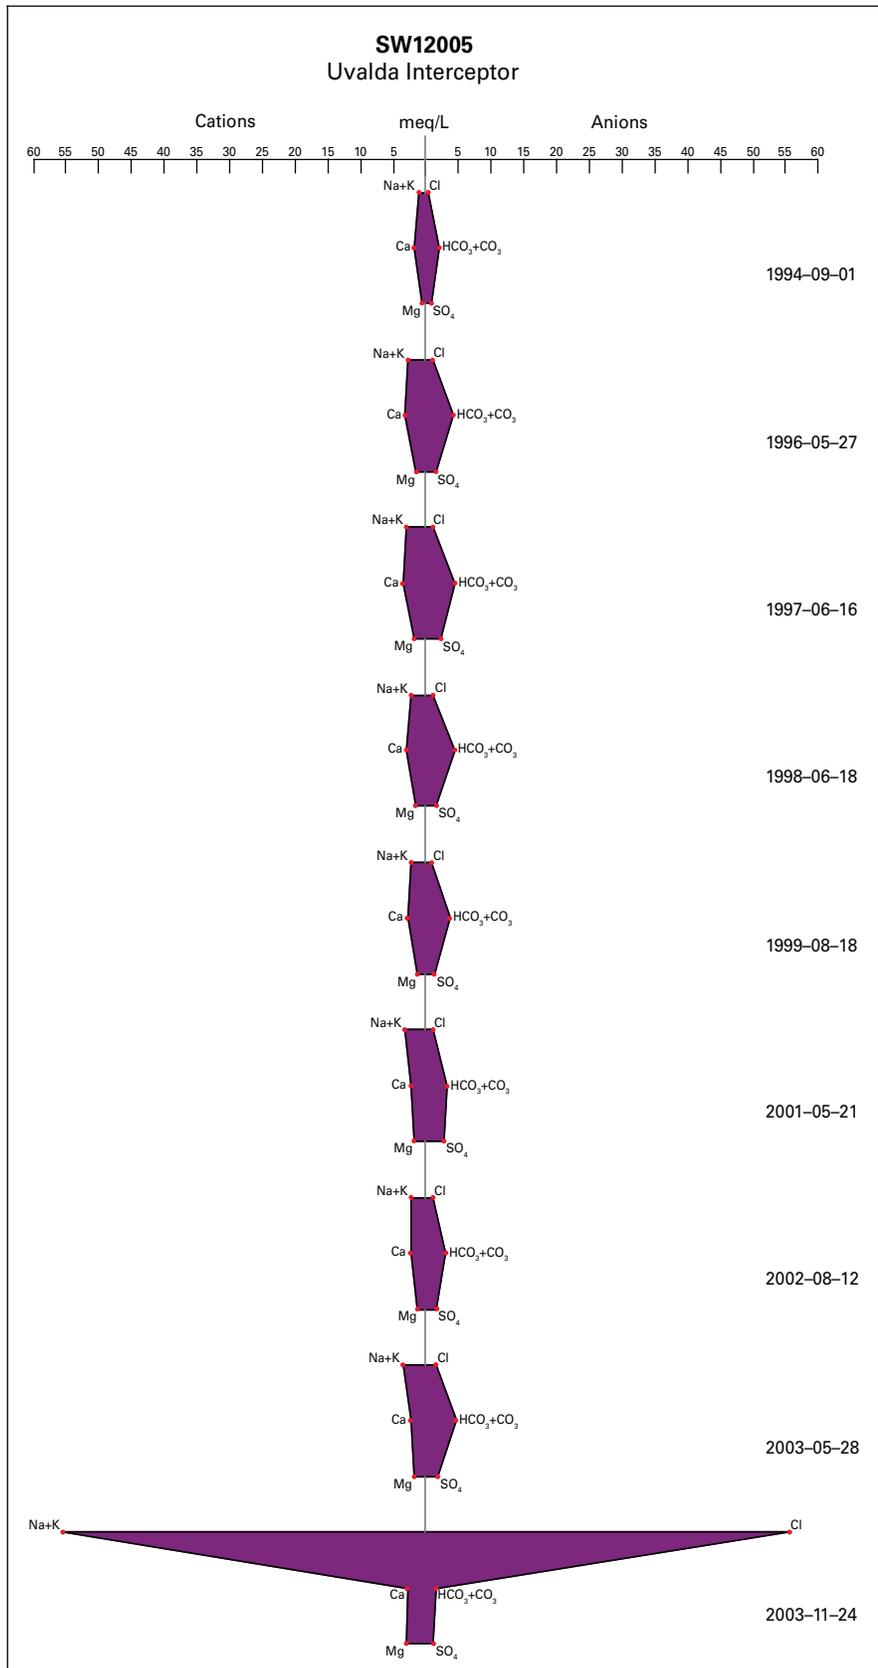
**Figure 20.** Concentrations of selected cations and anions in milliequivalents per liter for various sampling events at the Uvalda Interceptor below 56th Avenue gaging station, Commerce City, Colorado, 1994–2003.
