Use of Dye Tracing to Determine Ground-Water Movement to Mammoth Crystal Springs, Sylvan Pass Area, Yellowstone National Park, Wyoming

Scientific Investigations Report 2006-5126

U.S. Department of the Interior
U.S. Geological Survey

By Lawrence E. Spangler and David D. Susong

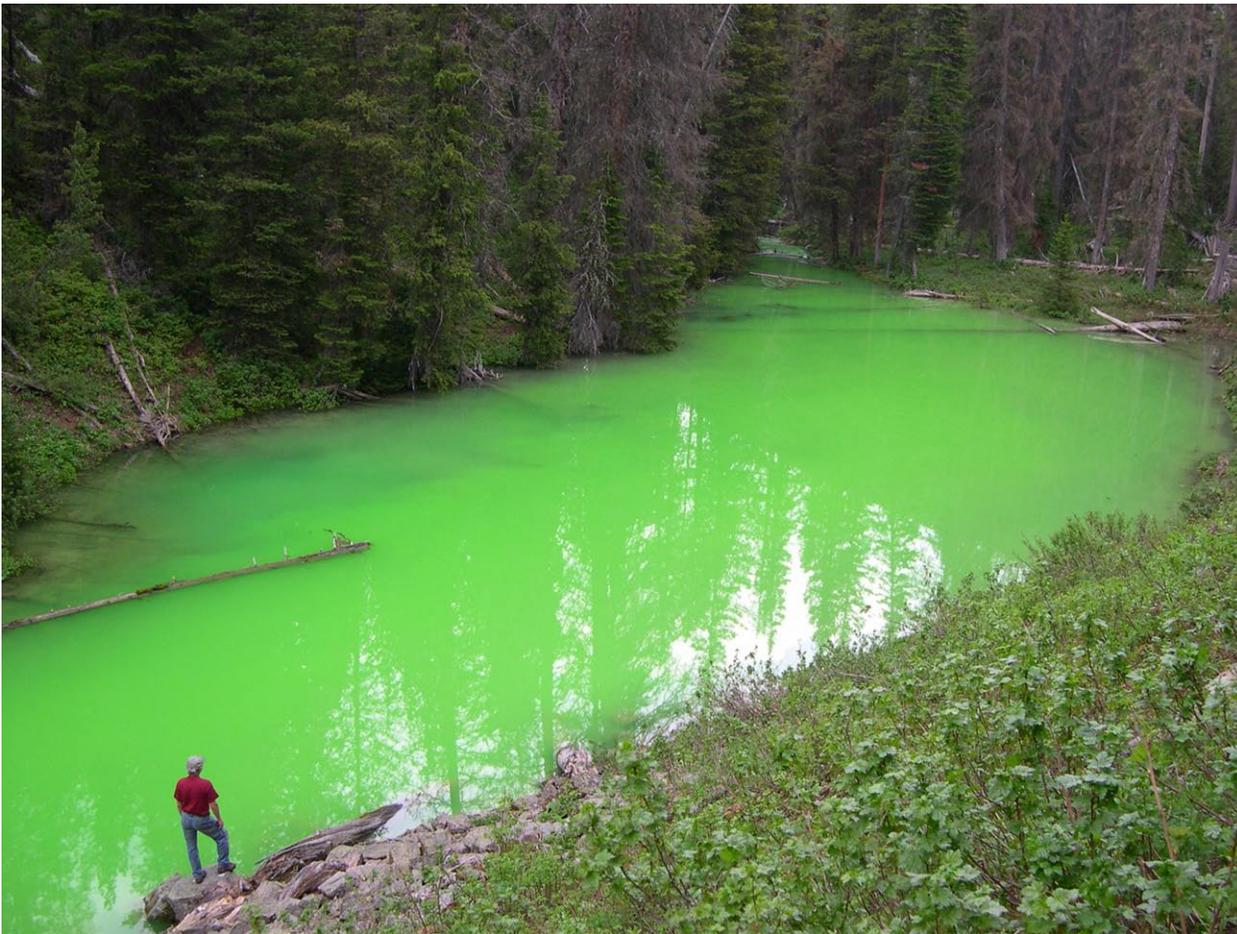
Cover photo: Mammoth Crystal Springs about 1 day after injection of fluorescein dye.
Photograph taken by David Susong, U.S. Geological Survey, June 22, 2005.

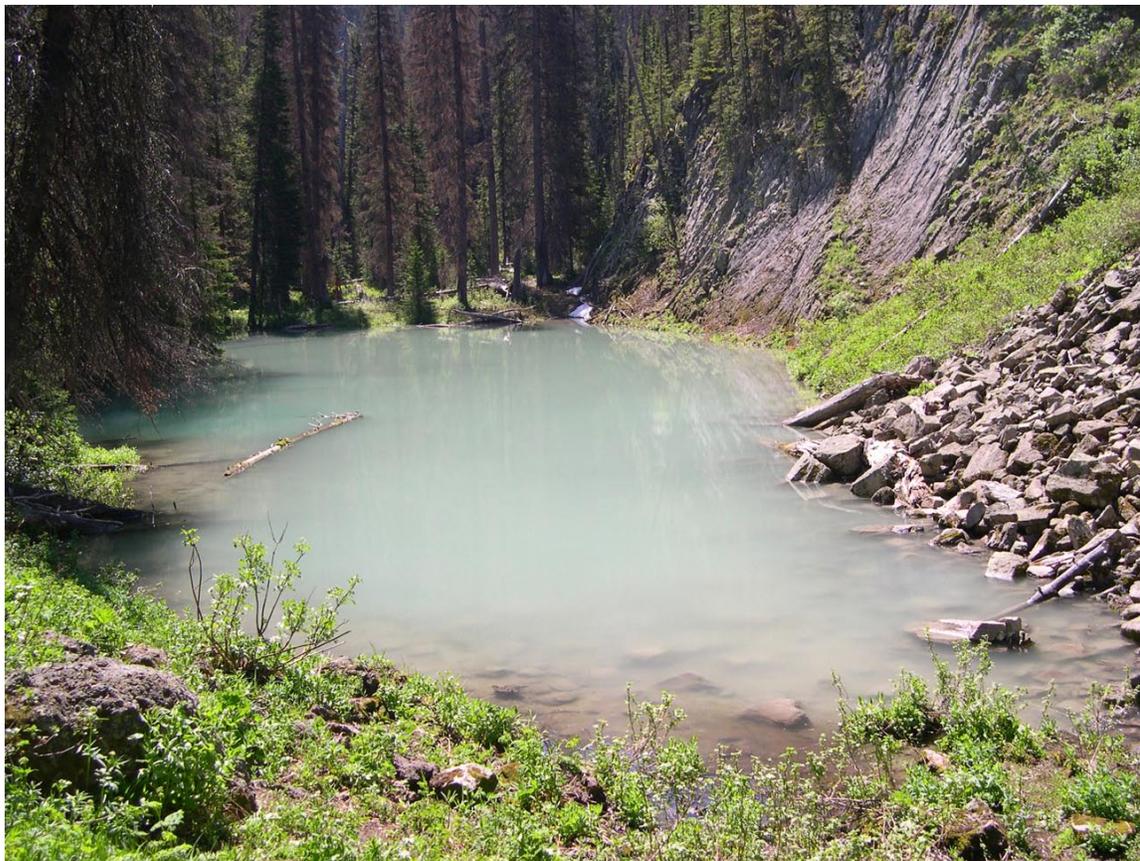
Figure 2. View of Mammoth Crystal Springs near Sylvan Pass, Yellowstone National Park, Wyoming.

The milky white turbidity in the lake results from very fine rock material in suspension. The springs discharge from talus at lower right. Photograph taken June 21, 2005.

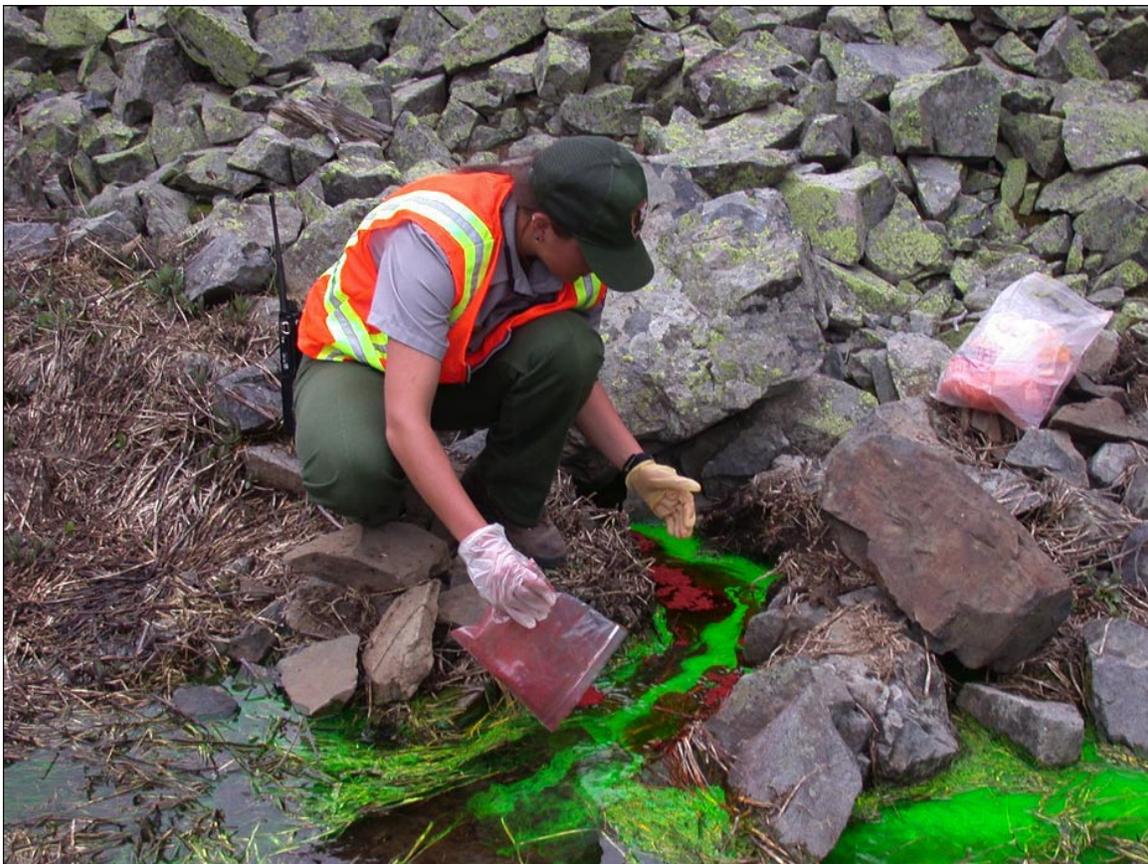
Figure 5. Injection of fluorescein dye into talus on Sylvan Pass, Yellowstone National Park, Wyoming. Dye was injected beginning at 2:50 PM on June 21, 2005, and observed visually less than 1 day later at Mammoth Crystal Springs. Photograph taken by Henry Heasler, National Park Service.

Fluorescein dye is manufactured as a red powder that turns a vivid fluorescent green when placed in contact with water. The dye was injected directly as a powder into the water at the point of loss (fig. 1, site 4; and fig. 5). The injection was initiated after all of the activated charcoal detectors were in place and the autosampler had been deployed. At the request of the National Park Service, the dye was injected in a sufficient amount to enable it to be seen visually in the spring-fed lake. On the basis of formulas derived by Worthington Groundwater (Stephen Worthington, written commun., 2004) and discussions with Geary Schindel (Edwards Aquifer Authority, oral commun., 2005), it was calculated that between 15 and 20 lbs of the dye would yield a concentration of at least 500 $\mu\text{g/L}$, more than adequate for a visual trace. The amount of the injected dye was determined on the basis of the measured discharge of the springs, the distance from the injection site to the springs, and the desired peak concentration at the springs.

On June 21, 2005, from about 14:50 to 15:25, 19 lbs of fluorescein dye were injected into each of five different losing points of a stream along the base of a talus slope on the south side of Sylvan Pass (fig. 1, site 4; and figs. 4 and 5). Total flow of the stream was visually estimated to be no more than about 1 ft³/s, and discharge of Mammoth Crystal Springs was estimated to have peaked at about 15 ft³/s (fig. 3A). On June 22, at about 13:50, dye was observed to be issuing from Mammoth Crystal Springs along the western margin of the spring-fed lake (fig. 6) (Henry Heasler, National Park Service, oral commun., 2005), indicating a hydraulic connection with the injection site and a ground-water travel time of about 23 hours from the time of injection. Results of analysis of a water sample collected from the spring inflow (fig. 1, site 6) at 11:00 indicate, however, that dye breakthrough (first arrival) may have been almost 3 hours earlier, or about 20 hours after

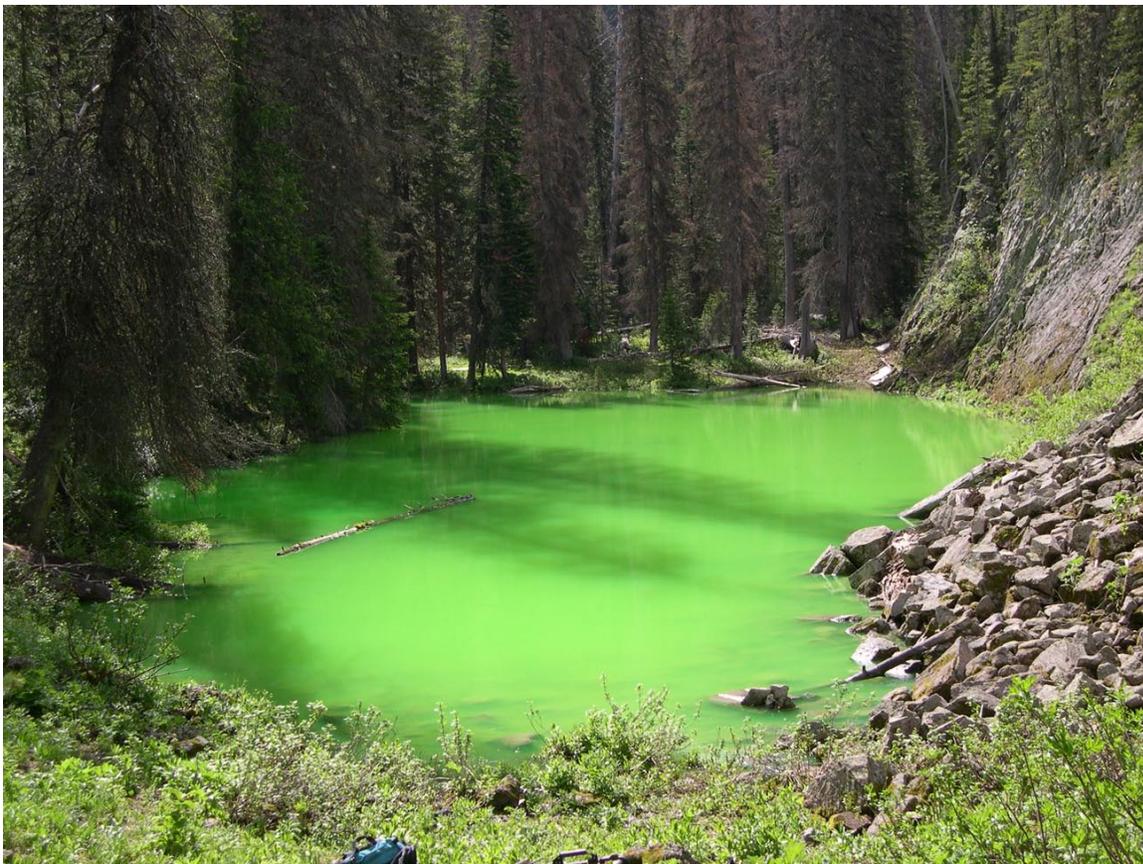
Figure 6. View of Mammoth Crystal Springs about 27 hours after injection of fluorescein dye on Sylvan Pass, Yellowstone National Park, Wyoming. Photograph taken June 22, 2005.
