Post-Wildfire Sedimentation in Saguaro National Park, Rincon Mountain District, and Effects on Lowland Leopard Frog Habitat

By John T.C. Parker

Scientific Investigations Report 2006–5235

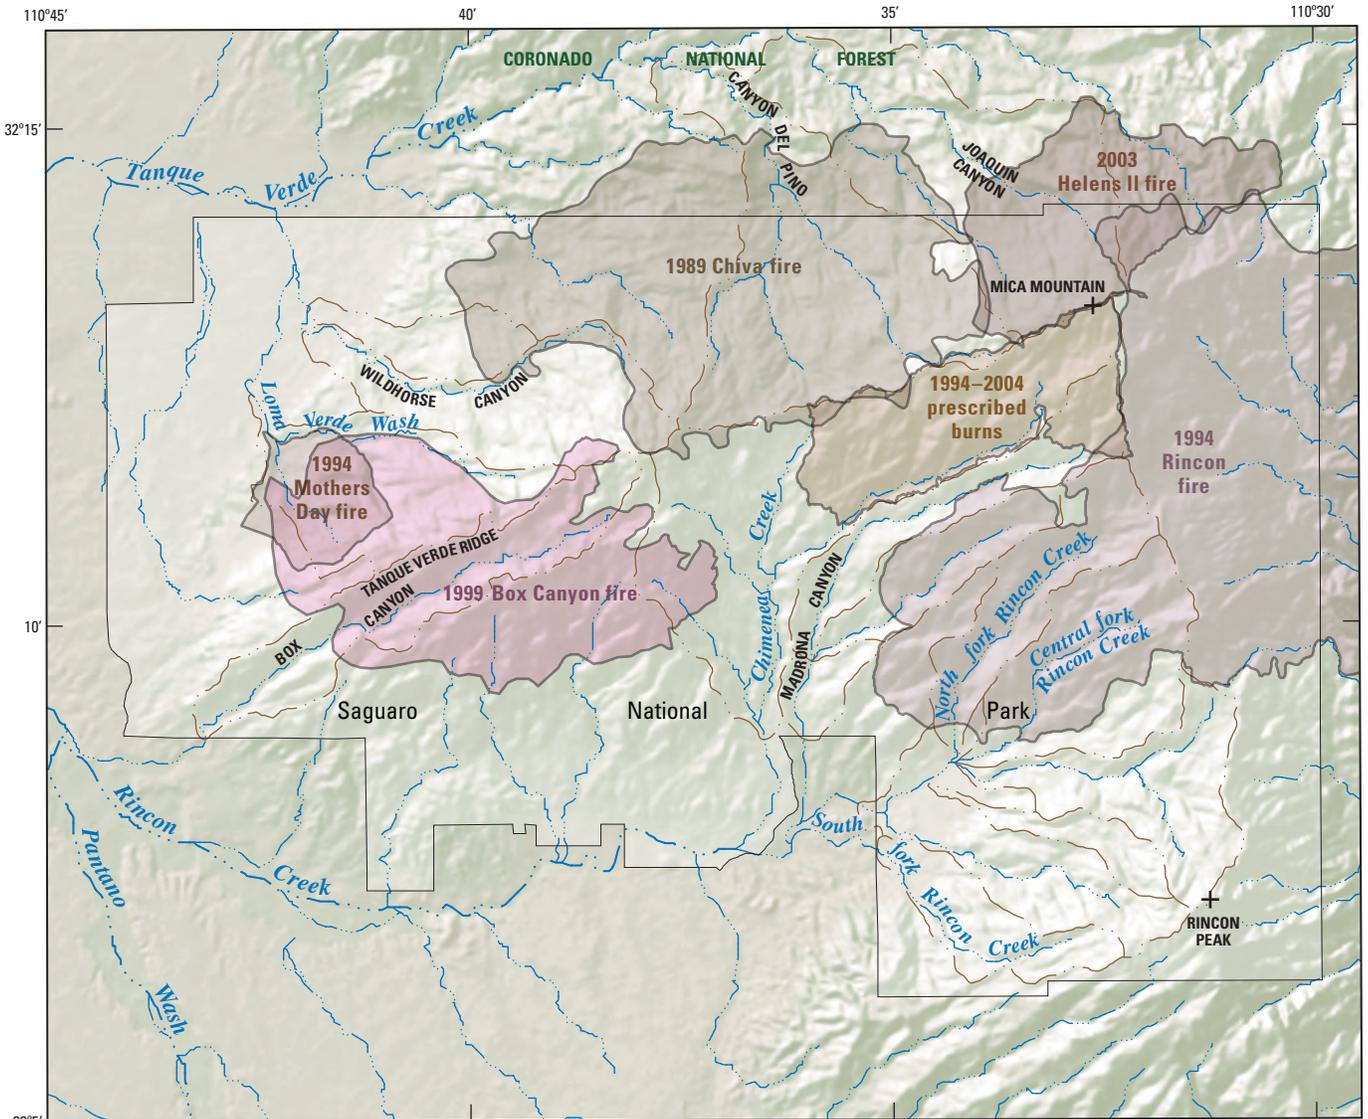
Figure 1. Location map of study area and extent of major burns occurring 1989–2004, Saguaro National Park, Rincon Mountain District, Arizona.

Most field surveys were conducted within the Helens II burn zone and in the stream channels of Joaquin Canyon in Coronado National Forest lands north of the park boundary as well as in the channels of Loma Verde Wash (fig. 1). Reconnaissance surveys of watersheds in older burn areas including the Chiva, Box Canyon, and Rincon burn areas (fig. 1) were conducted to assess watershed recovery and a reconnaissance was also conducted of the watershed east of Rincon Creek, which has had no significant wildfire in more than 60 years. Channel conditions were also assessed in one-day surveys of Wildhorse Canyon, Box Canyon, the North Fork of Rincon Creek and upper Chimenea Creek. The locations of field observations were determined using a hand-held GPS device and important sites were photographed. GPS failures and poor photographic quality at many sites frustrated efforts to get good repeat photos during successive visits to sites in the Helens II burn area. Consequently, photographs used to illustrate examples of sedimentation mechanisms are not necessarily presented in chronological order unless so stated.

Of the recent fires, the Rincon fire of 1994 was the largest historical fire, burning about 5,360 ha in the park and in Coronado National Forest lands surrounding the park (figs. 1 and 8). Fire size is based on the perimeter of the fire area and may include sizeable swaths of vegetation that are untouched by fire as well as many individual trees and other plants that are lightly burned and ultimately survive.

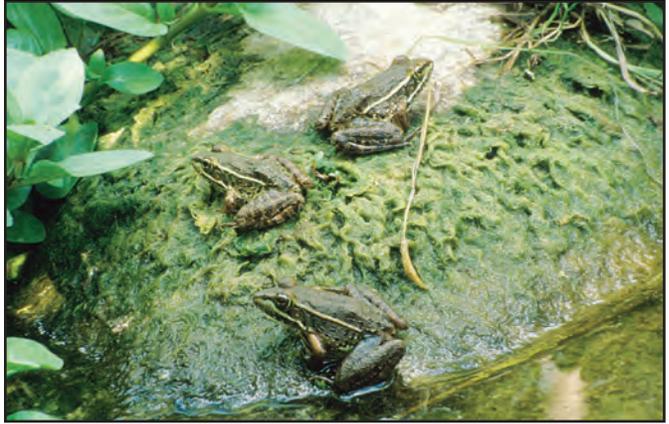
Figure 3. (Below) Location of leopard frog habitat in Saguaro National Park, Rincon Mountain District, Arizona.

From July 2005 to April 2006, volunteers and park staff conducted surveys of 23 tinajas in seven stream channels to measure pool dimensions and probe sediment deposits to determine depth of sedimentation and volume of the deposits (fig. 15, table 5). Tinajas in Loma Verde Wash contained highest volumes of sediment per pool volume with three of the seven pools sampled having 100 percent or greater of pool capacity filled with sand and gravel. The mean volume of pool capacity occupied by sediment for the Loma Verde pools was 81 percent, compared to 17.3 percent for the remaining 16 pools. Pools LV1 and LVAV2 had been artificially excavated before this survey. Both pools were approximately 100 percent filled at the time they were excavated. Wildhorse Canyon was the only other channel in which a tinaja was sampled that was more than 50 percent filled with sediment (pool WH4, figs. 3, 15; table 5).

burned watershed. Park staff; however, reported that the lower tinajas had not been filled with sediment following the Box Canyon fire as was the case with Loma Verde Wash. Tinajas BC1 and BC6 (fig. 3) were surveyed in winter 2005–06 and contained 9.7 and 0 percent sediment volume respectively (fig. 15, table 5). Only one adult leopard frog has been sighted since the 1999 fire, which might suggest some post-wildfire degradation of habitat though sightings of leopard frogs in the canyon were few before the fire and the population may never have been high (personal communication, Don Swann, biologist, Saguaro National Park, 2006).

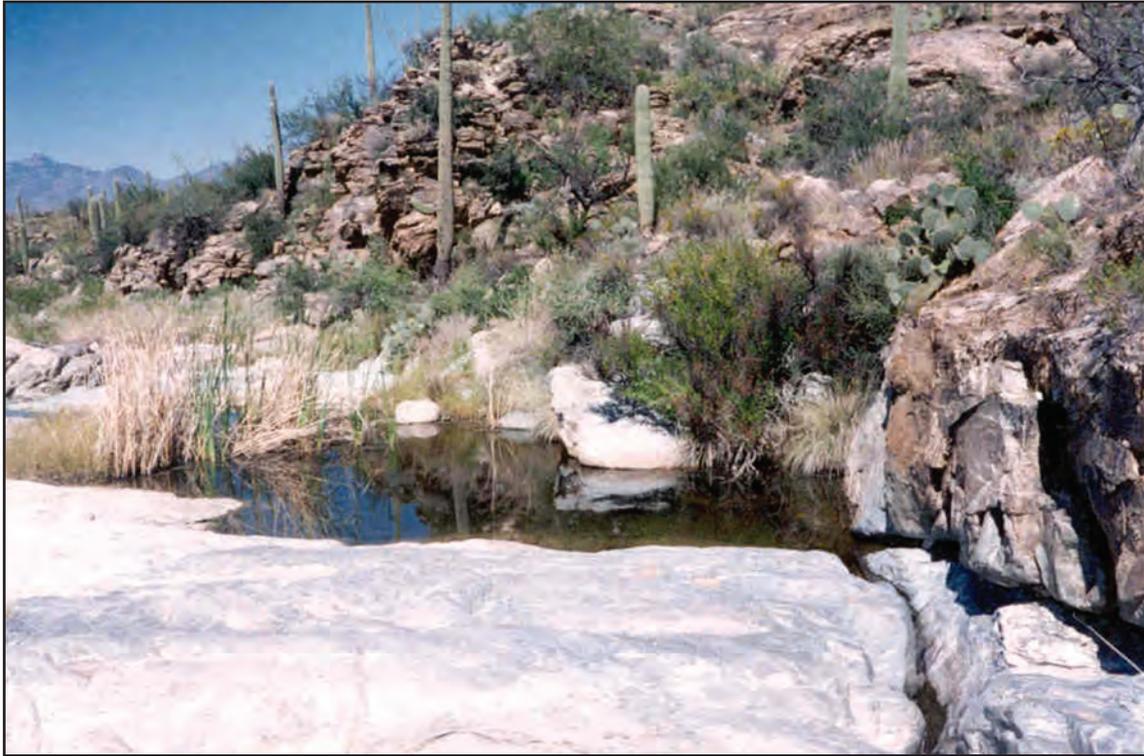
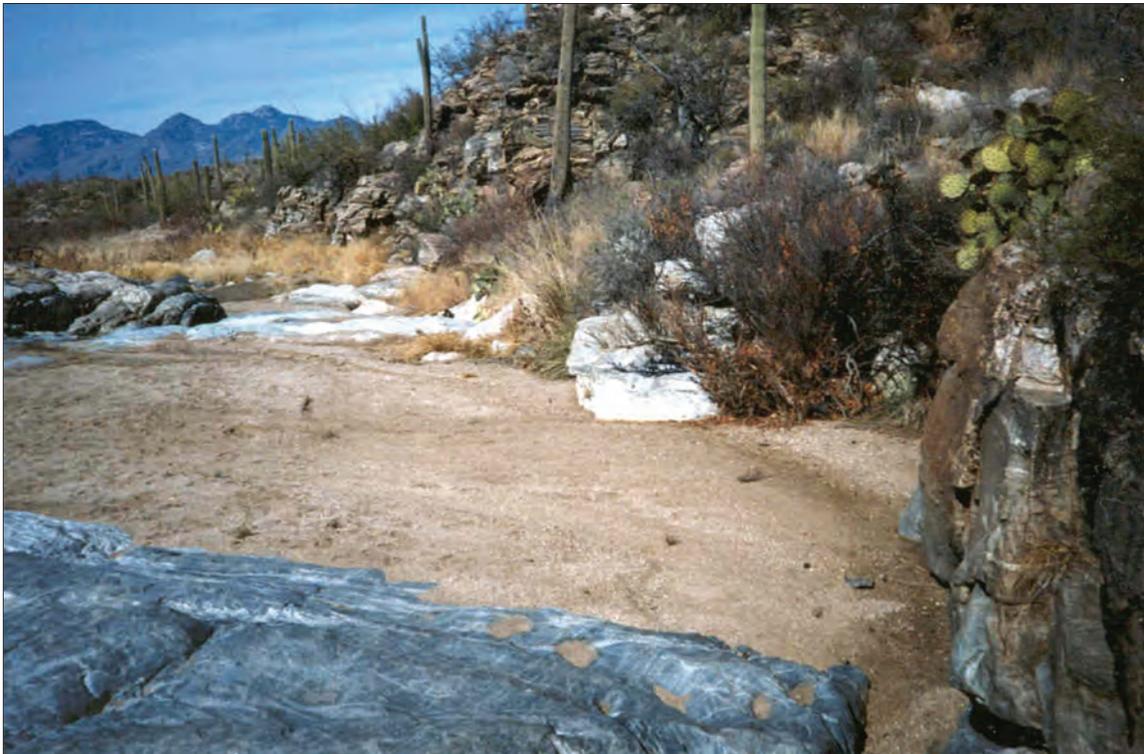
Figure 4. Sedimentation in tinajas in Saguaro National Park, Rincon Mountain District, Arizona. *A*, A tinaja in Loma Verde Wash, 1997, before the 1999 Box Canyon Fire; and *B*, the same tinaja several months after the 1999 Box Canyon Fire. (Photographs by Don Swann, Saguaro National Park.)

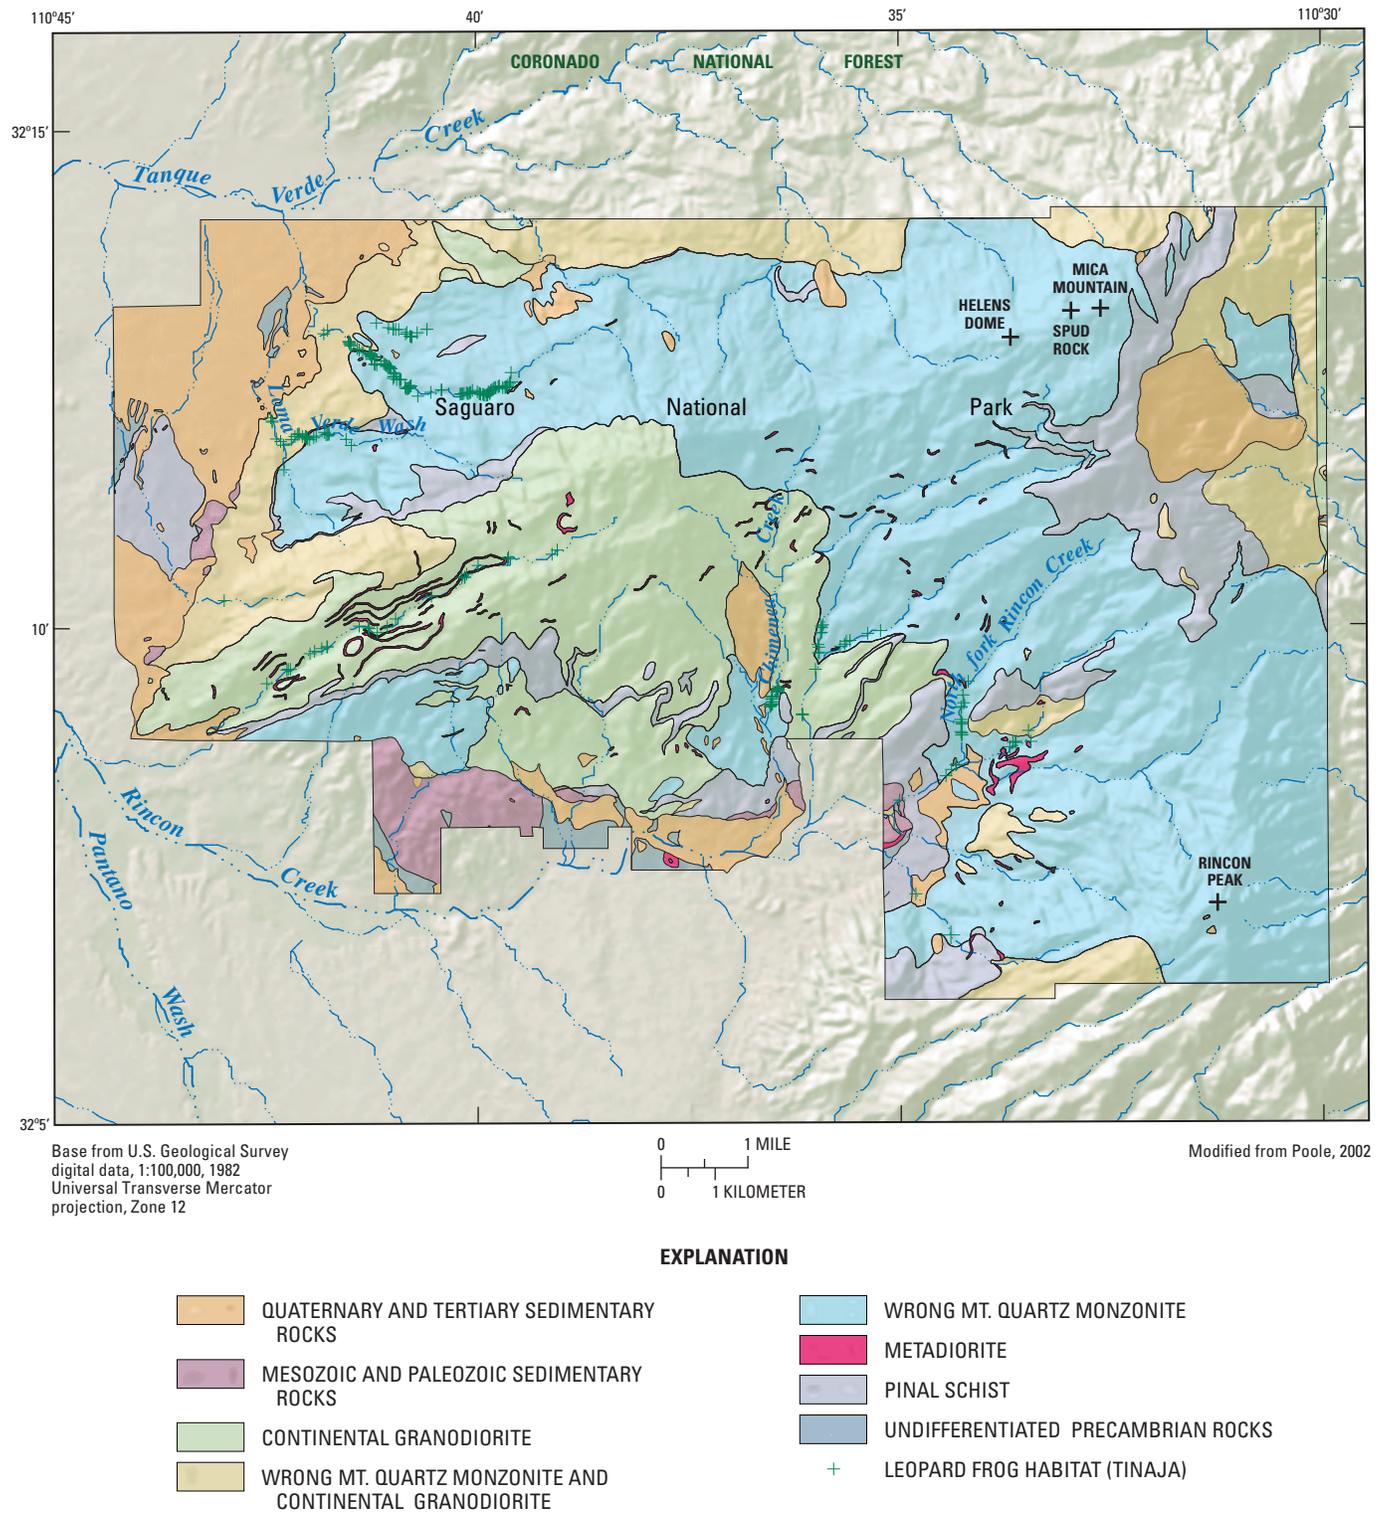
Figure 5. Geologic map of Saguaro National Park, Rincon Mountain District, Arizona.

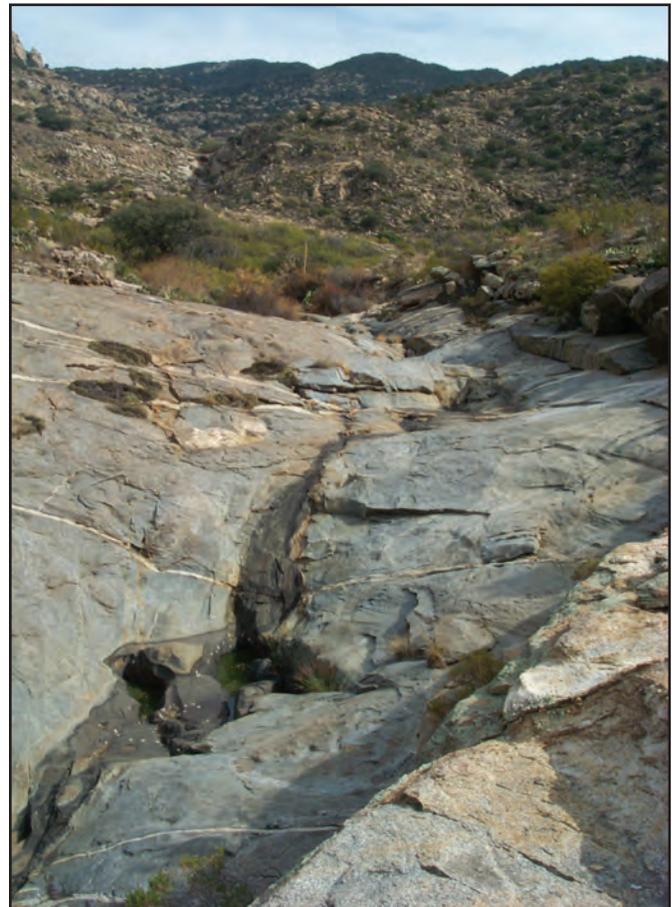
Figure 7. (Right) Typical polished bedrock channel, north fork of Rincon Creek, Saguaro National Park, Rincon Mountain District, Arizona.

Channel reaches characterized by smooth, polished banks and bottom contain little or no alluvium. The smooth bedrock surface in such reaches commonly is several times wider than the main channel, which can appear as a groove worn into that surface or as a narrow slot where the channel has followed the course of a fracture within the bedrock (fig. 7). In a few reaches, where the channel is contained within canyon walls of fractured rock, the channel is clogged with boulders that can be as much as 4 m in diameter, and most flows follow a circuitous path through the interstices within the boulder pile.

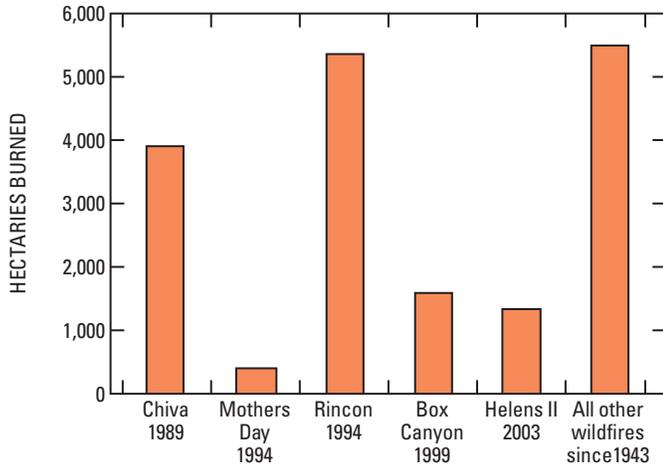
Figure 8. Fire history in Rincon Mountains since 1943, Saguaro National Park, Rincon Mountain District, Arizona.

Fire frequency declined in the late 19th and into the 20th century in the Rincon Mountains and throughout the Southwest as a result of fire suppression practices and livestock grazing that removed the forest understory (Baisan and Swetman, 1990). Except for large fires of 2,444 ha and 2,338 ha in 1943 and 1954 respectively, park records show only 409 ha burned in the period 1943–88. Then, in the period 1989–2003, five wildfires burned a total of 17,400 ha, more than 3 times the total area of all other fires combined for the period 1943–2003 (fig. 8, table 3).

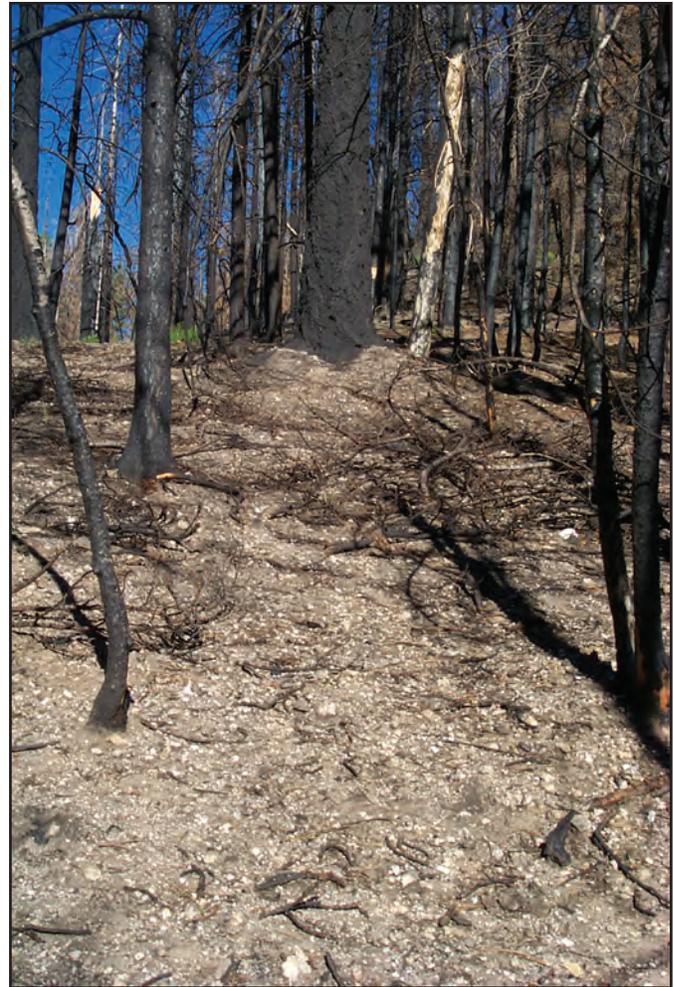
Figure 9. Mixed-conifer forest above the North Slope Trail after the Helens II fire of 2003, Saguaro National Park, Rincon Mountain District, Arizona.

In the area of greatest burn severity along the north slope of Mica Mountain and on the east slopes of Spud Rock, large patches of forest were totally destroyed (figs. 9, 11). Swaths of trees, standing and fallen, were completely blackened and the organic forest floor layer had been completely consumed by the fire though a new layer of dead conifer needles covered areas where the crowns had not been consumed in the fire. The exposed soil surface on hillsides in the Helens II burn area showed abundant evidence of erosion by overland flow including splays of sand and gravel and erosional pillars about 2–3 cm in height (fig. 12A). In general, rills were sparsely distributed, poorly formed and discontinuous and were seen mainly on slopes in finer-grained forest soils with gradients above about 60 percent. Typical rills were 10–30 cm wide and less than 5 cm deep. Little gully erosion had occurred; however, there was abundant evidence of weakly channelized flow (fig. 12B) and scouring of sediment from swales and headwater channels (fig. 12C). There was some evidence of debris flows, mainly coarse overbank and channel deposits in headwater tributaries of Joaquin Canyon (fig. 12D). By far, the most extensive process of sediment transport from hillslopes appeared to be the result of a combination of rainsplash erosion that resulted in winnowing of finer-grained sediment, mainly sand, from the poorly sorted, stony hillslope sediments and the subsequent downslope transport of the

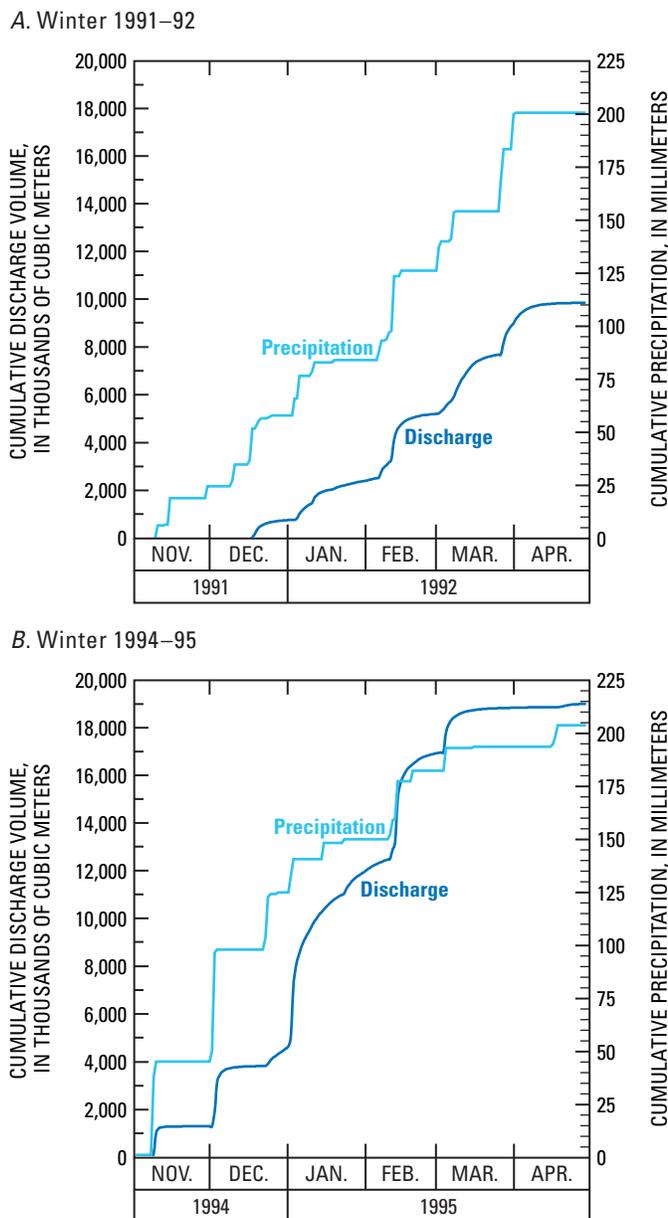
Figure 10. Cumulative daily discharge for Rincon Creek station (09485000) and cumulative daily precipitation at Tucson, Arizona. A, Winter 1991–92; B, Winter 1994–95.

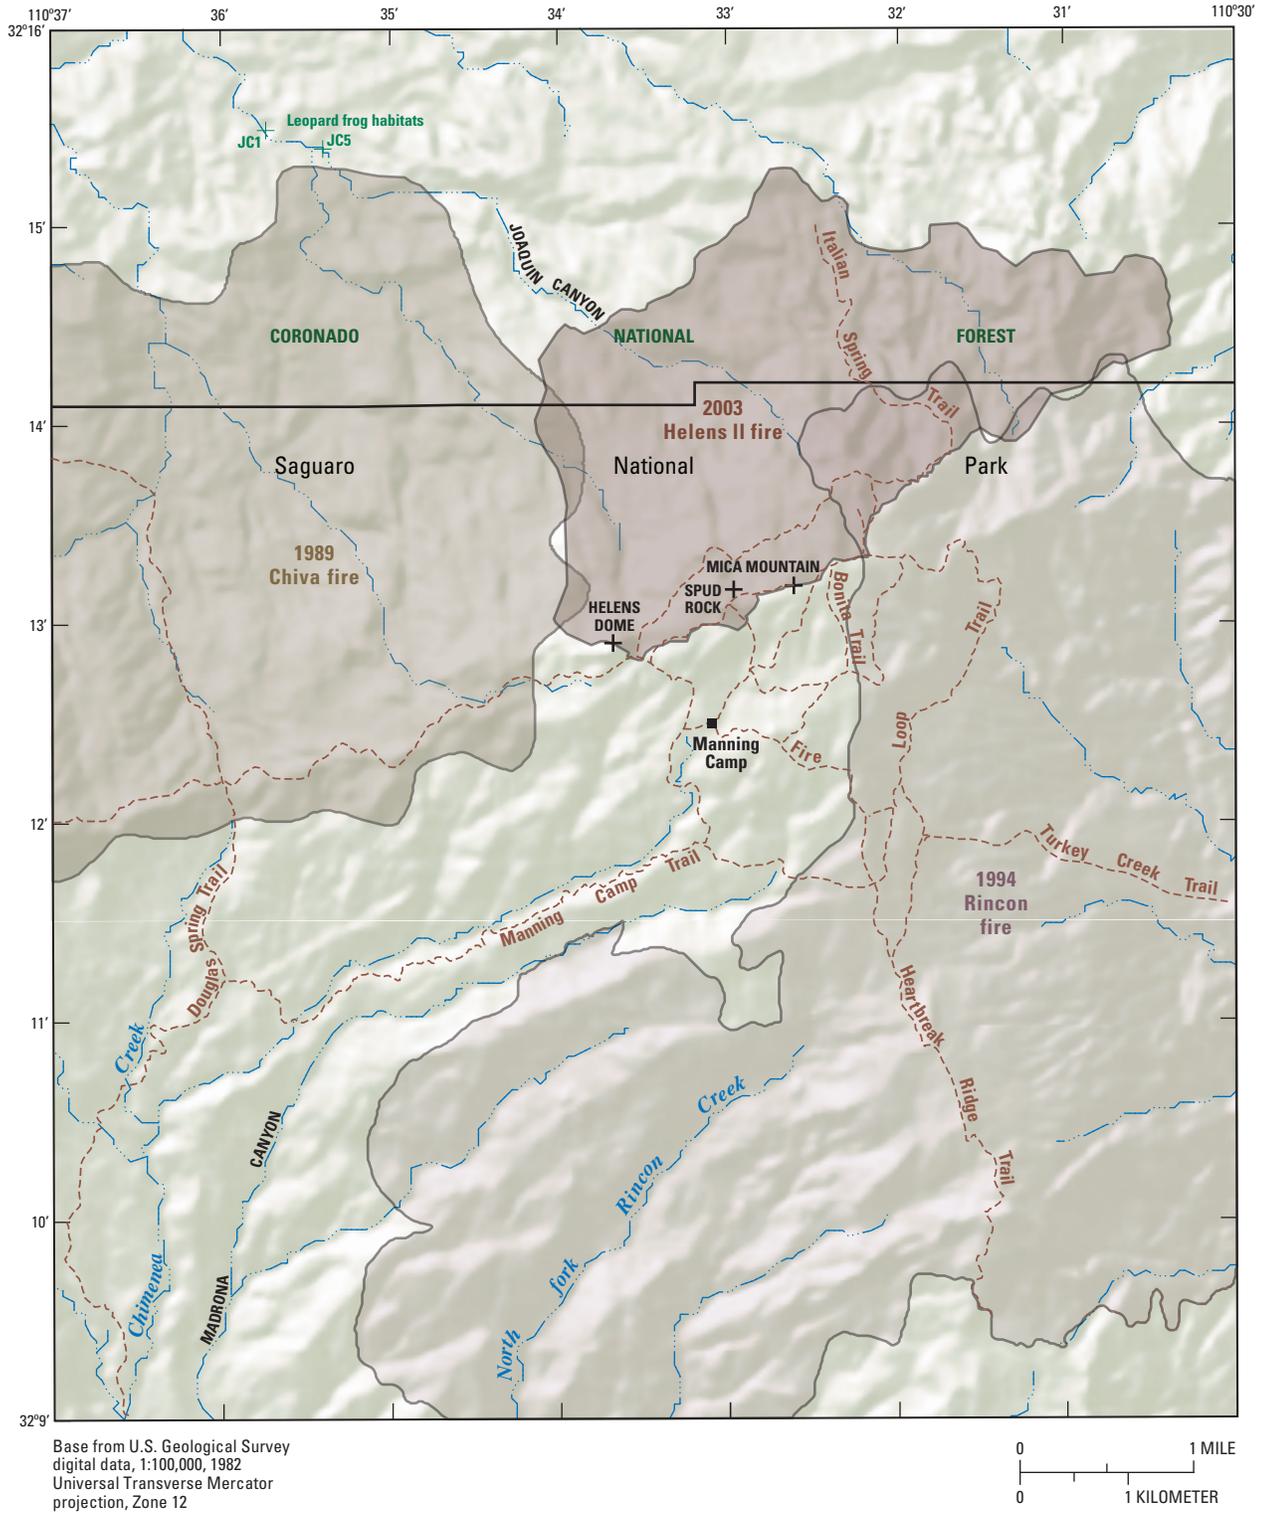
Figure 11. Helens II burn area and Joaquin Canyon, Saguaro National Park, Rincon Mountain District, Arizona.

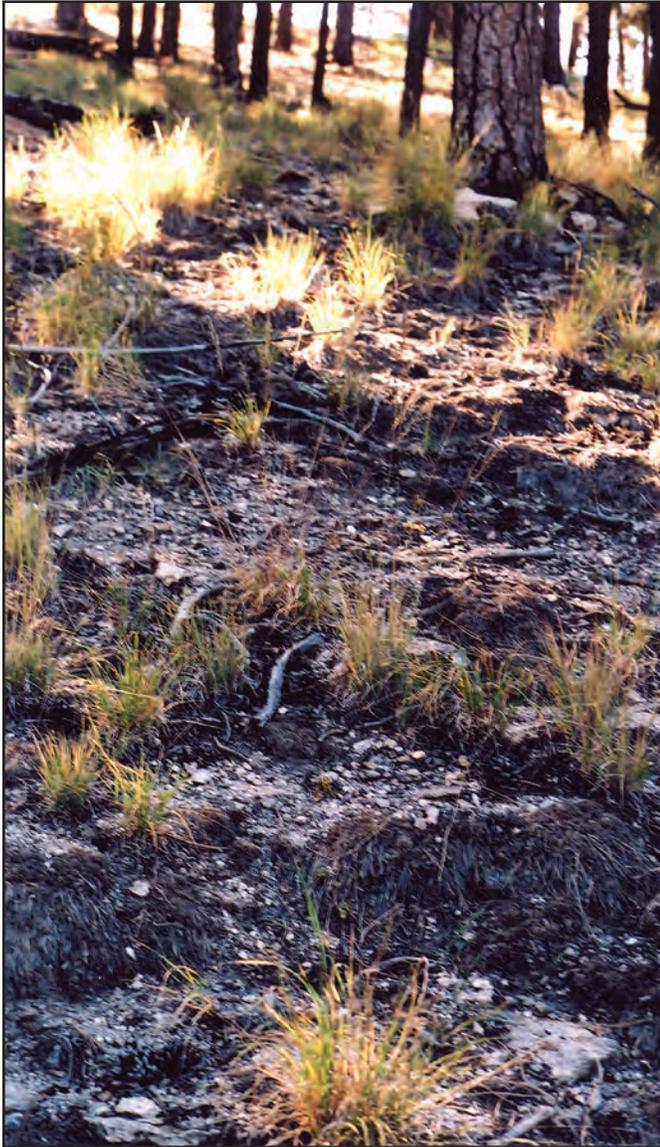
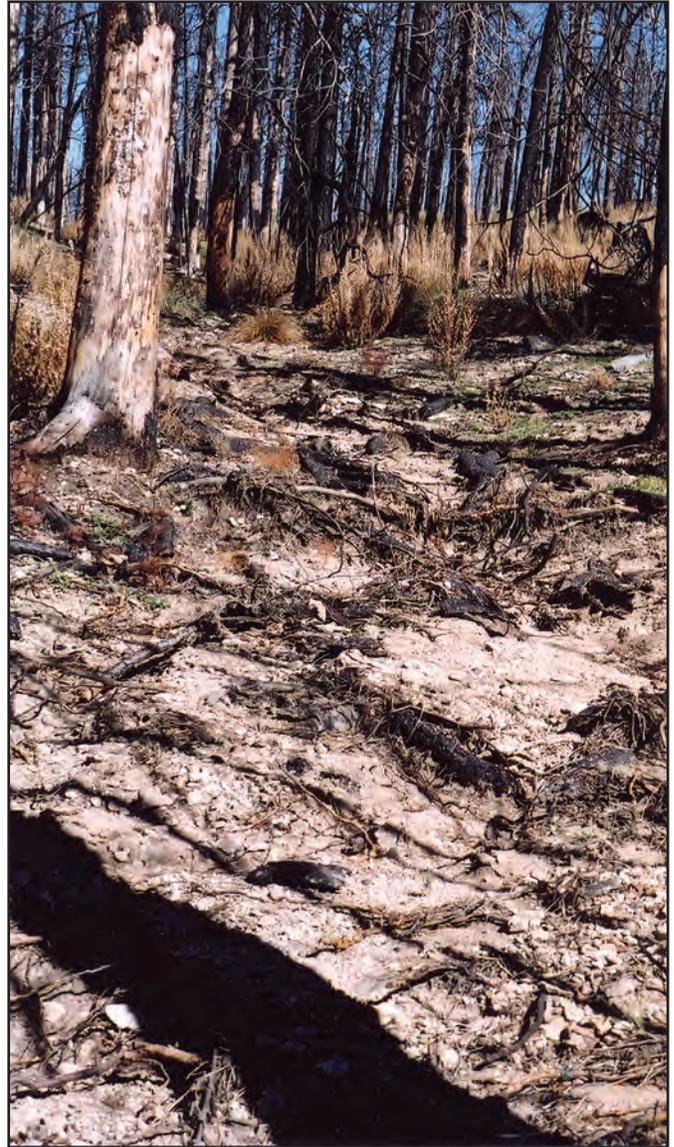
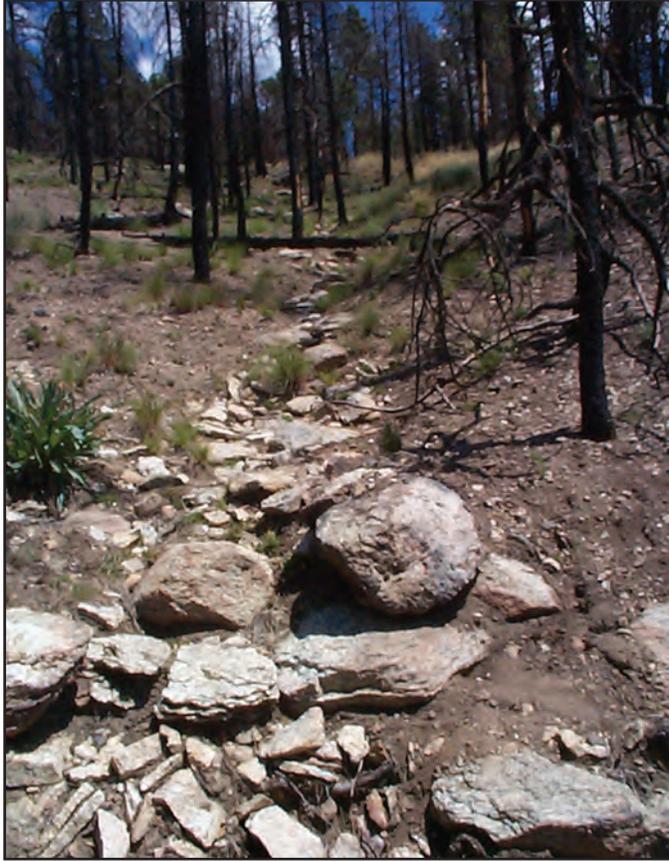
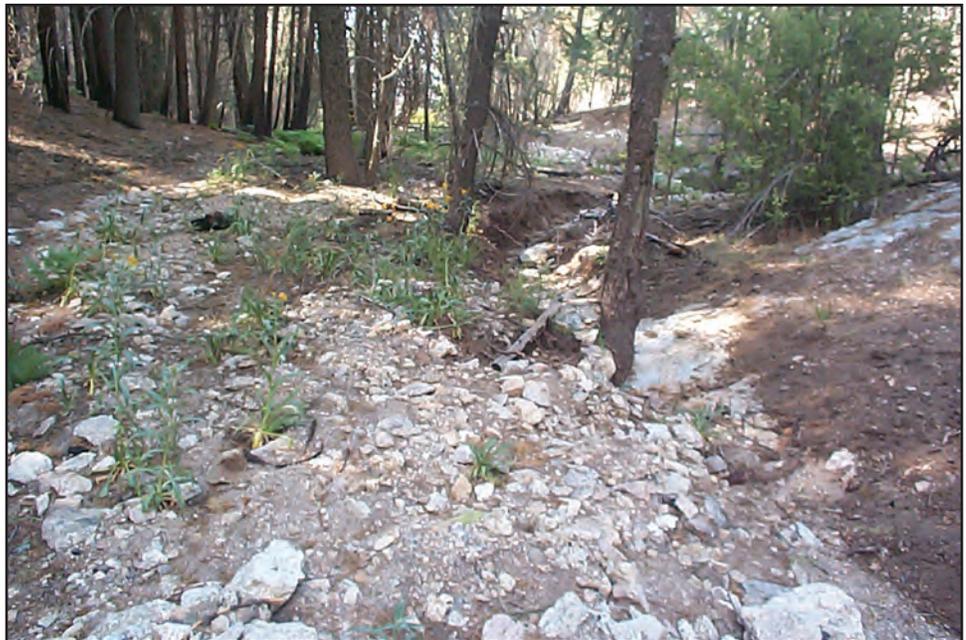
A. Erosion pillars created by sheetwash

B. Weakly channelized flow on burned hillslope

Figure 12. Post-wildfire erosion mechanisms, Saguaro National Park, Rincon Mountain District, Arizona. *A*, Erosion pillars created by sheetwash; *B*, Weakly channelized flow on burned hillslope; *C*, Boulder lag in scoured swale; *D*, Coarse, poorly sorted, post-wildfire overbank deposits in Joaquin Canyon tributary.

C. Boulder lag in scoured swale

D. Coarse, poorly sorted, post-wildfire overbank deposits

material by unchannelized and weakly channelized flow. There was no evidence of hillslope erosion to depths of greater than about 15 cm on the slopes and most evidence suggested that erosion depths were more commonly restricted to 2–3 cm. The absence of deep gullies or landslide scars indicates that sediment was moved downslope mainly by surface flow rather than being entrained as a mass. This sediment transport mechanism is characteristic of burned watersheds where the rapid delivery and accumulation of surface water to the bare ground surface and consequent increased runoff results in minimal infiltration into the soil layer (Wells, 1987; Cannon and others, 1998; 2001).

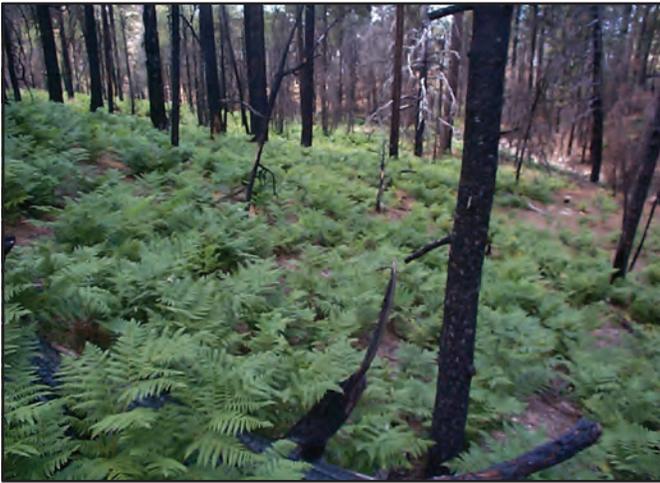
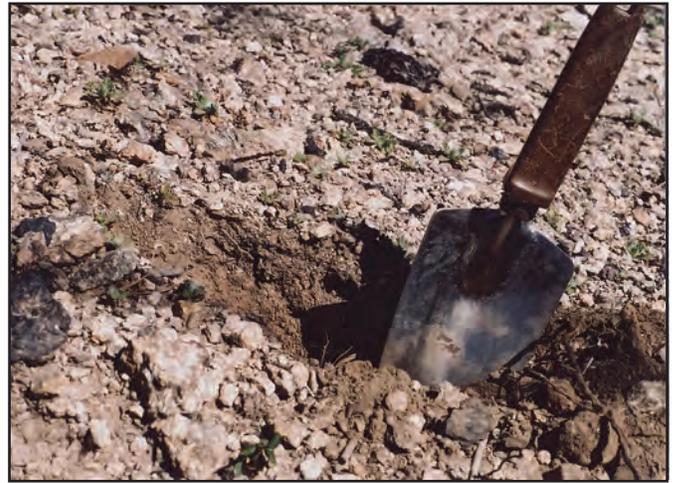
A. Revegetation two years after the fire

B. Formation of coarse gravel lag

Figure 13. Stabilization of hill slopes in Helens II burn area, Saguaro National Park, Rincon Mountain District, Arizona. *A*, Revegetation two years after the fire. *B*, Formation of coarse gravel lag above finer soil matrix.

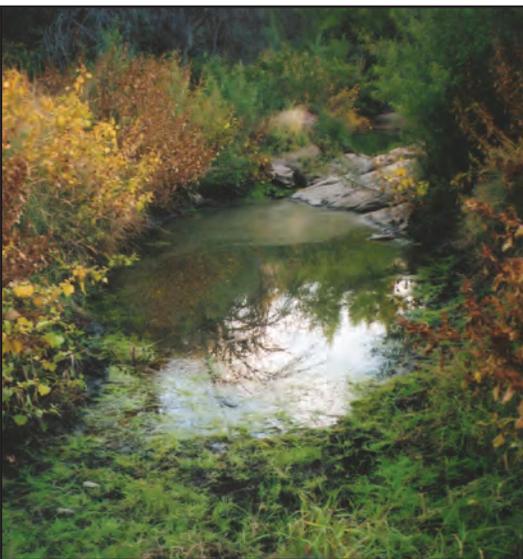
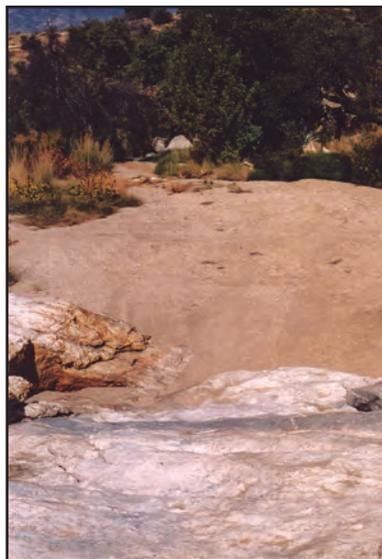
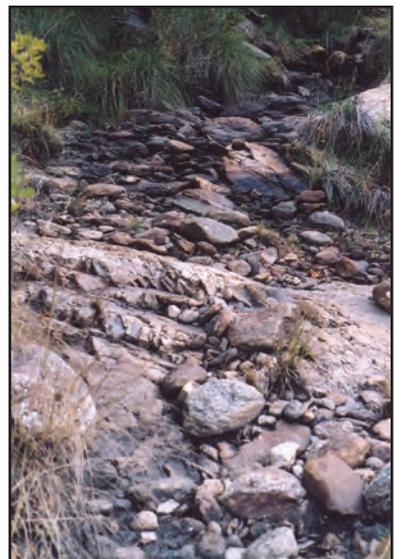
A. Pool JC1

B. Pool JC5

C. Downstream end of Joaquin Canyon

Figure 14. Joaquin Canyon tinajas and channel in October 2005, Coronado National Forest, Arizona. *A*, Pool JC1; *B*, Pool JC5; *C*, Downstream end of Joaquin Canyon near Tanque Verde Creek. (Photograph for fig. 14A from files of National Park Service, Saguaro National Park, Rincon Mountain District.)

14B; sample JCP11, table 2). At the time, that tinaja was the downstream limit of thick sand deposits, but by the time of the final survey in October 2005, thick deposits of sandy gravel had been deposited throughout the bouldery reach below pool JC5 for a distance of about 400 m downstream. The sand deposits ended abruptly at that point. The survey continued upstream another 750 m, where 7 more tinajas were examined, most of which had some sand deposition of varying degree but none were completely full. At the downstream end of Joaquin Canyon, the channel was an essentially sand-free gravel-bed channel at the time of the last survey (fig. 14C).

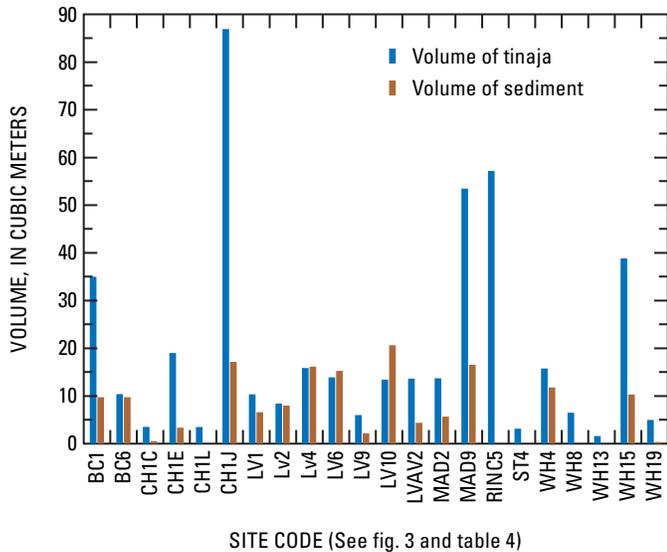
Figure 15. Volume of tinajas and volume occupied by sediment in channels of Rincon Mountains, 2005–06, Saguaro National Park, Rincon Mountain District, Arizona.

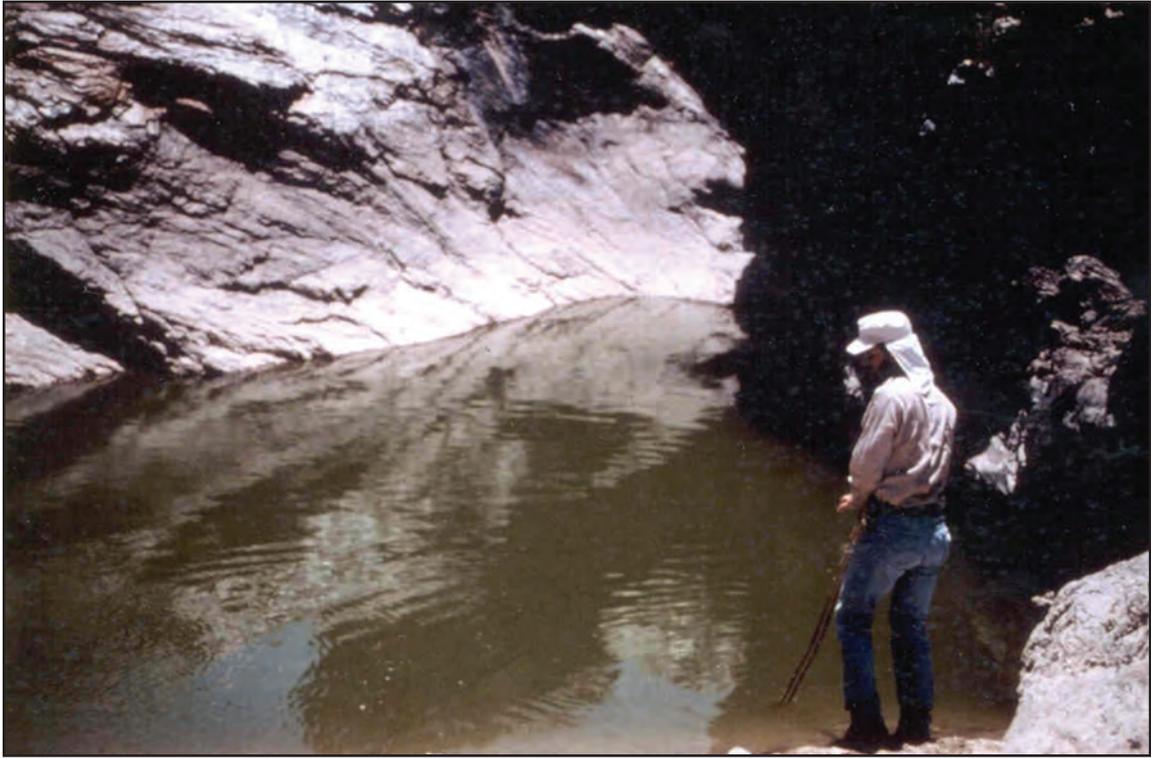
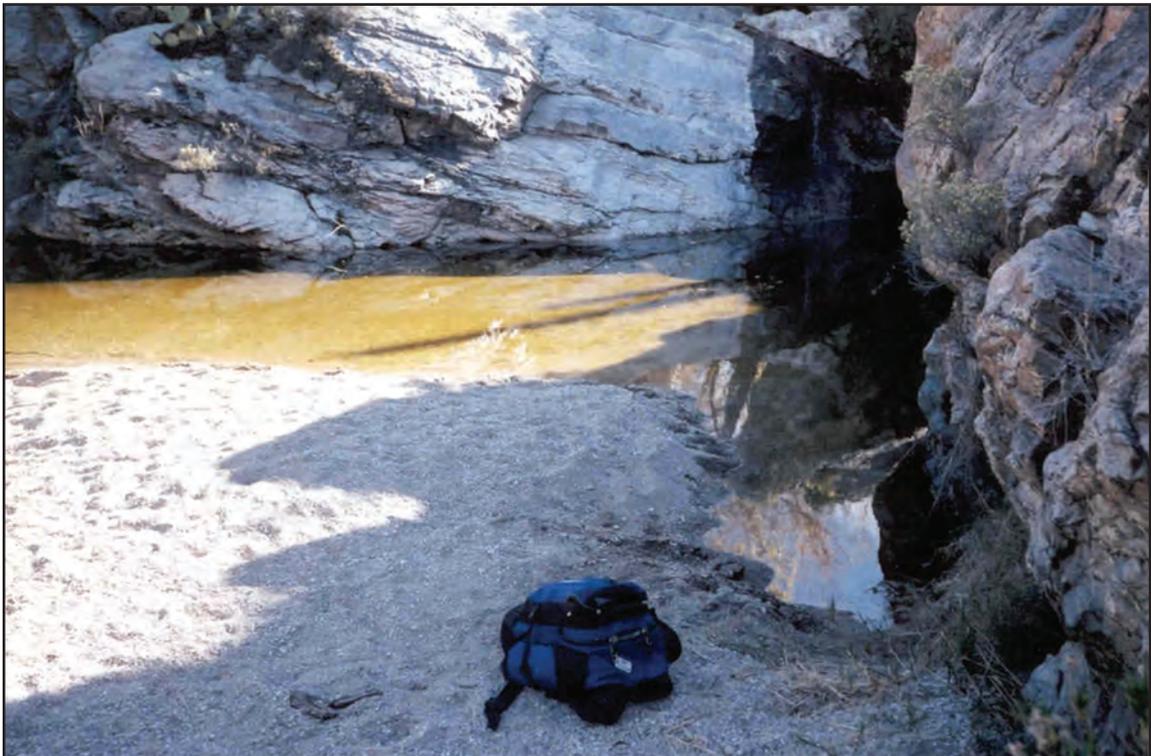
Figure 16. Tinaja in Wildhorse Canyon, Saguaro National Park, Rincon Mountain District, Arizona. A, Before Chiva fire of 1989; B, After Chiva fire. (Photo from files of National Park Service, Saguaro National Park, Rincon District, Arizona.)

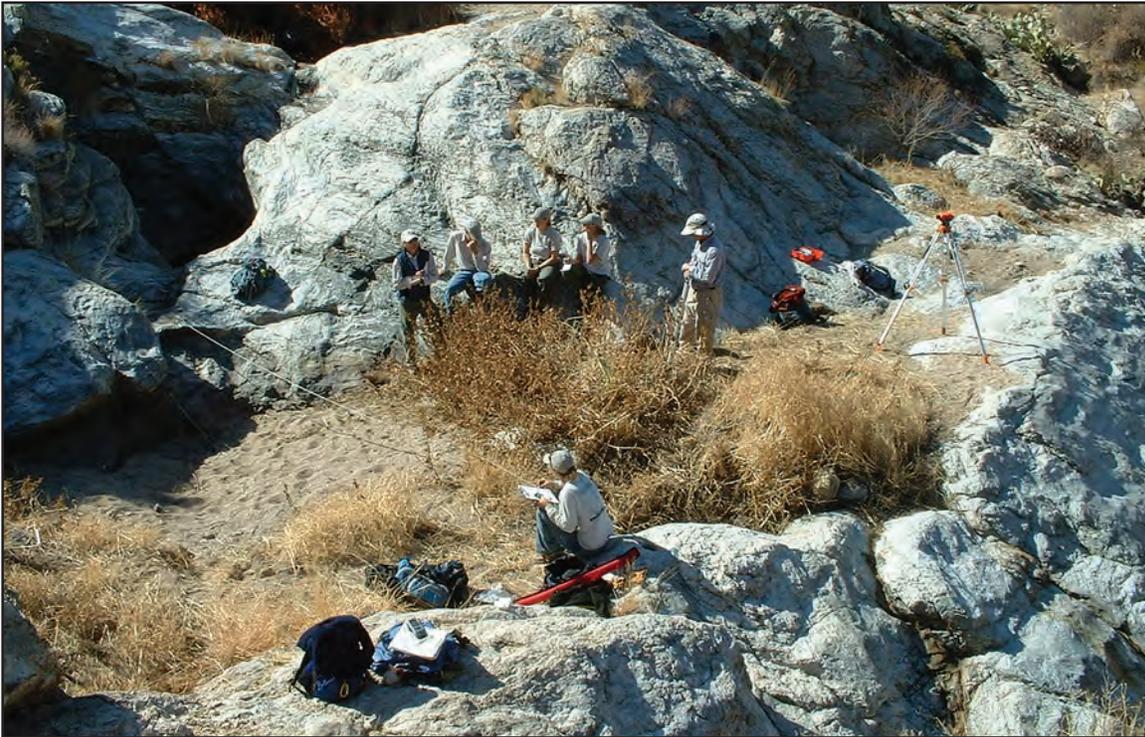
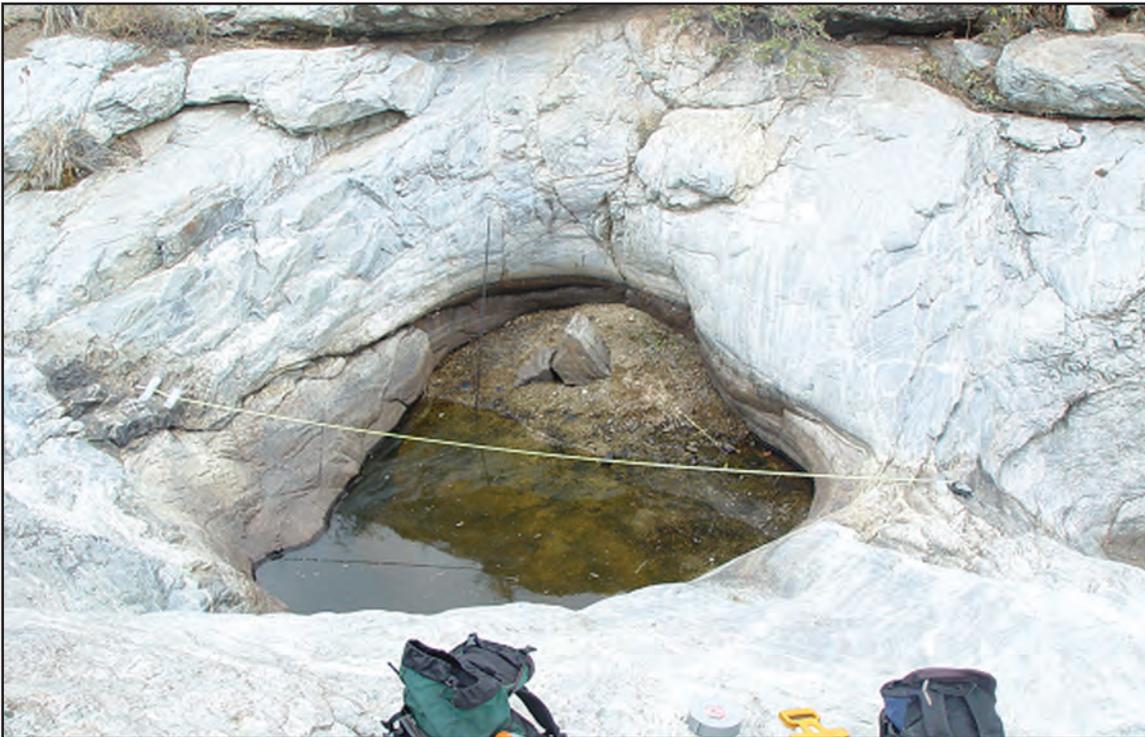
Figure 17. Tinajas in Loma Verde Wash, Saguaro National Park, Rincon Mountain District, Arizona. A, Tinaja LV4. B, Tinaja LV9. (Photographs from National Park Service.)
