Streamflow and Topographic Characteristics of the Platte River near Grand Island, Nebraska, 1938–2007

Scientific Investigations Report 2008–5106

By Brenda K. Woodward

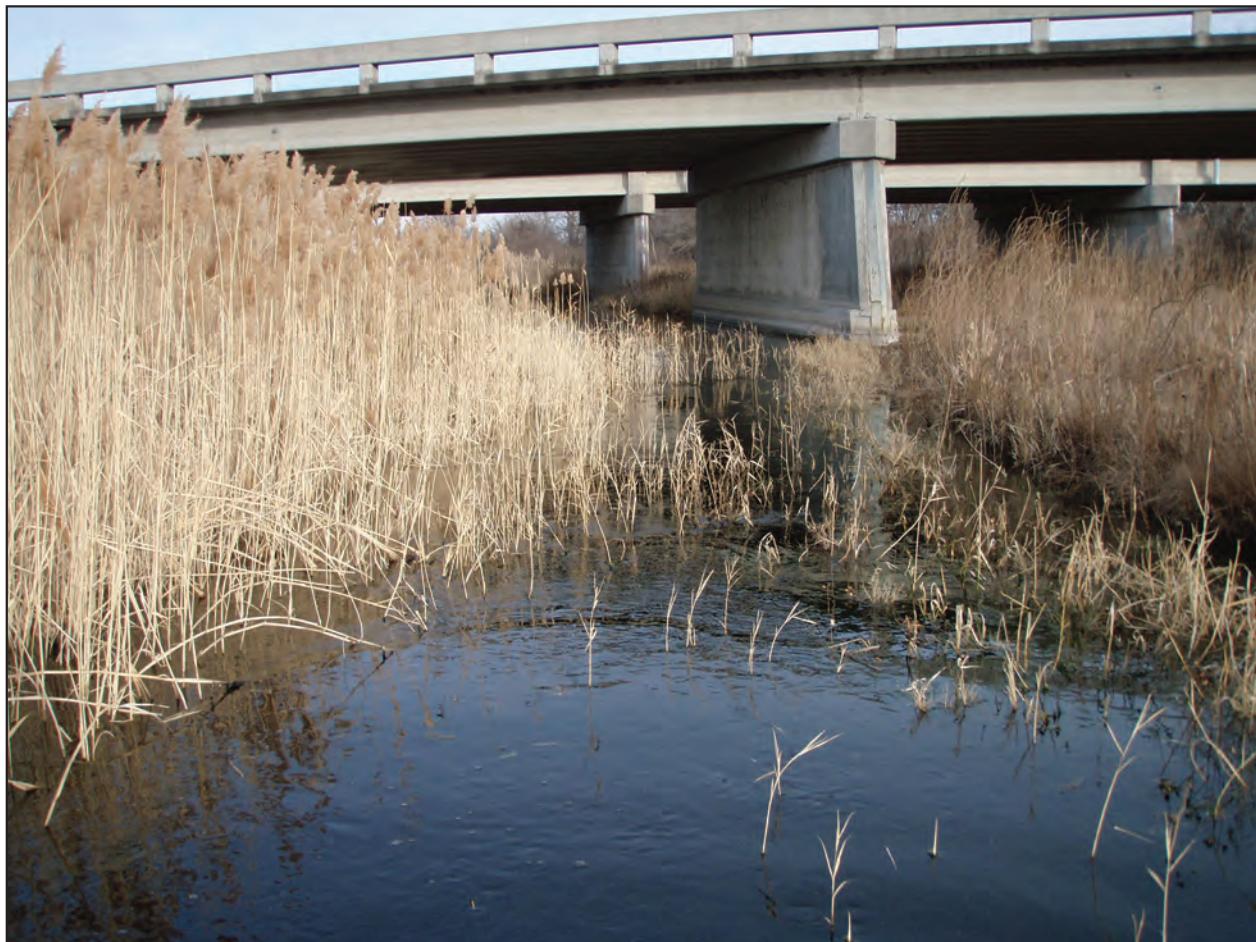
Figure 4. Common reed in the north channel of the Platte River upstream from U.S. Highway 281 (winter of 2007).

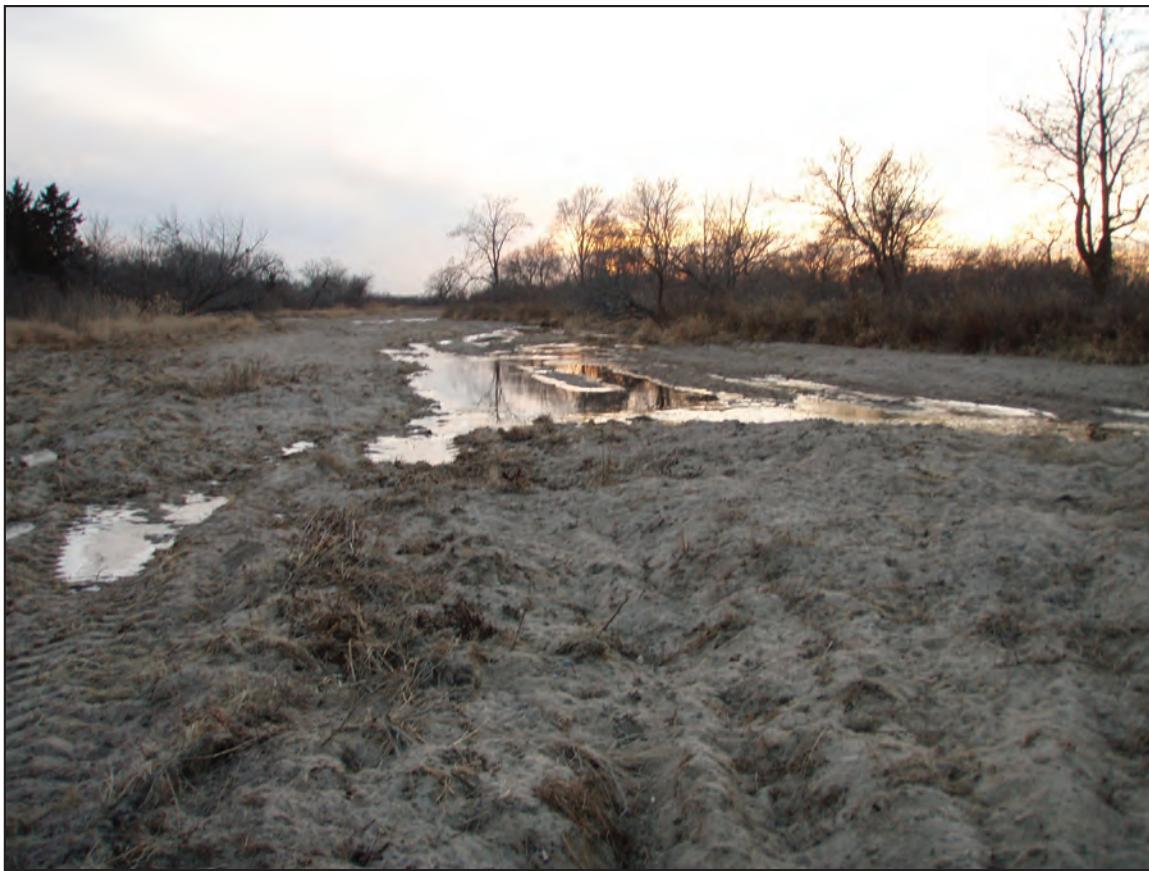
Figure 5. Results of in-channel disketing of the north channel at the Alda-Juniata Road.

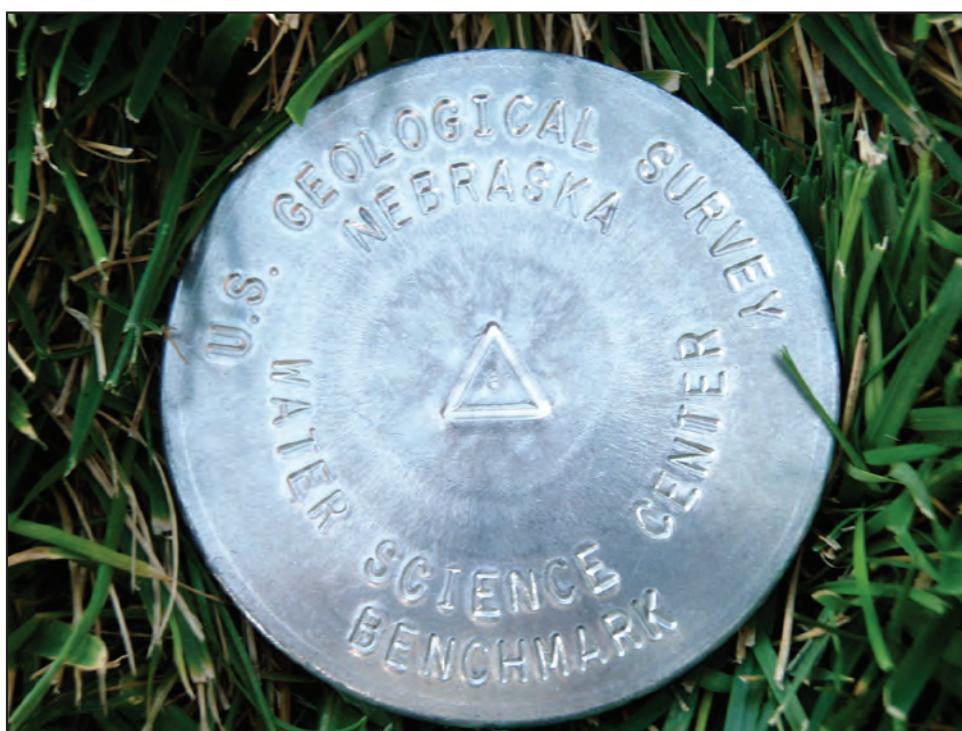
**Figure 7.** U.S. Geological Survey bench-mark cap.
