# **Channel Evolution on the Lower Elwha River, Washington, 1939–2006**

**Scientific Investigations Report 2008–5127**

By Amy E. Draut, Joshua B. Logan, Randall E. McCoy, Michael McHenry, and Jonathan A. Warrick

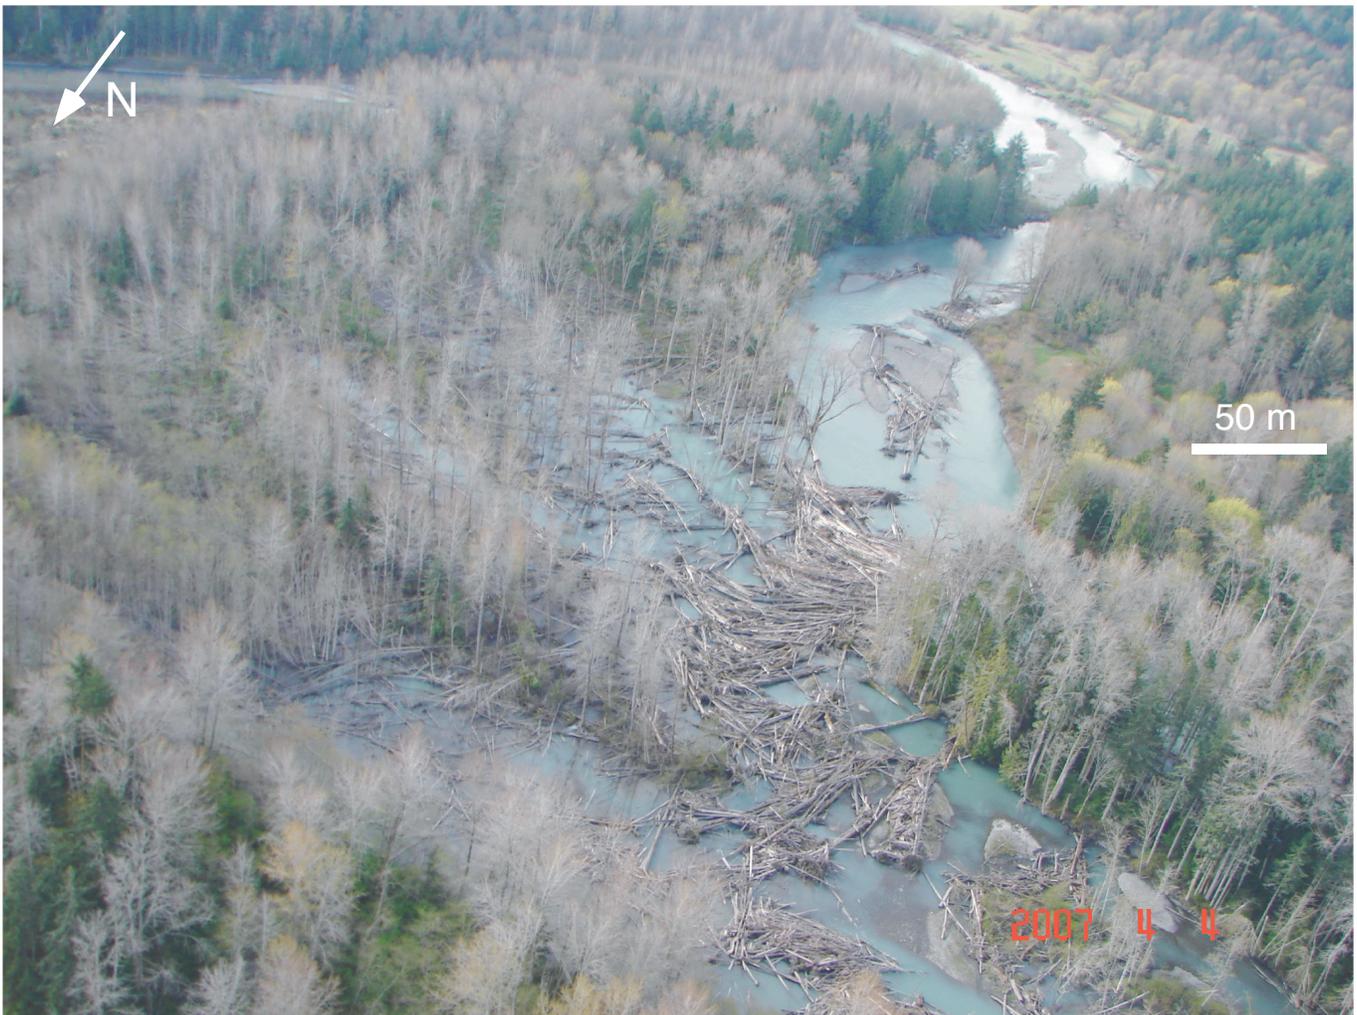
**Figure 19.** Large logjam 1.8 km upstream of the Elwha River mouth, Wash. (fig. 1), in western of two main channels. Photograph by T. Roorda of Northwestern Territories, Inc., taken April 4, 2007.

Changes in the morphology of the active Elwha River floodplain are a function of channel response to seasonally varying discharge, as well as to manmade floodplain modification. Along the lowermost ~3 km of the alluvial floodplain, absolute changes in the positions of channel margins averaged ~160 m between 1939 and 2006 (table 3). During this analysis, some subjectivity was inherent in identifying active-floodplain margins when a particular channel was being abandoned. Although new channels can be occupied suddenly in response to a single flood event, older channels are generally not abandoned instantaneously and may still appear to be active (unvegetated) in subsequent photographs even though newer avulsions have captured most of the flow. Numerous changes in channel position have occurred by migration of meander bends (progressive erosion of cutbanks toward the outer bend in a downstream direction), as well as by avulsion of new channels, a process that commonly occurs in anabranching rivers as the flow forms a new path around such obstacles as large woody debris and associated sedimentary deposits (figs. 17–19).
