Big Creek near Waynesville, North Carolina

Review of peak discharge for the flood of August 30, 1940

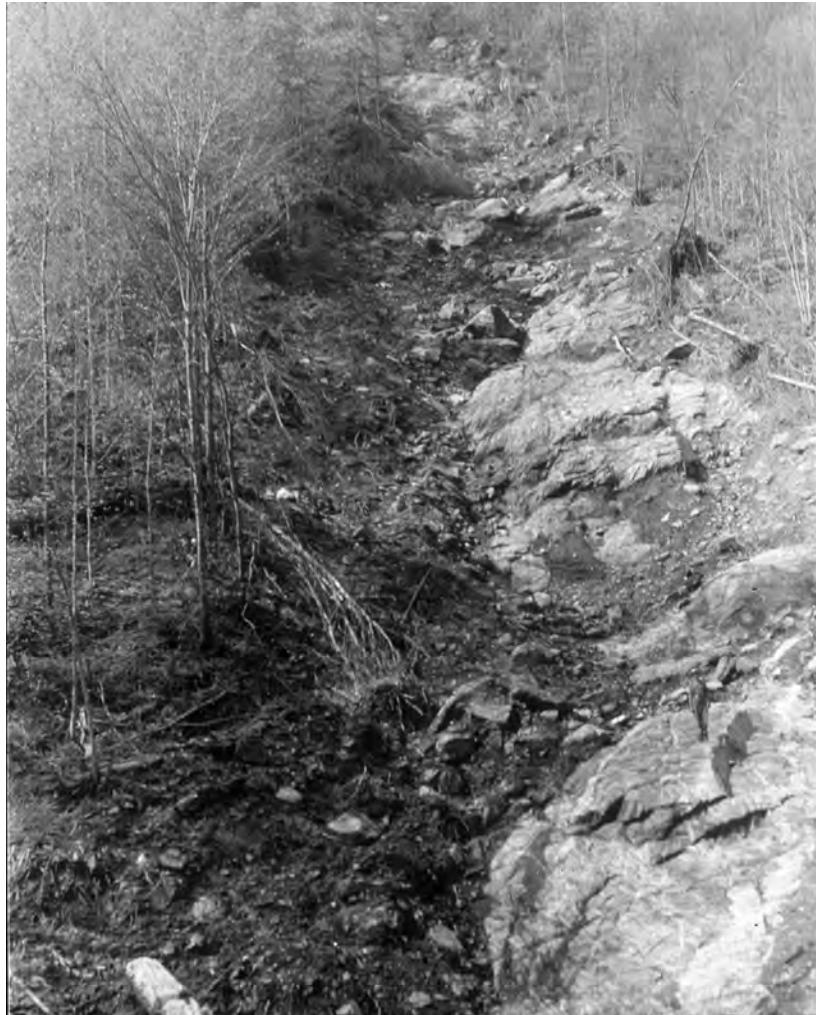
Figure A145. Debris avalanche scar in headwaters of Big Creek, Big Creek near Waynesville, North Carolina, August 1940.

Possible sources of error: The most obvious and significant source of error for this indirect measurement is that it was most probably a debris flow/debris avalanche rather than a water flood. First hand reports, including field observations, notes and photographs document the mountain slides that occurred in the upstream reaches of Big Creek and the resultant scour and deposition of rocks, boulders, and sediment in the downstream reaches. A report, "Mountain Slides on the West Fork of the Pigeon River", by the TVA (HD-1044, no date), provides a detailed description of the mountain slides in the Big Creek basin.

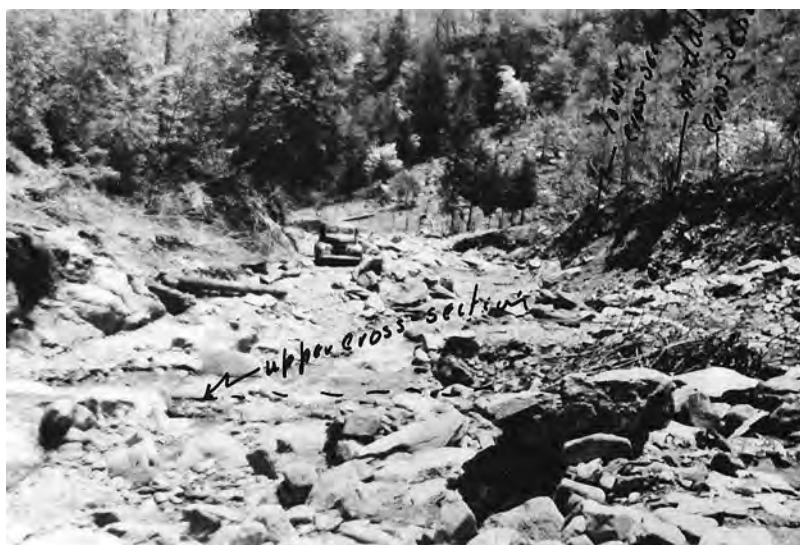
Figure A146. View looking downstream of slope-area reach, Big Creek near Waynesville, North Carolina, August 1940.

Photographs taken at or near the indirect measurement site show many large rocks and boulders in the channel. There is also evidence of significant scour of the banks, which contributes to uncertainty in cross-sectional area at the flood peak.
