El Rancho Arroyo near Pojoaque, New Mexico

(Miscellaneous ungaged site in the Rio Grande basin,
USGS New Mexico Water Science Center)

Review of peak discharge for the flood of August 22, 1952

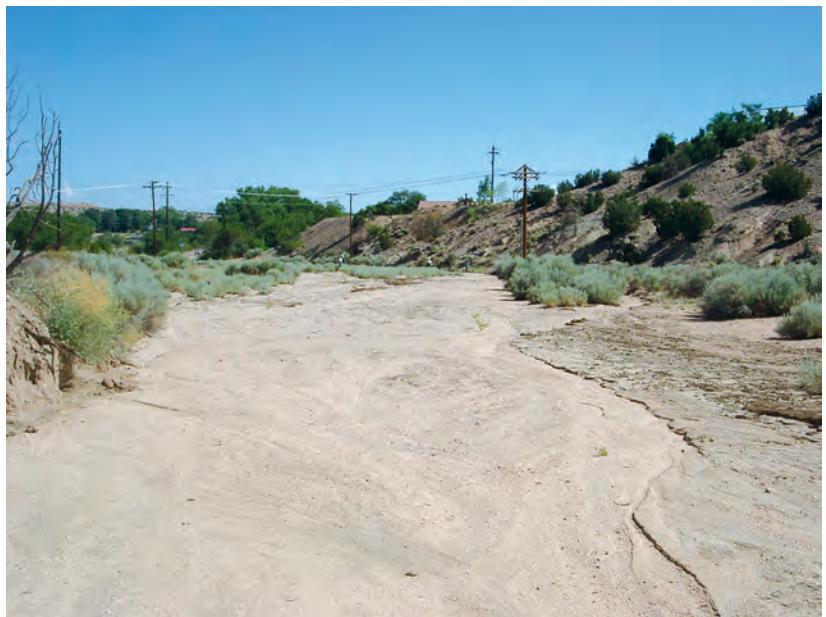
Figure A150. View looking downstream of cross section 1, El Rancho Arroyo near Pojoaque, New Mexico, August 5, 2003.

The site looks remarkably similar to the photographs taken in 1952, including a sand/gravel bed with small tufts of vegetation protruding. In viewing the reach as a whole, the channel alignment is slightly curving to the left throughout, and the right bank is largely a bluff. This alignment, coupled with high velocities (in the range of 20 ft/s), could explain the superelevation on the right bank; a velocity of 20 ft/s produces a potential static head of 6.2 ft.

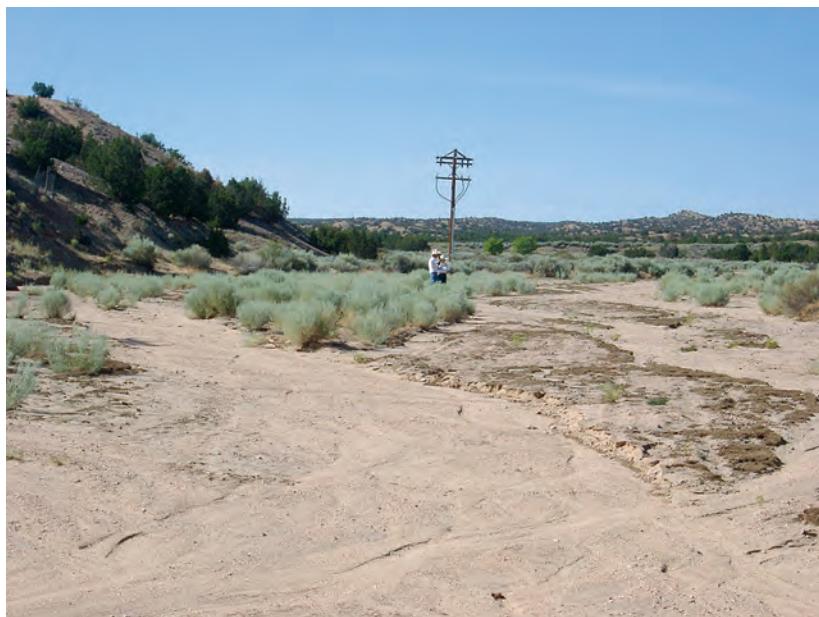
Figure A151. View looking upstream toward cross section 1, El Rancho Arroyo near Pojoaque, New Mexico, August 5, 2003.

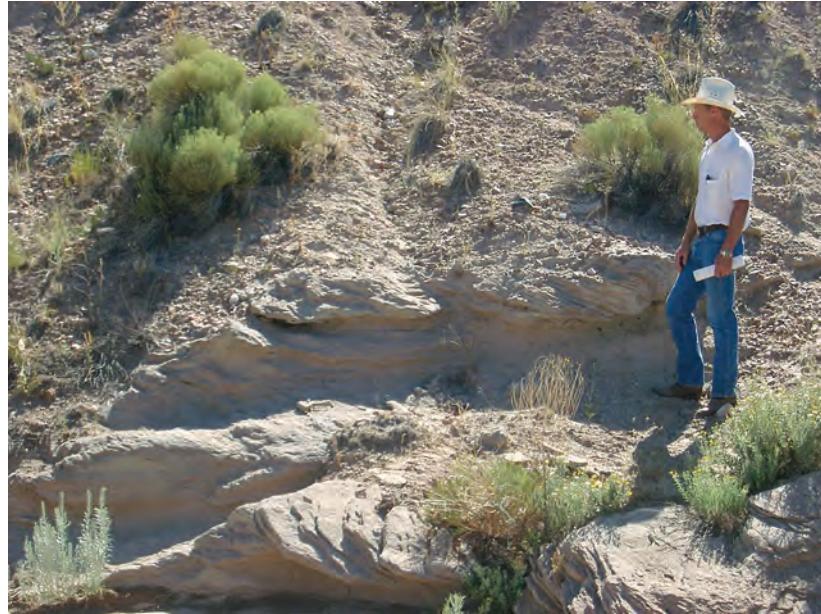
Figure A152. Right bank in slope-area reach with flood-scoured sandstone, El Rancho Arroyo near Pojoaque, New Mexico, August 5, 2003.

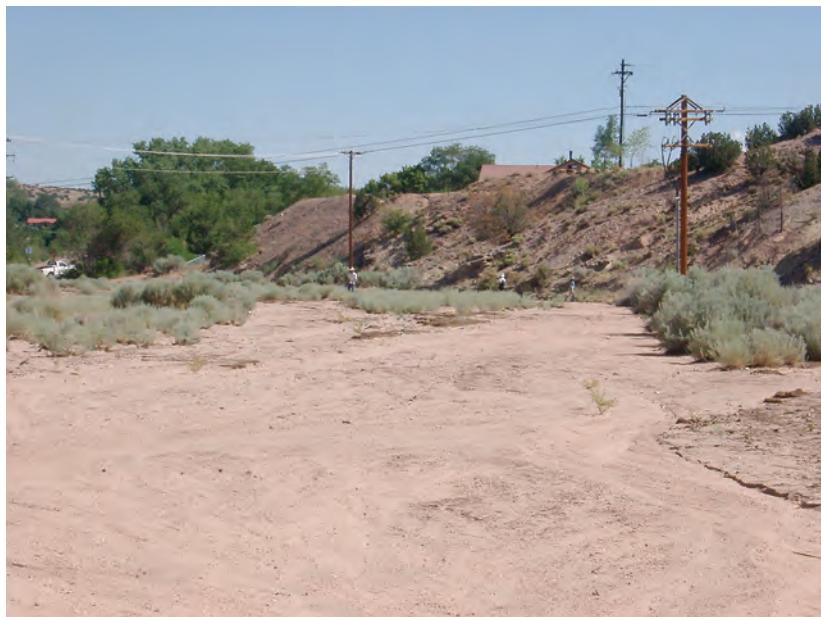
Figure A153. View downstream toward right bank, El Rancho Arroyo near Pojoaque, New Mexico, August 5, 2003.

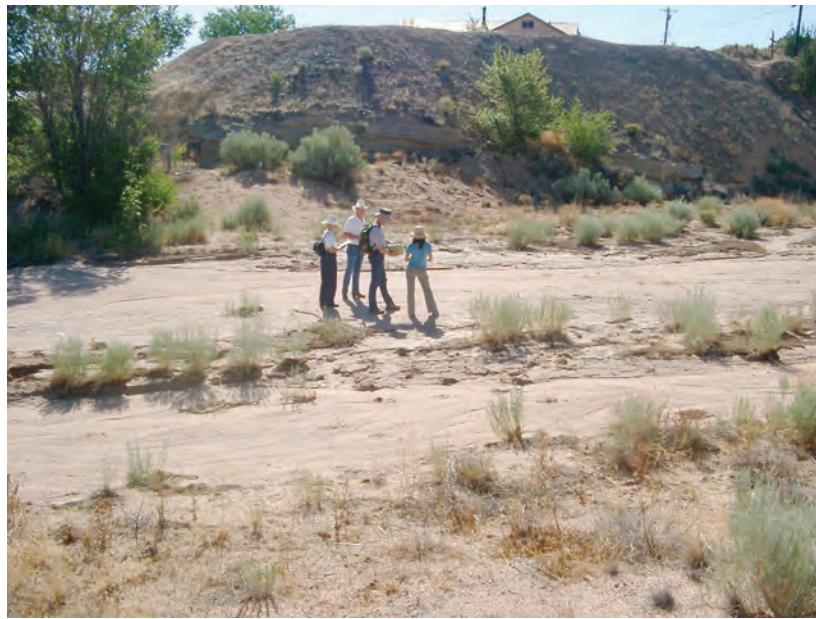
Figure A154. View to right bank at new cross-section 3, El Rancho Arroyo near Pojoaque, New Mexico, August 5, 2003.

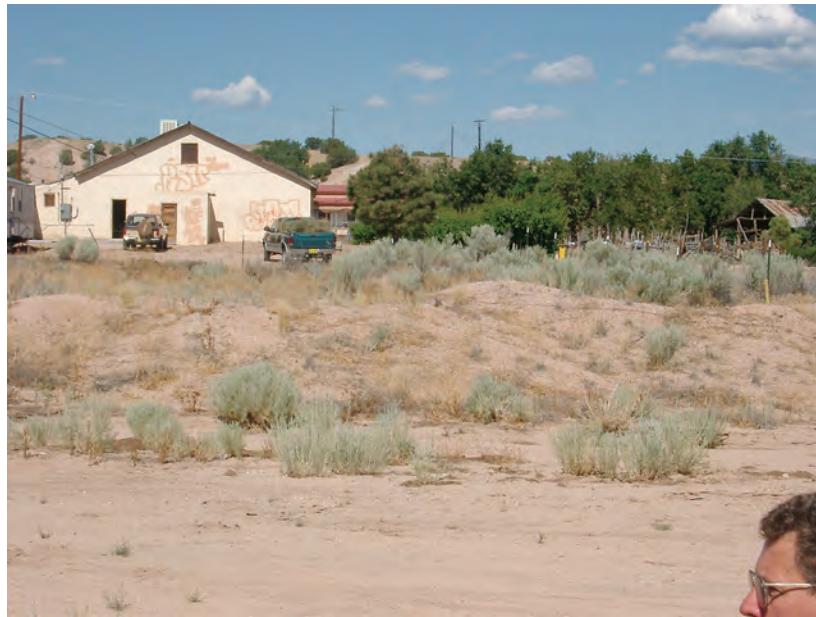
Figure A155. View toward left bank at new cross section 3, El Rancho Arroyo near Pojoaque, New Mexico, August 5, 2003.
