# 10335080 Humboldt River Tributary near Rye Patch, Nevada

(Miscellaneous ungaged site in the Humboldt River basin,  
USGS Nevada Water Science Center)

## Review of peak discharge for flood of May 31, 1973

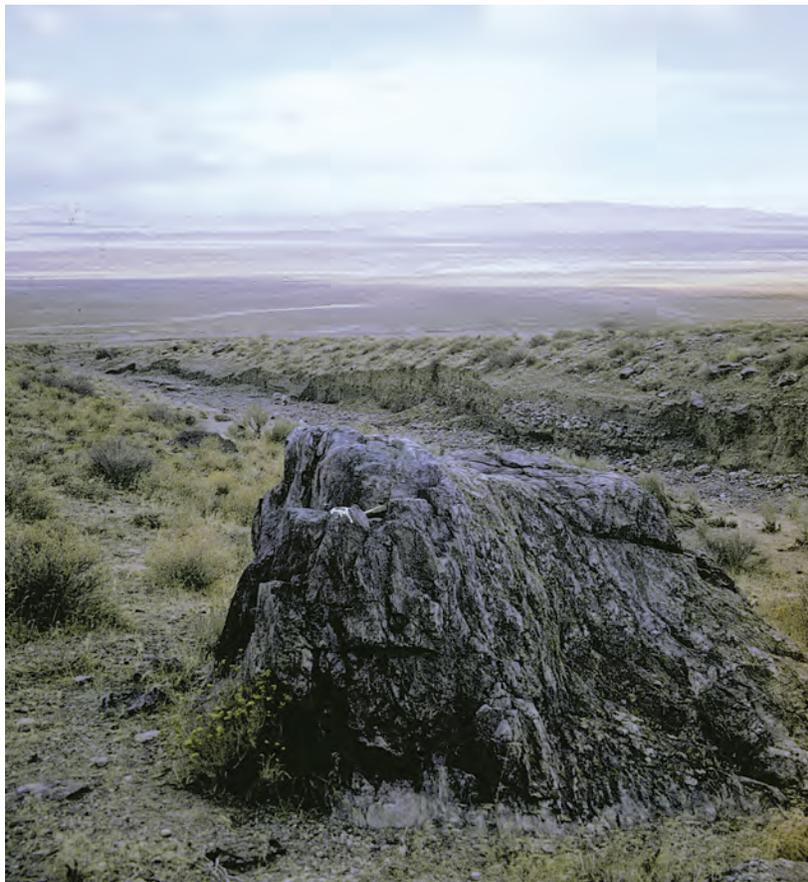
**Figure A106.** View looking downstream of range marker 1 (painted white spot on rock), Humboldt River Tributary near Rye Patch, Nevada, June 1973.

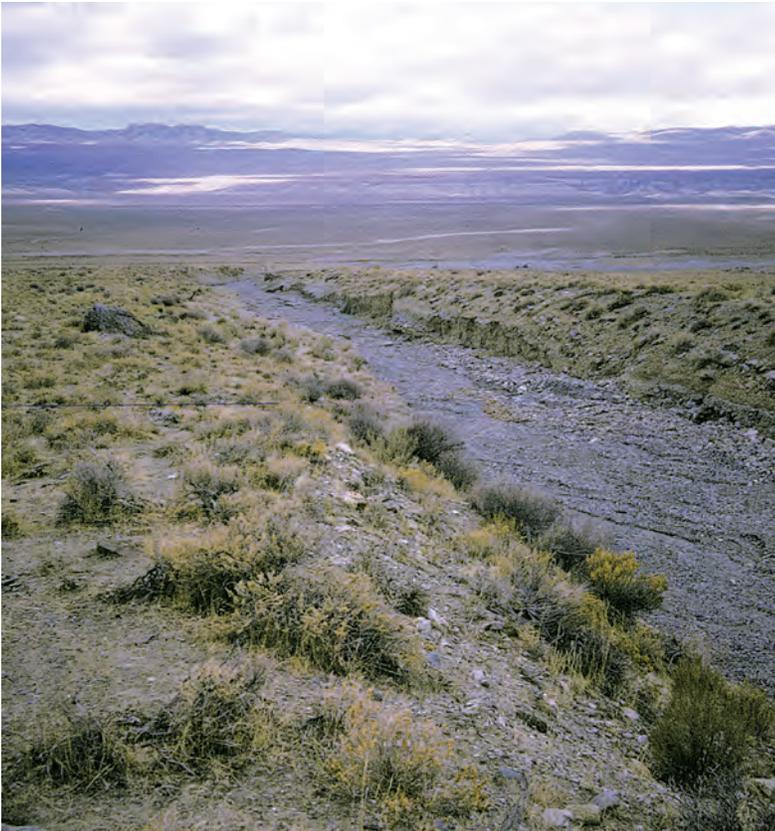
**Figure A107.** View looking downstream of hill near left end of cross section 3, Humboldt River Tributary near Rye Patch, Nevada, June 1973.

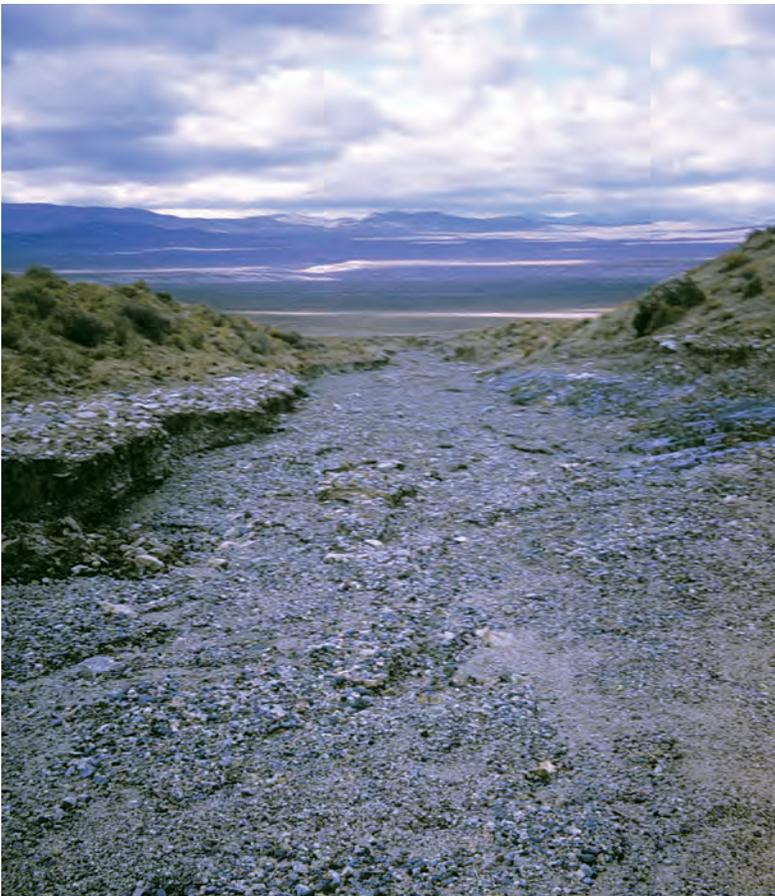
**Figure A108.** View looking downstream through slope-area reach, Humboldt River Tributary near Rye Patch, Nevada, June 1973.

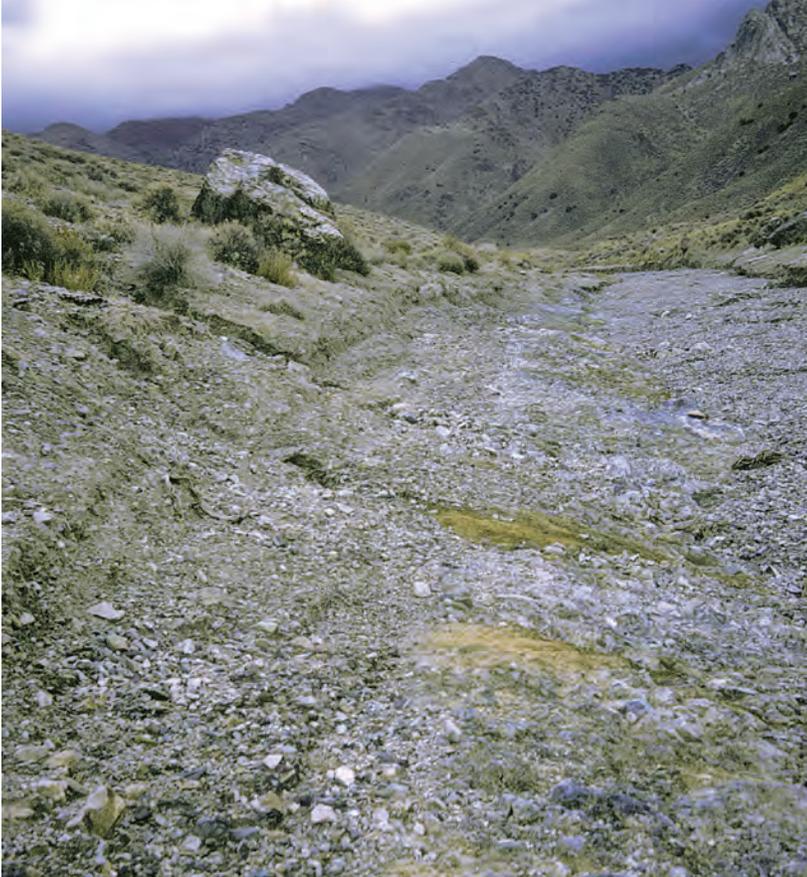
**Figure A109.** View looking upstream at right bank through cross section 3, Humboldt River Tributary near Rye Patch, Nevada, June 1973.

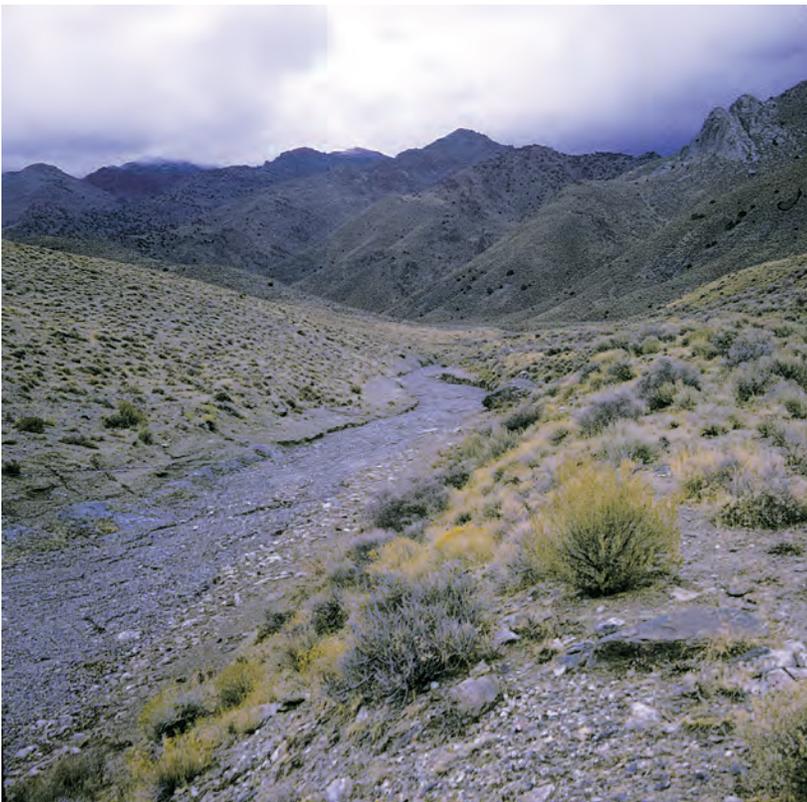
**Figure A110.** View looking upstream of hilltop near left end of cross section 3, Humboldt River Tributary near Rye Patch, Nevada, June 1973.

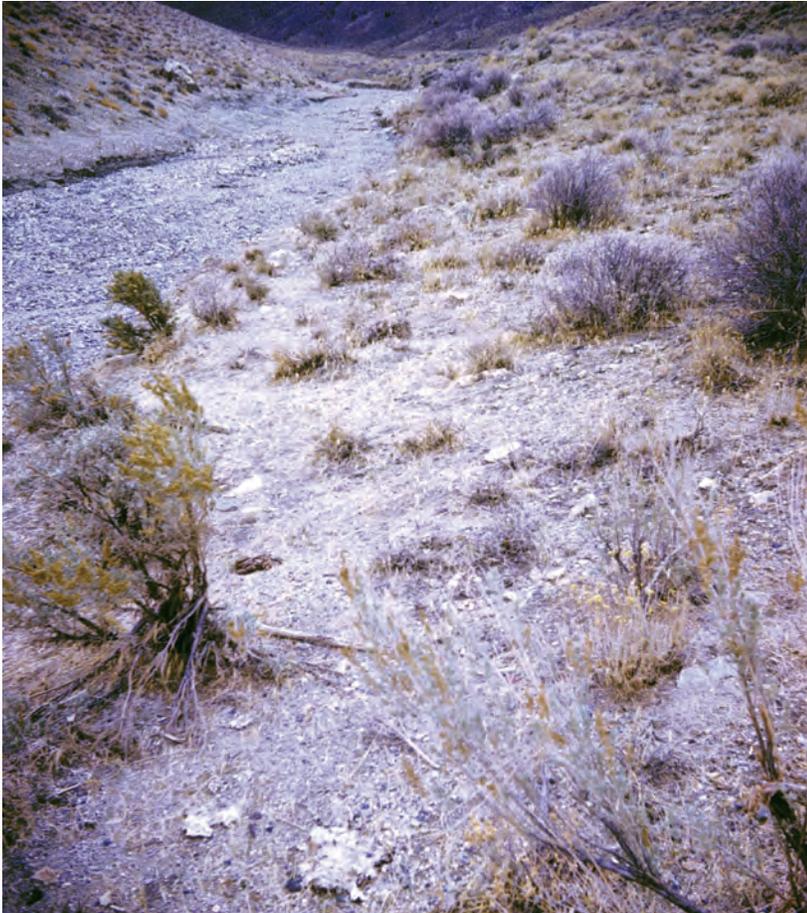
**Figure A111.** View looking upstream through cross section1 overbank flow area, Humboldt River Tributary near Rye Patch, Nevada, June 1973.

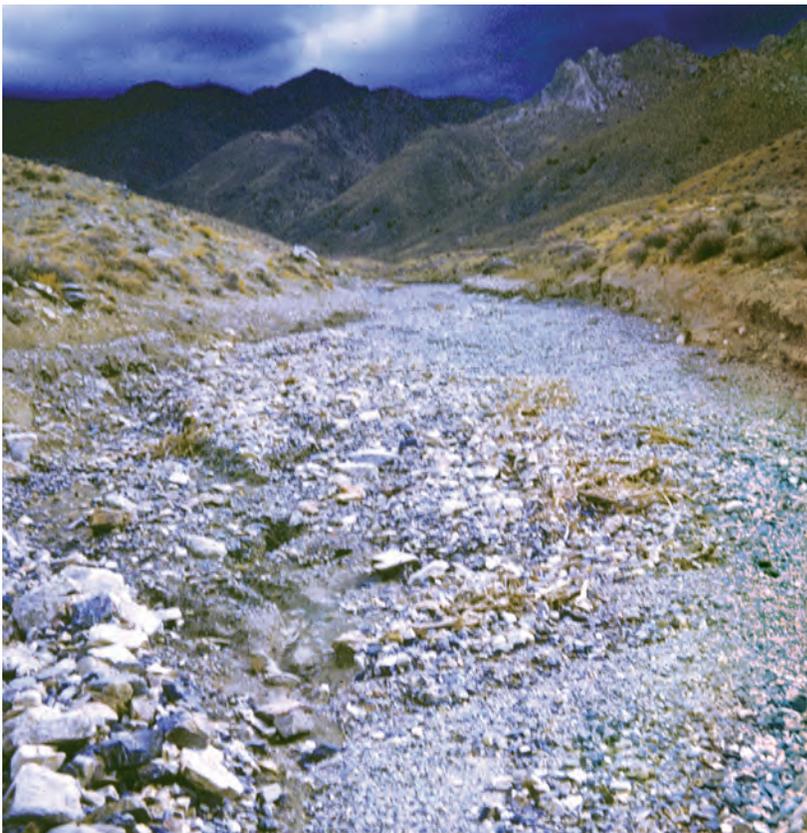
**Figure A112.** View looking upstream through slope-area reach, Humboldt River Tributary near Rye Patch, Nevada, June 1973.

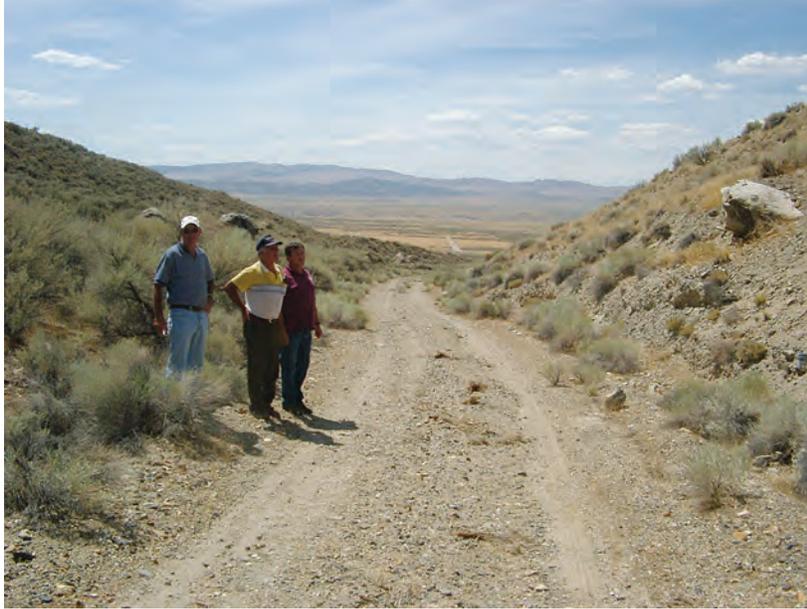
**Figure A113.** View looking downstream through slope-area reach, Humboldt River Tributary near Rye Patch, Nevada, July 30, 2003.

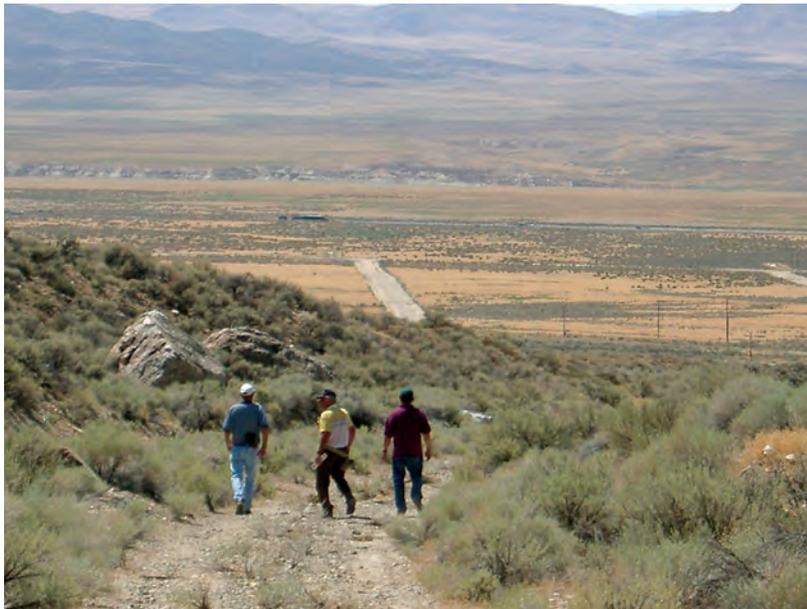
**Figure A114.** View looking downstream through slope-area reach, Humboldt River Tributary near Rye Patch, Nevada, July 30, 2003. Rock with painted registered mark shown on left.

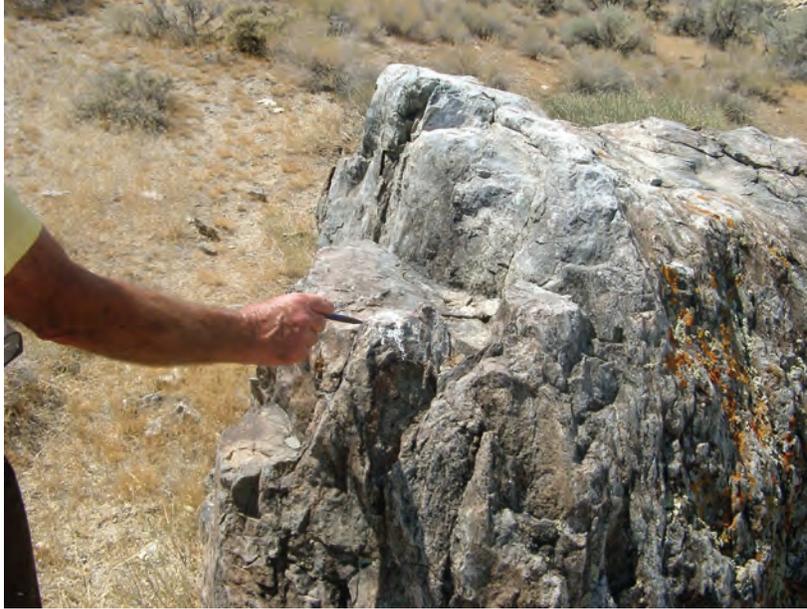
**Figure A115.** Original registered mark (white paint on rock) found 30 years later, Humboldt River Tributary near Rye Patch, Nevada, July 30, 2003.

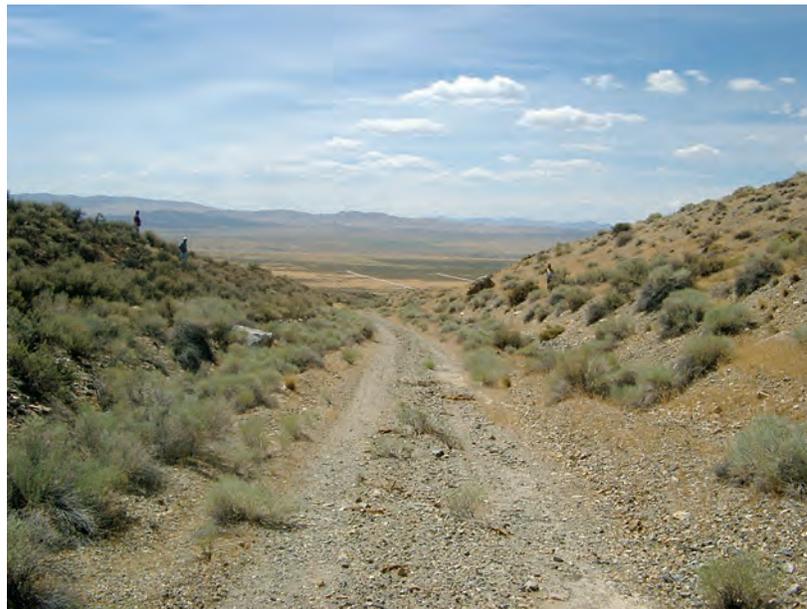
**Figure A116.** View looking downstream of top of slope-area reach, Humboldt River Tributary near Rye Patch, Nevada, July 30, 2003. People standing at cross sections.

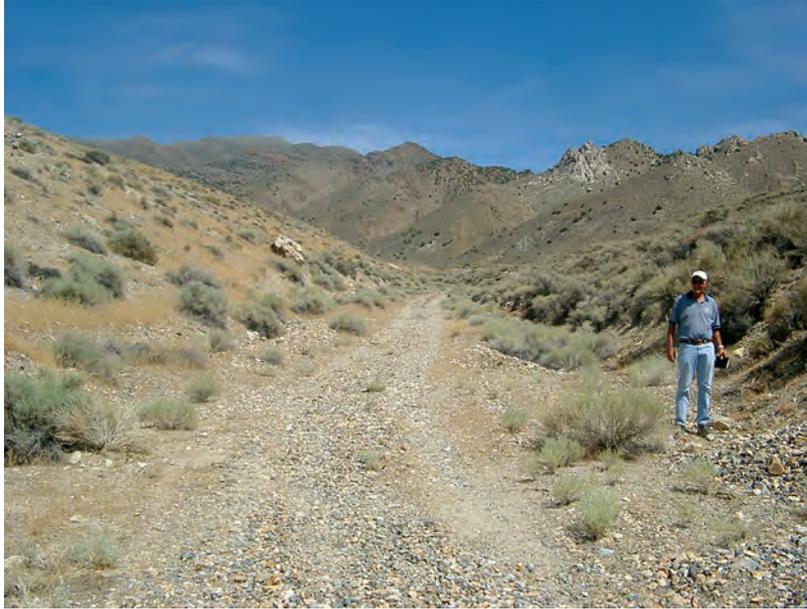
**Figure A117.** View looking upstream through slope-area reach, Humboldt River Tributary near Rye Patch, Nevada, July 30, 2003.

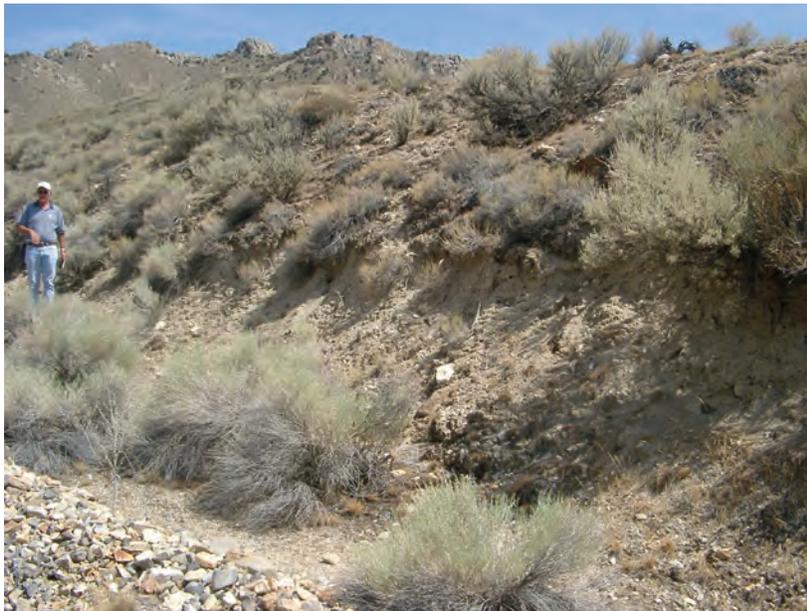
**Figure A118.** View of left bank near top of slope-area reach, Humboldt River Tributary near Rye Patch, Nevada, July 30, 2003.
