Little Pinto Creek Tributary near Newcastle, Utah

(Miscellaneous ungaged site in the Virgin River basin, USGS Utah Water Science Center)

Review of peak discharge for the flood of August 11, 1964

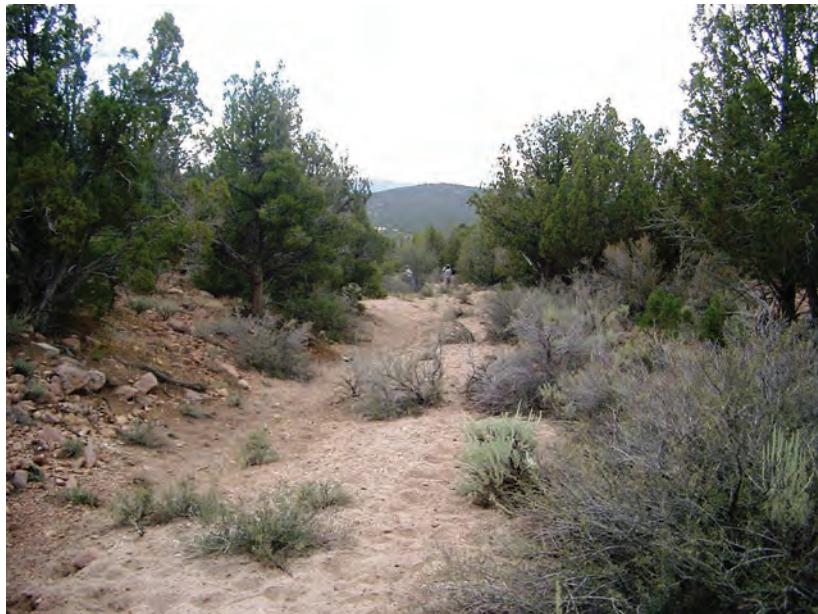
Little else is known about the storm. There is no evidence of similar flooding on any area gaging stations, but there are few gages in the vicinity and none on small streams. A photograph taken during the 2003 review and described herein is provided in figure A197.

There is considerable evidence of old debris flows along the channel upstream of the survey reach, but the surveyed reach showed none of the characteristics of debris flow. Therefore, the reviewers concluded that the flow had been a water flood. Although the reach appears to be straight on the plan view, the site visit revealed that there is a slight curvature to the right throughout the reach. That curvature, combined with the high velocities, could easily produce the 0.5 ft of superelevation shown for the left bank.

Figure A197. View looking downstream through slope-area reach, Little Pinto Creek tributary near Newcastle, Utah, August 26, 2003.

Recommendation: The original peak discharge of 2,630 ft³/s should be accepted as published.

The flood appears to have been a water flood, the computation was done correctly, and there is no new evidence to support a recomputation.
