Wenatchee River Tributary near Monitor, Washington

(Miscellaneous ungaged site in the Columbia River basin,
USGS Washington Water Science Center)

Review of peak discharge for the flood of August 25, 1956

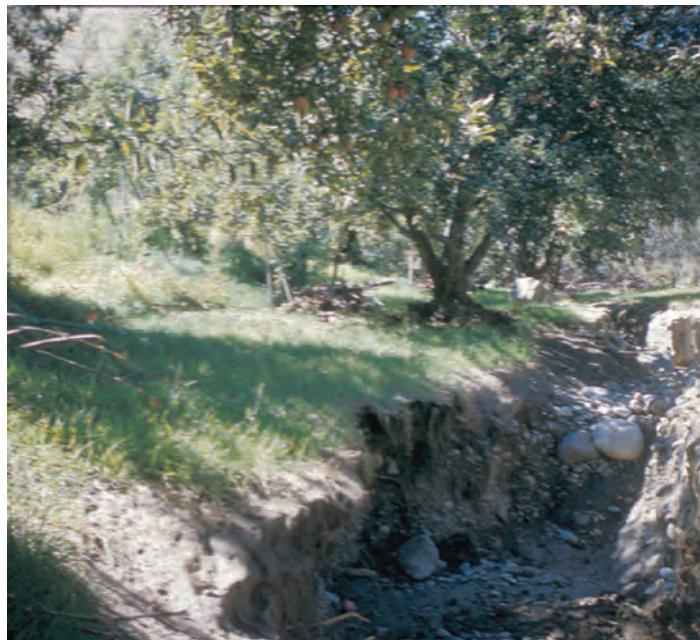
Figure A234. View upstream of sections A and B of lower reach of Wenatchee River tributary near Monitor, Washington, 1956.

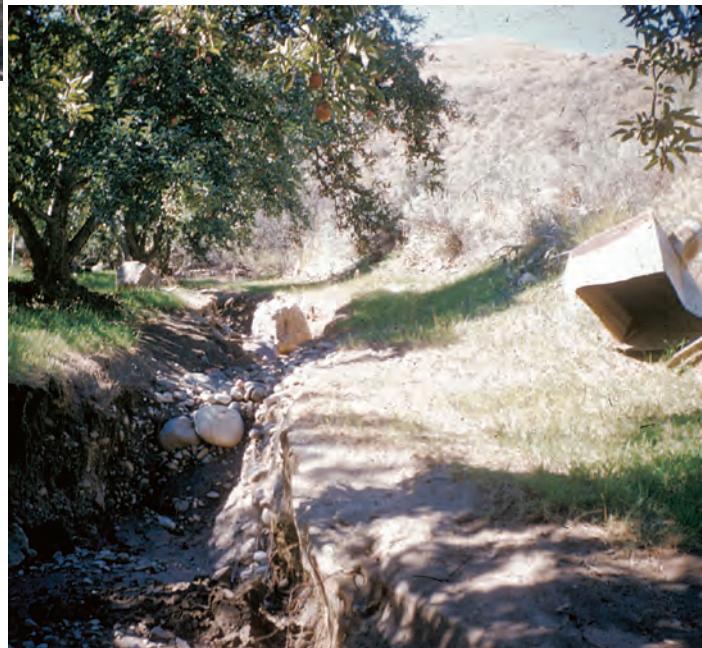
Figure A233. View upstream of lower reach of Wenatchee River tributary near Monitor, Washington, 1956. Section B at top of falls. Section A upstream of large rock.

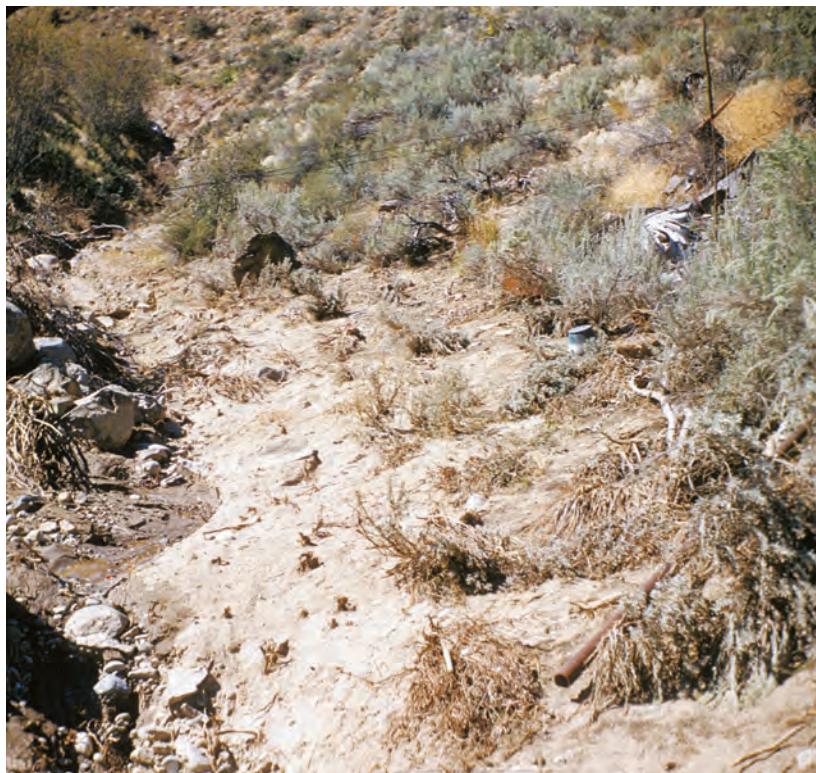
Figure A235. View upstream of sections A and C of upper reach of Wenatchee River tributary near Monitor, Washington, 1956. Section C at blue bucket.

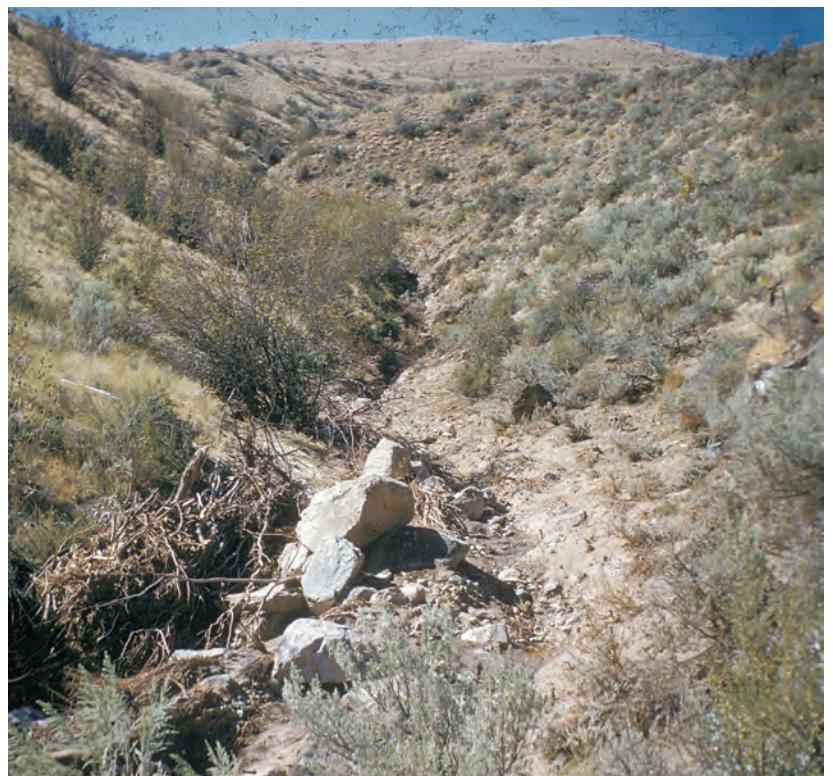
Figure A236. View upstream of sections A and B of lower reach of Wenatchee River tributary near Monitor, Washington, 1956.

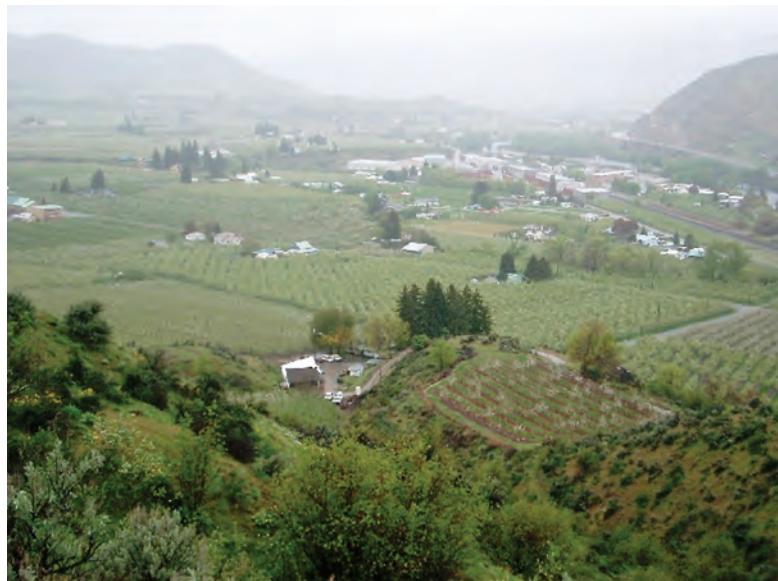
Figure A237. View downstream of headwaters, Wenatchee River tributary near Monitor, Washington, May 2003.

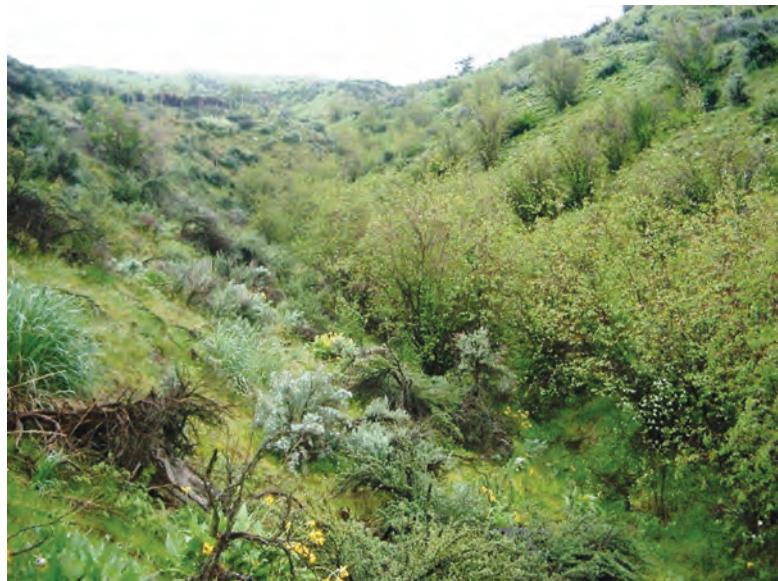
Figure A238. View upstream toward headwaters, Wenatchee River tributary near Monitor, Washington, May 2003.

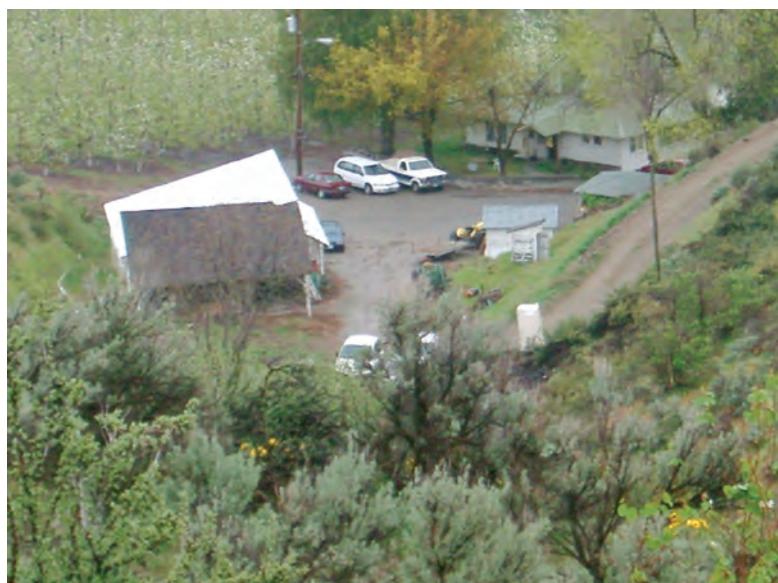
Figure A239. View downstream toward damaged house at mouth of basin, Wenatchee River tributary near Monitor, Washington, May 2003.
