Wilson Creek near Adako, North Carolina

(Miscellaneous ungaged site in the Yadkin basin,
USGS North Carolina Water Science Center)

Review of peak discharge for the flood of August 13, 1940

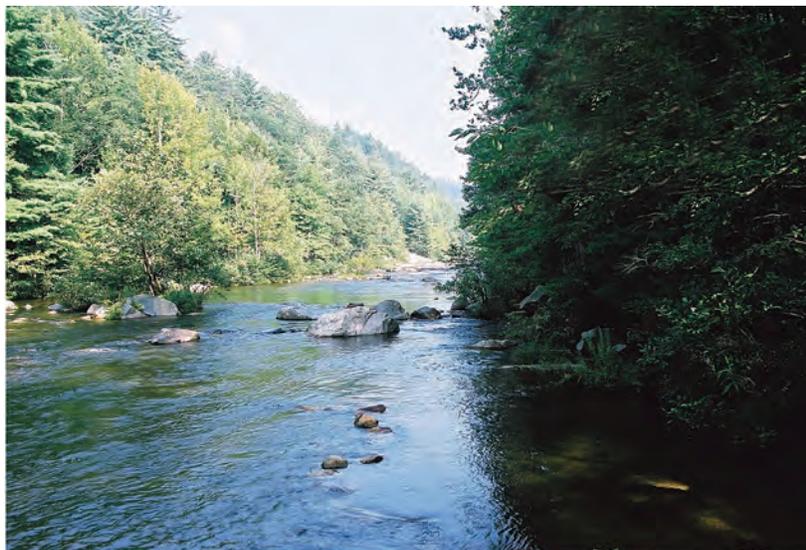
Figure A149. View looking upstream of slope-area reach, Wilson Creek near Adako, North Carolina, August 25, 2003. No original photographs of 1940 flood were found.

Possible sources of error: The fact that the original slope-area measurement has been lost and can not be reviewed in detail makes it difficult to determine possible sources of error. The field visit of August 25, 2003, to the probable location of the measurement did not reveal any obvious sources of error. The reach is straight for a long distance, with fairly steep banks. The streambed consists of gravel, large cobbles, and some small- to medium-size boulders.

Recommendations: The original peak discharge of 99,000 ft³/s should be accepted as published on the basis of the field inspection and the rating should be an “estimate.” The drainage area should be checked using 1:24,000-scale maps.
