Streamflow Gains and Losses for Hellbranch Run, Franklin County, Ohio, August 2007

Scientific Investigations Report 2008–5191

By Denise H. Dumouchelle

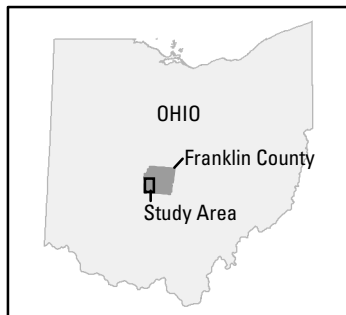
Figure 1. Location of study area.

- 1 Mainstem discharge-measurement site
- ▲ Gaging station (03230450)

The purpose of this report is to present data on and describe the gain (or loss) of streamflow along reaches of Hellbranch Run. Findings are based on 26 stream and pipe discharge measurements made on August 7, 2007. Discharge measurements were made on the mainstems of the Hamilton and Clover-Groff Ditches from Feder Road to Hellbranch Run and downstream on Hellbranch Run to Lambert Road (fig. 1). Inflow to the ditches and Hellbranch Run was also measured.

The study area (fig. 1) is the Hellbranch Run, in western Franklin County. The land use in the area is changing from mostly agricultural to suburban. The mainstem of Hellbranch Run is a natural stream that has not been channelized. The soils in the area drain poorly; as a result, drainage ditches and underground drainage tiles are common sources of discharge to the run (Fuller, Mossbarger, Scott, & May Engineers Inc., 2006). The topography of the watershed is characterized by nearly level till plains with minor relief due to erosion and glacial features. Buried bedrock valleys, filled with glacial sediments, are present in the county. The bedrock underlying western Franklin County consists of dolomitic limestone. A bedrock valley in the study area is as much as 330 ft deep, but the average depth to bedrock is about 100 ft. The carbonate bedrock is the principal aquifer in the area, with wells yielding as much as 250 gal/min. The surficial glacial sediments consist of fine-grained tills and minor sand and gravel deposits. Thickness of the glacial sediments ranges from 30 to more than 300 ft in the bedrock valley. Wells in the glacial sediments generally yield less than 20 gal/min (Schmidt, 1958, 1993).

The streamflow was investigated along reaches of Hamilton Ditch, Clover-Groff Ditch, and Hellbranch Run from Feder Road to Lambert Road (fig. 1). The ditches and run are generally just a few feet deep, with streambed that ranges from silty to sandy with gravel and cobbles. Inflow to the ditches and Hellbranch Run comes from natural tributaries and numerous pipes of various sizes discharging from multiple sources.

Hellbranch Run is crossed by roads at frequent intervals, and most of the mainstem discharge measurements were made near a road (fig. 1). Therefore, the reaches were essentially defined by the interval between two roads. Table 2 lists the various reaches for which gains or losses were calculated. The gain or loss for six of reaches could not be determined because the UIs for the discharge measurements were greater than the differences in discharge between measurements. The mainstem measurement at Alton Road was not used in the gain/loss calculations because there was no measurable flow at this site, possibly an effect of the beaver dams found above and below Alton Road (table 1).
