**Map showing magnitude and extent of January 2009 flooding on river mile 17.5 to 22.6, Puyallup River, Pierce County, Washington.**

By  
Mark C. Mastin, Andrew S. Gendaszek, and Christiana R. Barnas  
2010

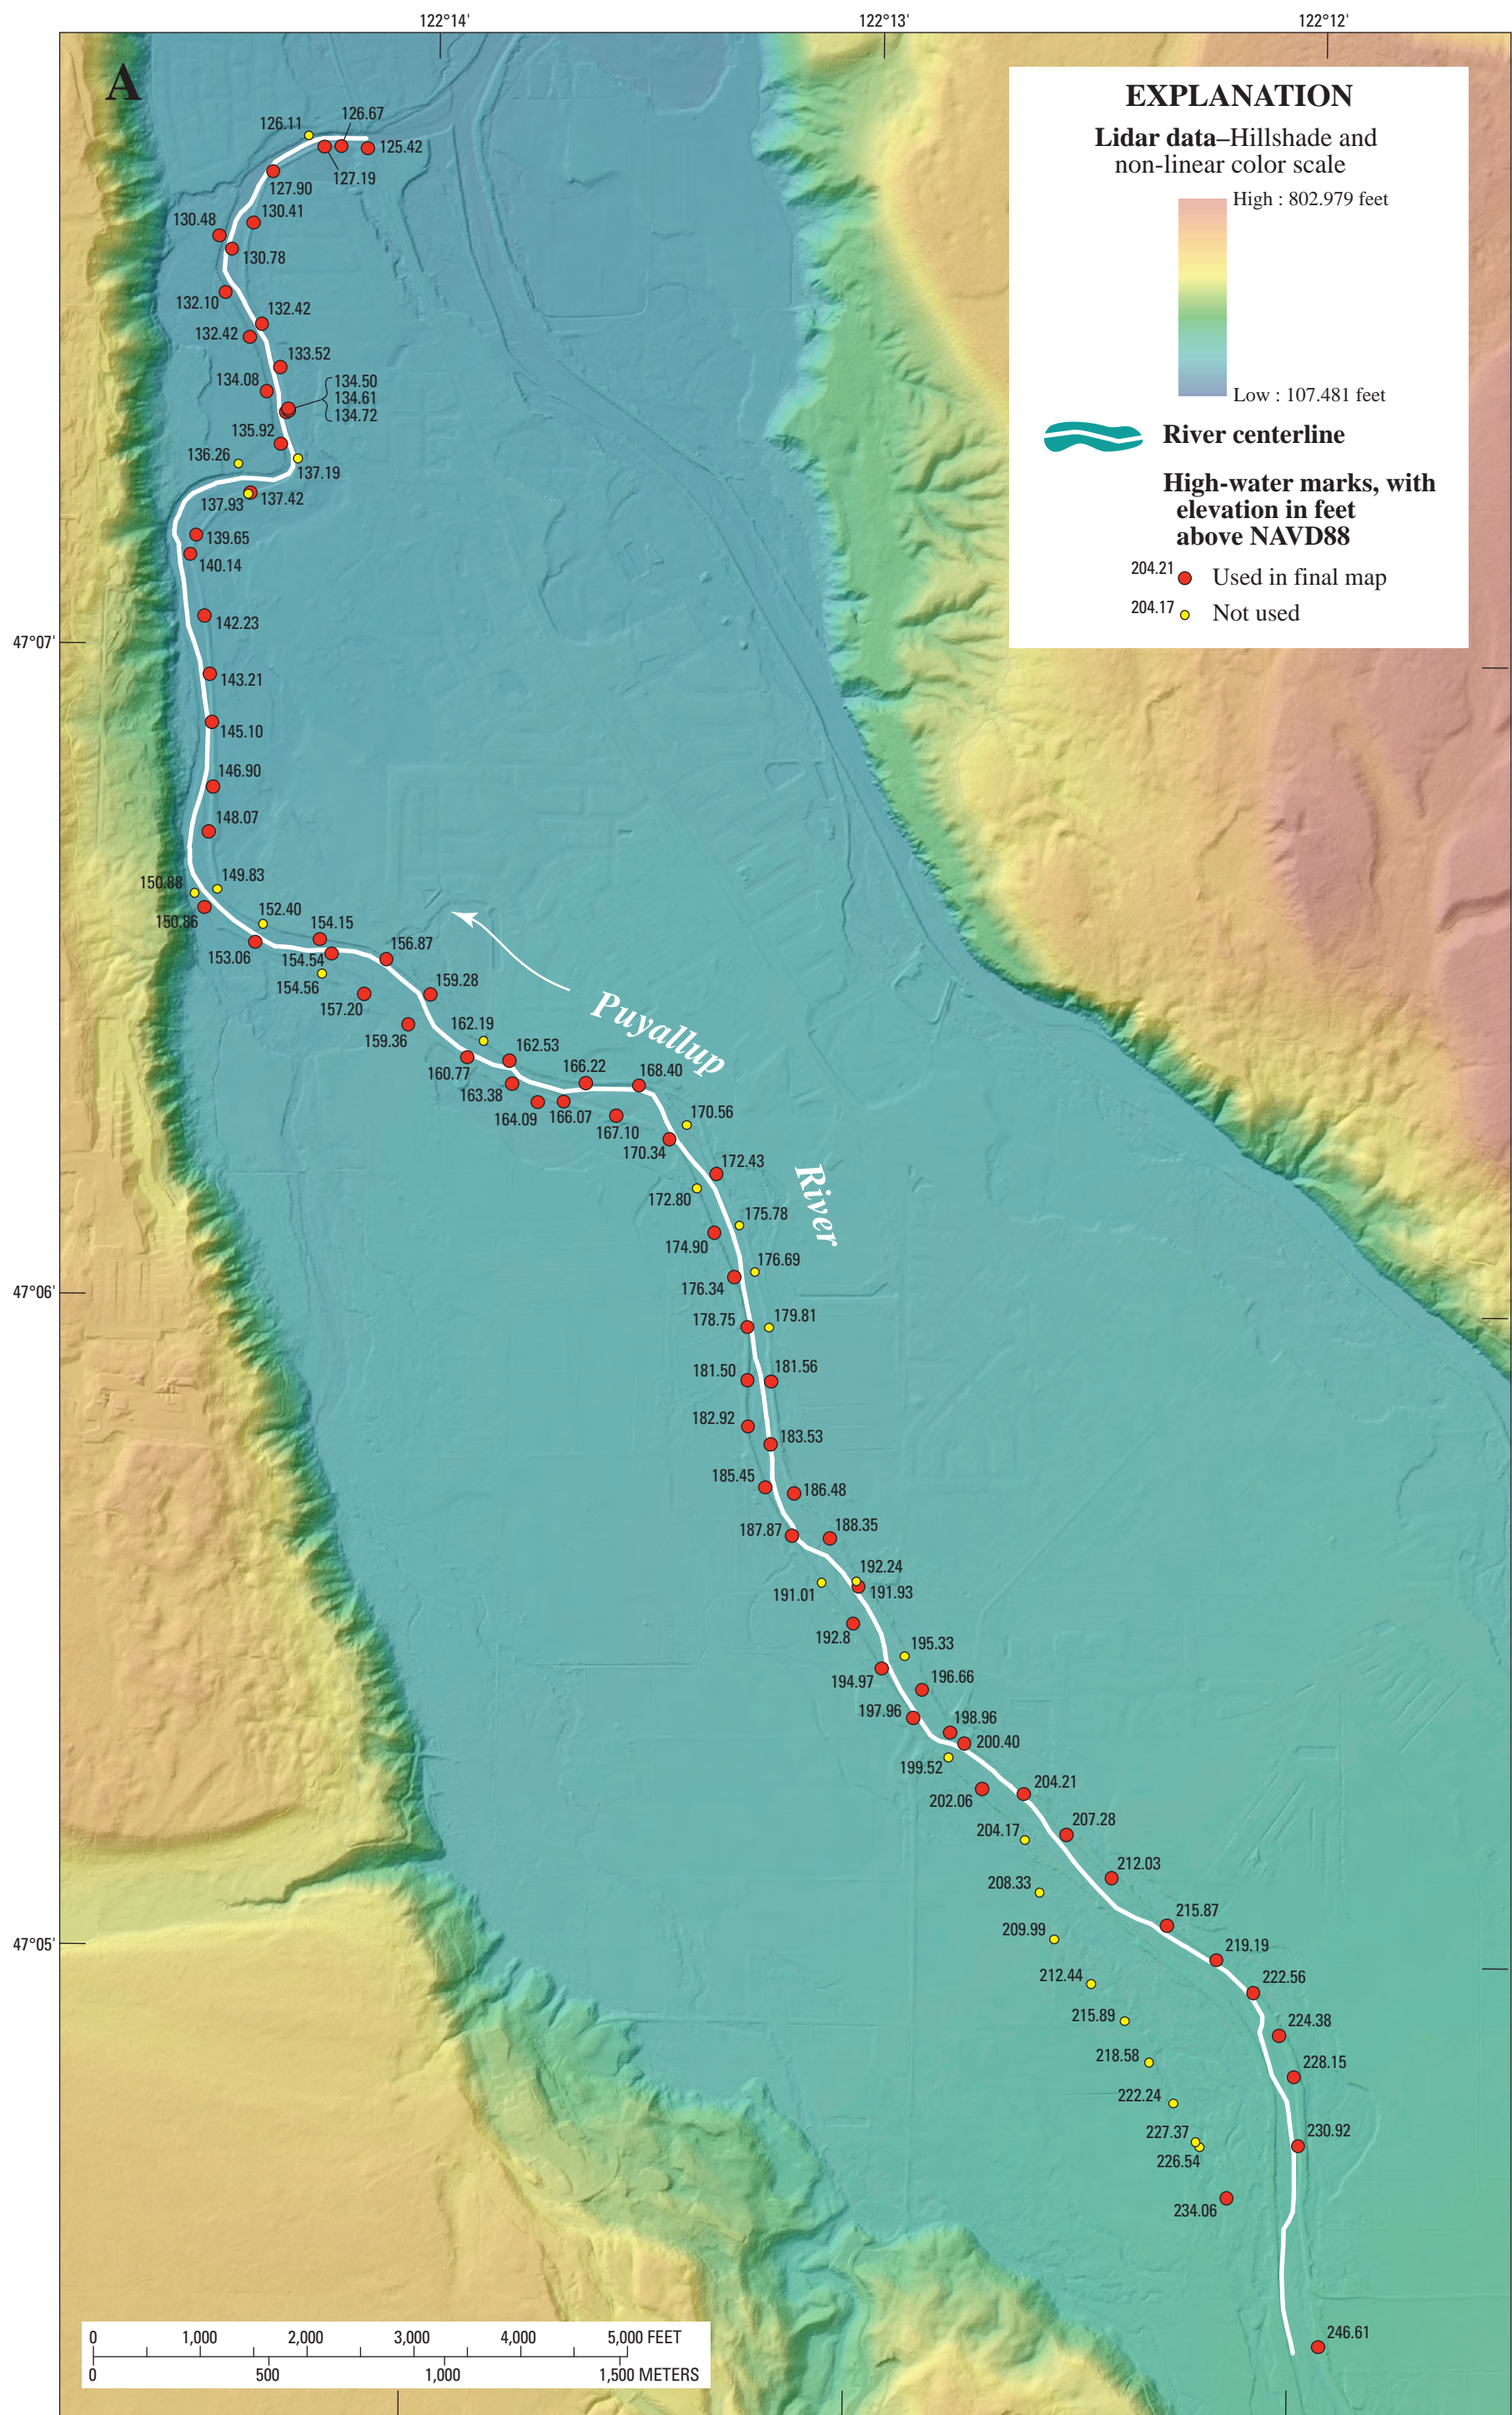
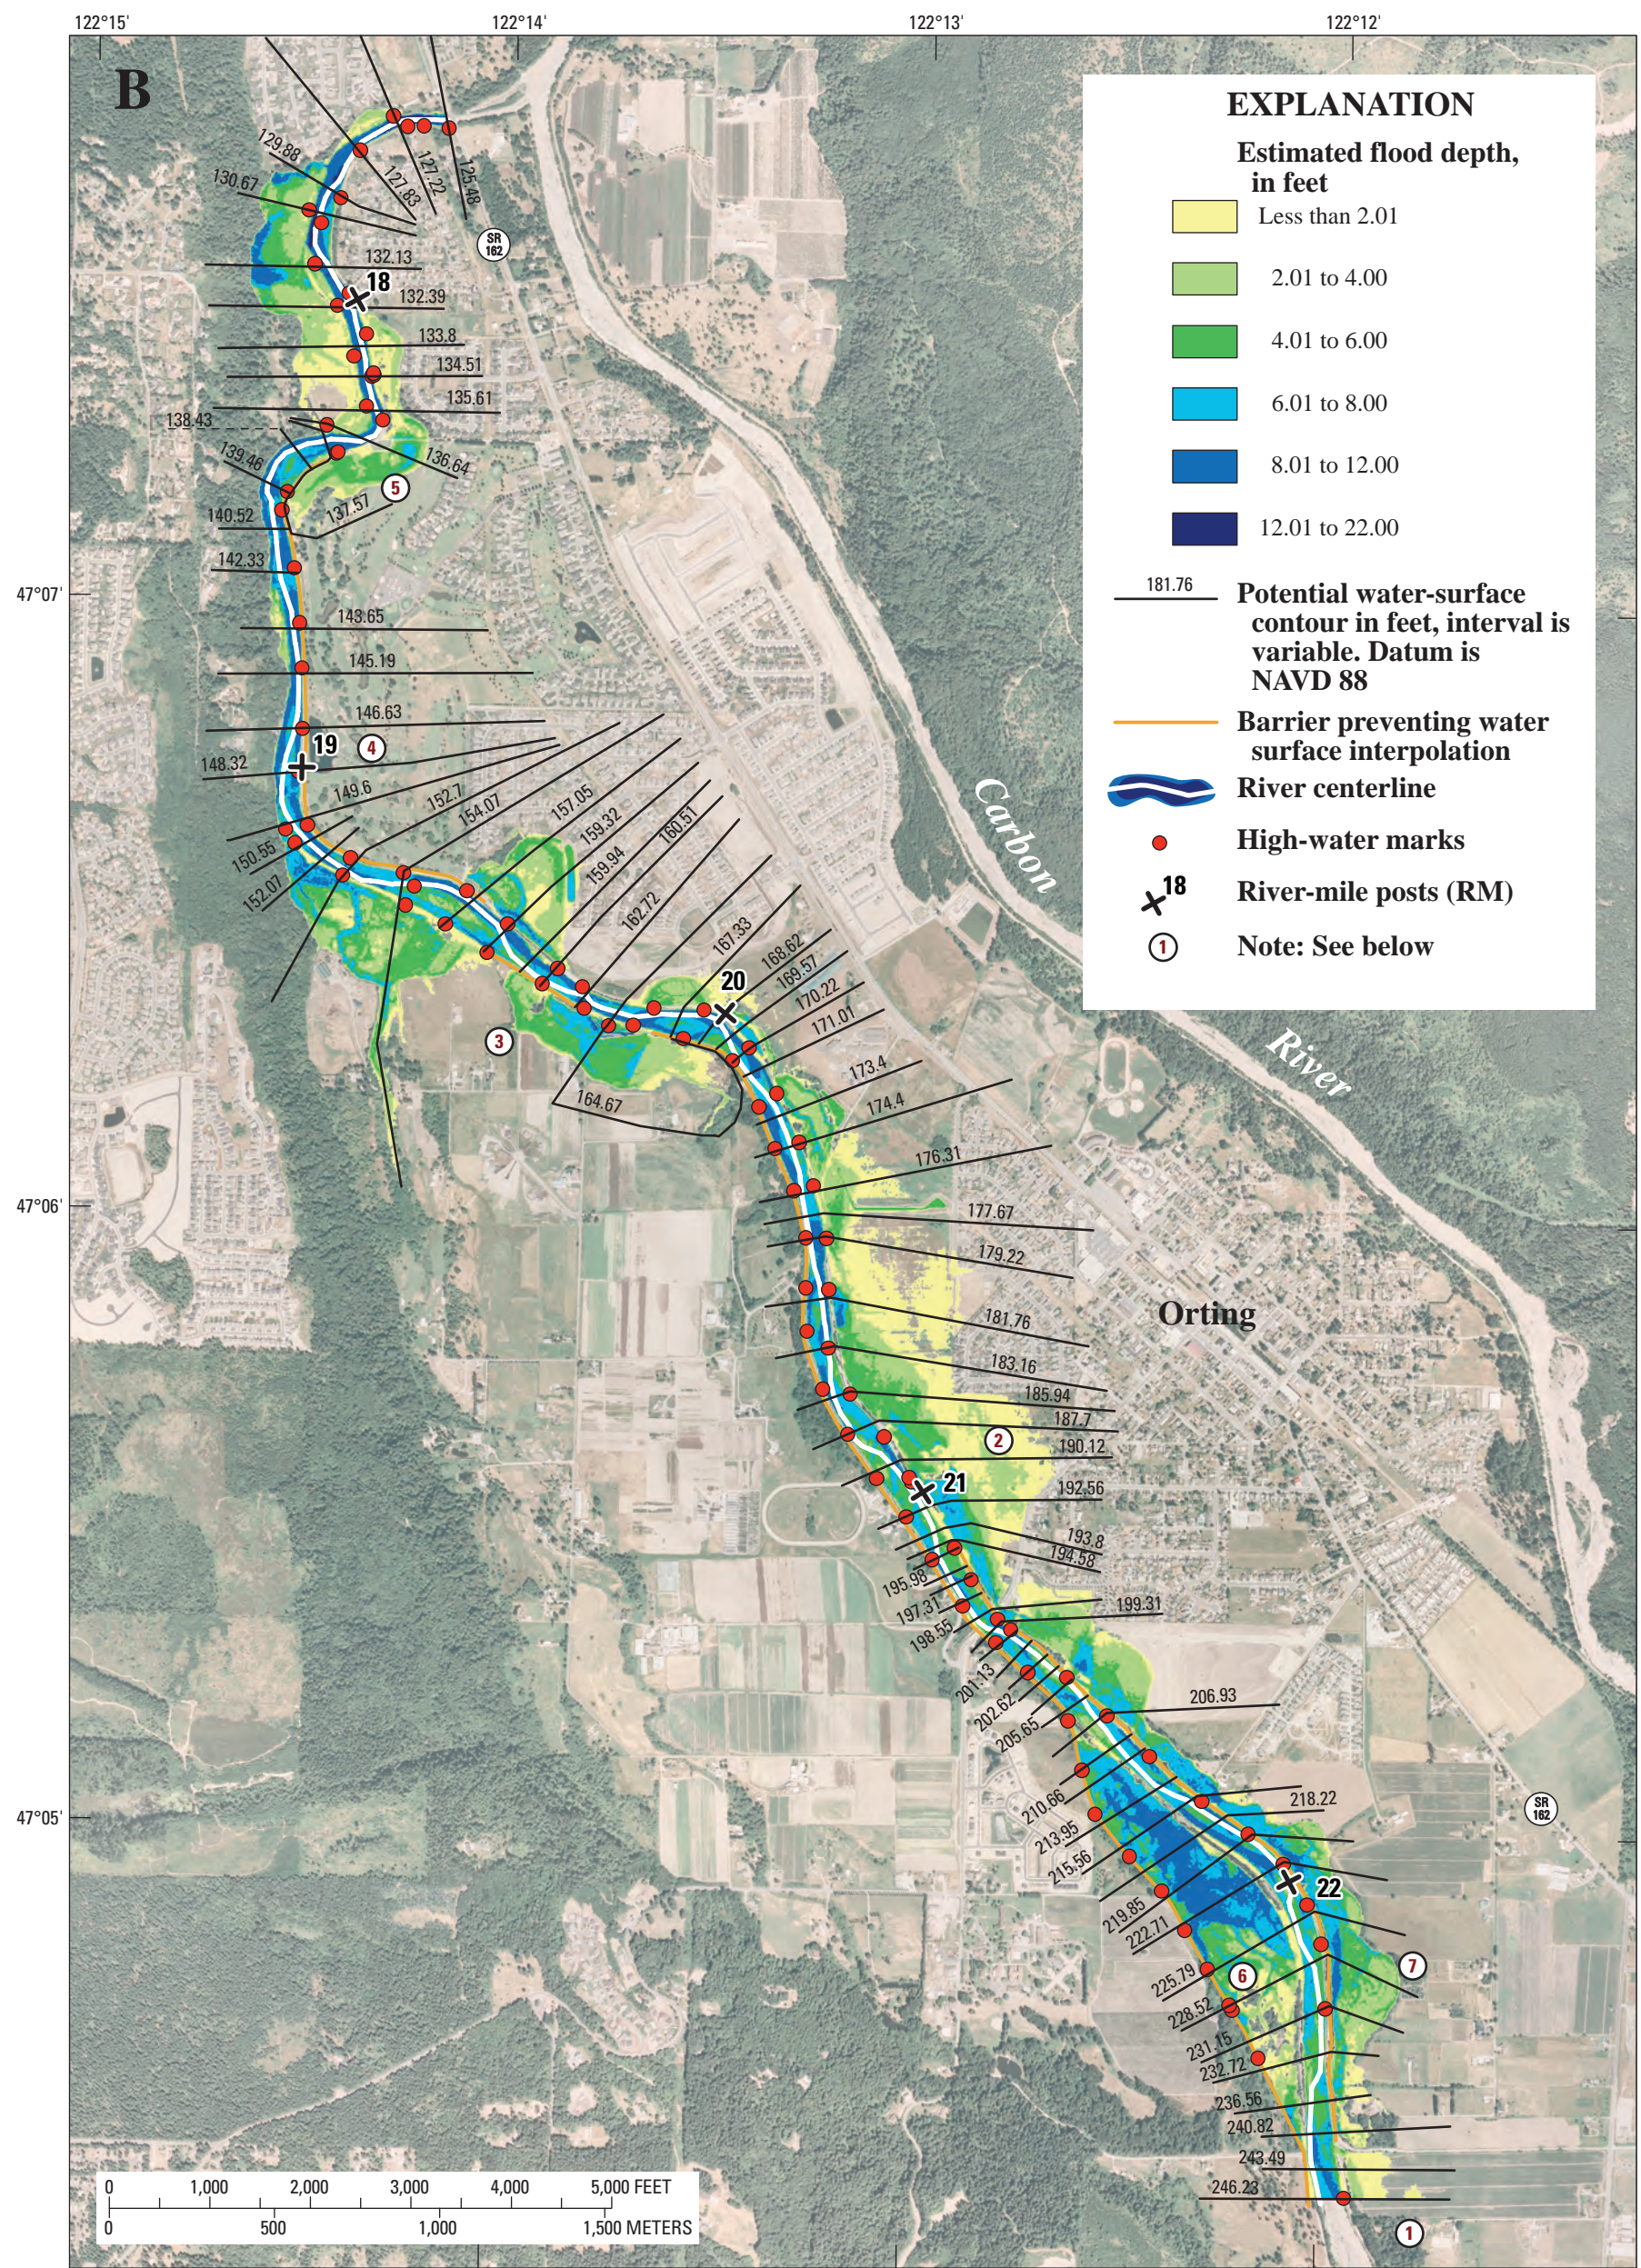
**Note:** Small unconnected mapped areas of inundation may or may not have been flooded.

**Note 1:** GIS analysis suggests that water overtopped levee here. It was reported that water overtopped the right bank levee in this general area and flowed north along 178th and then into the city of Orting causing minor, localized flooding.

**Note 2:** It was reported that the right bank levee was overtopped in places from river mile 19.8 to 21.0. Approximate extent of flooding was delineated by Ken Wolfe, City of Orting.

**Note 3:** It was observed during the high-water mark survey that the left bank levee was overtopped in this area.

**Note 4:** Aerial photographs at the time of the flood show localized flooding on the golf course disconnected from the river. This area was removed from the inundation mapping. Aerial photographs provided by Pierce County Surface Water Management (Randy Brake, written commun., 2009).

**Note 5:** It was reported that there was some flooding over the levee on the right bank in this portion of the golf course.

**Note 6:** There is a new setback levee on the left bank here that is not represented in the terrain data. The actual depths of inundation in this area may be different than shown.

**Note 7:** Floodwaters inundated the riparian area outside the right bank levee in this area according to Ken Wolfe, City of Orting. Actual inundated depths and extent may be different.
