Map showing magnitude and extent of January 2009 flooding on river mile 4.8 to 6.5, South Prairie Creek, Pierce County, Washington.

By
Mark C. Mastin, Andrew S. Gendaszek, and Christiana R. Barnas
2010

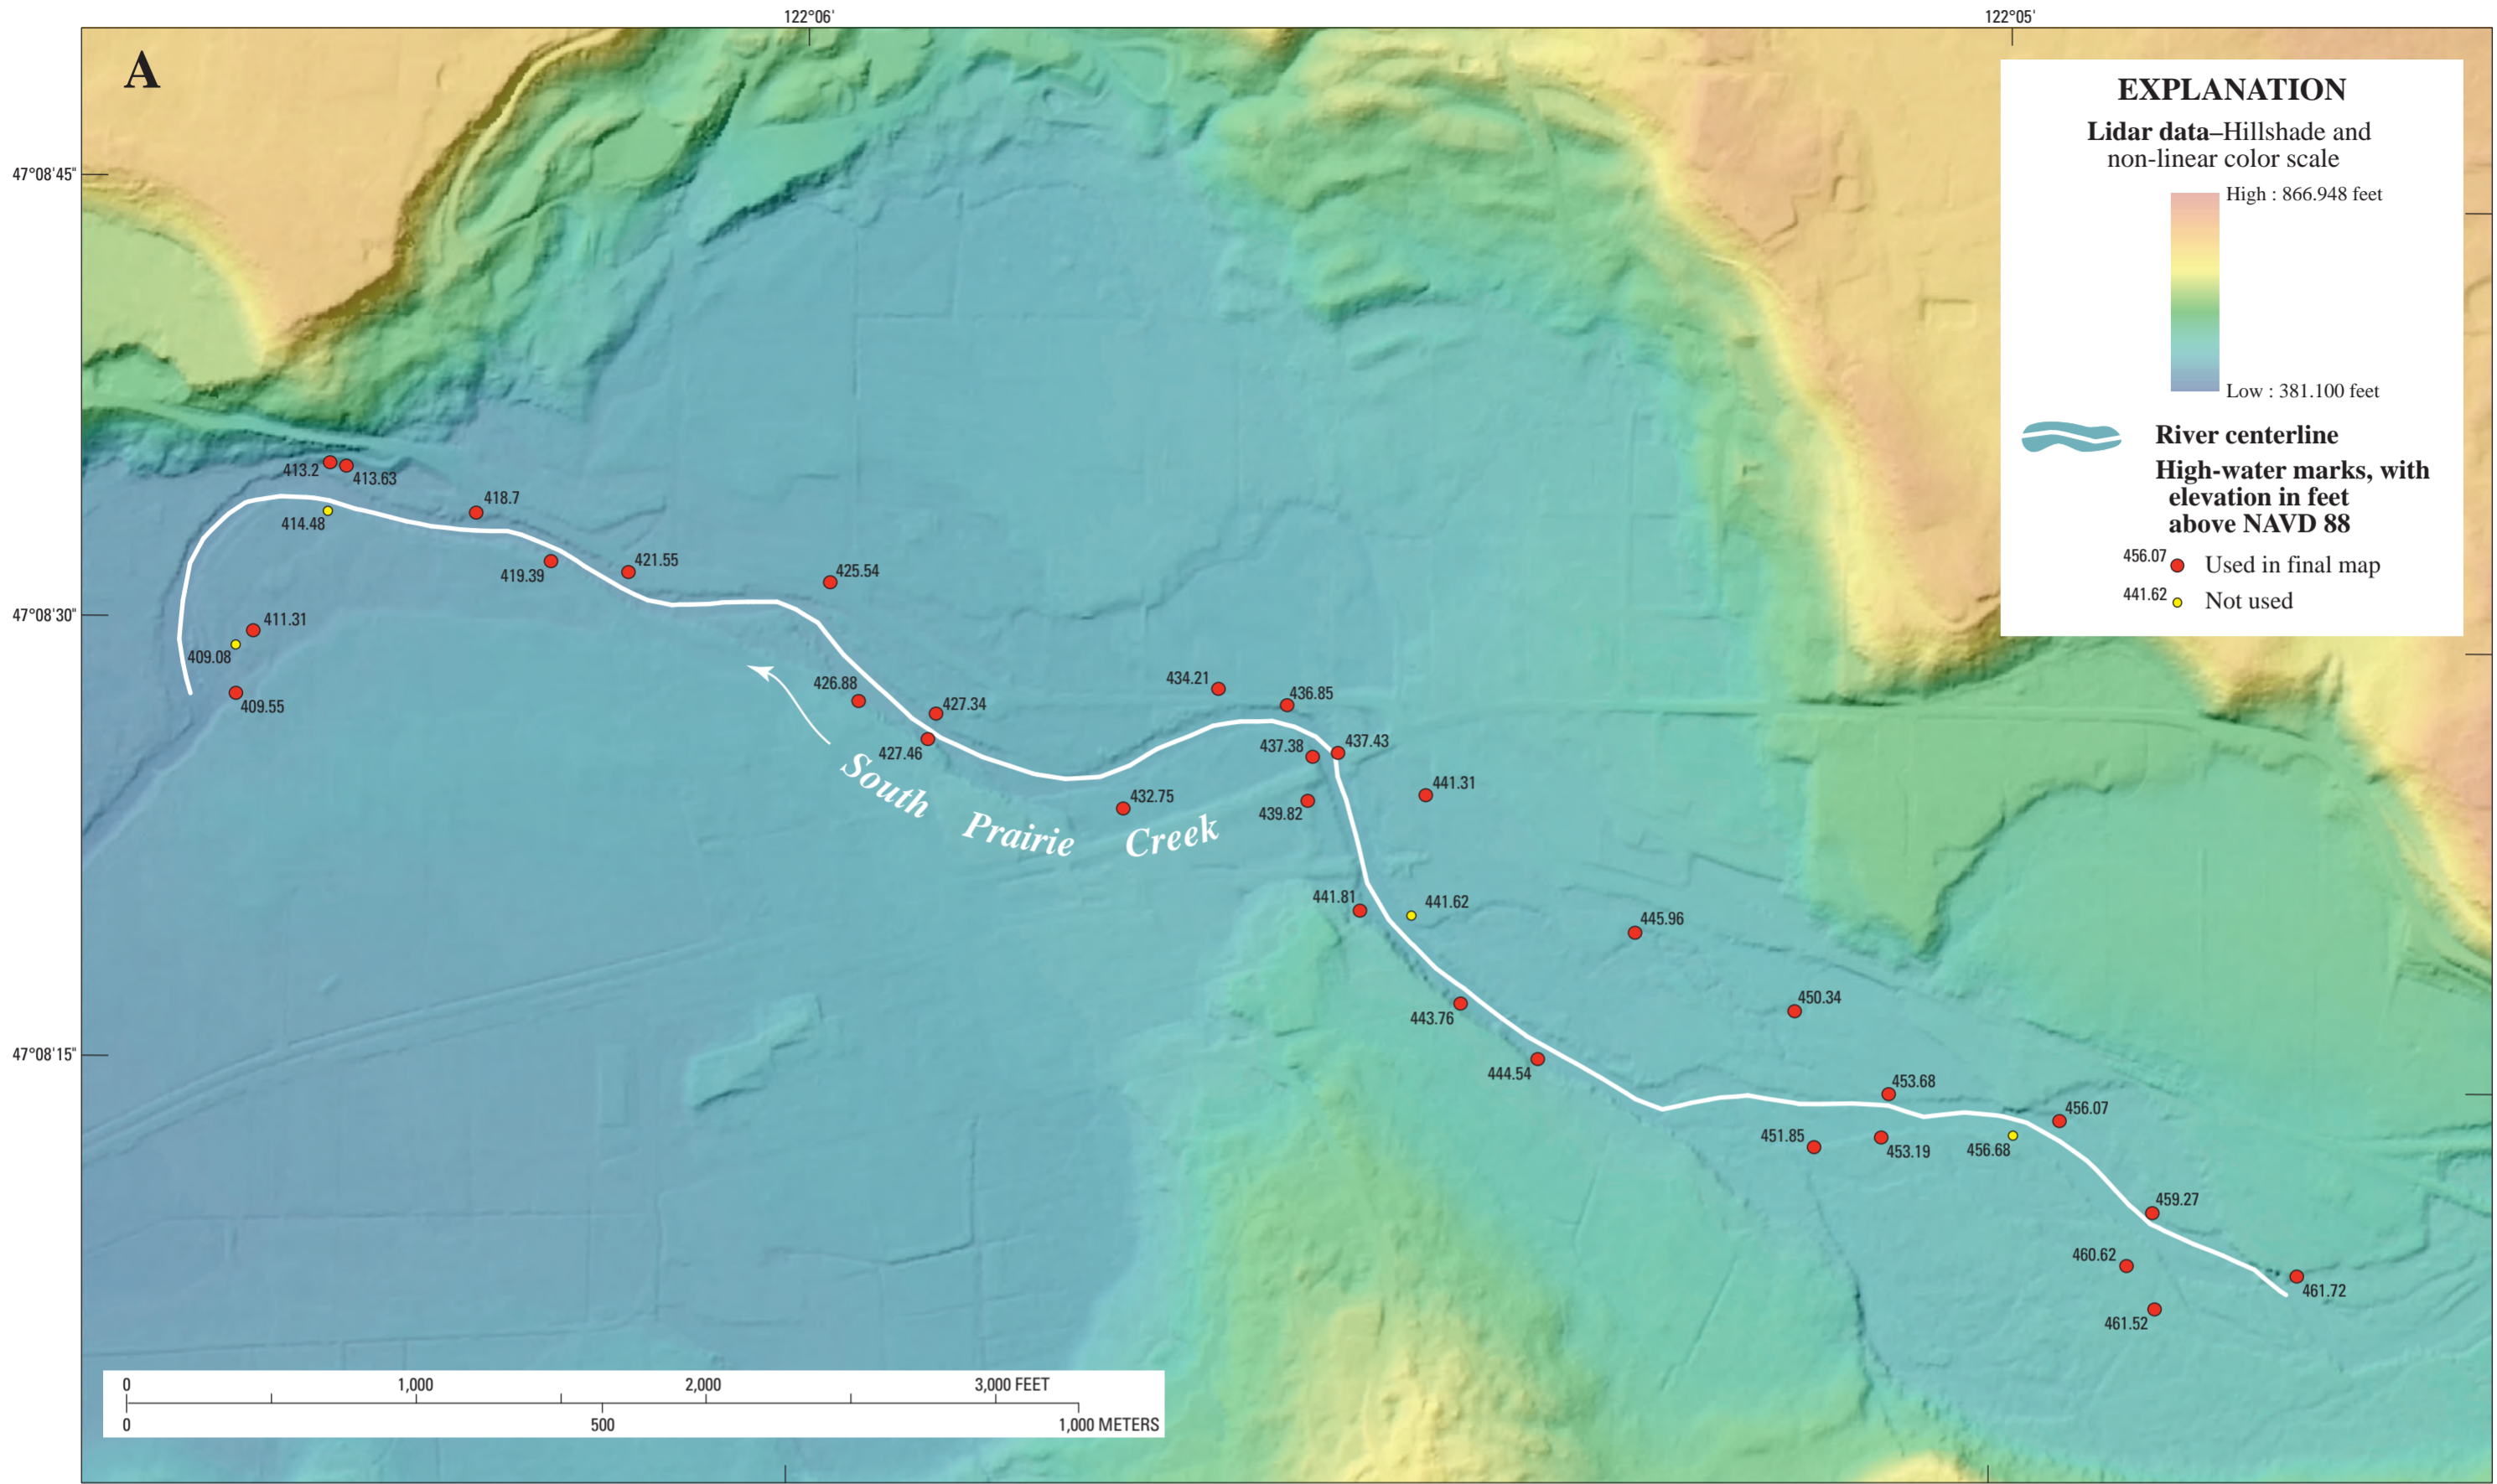
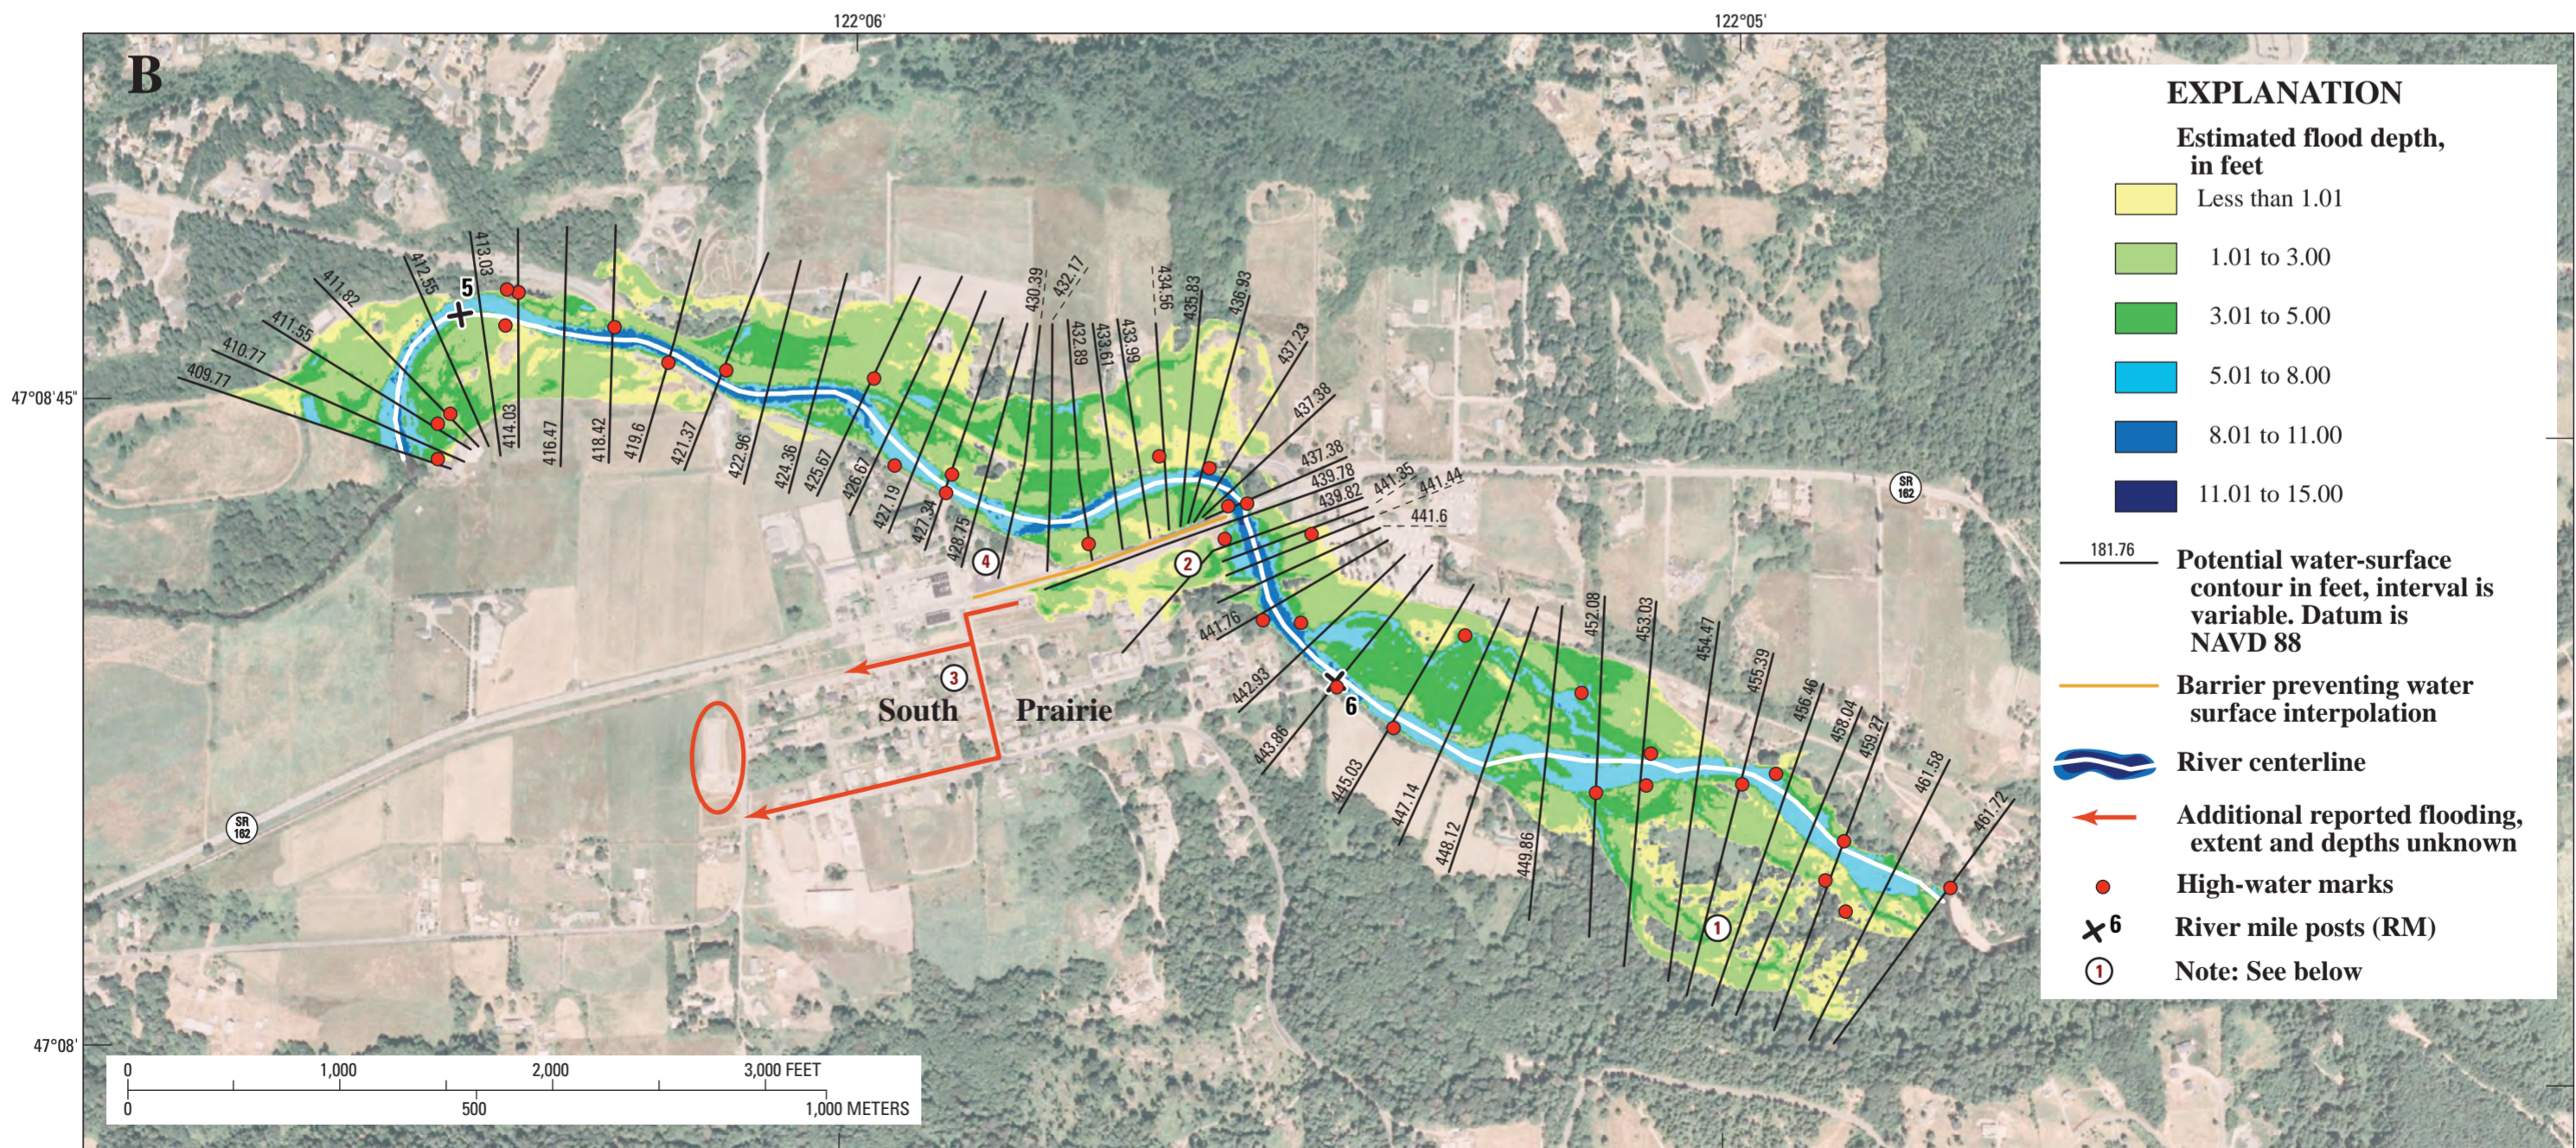
Note 1: The origin and extent of the inundation in the left floodplain is unknown. Actual flood depths and extent may be different.

Note 2: There was reported minor flooding at the fire station behind the levee, extent is unknown.

Note 3: Flooding was also reported by Tony Caldwell (Project Manager, Town of South Prairie) at the intersection of Pioneer Way and Emery Avenue (not shown); however, the extent and inundation depths are unknown. Flood waters then flowed south on Emery and then west on 3rd Street, as well as west on 1st Avenue, to a storm and sewage treatment facility (circled area on map) just west of South Prairie Carbon River Road.

Note 4: Barrier line was used to prevent water surface interpolation across the roadway, which was not flooded.
