Map showing magnitude and extent of January 2009 flooding on river mile 12.3 to 17.7, Stillaguamish River, Snohomish County, Washington.

By  
Mark C. Mastin, Andrew S. Gendaszek, and Christiana R. Barnas  
2010

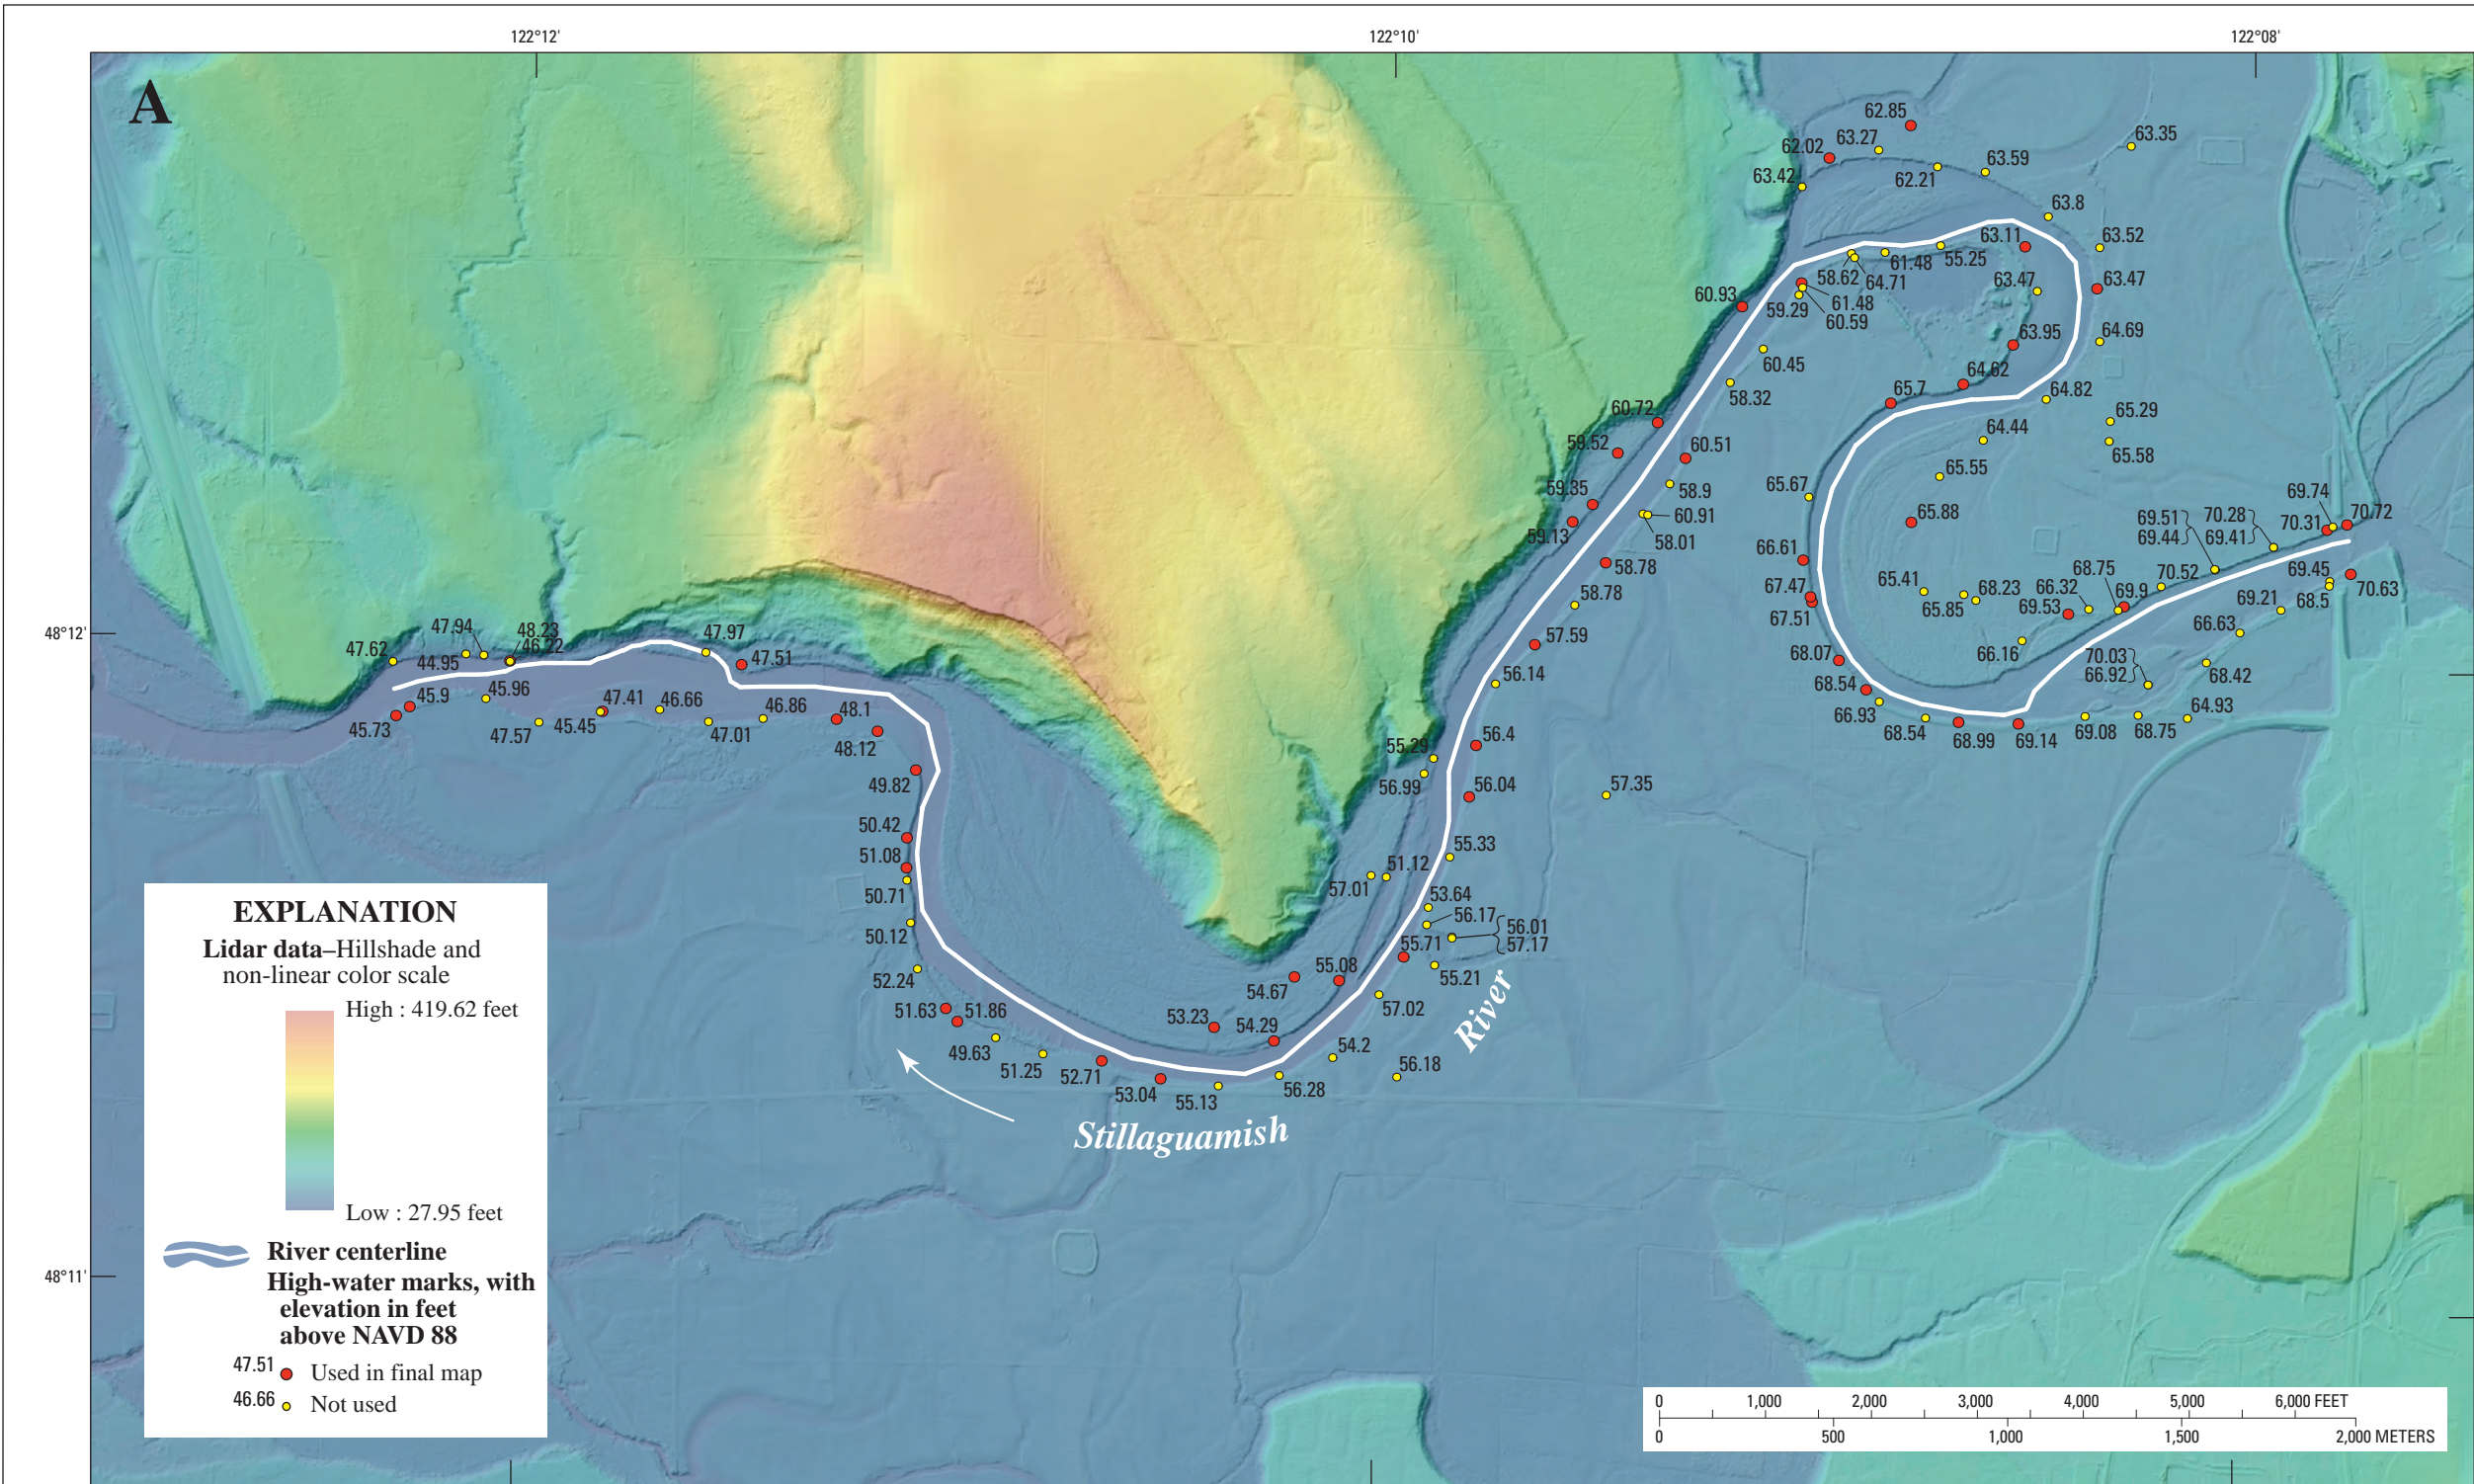
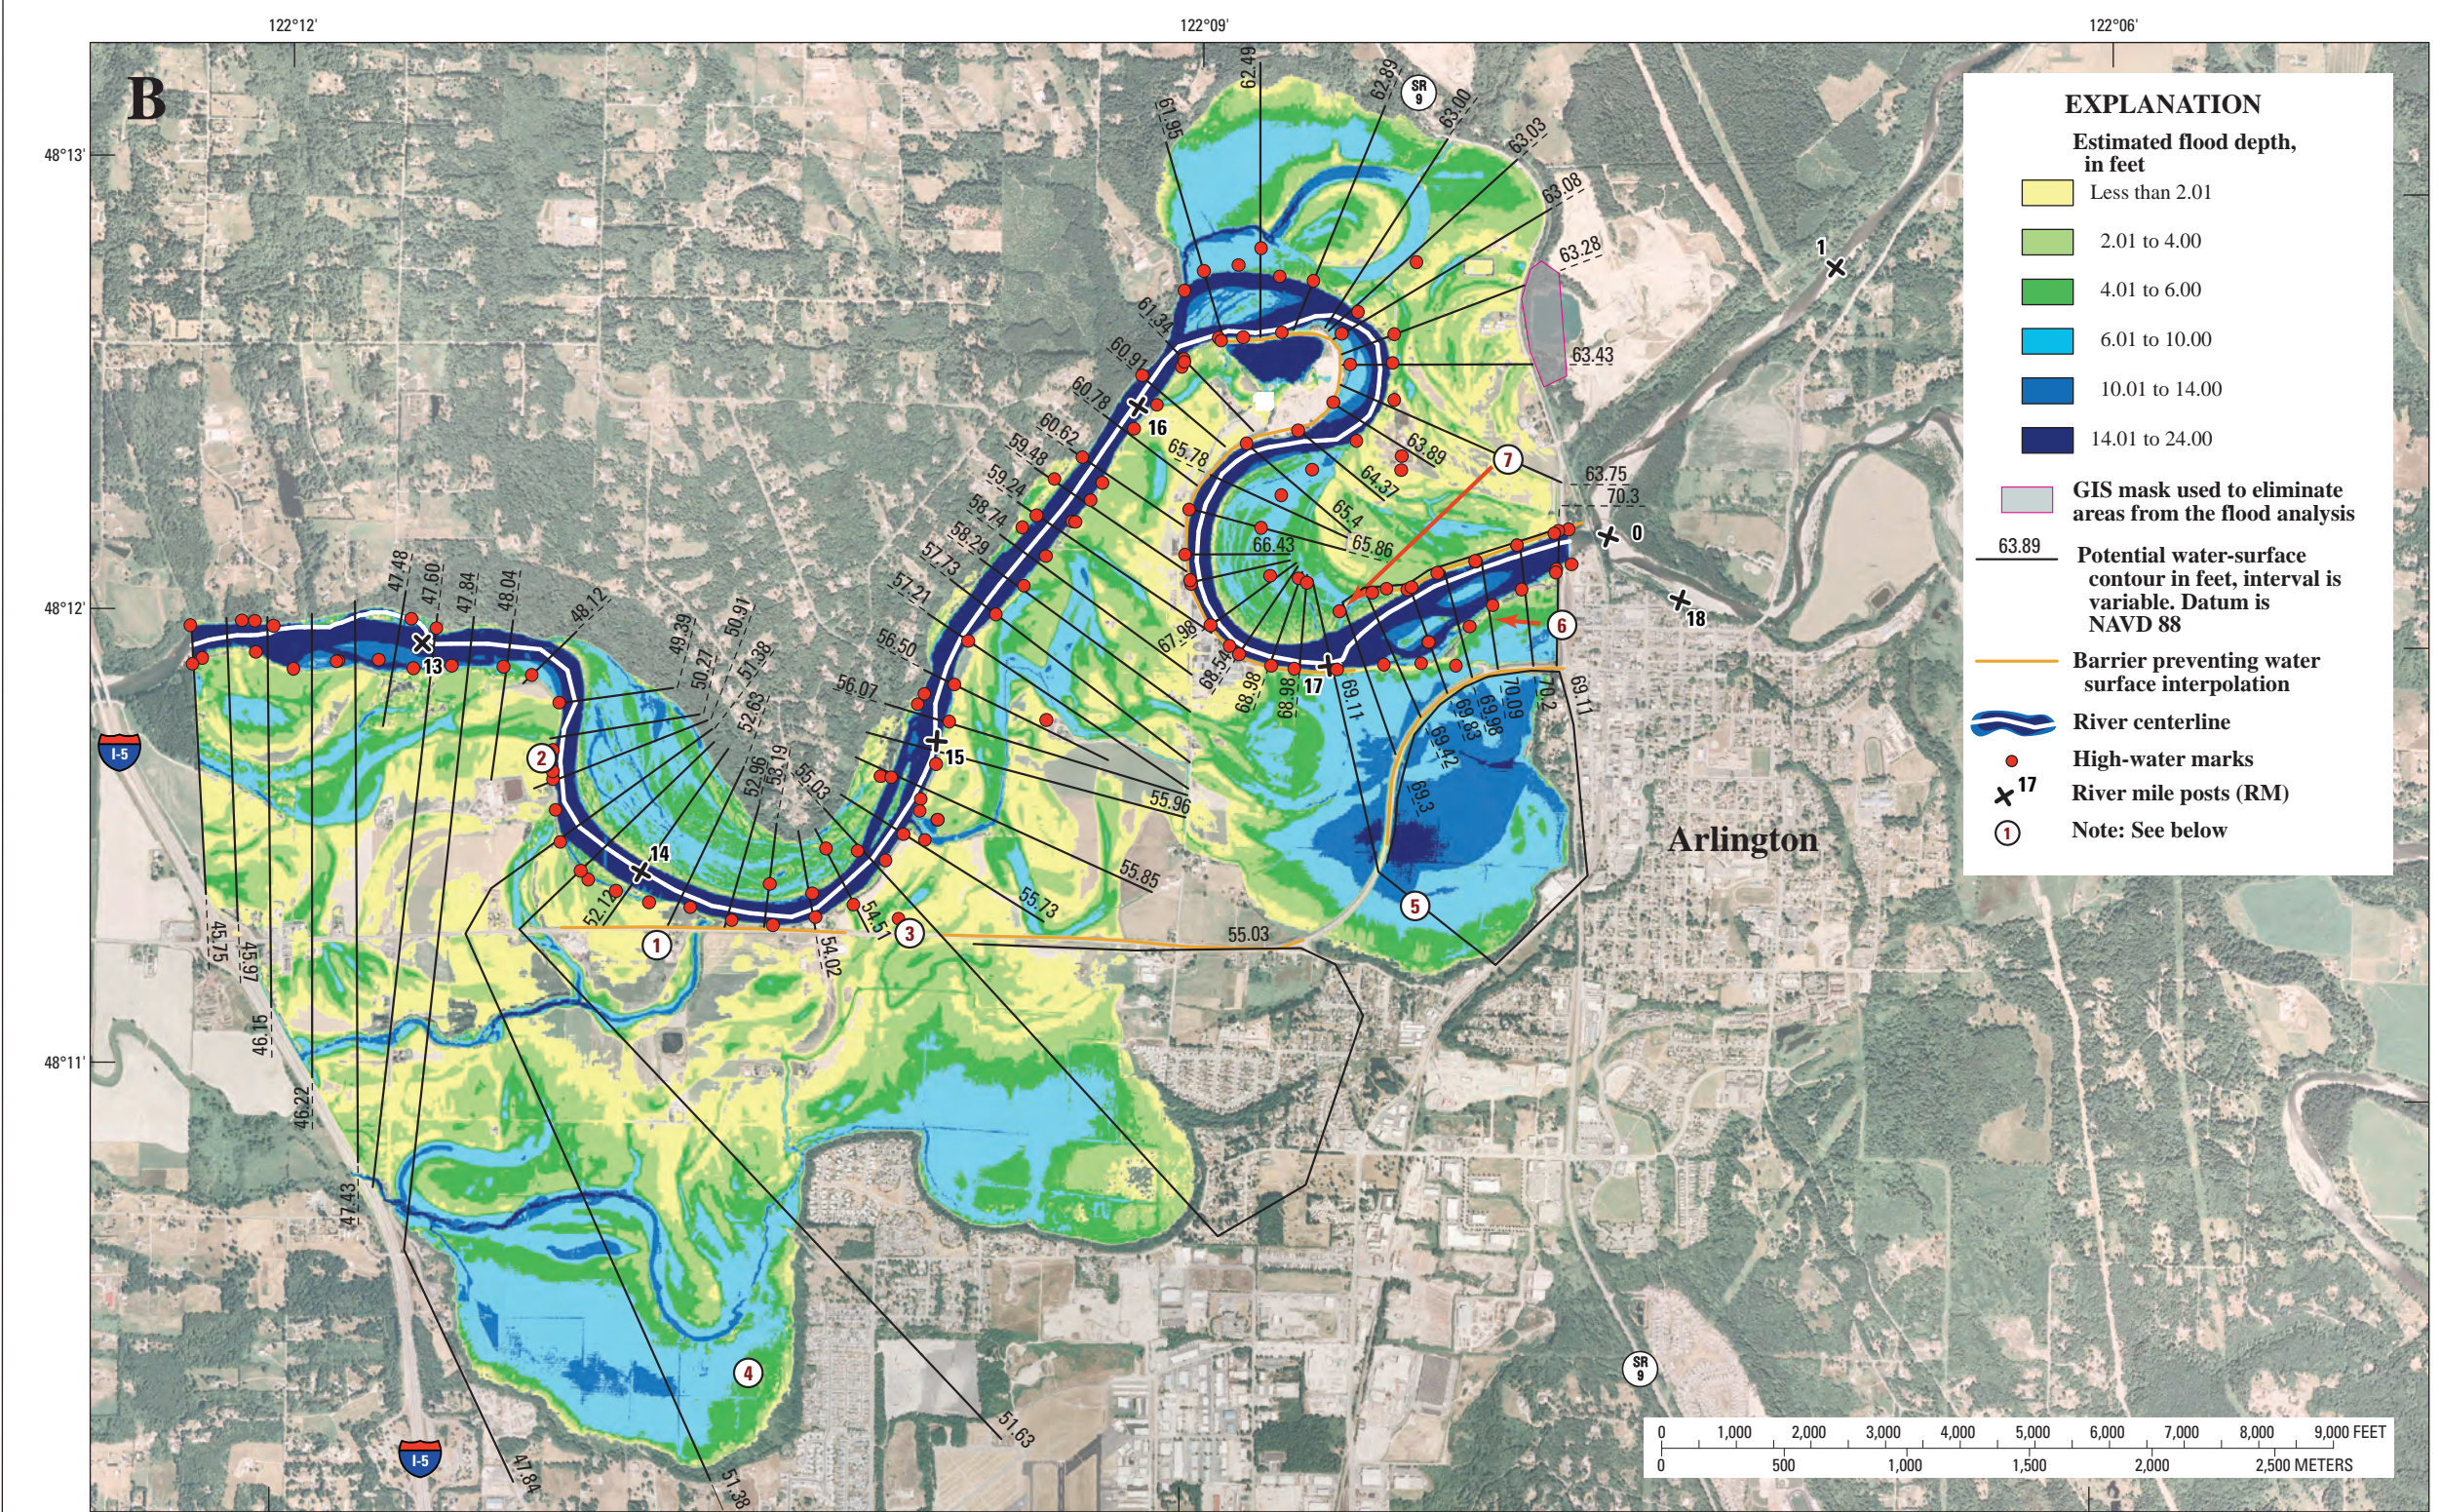
Note: Small unconnected mapped areas of inundation may or may not have been flooded.

Note 1: Landowner says floodwaters did not come over Highway 530 at his property, but crossed highway farther to the west and came around from the south to near his home along the creek. His home did not flood.

Note 2: Landowner says floodwaters did not come over the left river bank, but came onto his property from overbank flows farther upstream.

Note 3: Water flowed over the highway at this location according to Max Albert, Stillaguamish Flood Control District.

Note 4: The water-surface contours at the approximate locations where flood waters were thought to cross Highway 530 were extended to the likely southern limit of flooding so that the analysis would extend this far.

Note 5: There were reports of flooding on this side of Highway 530 in this area from flow through culverts (Max Albert, Stillaguamish Flood Control District).

Note 6: A large breach of the levee was found here (State Plane North, NAD 83 coordinates: 440,513.3 1,323,117.2)

Note 7: A large breach of the levee was found here (State Plane North, NAD 83 coordinates: 440,695.2 1,321,290.3)
