# Appendix B. Puget Sound Shoreline Field Trip: Kitsap County and Bainbridge Island

Shoreline Armoring on Puget Sound: State of the Science Workshop

May 13, 2009

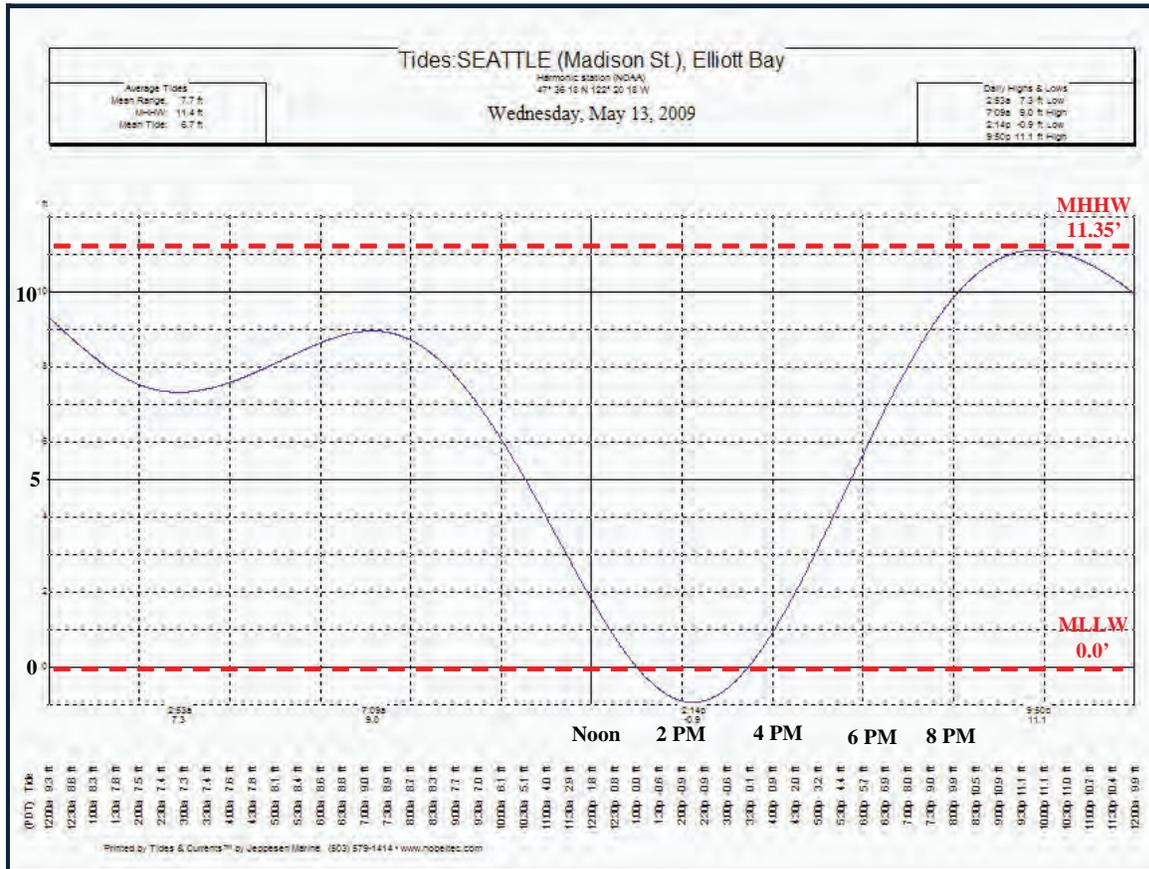
### Tides During May 13 Field Trip

Tides, shown here for Seattle, are fairly similar in timing and height throughout the area of our field trip. The tides during the field trip will be lowest around 2PM (1 ft below MLLW) and will be rising throughout the boat trip.

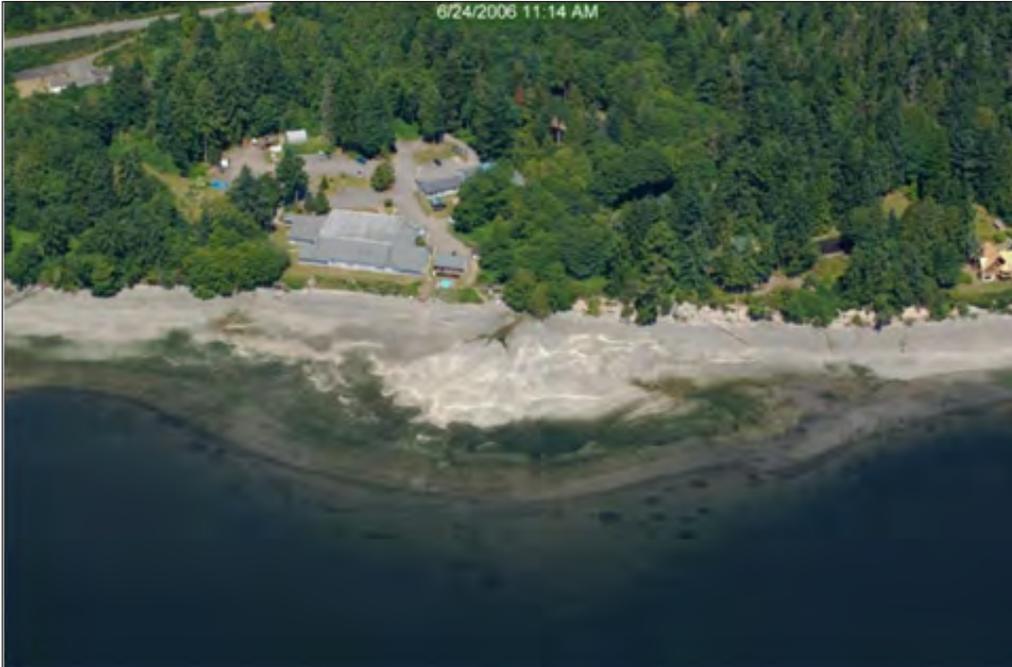
Oblique aerial photograph of Suquamish site. Note bluffs in each direction, variability in bank vegetation, and the distinct intertidal delta fan at the stream mouth.

The beach at this site is dominated by the intertidal delta of the small creek (see oblique aerial photo). Stream mouth deltas such as this are common on Puget Sound. Little is known about their relative importance, compared to the eroding bluffs, in delivering sediment to the littoral system, although it likely varies significantly between sites.

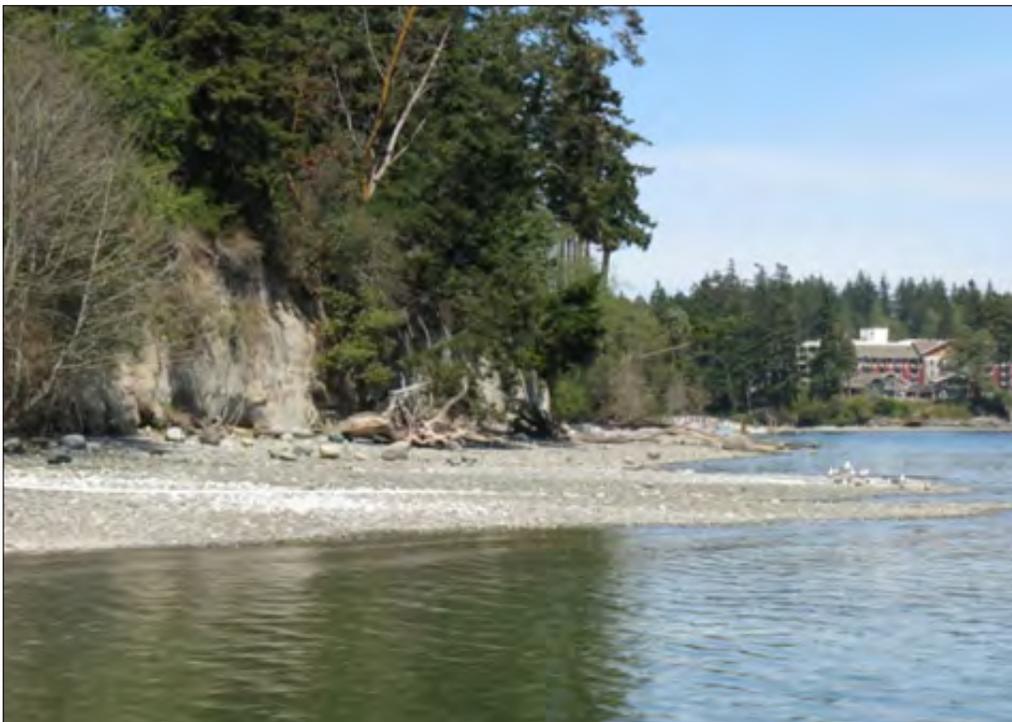
View northeast, looking across the stream delta at a mid-tide. The bluff is developed in glacial drift which often forms steep, bare cliffs.

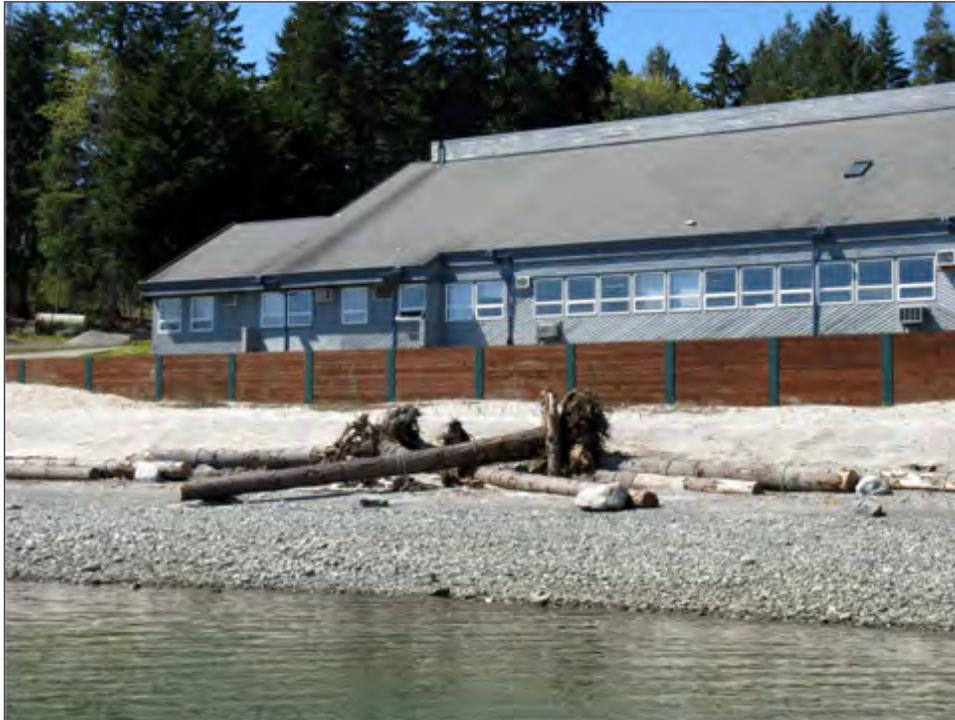
Bank stabilization project in front of building, showing vertical pile wall, recently planted and regraded slope (covered with mesh), and large anchored logs.

Concerns about the eroding bank in front of the large building led to the recent stabilization project. This project is typical of others on Puget Sound where there is tension between the need to protect upland structures using standard accepted engineering techniques and the desire to protect shoreline processes and ecologic functions. As is often the case, the result is some interesting compromises. The project employs a deep pile wall, a reconfigured soil bank with plantings, and the structural incorporation of large wood on the beach.

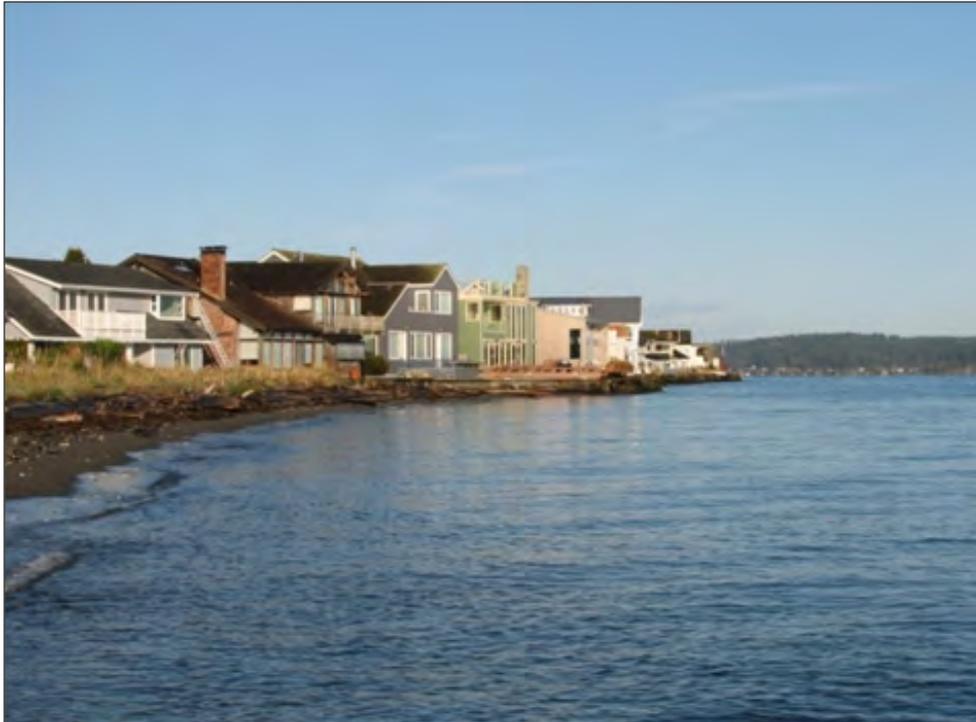
View north from the State Park showing homes along the Point Monroe spit. Note that many seawalls extend well below the waterline at the time of this picture (approx. Mean Higher High Water).

Point Monroe itself is developed with waterfront homes, many of which are heavily armored to protect against erosion and storm damage. The spit experienced serious damage in December, 1990, following a pair of unusual northerly windstorms (most major storms and wave action on the Sound come from the south). Many seawalls were destroyed and in some cases homes themselves were damaged when walls collapsed or when backfill was eroded out from under the walls during the height of the storm.

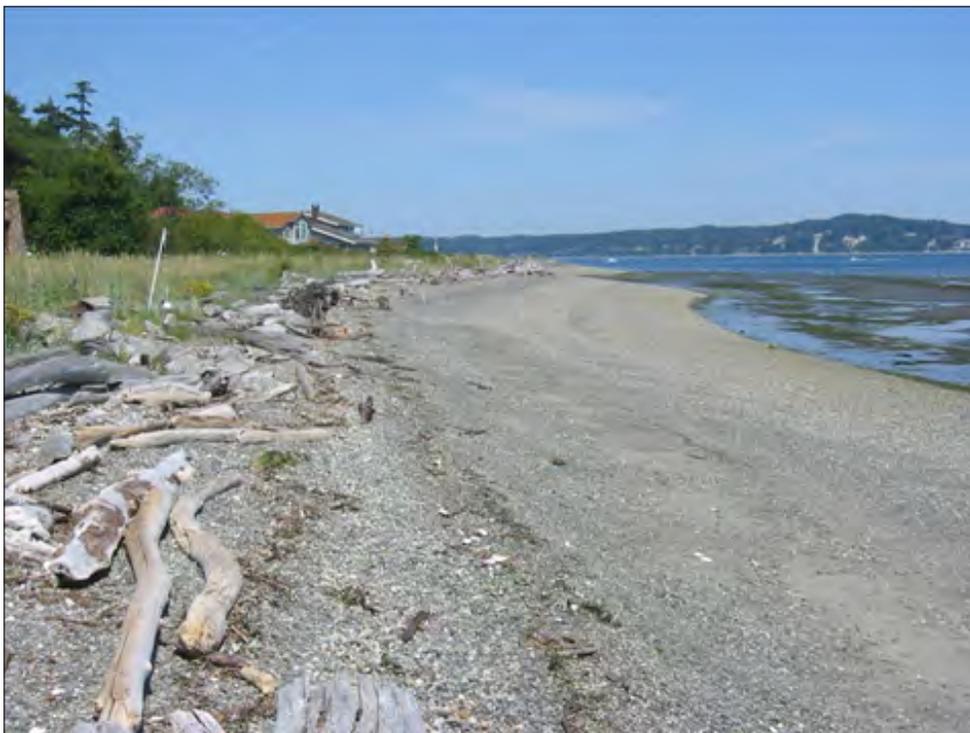
View north of the beach from south of Fay Bainbridge Park. Illustrates typical berm with drift wood, gravelly foreshore, and broad sandy low tide terrace.

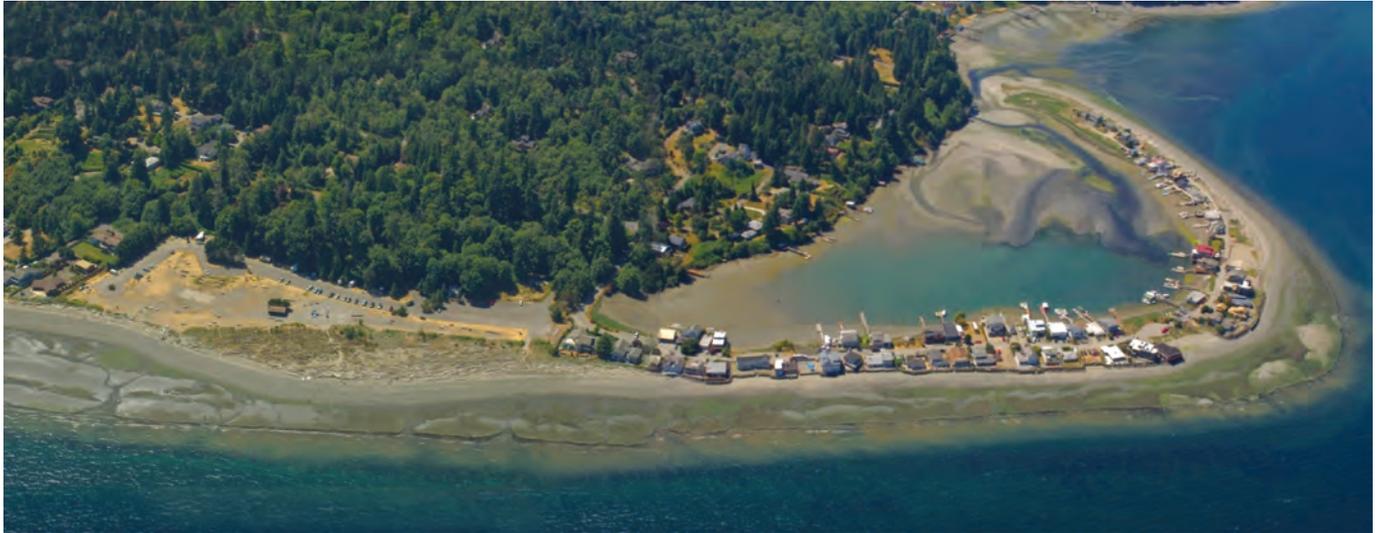
Point Monroe is a recurved spit that actually begins 1-2 kms south (left) of these images. The broad backshore at the park and where the homes are to the south historically contained an extensive wetland system that drained north towards the lagoon. This photo illustrates the extent of residential development on the spit itself, with homes located on both exposed beach and on the lagoon. Note the extensive use of seawalls to protect homes.

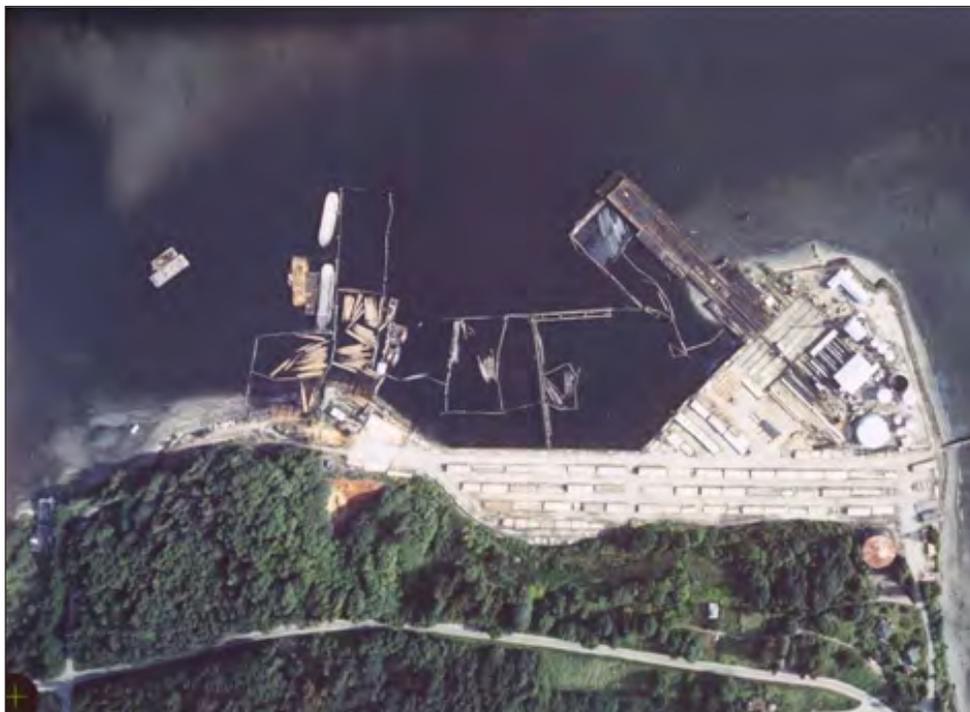
Aerial photo of site when creosote treatment facility was still in operation.  
(Source: Eric Nelson, U.S. Army Corps of Engineers)

Throughout much of the 20th century, a creosote plant operated at this location. The facility closed in the 1980s and was taken over by EPA as a Superfund site. Remediation began in the late 1990s, with construction of a steel sheet pile containment wall and treatment of contaminated soils.

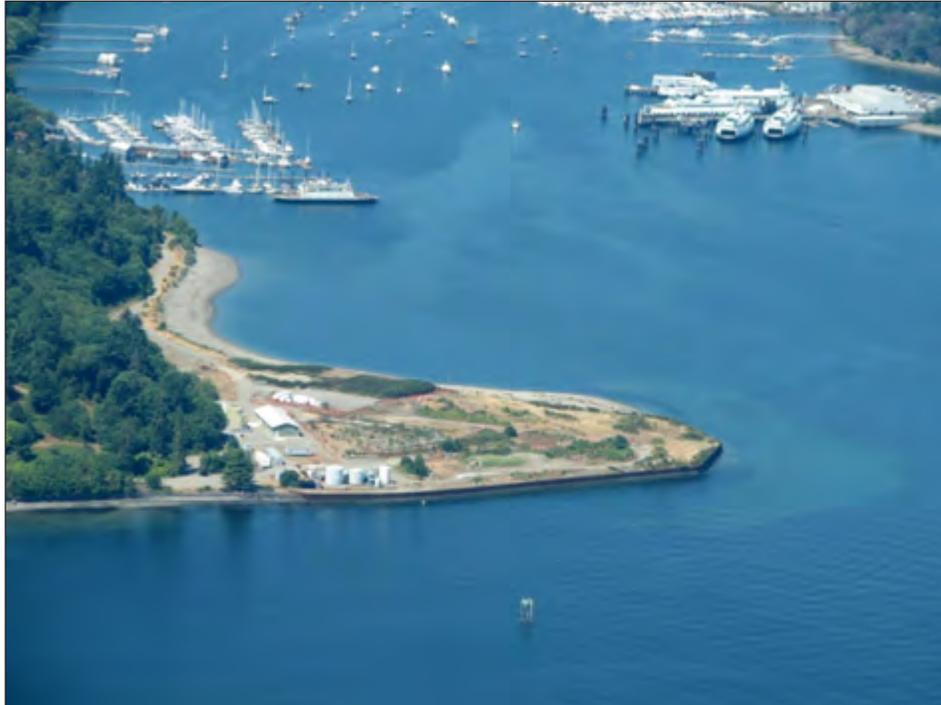
Aerial view of Pritchard Park site taken in July, 2009. Sheet pile wall and soil remediation facilities are located on the point in the foreground. The created beach can be seen behind point.

Under the guidance of the Corps of Engineers, historic fill, overwater structures, and debris were removed from the western portion of the site, a large sediment cap was placed to isolate contaminants, and a broad sandy gravel beach was created. This beach has become a popular recreational site for local residents.

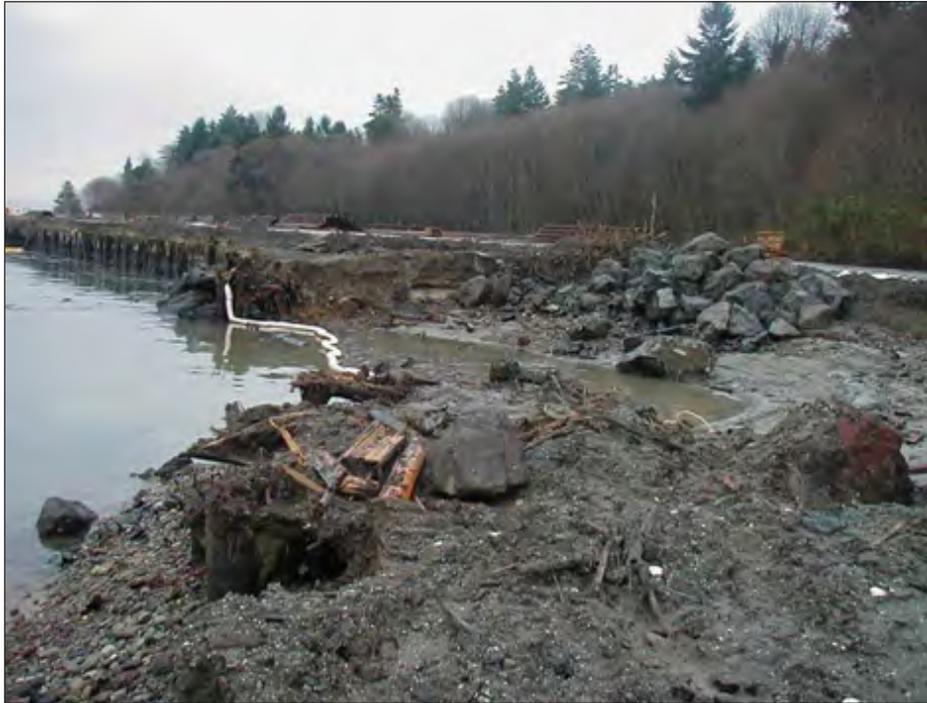
Initial excavation of historic fill and debris on western portion of the site (Source: Eric Nelson, U.S. Army Corps of Engineers.)

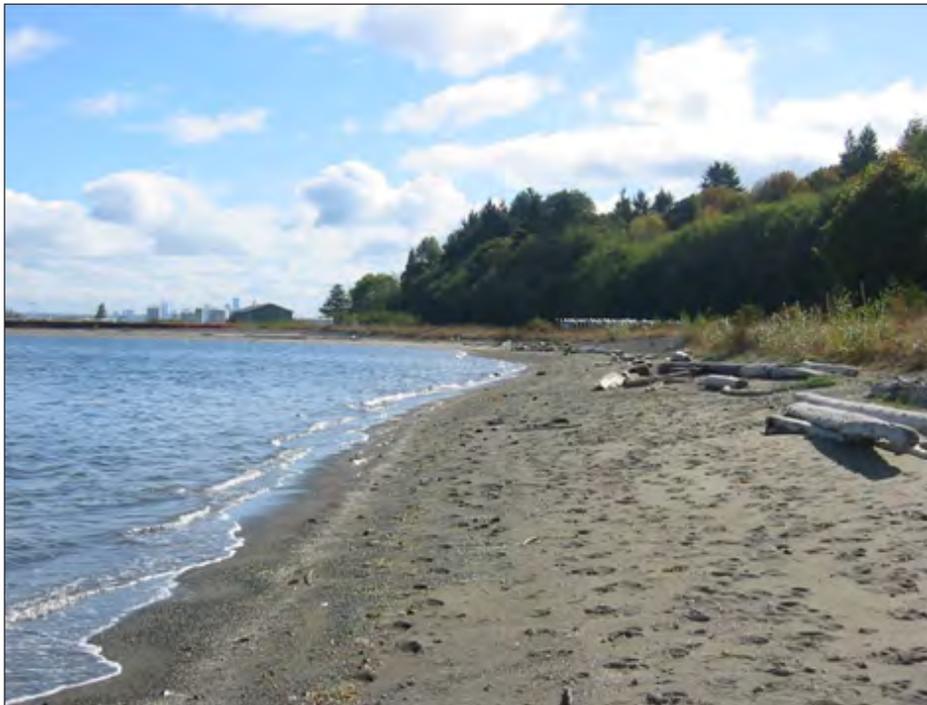
Photo of the same area as above, taken in 2005, following capping and beach creation.
