## Lateral and Vertical Channel Movement and Potential for Bed-Material Movement on the Madison River Downstream from Earthquake Lake, Montana

Scientific Investigations Report 2012–5024

By Katherine J. Chase and Peter M. McCarthy

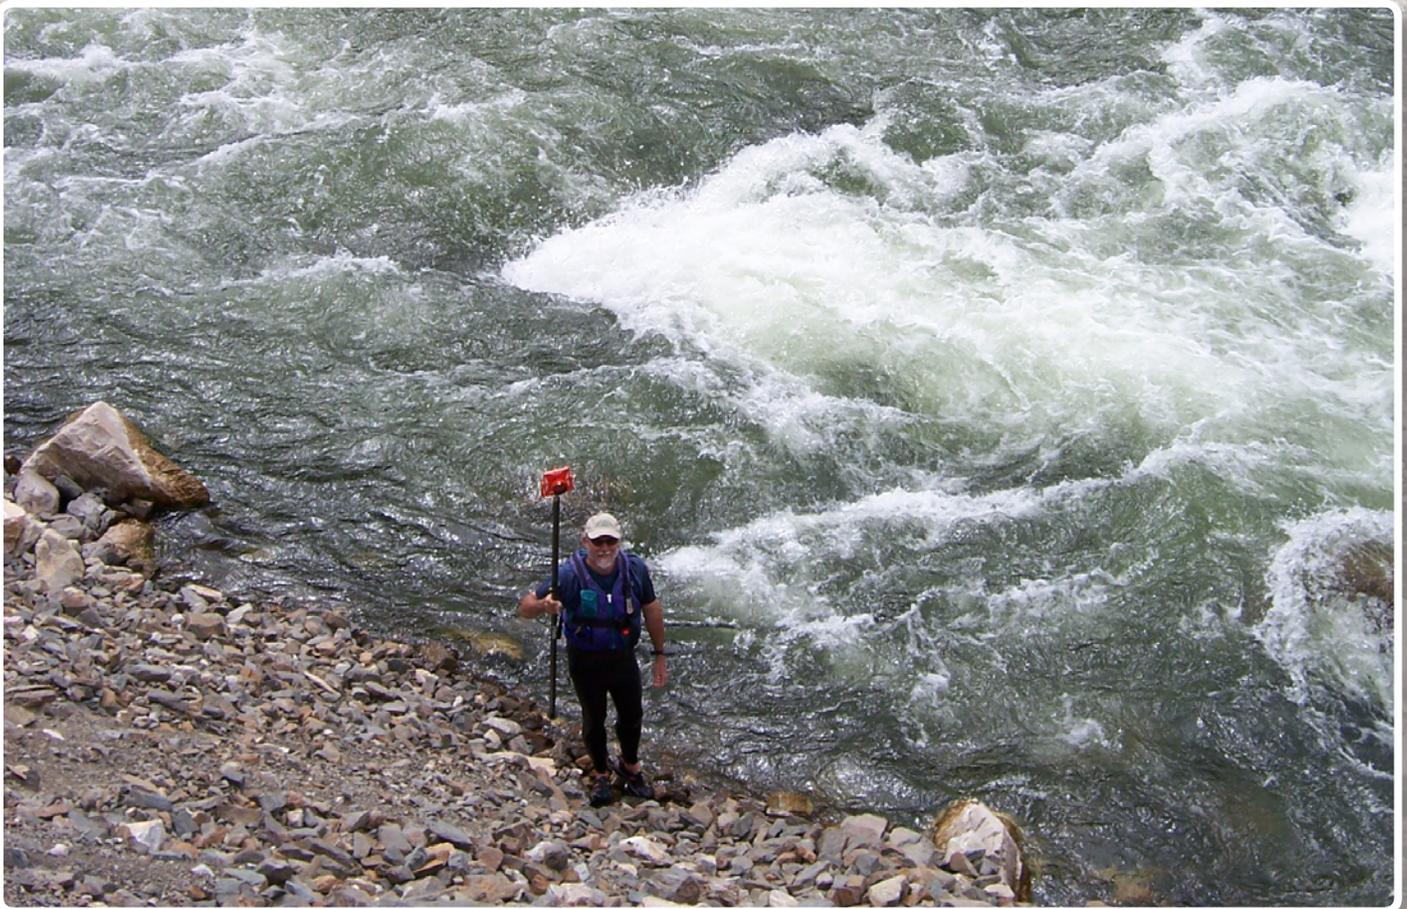
**Front cover.** U.S. Geological Survey personnel surveying the Madison River downstream from Earthquake Lake, Montana, near cross section 600 (photograph by the U.S. Geological Survey, 2006).

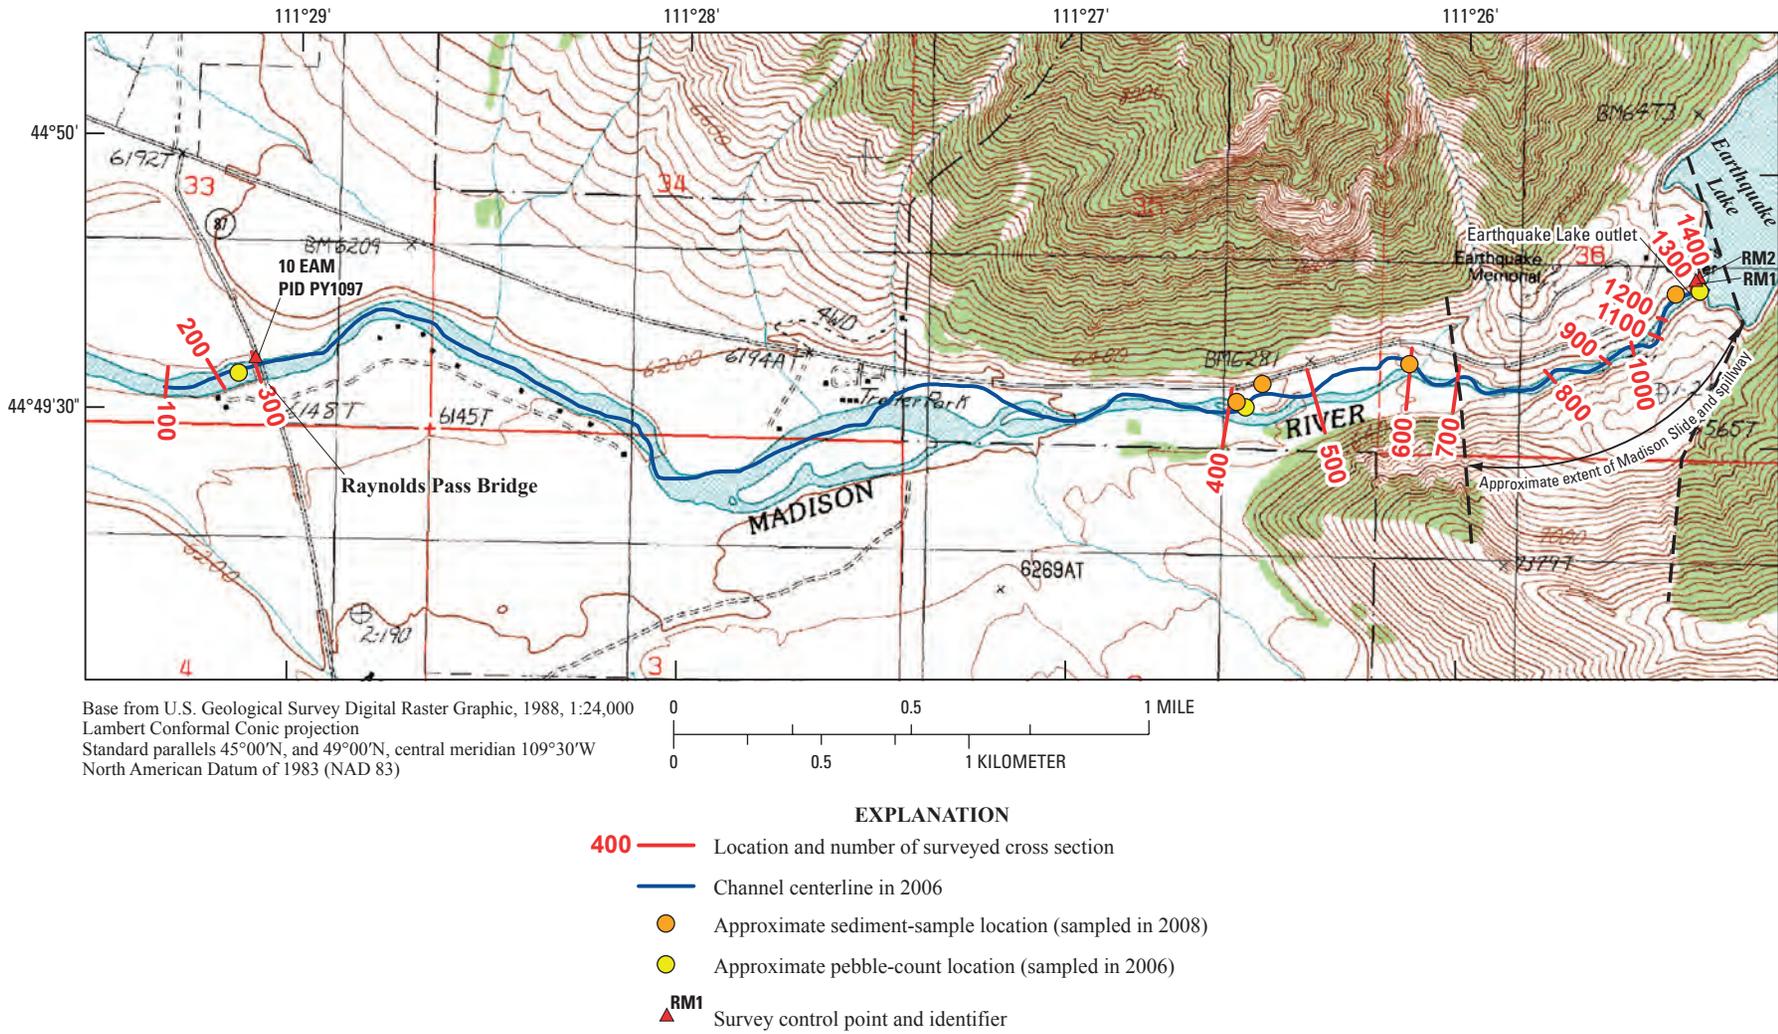
**Figure 2.** Location of surveyed cross sections, channel centerline in 2006, approximate locations of sediment samples collected in 2006 and 2008, and survey reference marks along the Madison River downstream from Earthquake Lake, Montana.

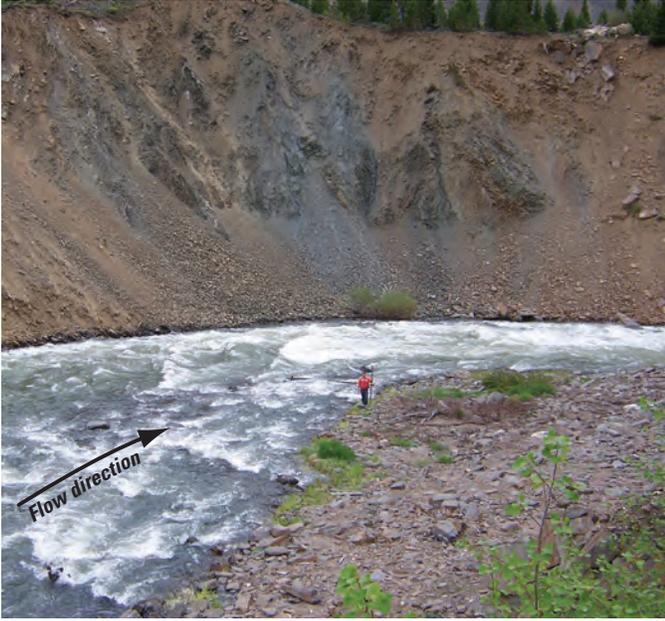
**Figure 3.** Madison River downstream from Earthquake Lake, Montana, looking downstream from right bank at cross section 1100.

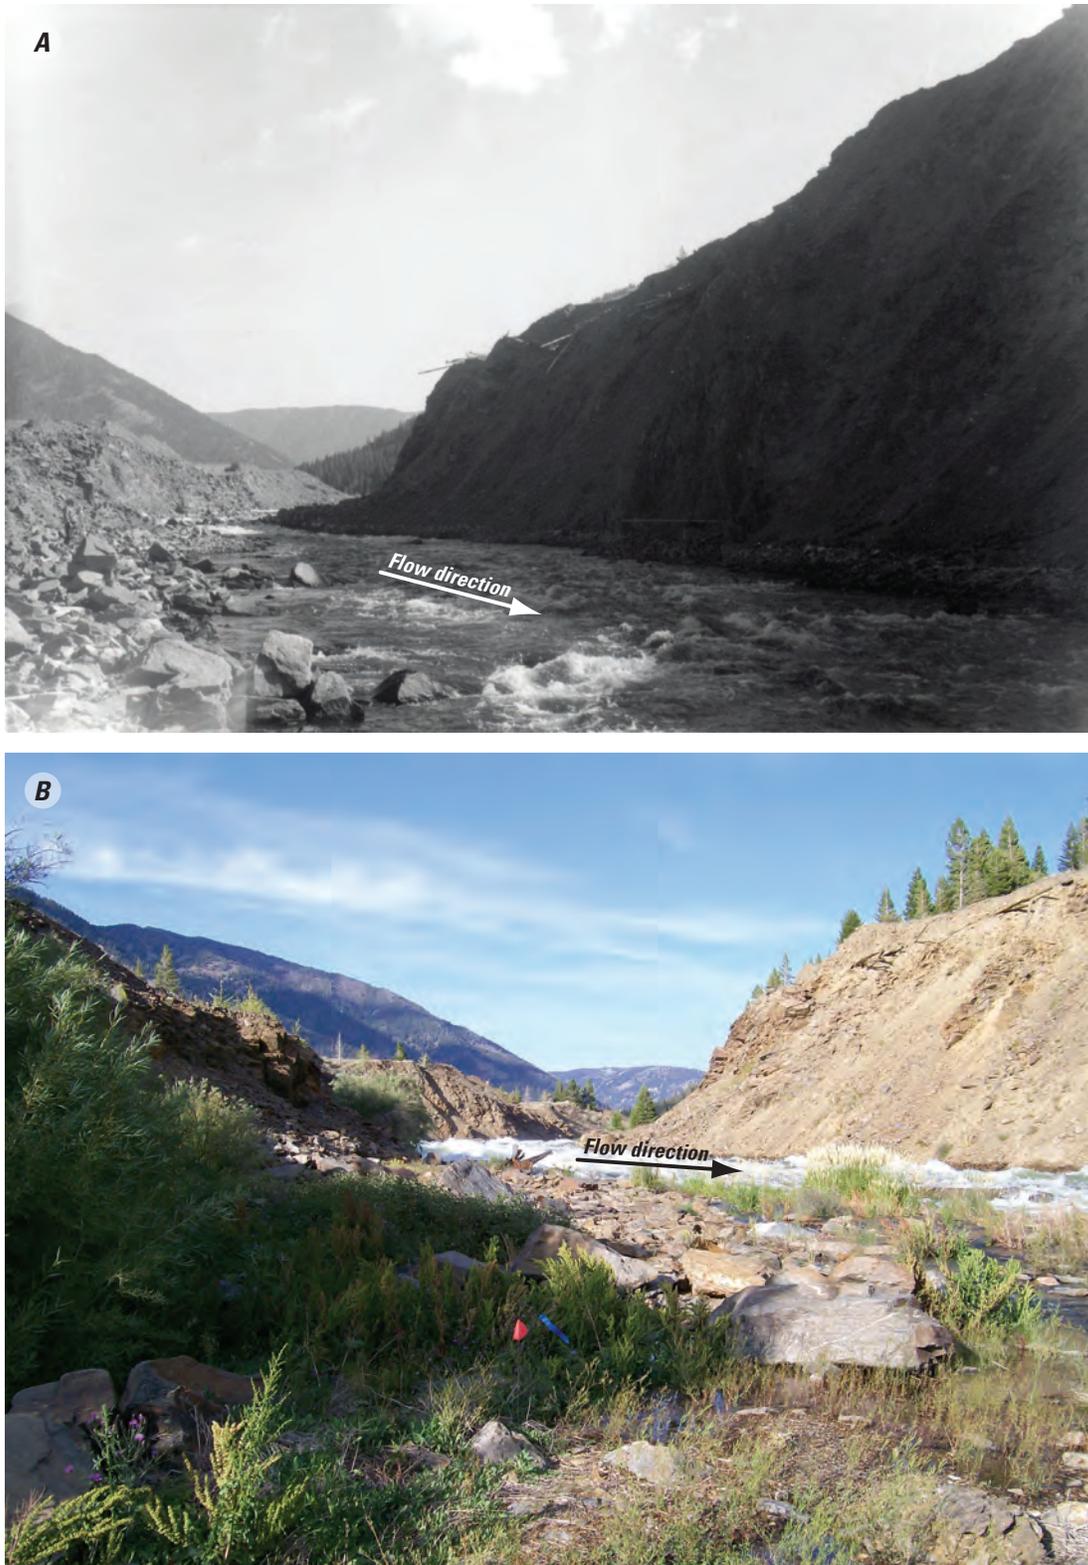
**Figure 4.** Madison River downstream from Earthquake Lake, Montana. *A*, Looking upstream from cross section 1100, September 1971 [streamflow 400 cubic feet per second at Madison River below Hebgen Lake, near Grayling, Montana (06038500)]. *B*, Looking upstream from farther downstream and slightly south when compared to photograph *A*, September 2008 [streamflow 3,650 cubic feet per second at Madison River at Kirby Ranch near Cameron, Montana (06038800)].

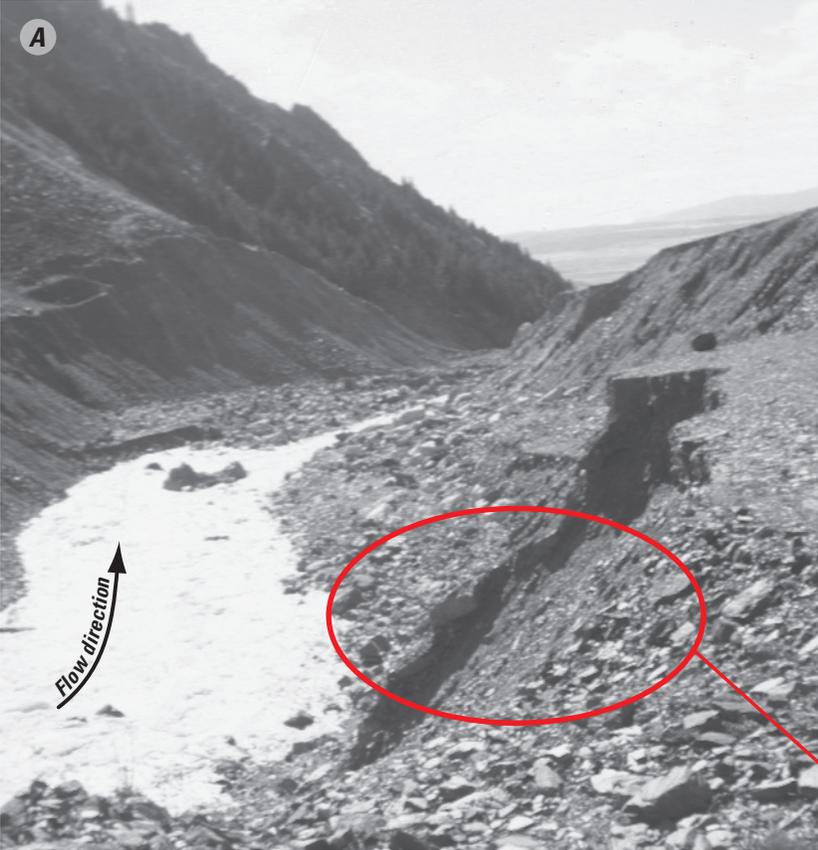
**Figure 5.** Madison River downstream from Earthquake Lake, Montana, looking downstream at cross section 800. *A*, September 1971, [streamflow 400 cubic feet per second at Madison River below Hebgen Lake, near Grayling, Montana (06038500)]. *B*, June 2006, [streamflow 1,040 cubic feet per second at Madison River at Kirby Ranch near Cameron, Montana (06038800)].

Right bank eroded between 1971 and 2006

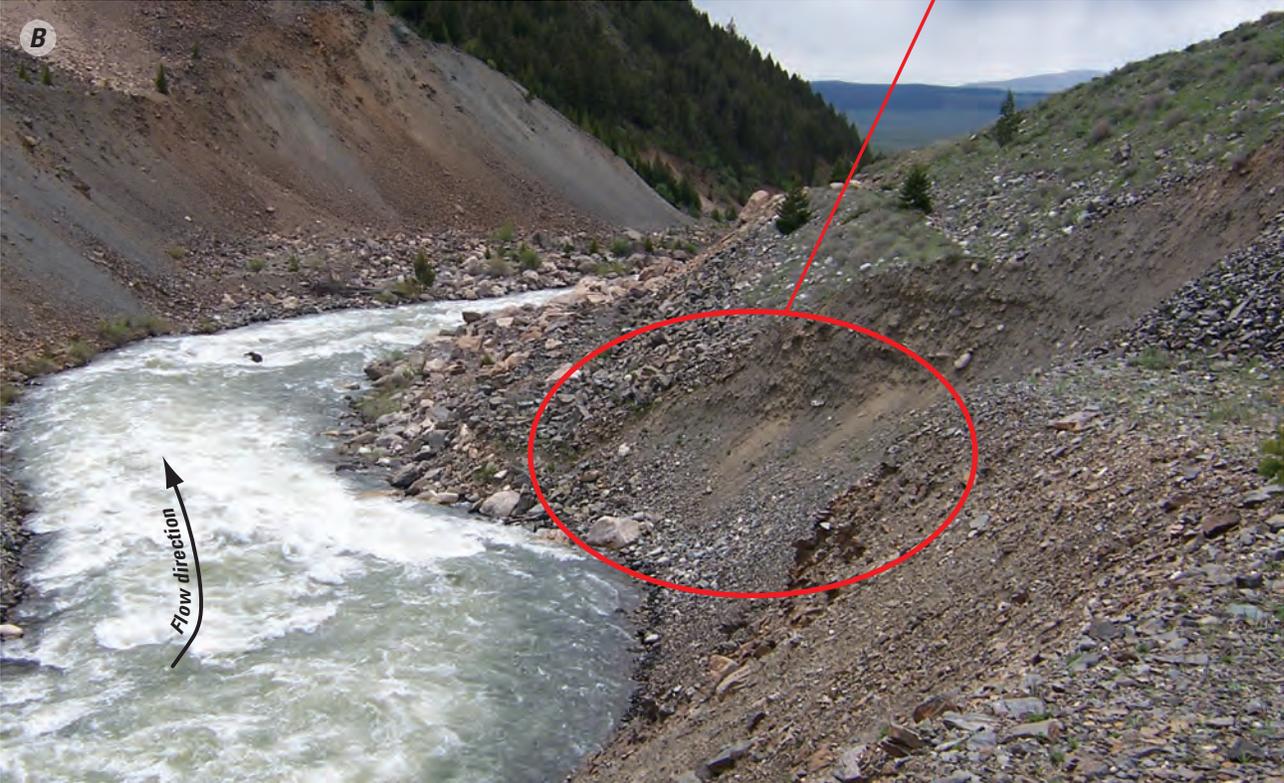
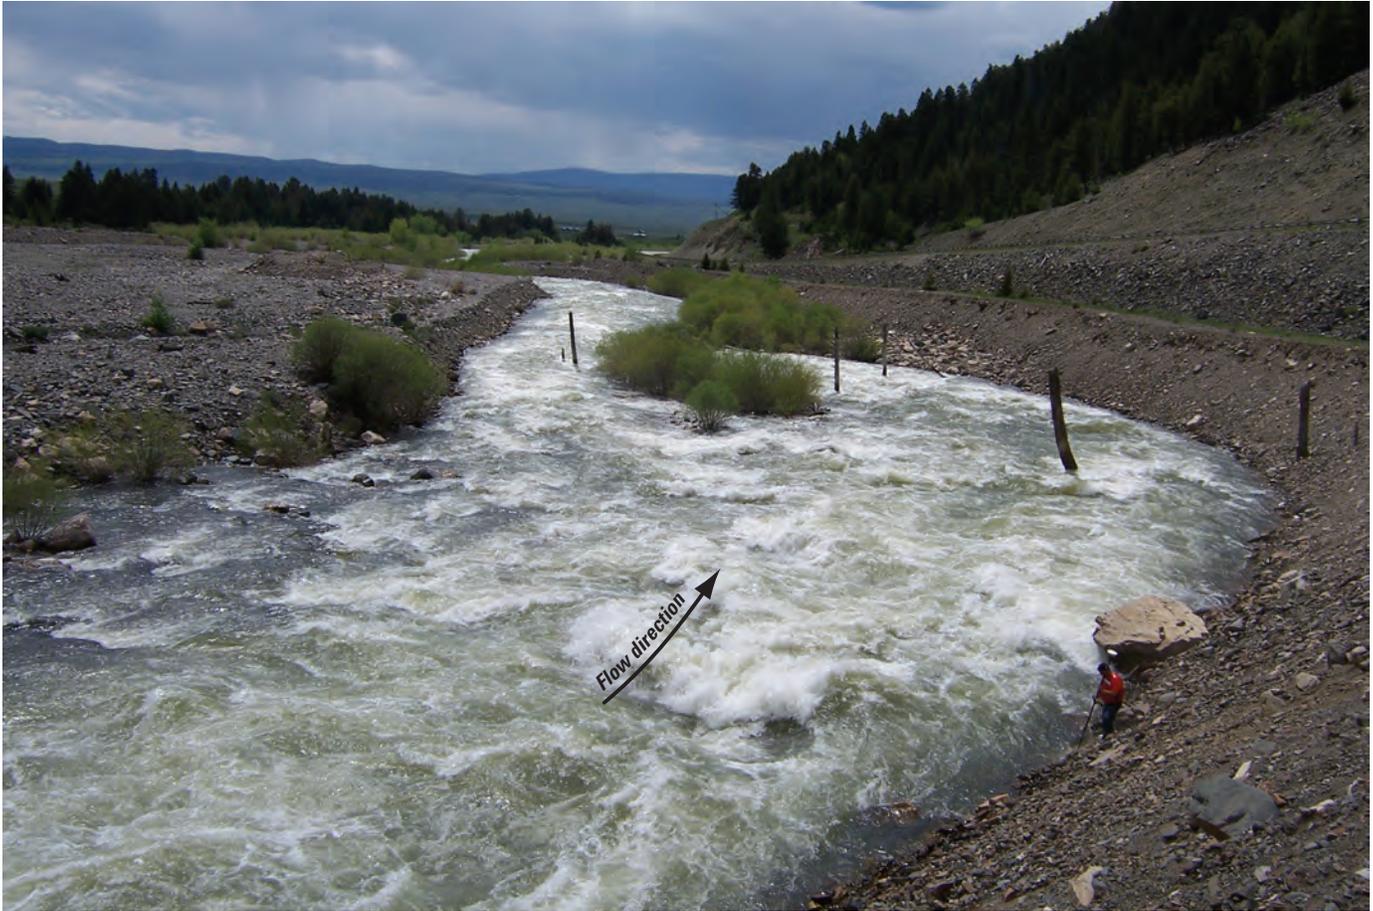
**Figure 6.** Madison River downstream from Earthquake Lake, Montana, looking downstream at cross section 600.

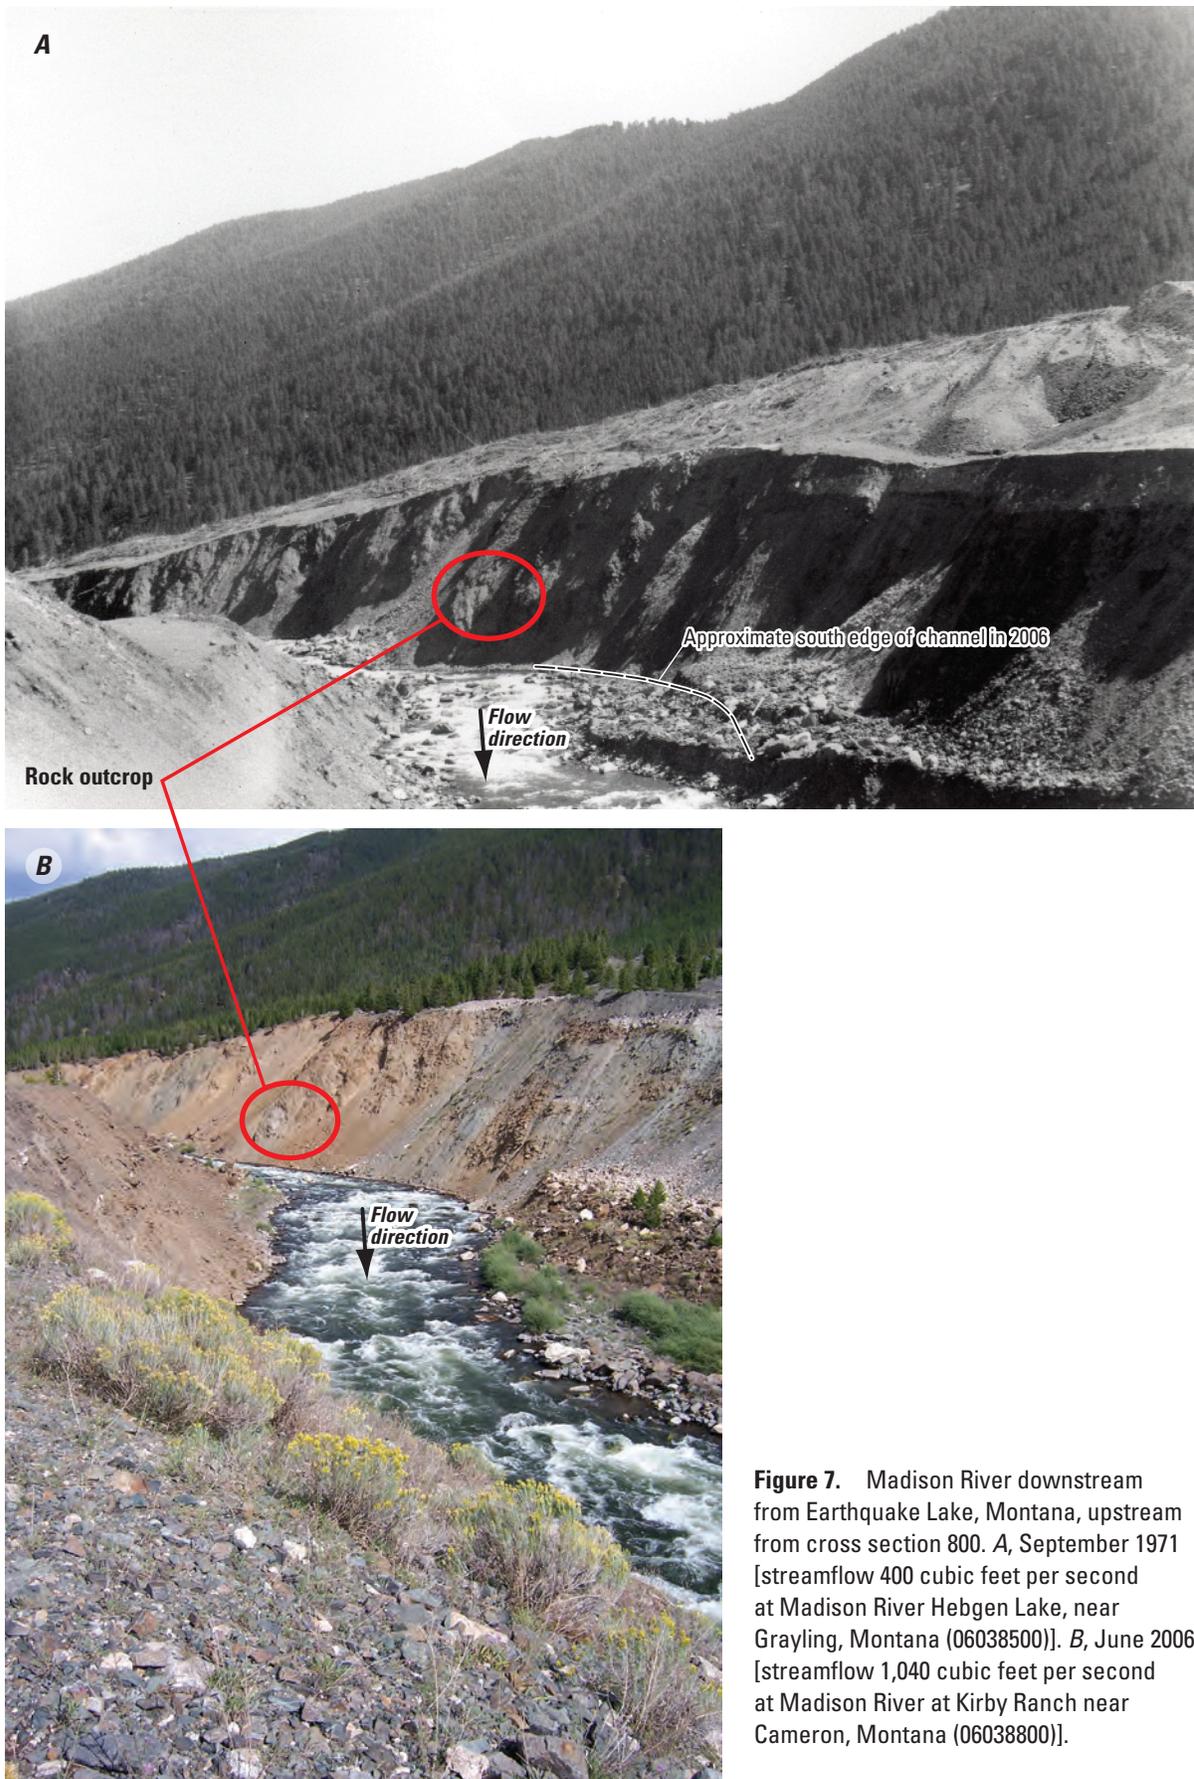
**Figure 7.** Madison River downstream from Earthquake Lake, Montana, upstream from cross section 800. *A*, September 1971 [streamflow 400 cubic feet per second at Madison River Hebgen Lake, near Grayling, Montana (06038500)]. *B*, June 2006 [streamflow 1,040 cubic feet per second at Madison River at Kirby Ranch near Cameron, Montana (06038800)].

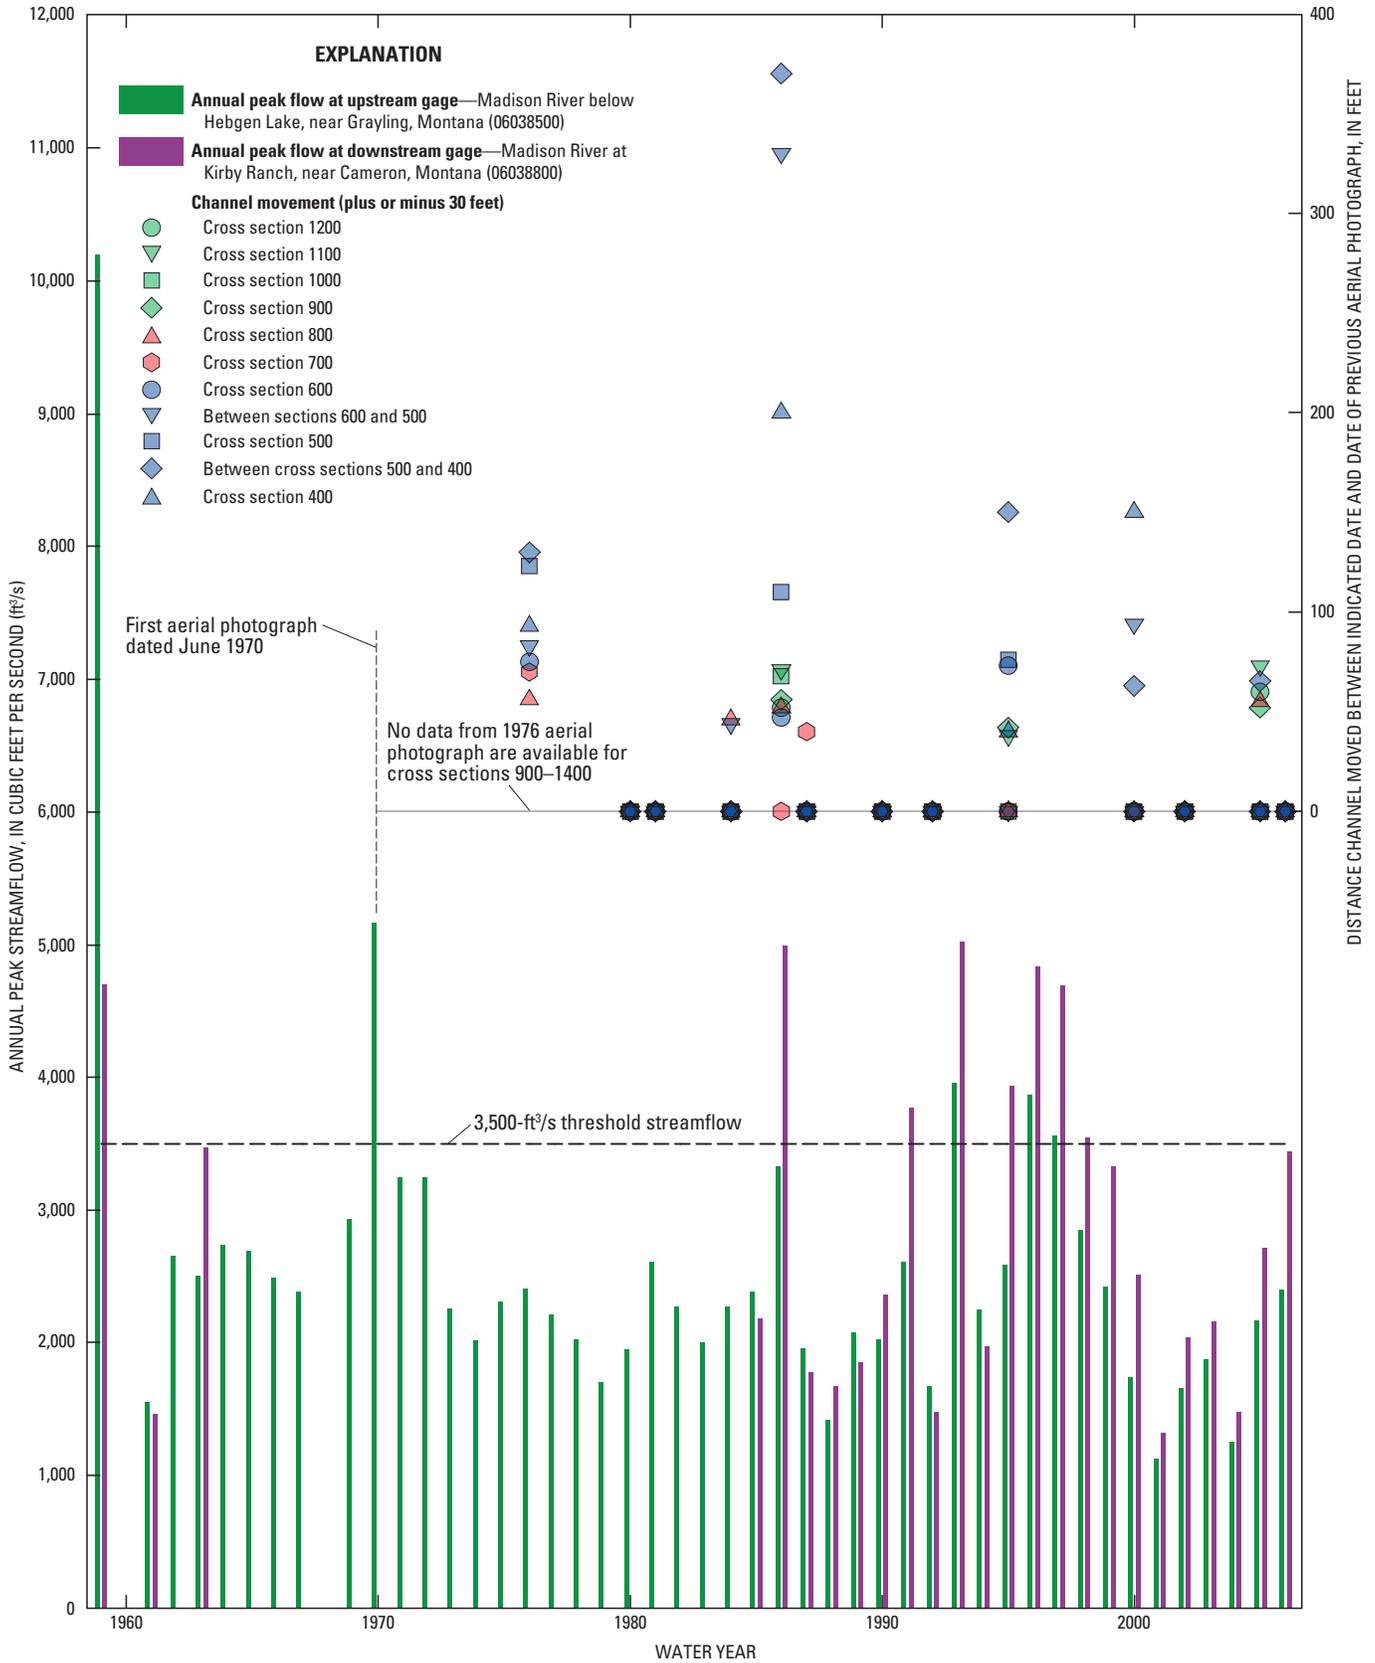
Figure 8. Lateral channel movement for selected sites along the Madison River and annual peak streamflow for the Madison River, Montana.

Lateral channel-movement and peak-flow data are shown in figure 8. Where more than one year lapsed between aerial photographs, it is not possible to discern whether the channel moved gradually or all in one year. It also is unclear whether the channel moved in response to one peak flow, to several peak flows, or to sustained flows.

Data in figure 8 indicate that streamflows higher than the 3,500-ft<sup>3</sup>/s threshold were followed by lateral channel movement except from 1991 to 1992 and possibly from 1996 to 1997. Flows exceeded the threshold in 1996 and 1997, but no aerial photographs were available between 1995 and 2000; thus, aerial photography data from which to determine channel movement between the 1996 and 1997 high flows were unavailable. However, the stream moved laterally 120 to 150 ft between cross sections 500 and 600 during the relatively high streamflows in 1996 (Brent Mabbott, PPL-Montana, written commun., 2010). Moreover, the channel moved between 2002 and 2005 even though streamflows during that period were less than the 3,500-ft<sup>3</sup>/s threshold streamflow (fig. 8).

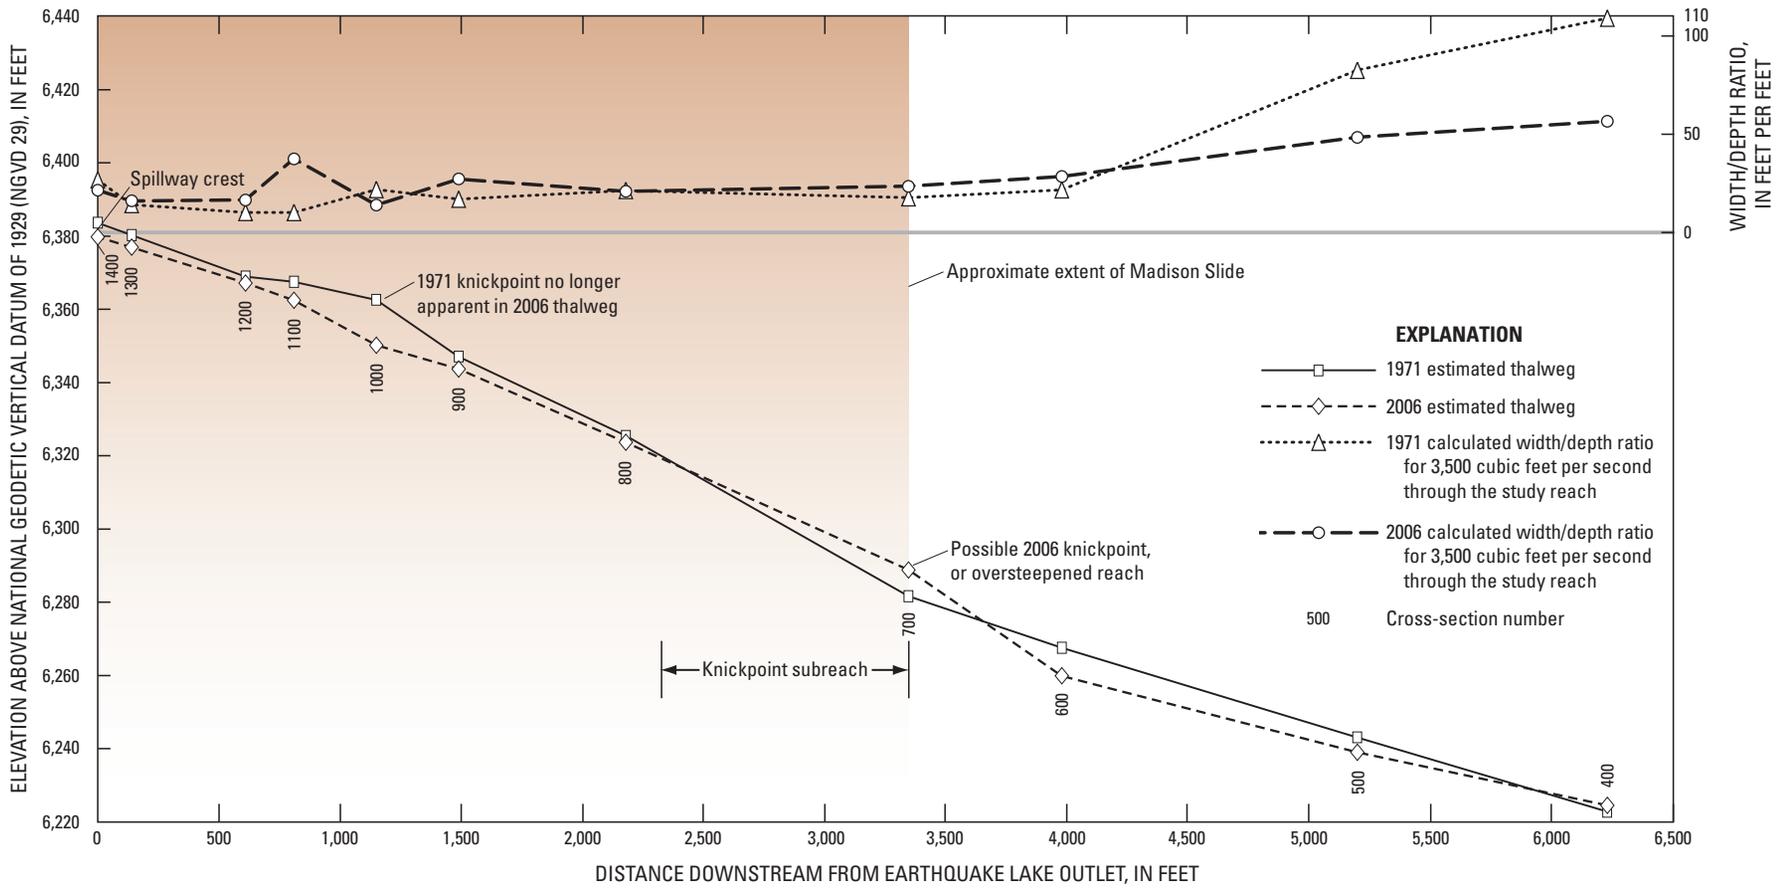
Figure 9. Estimated thalweg profiles and calculated width/depth ratios of the Madison River downstream from Earthquake Lake, Montana.

At the Earthquake Lake outlet (cross section 1400), the channel incised by about 4–5 ft. In addition, a knickpoint between cross sections 1000 and 900 that was present in the surveyed 1971 thalweg profile was smaller or no longer present in the surveyed 2006 thalweg profile (fig. 9). Foundation and Materials Consultants, Inc. (1972) reported that a “massive piece of rock” near cross section 1000 provided resistance to erosion. This rock might have moved downstream, or the channel could have moved to the side of the rock, causing the channel thalweg to lower by about 12 ft at cross section 1000.

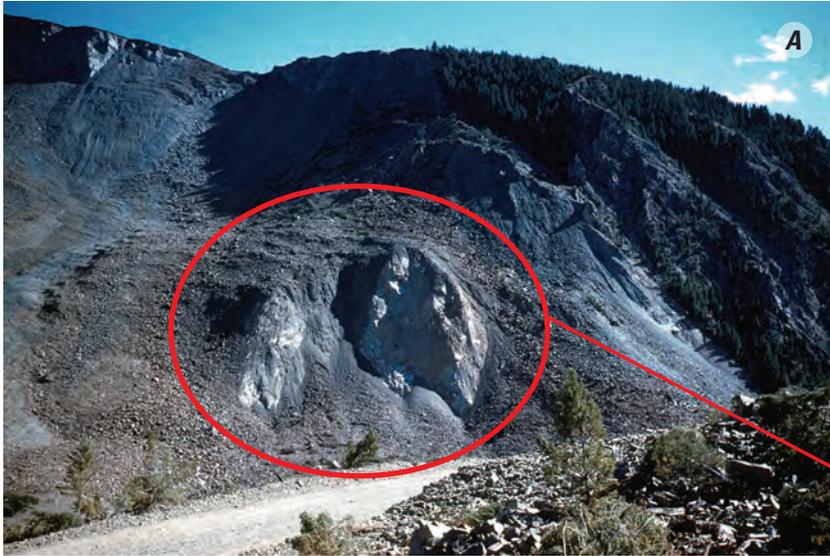
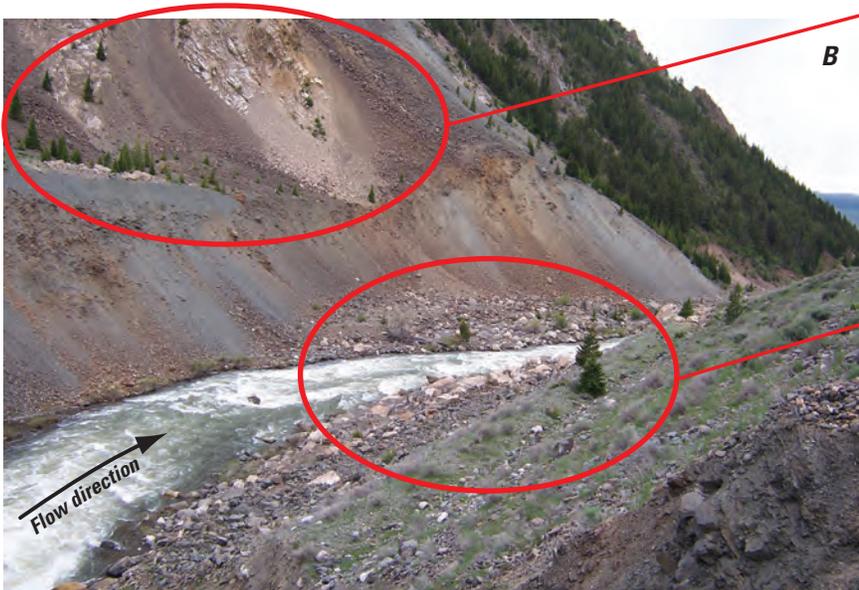
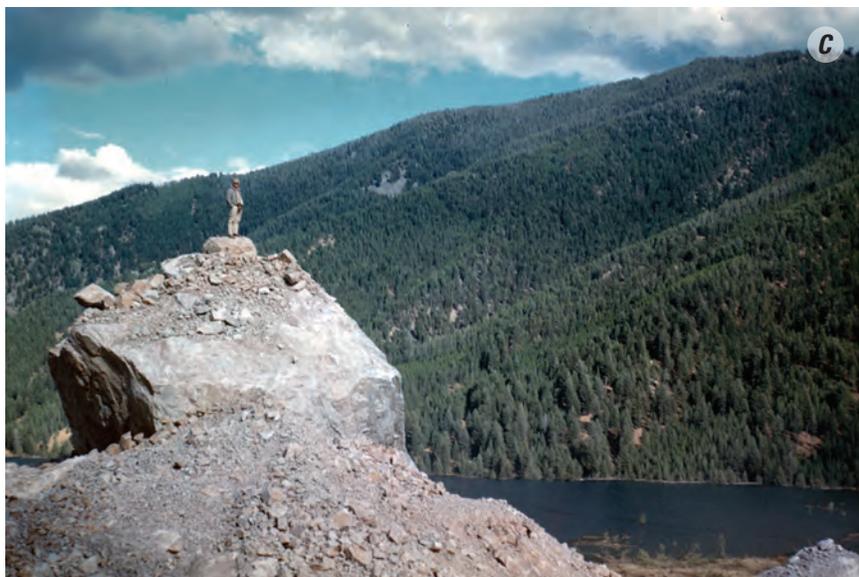
Dolomite outcrop above left (south) bank of Madison River

Large dolomite boulders on streambed and banks

**Figure 10.** Erosion-resistant materials above the Madison River, downstream from Earthquake Lake, Montana. *A*, Dolomite outcrop above left bank of Madison River between cross sections 700 and 800, looking south from above road, August, 1959. *B*, Portion of same outcrop looking southwest from right bank of river, June, 2008. *C*, Large boulder above right bank between cross sections 700 and 800, September 1959.

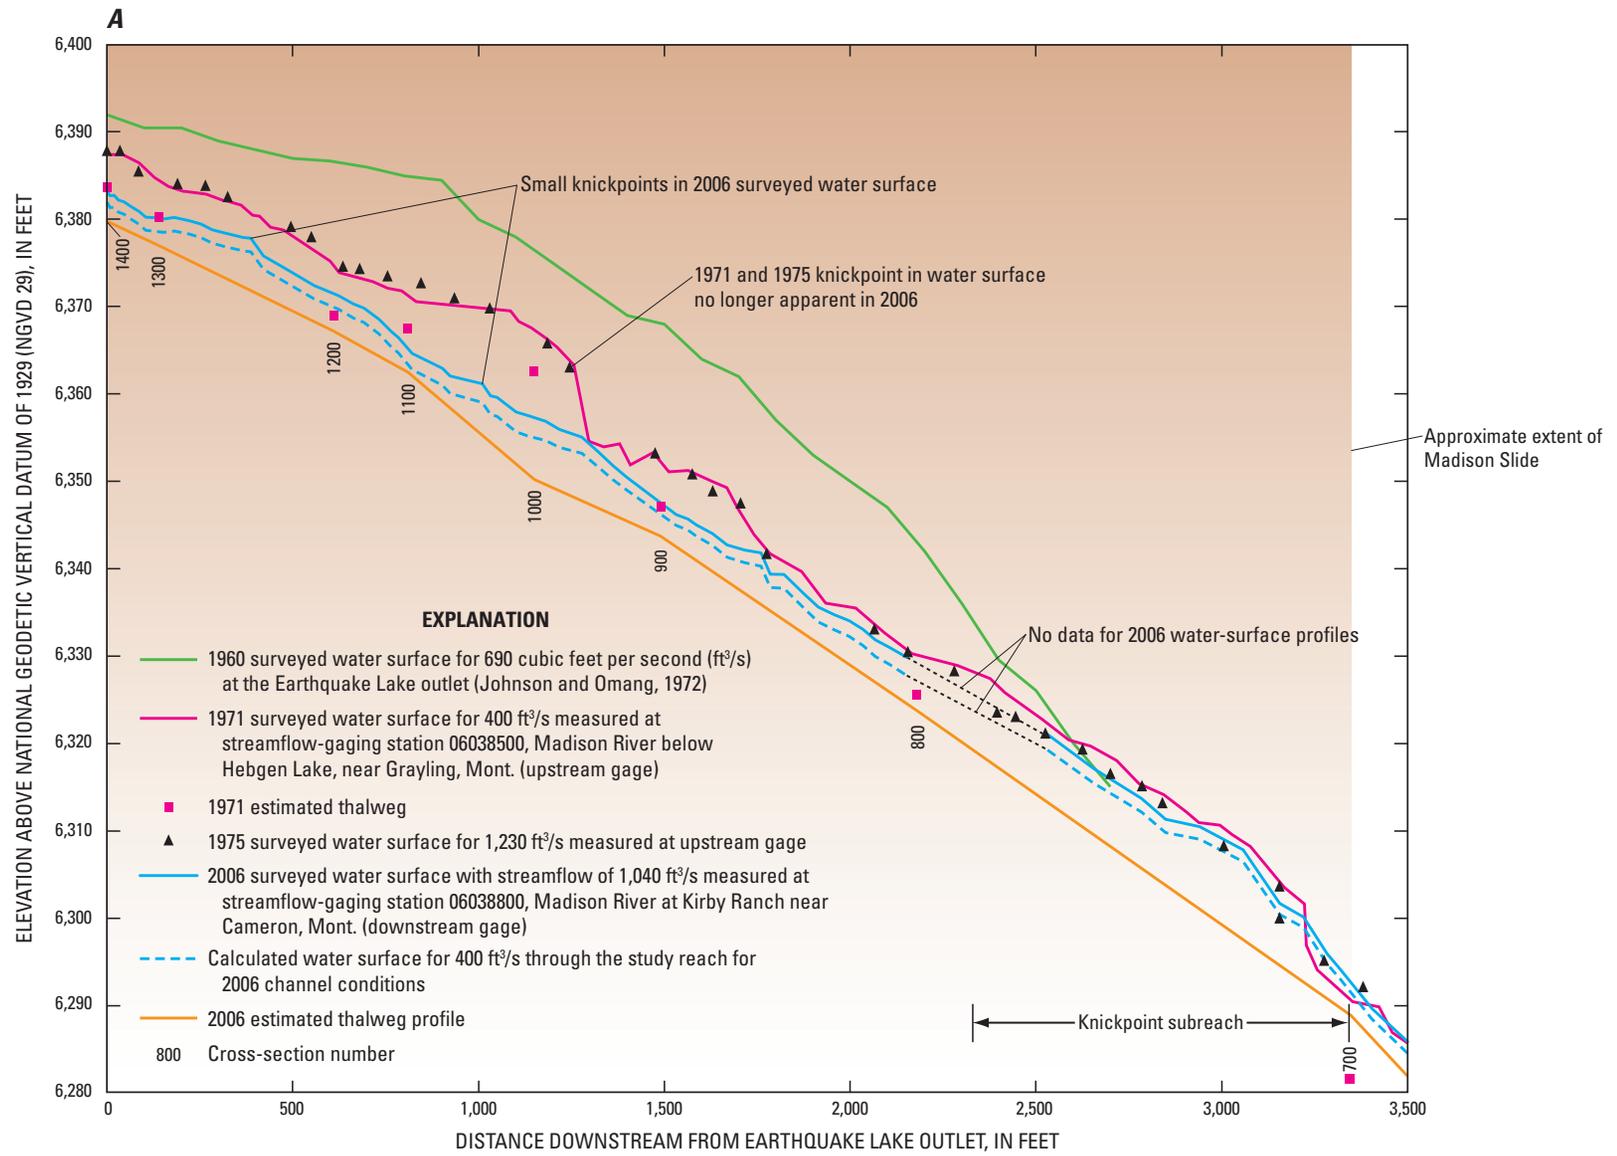
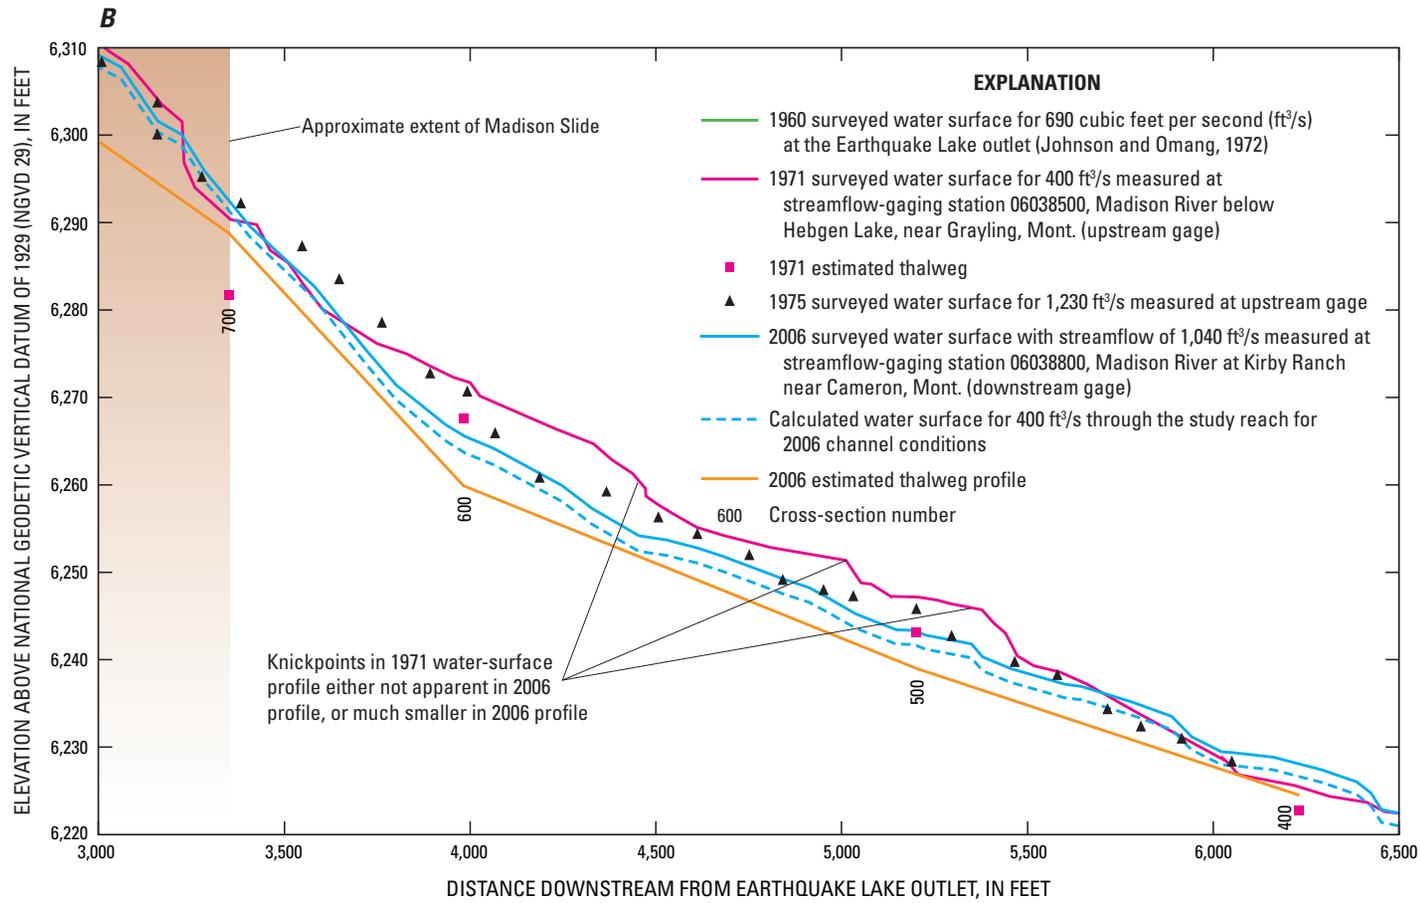
**Figure 11.** Surveyed water-surface profiles, calculated water-surface profile, and estimated thalweg profiles of the Madison River downstream from Earthquake Lake, Montana. *A*, Profiles from cross section 1400 to cross section 700. *B*, Profiles from cross section 700 to cross section 400.

**Figure 11.** Surveyed water-surface profiles, calculated water-surface profile, and estimated thalweg profiles of the Madison River downstream from Earthquake Lake, Montana. A, Profiles from cross section 1400 to cross section 700. B, Profiles from cross section 700 to cross section 400.—Continued

Accordingly, the water-surface profiles from the 1971 and 2006 data are difficult to compare because streamflows were different during the two surveys (400 ft<sup>3</sup>/s at the upstream gage in 1971; 1,040 ft<sup>3</sup>/s at the downstream gage in 2006). Therefore, a water-surface profile was computed using HEC-RAS to represent water-surface elevations (referred to as the calculated 2006 water-surface profile in this report) for a streamflow of 400 ft<sup>3</sup>/s through the study reach for channel conditions in 2006 (fig. 11).

Comparisons of the water-surface profiles surveyed in 1960 and 1971 and the calculated 2006 water-surface profile indicate that the upper 2,500 ft of the study reach experienced the largest decrease in water-surface elevations since 1960, and the upper 1,500 ft of the study reach experienced the

largest decrease since 1971 (fig. 11). The water-surface elevation at cross section 1100 decreased by about 20 ft between 1960 and 2006. Most of this change occurred between 1960 and 1971; however, at cross section 1100 the water surface elevation decreased as much as 8 ft between 1975 and 2006.
