## Lateral and Vertical Channel Movement and Potential for Bed-Material Movement on the Madison River Downstream from Earthquake Lake, Montana

Scientific Investigations Report 2012–5024

By Katherine J. Chase and Peter M. McCarthy

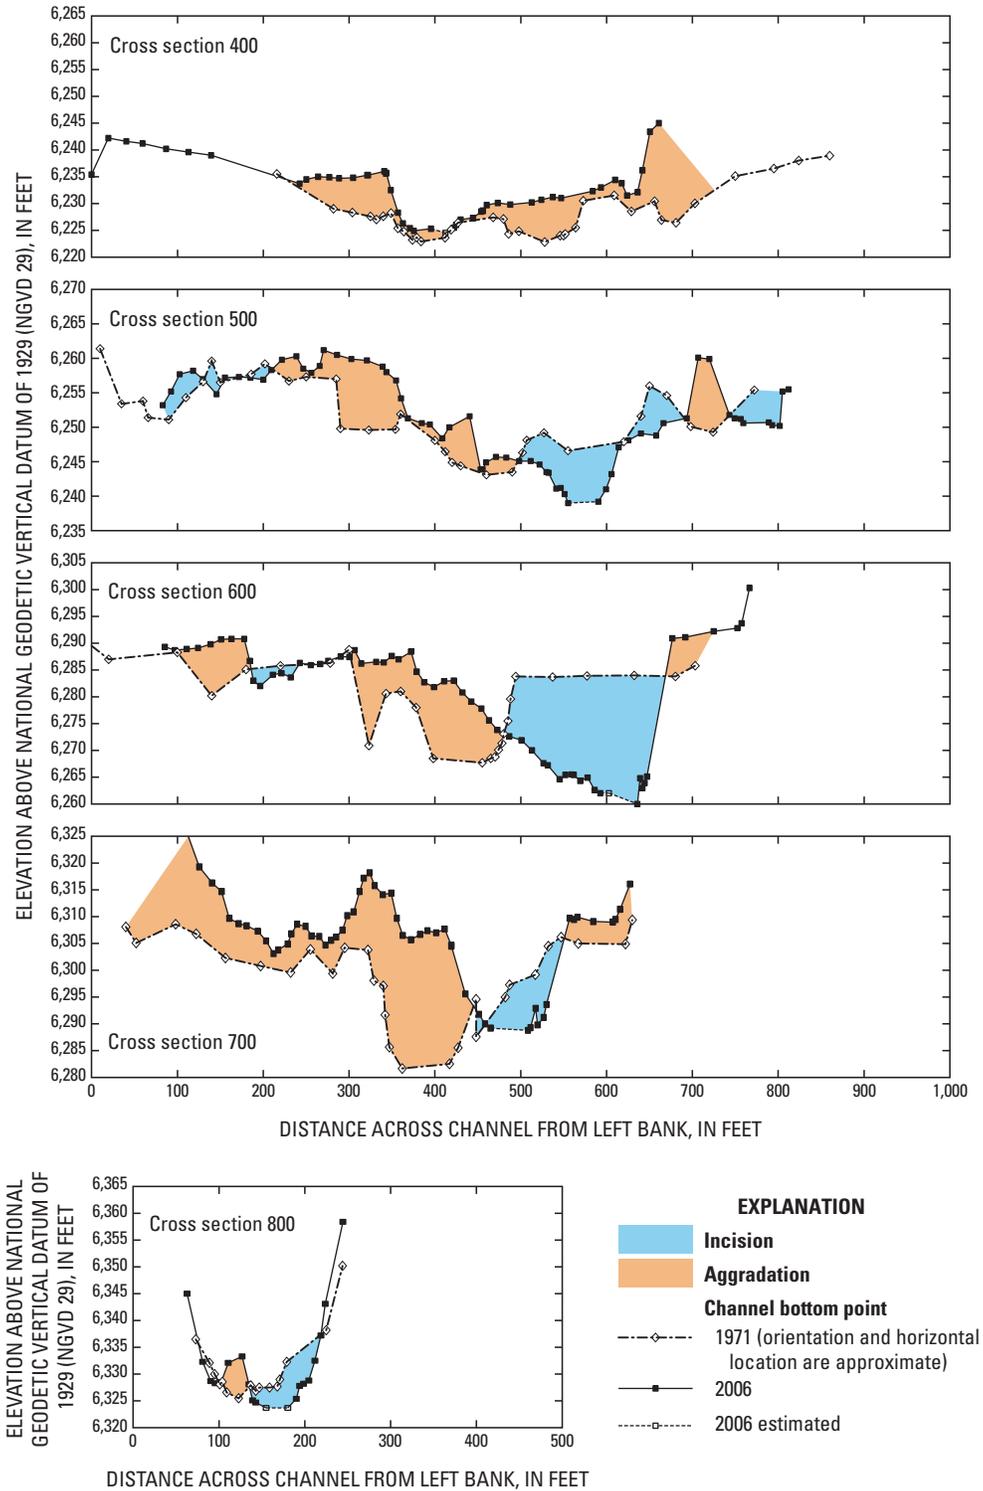
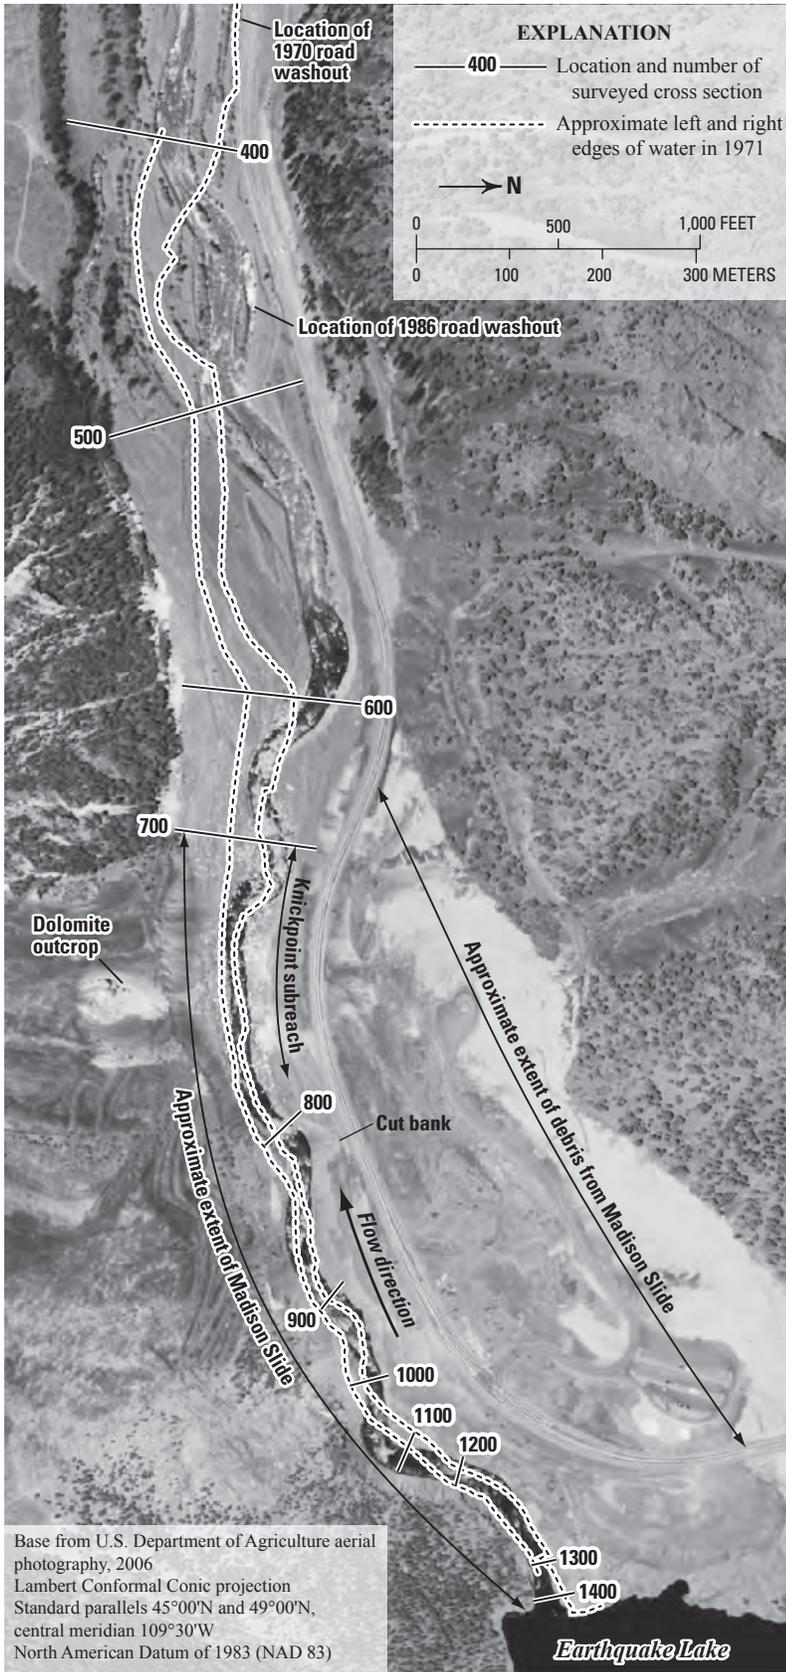
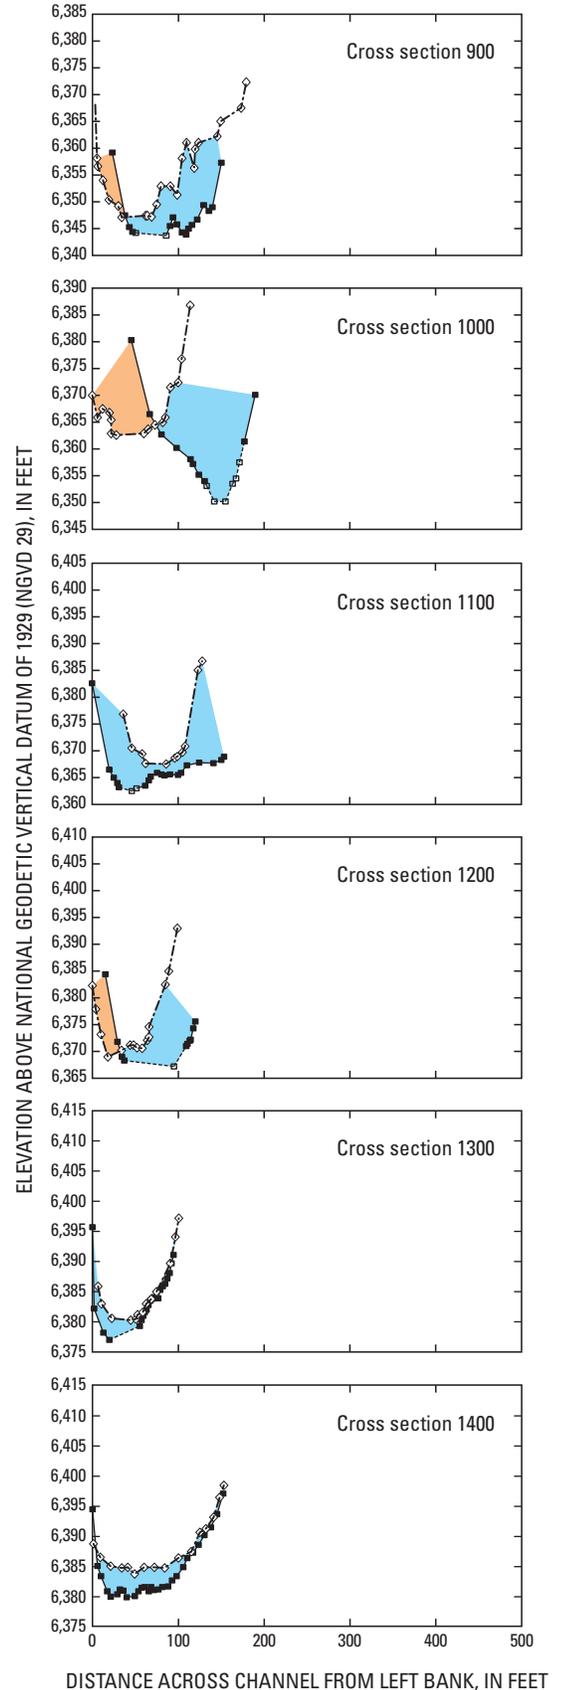
**Figure 12.** Lateral migration, incision, and aggradation of the Madison River channel downstream from Earthquake Lake, Montana between 1971 and 2006.

Figure 12. Lateral migration, incision, and aggradation of the Madison River channel downstream from Earthquake Lake, Montana between 1971 and 2006.—Continued

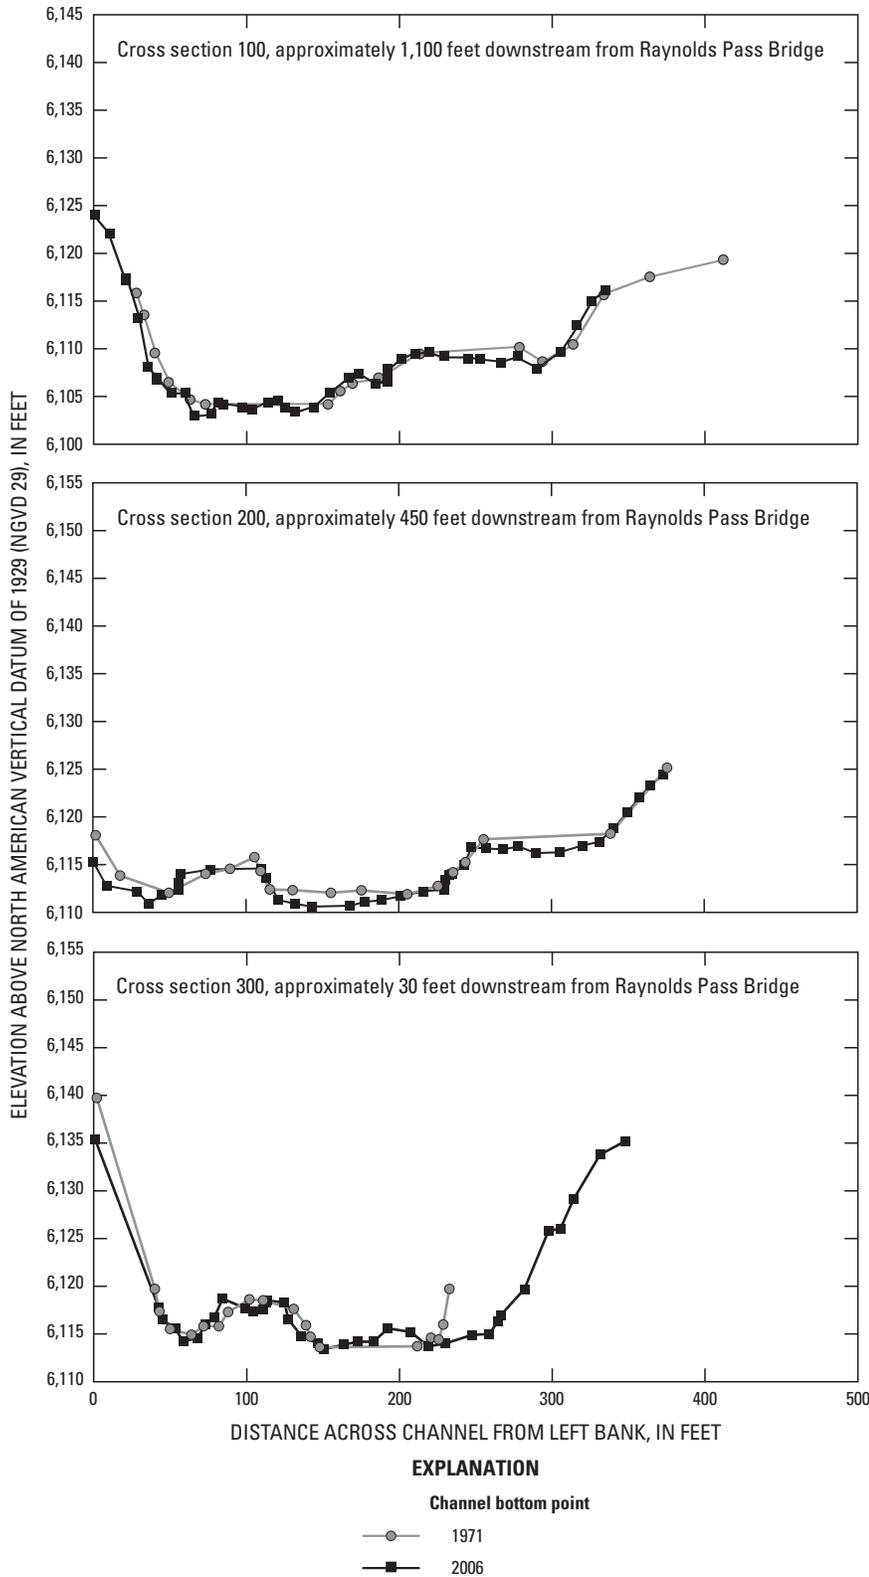
**Figure 13.** Cross sections 100, 200, and 300, from 1971 and 2006 surveys on the Madison River near Reynolds Pass Bridge downstream from Earthquake Lake, Montana.

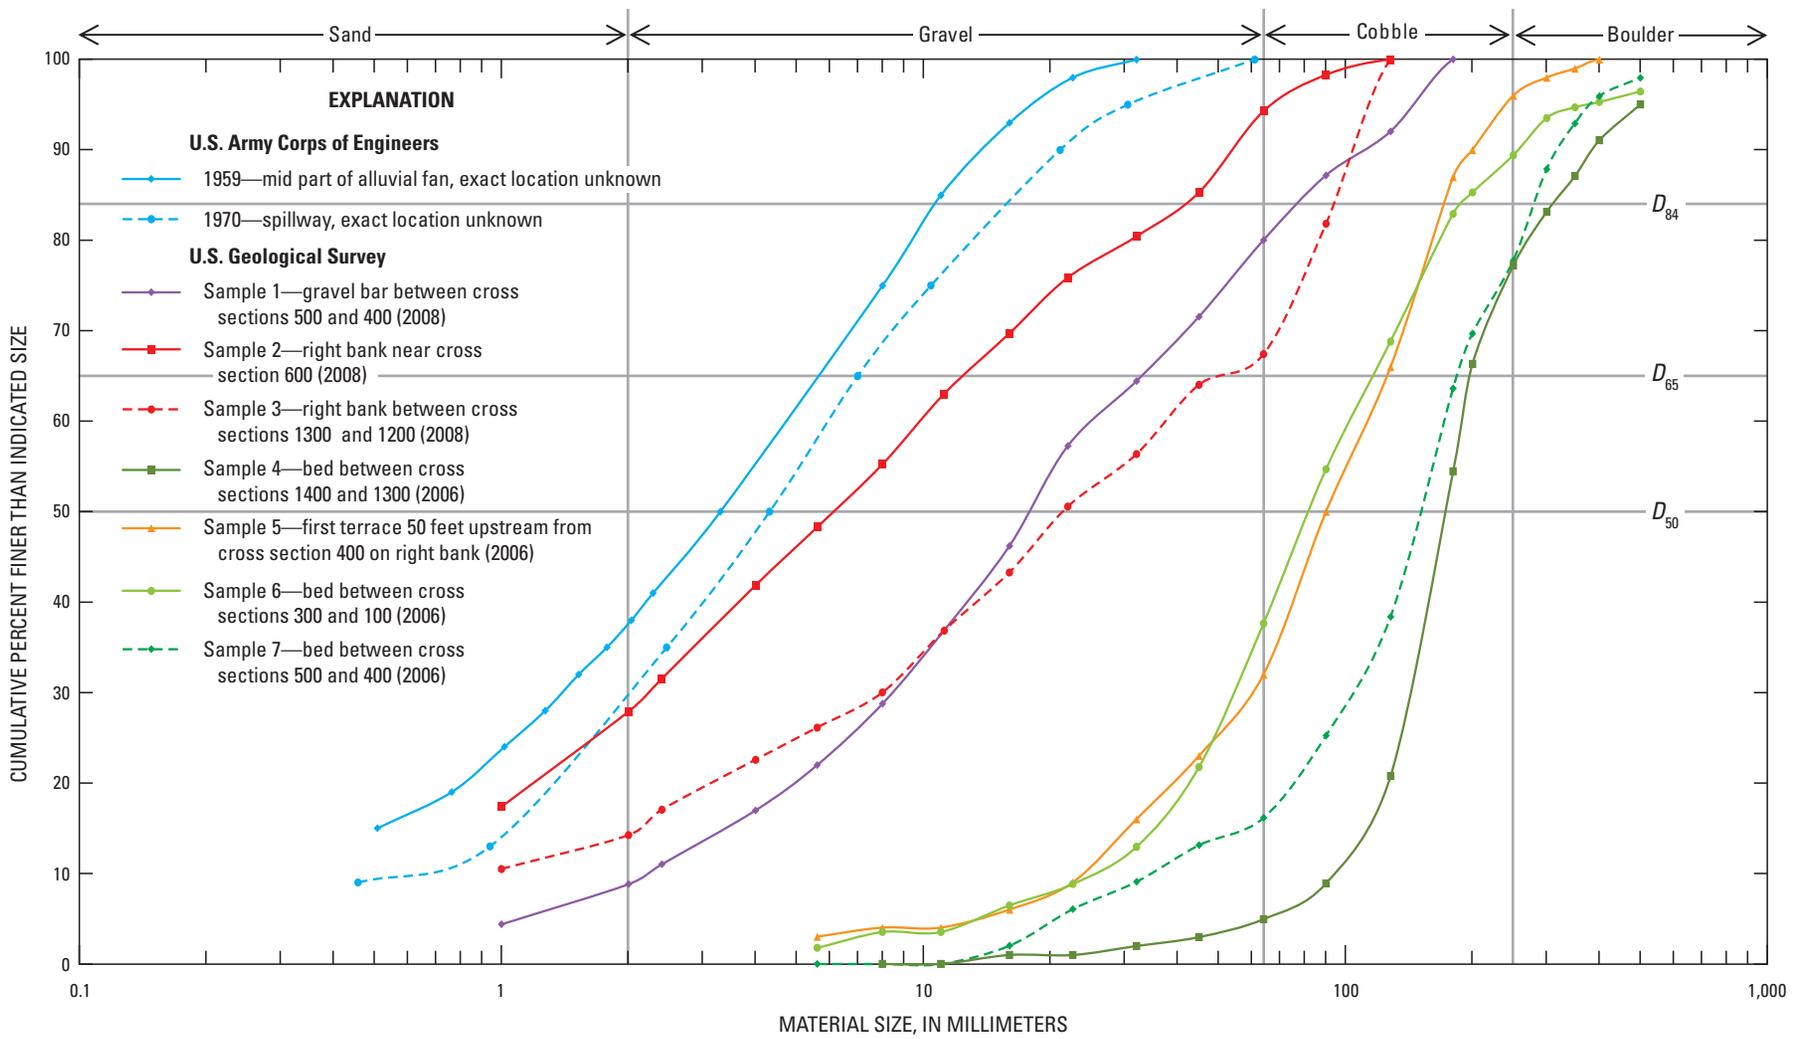
Figure 14. Distribution of particle sizes of material in and near the Madison River downstream from Earthquake Lake, Montana.

Data for particle sizes measured in and near the channel in 2006 and 2008, as well as particle sizes measured by the USACE in 1959 and in 1970 (U.S. Army Corps of Engineers, 1972), are summarized in table 4 and figure 14. The  $D_{50}$  for all of the measurements (not including the rough visual estimate for the subreach between cross sections 700 and 800) ranged from 3.3 to 170 mm. The largest measured median particle sizes ( $D_{50}$  equal to 170 mm) were collected on the surface of the bed at the Earthquake Lake outlet (between cross sections

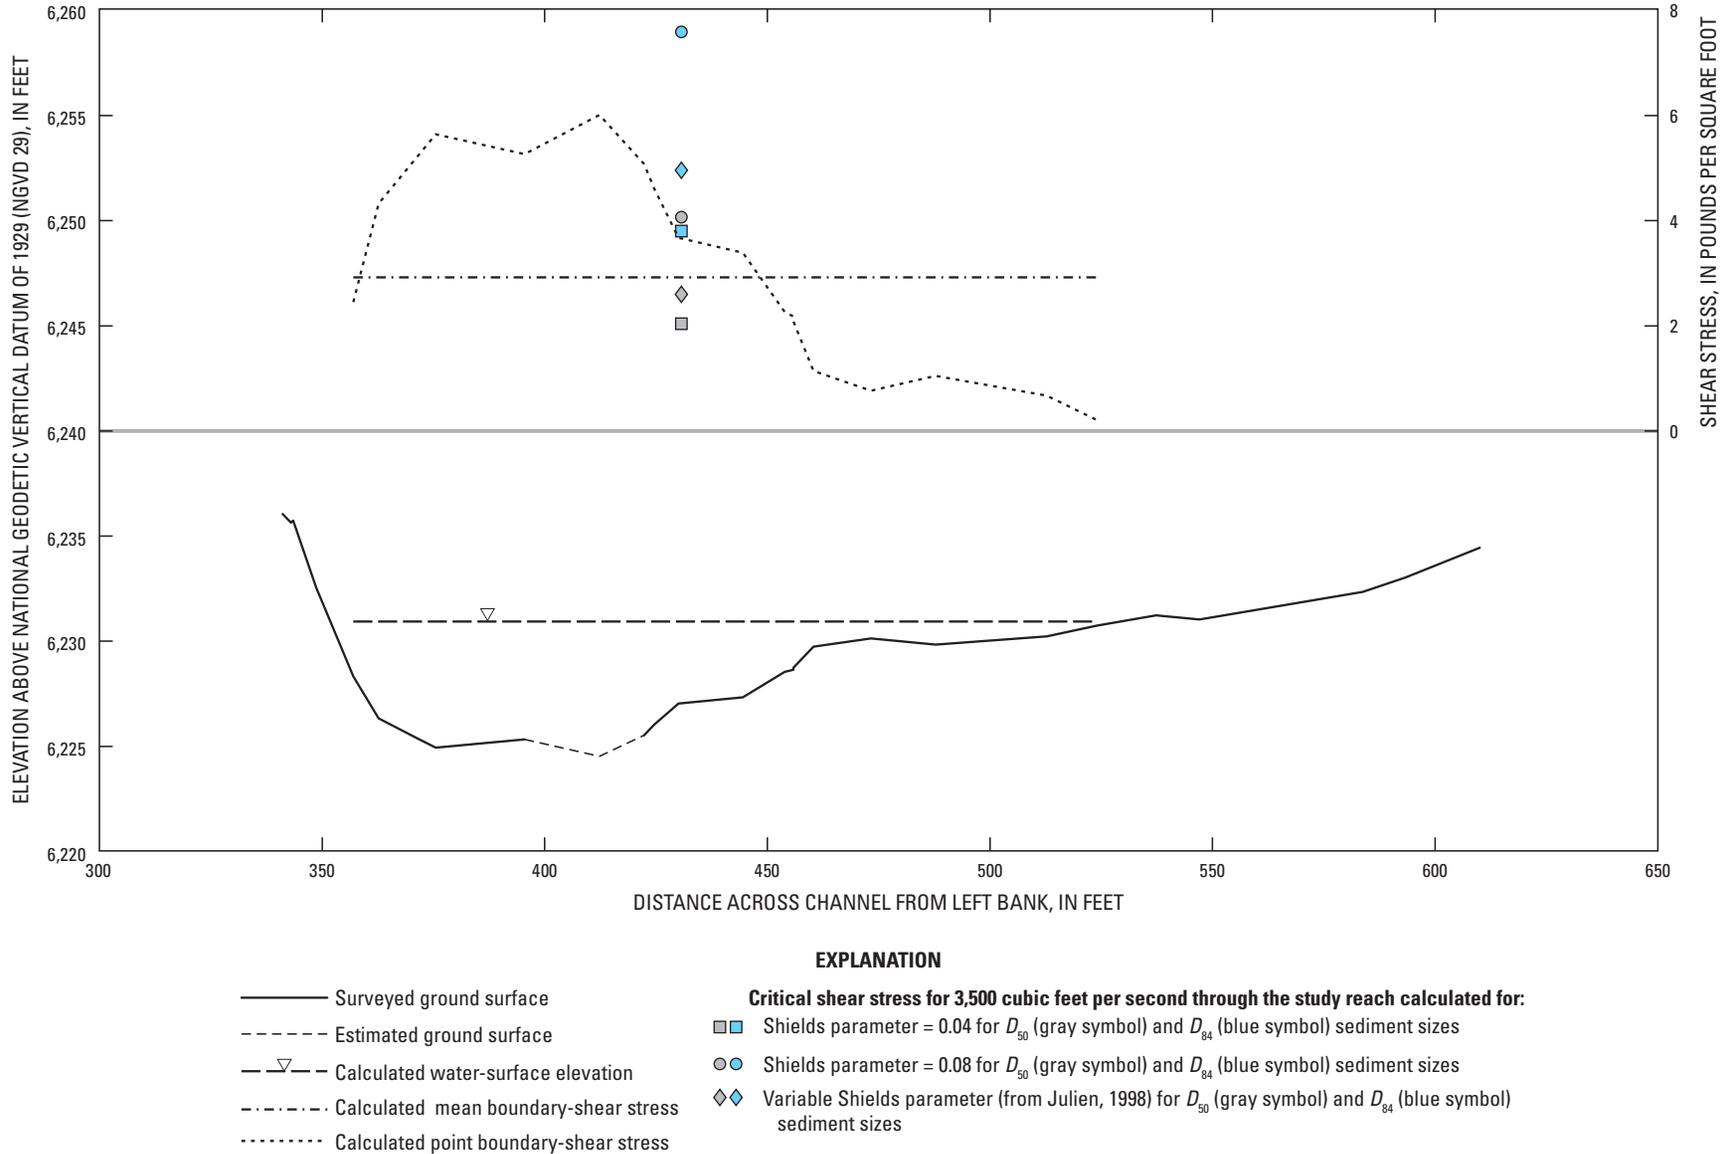
**Figure 15.** Calculated mean and point boundary-shear stresses at cross section 400 and calculated critical shear stresses for movement of selected sediment sizes between cross sections 500 and 400, Madison River downstream from Earthquake Lake, Montana.

boundary-shear stress calculated for the 3,500-ft<sup>3</sup>/s threshold streamflow, indicating that the larger size fractions along the bed near cross section 400 are not likely to move at the 3,500-ft<sup>3</sup>/s threshold streamflow. This lack of movement for the larger particles could lead to further coarsening or armor-ing of the bed if the  $D_{50}$  and smaller sizes are removed from the bed and transported downstream. However, these smaller particles could be replenished by particles eroded from the steep banks upstream.

In summary, some of the  $D_{50}$  particle sizes along the right side of the bed between cross sections 500 and 400 could be moved by the 3,500-ft<sup>3</sup>/s threshold streamflow. However, the  $D_{84}$  particle sizes probably would not move.

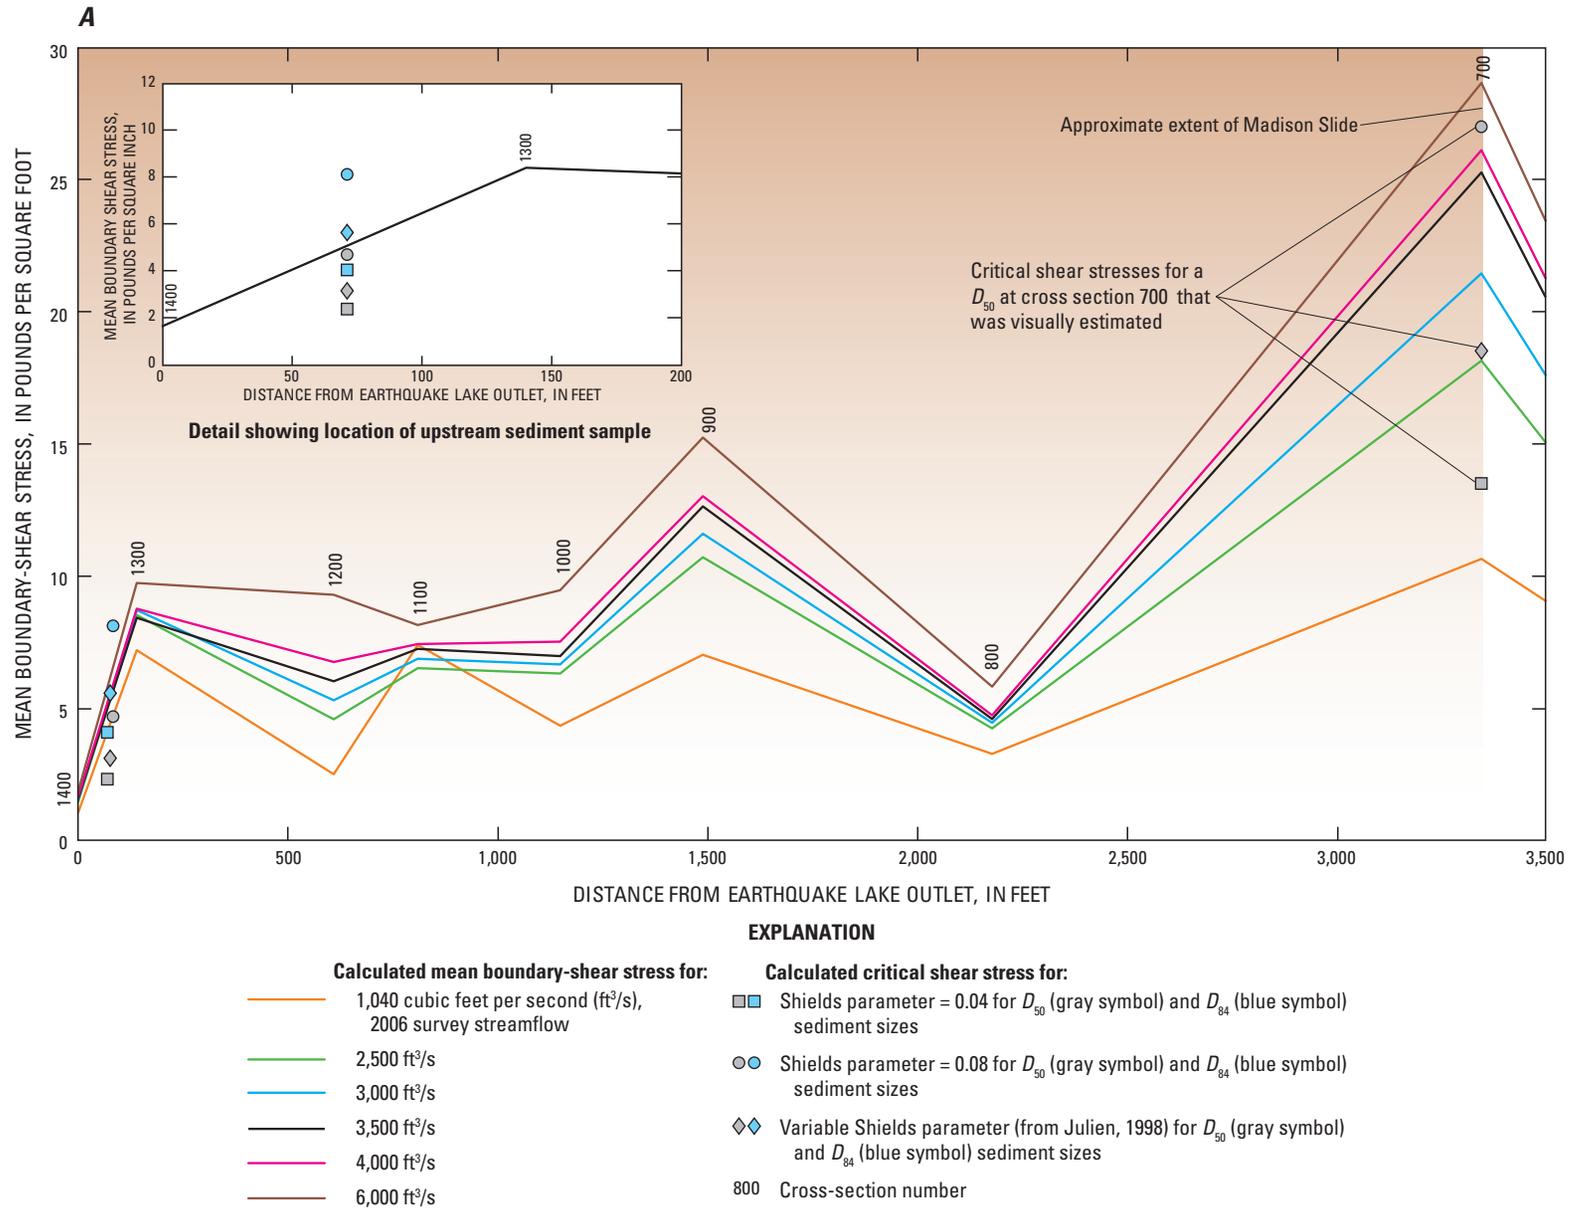
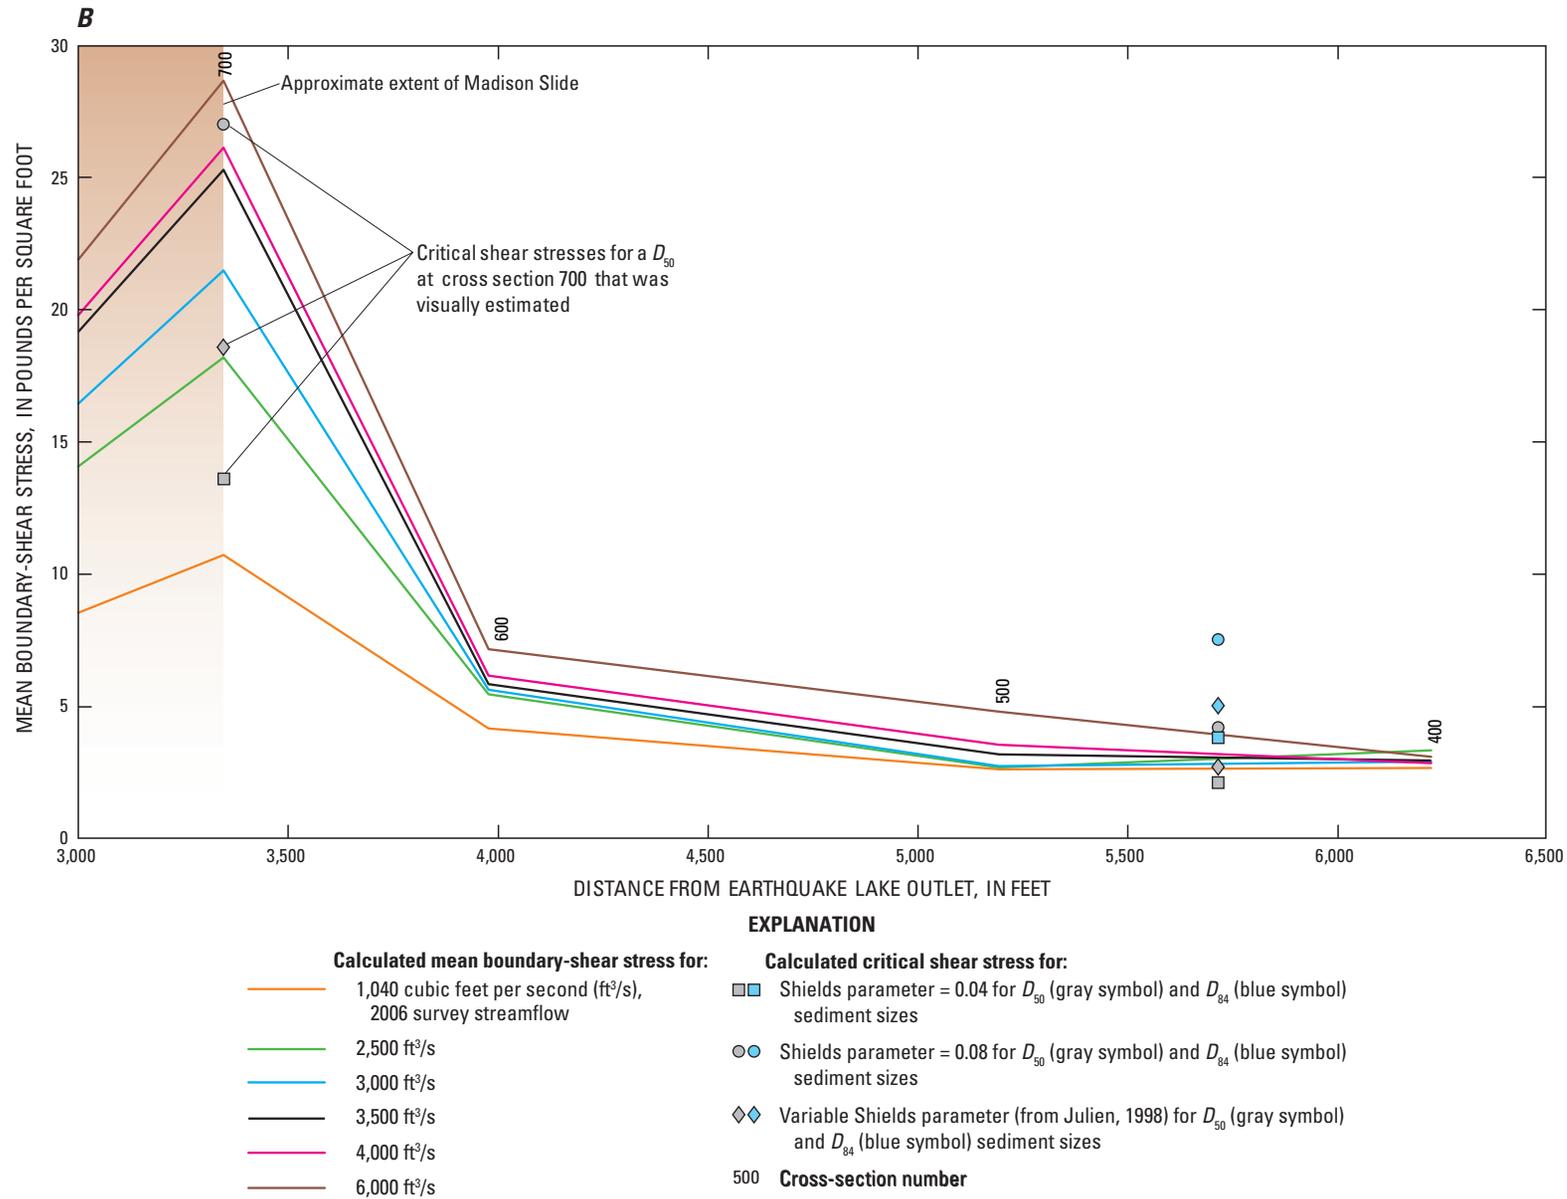
**Figure 16.** Calculated mean boundary-shear stress at various streamflows and calculated critical shear stresses for selected sediment sizes, Madison River downstream from Earthquake Lake, Montana. *A*, From cross section 1400 to cross section 700. *B*, From cross section 700 to cross section 400.

**Figure 16.** Calculated mean boundary-shear stress at various streamflows and calculated critical shear stresses for selected sediment sizes, Madison River downstream from Earthquake Lake, Montana. *A*, From cross section 1400 to cross section 700. *B*, From cross section 700 to cross section 400.—Continued
