# Streamflow Gains and Losses in the Colorado River in Northwestern Burnet and Southeastern San Saba Counties, Texas, 2012–14

Scientific Investigations Report 2015–5098

U.S. Department of the Interior  
U.S. Geological Survey

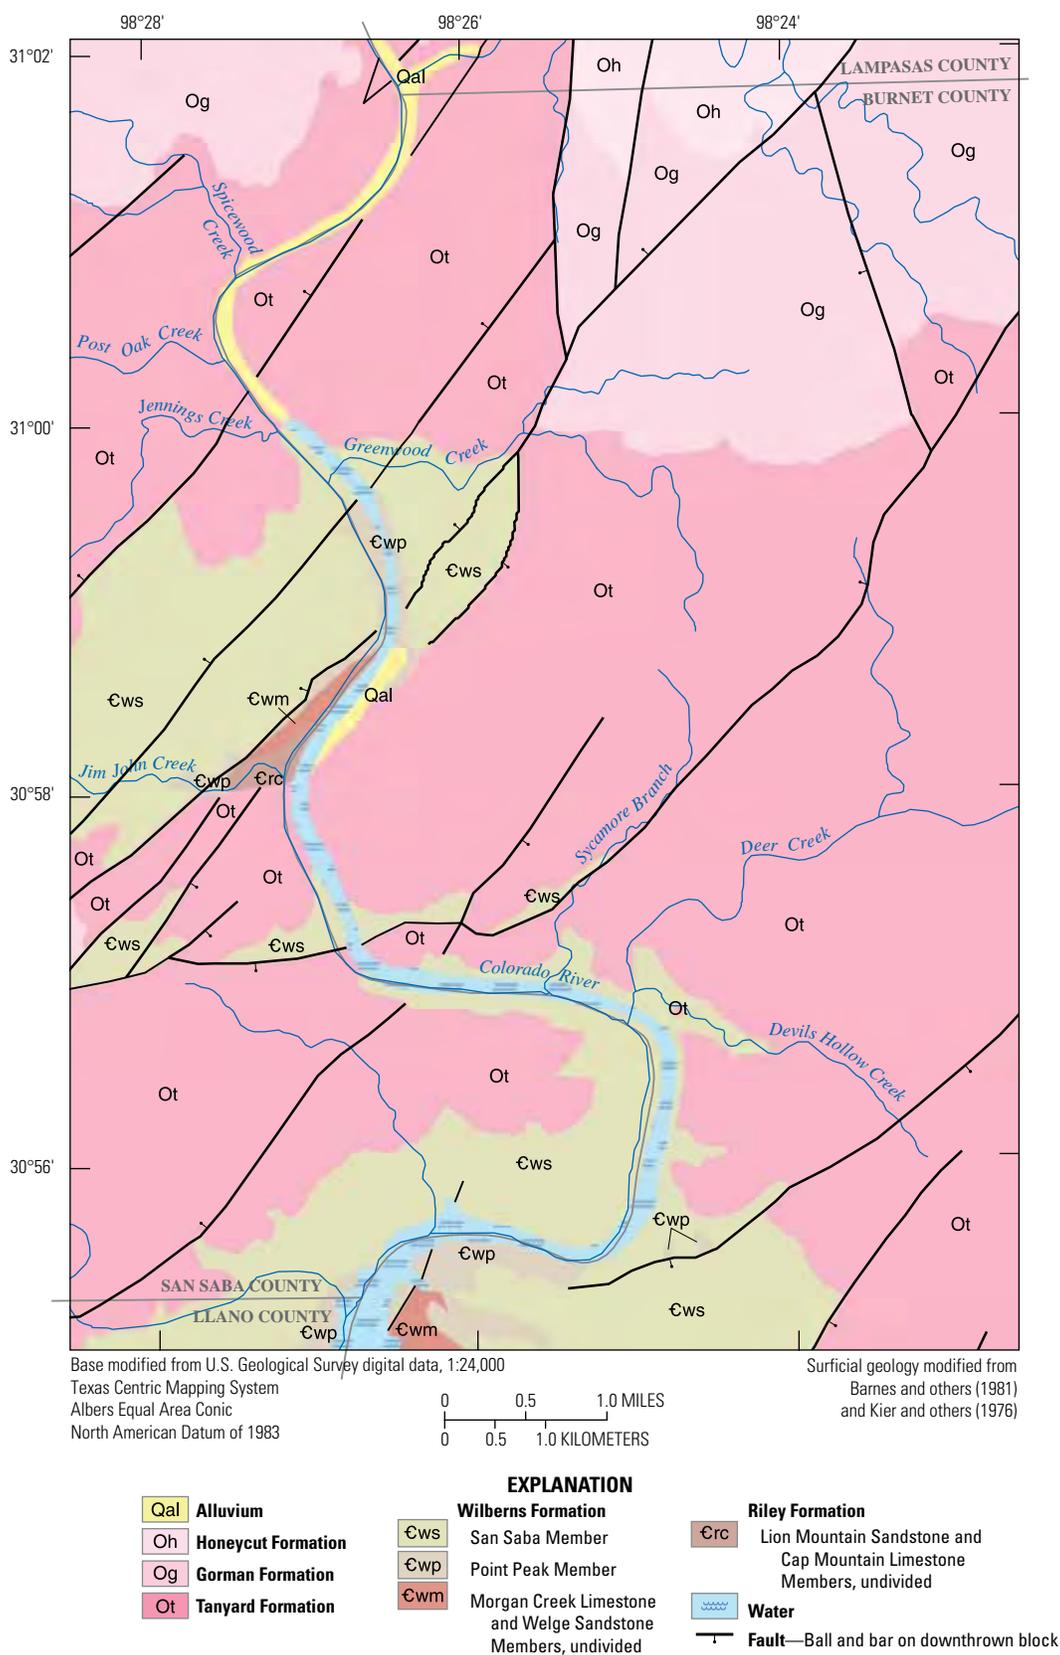
Figure 3. Surficial geology in northwestern Burnet and southeastern San Saba Counties, Texas.

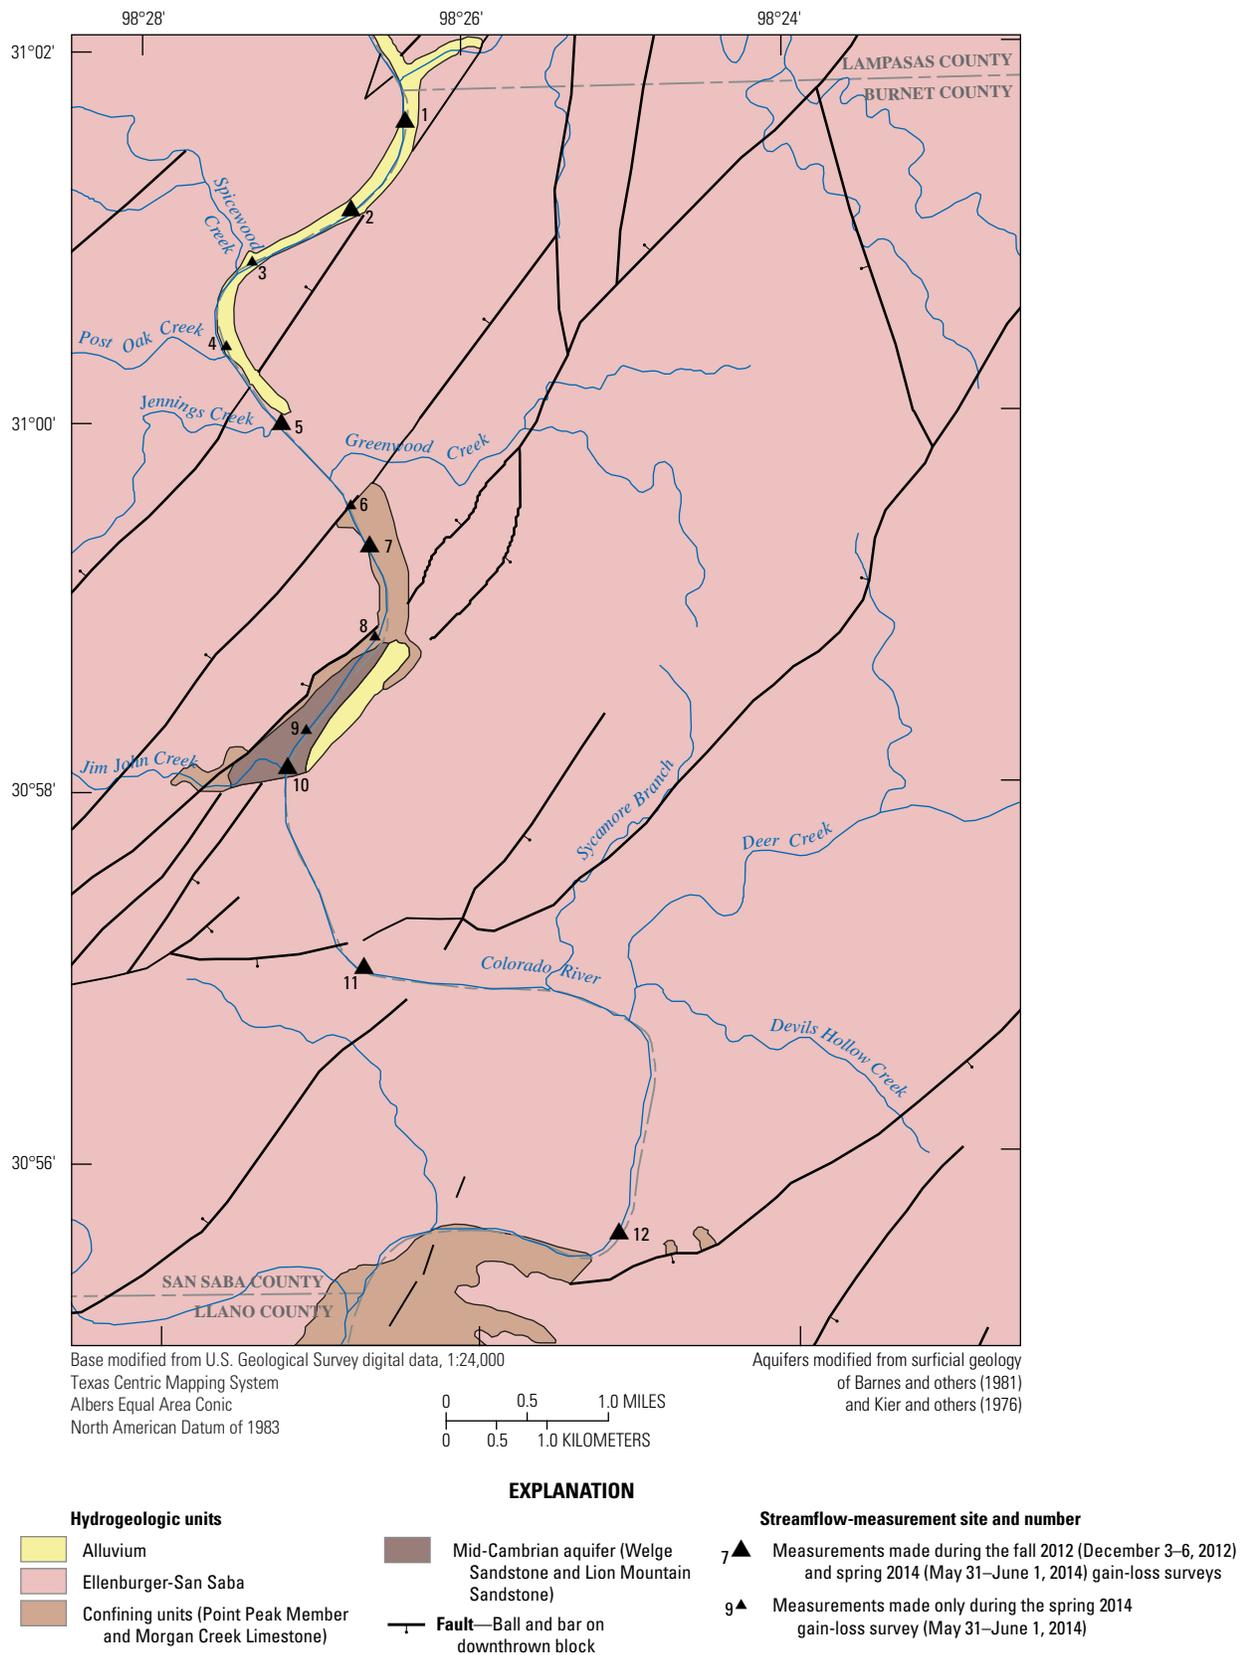
Figure 4. Hydrogeologic units and discharge measurement sites in northwestern Burnet and southeastern San Saba Counties, Texas.

Discharge measurement locations were selected for the gain-loss surveys (table 1) based on the locations of (1) hydrogeologic unit contacts (fig. 4); (2) faults (fig. 7); (3) seeps, springs, and travertine deposits (fig. 8); and (4) tributary inflows (fig. 9). Figures 4 and 7 illustrate the spatial location and extent of the hydrogeologic unit contacts and faults, respectively, that were used to select measurement locations in the study area. Measurement locations on the Colorado River were selected to bracket hydrogeologic units, where possible, in order to quantify gains and losses associated with the hydrogeologic units. Site 2 was selected downstream from a major fault (fig. 4) and just downstream from an area with known seeps (fig. 8). All of the reaches evaluated for streamflow gains or losses on the Colorado River in northwestern Burnet and southeastern San Saba Counties are depicted in table 2.

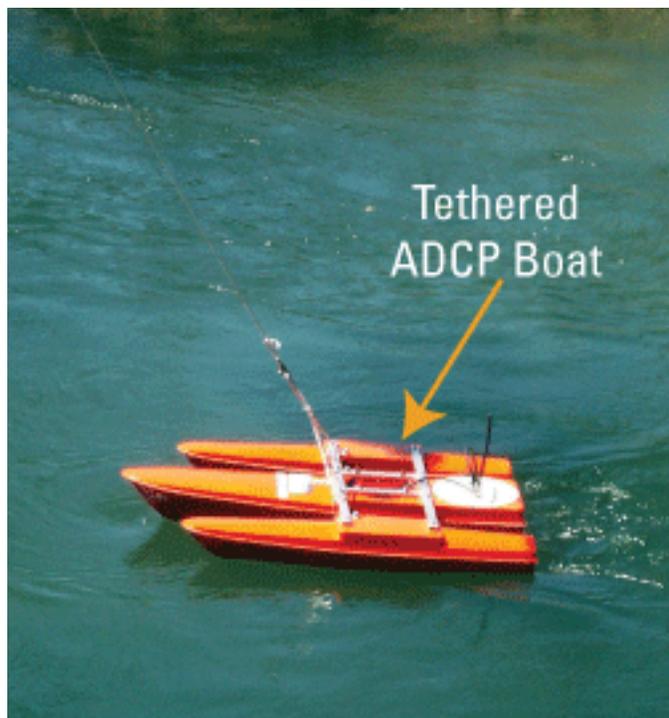
**Figure 5.** A tethered Acoustic Doppler current profiler (ADCP) boat (photograph by Geoffrey D. Cartano, U.S. Geological Survey, from Oberg and others, 2005).

or four passes across the stream. The small boat moved freely in the water and orientated itself to the direction of the current as it collected acoustic data throughout the water column, which minimized directional bias in the measured discharge (Oberg and others, 2005). Additional details of the standard USGS protocols that were used for measuring discharge are described in Rantz and others (1982) and Turnipseed and Sauer (2010).

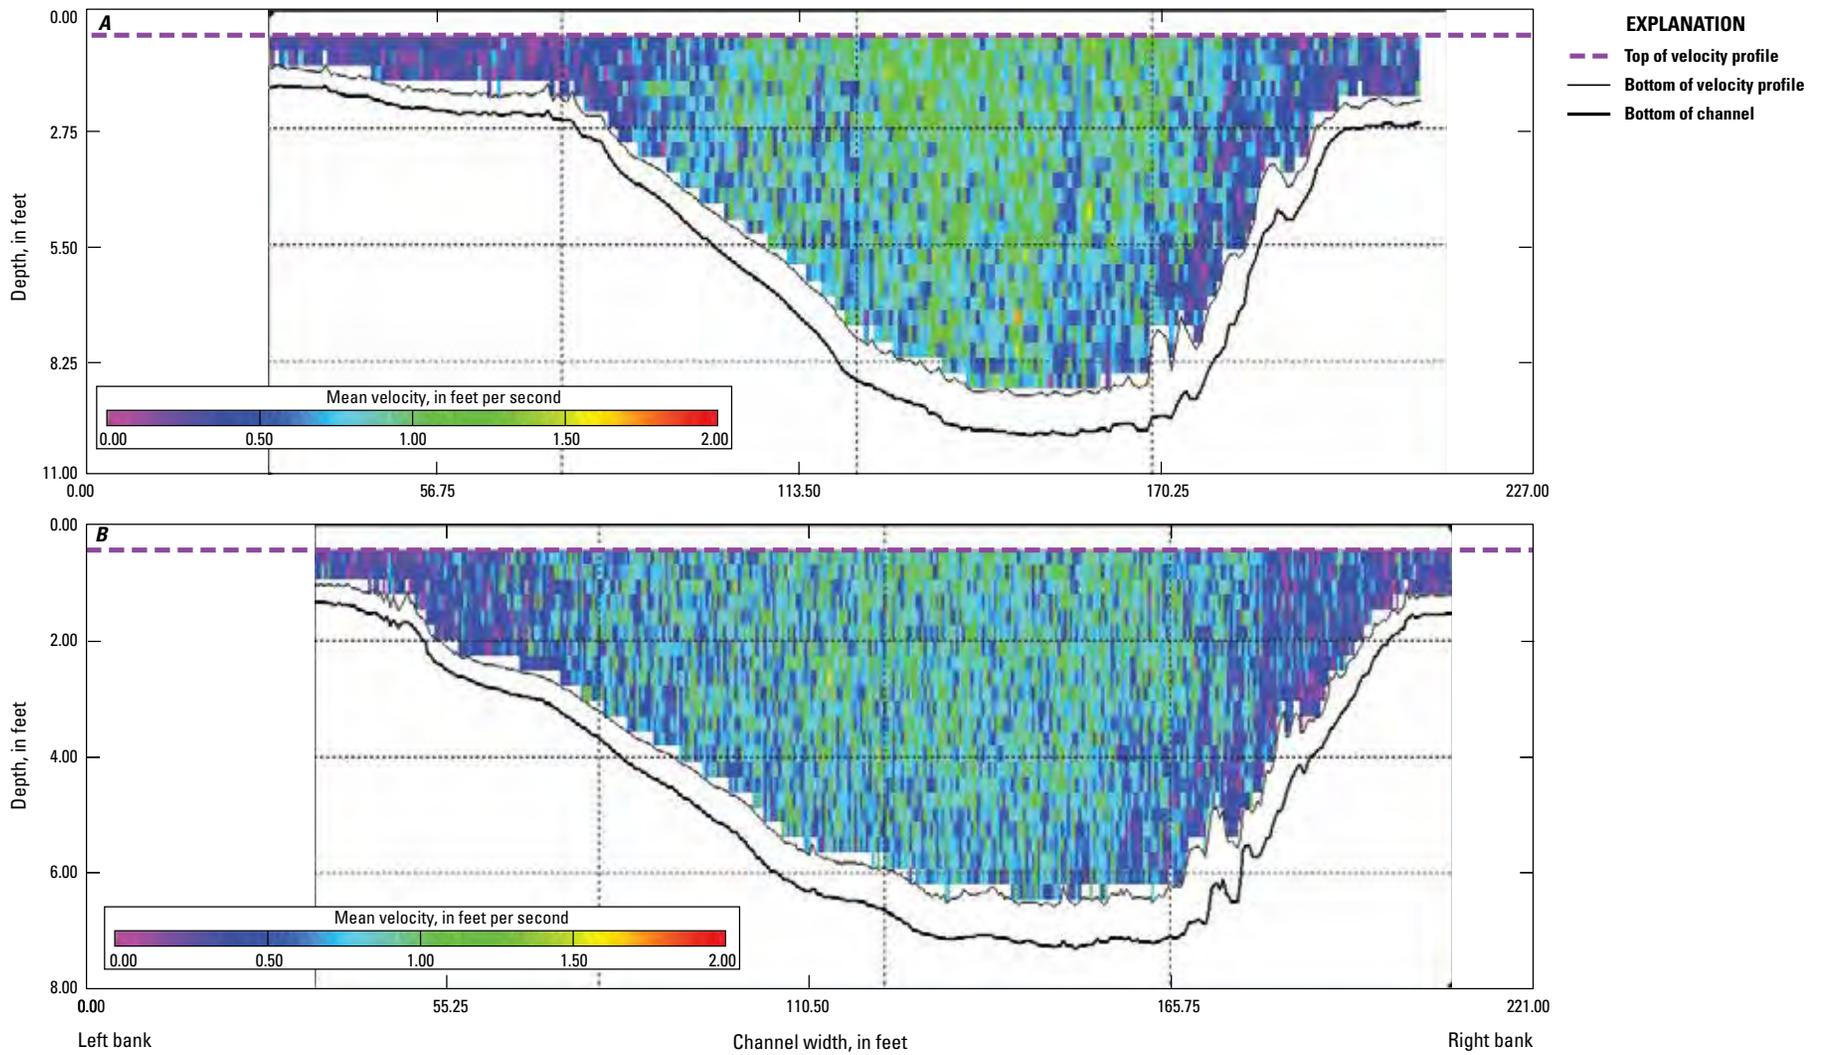
**Figure 6.** Acoustic doppler current profiles made at the same location on *A*, May 31, 2014, at 5:35 p.m. and on *B*, June 1, 2014, at 10:41 a.m. at U.S. Geological Survey station 310022098273300 Colorado River at Post Oak Falls near Tow, Texas.

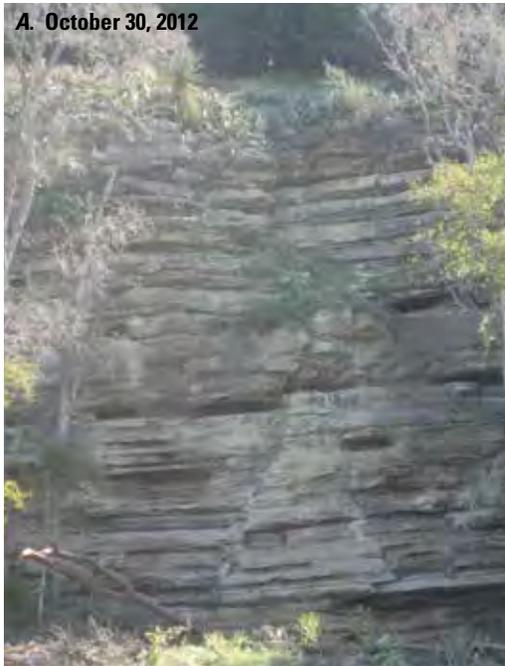
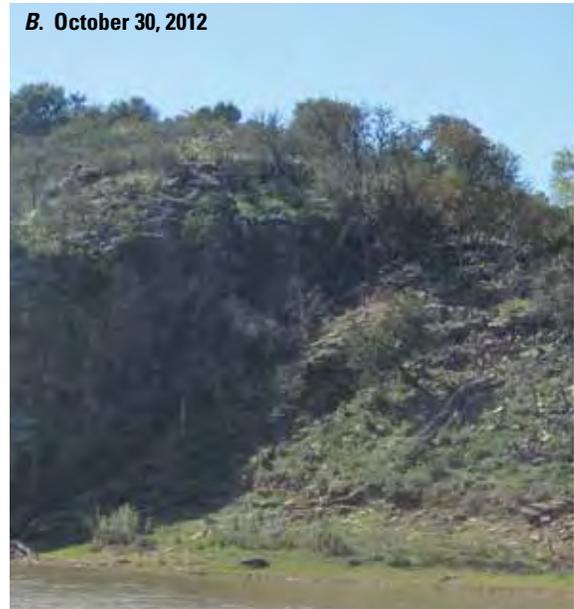
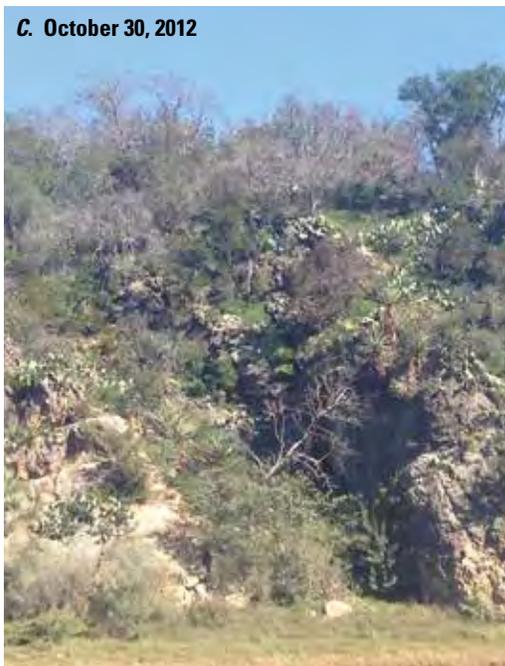
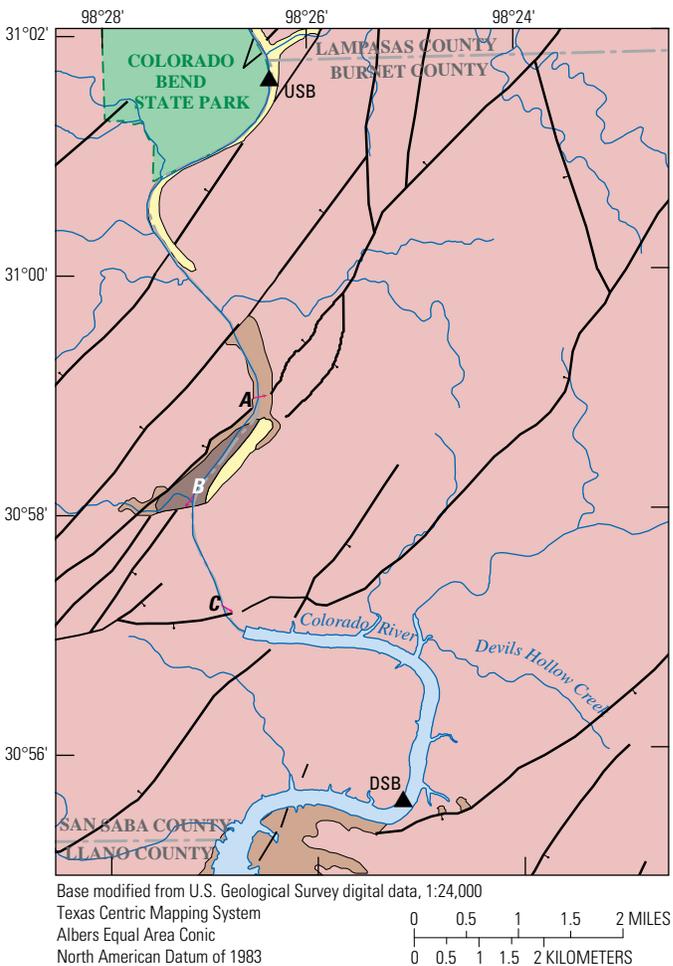
**Figure 7.** Faults and hydrogeologic unit contacts along the Colorado River in northwestern Burnet and southeastern San Saba Counties, Texas, and a map depicting photograph locations. *A*, faulting within confining units (Point Peak Member and Morgan Creek Limestone); *B*, fault at contact between the Mid-Cambrian aquifer and Ellenburger-San Saba aquifer; and *C*, fault in the Ellenburger-San Saba aquifer.

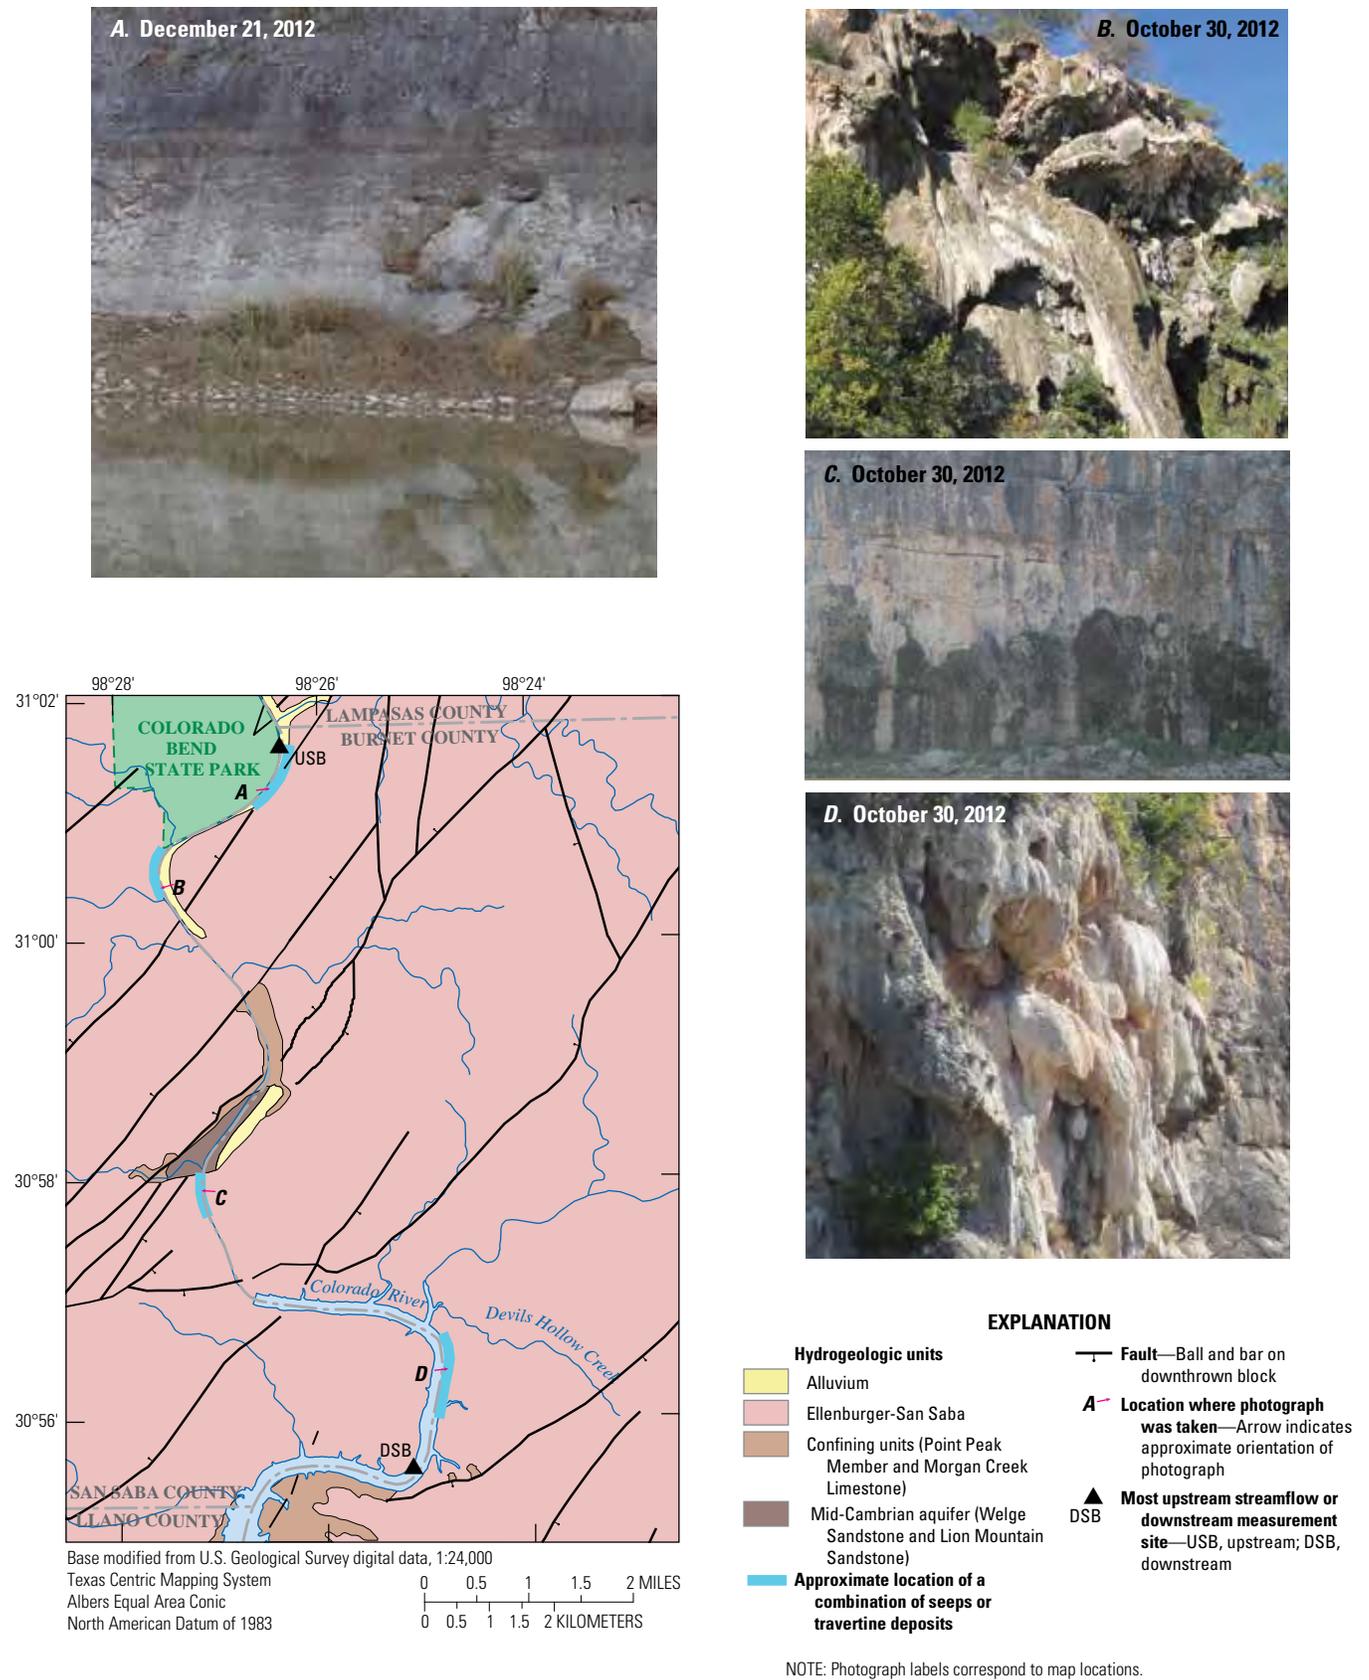
**Figure 8.** Seeps, springs, and travertine deposits along the Colorado River in northwestern Burnet and southeastern San Saba Counties, Texas, and a map depicting photograph locations. *A* and *C*, seeps; and *B* and *D*, springs and associated travertine deposits.

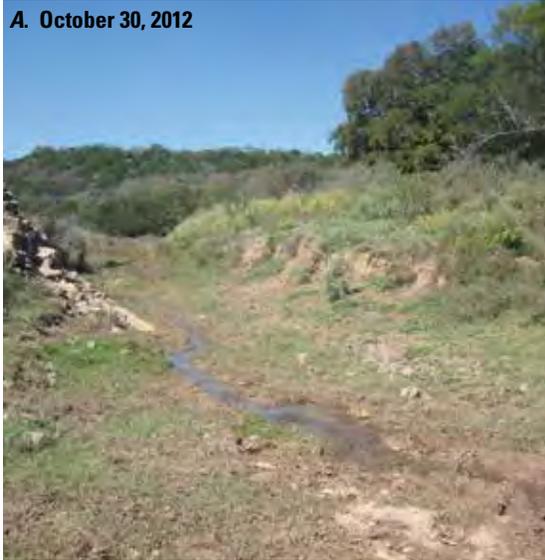
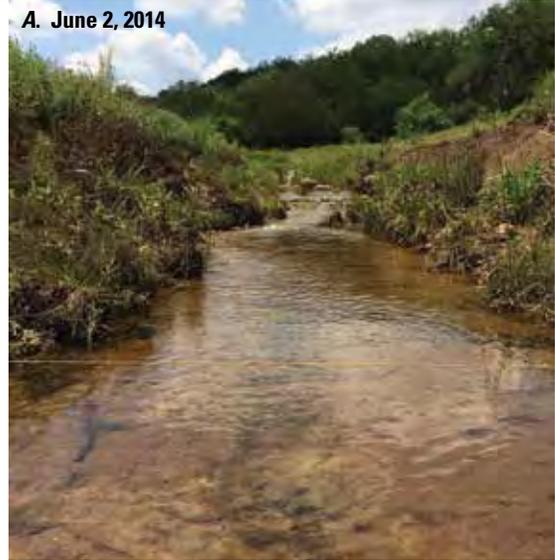
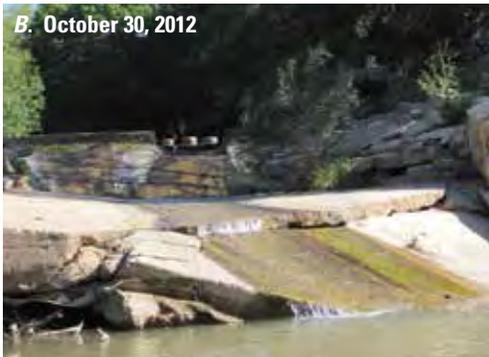
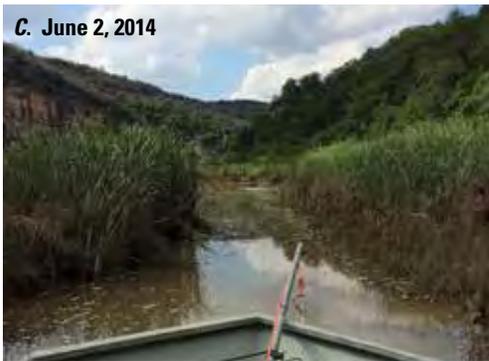
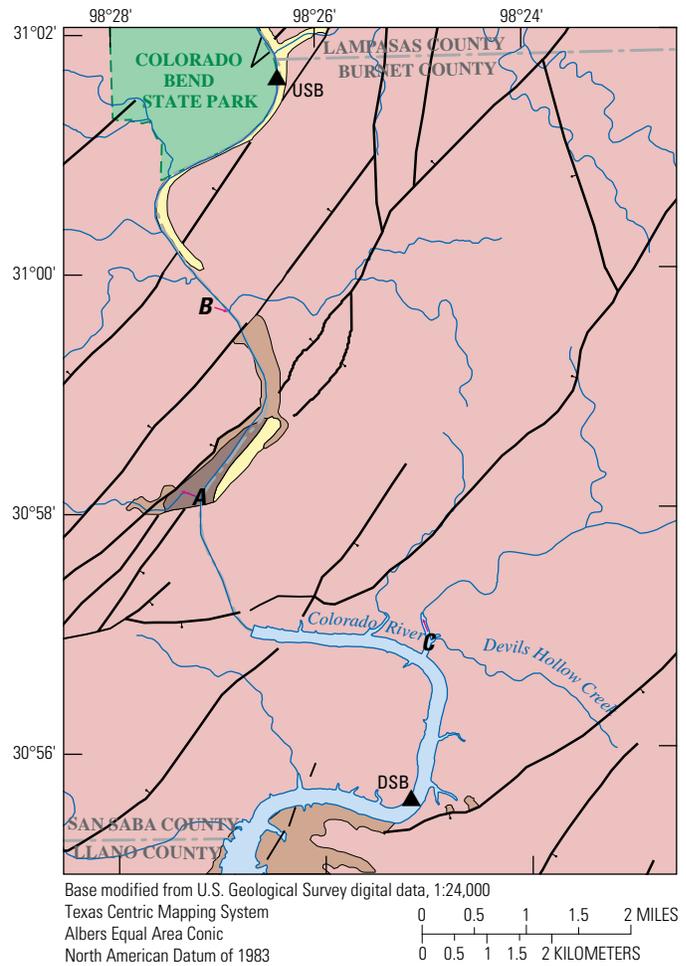
**Figure 9.** Tributary streams, which act as discharge points to the Colorado River in northwestern Burnet and southeastern San Saba Counties, Texas, and a map depicting photograph locations. *A*, Jim John Creek; *B*, Greenwood Creek; and *C*, Deer Creek.

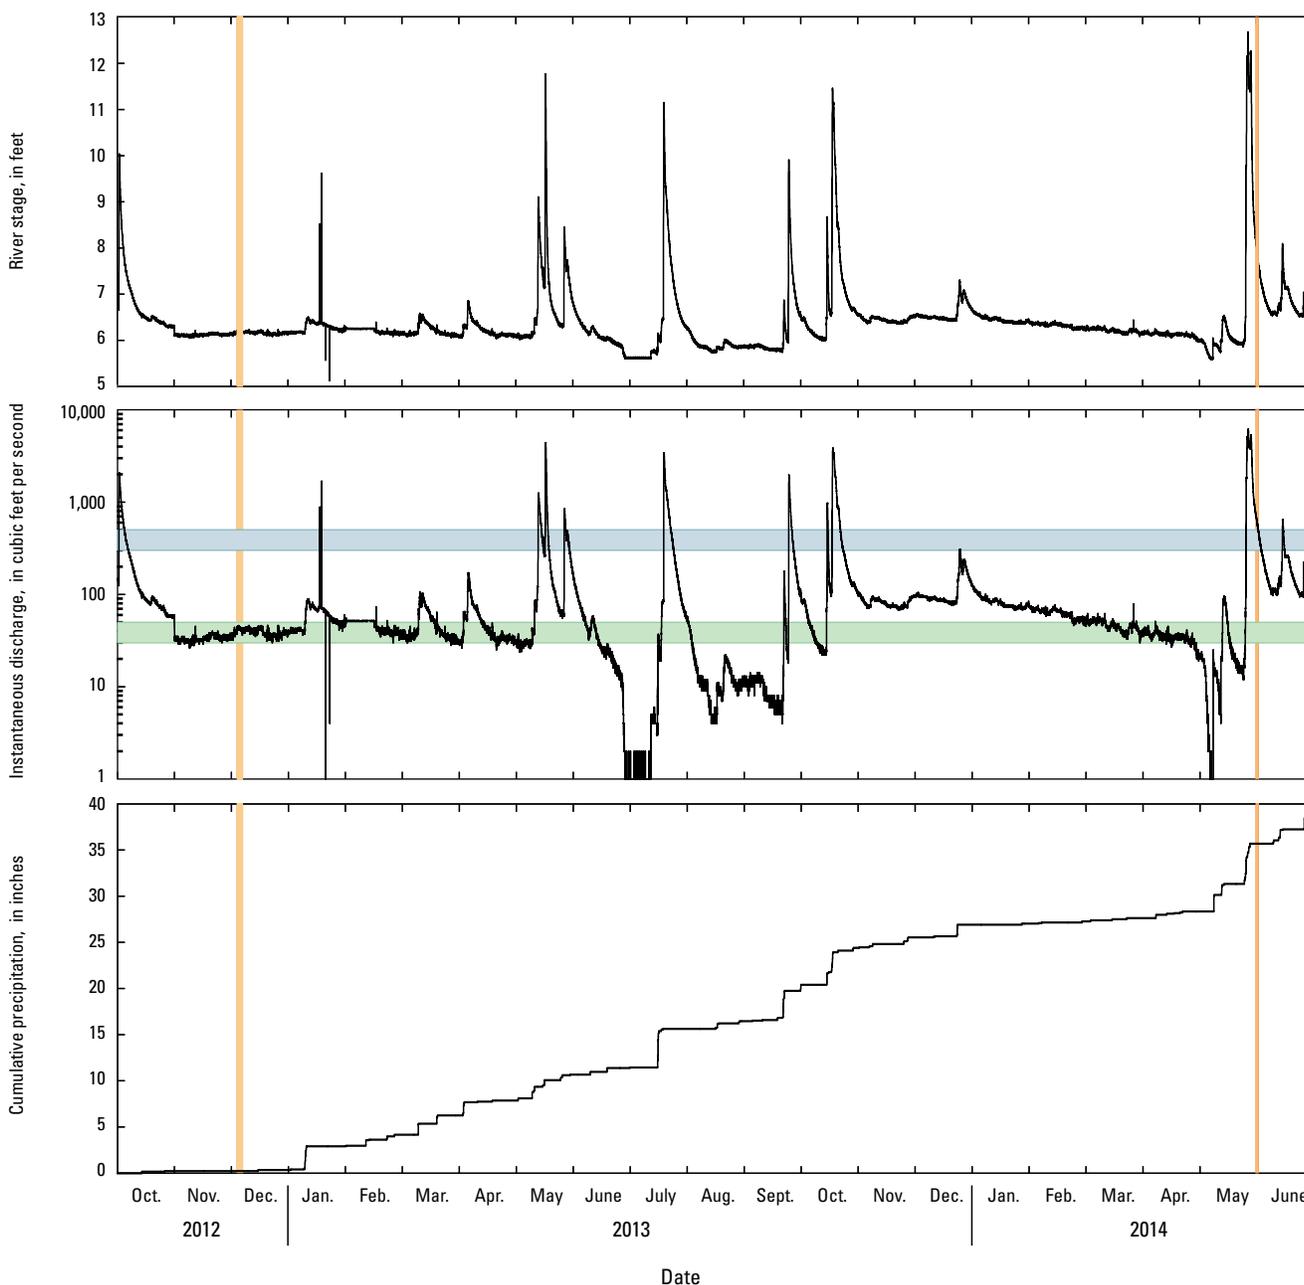
**Figure 10.** River stage, instantaneous discharge, and cumulative precipitation at Lower Colorado River Authority streamflow-gaging station 1925 Colorado River at Bend, Texas, October 1, 2012–June 30, 2014.

The fall 2012 gain-loss survey represented a period of relatively stable base flow when appreciable rainfall and storm runoff were not occurring and had not occurred for at least the previous 2 weeks (figs. 10–11). The completion of gain-loss surveys during periods of relatively stable base flow helps minimize variations in streamflow conditions that might introduce errors into the estimation of gains and losses. Because unwadeable streamflow conditions were anticipated based on preliminary reconnaissance measurements made in October and November 2012, FlowTrackers attached to 8-foot (ft) wading rods were used to make discharge measurements from an inflatable raft as described in the “Methods” section. During the fall 2012 gain-loss survey, stream velocities were so low in some parts of the Colorado River that the FlowTrackers were not able to accurately measure the velocities. As a result, four of the predetermined measurement

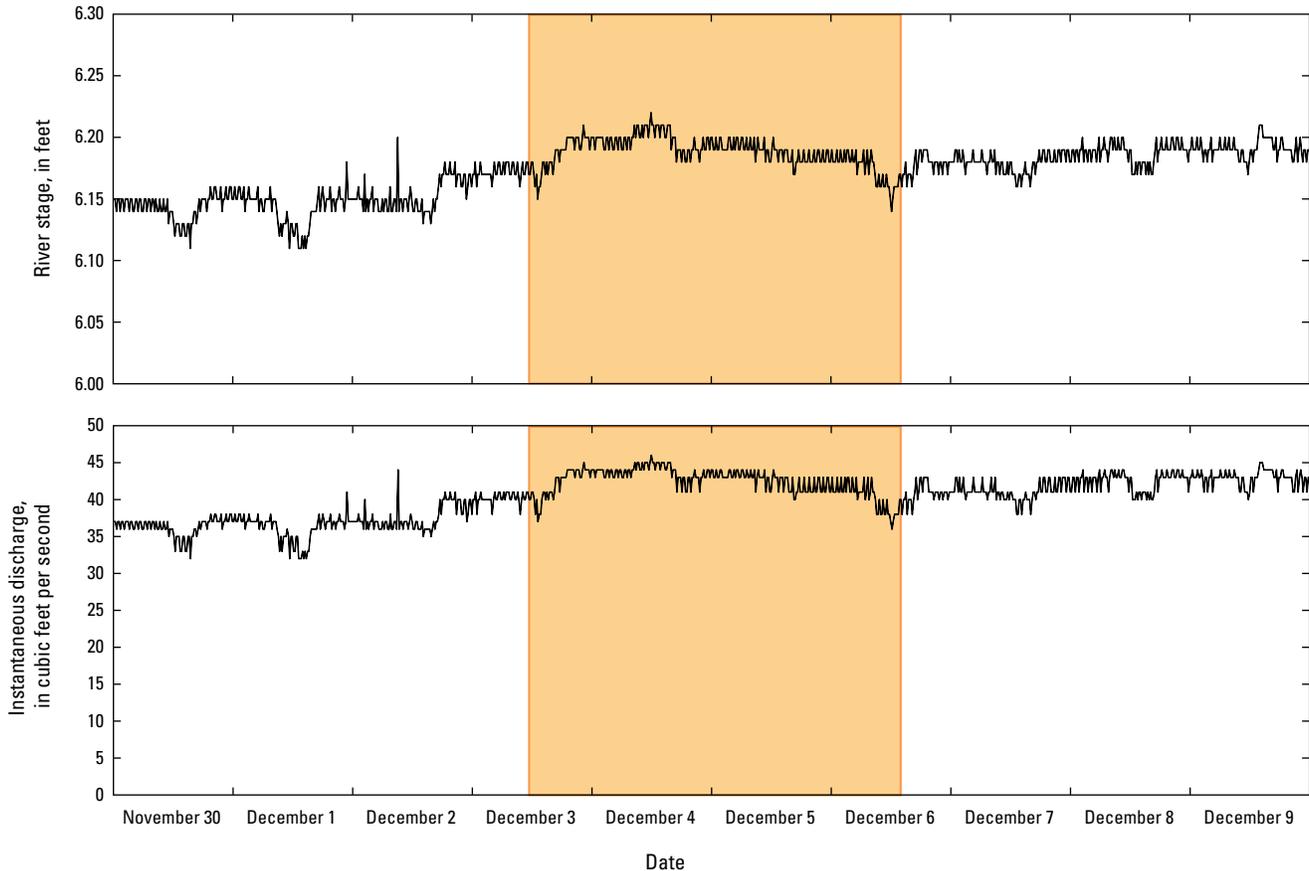
**Figure 11.** River stage and instantaneous discharge at Lower Colorado River Authority (LCRA) streamflow-gaging station 1925 Colorado River at Bend, Texas, November 30–December 9, 2012.

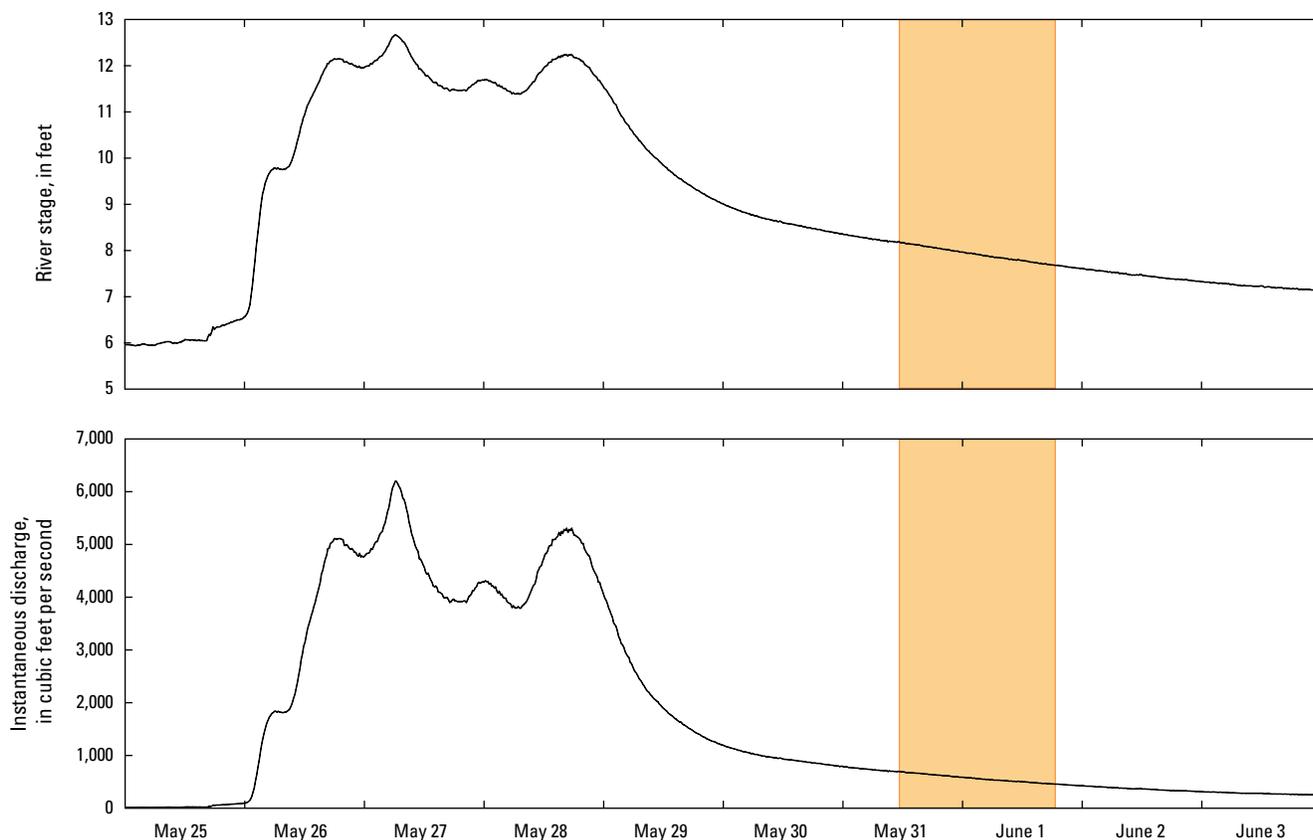
**Figure 12.** River stage and instantaneous discharge at Lower Colorado River Authority (LCRA) streamflow-gaging station 1925 Colorado River at Bend, Texas, May 25–June 3, 2014.

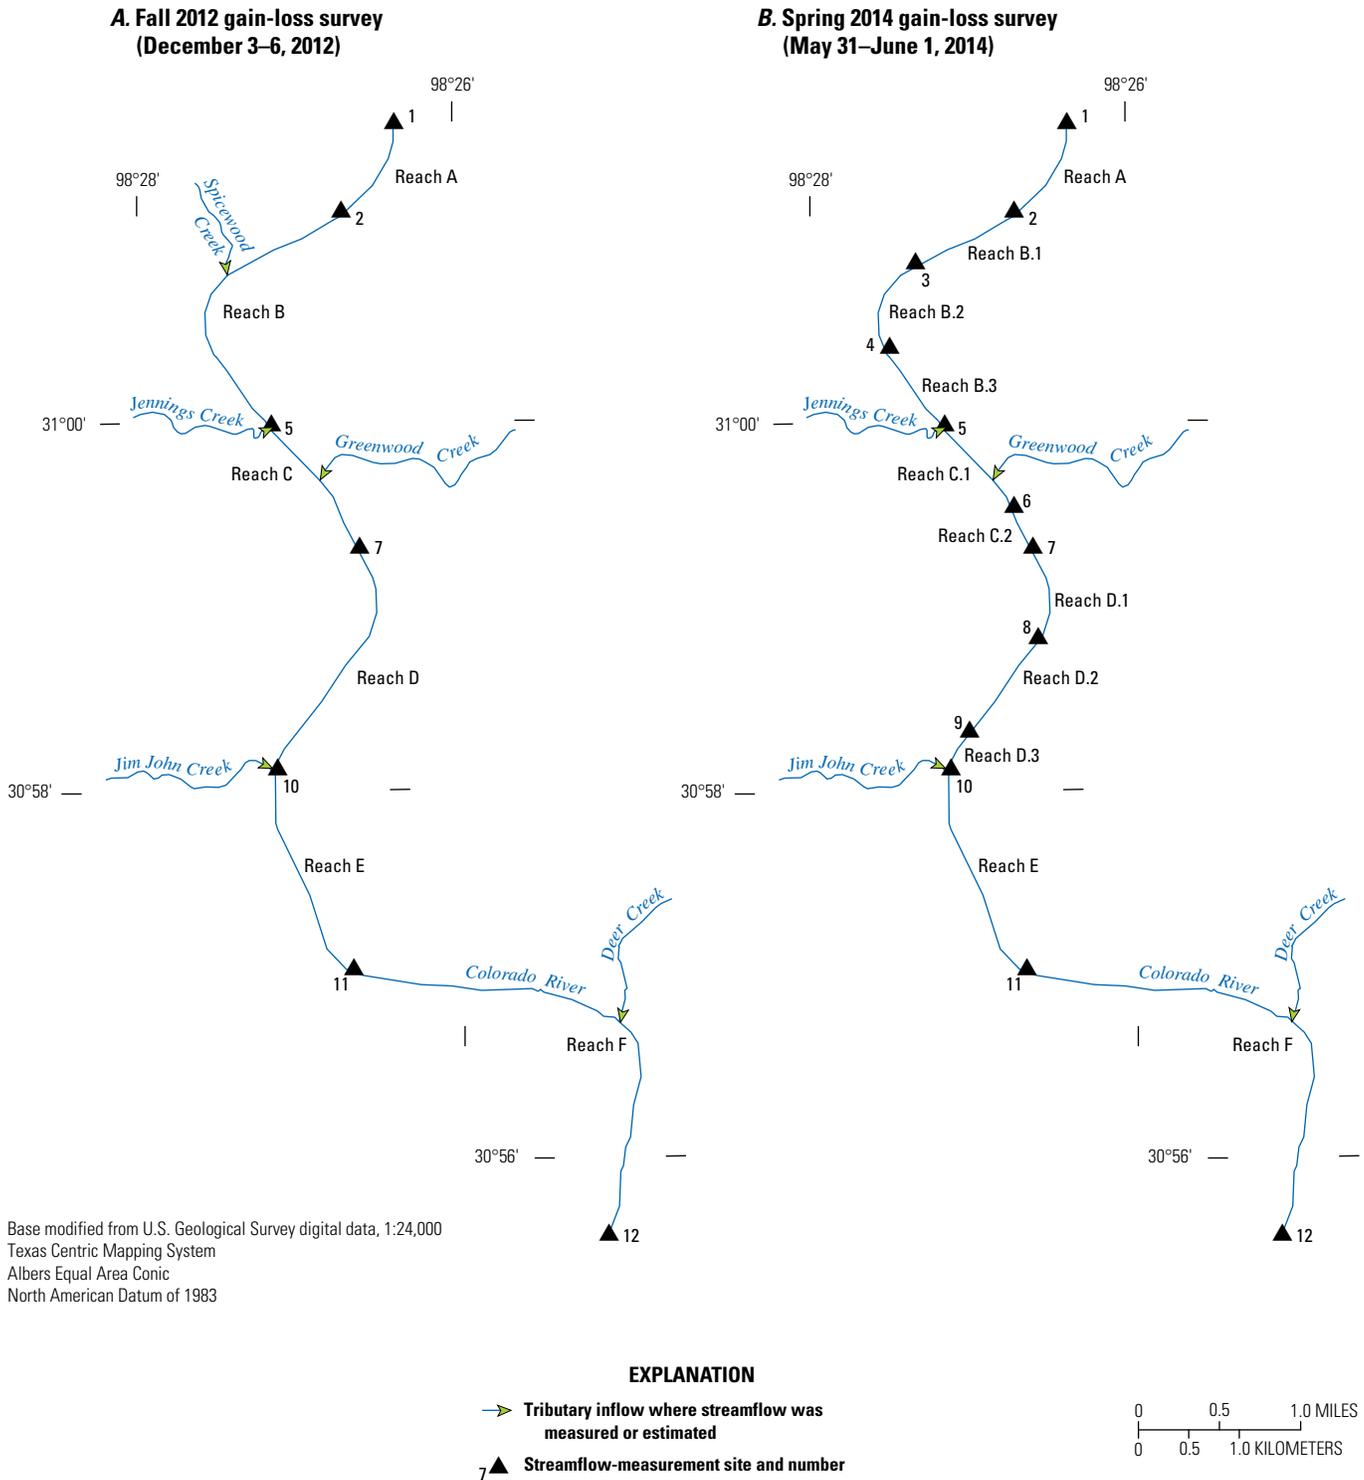
**Figure 13.** Study area reaches showing streamflow-measurement sites and tributary inflows along the Colorado River in northwestern Burnet and southeastern San Saba Counties, Texas.

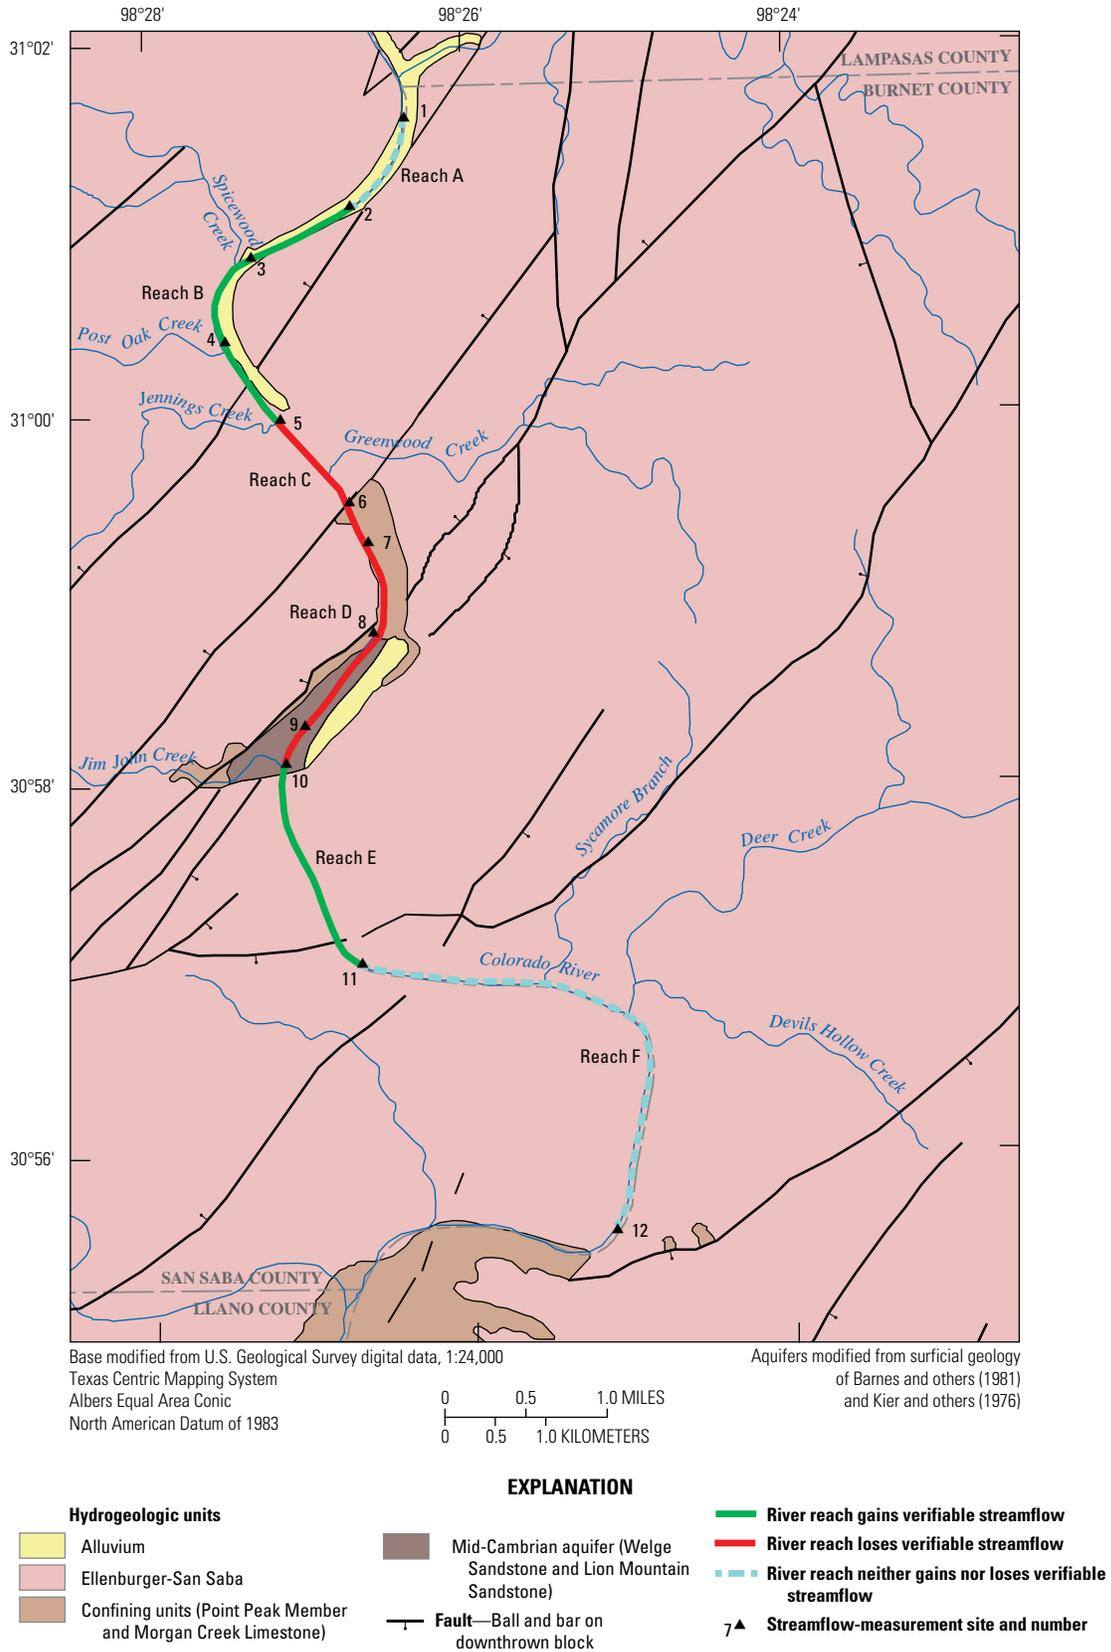
**Figure 14.** Reaches that were verifiably gaining or losing or unverifiably gaining or losing during the fall 2012 gain-loss survey in northwestern Burnet and southeastern San Saba Counties, Texas.

others, 2012). The Colorado River in reach D crosses the same confining units as reach C in the upper 40 percent of the reach before transitioning to the Mid-Cambrian aquifer in the lower 60 percent of the reach (fig. 14; table 4). Because the upper part of reach D flows across a confining unit, it is more likely that most of the streamflow losses in this reach are associated with water infiltration into the subsurface from the streambed and recharge provided to the Mid-Cambrian aquifer.

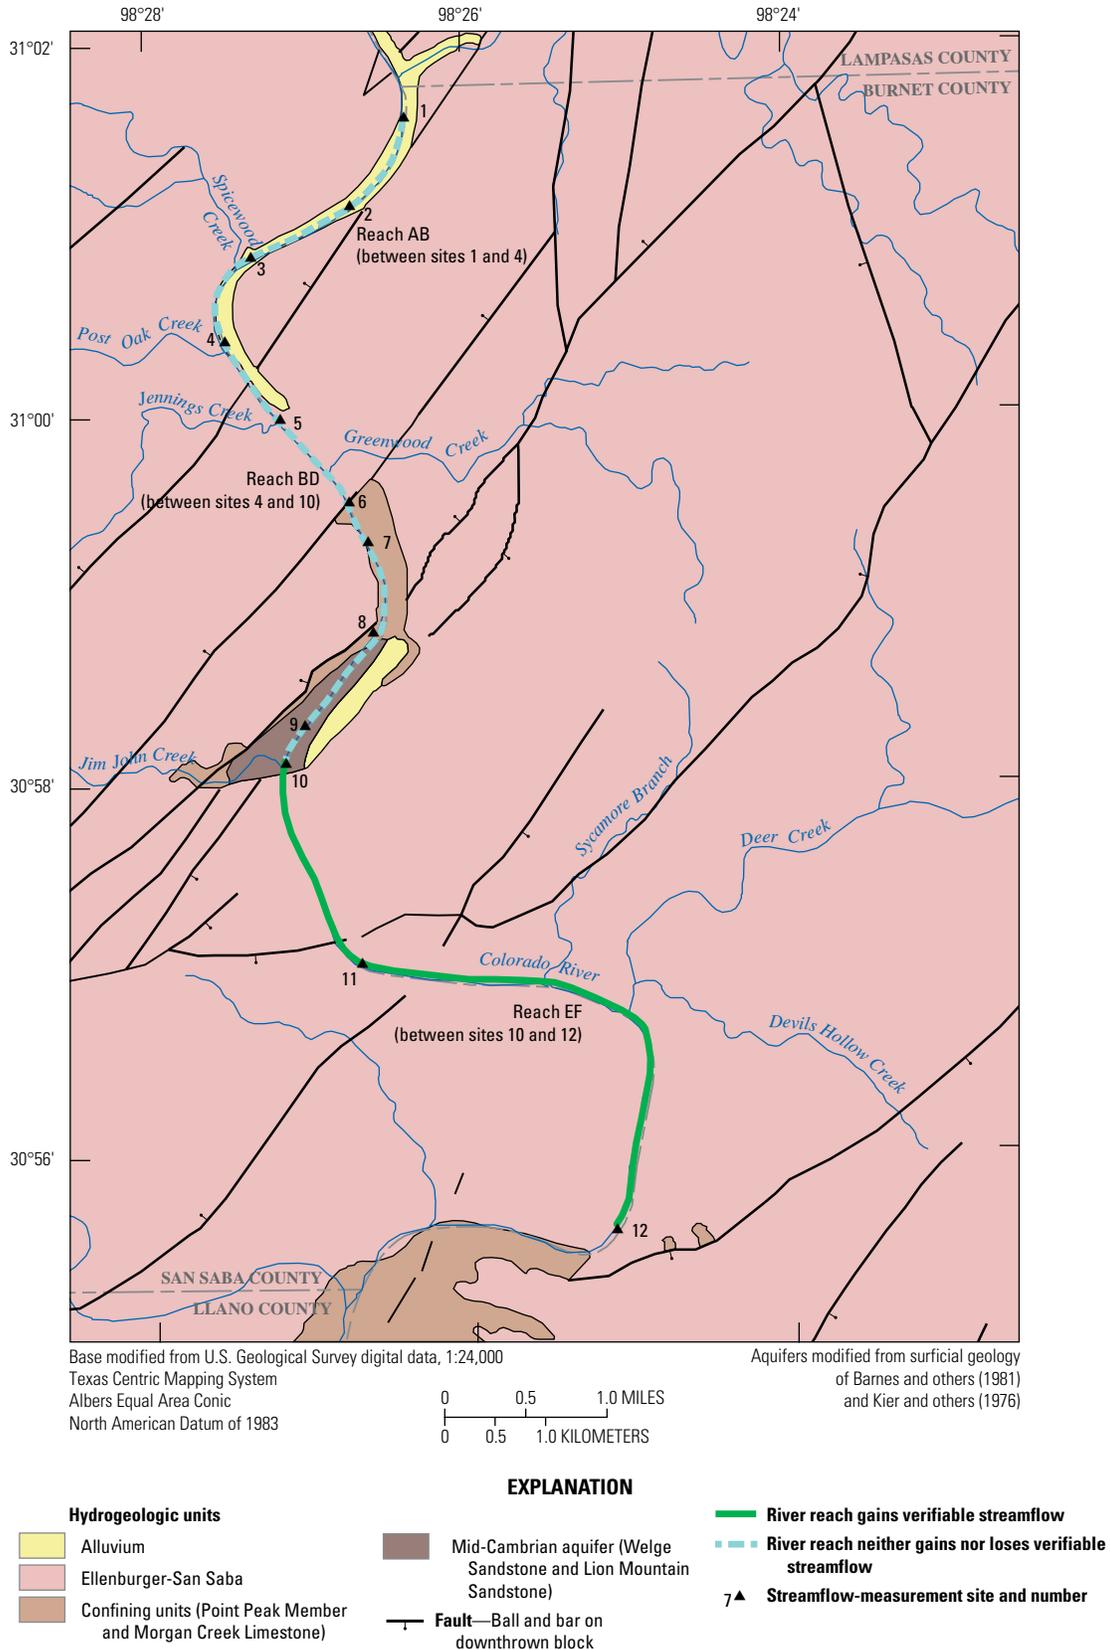
**Figure 15.** Reaches that were verifiably gaining or losing or unverifiably gaining or losing during the spring 2014 gain-loss survey in northwestern Burnet and southeastern San Saba Counties, Texas.
