# Streamflow Gains and Losses in the Colorado River in Northwestern Burnet and Southeastern San Saba Counties, Texas, 2012–14

Scientific Investigations Report 2015–5098

U.S. Department of the Interior  
U.S. Geological Survey

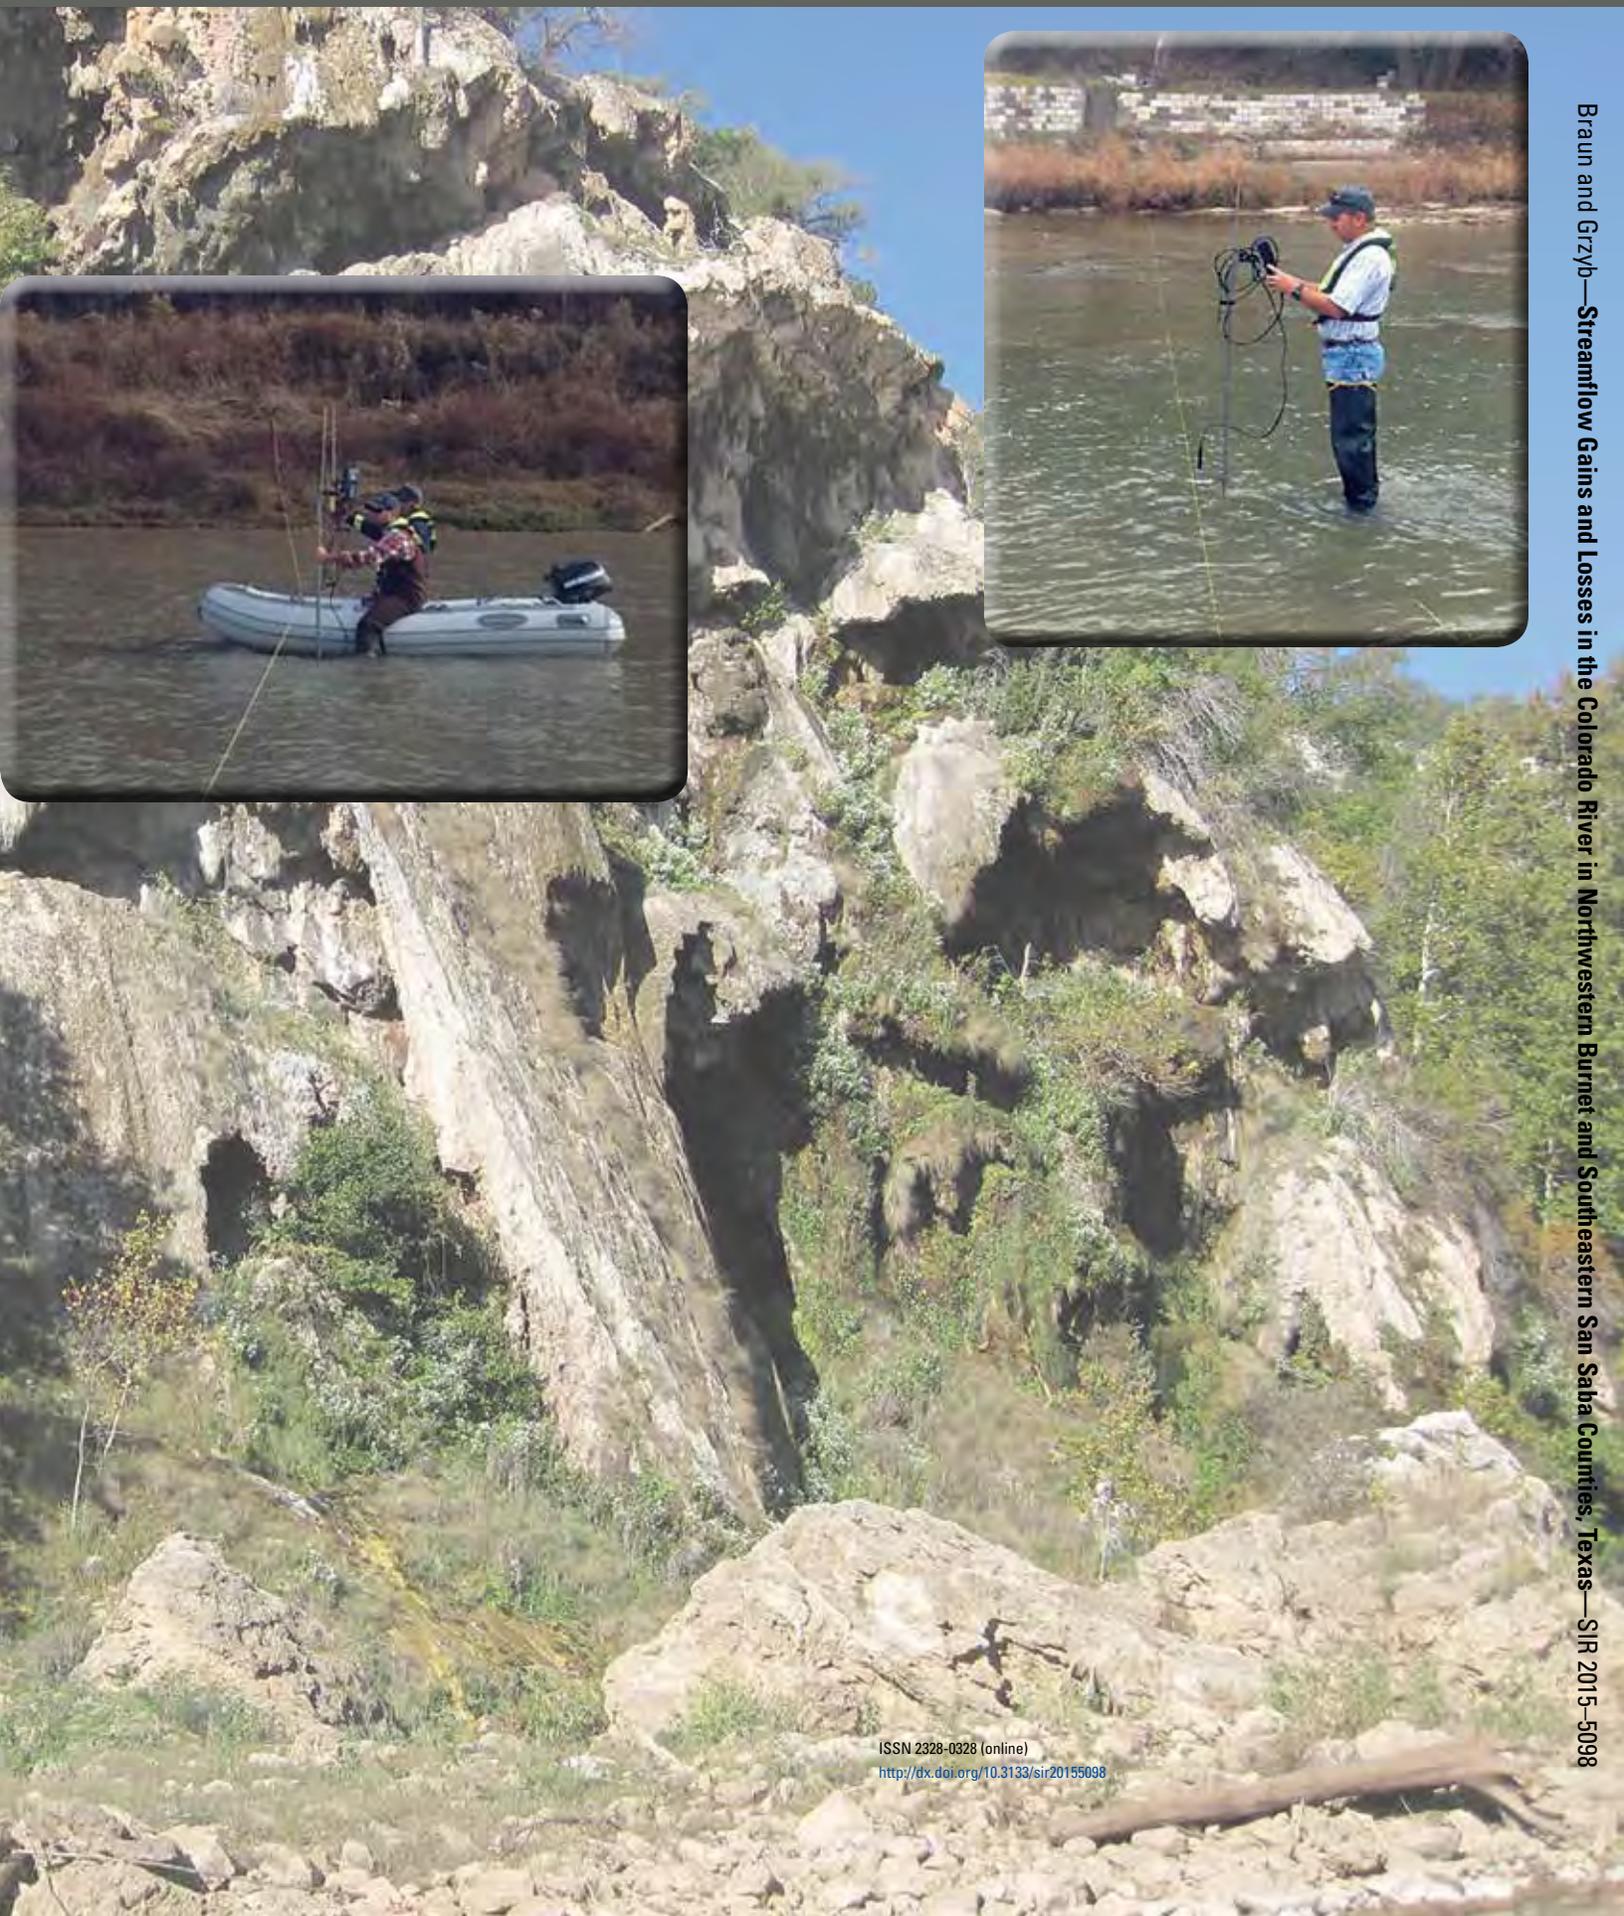
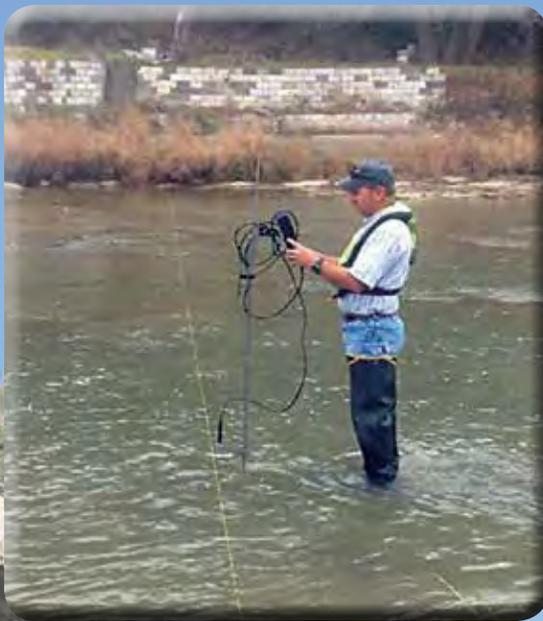
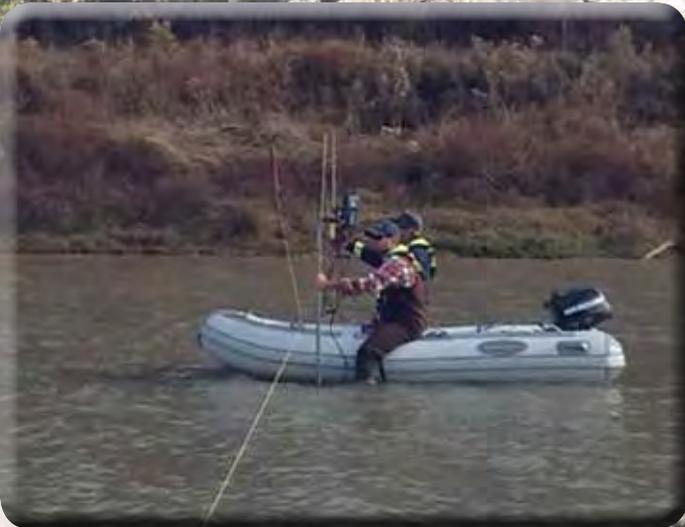
**Background,** Travertine deposits near site 4 (Post Oak Falls near Tow, Texas, October 31, 2012) (photograph by Jennifer Wilson, U.S. Geological Survey).

**Top right,** Wading discharge measurement made using the U.S. Geological Survey midsection method at site 1 (Colorado River downstream from Yancey Creek near Tow, Texas, December 3, 2012) (photograph by Christopher Braun, U.S. Geological Survey).

**Top left,** Concurrent discharge measurements made with extended wading rods using the U.S. Geological Survey midsection method at site 5 (Colorado River at confluence of Jennings Creek near Tow, Texas), December 4, 2012 (photograph by Christopher Braun, U.S. Geological Survey).
