Estimates of Peak Discharge for 21 Sites in the Front Range in Colorado in Response to Extreme Rainfall in September 2013

Scientific Investigations Report 2016–5003

By John A. Moody

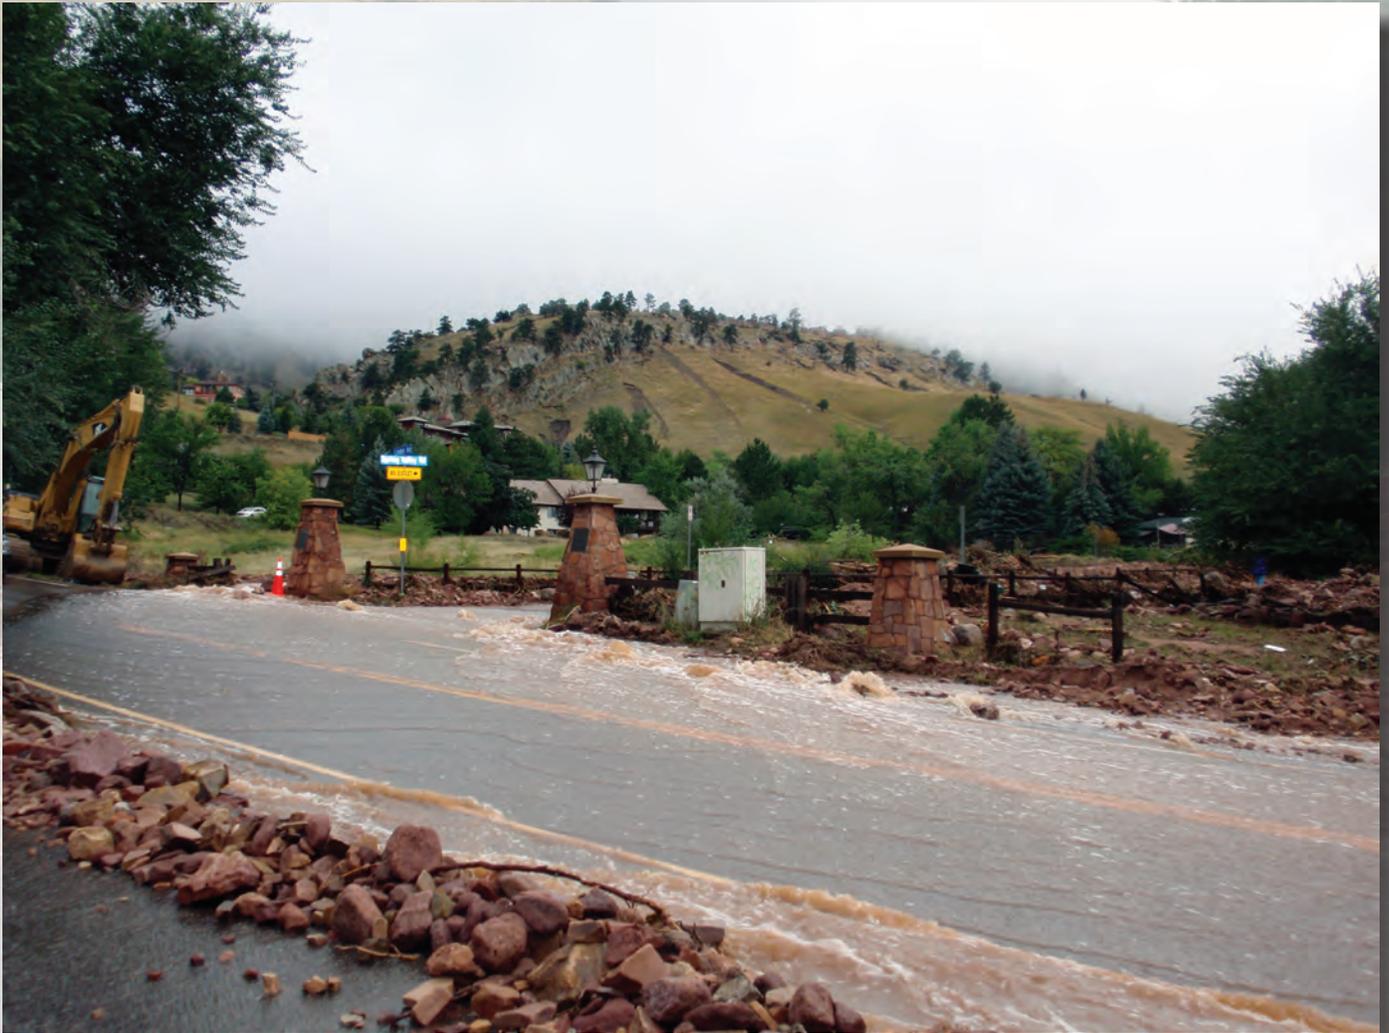
Cover photograph. Floodwater was still spilling out from Twomile Creek onto Linden Avenue on September 15, 2013, in North Boulder, Colorado. The effects of several landslide/debris flows generated by saturated conditions during the night of September 11–12 can be seen on Dakota Ridge near the center of the photograph.

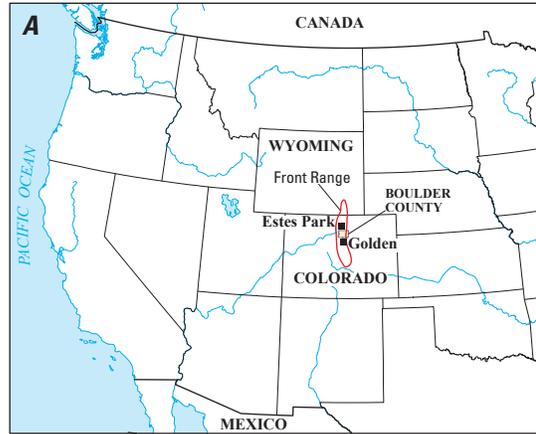
Figure 1. Location of the Front Range, study area, indirect measurement sites, and rain gages. *A*, Front Range relative to the Pacific Ocean. *B*, Part of the Front Range, the study area, and some of the major streams in northern Colorado. *C*, Location of 21 U.S. Geological Survey indirect discharge measurement sites, 6 rain gages, and accumulative rainfall from September 9–16, 2013, in Boulder County, Colorado.

were located within this alpine area or near its boundaries; therefore, based on the rainfall pattern shown in figure 1C, the average peak rainfall intensity of (6.8 millimeters per hour [mm h^{-1}]) for the Hills Mills rain gage (at about the same elevation as the alpine area) was used (table 1). Peak discharge at this site was in response to the lowest average rainfall intensity at any site and had one of the lowest bed slopes (0.011, table 1). The different indirect methods estimated that 82–97 percent of the flow was in the main channel (fig. 6).

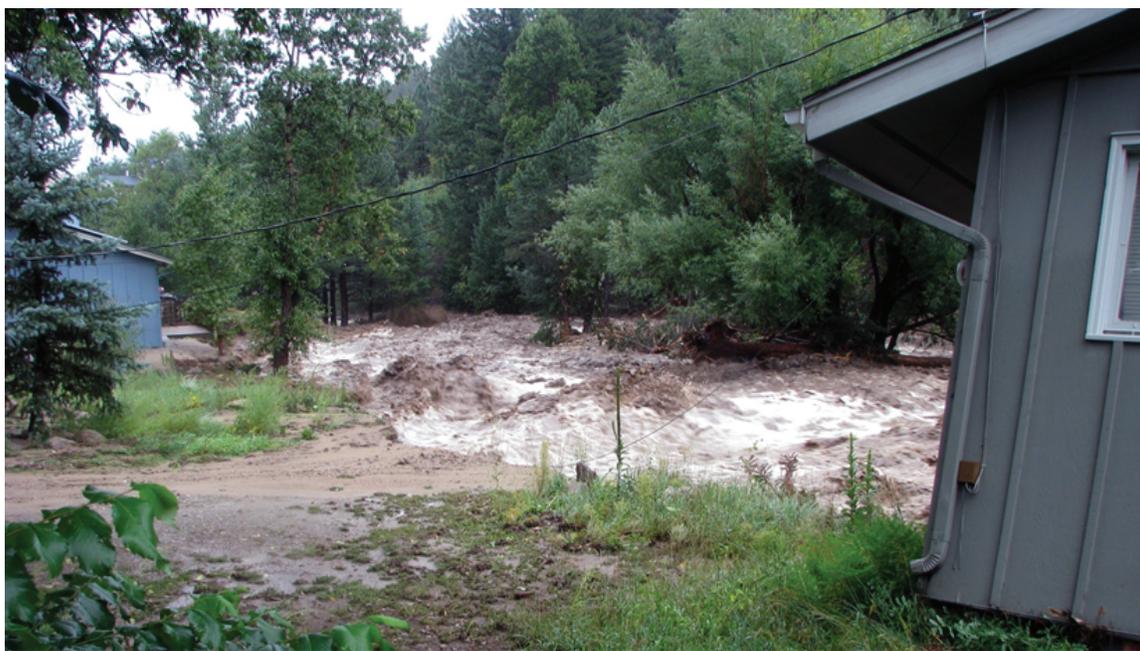
Figure 3. Turbulent flow in James Creek through Jamestown, Colorado, on September 12, 2013. View is downstream after peak flow showing how surface waves create uncertainty in the actual elevation of the high-water marks along creek banks. Photograph taken by Mark Williams.

however, for floodflows, R/D_{84} can be greater than ($>$) 1. Even so, the surface water is generally turbulent caused by the large submerged roughness elements and irregular banks (fig. 3). Water surging up and down the banks makes estimating high-water elevations difficult, and estimates can vary substantially across the channel.

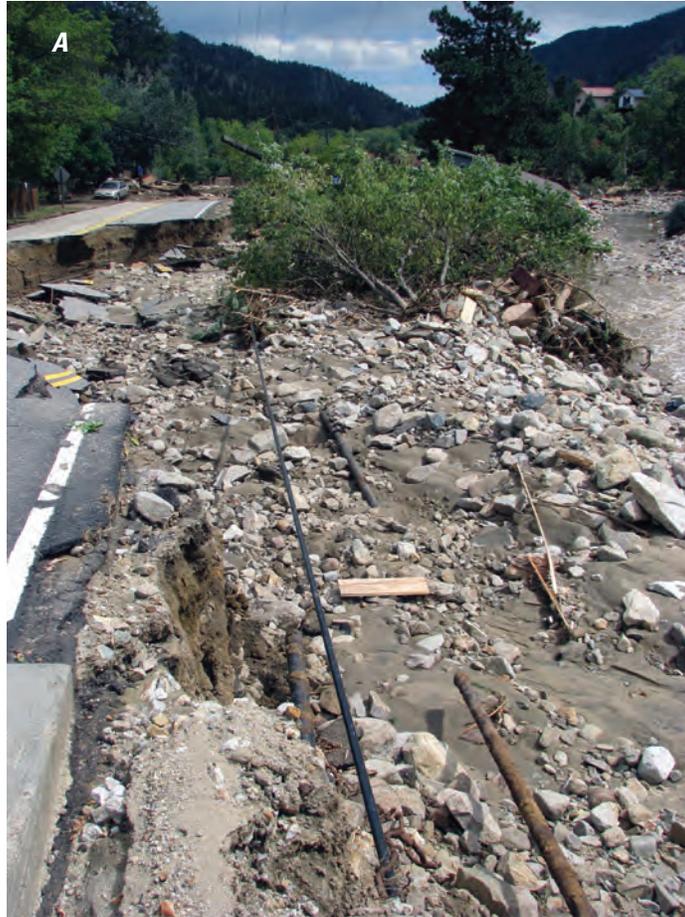
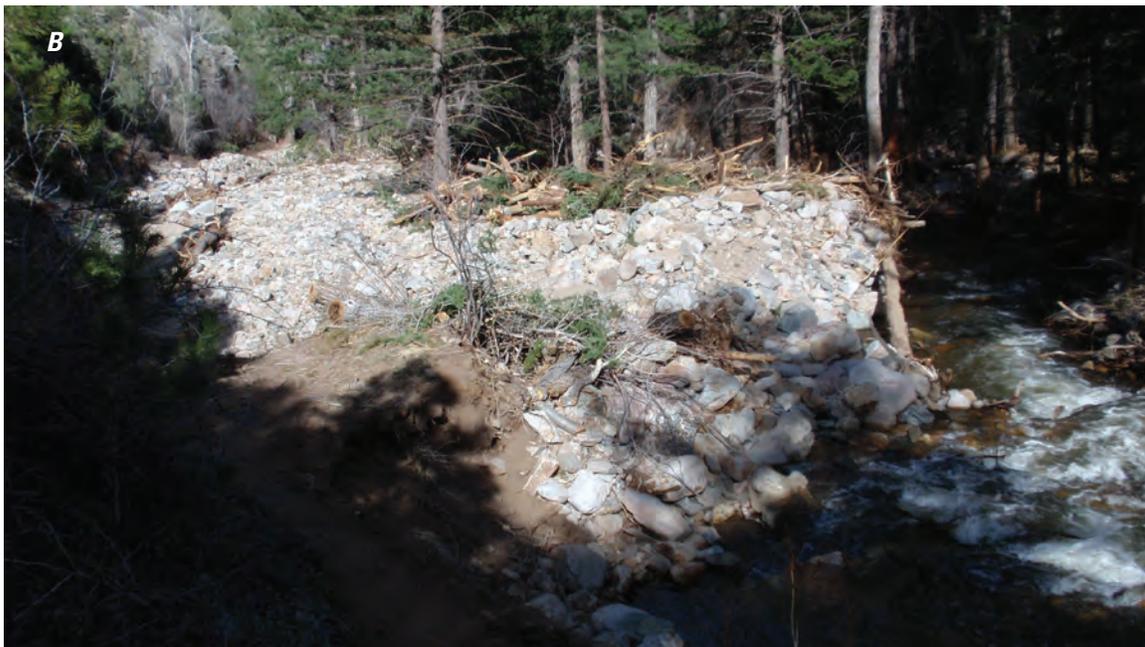
Figure 5. Typical examples of erosion and deposition of sediment from the September 2013 floods, Boulder County, Colorado. *A*, View downstream of bank erosion, and road and utility damage caused by the flood waters of James Creek below Jamestown, Colorado. Photograph was taken on September 13, 2013, by Mark Williams. *B*, View downstream of a depositional reach above Jamestown, Colorado, on James Creek and downstream from Moorhead Gulch where there was a landslide/debris flow that probably blocked the old channel (left side) until the water eroded out a new channel (right side). Photograph taken on April 28, 2014.

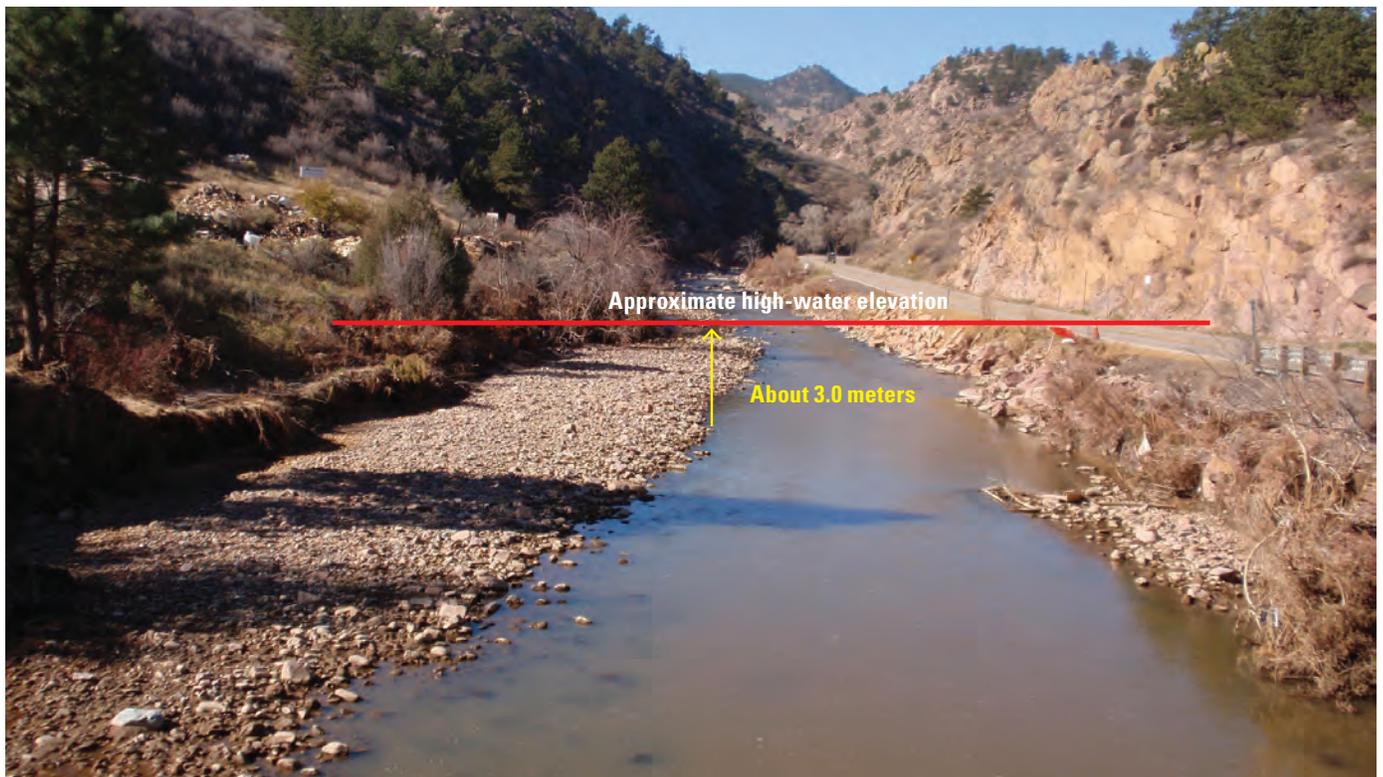
Figure 7. North Saint Vrain Creek above Apple Valley Bridge on November 12, 2013. View is upstream from the Apple Valley Bridge. Flood waters had covered Highway 36 (on the right-hand side of the photo) to a depth of 0.3–0.5 meter.

The indirect peak discharge ($385 \text{ m}^3 \text{ s}^{-1}$, tables 1 and 3) was measured on March 9, 2014, after some of the left-bank, high-water marks had been destroyed by blasting at the mouth of North St. Vrain Canyon for flood repair work on U.S. Highway 36 (fig. 7). Manning's n was selected for four

subareas (highway, left bank, main channel, and right bank) of each cross section. Flow at this measurement site was modified by flow from the Button Rock Reservoir located about 5.7 km upstream from this site. Bed slope was the lowest of all sites (0.006, table 1). The different indirect methods estimated that 91–94 percent of the flow was in the main channel (fig. 7).

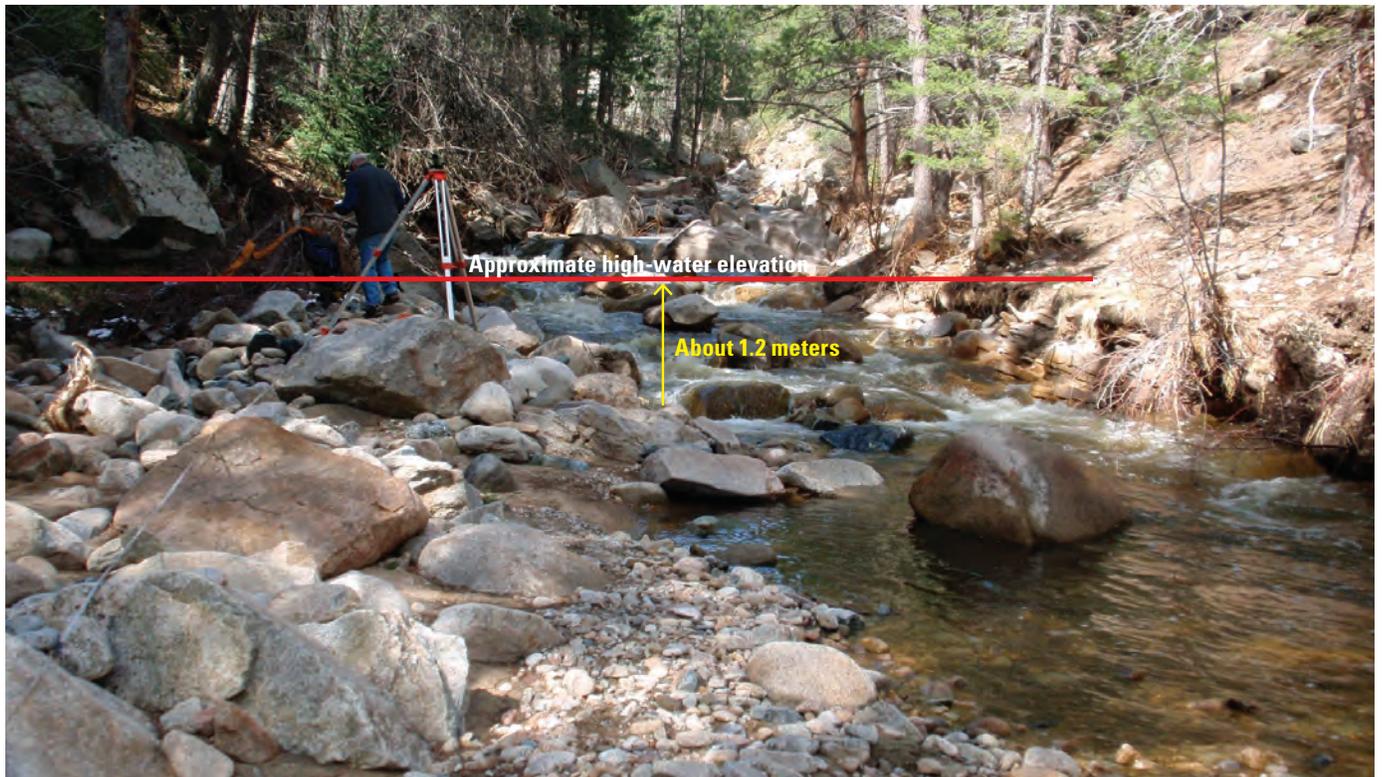
Figure 8. South Saint Vrain Creek above confluence with Middle Saint Vrain Creek on May 16, 2014. View is upstream from cross section 2 (XS2, table 4). Water is diverted from this creek into James Creek for irrigation; thus, the channel conveys less water than its size would suggest. The survey level is about 1.5 meters above the streambed.

St. Vrain Creek into James Creek near the headwaters of the South St. Vrain Creek. This diversion was in operation during the peak flow on the night of September 11–12, 2013, so the drainage areas of the South St. Vrain and James Creeks have been adjusted to reflect this diversion (see footnote in table 1). The different indirect methods estimated that 96–98 percent of the flow was in the main channel (fig. 8).

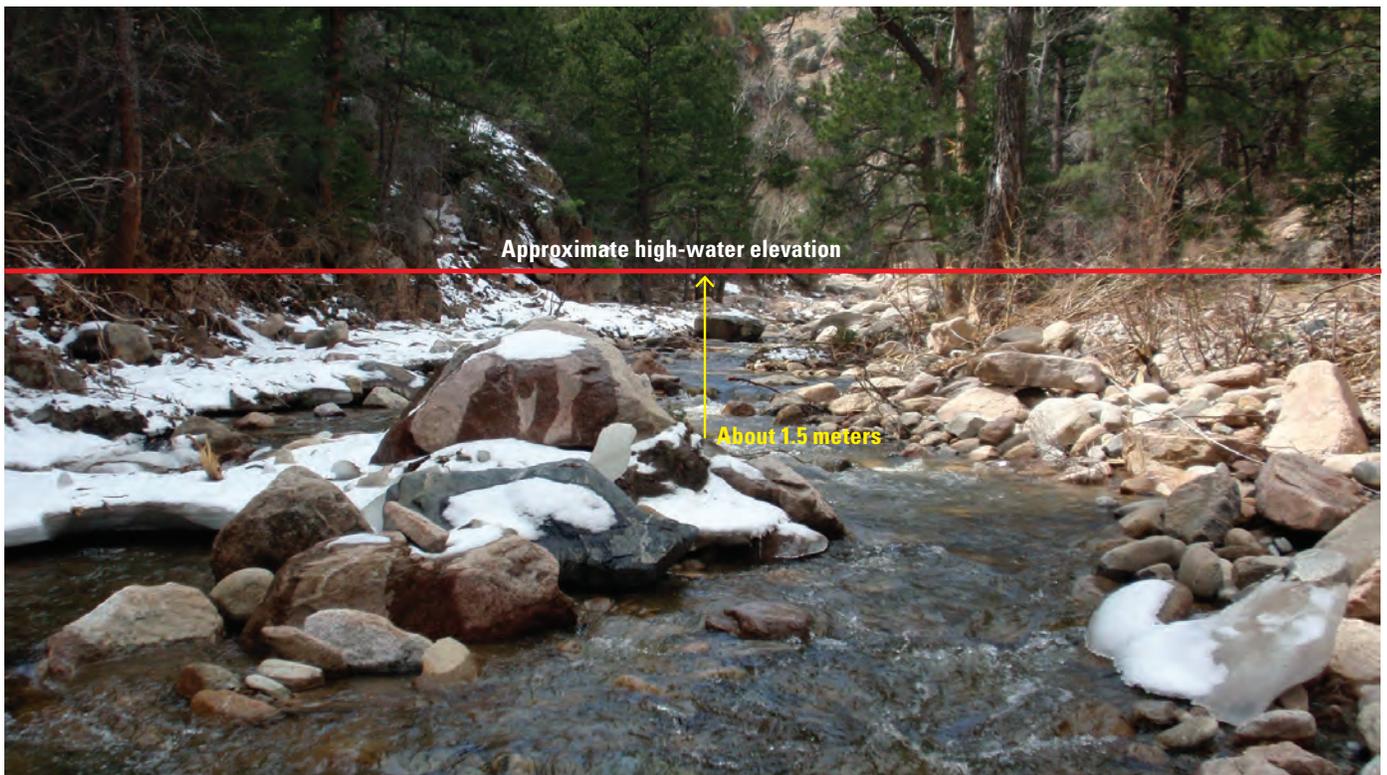
Figure 9. South Saint Vrain Creek below confluence with Middle Saint Vrain Creek on March 26, 2014. View is upstream from cross section 5 (XS5, table 5). Highway 7 (upper right) is running next to the narrow flood plain along the left bank.

for the North St. Vrain Creek above Apple Valley Bridge ($385 \text{ m}^3 \text{ s}^{-1}$) and this site ($123 \text{ m}^3 \text{ s}^{-1}$) is $508 \text{ m}^3 \text{ s}^{-1}$. This sum is less than the value ($675 \text{ m}^3 \text{ s}^{-1} \pm 10$ percent) estimated downstream from the confluence of the North St. Vrain and South St. Vrain Creeks in Lyons, Colo. (fig. 1B) by the U.S. Geological Survey's Colorado Water Science Center using a two-dimensional hydraulic model (http://nwis.waterdata.usgs.gov/co/nwis/peak/?site_no=06724000&agency_cd=USGS; R. Kimbrough, U.S. Geological Survey, written commun., 2015). This estimated combined flow downstream from the confluence was not confined to a single channel but spread out over a wide flood plain with many channels and damaged and destroyed many homes (Lukas, 2013). The different indirect methods estimated that 95–97 percent of the flow was in the main channel (fig. 9).

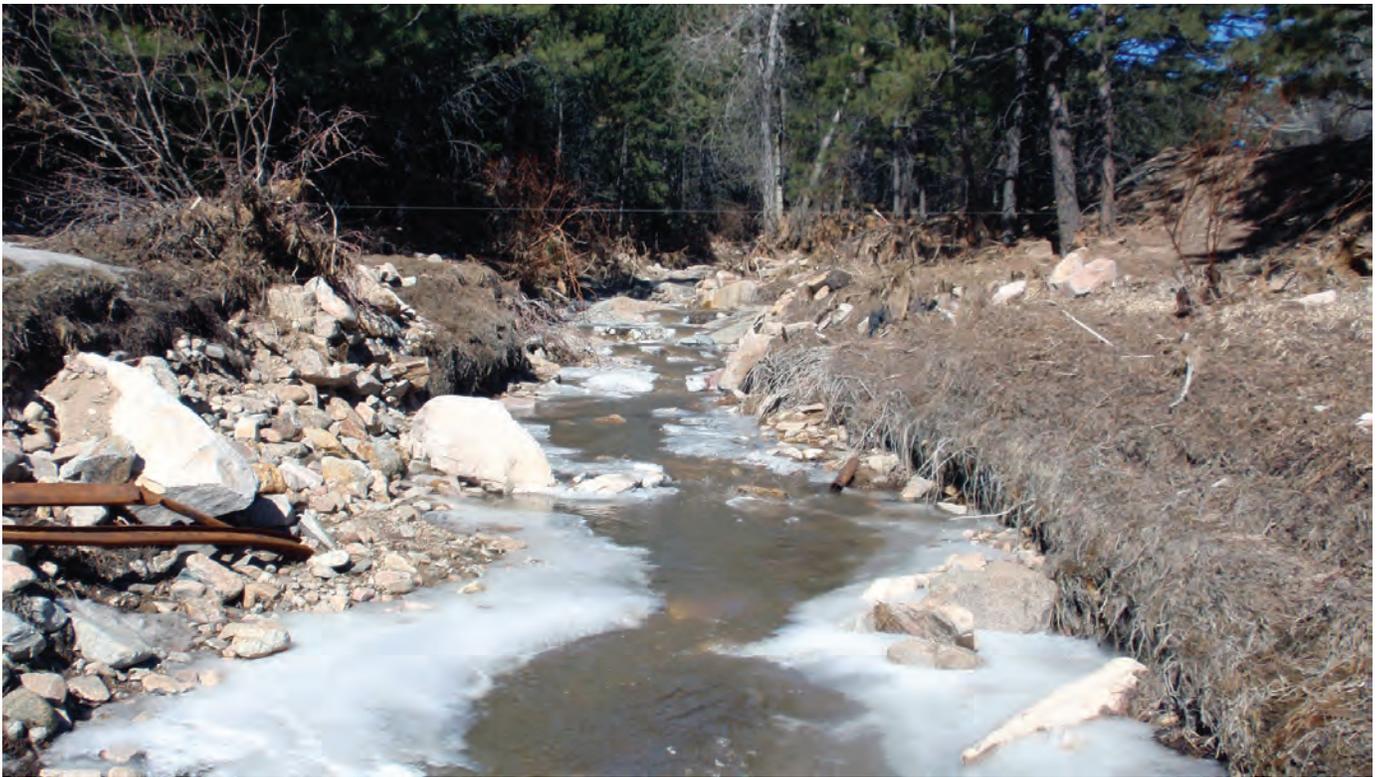
Figure 10. Little James Creek above confluence with James Creek on March 19, 2014. View is upstream from cross section 1 (XS1, table 6). The steel tagline is about 0.1–0.2 meter above the high-water elevation. The channel is about 5 meters wide below the steel tagline.

Moore, 2013), which is essentially the same as the average value for the Critical flow method in table 6 ($54 \text{ m}^3 \text{ s}^{-1}$). The drainage area (7.76 km^2) is small, but the unit peak discharge ($9.5 \text{ m}^3 \text{ s}^{-1} \text{ km}^{-2}$, table 1) is large, which may be the result of increased runoff from part of the area burned by the 2003 Overland fire (Kinner and Moody, 2008). Several landslide/debris flows were generated during the evening of September 11–12, 2013, on Porphyry Mountain within the drainage basin of Little James Creek. Only one rain gage (Porphyry Mountain, fig. 1C) was used to calculate the peak rainfall intensity for T_c about=1 h, and this may underestimate the rainfall intensity. The 30- and 10-min peak rainfall intensities were 29.4 and 44.3 mm h^{-1} corresponding to peak runoff coefficients of 1.0 and 0.77, respectively. Runoff coefficients this large suggest that the T_c might be much shorter than estimated, but the possible reasons are not apparent. The different indirect methods estimated that 72–90 percent of the flow was in the main channel (fig. 10).

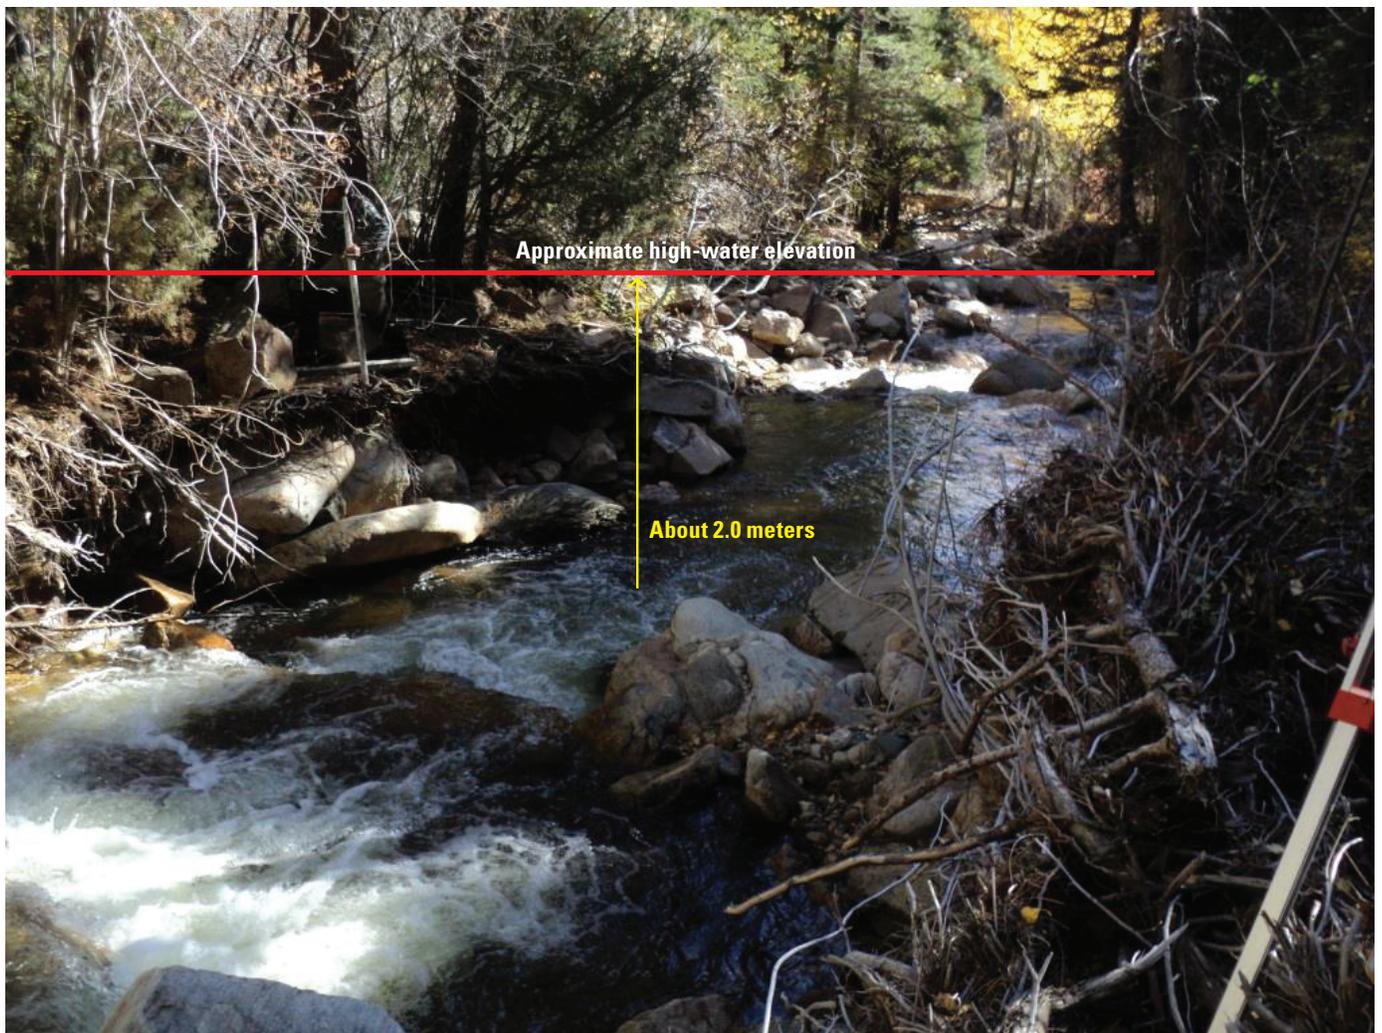
Figure 11. James Creek above Jamestown, Colorado, on October 11, 2014. View is downstream from right bank at cross section 1 (XS1, table 7). Photograph taken by G. Patterson.

Barnes (1967); thus, Manning's n values for the Cowan method were $0.050 \text{ m}^{-1/3} \text{ s}$ for the main channel and $0.28 \text{ m}^{-1/3} \text{ s}$ for the flood plain (fig. 11). Values estimated by the Empirical method ranged from 0.037 to $0.071 \text{ m}^{-1/3} \text{ s}$. Both sets of n seem low because the mean cross-sectional velocities in the main channel ranged from 6.3 to 9.9 m s^{-1} , and the average peak discharge of the six cross sections ($133 \text{ m}^3 \text{ s}^{-1}$, Cowan method and $158 \text{ m}^3 \text{ s}^{-1}$, Empirical method; table 7) was about twice the estimates using the other methods except for the SAC method estimate ($86 \text{ m}^3 \text{ s}^{-1}$). The different indirect methods estimated that 95–98 percent of the flow was in the main channel (fig. 11).

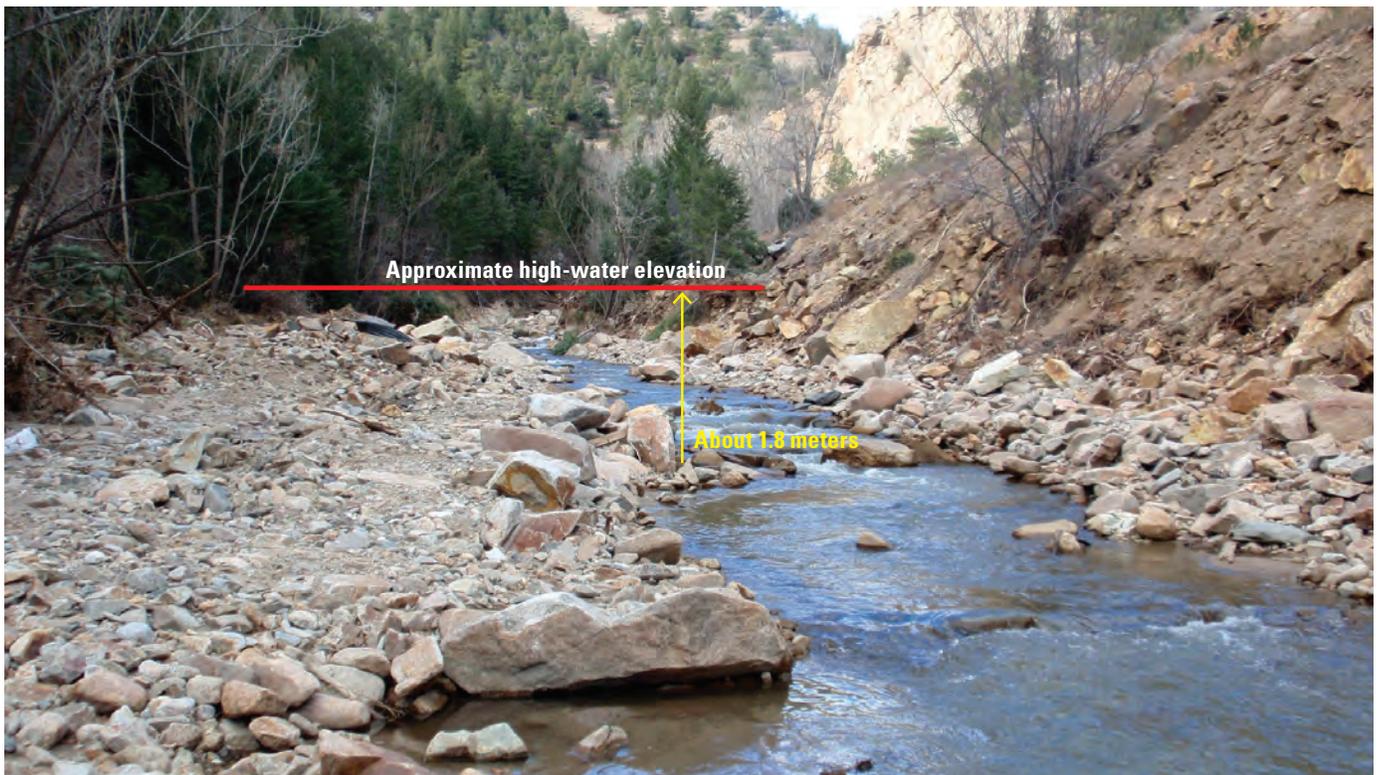
Figure 12. James Creek below Jamestown, Colorado, on November 20, 2013. View is upstream from right bank at cross section 5 (XS5, table 8). Cross section 1 is about where the creek disappears behind the left-bank flood plain. Highway 7 (top right) is at the top of the bare bank.

response to landslide/debris flows temporarily blocking the stream and then eroding out. One such landslide/debris flow from Moorhead Gulch blocked James Creek about 450 m downstream from the James Creek above Jamestown site, and about 750 m upstream from the confluence of Little James and James Creek. Another reason for the difference is the attenuation of the peak discharge with distance downstream (Gilcrest, 1950). A separate estimate made in Jamestown was $136 \text{ m}^3 \text{ s}^{-1}$ (Yochum and Moore, 2013), which is closer to the sum of Little James Creek and James Creek above Jamestown. The different indirect methods estimated that 90–95 percent of the flow was in the main channel (fig. 12).

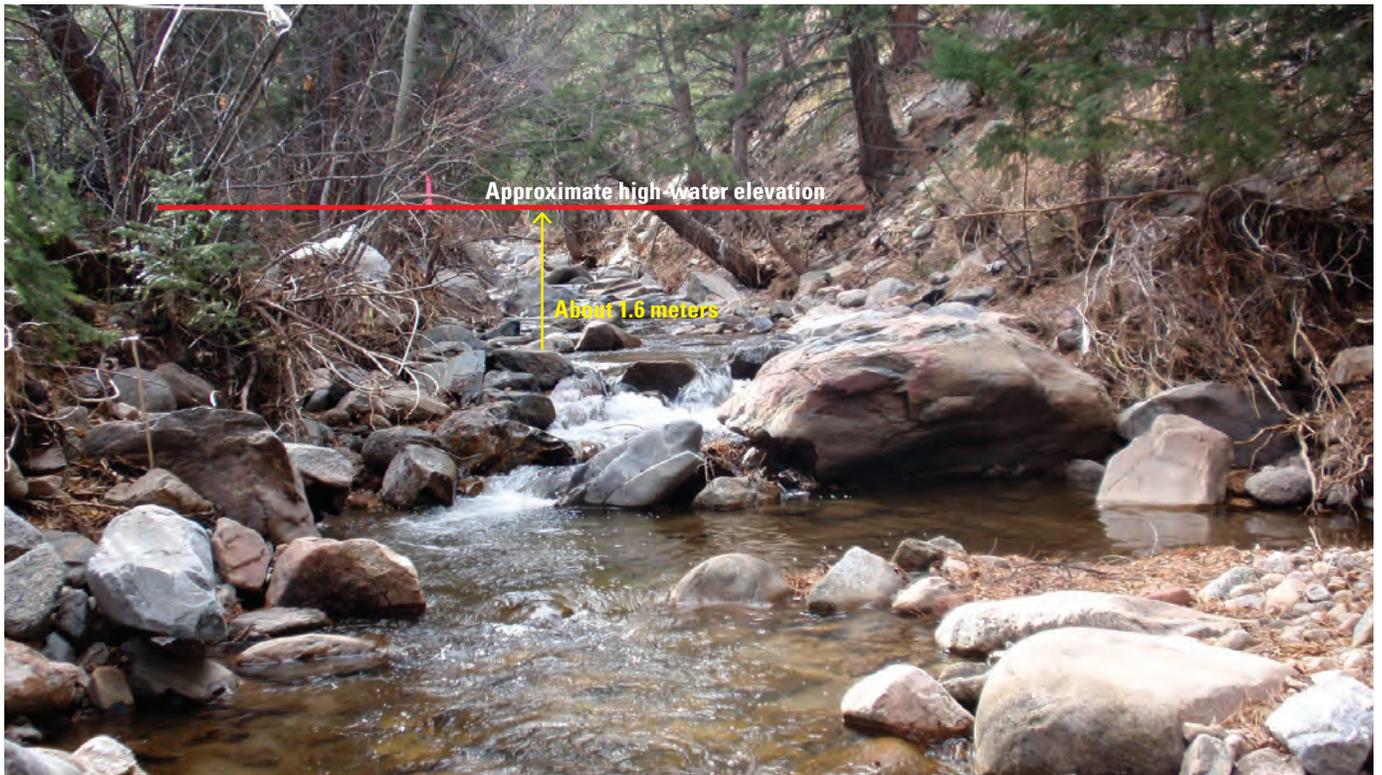
Figure 13. Left Hand Creek below Nugget Gulch on November 20, 2013. View is upstream from cross section 6 (XS6, table 9).

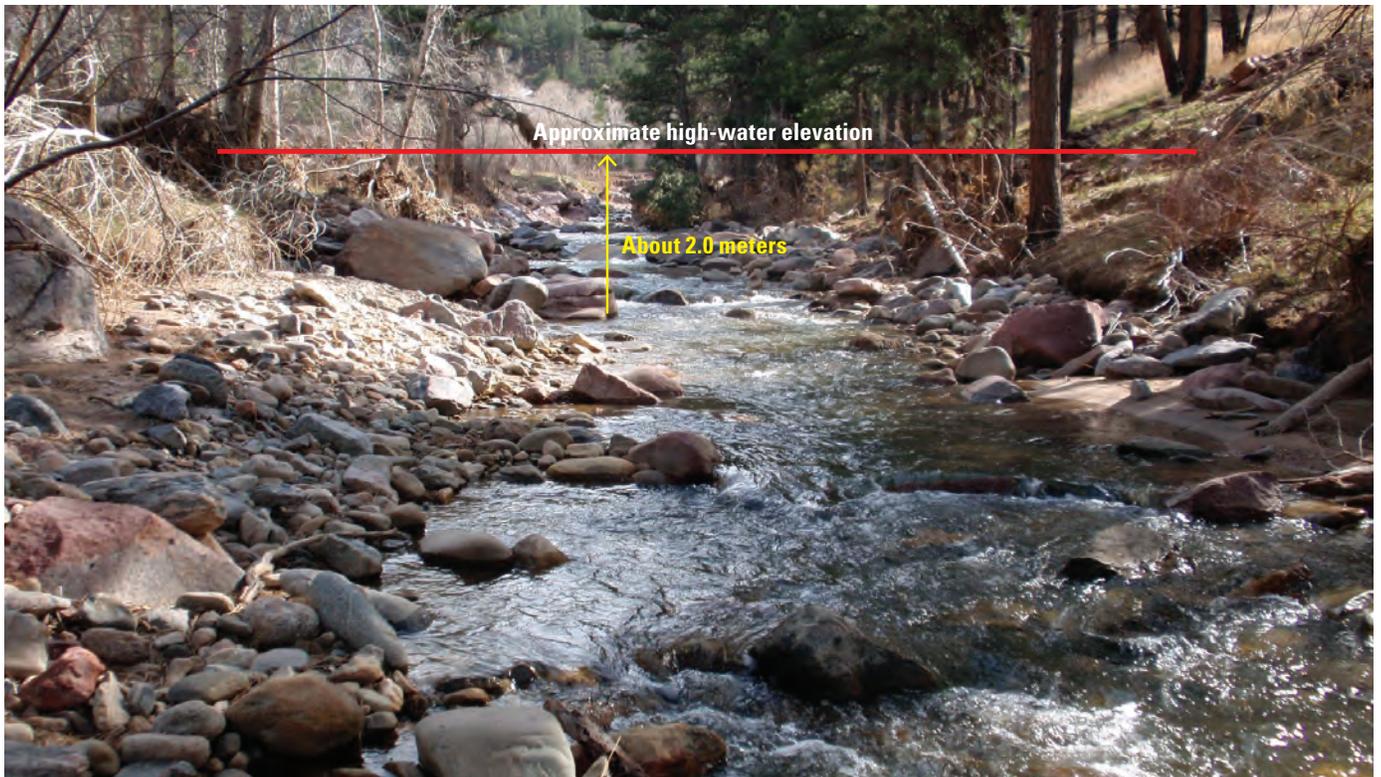
Figure 14. Left Hand Creek at Buckingham Park on March 21, 2014. View is upstream from cross section 10 (XS10, table 10) at the bottom of the measurement reach.

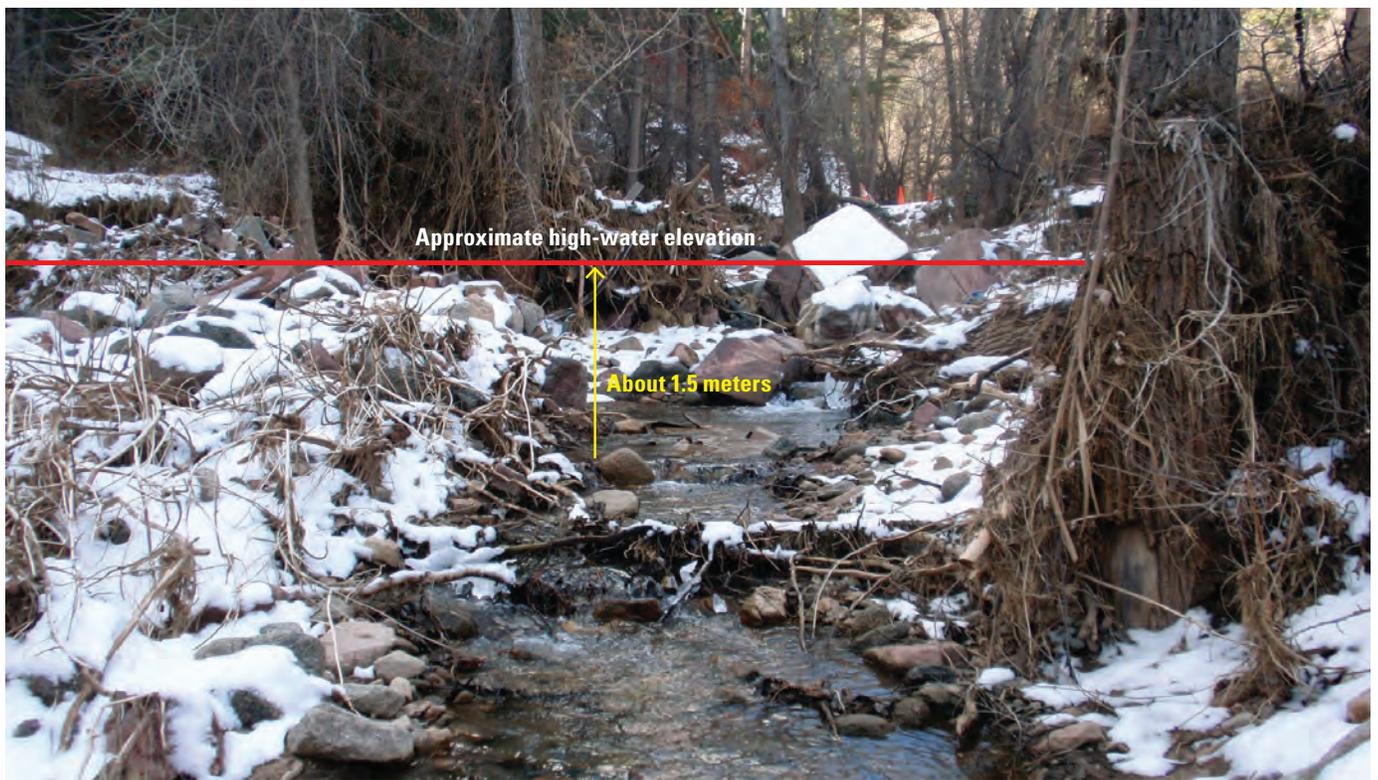
Figure 15. Fourmile Canyon Creek at 491 Wagonwheel Gap on December 1, 2013. Upstream view from cross section 3 (XS3, table 10) at the bottom of the measurement reach.

The indirect peak discharge ($75 \text{ m}^3 \text{ s}^{-1}$, tables 1 and 11) was measured on December 3, 2013, when the water was still unfrozen because the measurement site (fig. 15) is at a lower elevation (1,822 m) than most of the other sites. The upper basin of Fourmile Canyon Creek (drainage area 4.64 km^2) had previously been burned by the 2010 Fourmile Canyon fire. At this upper site (Fourmile Canyon Creek near Sunshine, Colo.; http://nwis.waterdata.usgs.gov/co/nwis/peak/?site_no=06730160&agency_cd=USGS), the U.S. Geological Survey's Colorado Water Science Center estimated a peak discharge of $31 \text{ m}^3 \text{ s}^{-1} \pm 25$ percent (R. Kimbrough, U.S. Geological Survey, written commun., 2015) with a unit peak discharge of $6.7 \text{ m}^3 \text{ s}^{-1} \text{ km}^{-2}$. At the measurement site ($\approx 1,500 \text{ m}$ downstream from the upper basin) the unit peak

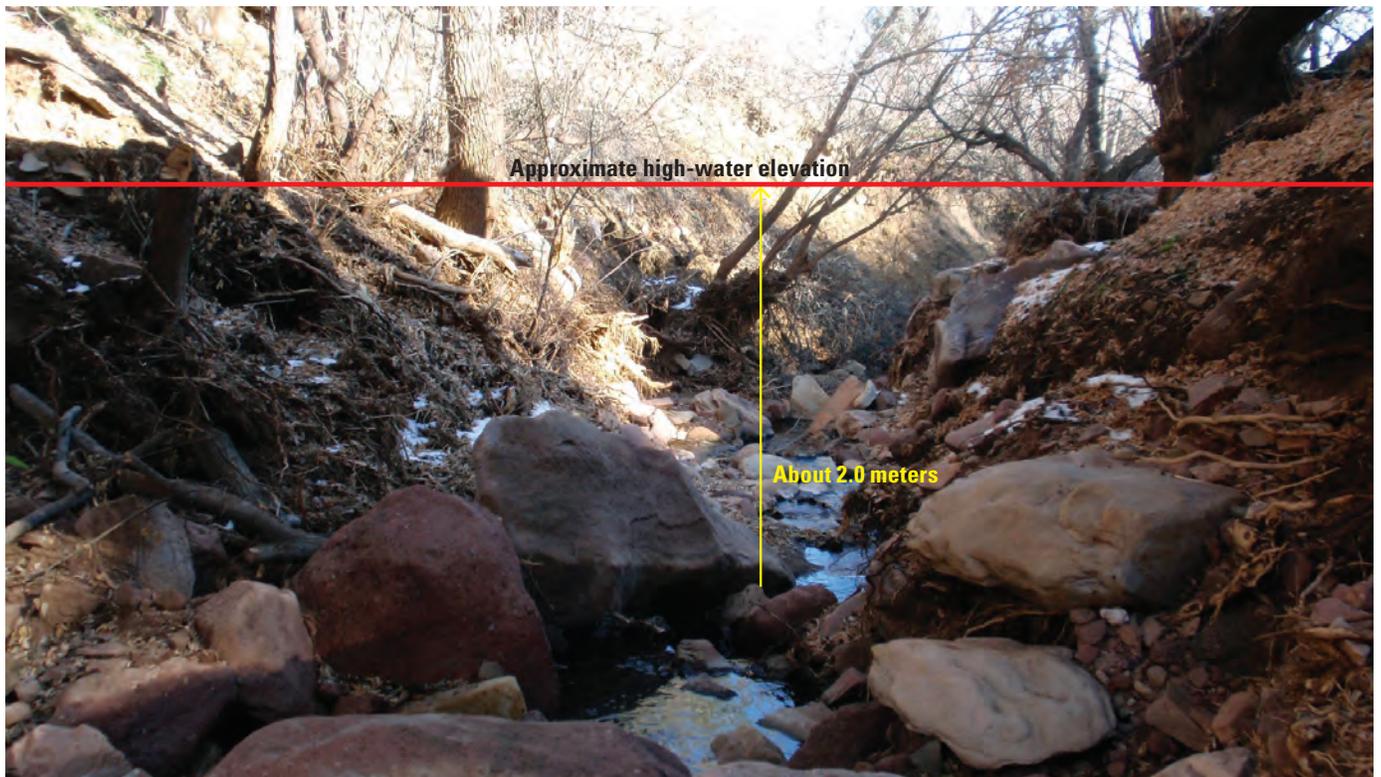
Figure 16. Twomile Canyon Creek at 215 Linden on November 27, 2013. View is downstream from cross section 1 (XS1, table 11).

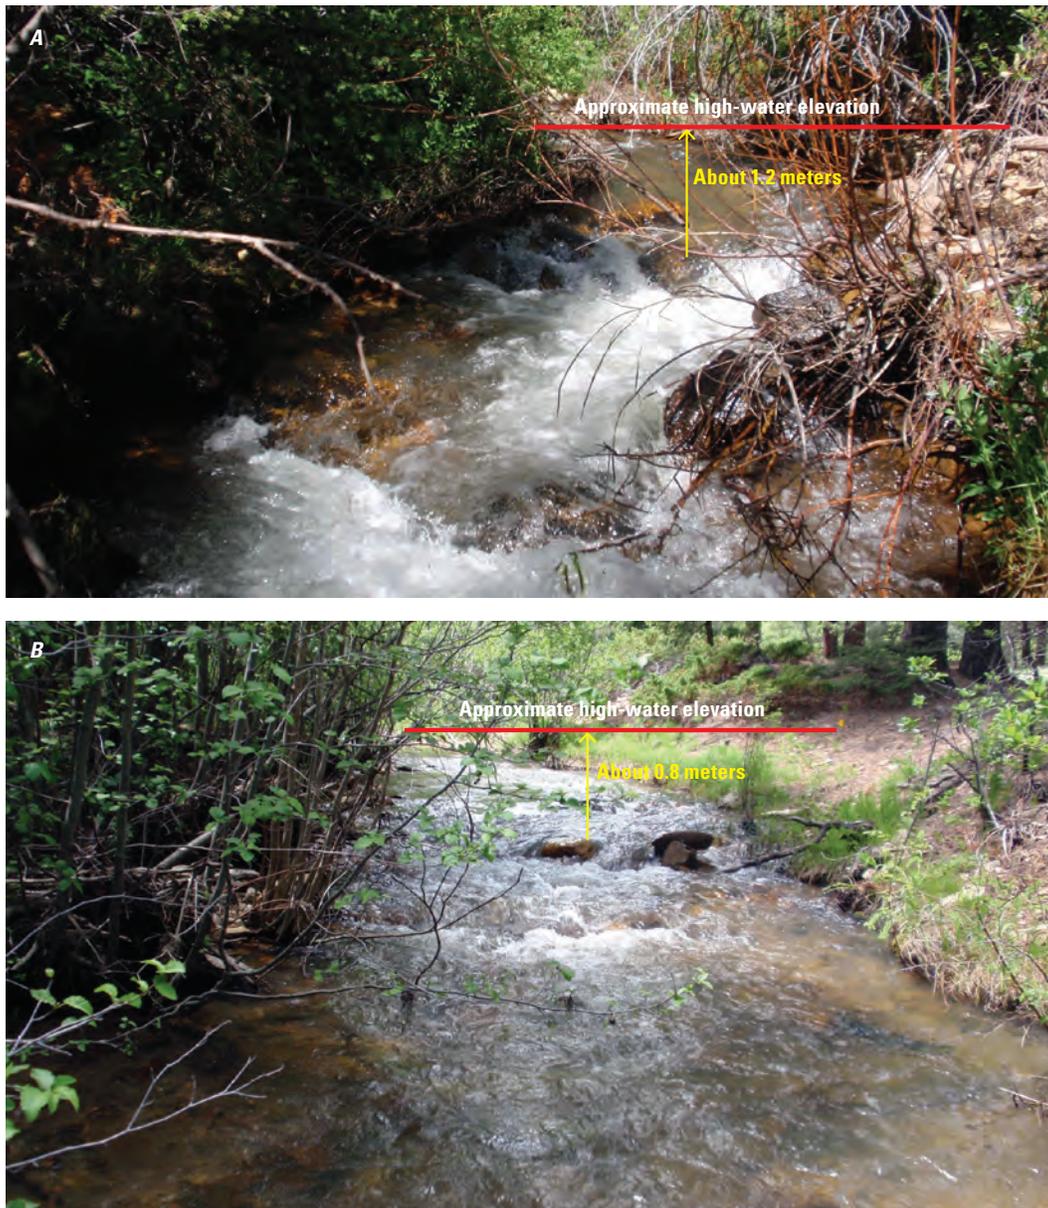
Figure 17. Fourmile Creek above Long Gulch on June 17, 2014. *A*, View is upstream from cross section 2 (XS2, table 13) and upstream from the bend at cross section 4 (XS4). *B*, View is upstream from cross section 9 (XS9, table 13) and downstream from the bend at XS4.

the bend) with slightly higher estimates of discharge at the cross sections above the bend than below the bend (table 13, fig. 17). Bed material was relatively small (table 1) and similar in size to the bed material of North St. Vrain Creek above the Highway 7 Bridge (also outside the high-accumulation, high-intensity rainfall band). Bedload estimates from equation 8 during the flood upstream from XS4 ranged from 190 to $390 \text{ kg m}^{-1} \text{ s}^{-1}$ and 20 to $130 \text{ kg m}^{-1} \text{ s}^{-1}$ downstream from XS4. Dense willows lined most of both banks (fig. 17); and the different indirect methods estimated that 84–93 percent of the flow was conveyed in the main channel, and the remainder was conveyed through the adjacent flood plains.

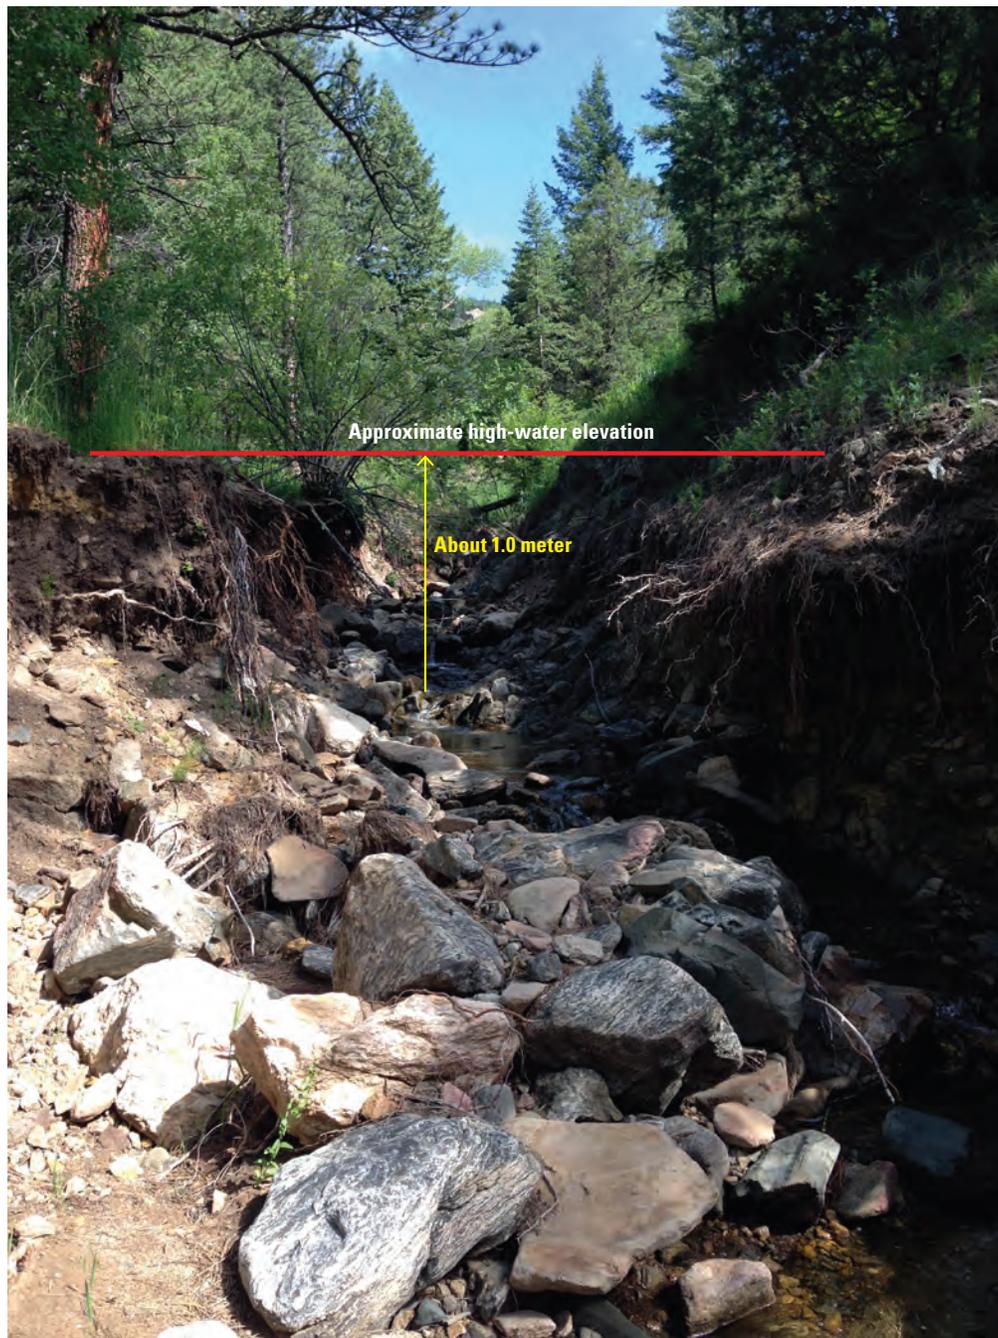
Figure 18. Long Gulch above Loretta-Linda on June 25, 2014. View is upstream from about cross section 7 (XS7, table 14). Photograph taken by J. Smith, III.

whereas the east-facing slopes were unburned. Loretta-Linda refers to an unnamed tributary downstream from this measurement site that drains a small basin (Loretta-Linda at flume 9–1, 0.39 km^2 , table 1) severely burned by the 2010 Fourmile Canyon fire. The different indirect methods estimated that 87–94 percent of the flow was conveyed in the main channel with the remainder flowing overbank on the right side of the channel (fig. 18).

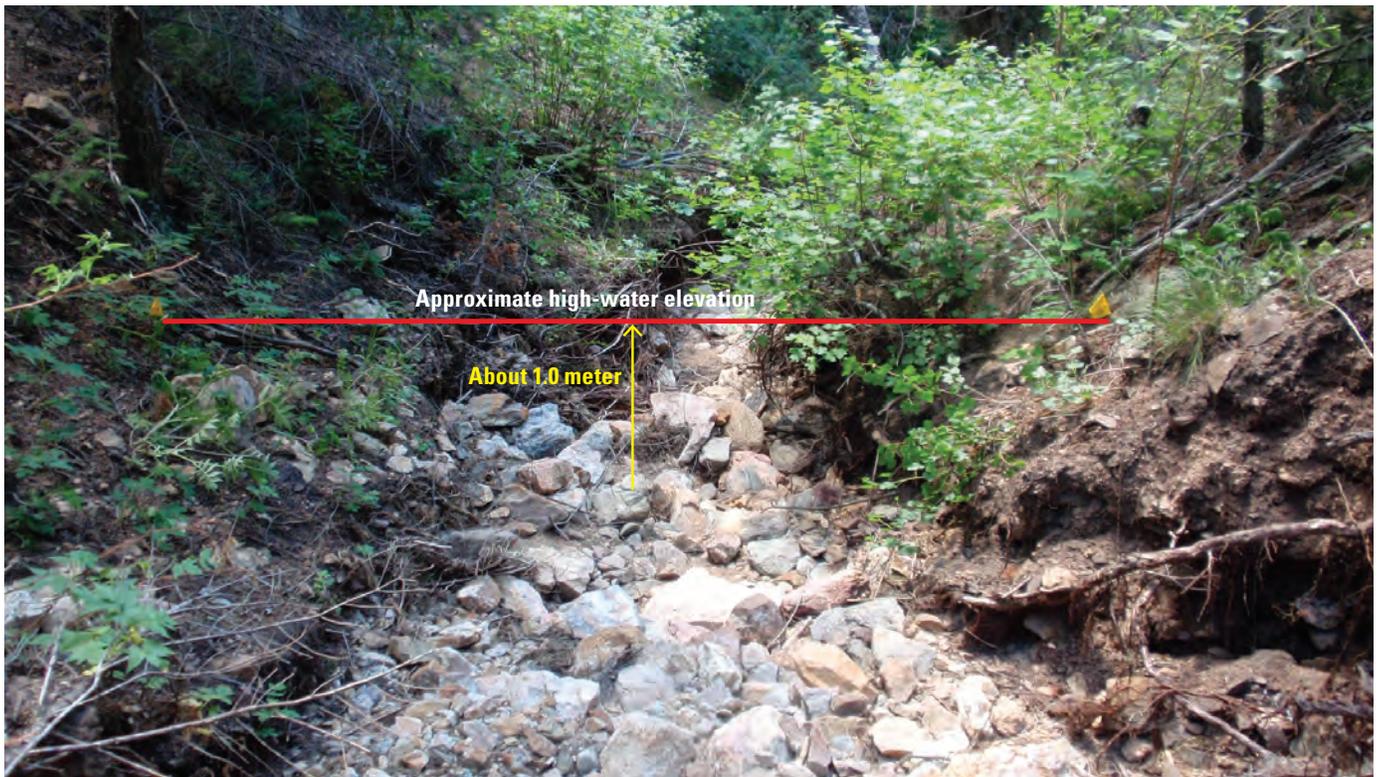
Figure 19. Loretta-Linda at flume 9–1 on July 7, 2014. View is downstream from cross section 1 (XS1, table 15) at the old site for the flume.

(assuming critical flow at two cross sections) was $4.6 \text{ m}^3 \text{ s}^{-1}$, and the unit peak discharge was $12 \text{ m}^3 \text{ s}^{-1} \text{ km}^{-2}$ (U.S. Geological Survey, Boulder, Colo., unpub data) similar to the unit peak discharge ($16.2 \text{ m}^3 \text{ s}^{-1} \text{ km}^{-2}$) for the September 2013 storms associated with an average peak rainfall intensity of 51.0 mm h^{-1} (table 1). Whereas the high-water marks for the 2011 flood were on the order of 0.2–0.8 m higher than the September 2013 high-water marks at XS4 and XS5, the channel bed had scoured during the 2013 floods by about 0.5 to 1.5 m. The different indirect methods estimated that 88–97 percent of the flow was conveyed in the main channel with the remainder flowing overbank on both sides of the channel (fig. 19).
