Estimates of Peak Discharge for 21 Sites in the Front Range in Colorado in Response to Extreme Rainfall in September 2013

Scientific Investigations Report 2016–5003

By John A. Moody

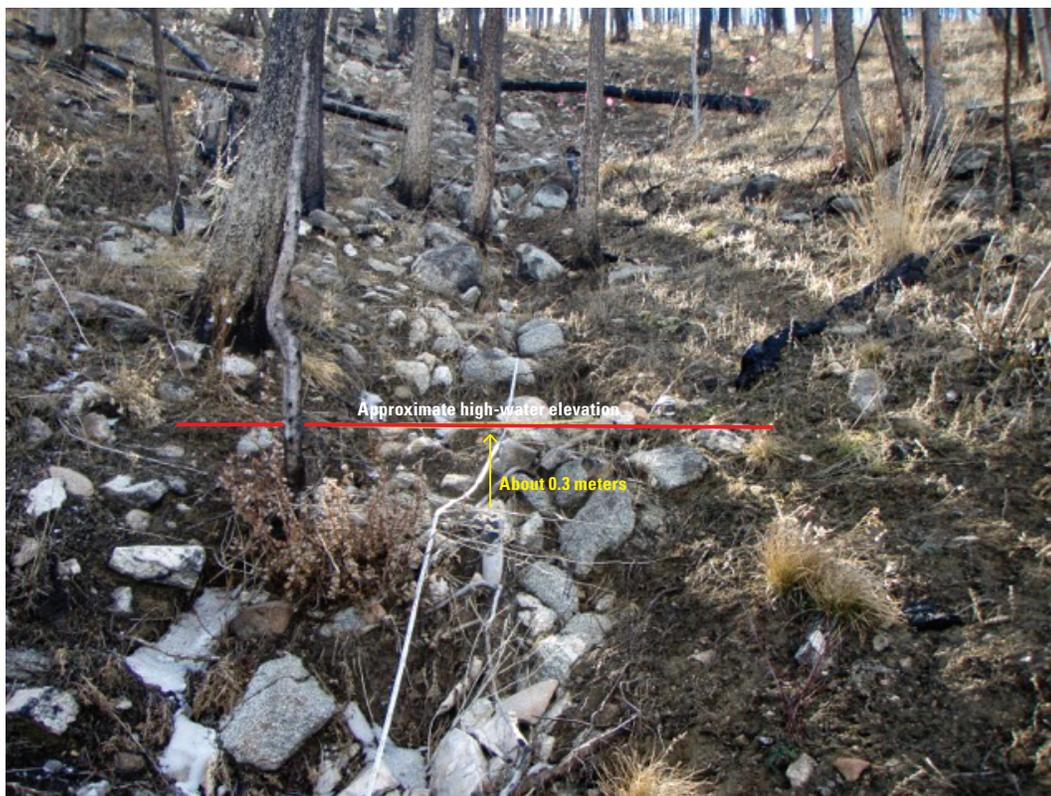
Figure 20. Sugarloaf on September 22, 2013. View is upstream from cross section 2 (XS2, table 16). The upper six cross sections extend from cross section 3 (high-water elevation line) to just downstream of the black log directly up the channel.

Peak discharges estimates for the lowest two cross sections (XS1 and XS2, table 16) were quite different than for the upper six cross sections (XS3–XS8). No obvious tributary entered the channel downstream from the upper six cross sections (fig. 20), which might explain the increase in flow. The characteristics of the channel appear to change downstream from the upper six cross sections. The cross-sectional area and mean velocities are different, and the average relative submergence (R/D_{84}) was 1.1 and 0.7 for XS1 and XS2, respectively, which is more characteristic of the other sites for which R/D_{84} was always >1 . For the upper six cross sections, R/D_{84} ranged from 0.4 to 0.8, which is typical of the step-pool type channels used to develop the Yochum and Comiti methods. Using all eight cross sections gives an ensemble average of $0.12 \text{ m}^3 \text{ s}^{-1}$ (unit peak discharge= $14.2 \text{ m}^3 \text{ s}^{-1} \text{ km}^{-2}$) and a physically unrealistic peak runoff coefficient of 1.1. It appears XS1 and XS2 are outliers compared to the upper six cross sections, and perhaps the high-water marks for these XS1 and XS2 were incorrect. For such relatively small cross-sectional areas (table 16), a change in the elevation of the high-water mark can represent a substantial change in peak discharge. Lowering the estimated high-water elevation at XS1 and XS2 by 0.05 m reduces the peak discharge estimates by 40–60 percent. For these reasons, the estimate peak discharge for this site was based on the six upper cross sections. This value given above ($0.057 \text{ m}^3 \text{ s}^{-1}$) is also similar to the indirect peak discharge of the convective storm in 2011 in response to similar rainfall intensities (45.8 and 45.7 mm h^{-1} for the convective storm and September 2013 storms, respectively). All flow was within the main channel because no flood plain existed.

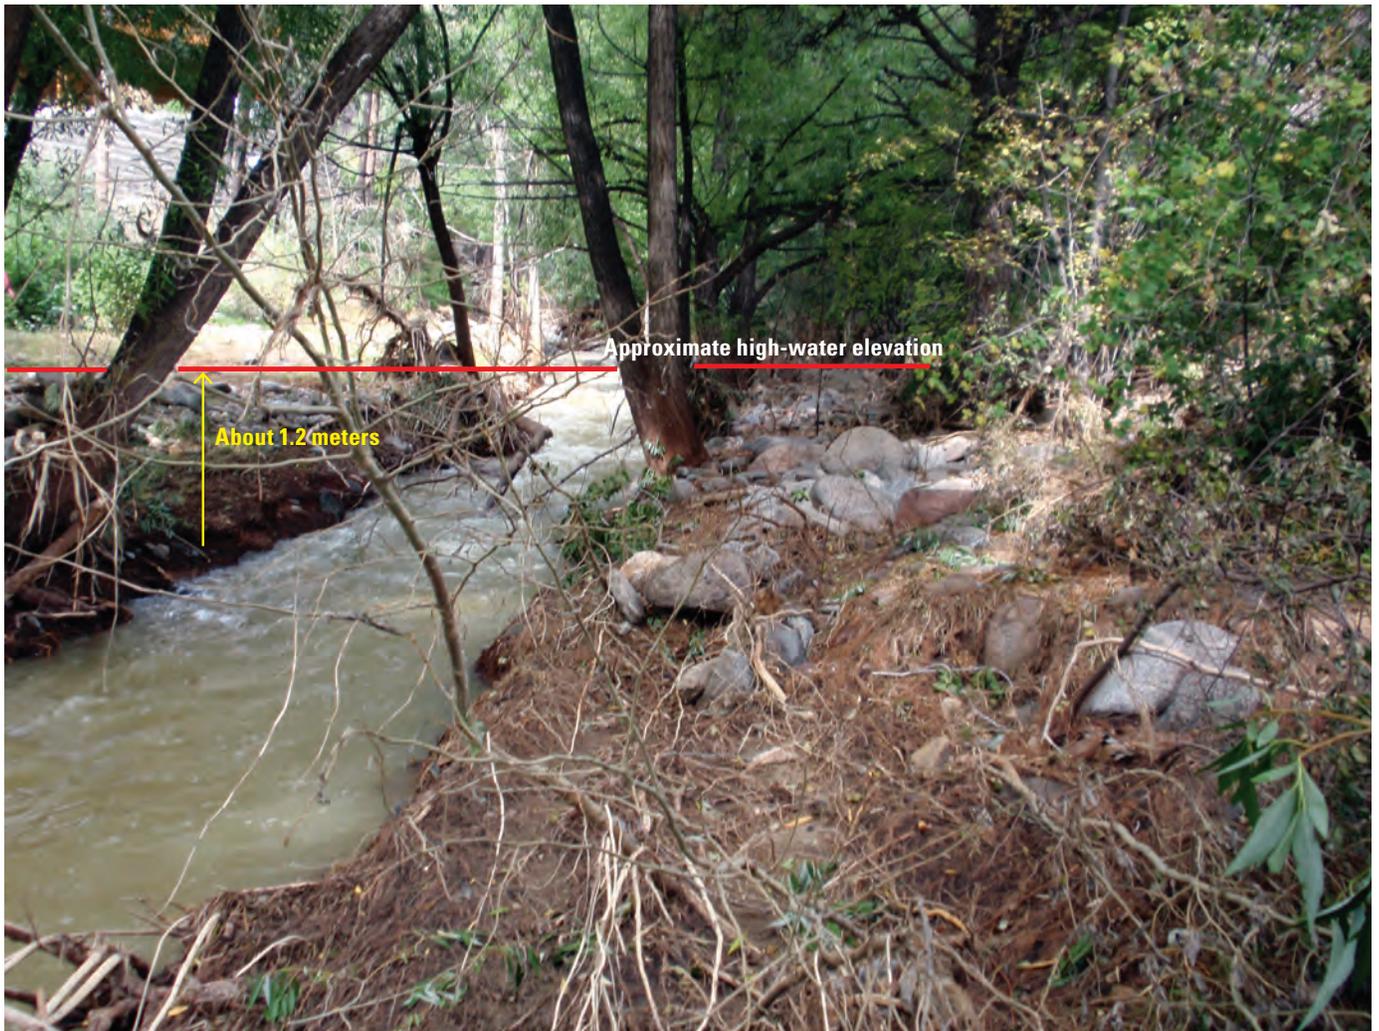
Figure 21. Fourmile Creek at Logan Mill on September 22, 2013. View is upstream from cross section 2 (XS2, table 17).

estimate of $53 \text{ m}^3 \text{ s}^{-1}$ was made by Ritsch and others (2013) using the flow simulation Hydrologic Engineering Center's River Analysis System (HEC-RAS) model. The lower value estimated by Ritsch and others (2013) reflects the different values of Manning's n ($0.05 \text{ m}^{-1/3} \text{ s}$ for the main channel and $0.08 \text{ m}^{-1/3} \text{ s}$ for the flood plains). The Urban Drainage and Flood Control Districts lists a peak discharge of $65 \text{ m}^3 \text{ s}^{-1}$ for the site Fourmile Creek d/s Poorman Rd upstream from #1267 Fourmile Cr Rd nr Orodell (http://alert5.udfcd.org/wp/?page_id=115, accessed August 3, 2015), which is about 2,000 m downstream from Fourmile Creek at Logan Mill. With definite flood plains on both sides, the different indirect methods estimated that 73–86 percent of the flow was conveyed in the main channel with the remainder across the flood plain (fig. 21).

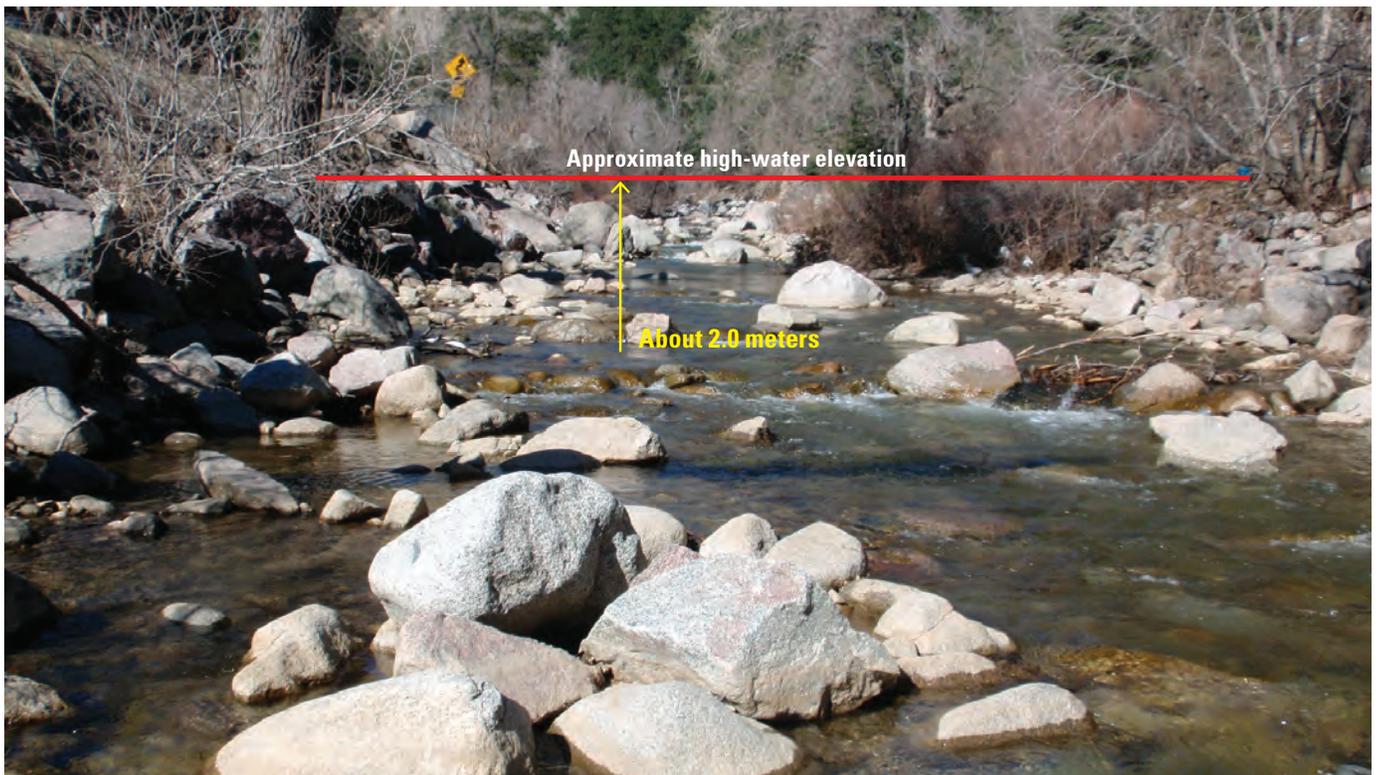
Figure 22. Boulder Creek at mouth of Boulder Canyon on March 16, 2014. View is upstream from cross section 9 (XS9, table 18). Highway 119 begins in the upper left and passes the yellow highway sign.

of the bed (fig. 22), and the bed in this reach most resembled Rock Creek near Darby, Montana (Barnes, 1967). This measurement site had the lowest coefficient of variation reflecting the relative uniform channel properties (table 18). Because the flow was confined by protective material along each bank, the different indirect methods estimated that 91–94 percent of the flow was conveyed in the main channel. The Urban Drainage and Flood Control District lists a peak discharge of $107 \text{ m}^3 \text{ s}^{-1}$ for their site, 4420 Bridge, about 1,500 m upstream from Boulder Creek at Mouth of Canyon (http://alert5.udfcd.org/wp/?page_id=115, accessed August 3, 2015).

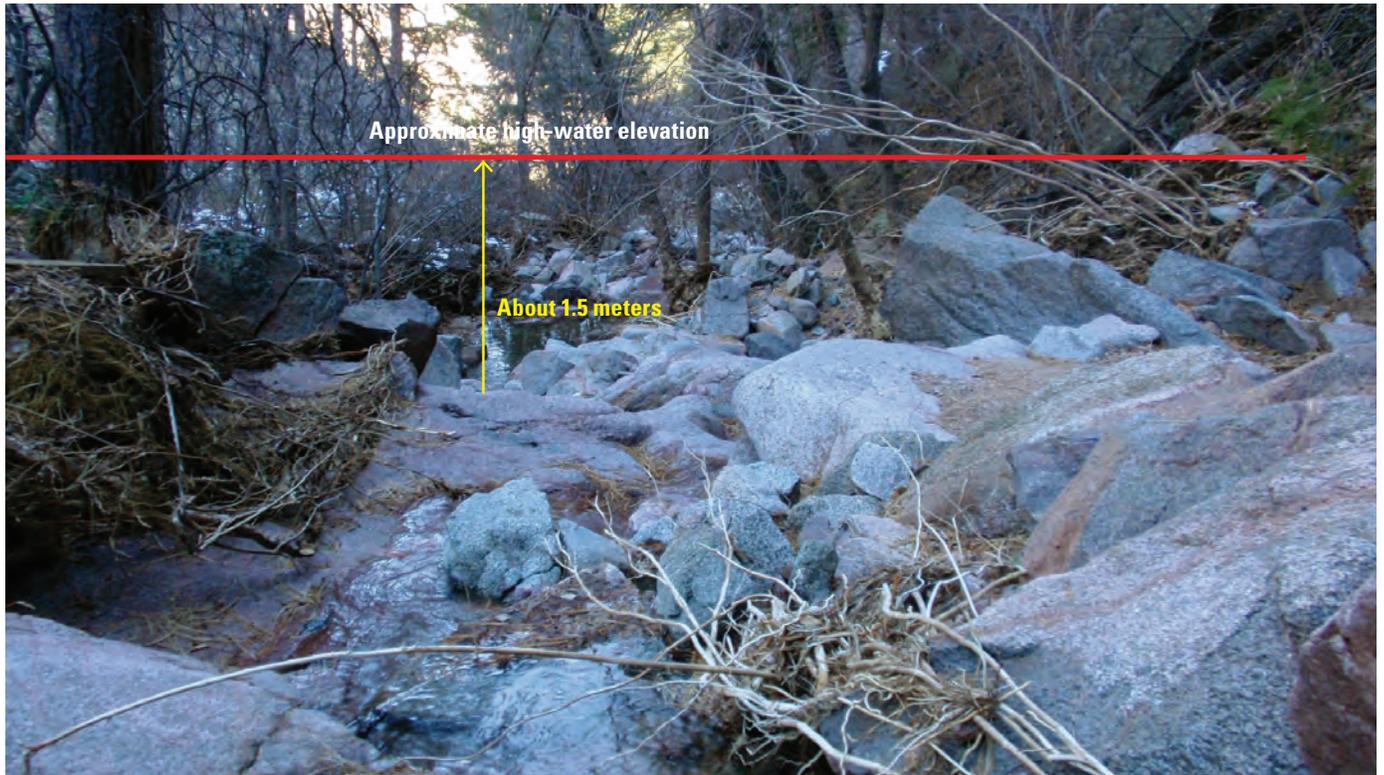
Figure 23. Gregory Creek below Long Canyon on December 2, 2013. View is downstream from cross section 3 (XS3, table 19 upper).

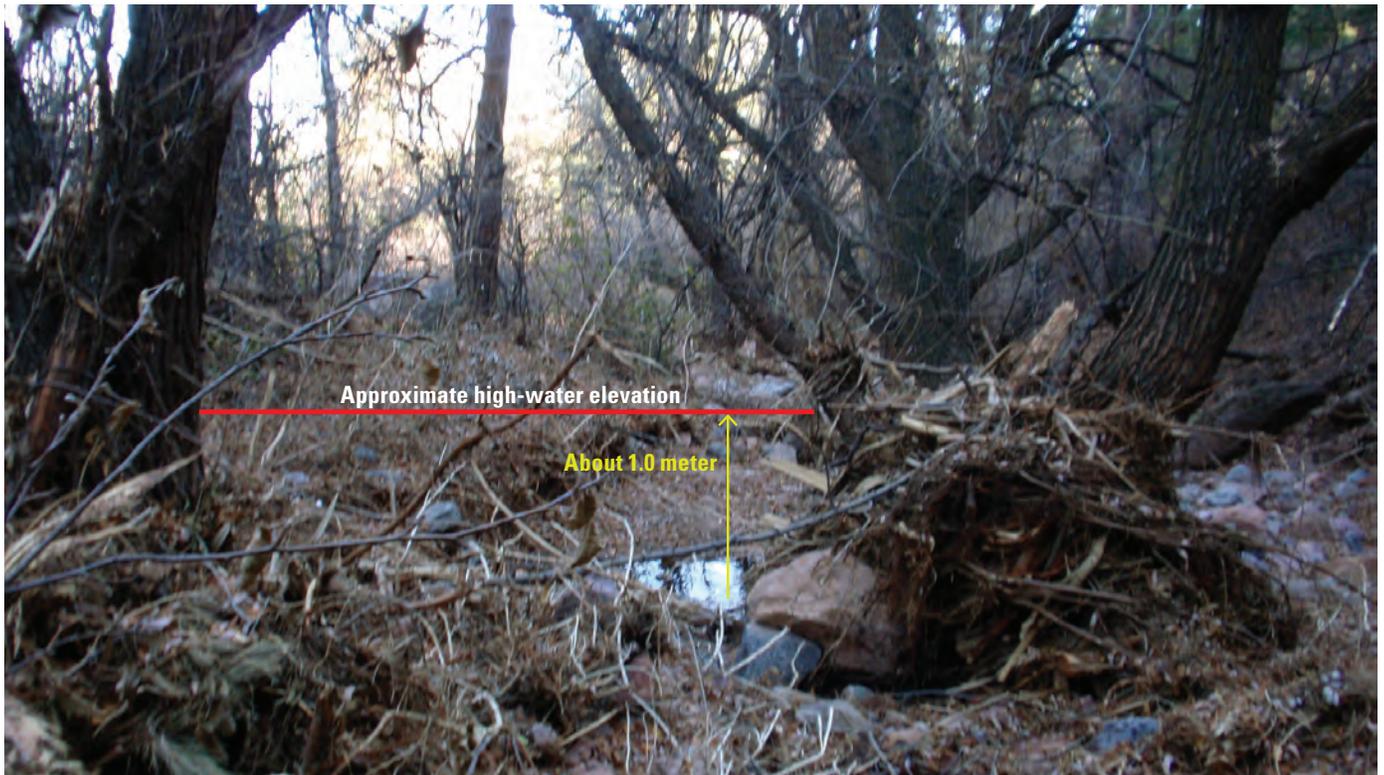
Figure 24. Gregory Creek at Rest Area on December 2, 2013. View is downstream from cross section 3 (XS3, table 19 lower).
