Scour Assessment at Bridges From Flag Point to Million Dollar Bridge, Copper River Highway, Alaska

By Timothy P. Brabets

U.S. GEOLOGICAL SURVEY

Water-Resources Investigations Report 94-4073

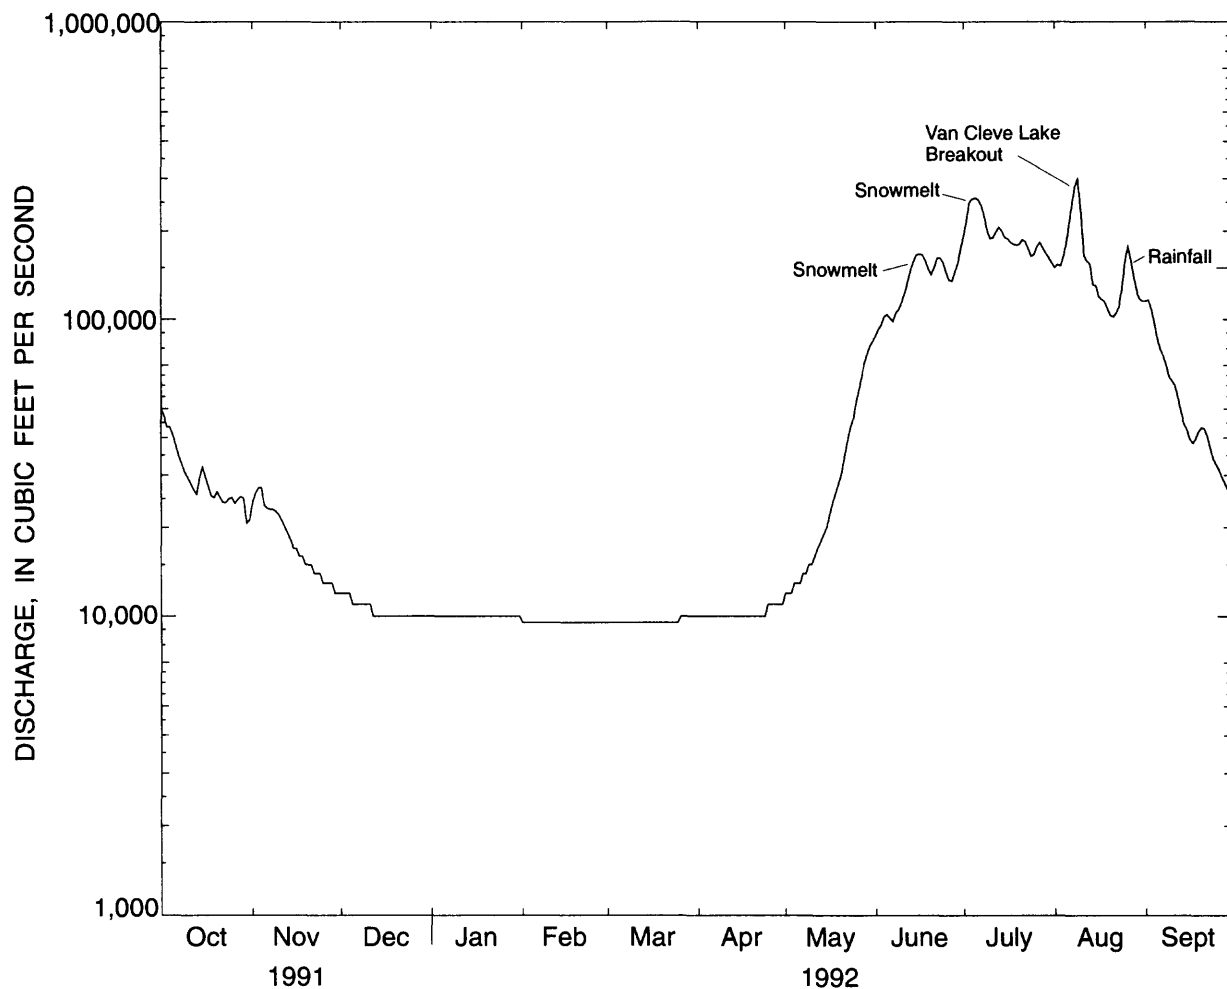
Figure 3. Daily mean discharge of the Copper River at Million Dollar Bridge, 1992 water year.

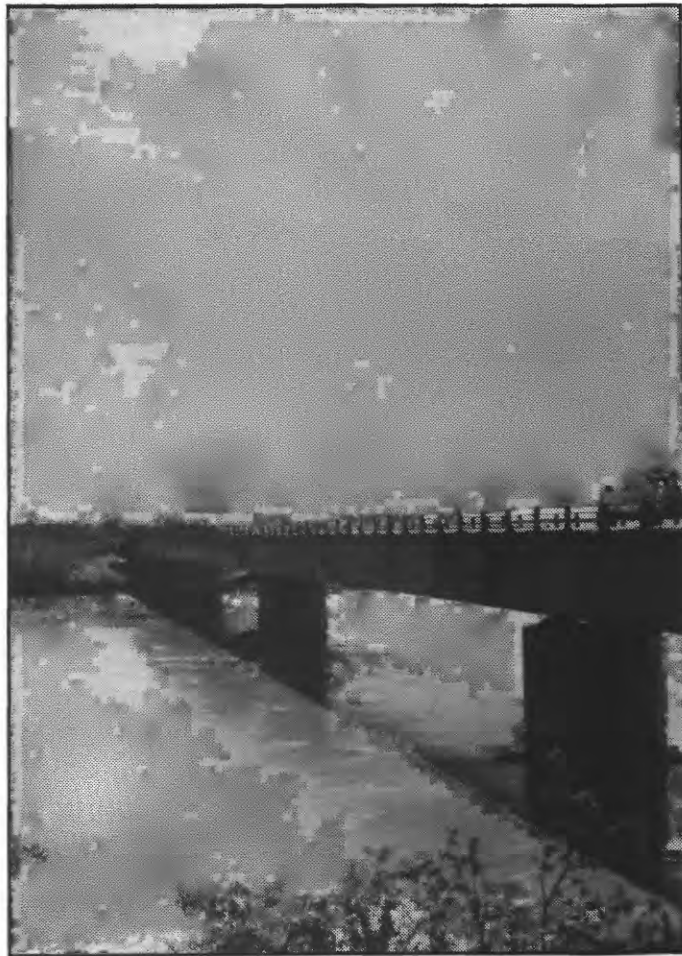
Figure 4. Bridge 331 on the Copper River Highway in 1991.

Bridges 331, 1187, and 332 (fig. 2) are located at Flag Point, Mile 27 of the Copper River Highway, and are the first bridges that cross the Copper River east of Cordova. The present bridges were constructed during 1970-72 and are supported by concrete piers 5.5 ft wide, 18 ft long, and pointed at both ends (fig. 4-5). Bridges 331 and 332 are both 780 ft long and each bridge is supported by three piers spaced 220 ft apart. Bridge 1187 is 1,220 ft long and is supported by five piers spaced 220 ft apart. Spur dikes were constructed at the left upstream abutment of Bridge 331 and at both upstream abutments of Bridge 1187. The total design discharges for these three bridges was 440,000 ft³/s, approximately 120,000 ft³/s each for Bridges 331 and 332, and 200,000 ft³/s for Bridge 1187.

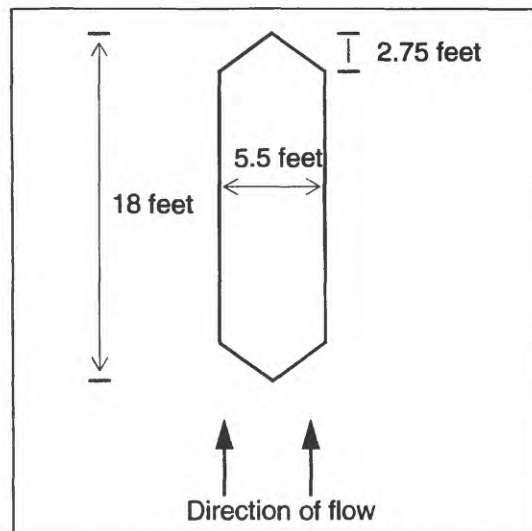
Figure 5. Plan view of piers constructed at Bridges 331, 1187, and 332 on the Copper River Highway.

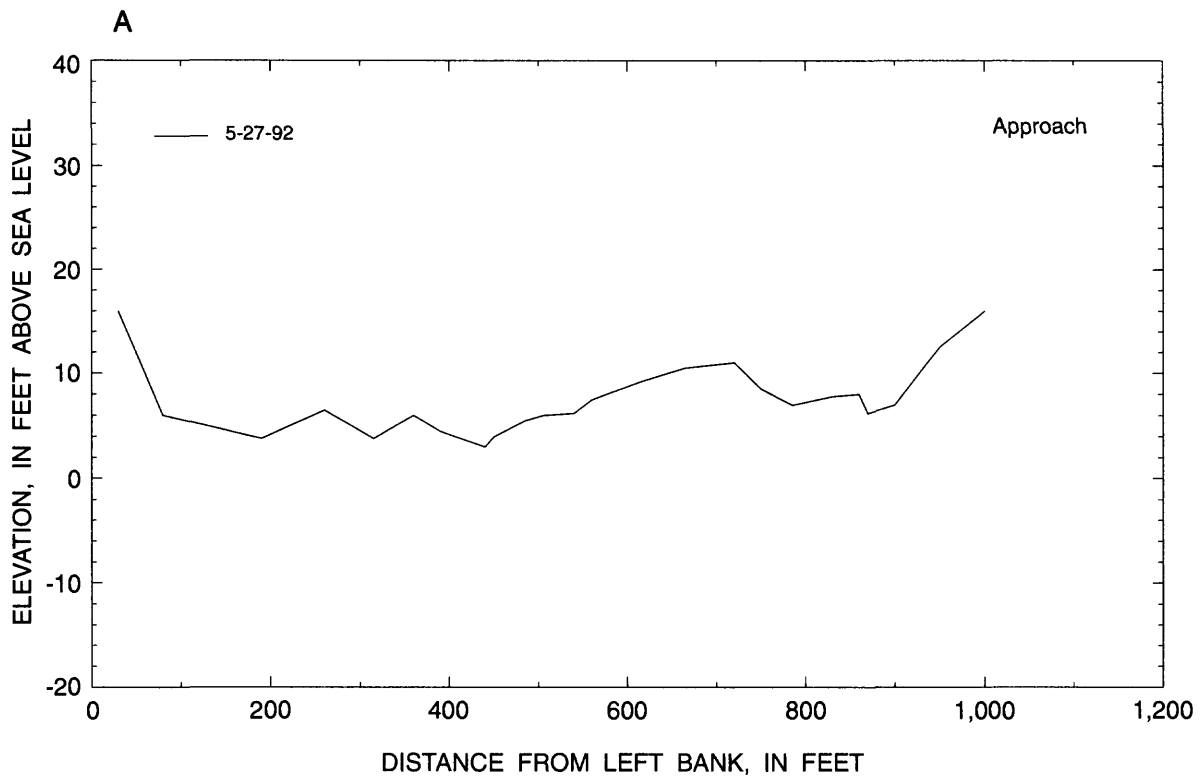
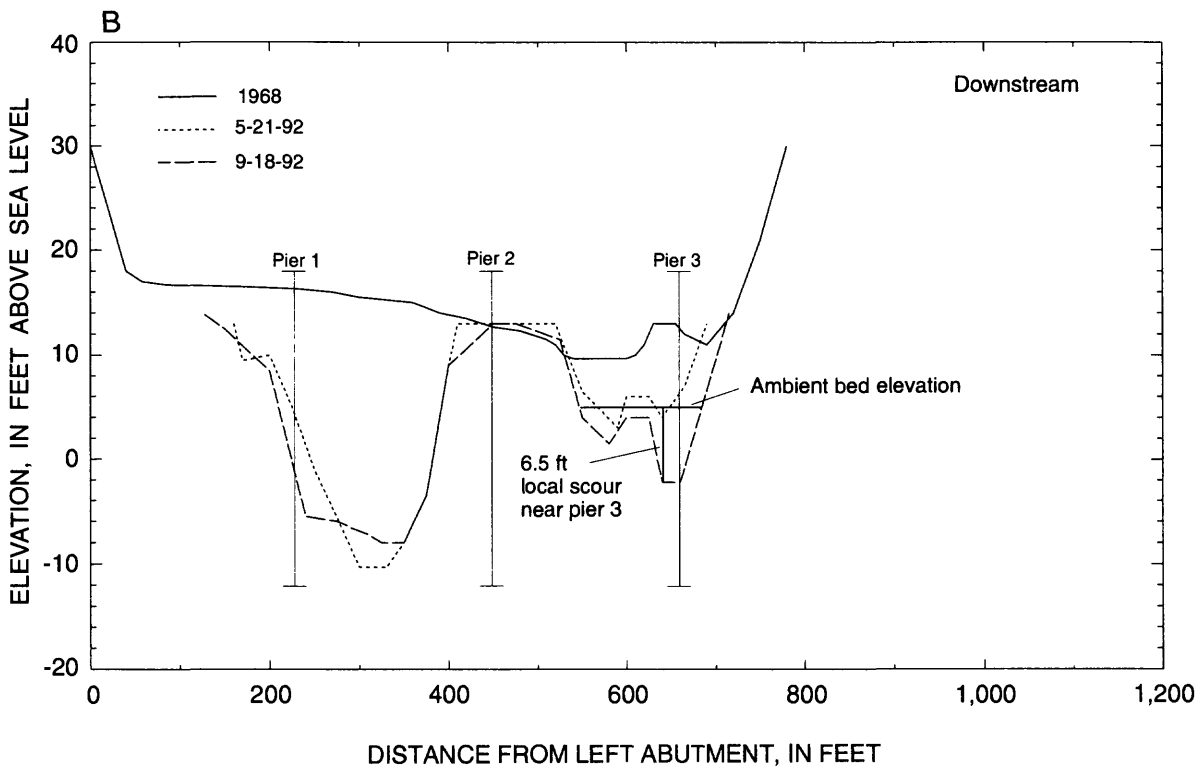
Figure 8. Approach and downstream cross sections of the Copper River at Bridge 331.

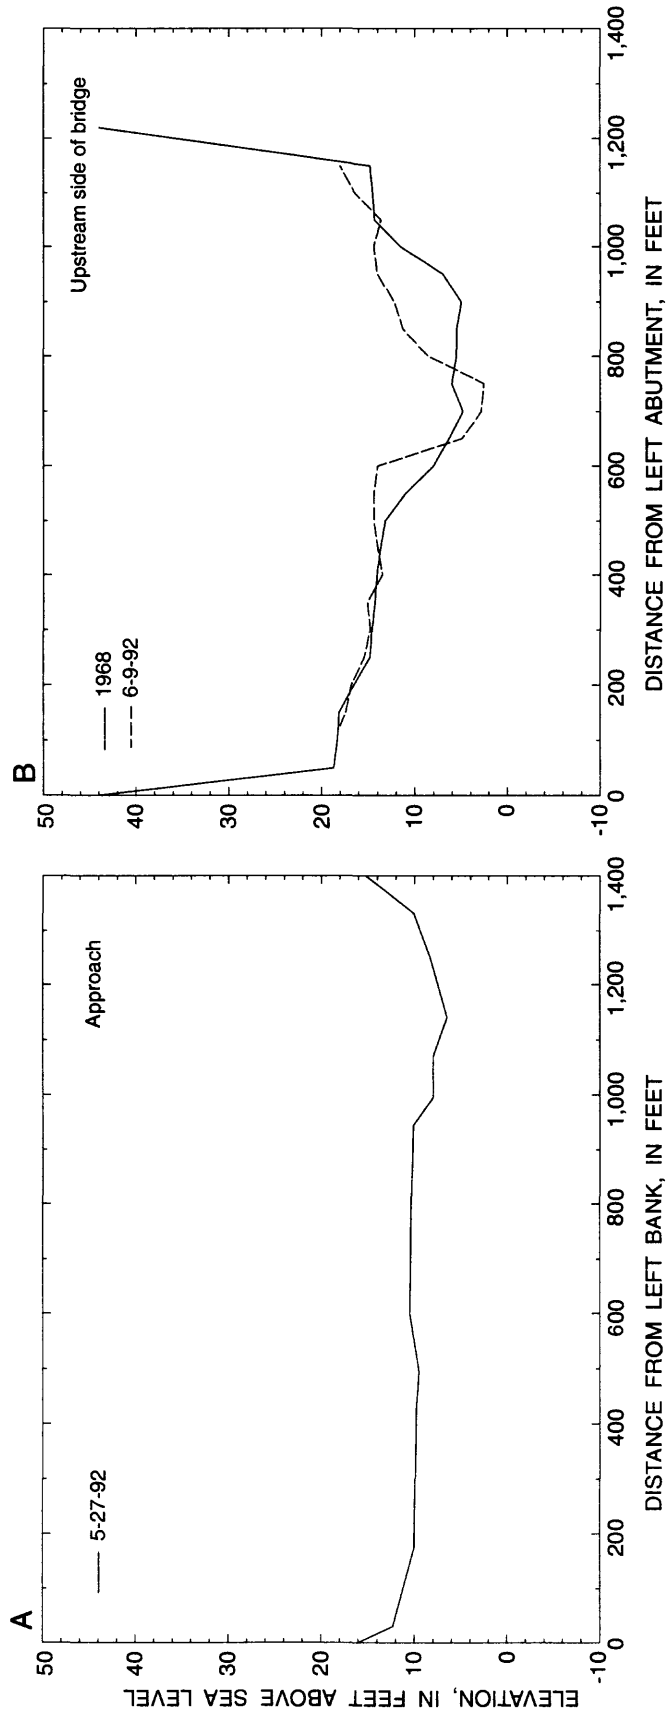
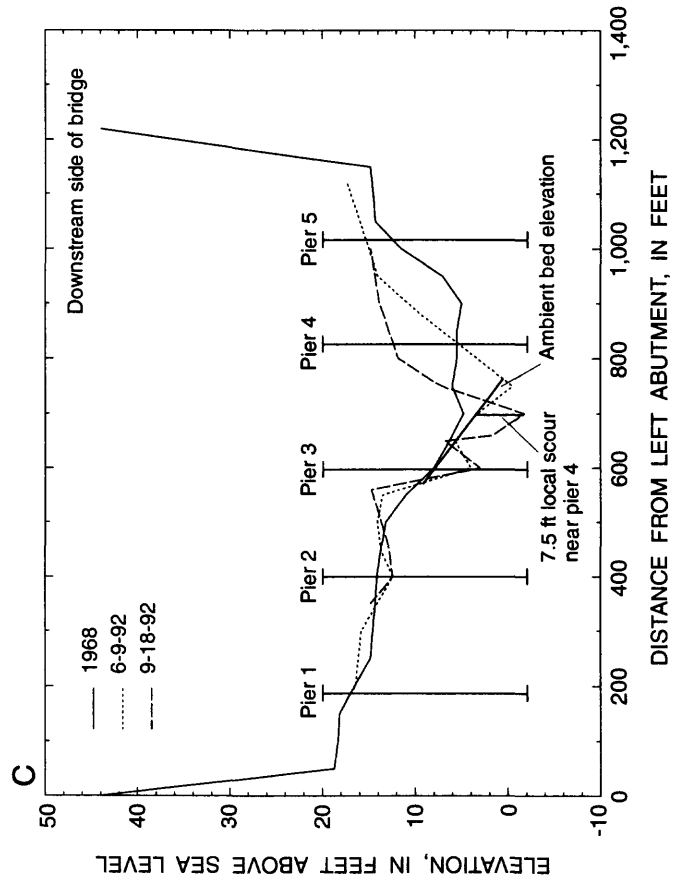
Figure 9. Approach, upstream, and downstream cross sections of the Copper River at Bridge 1187.

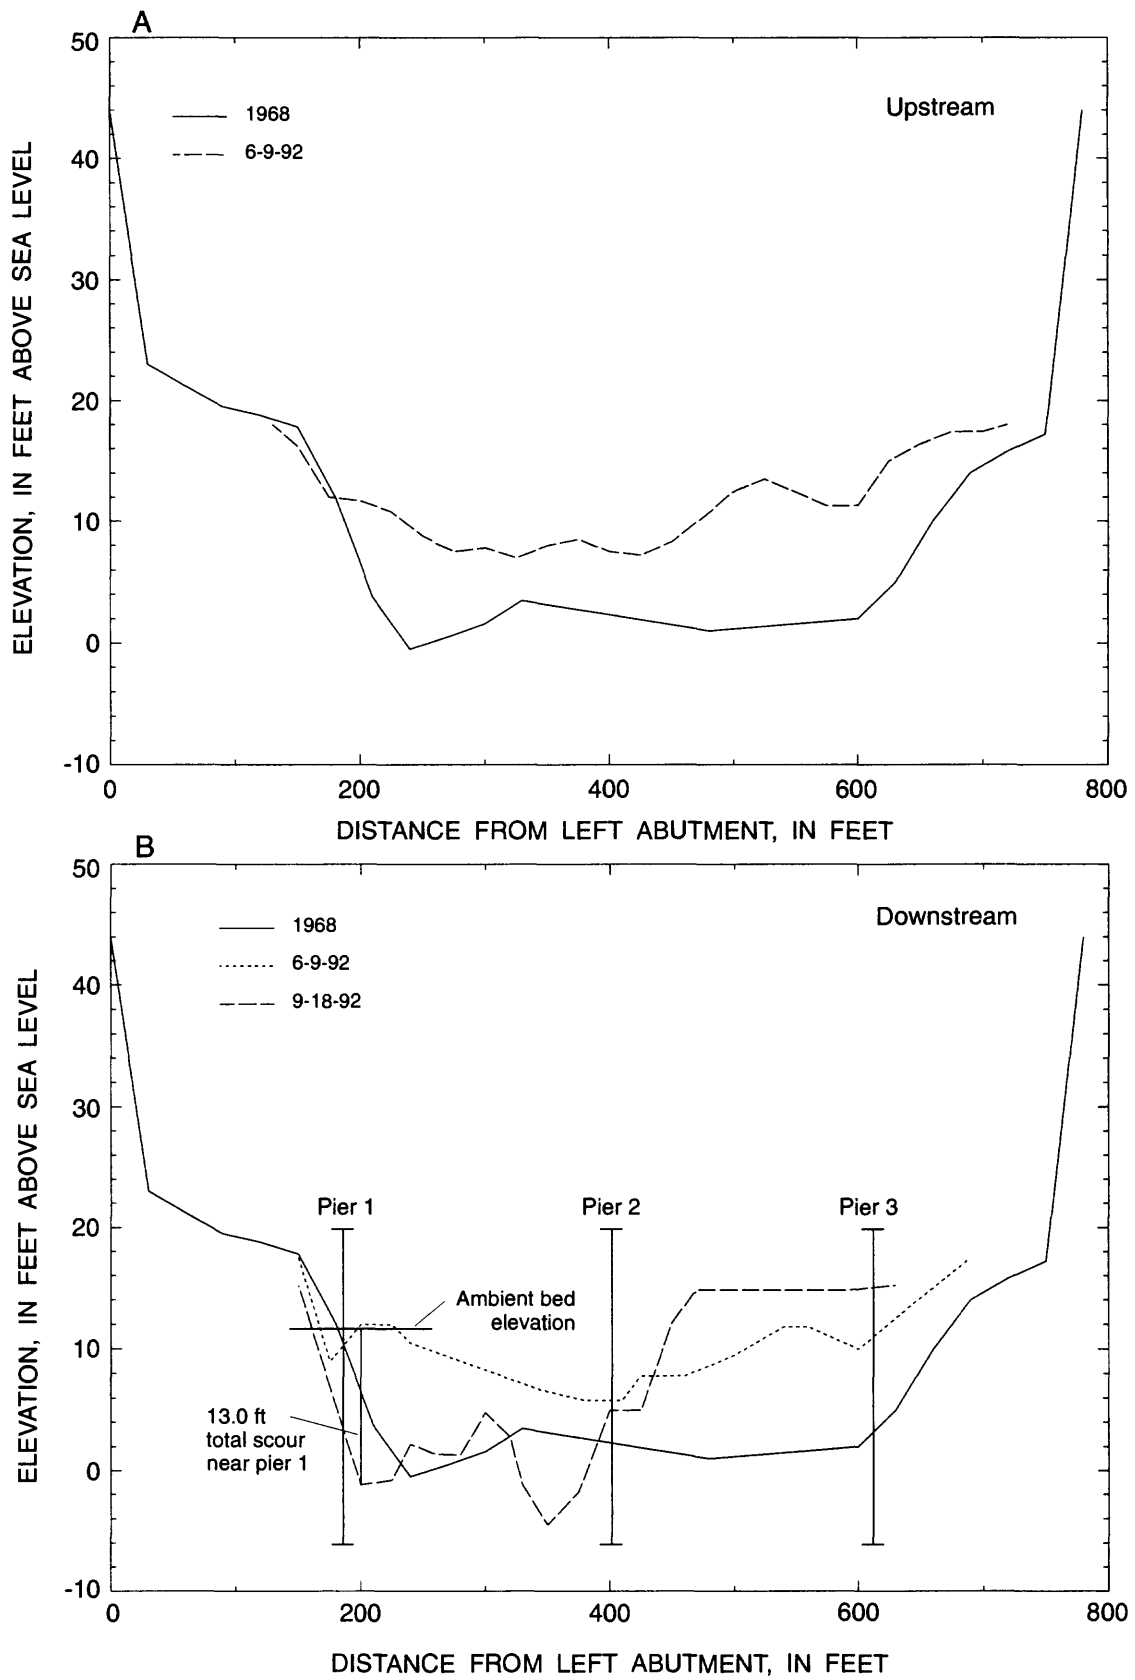
Figure 10. Upstream and downstream cross sections of the Copper River at Bridge 332.

Comparison of cross sections at both the upstream (fig. 10A) and downstream (fig. 10B) sides of Bridge 332 indicates that the channel filled in at this bridge between 1968 and June 1992. In 1968, the mean bed elevation of the channel was 8.5 ft and in June 1992, the mean bed elevation was 10.4 ft, indicating almost 2 ft of filling. However, during 1992, the left part of the channel scoured out and the right part of the channel filled in. The net effect of the scour and fill lowered the mean bed elevation from 10.4 ft in June to 5.0 ft in September. A relatively large quantity of bedload was transported past this site in 1992 indicating that the channel may have been somewhat unstable. Although the maximum scour measured near pier 1 was 13.0 ft, it is probably not local scour.

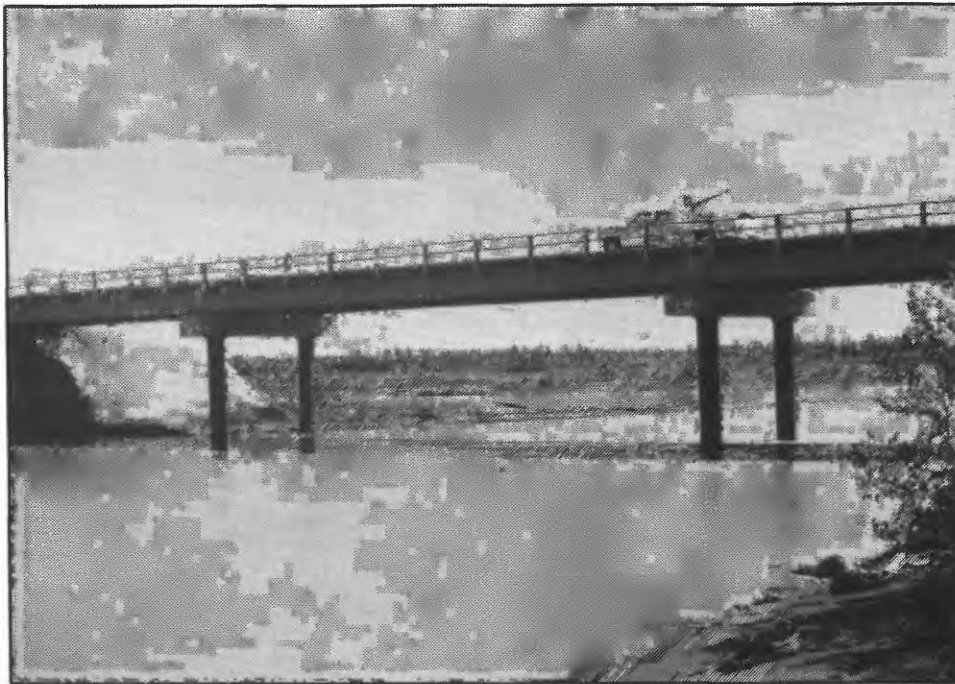
Figure 11. Bridge 333 on the Copper River Highway in 1991.

Bridge 333 and 334 are located at Miles 33.3 and 34.3 of the Copper River Highway (fig. 2). The bridges were constructed during 1976-78. Bridge 333 is 240 ft long and is supported by two sets of concrete-filled steel cylindrical piers, spaced 80 ft apart (fig. 11). Bridge 334 is 1,200 ft long and is supported by 14 sets of concrete-filled steel cylindrical pipes, spaced 80 ft apart. Each pipe is circular and has a diameter of 30 in. The two pipes in a set are connected by a concrete cap (fig. 12). Spur dikes were constructed at the upstream right abutment at Bridge 333 and at both upstream abutments at Bridge 334. The design discharge of Bridge 333 is 10,500 ft³/s and the design discharge of Bridge 334 is 82,000 ft³/s.

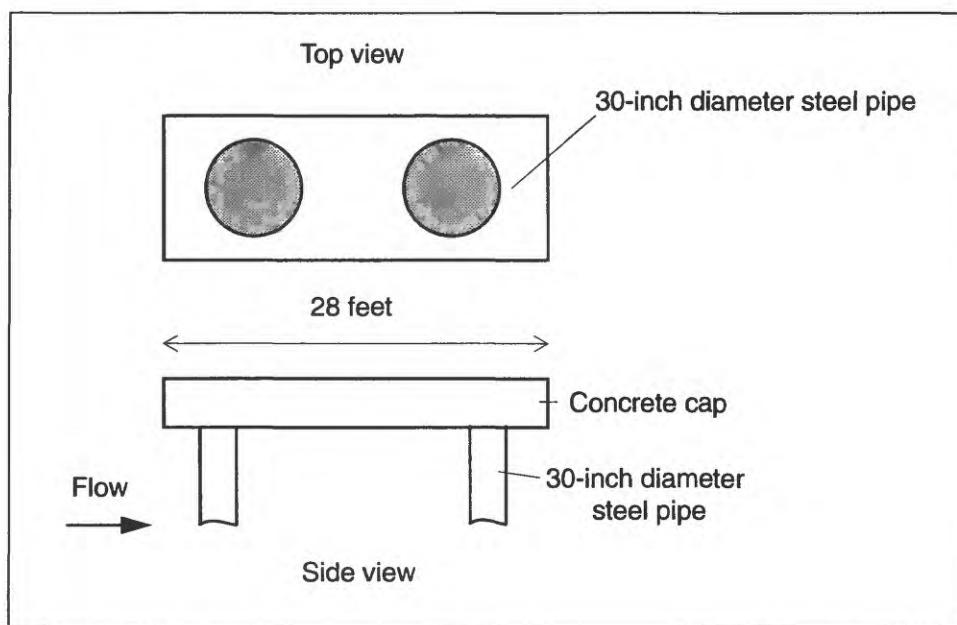
Figure 12. Top and side views of piers at Bridges 333 and 334 on the Copper River Highway.

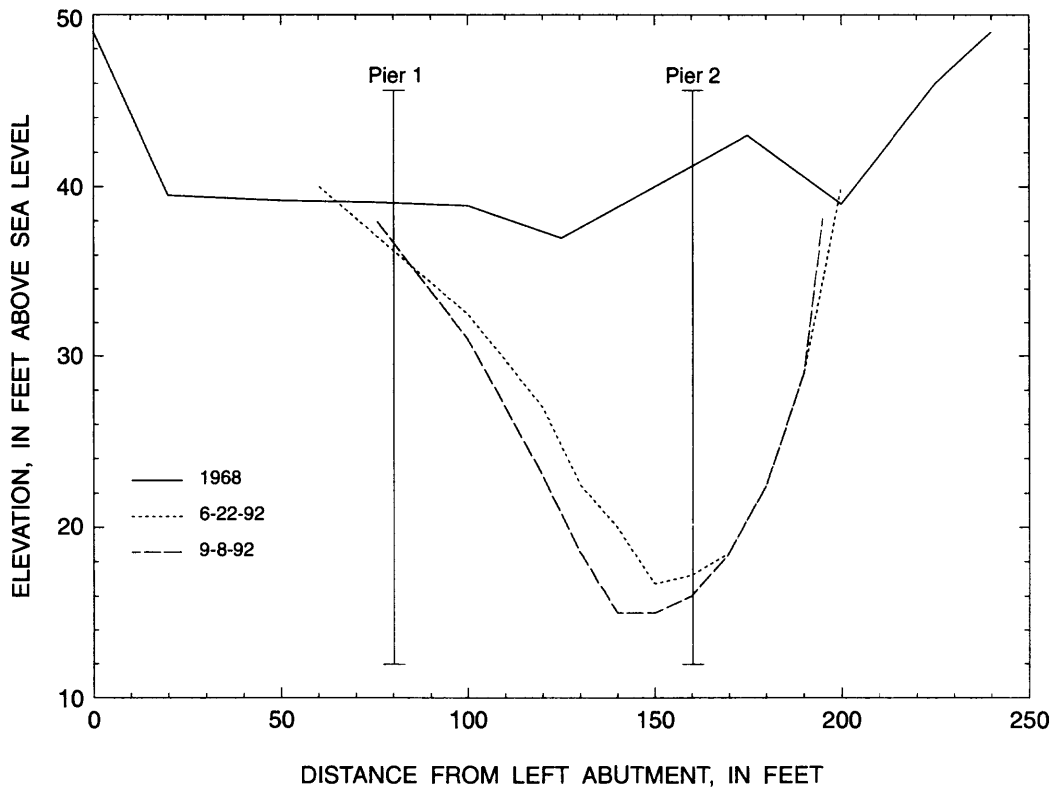
Figure 14. Cross sections of the Copper River, downstream side of Bridge 333.

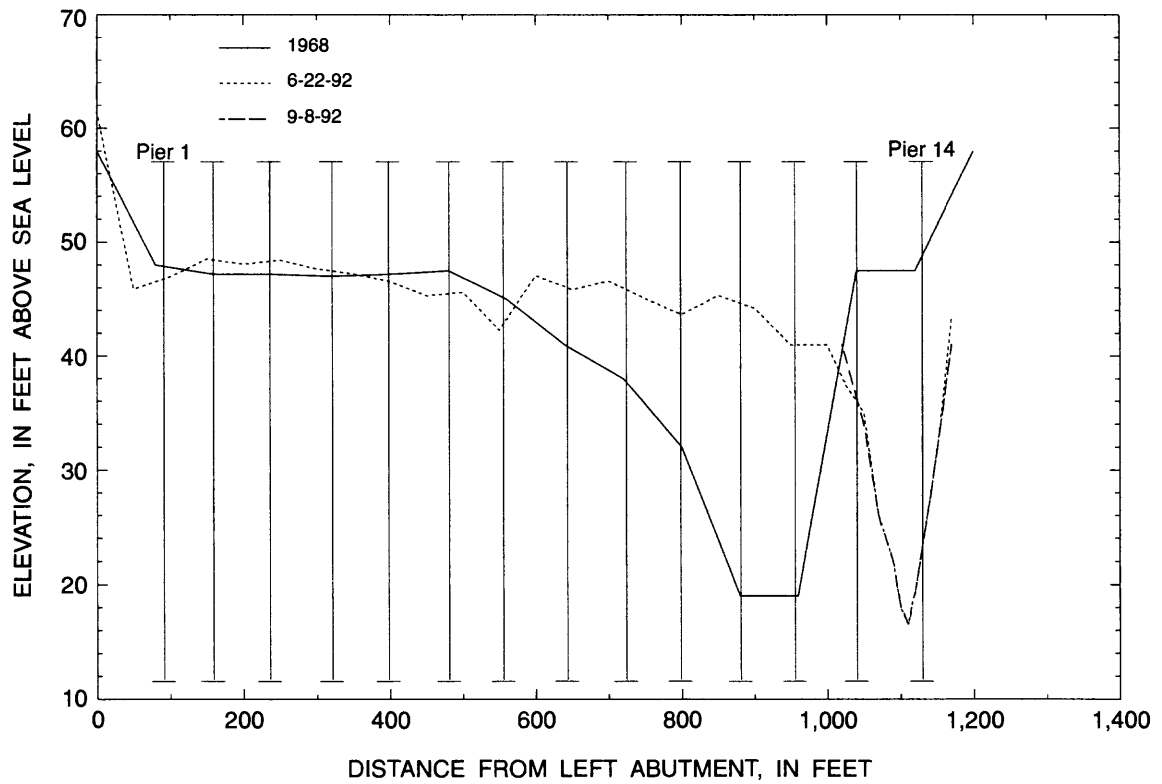
Figure 15. Cross sections of the Copper River, downstream side of Bridge 334.

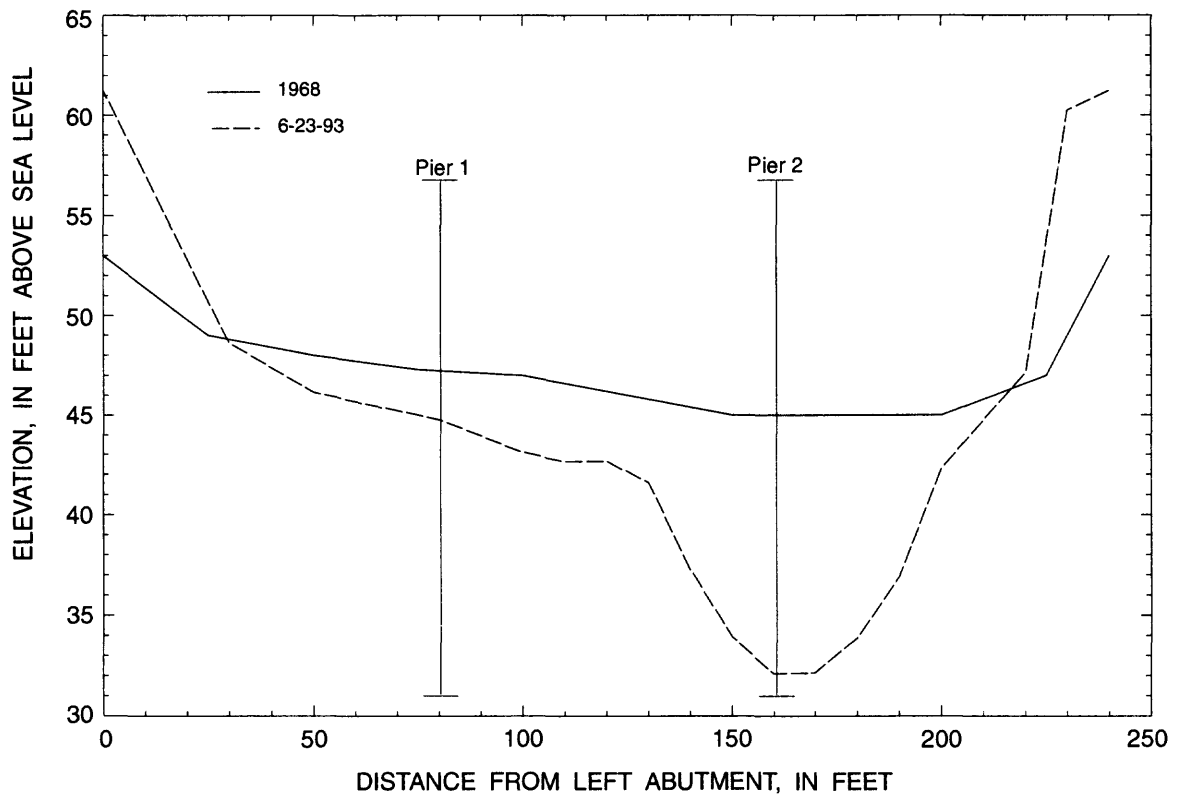
Figure 16. Cross sections of the Copper River, downstream side of Bridge 336.

In 1968, the mean bed elevation at Bridge 336 was 47.0 ft and in 1993 it was 43.0 ft, indicating that 4 ft of scour had occurred. The cross section surveyed in 1993 (fig. 16) showed that a distinct channel has formed on the right side of the bridge. At Bridge 339, two distinct channels have formed since 1968 (fig. 17): the major channel is on the right side of the bridge. The mean bed elevation from 1968 (47.0 ft) to 1992 (40.7 ft) indicates about 6.0 ft of scour at this bridge. No significant scour occurred during 1992, similar to Bridges 333 and 334. At Bridge 340, a somewhat uniform stable channel has developed (fig. 18). The mean bed elevation from 1968 (46.3 ft) to 1992 (41.4 ft) indicates about 5 ft of scour has occurred. Minor scouring and filling occurred at this site during 1992.

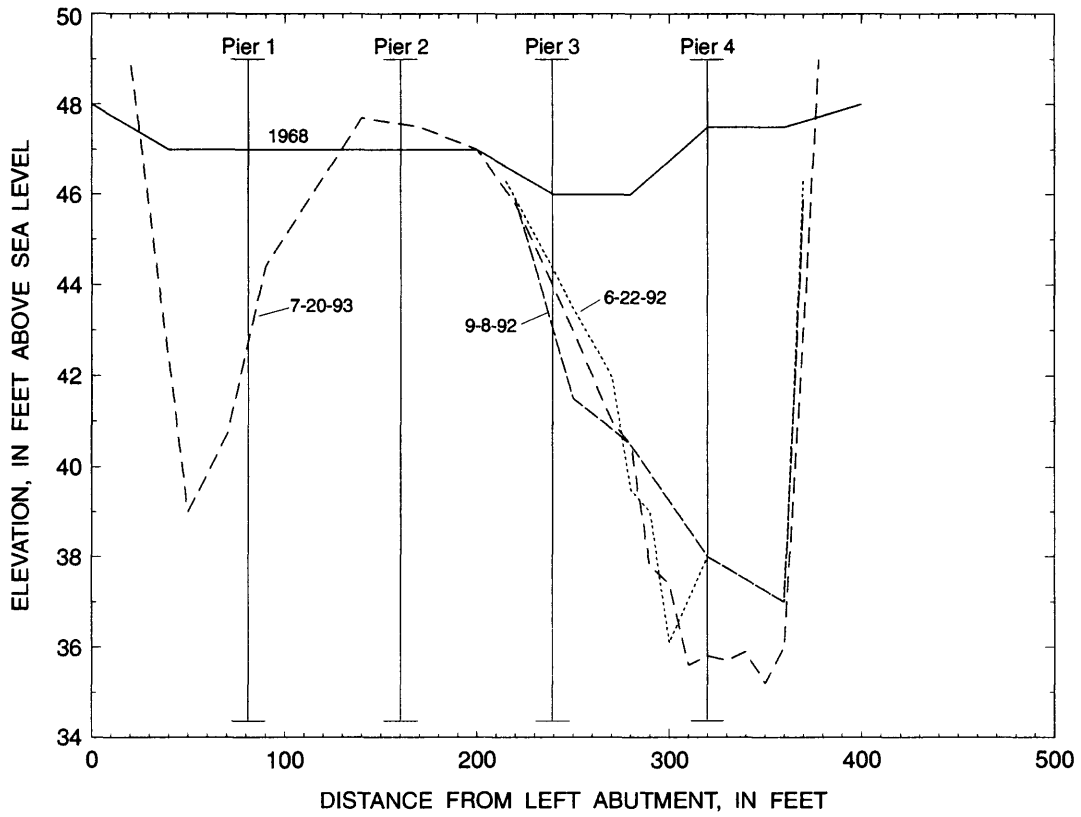
Figure 17. Cross sections of the Copper River, downstream side of Bridge 339.

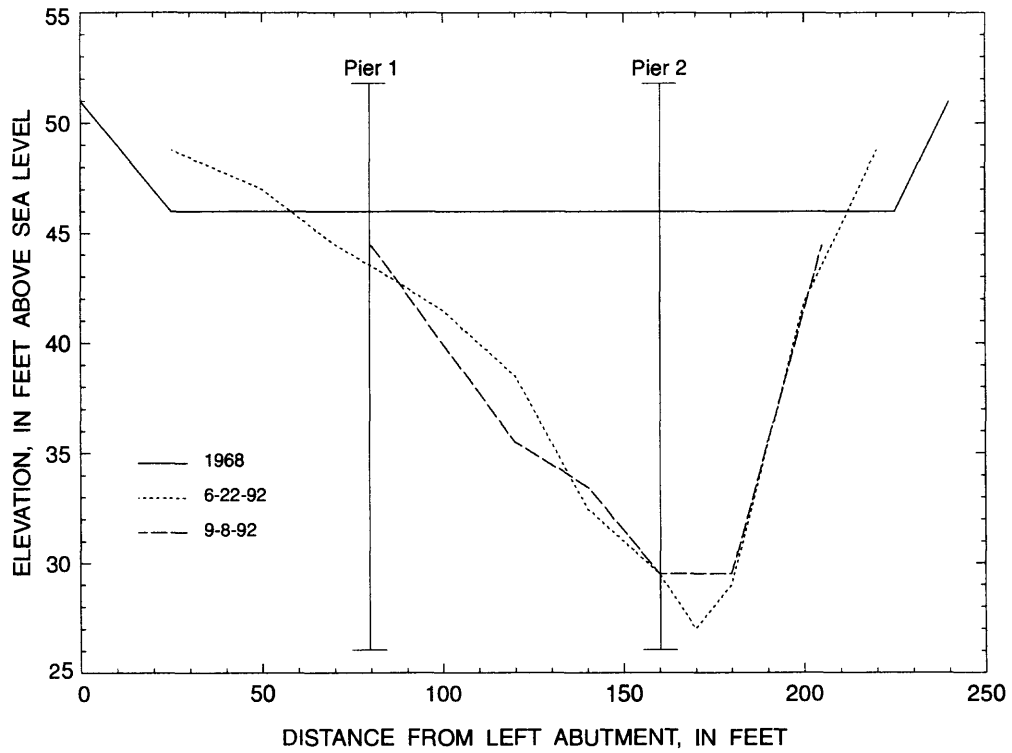
Figure 18. Cross sections of the Copper River, downstream side of Bridge 340.

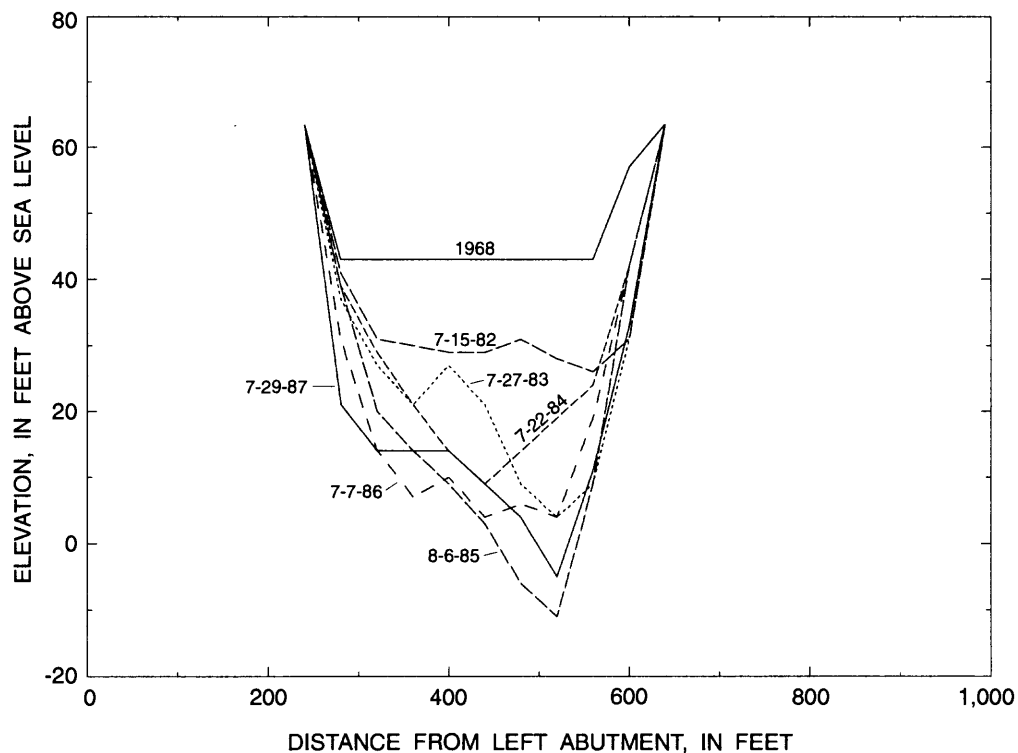
Figure 19. Cross sections of the Copper River, downstream side of Bridge 342, 1968-87.

Beginning in 1982, the ADOT&PF began to monitor the streambed at Bridge 342 on a regular basis. As expected, significant contraction scour occurred because of the increased flow through the width of the bridge (fig. 19). The channel continually scoured and filled and as much as 54 ft of scour occurred from 1968 to 1985 at one point in the channel. From 1982 to 1987, the mean bed elevation of the channel decreased from 36.6 ft to 22.0 ft (table 12). Concern for the safety and integrity of the bridge led ADOT&PF to make major repairs to the structure in 1987. These repairs consisted of lengthening the bridge at each end by 240 ft (480 ft total) and constructing spur dikes at the left and right upstream abutments. Construction was completed in November 1988.

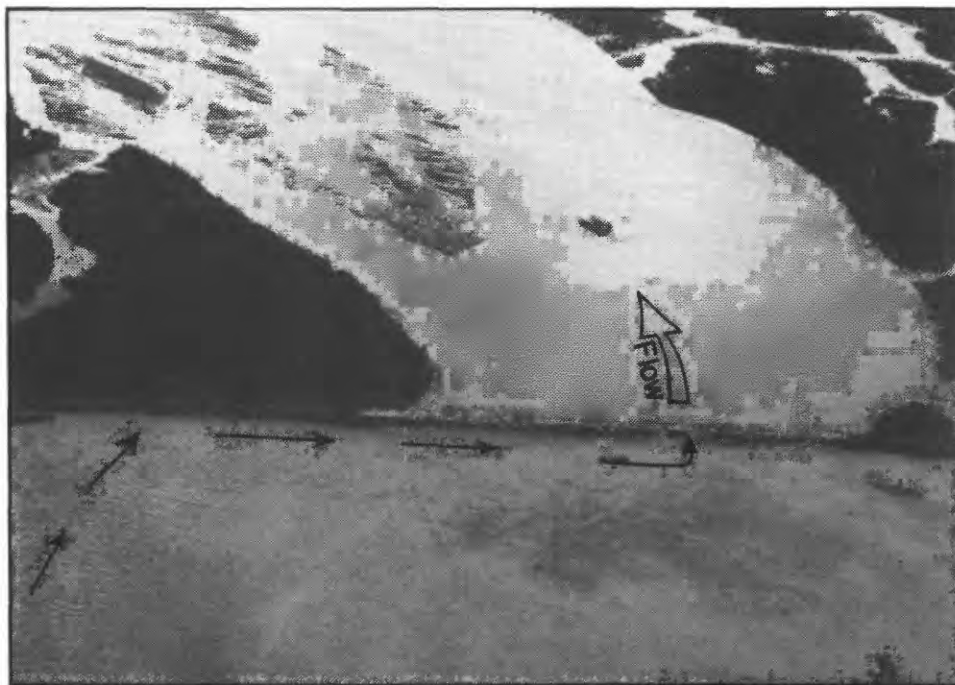
Figure 20. Bridge 342 on the Copper River Highway, looking downstream, September 1989.
 [Photograph from Mark Miles, Alaska Department of Transportation and Public Facilities.]

After construction, the first cross section at Bridge 342 was obtained in August 1989. The mean bed elevation was 46.3 ft. High water of 1989 overtopped and destroyed the left bank upstream spur dike (fig. 20). The flow of the Copper River was directed at the highway embankment and then flowed westward under the bridge. This resulting change in flow direction caused considerable scour on the right side of the channel (fig. 21A) and lowered the mean bed elevation to 34.9 ft. In 1990-91, the spur dikes were rebuilt to a higher elevation. Since that time, the right side of the channel continued to scour during 1991, but appeared fairly stable during 1992 (fig. 21B). The left side of the channel filled in during 1991, but began to scour in 1992 (fig. 21B). Scour and fill are probably due to the effect of the spur dike on the approach channel to the bridge. From September 1991 to September 1992, the channel began to shift and align itself with the bridge opening (fig. 22).

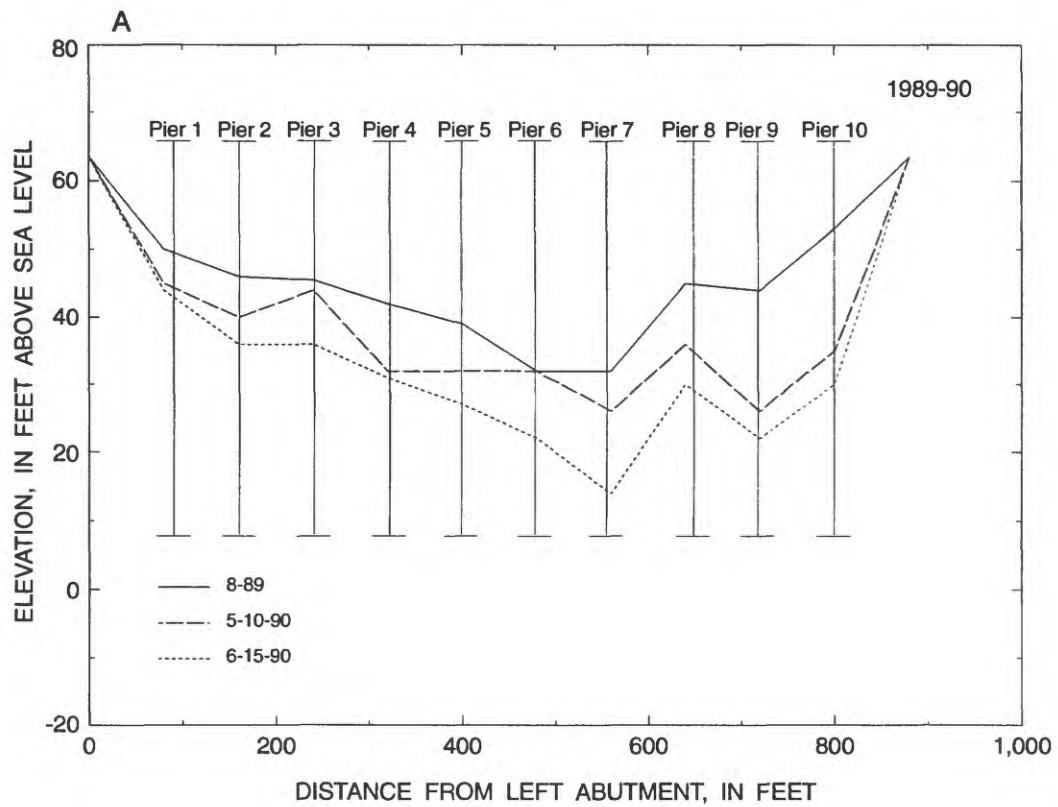
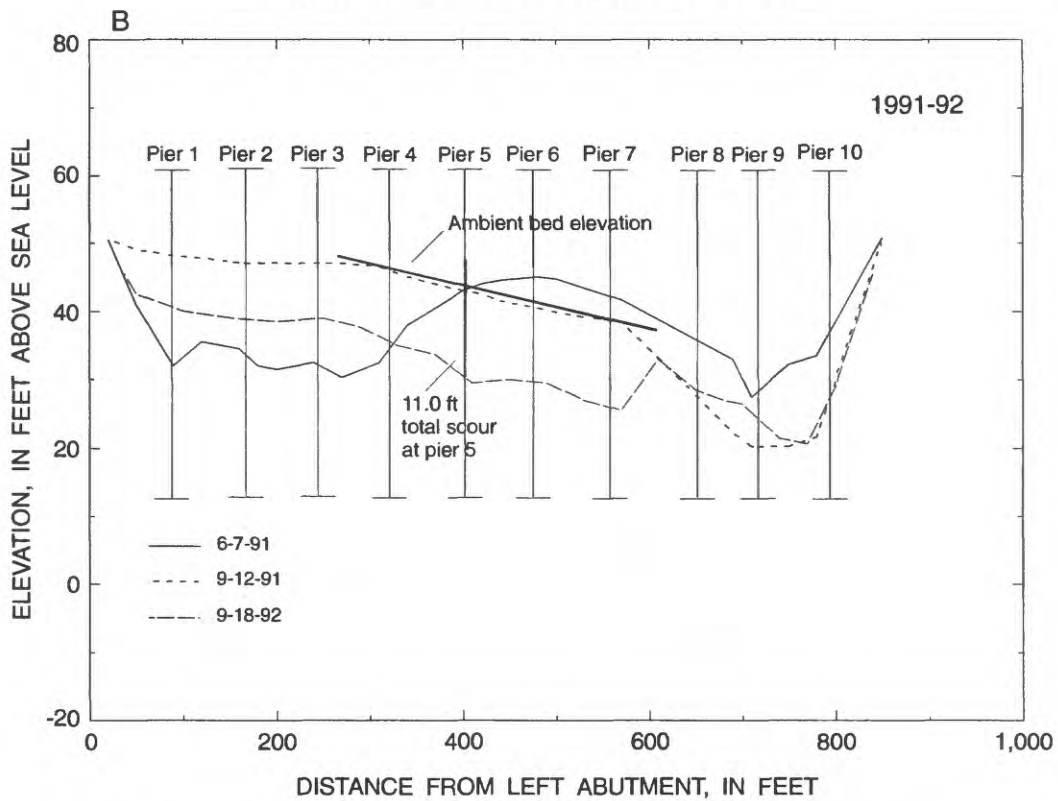
Figure 21. Cross sections of the Copper River, downstream side of Bridge 342, 1989-90 and 1991-92.

During the 1992 open-water season, 11.0 ft of scour was measured near pier 5 (fig. 21B). Because the channel at Bridge 342 is undergoing constant change and realignment, this scour is considered to be aggradation and degradation of the channel. Thus, the local scour equations were not tested at this bridge.

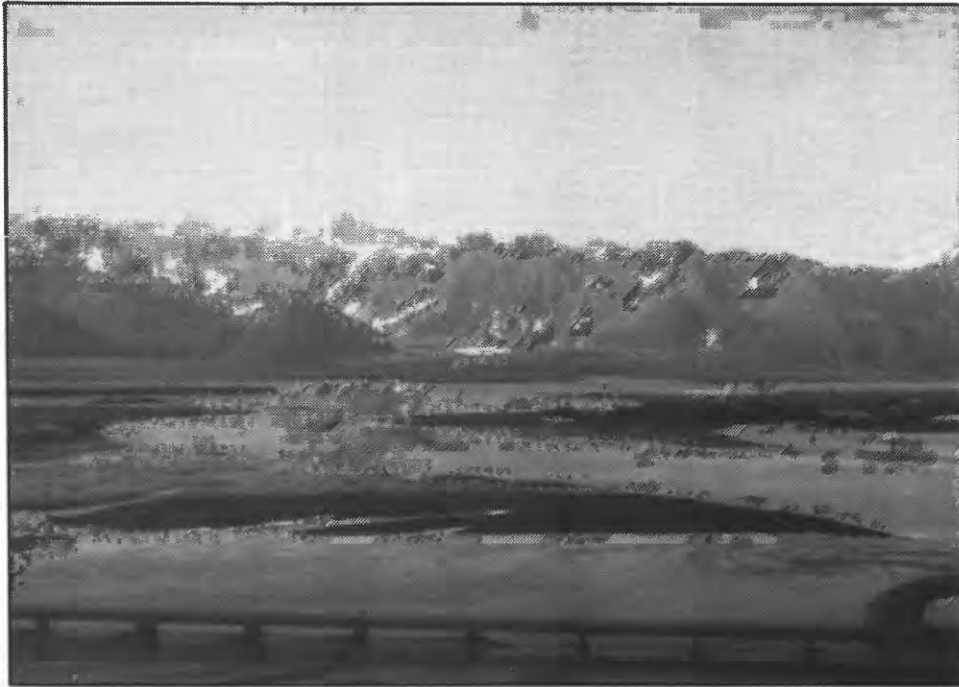
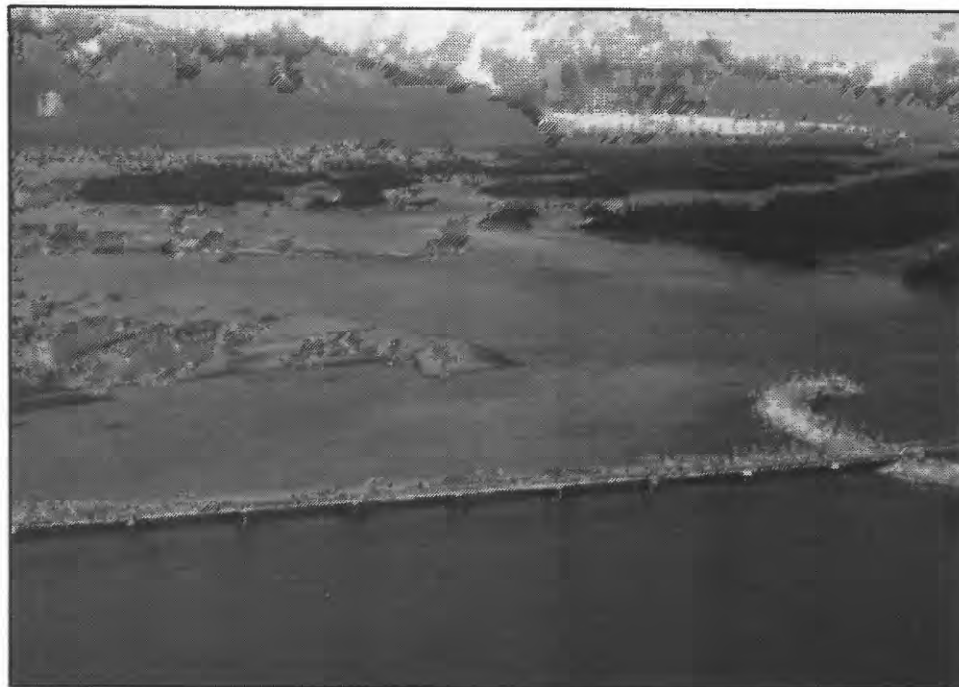
Figure 22A. Bridge 342 on the Copper River Highway, looking upstream; top, September 1991; bottom, September 1992.

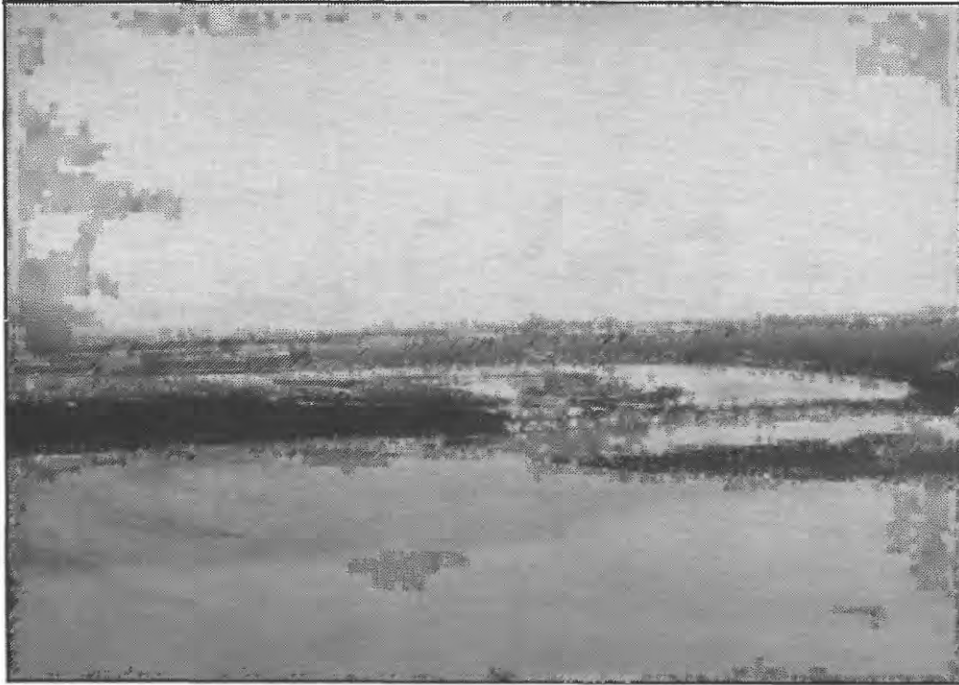
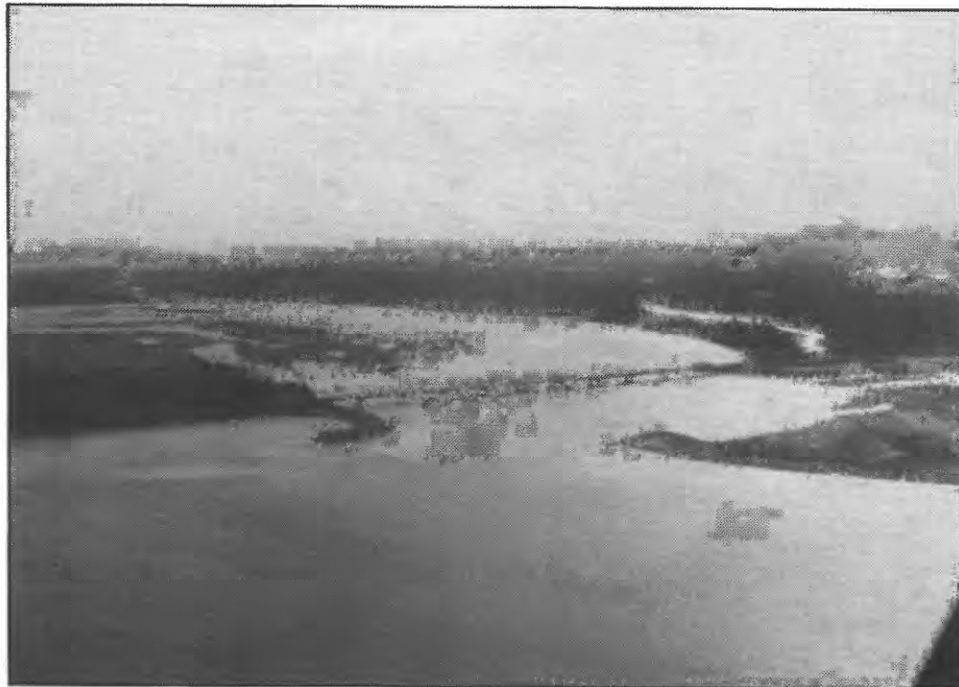
Figure 22B. Bridge 342 on the Copper River Highway, looking downstream; top, September 1991; bottom, September 1992.

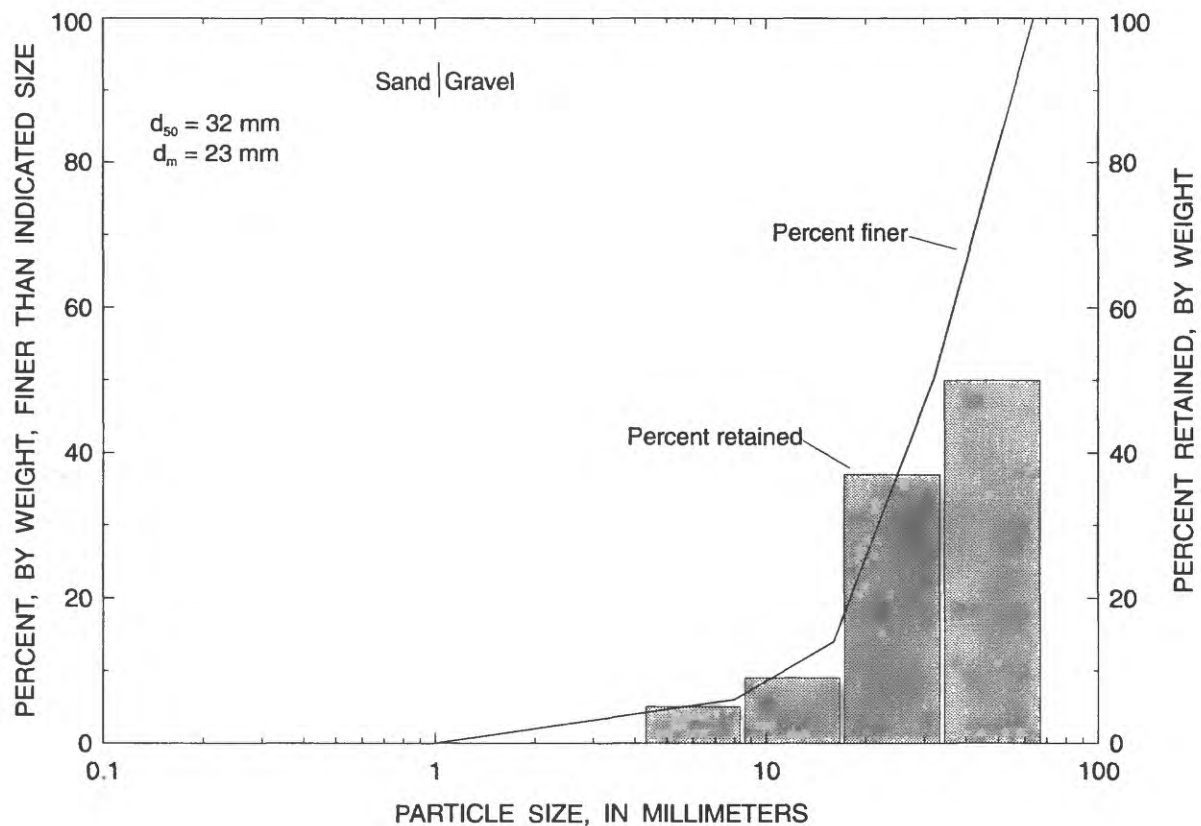
Figure 23. Particle-size distribution, median diameter (d_{50}), and mean diameter (d_m), of bed material, Copper River at Bridge 342.

During the open-water periods of 1991 and 1992, discharge at Bridge 342 ranged from 13,400 to 91,400 ft³/s (table 13). These discharges represent between 33 and 67 percent of the total flow of the Copper River past the Million Dollar Bridge indicating that a major channel has formed in the vicinity of Bridge 342. Suspended-sediment concentrations ranged from 262 to 2,316 mg/L. Most of the sediment is finer than 0.062 mm (table 14). Measured bedload discharge ranged from 1,000 to 14,700 ton/d (table 13). The median diameter, d_{50} , of the bedload ranged from 0.8 to 16.0 mm. Although the relatively large range in bedload transport probably reflects the corresponding range in water discharge, the continuing erosion of the gravel bar just upstream from the bridge may also be supplying additional bedload. Most of the bed material is composed of coarse to very coarse gravel (fig. 23) and had a median diameter, d_{50} , of 32 mm.

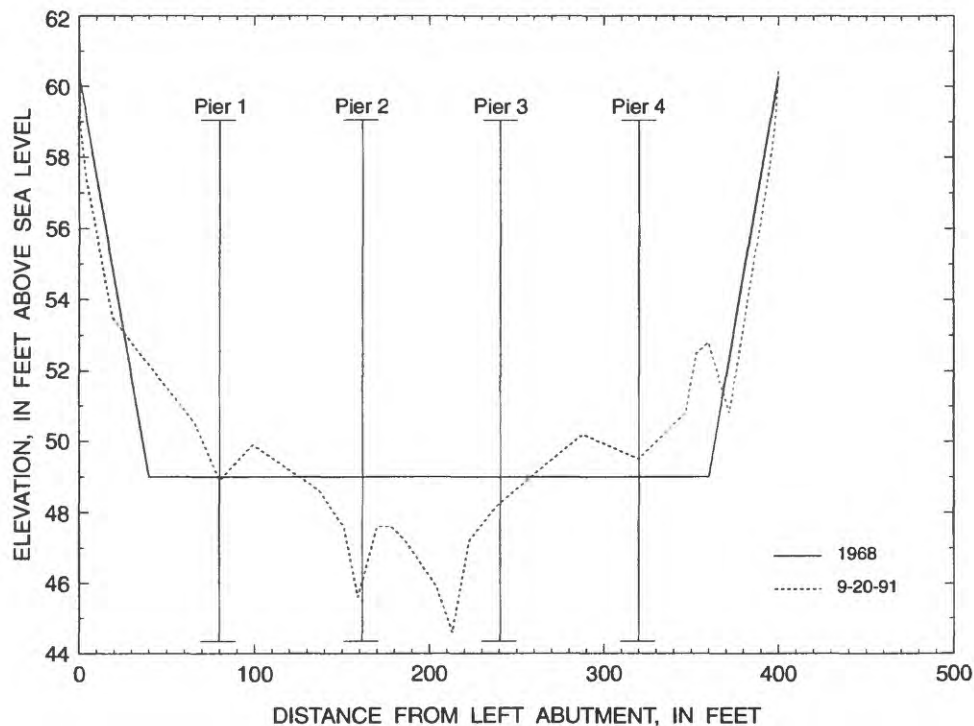
Figure 24. Cross sections of the Copper River, downstream side of Bridge 344.

Comparison of cross sections at Bridge 344 indicates some scour in the main channel from 1968 to 1991 (fig. 24) and the maximum scour is approximately 5 ft. The mean bed elevation at this bridge decreased from 52.1 ft in 1968 to 50.0 ft in 1991. At Bridge 345, the center of the channel has filled but the left and right parts of the channel have scoured (fig. 25). The mean bed elevation, 48.0 ft, has remained constant from 1968 to 1991.
