Scour Assessment at Bridges From Flag Point to Million Dollar Bridge, Copper River Highway, Alaska

By Timothy P. Brabets

U.S. GEOLOGICAL SURVEY

Water-Resources Investigations Report 94-4073

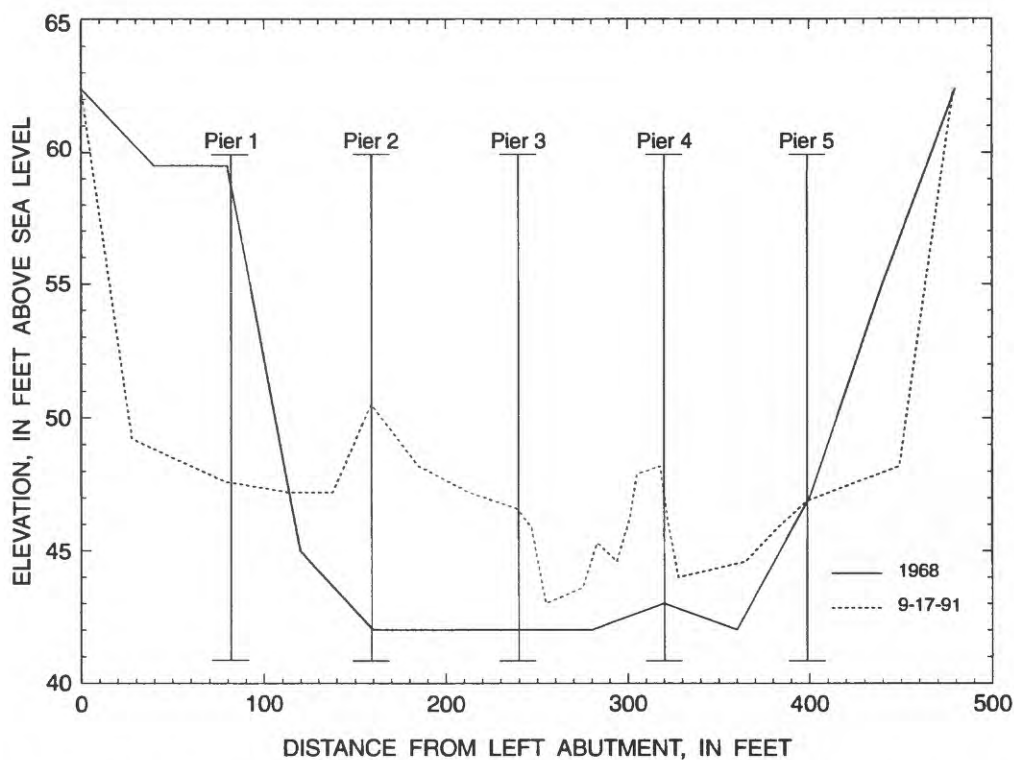
Figure 25. Cross sections of the Copper River, downstream side of Bridge 345.

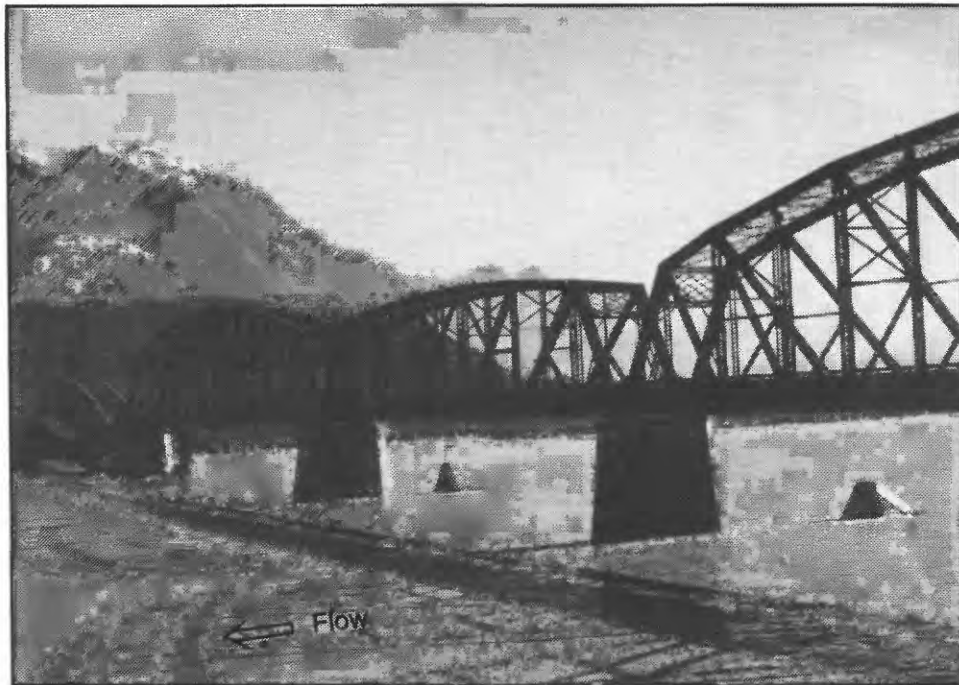
Figure 26. Million Dollar Bridge on the Copper River Highway, 1991.

To meet these conditions, three massive concrete piers were built on pneumatic caisson foundations 70 by 32 ft in size. The caissons were placed at a depth of 44 ft below low water. Two of the piers were protected with separate ice-breaker piers upstream to break or divert the floating ice and protect the bridge piers from damage (fig. 26). Four simple steel-through truss spans of 404 ft, 305 ft, 455 ft, and 405 ft, respectively, were placed on the piers from south to north. The total cost of the bridge when completed was \$1,500,000 and thus the bridge became known as the Million Dollar Bridge.

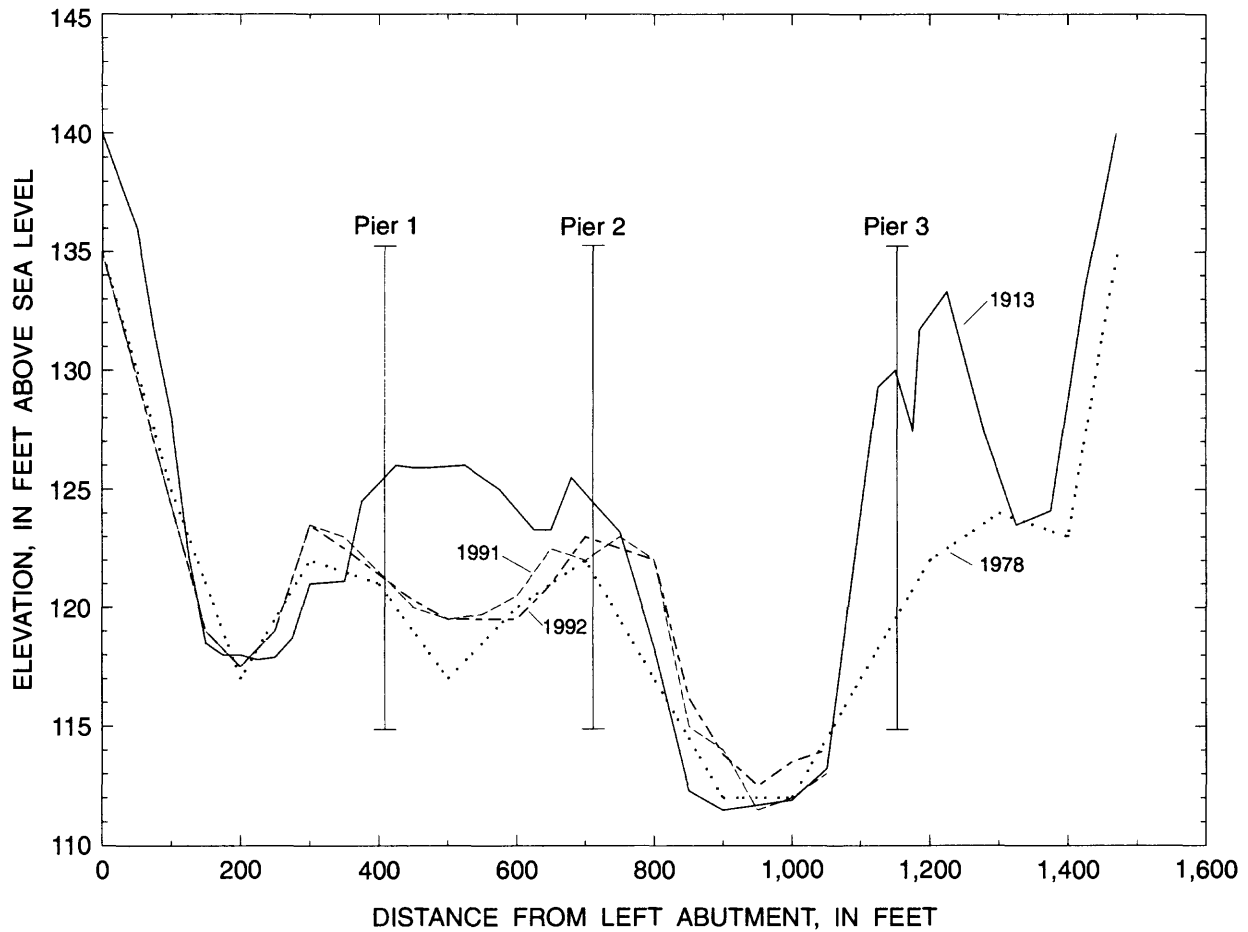
Figure 27. Cross sections of the Copper River, downstream side of the Million Dollar Bridge.

In 1908, exploratory drilling at the Million Dollar Bridge site indicated 20 ft of sand and loose gravel. Beyond 20 ft, the riverbed consisted of cemented sand, gravel, and boulders (O'Neel and Hawkins, 1910). Pile-driving records from the 1975 bridge repair (when a support pier was installed) also indicated the presence of numerous large hard unweathered boulders nested in dense gravel. Because of this type of material, no significant scour or channel change at the site is expected.
