Sedimentation History of Lago Loíza, Puerto Rico, 1953–94

By Richard M.T. Webb and Luis R. Soler-López

Water-Resources Investigations Report 97–4108

PUERTO RICO AQUEDUCT AND SEWER AUTHORITY

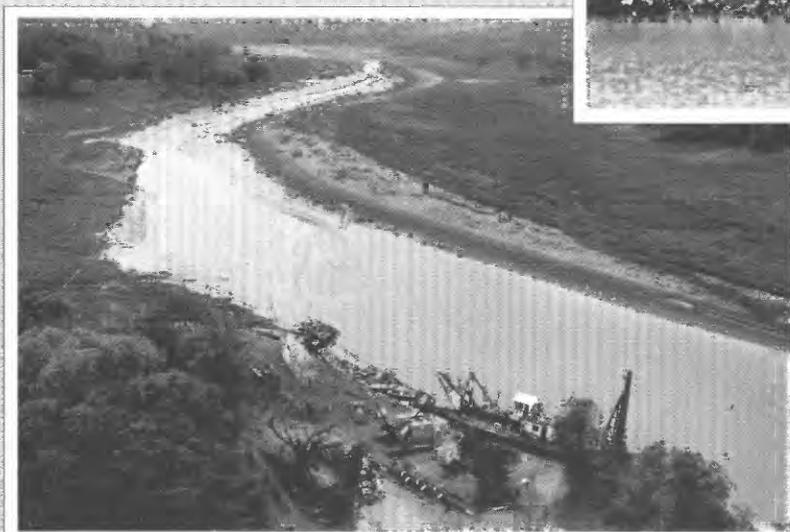
Photo 2. House and Pelicans

Photograph of a house built next to the Río Grande de Loíza before its impoundment, approximately 900 meters upstream of the eventual location of Carraízo Dam, August 12, 1994 -- pool elevation is 33.36 meters above mean sea level - Courtesy of El Nuevo Día, Inc.

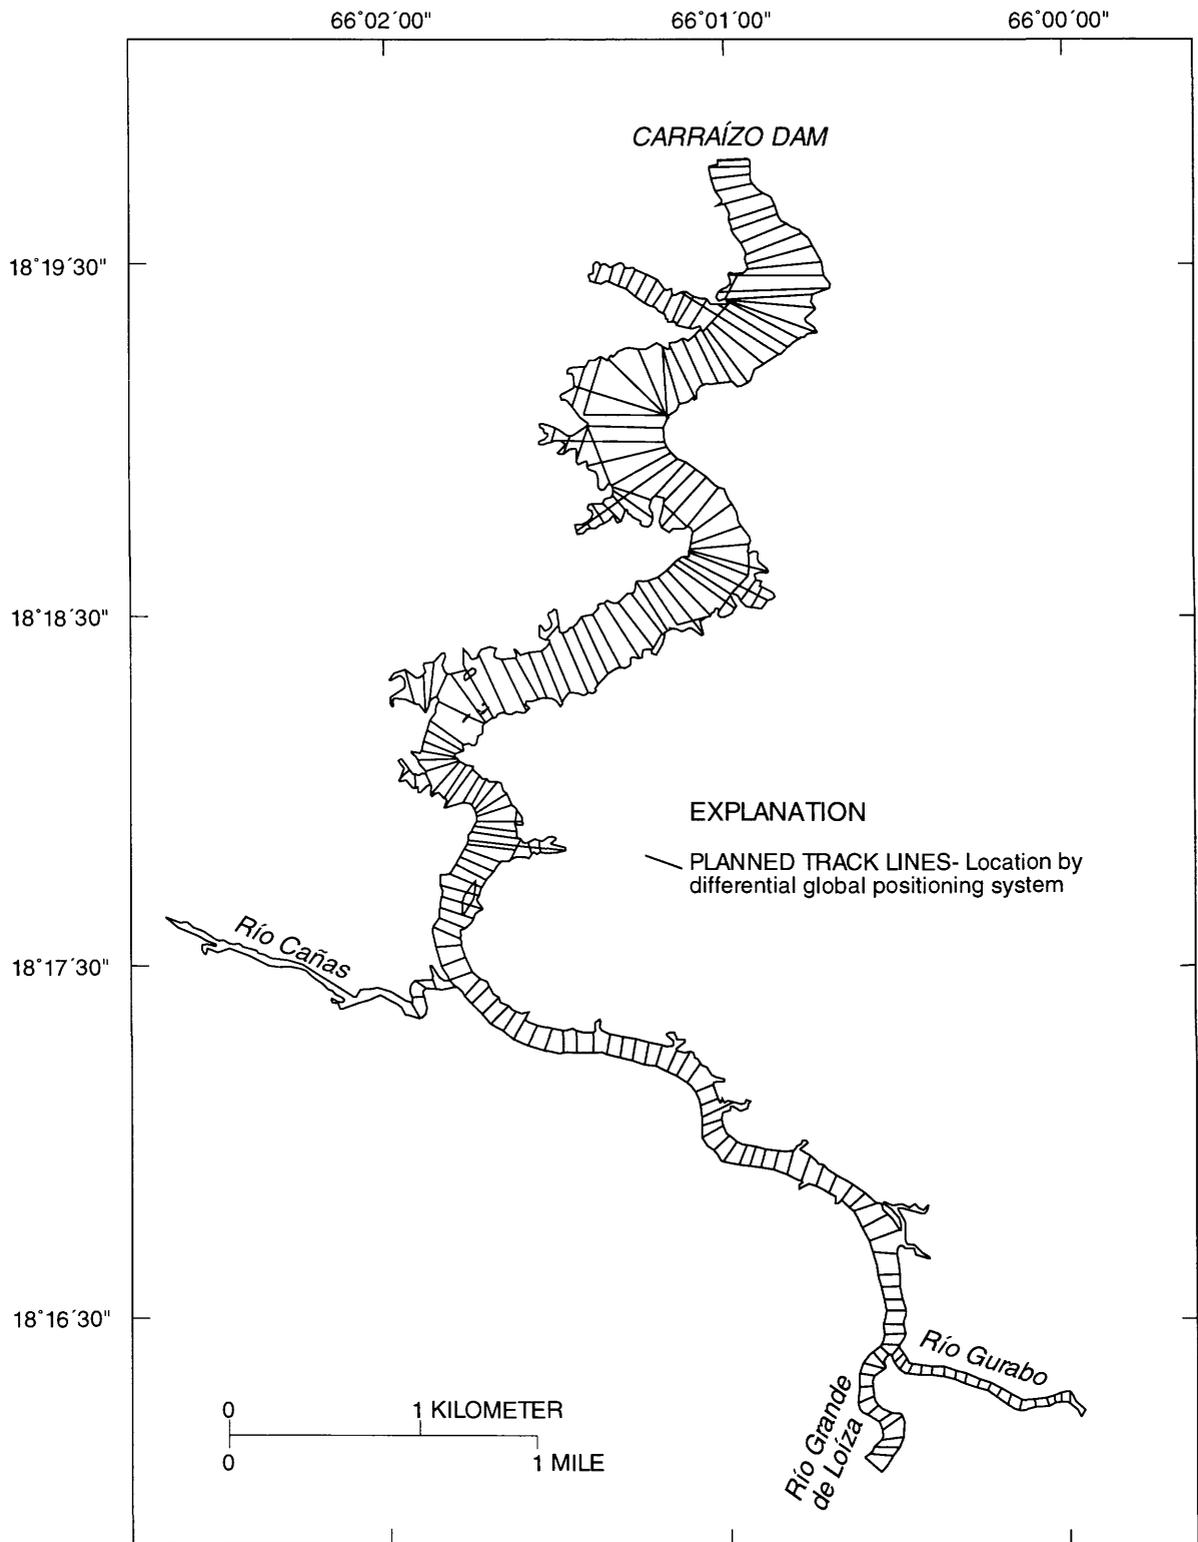
Figure 2. Track lines for 1994 bathymetric survey of Lago Loíza, Puerto Rico.

Bathymetric data were obtained from the Carraízo Dam upstream to the confluence of the Río Grande de Loíza and the Río Gurabo (9.9 kilometers) and approximately 800 meters upstream into the Río Grande de Loíza branch and approximately 1,000 meters upstream into the Río Gurabo branch (fig. 2). Longitudinal distances in meters from the dam were

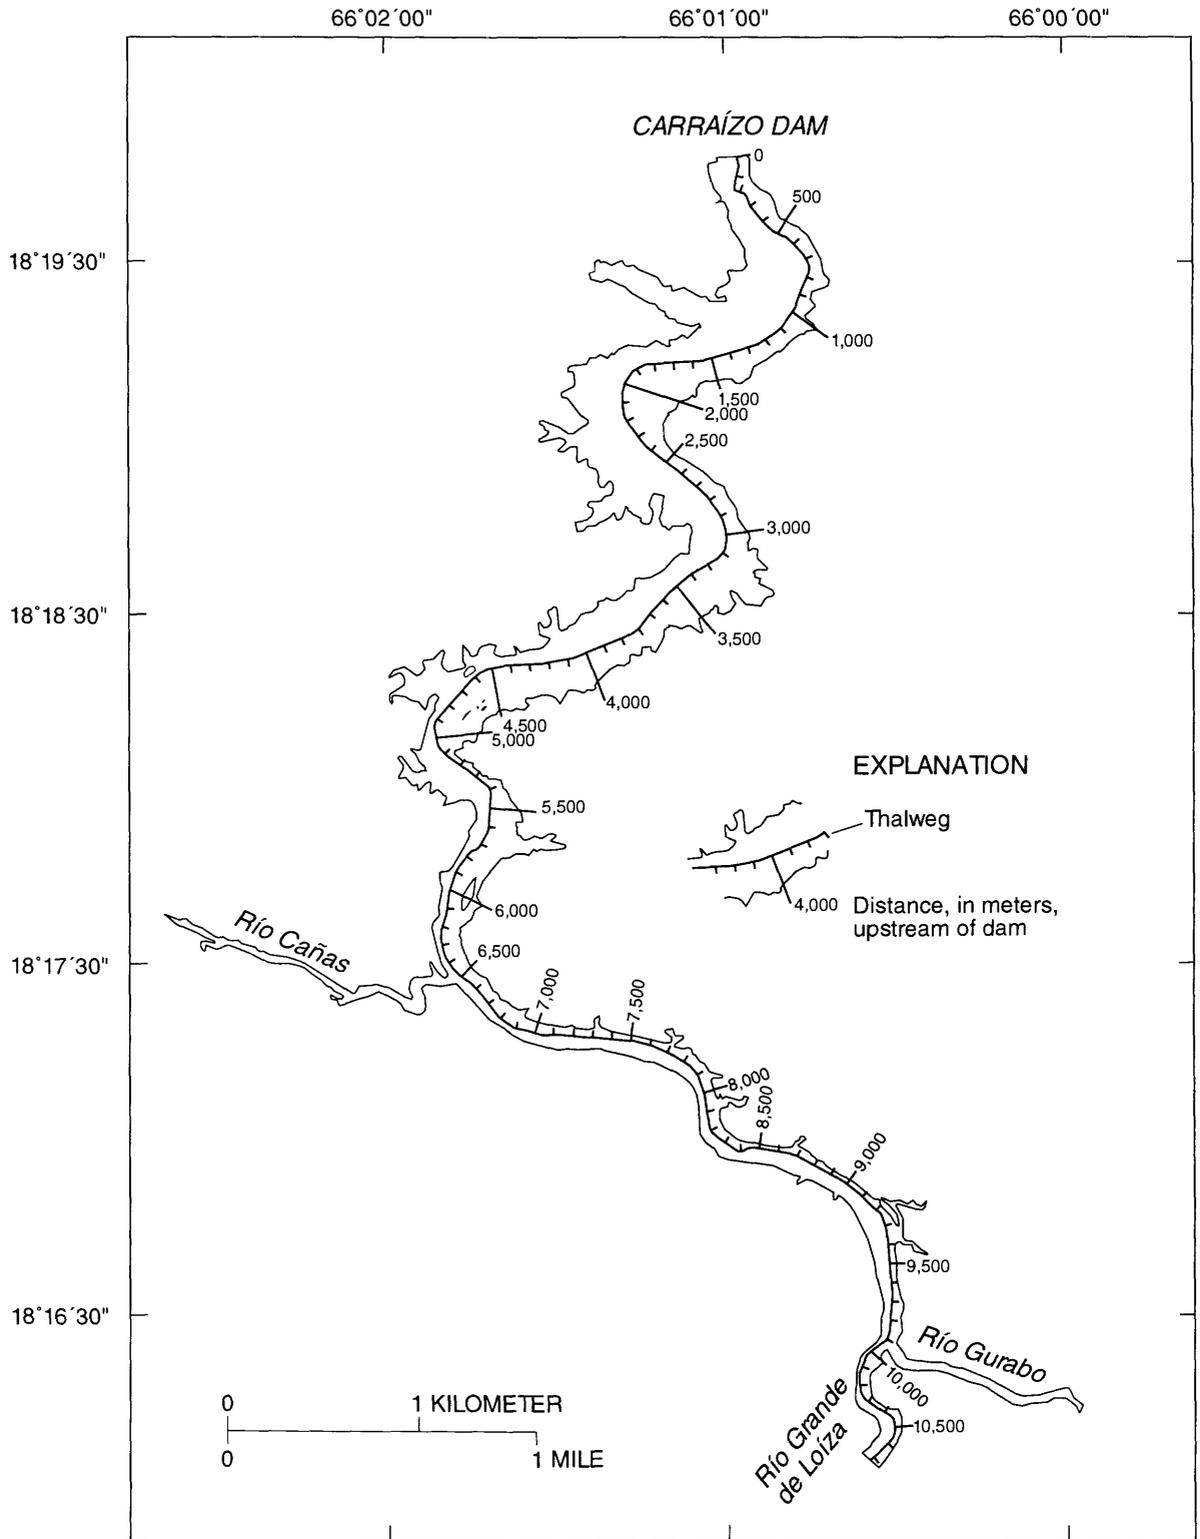
Figure 3. Reference distances (in meters) for longitudinal sections of Lago Loíza, Puerto Rico, along the thalweg of the original stream channel.

determined along the thalweg of the river as it appeared in the 1947 topography (fig. 3).

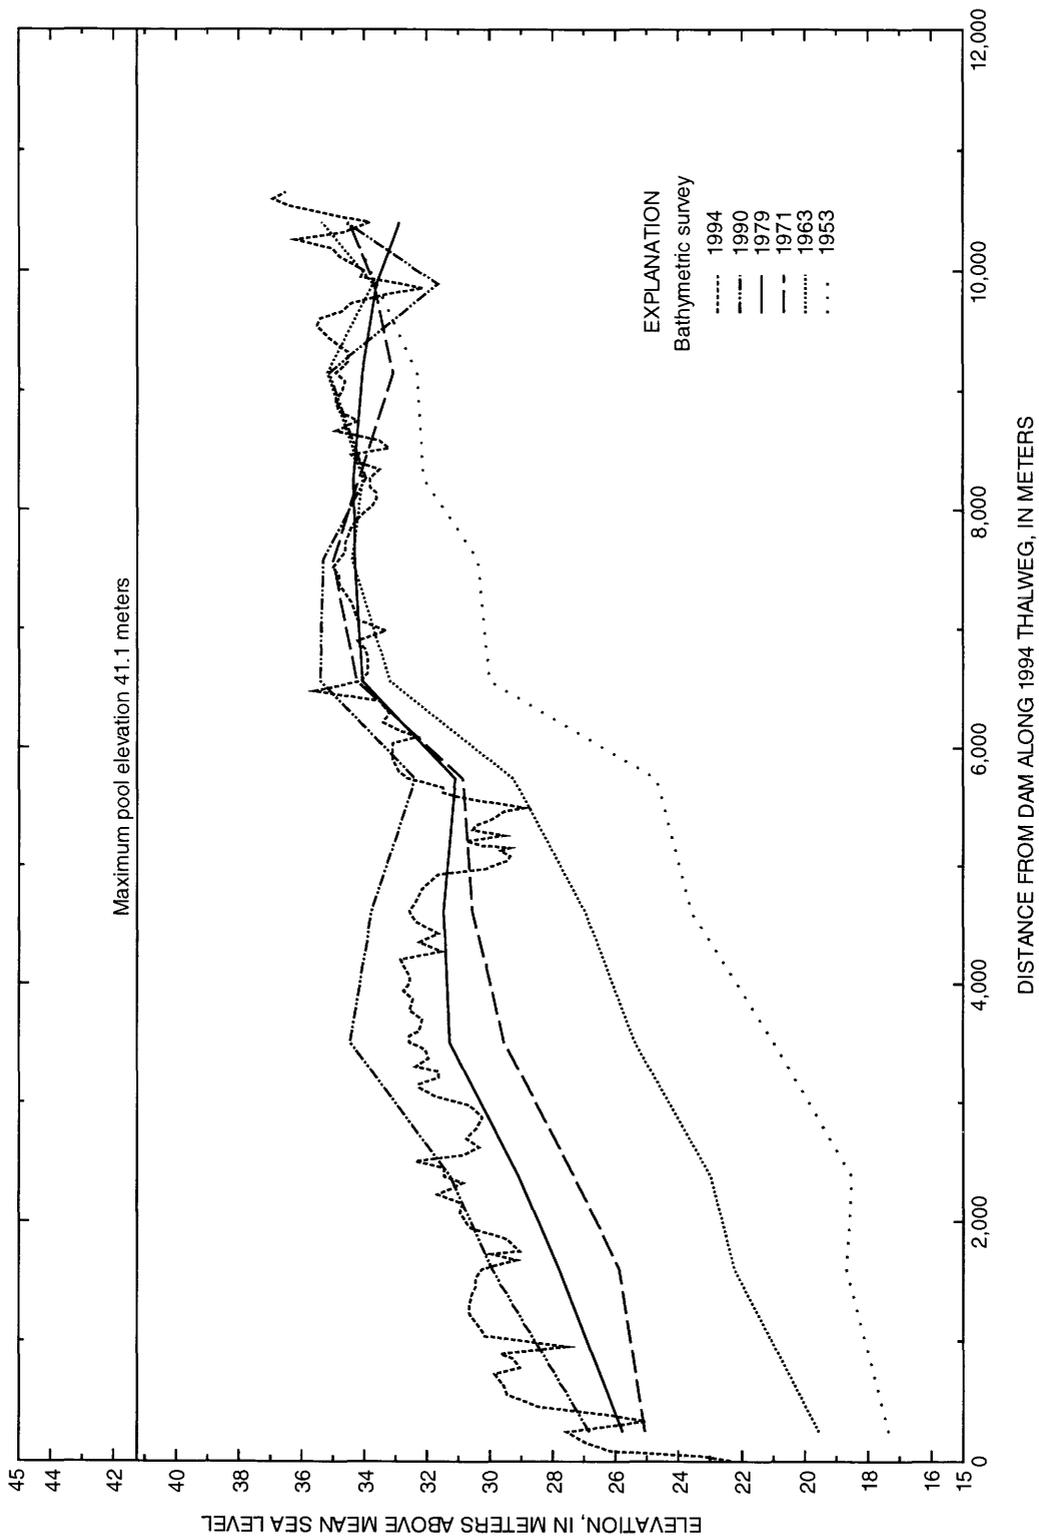
Figure 4. Historical longitudinal profiles of Lago Loíza, Puerto Rico, 1953–94.

The adjusted volumes and sedimentation calculations are consistent with the changes observed in the cross sections surveyed in 1953, 1963, 1971, 1979, 1990, and the current 1994 profiles. The deepest points of the cross sections were used to generate longitudinal sections for each year. The cross sections and the longitudinal sections graphically display how the southern section of the reservoir, upstream of the Río Cañas, quickly reached a new channel equilibrium. Within the first 10 years (1953 to 1963), from 1 to 3 meters of sediment accumulated, after which no further net deposition occurred as sediments would be transported through this shallow section to be deposited in the deeper sections further downstream.

Approximately 54 percent of the total sediments deposited in the reservoir were deposited in the 18-year period from 1953 to 1971. As seen in the longitudinal profiles and the cross sections (figs. 4, 5, 6), sediments continue to deposit at rates up to 0.4 meter of sediment per year in areas where the reservoir broadens (such as sections 21 and 28). Section 28 indicates that the line for 1990 may have been improperly located at that site, because water depths shown in the 1990 profile are typical of sections a couple hundred meters upstream.

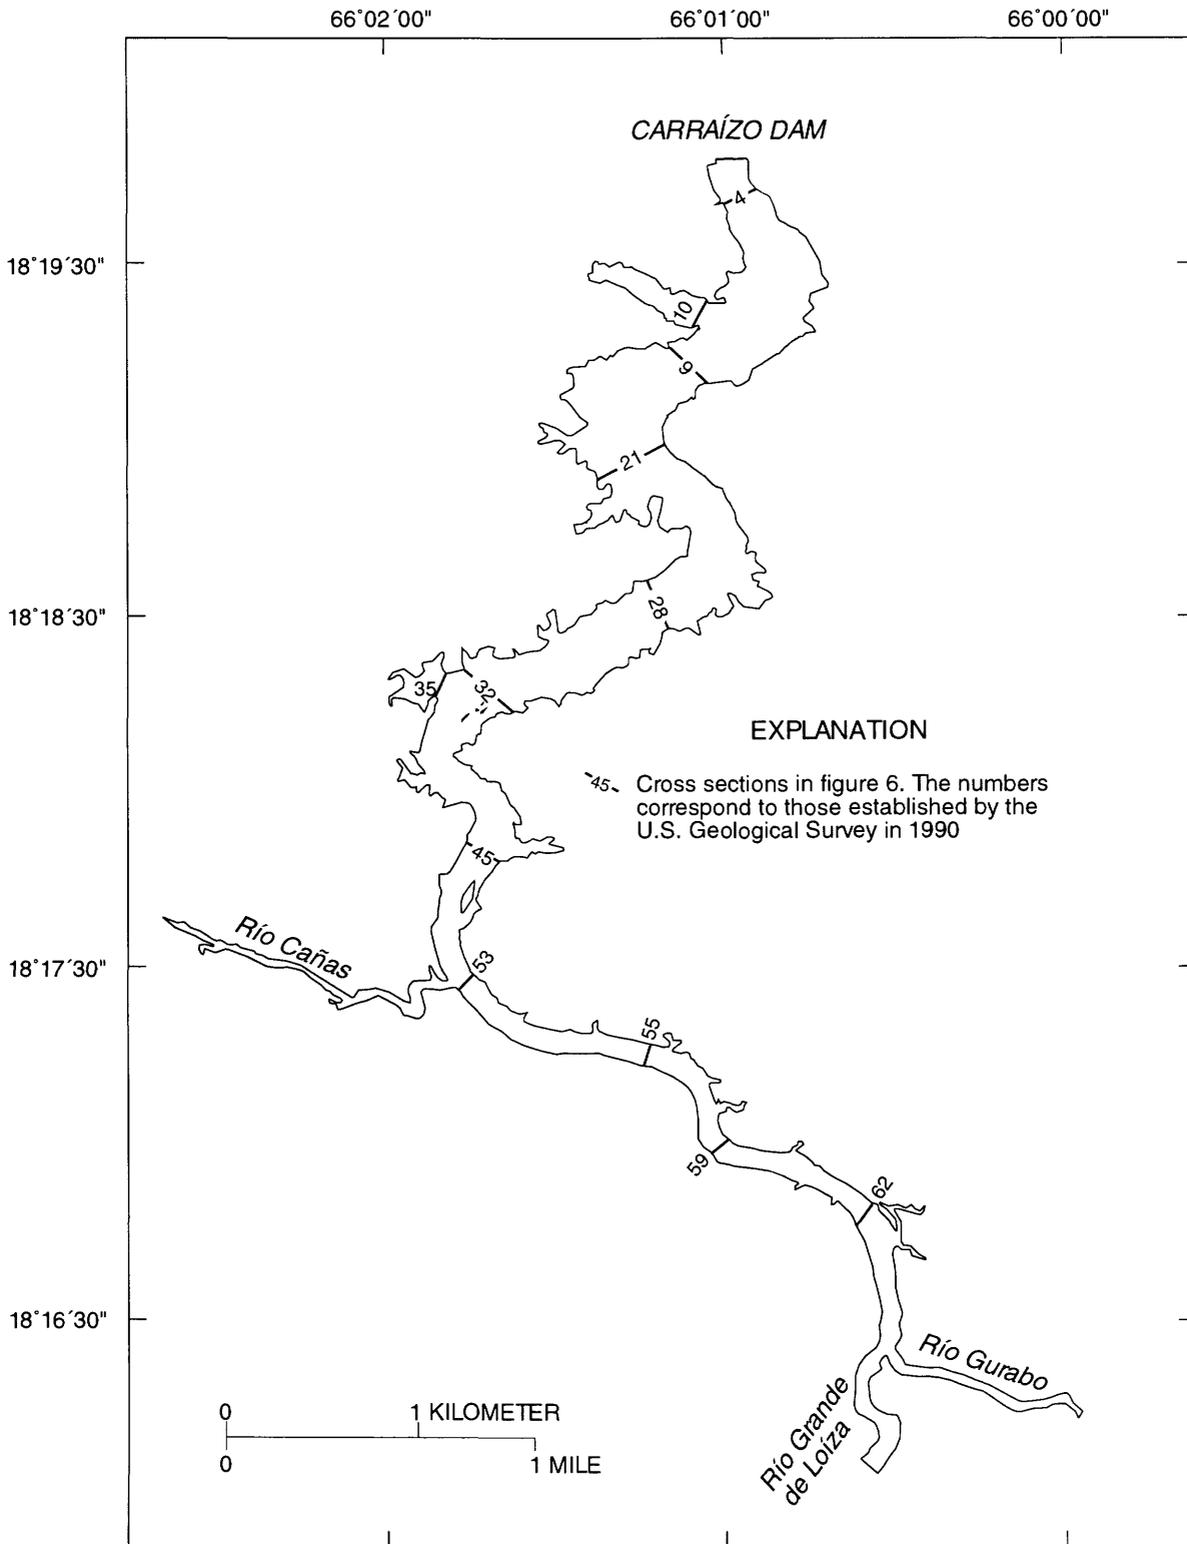
Figure 5. Map of Lago Loíza, Puerto Rico, locating cross sections that have been surveyed both by the Soil Conservation Service and the U.S. Geological Survey, 1953–94.

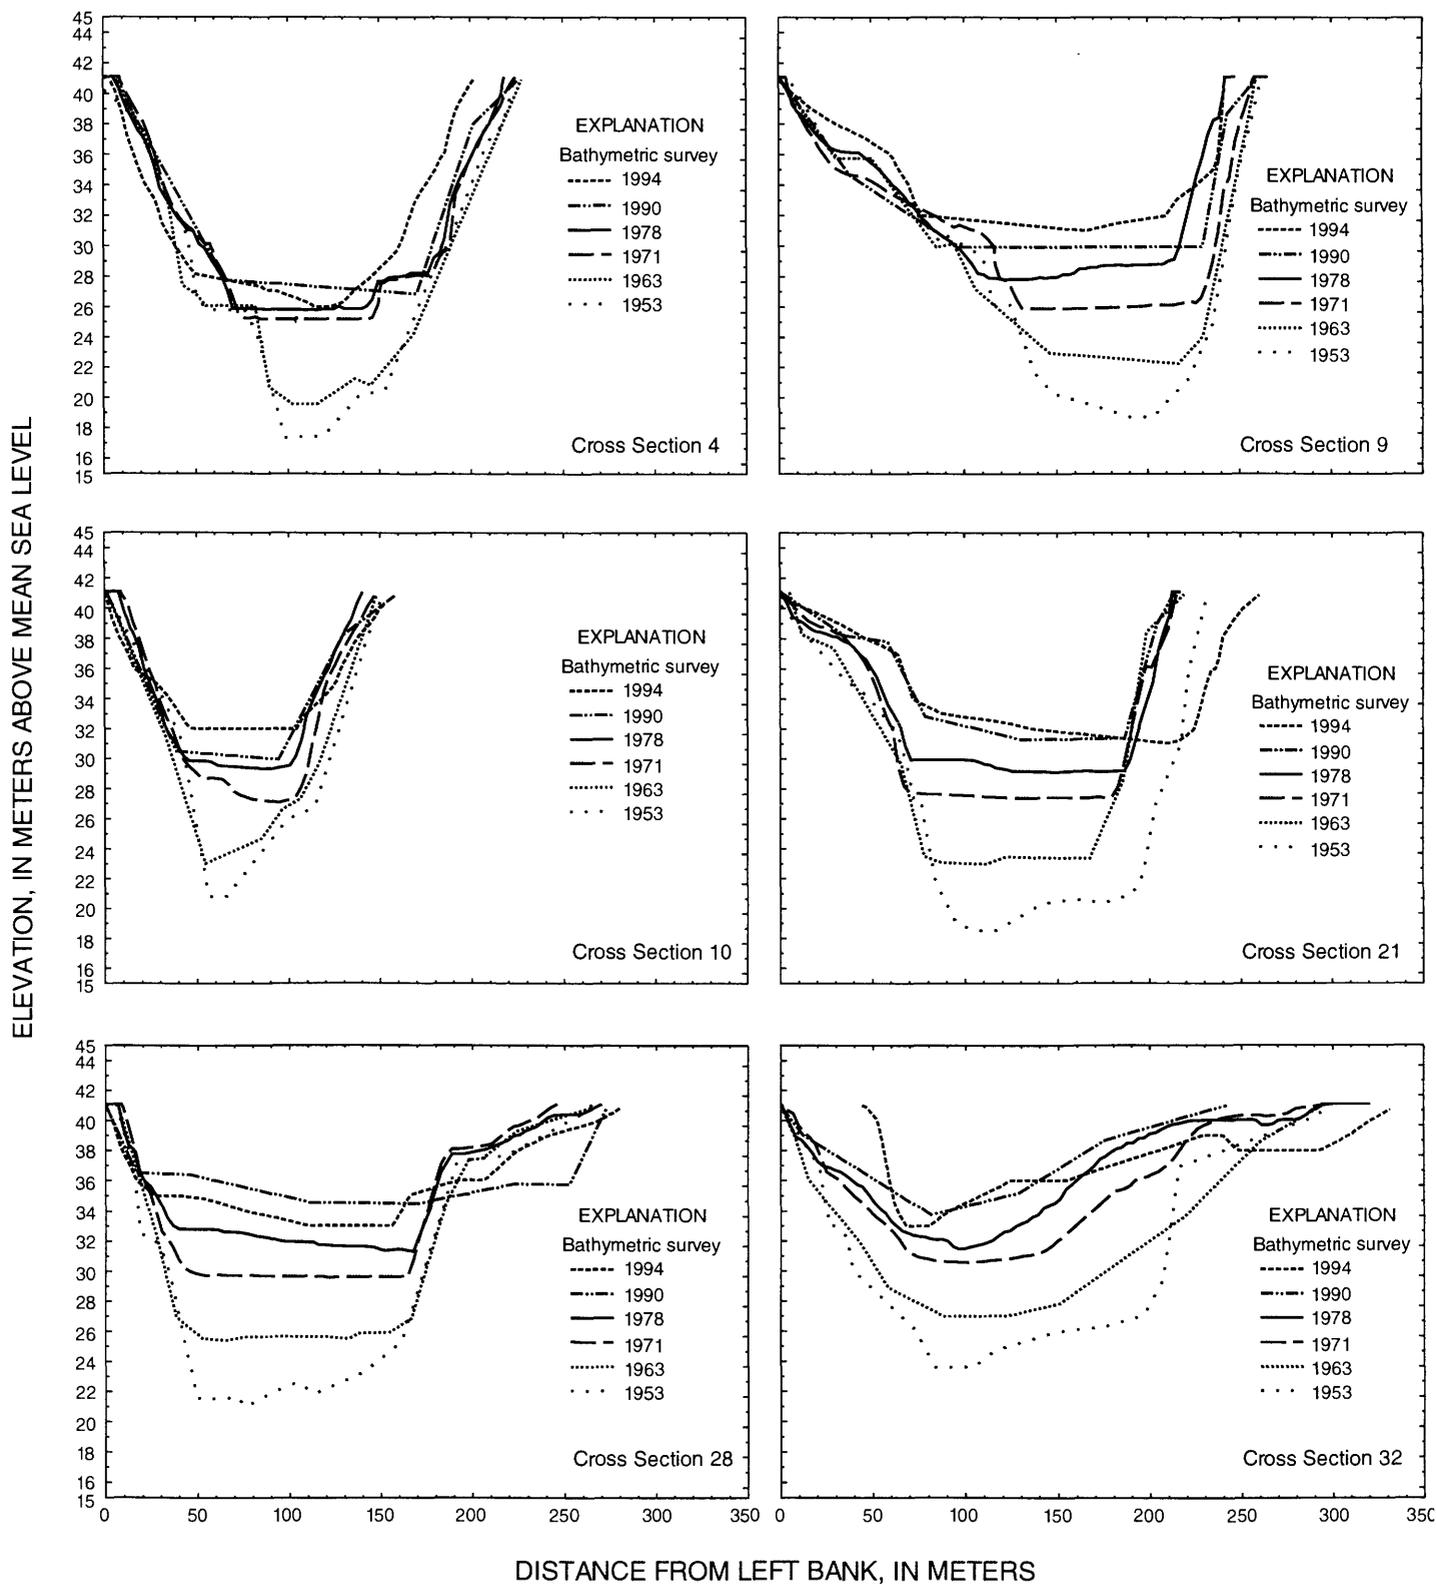
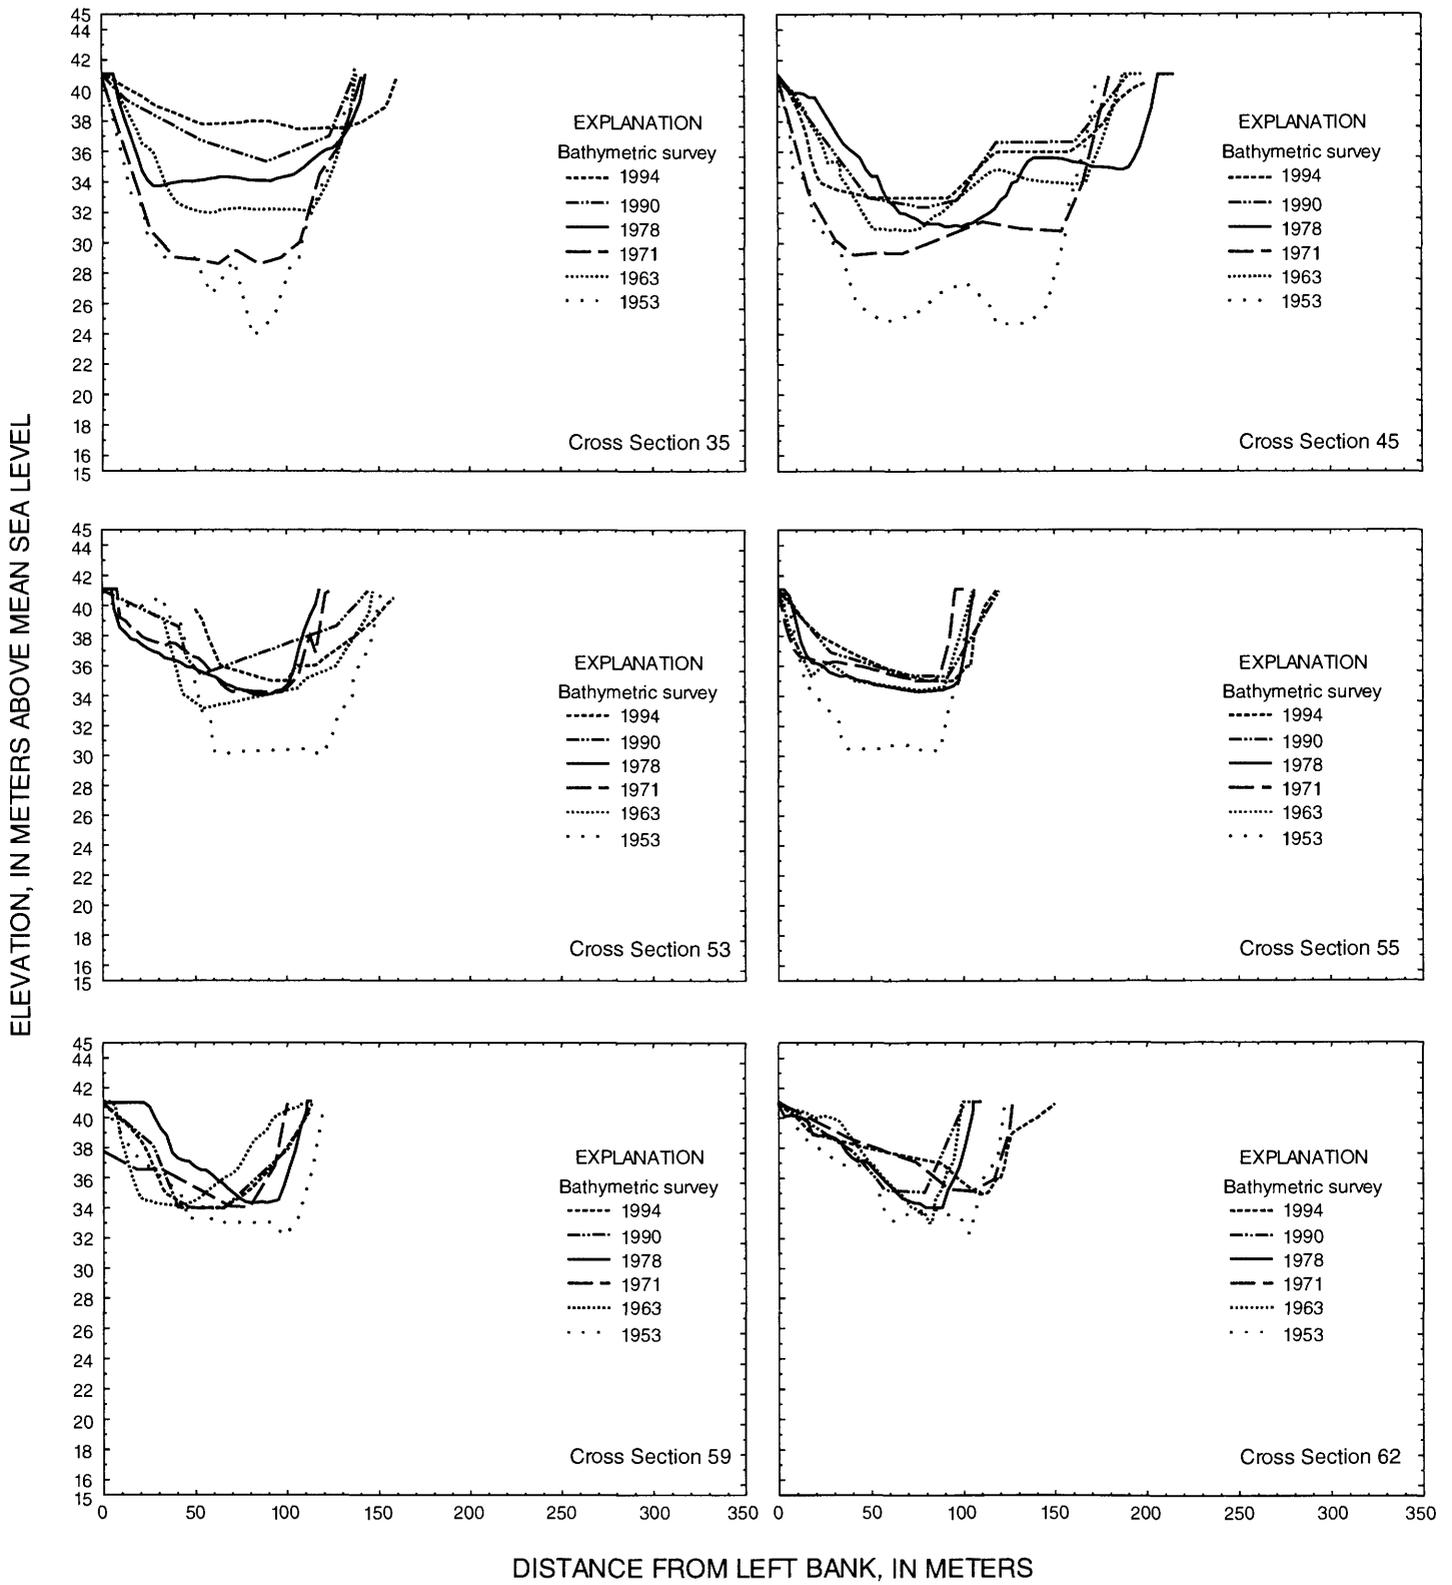
Figure 6. Historical cross sections of Lago Loíza, Puerto Rico, 1953–94. Locations of cross sections shown on figure 5.

Figure 6. Historical cross sections of Lago Loíza, Puerto Rico, 1953–94. Locations of cross sections shown on figure 5—Continued.

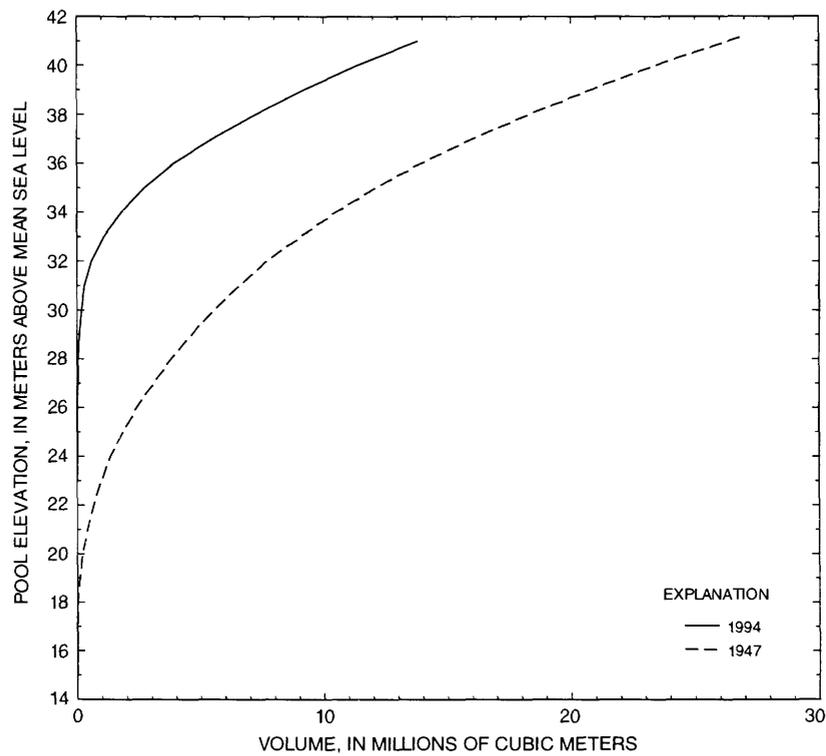
Figure 7. Stage-volume curves for Lago Loíza, Puerto Rico. The curves were determined based on hydrographic data collected in November 1994 and topographic data of the reservoir site collected in 1947.

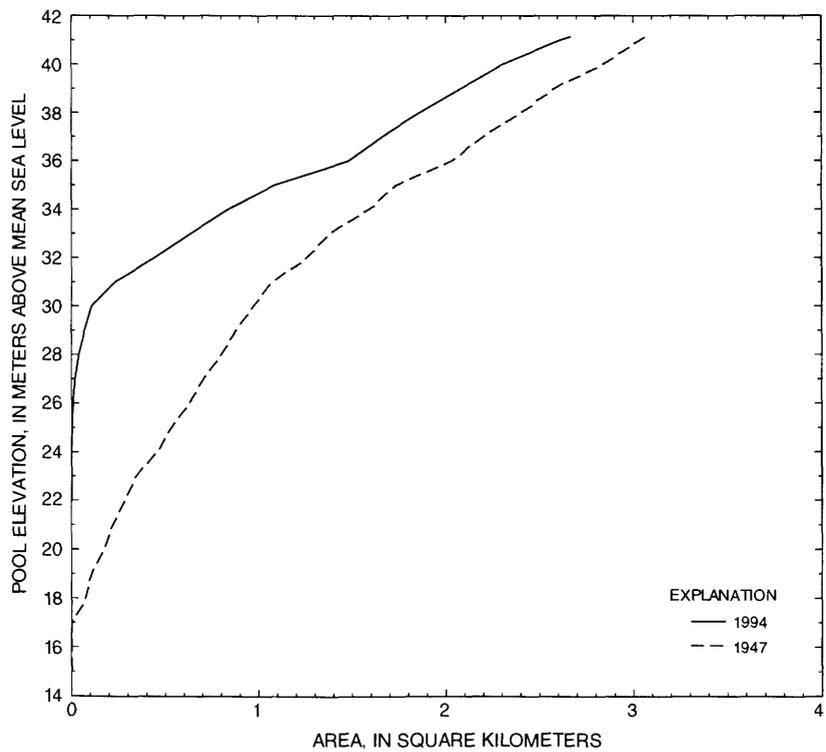
Figure 8. Stage-area curves for Lago Loíza, Puerto Rico. The curves were determined based on hydrographic data collected in November 1994 and topographic data of the reservoir site collected in 1947.

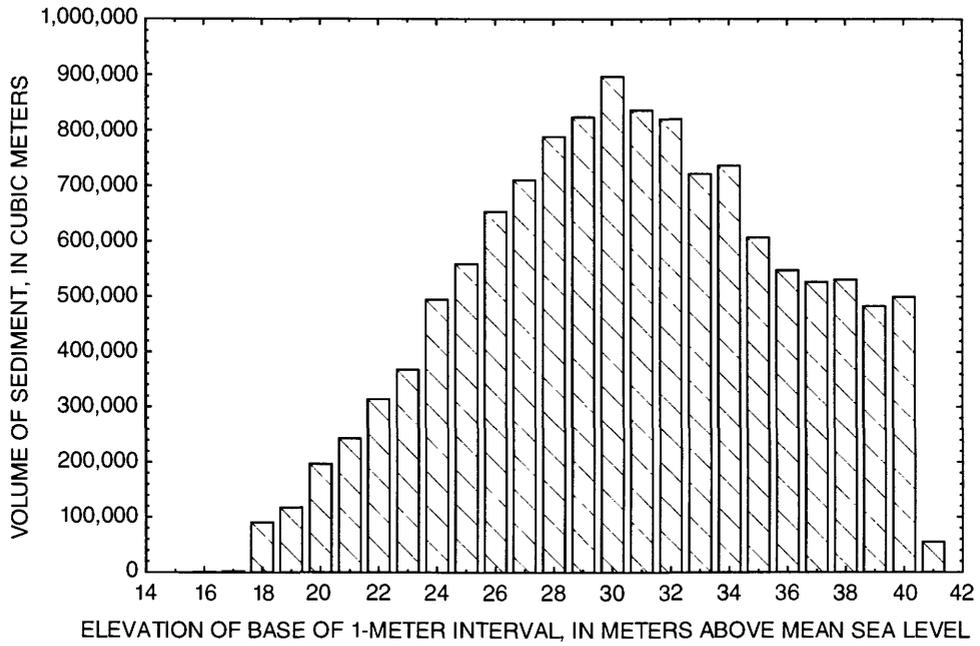
Figure 9. Volume of sediment deposited in Lago Loíza from 1953 to 1994, in 1-meter intervals.

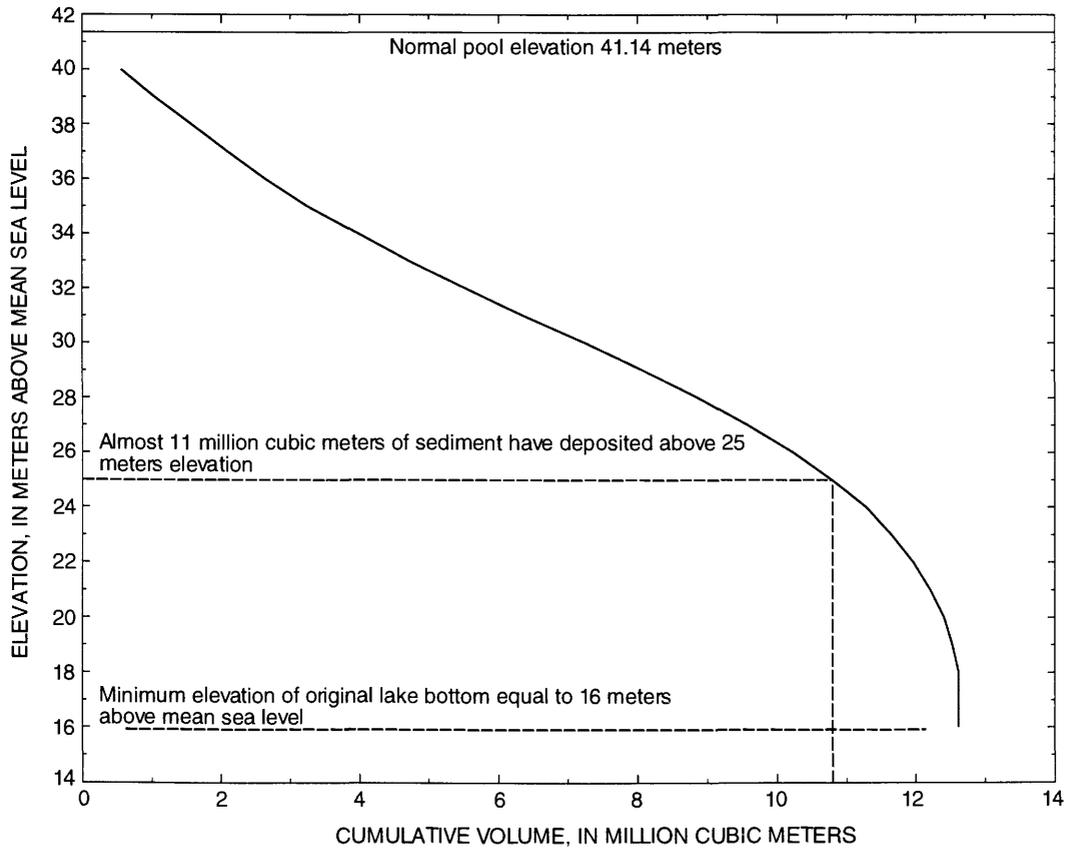
Figure 10. Total volume of sediments accumulated in Lago Loíza above a given elevation for the period 1953 to 1994.

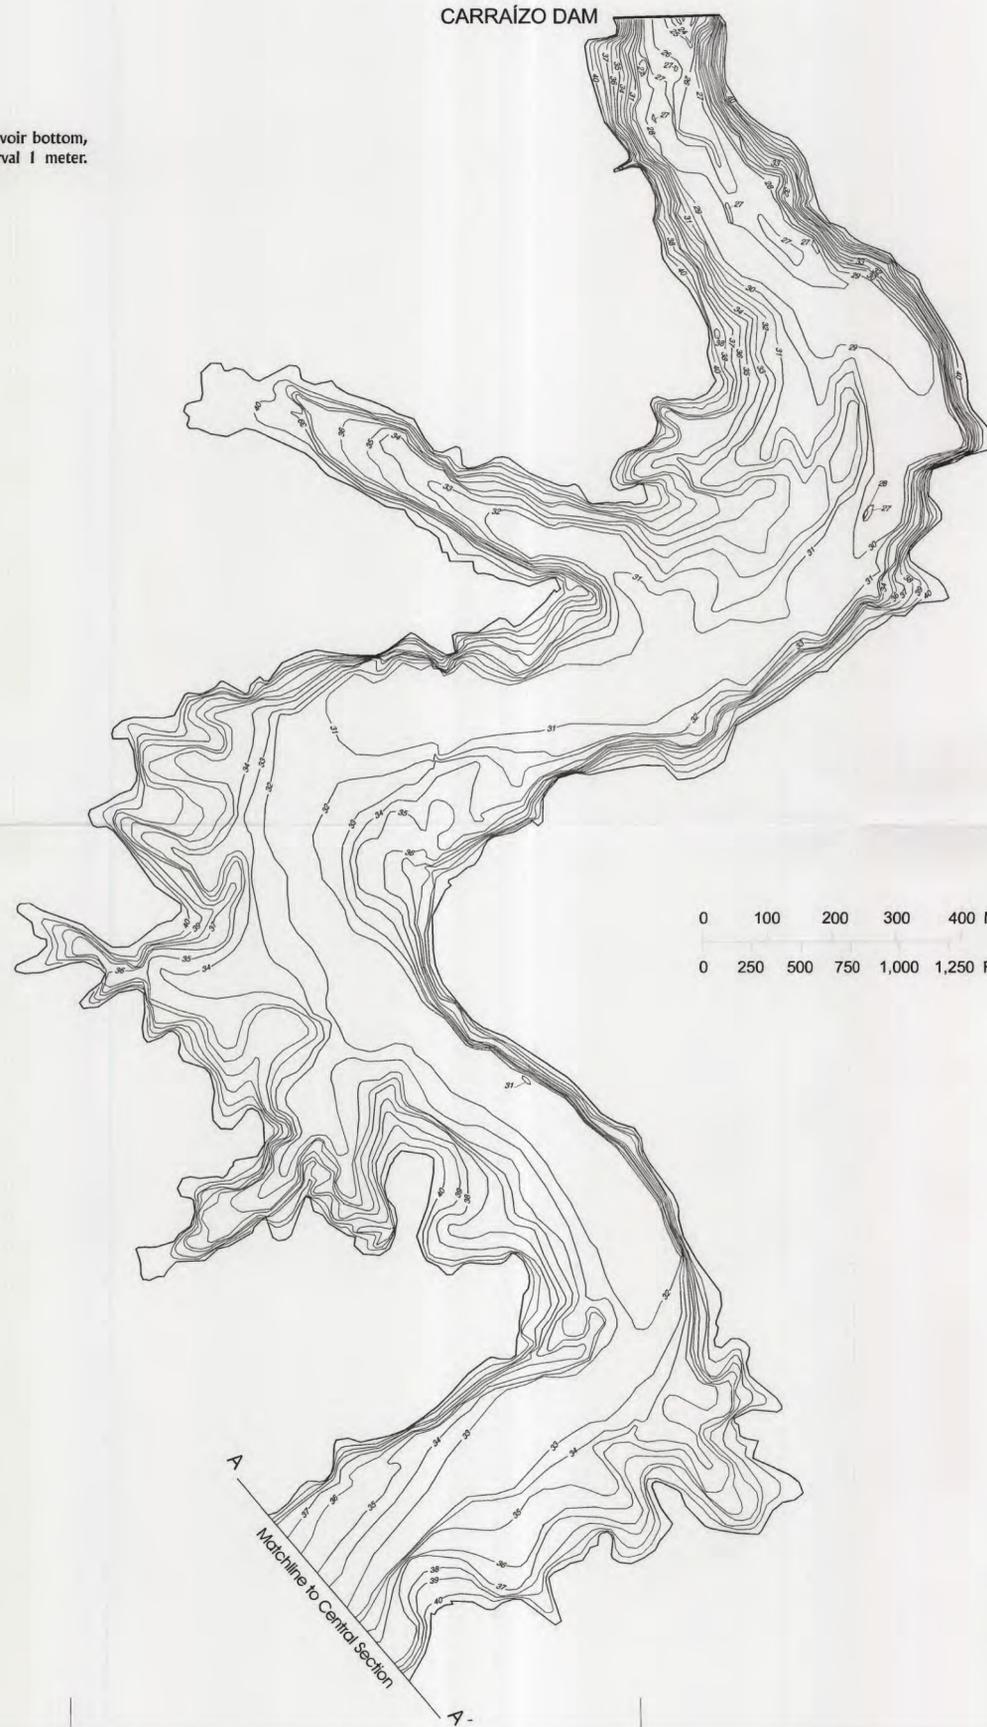
**LAGO LOÍZA, PUERTO RICO,
BATHYMETRY, 1994 (Northern Section)**
By
Richard M.T. Webb and Luis R. Soler-López
1997

— 40 — RESERVOIR BOTTOM CONTOUR - Elevation of the reservoir bottom, in 1994, in meters above mean sea level. Contour interval 1 meter. Shoreline at 41.14 meters above mean sea level

were drawn at 1-meter intervals and a map produced at a scale of 1:5000 (pls. 1, 2, 3). The contour map was used to create a TIN. Stage-storage relationships were then calculated using the TIN as the surface model. The VOLUME algorithm (Environmental Systems Research Institute, Inc., 1992) integrates the volume between the surface model (TIN) and a given datum.

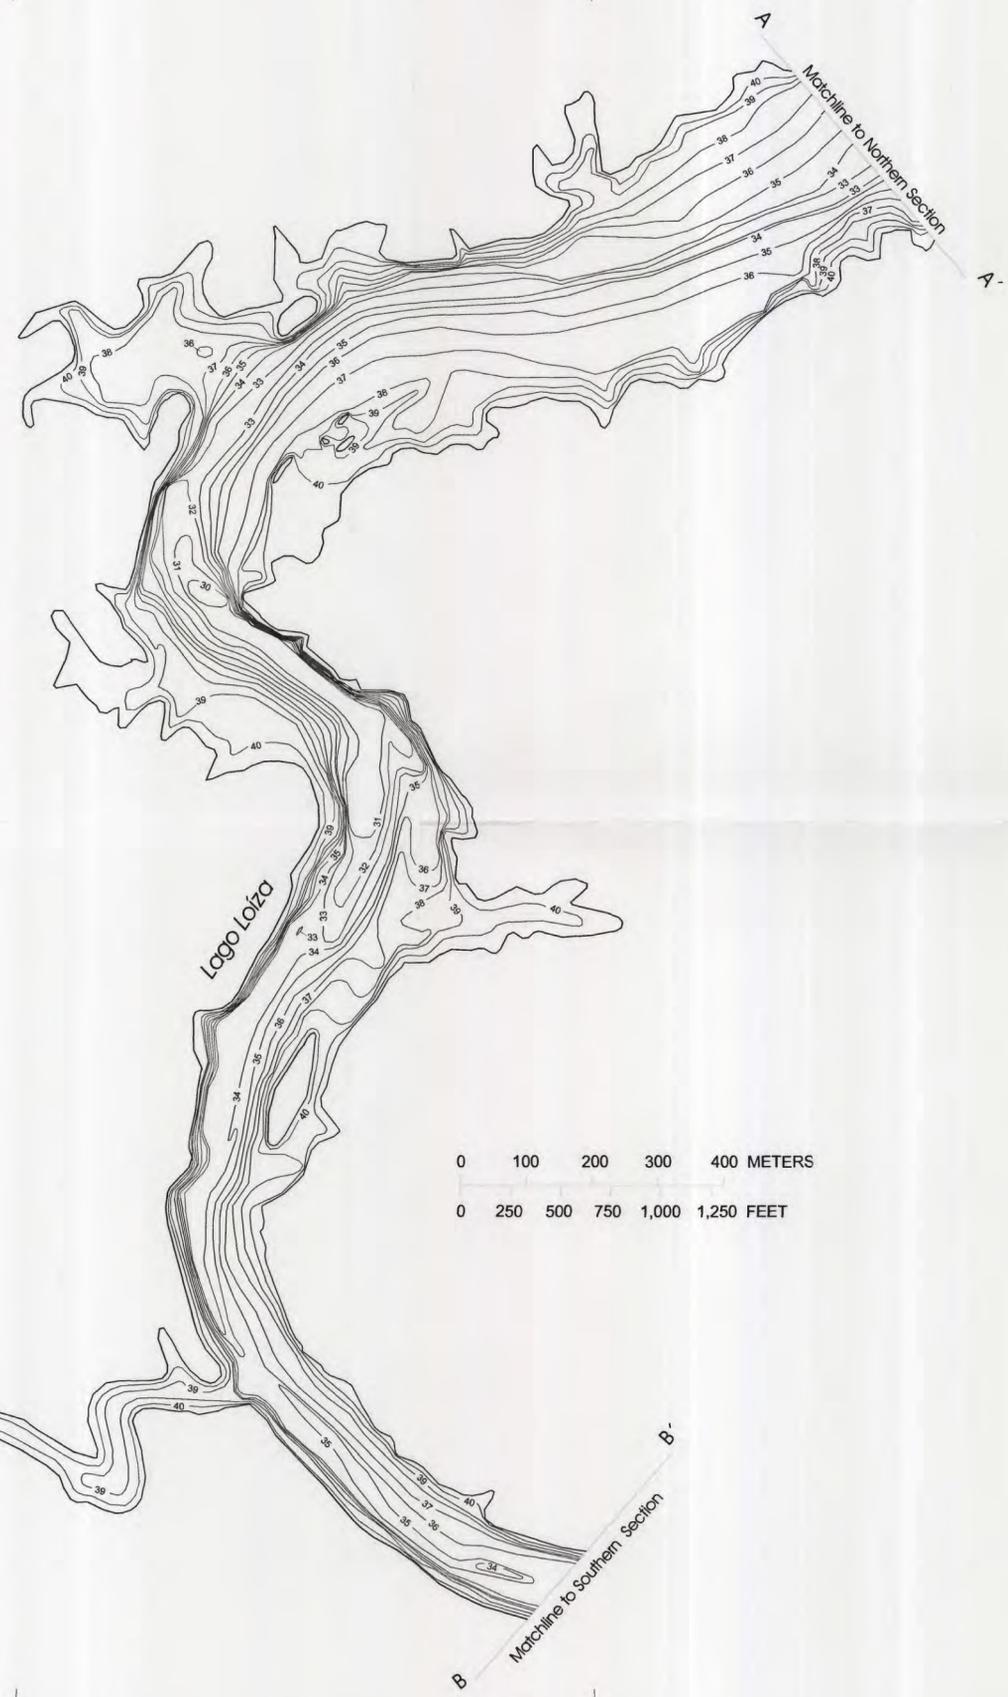
**LAGO LOÍZA, PUERTO RICO,
BATHYMETRY, 1994 (Central Section)**
By
Richard M.T. Webb and Luis R. Soler-López
1997

— 40 — RESERVOIR BOTTOM CONTOUR - Elevation of the reservoir bottom, in 1994, in meters above mean sea level. Contour interval 1 meter. Shoreline at 41.14 meters above mean sea level

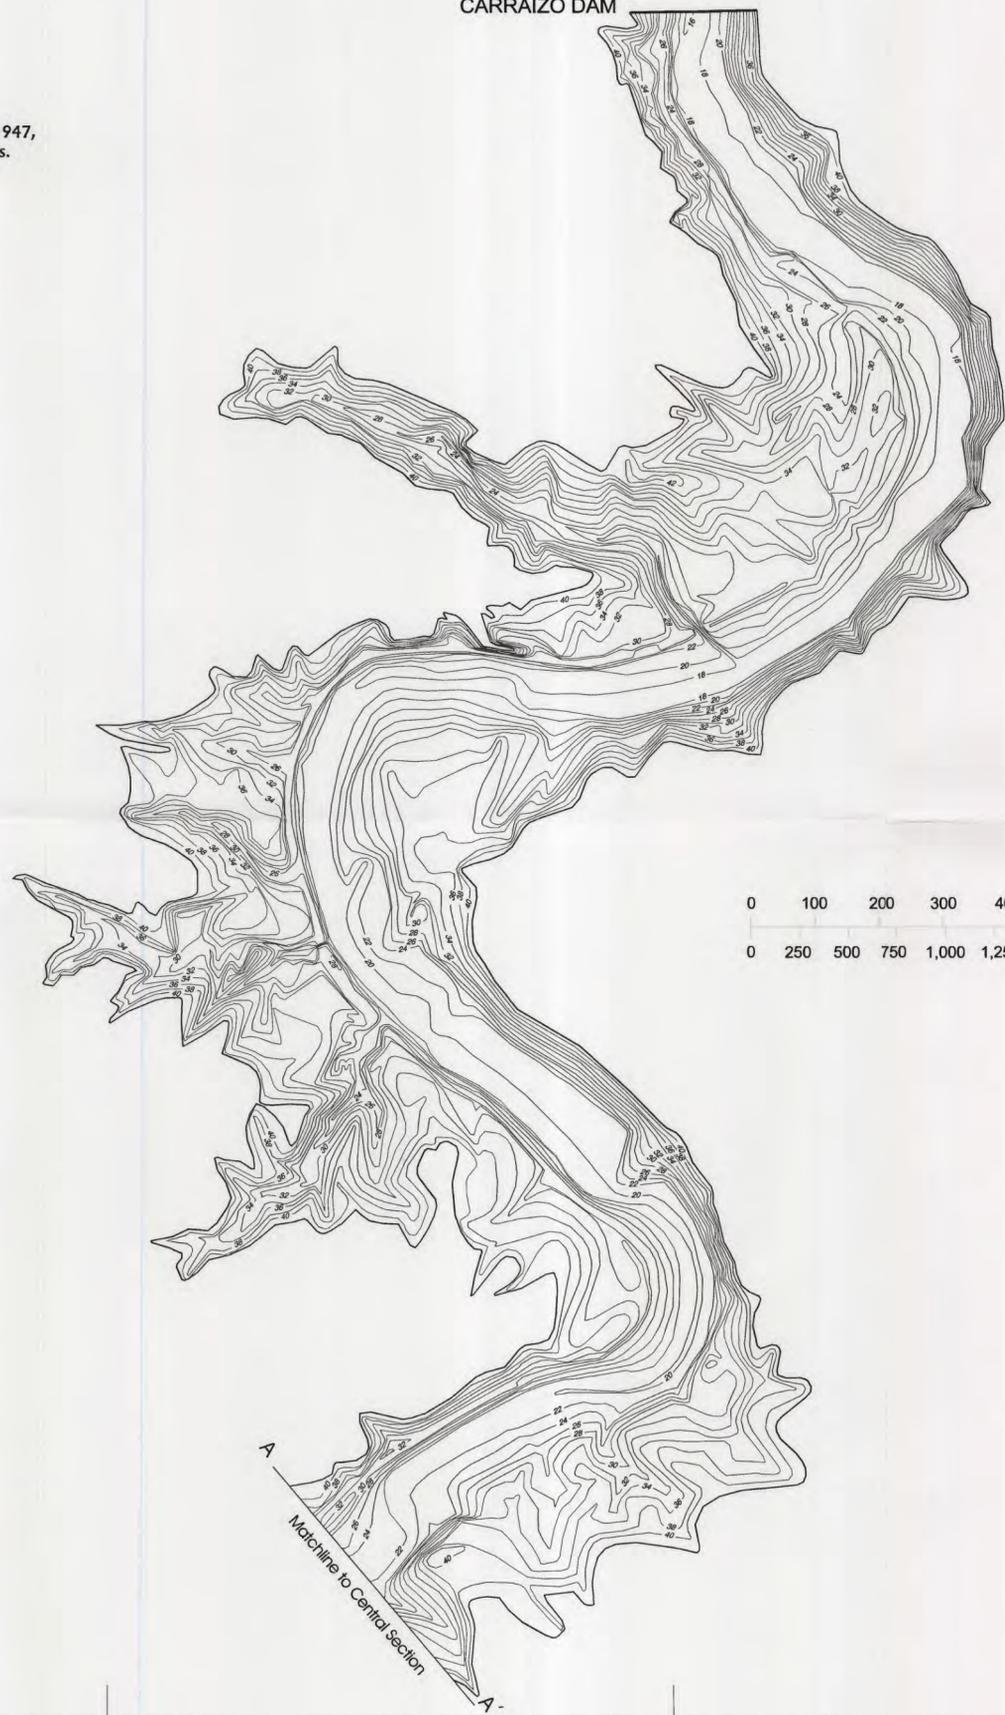
**LAGO LOÍZA, PUERTO RICO,
TOPOGRAPHY, 1947 (Northern Section)**
By
Richard M.T. Webb and Luis R. Soler-López
1997

— 40 — ORIGINAL TOPOGRAPHY - Line of equal elevation, in 1947,
in meters above mean sea level. Contour interval 2 meters.
Maximum contour at 42 meters above mean sea level
