Sedimentation History of Lago Loíza, Puerto Rico, 1953–94

By Richard M.T. Webb and Luis R. Soler-López

Water-Resources Investigations Report 97–4108

PUERTO RICO AQUEDUCT AND SEWER AUTHORITY

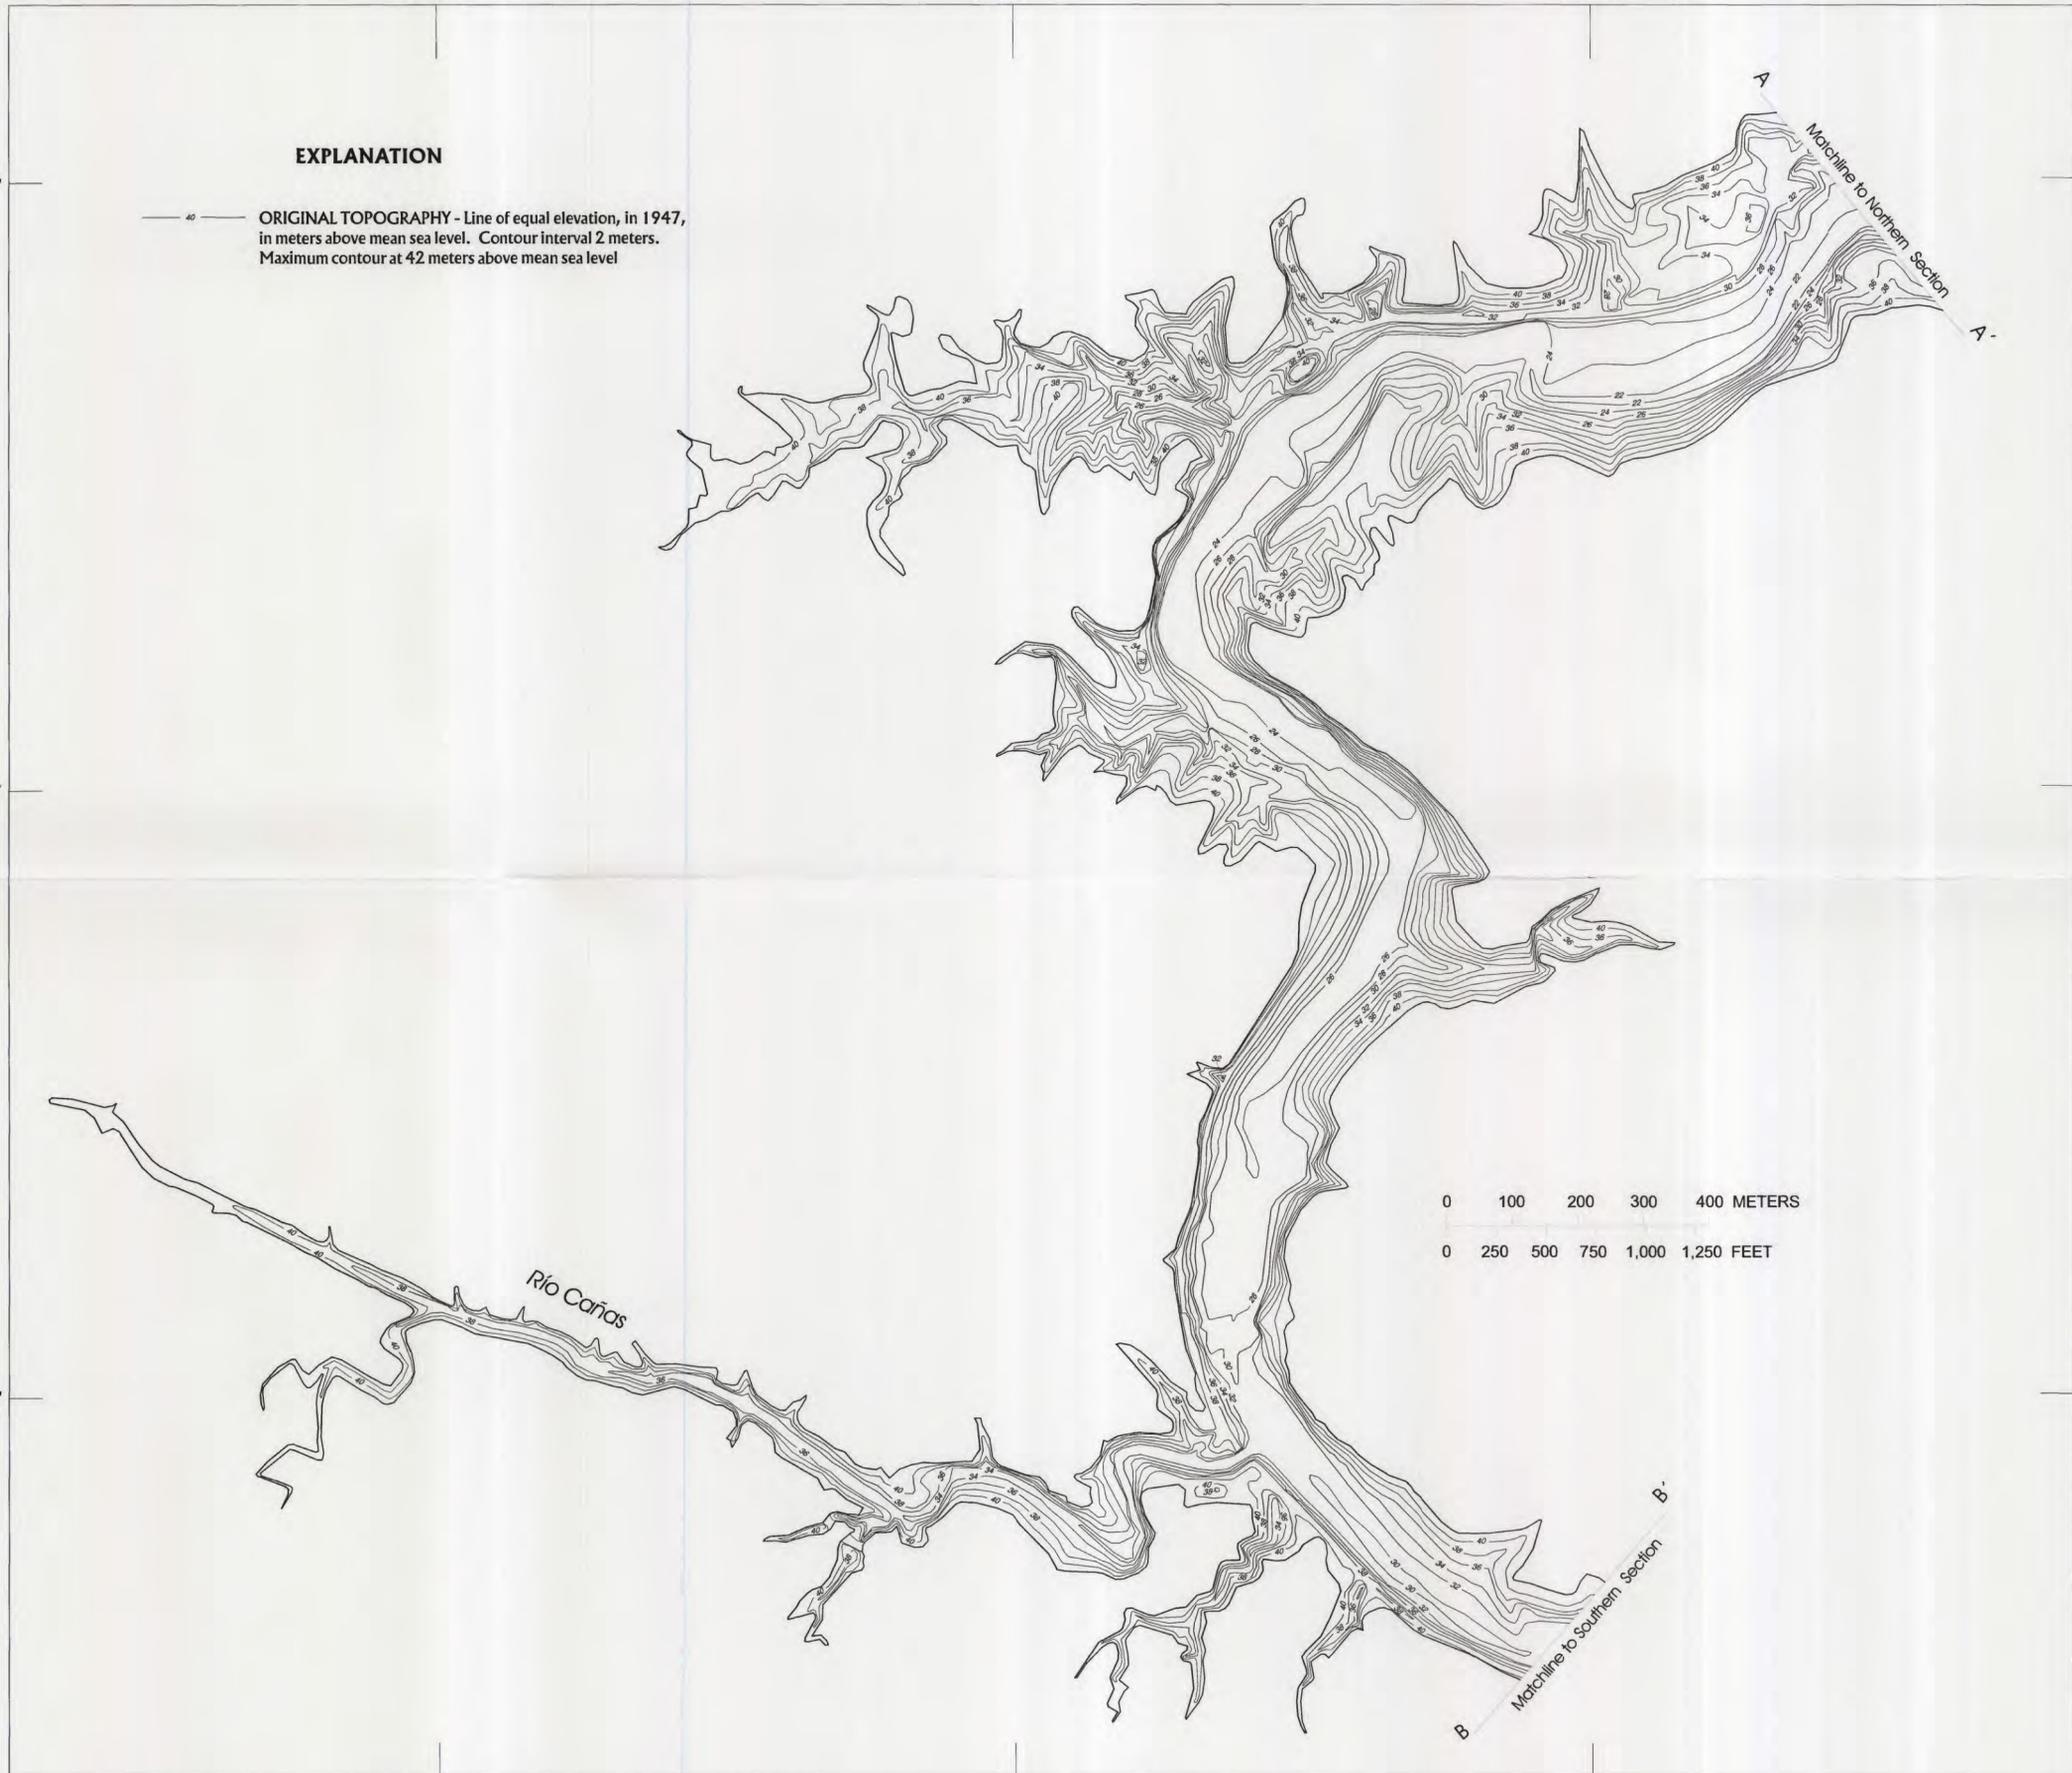
**LAGO LOÍZA, PUERTO RICO,
TOPOGRAPHY, 1947 (Central Section)**

— 40 — ORIGINAL TOPOGRAPHY - Line of equal elevation, in 1947,
in meters above mean sea level. Contour interval 2 meters.
Maximum contour at 42 meters above mean sea level
