State of Flood Plain Vegetation Within the Meander Belt of the Clark Fork of the Columbia River, Deer Lodge Valley, Montana

Water-Resources Investigations Report 02-4109

By Eleanor R. Griffin and J. Dungan Smith

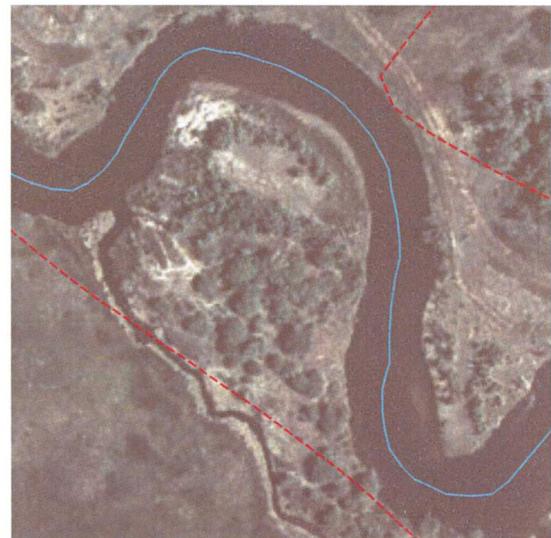
B. Tab 145 at RM 22.38; an example of vulnerability class 20.0, with 20 percent - 40 percent shrub canopy cover, but few shrubs along the tab edges. Flow is from right to left. The smaller channel ending at the downstream edge of the tab neck is connected to a marshy area a short distance up-valley.

Figure 12. Examples of tabs with characteristics representative of the various classes. The images shown are all taken from the 1997 aerial photographs. The blue line is the river centerline identified for the bank erosion rate study (R2 Resource Consultants, Inc, unpub. data, 1998), and the red dashed lines are the edges of the meander belt.

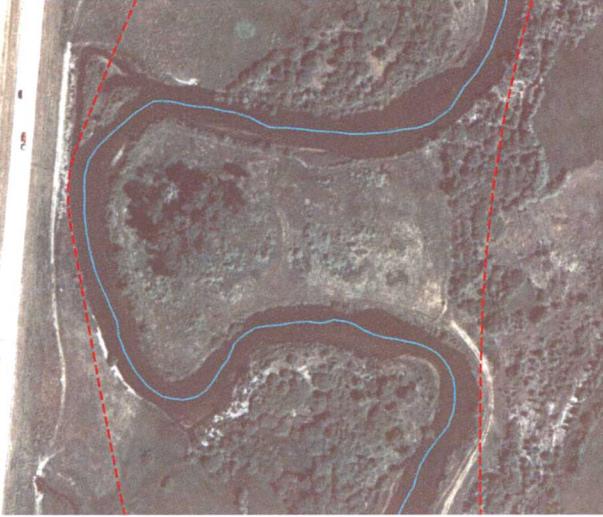
C. Tab 134 at RM 20.67; an example of vulnerability class 31.1, with 20 percent - 40 percent shrub canopy cover and sparse shrubs along the downstream tab edge. Flow is from bottom to top. The few shrubs along the downstream edge of this tab are about the minimum considered as sparse density. This tab includes the first stand of cottonwoods encountered when traveling downstream from Warm Springs.

Figure 12. Examples of tabs with characteristics representative of the various classes. The images shown are all taken from the 1997 aerial photographs. The blue line is the river centerline identified for the bank erosion rate study (R2 Resource Consultants, Inc, unpub. data, 1998), and the red dashed lines are the edges of the meander belt--Continued.

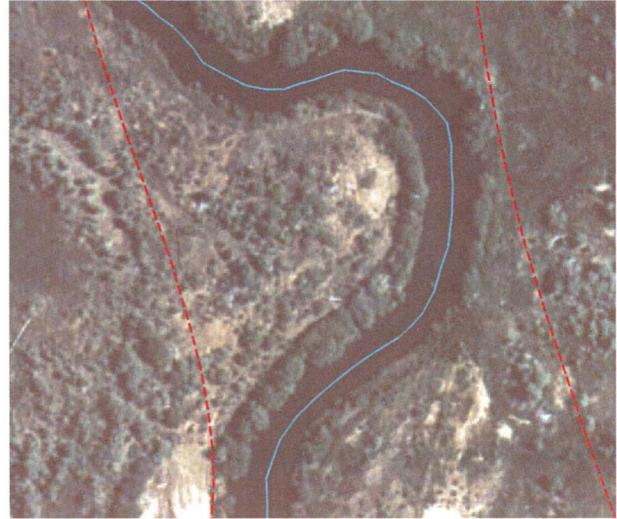
D. Tab 31 at RM 4.95; an example of vulnerability class 32.3, with 20 percent - 40 percent shrub canopy cover and dense shrubs along the upstream tab edge. Flow is from bottom to top.

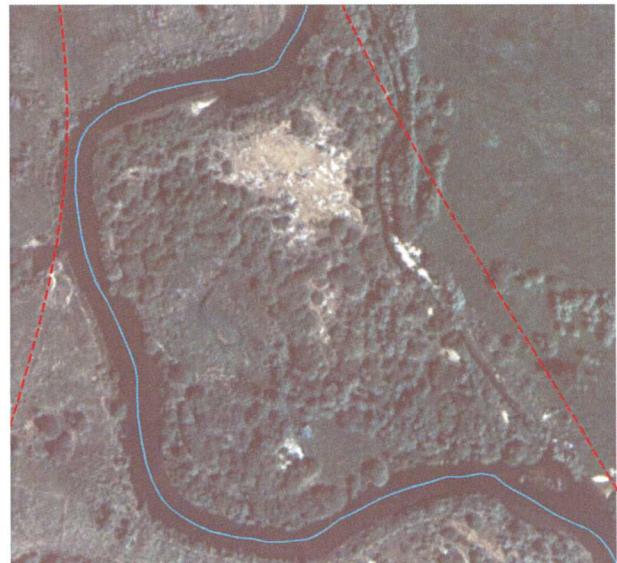
F. Tab 59 at RM 8.95; an example of vulnerability class 43.3, with 40 percent - 60 percent shrub canopy cover, generally clumped in the tab interior, and dense shrubs along both tab edges. Flow is from bottom to top.

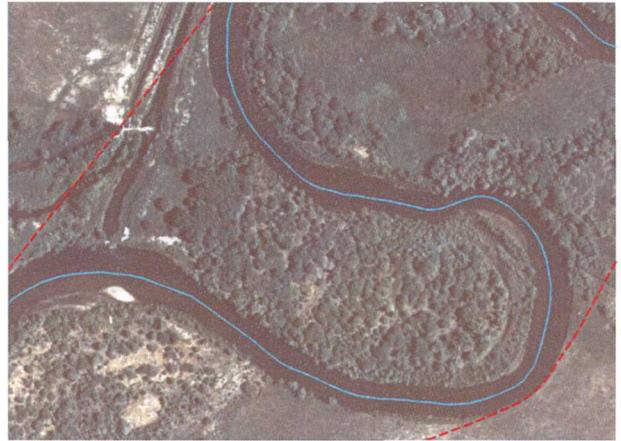
H. Tab 72 at RM 11.02; an example of vulnerability class 63.2, with 60 percent - 85 percent shrub canopy cover, shrubs clumped in the tab interior, leaving an open flow path across the tab neck, and moderate density of shrubs along both tab edges. Flow is from left to top, and an irrigation ditch runs along the tab neck.

Figure 12. Examples of tabs with characteristics representative of the various classes. The images shown are all taken from the 1997 aerial photographs. The blue line is the river centerline identified for the bank erosion rate study (R2 Resource Consultants, Inc, unpub. data, 1998), and the red dashed lines are the edges of the meander belt--Continued.

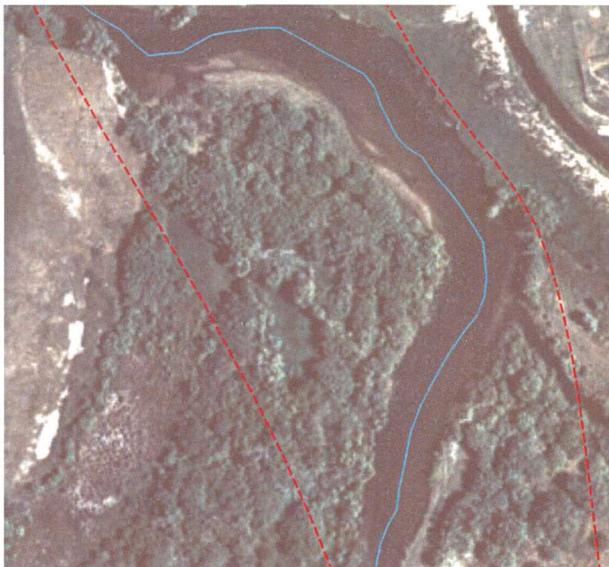
I. Tab 109 at RM 16.54; an example of vulnerability class 73.2, with 60 percent - 85 percent shrub canopy cover, shrubs fairly evenly distributed on tab interior, and moderate density of shrubs along both tab edges. Flow is from bottom to top. Although the shrubs along the upstream edge are dense, the classification was based on an average density of shrubs along the two edges.

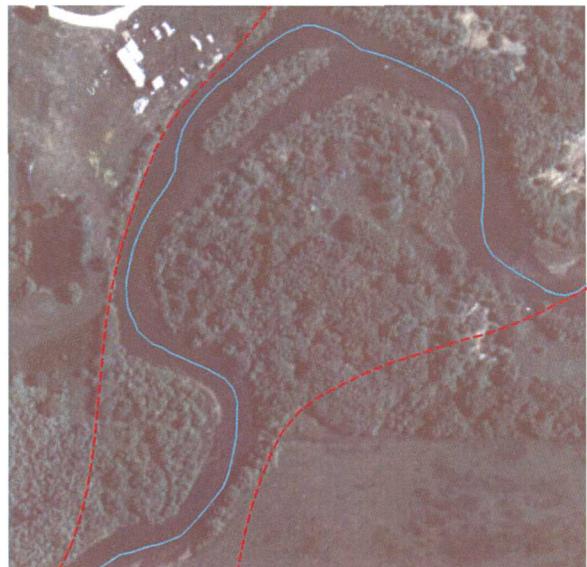
J. Tabs 78 (the smaller tab at lower left) and 79 (the large tab in the center) at RMs 12.01 and 12.13, respectively; both are examples of vulnerability class 80.0, with greater than 85 percent shrub canopy cover. These tabs are examples of the class least vulnerable to surface erosion during overbank flows. Flow is from left to right.
