**Figure 23.** Locations at which shoreline change and overwash were documented.

**Figure 24.** Storm wave overwash along N.C. Highway 12 north of Buxton, N.C., September 8, 1999.

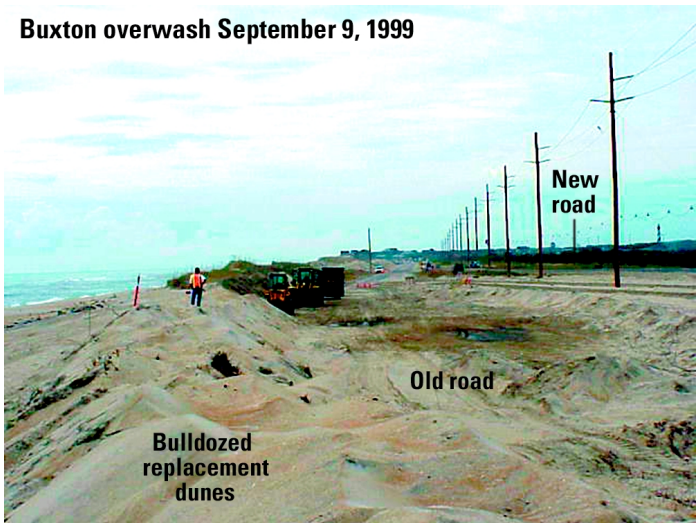
N.C. Highway 12 (figs. 24, 25, and 26). Before Hurricane Dennis, the dunes at a location north of Buxton (fig. 23) were nearly 20 feet high (fig. 26). Replacement dunes were constructed by using bulldozers

**Figure 25.** Former location of N.C. Highway 12 near Buxton and replacement dunes.

following the storm, and were located landward of the original dune line. The replacement dunes were approximately 5 feet lower than the dunes destroyed during the storm.

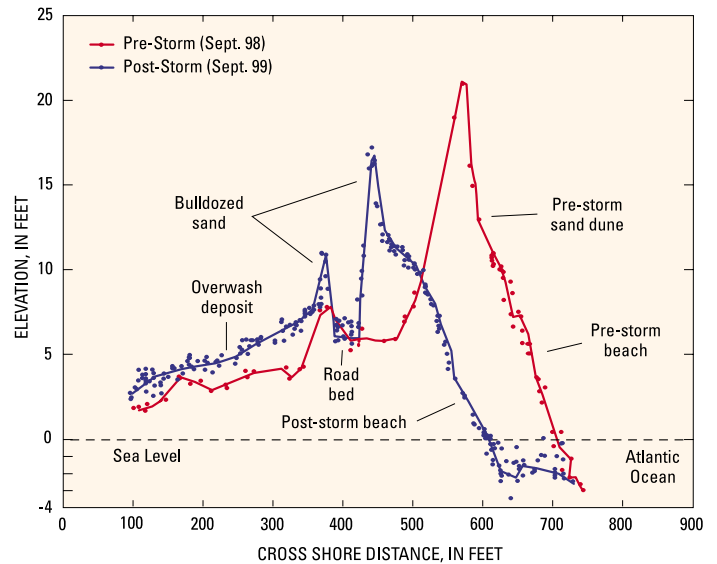
**Figure 26.** Cross-shore profiles of the area north of Buxton where N.C. Highway 12 was destroyed. Profiles were obtained after Hurricane Dennis by using laser altimetry. The pre-storm dune was completely eroded, and the area was overwashed. After the storm, a new dune was created using bulldozers.

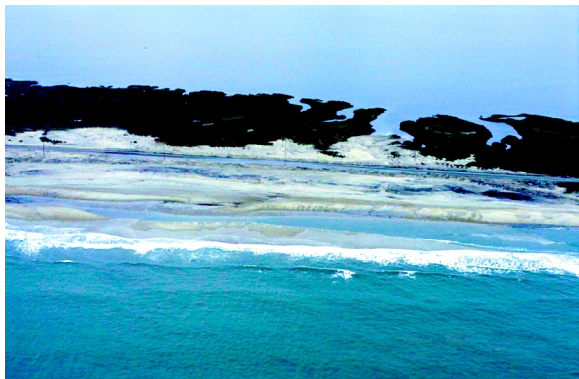
Ocean overwash resulting from Hurricane Floyd

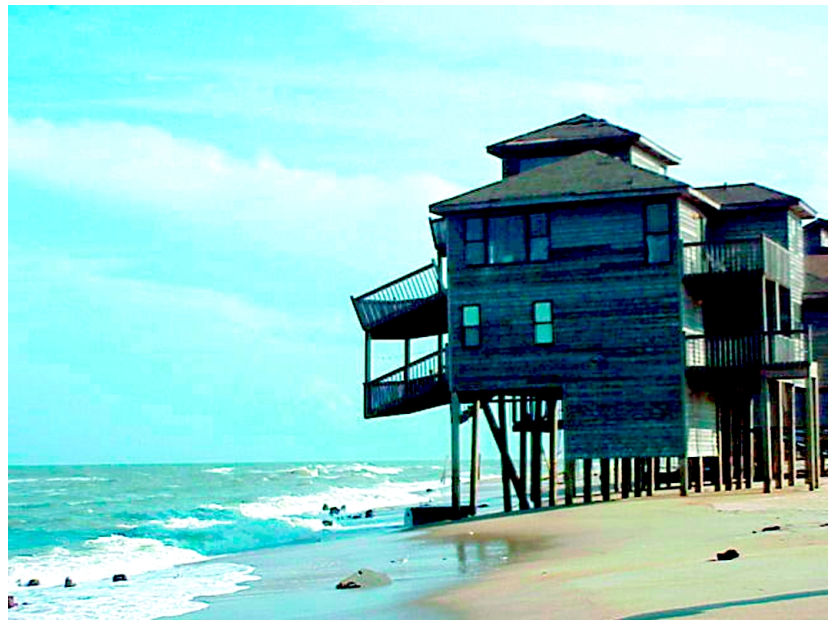
Another heavily eroded area at Rodanthe (fig. 23) led to the condemnation (fig. 27) and loss of several ocean-front houses. The laser altimetry data clearly reveal the lost houses (fig. 28). This spatial variability of high erosional rates and lower erosional rates was repeated along the coast over scales of miles, and may be related to varying nearshore geology. Identification of the causes of the variability in erosional rates is a major research objective of the USGS Coastal and Marine Geology Program.

**Figure 27.** Houses standing in the surf at Rodanthe, N.C. With no protective dunes remaining to protect the houses, the balcony supports were destroyed during the storm. These houses have been condemned.

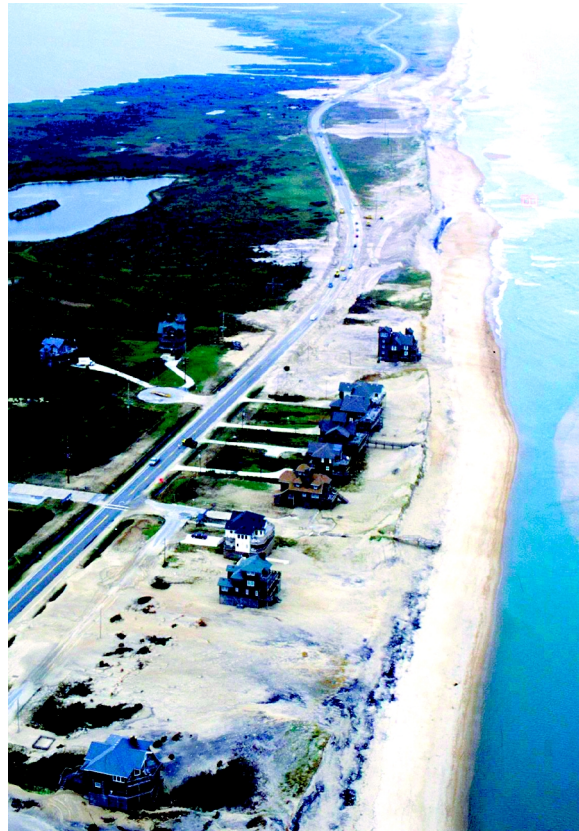
Houses near the surf with little or no protective dunes, Oak Island, N.C.

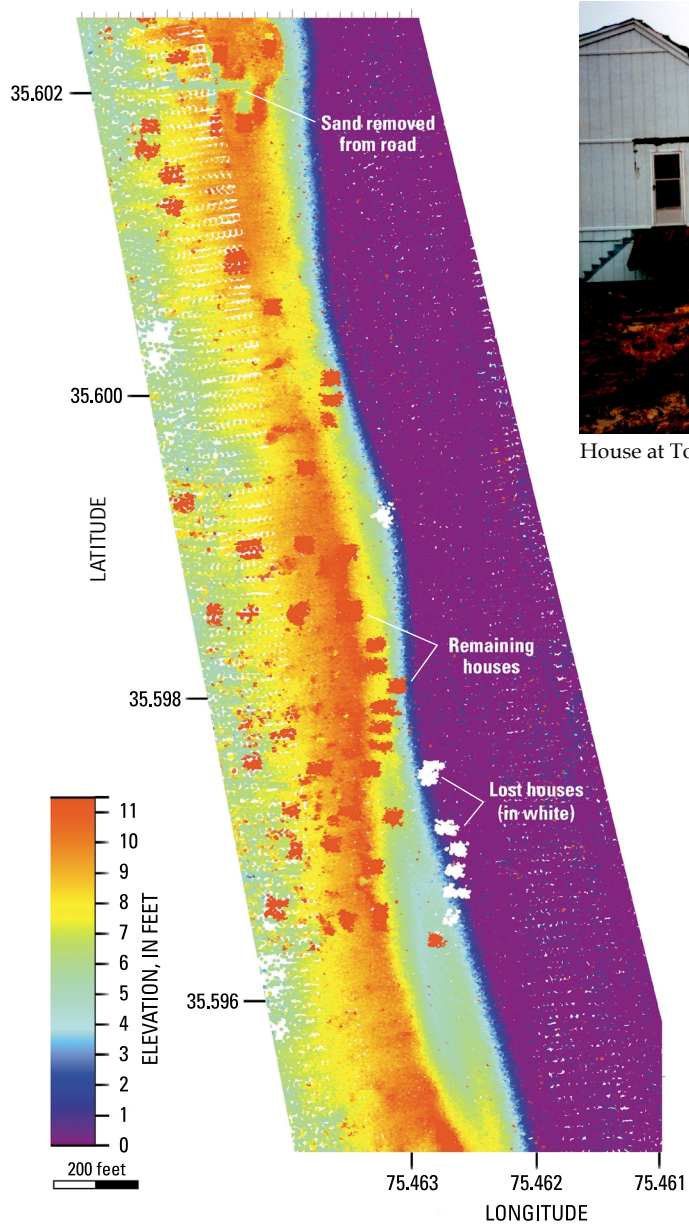
**Figure 28.** Post Hurricane Dennis topography generated from laser altimeter data of an area near Rodanthe, N.C. The dark blue/purple colors are water. Note the red “rectangles” which indicate houses that survived the storm. The white “rectangles” are houses observed in the pre-storm topography that were destroyed during the storm.

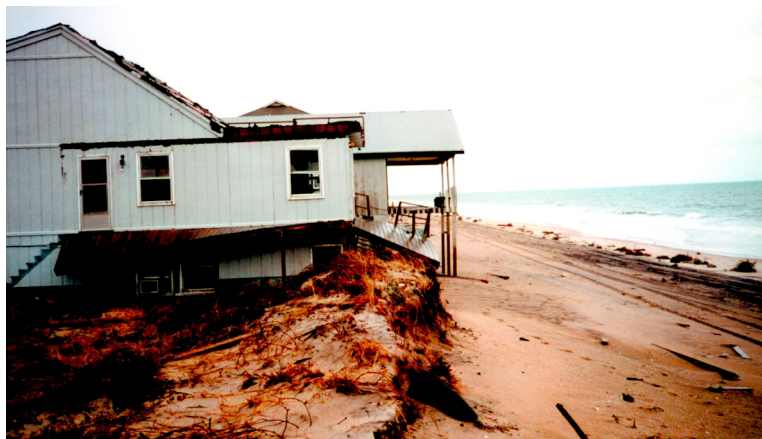
House at Topsail Beach now located seaward of dunes after Hurricane Floyd

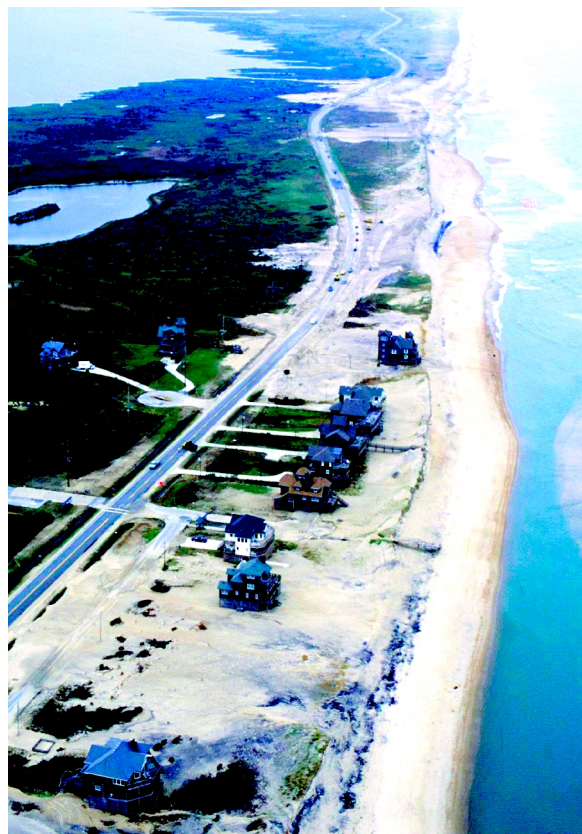
Extensive dune erosion resulting from Hurricane Dennis, northern Outer Banks
