Roughness Characteristics of Natural Channels

U.S. GEOLOGICAL SURVEY WATER-SUPPLY PAPER 1849

*Color photographs and descriptive
data for 50 stream channels for
which roughness coefficients have
been determined*

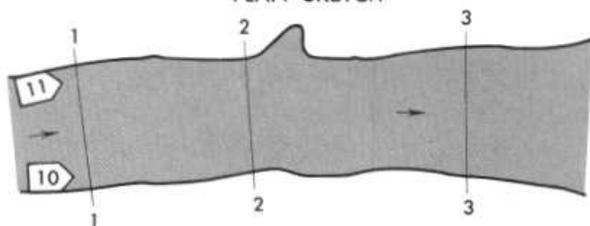
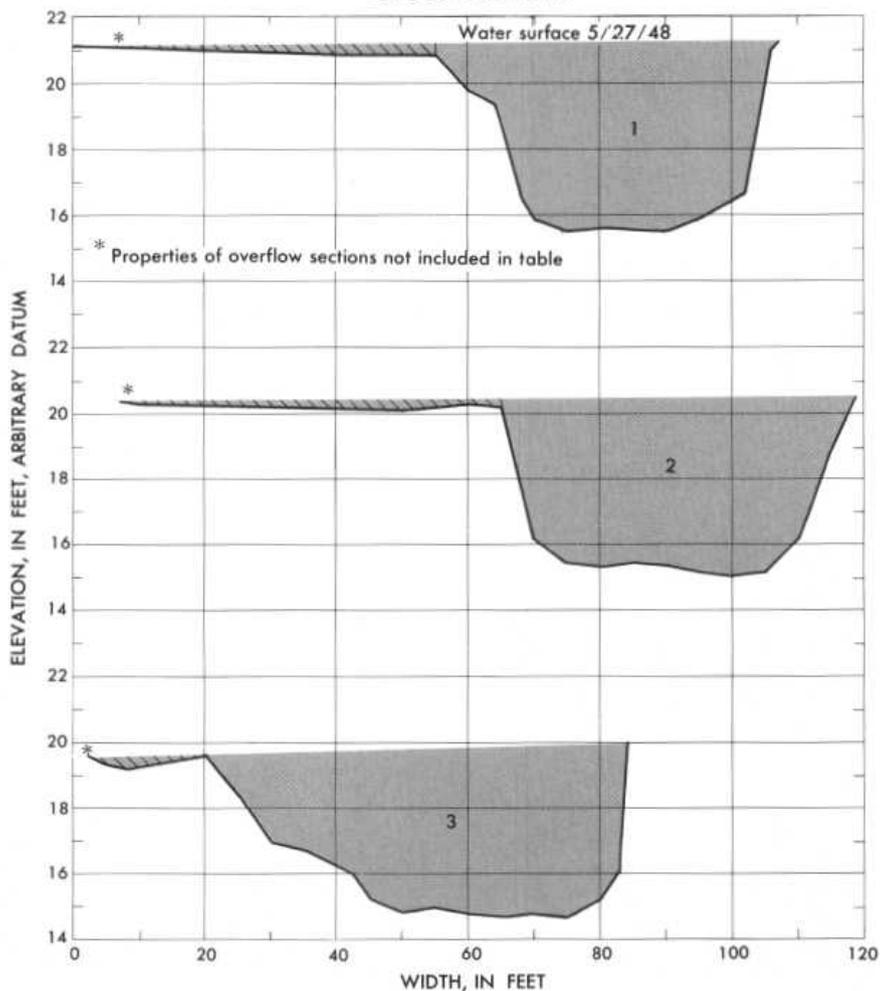
Plan sketch and cross sections, Catherine Creek near Union, Oreg.

Description of channel.—Bed consists of cobbles and small boulders. Banks are lined with small trees and brush, and limbs overhang along left bank.

Section	Area (sq ft)	Top width (ft)	Mean depth (ft)	Hydraulic radius (ft)	Mean velocity (ft per sec)	Length (ft) between sections	Fall (ft) between sections
1	220	52	4.23	4.00	7.91
2	236	54	4.37	4.15	7.37	102	0.73
3	256	64	4.00	3.76	6.80	116	.72

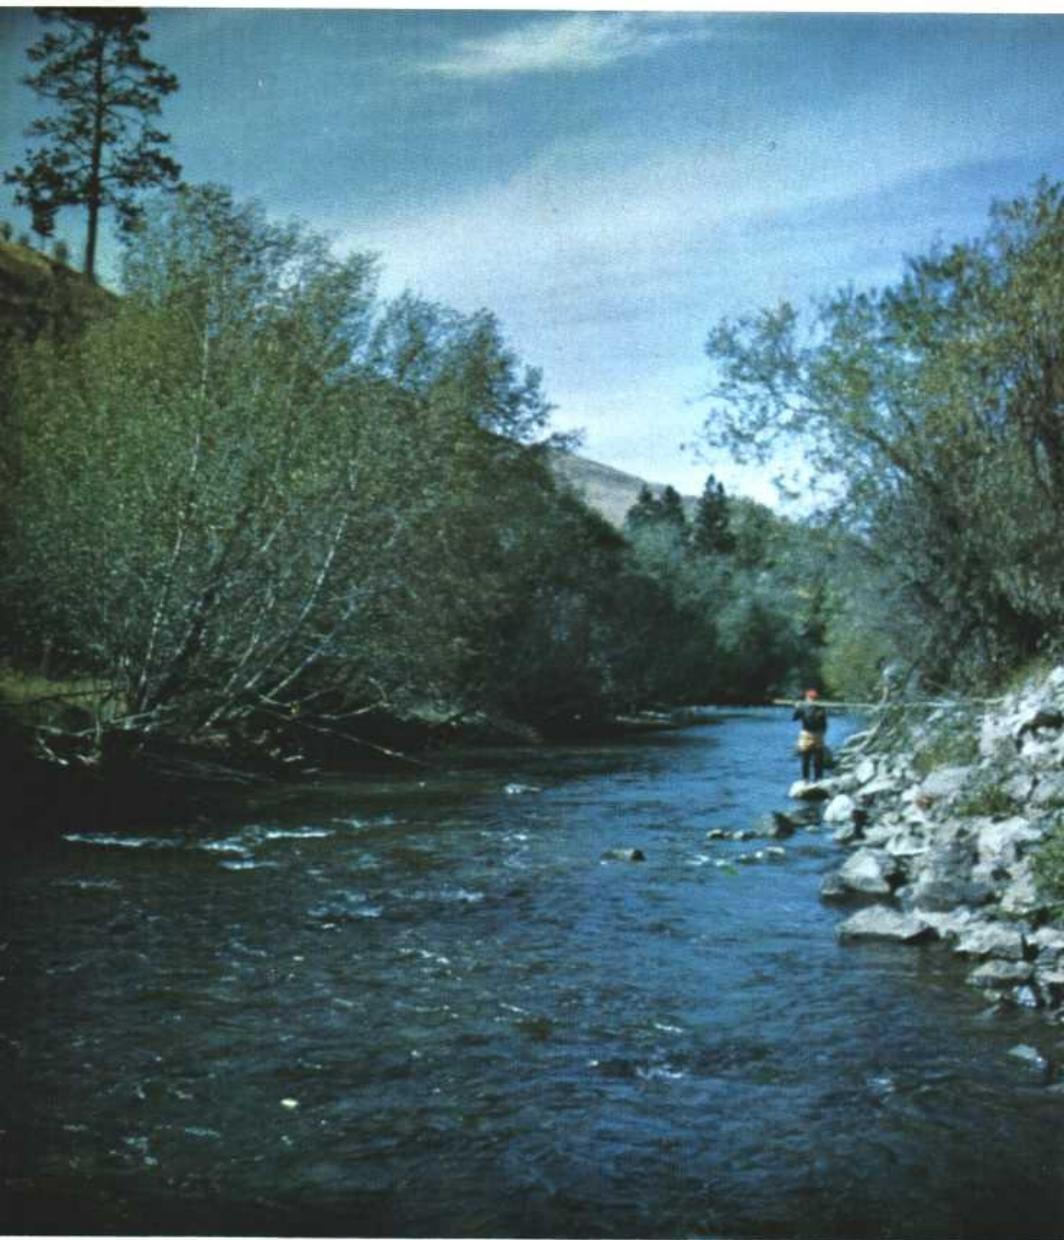
No. 10 downstream along right bank from above reach,
Catherine Creek near Union, Oreg.

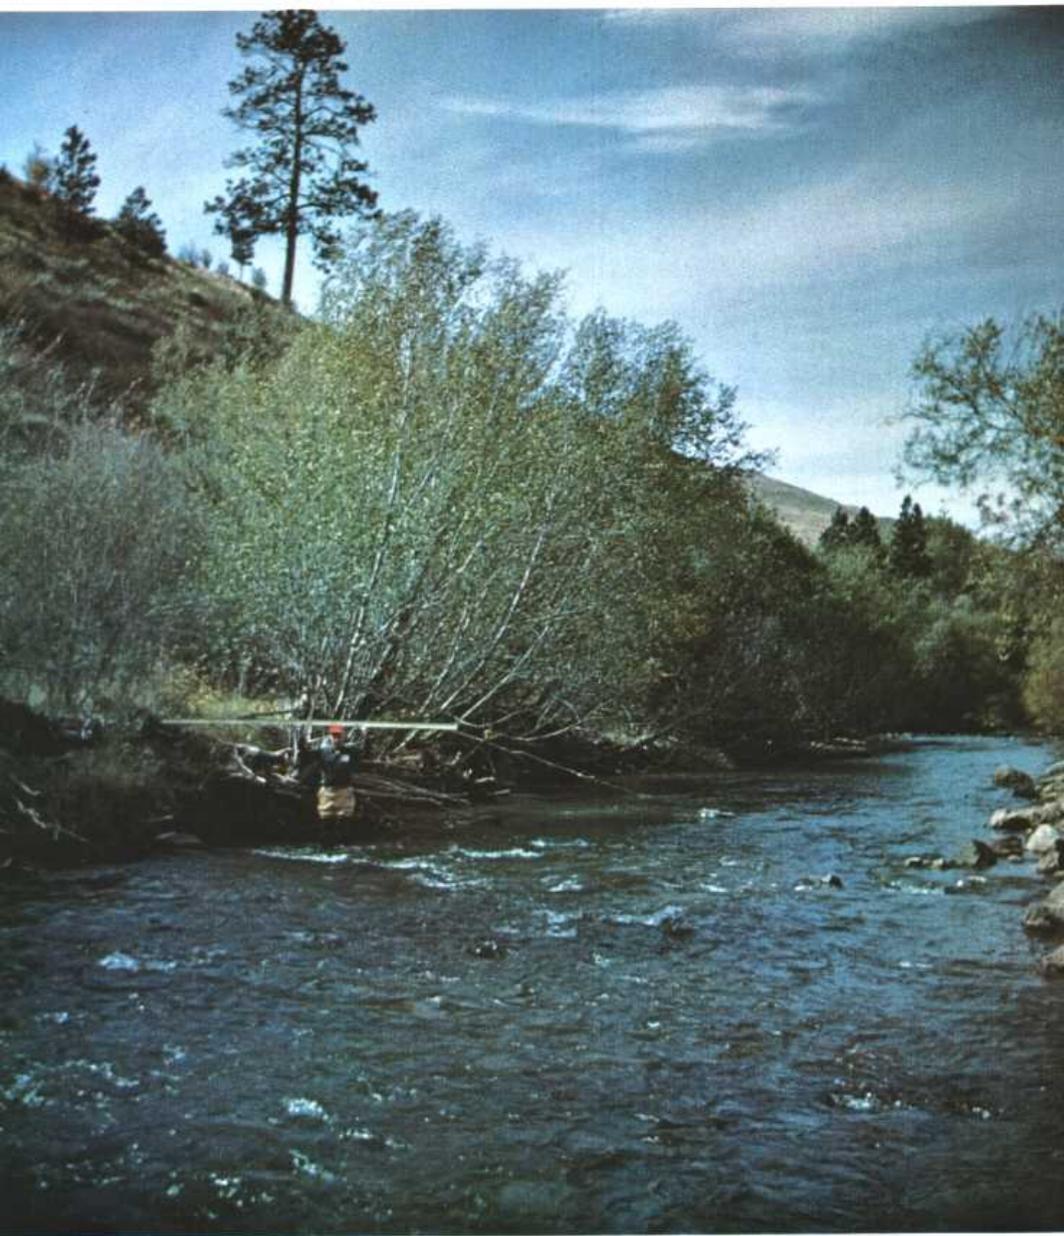
No. 11 downstream along left bank from above reach,
Catherine Creek near Union, Oreg.

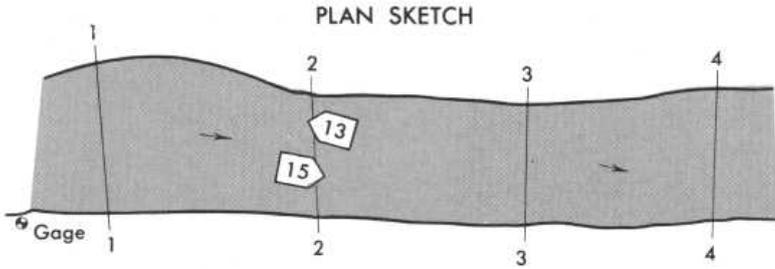
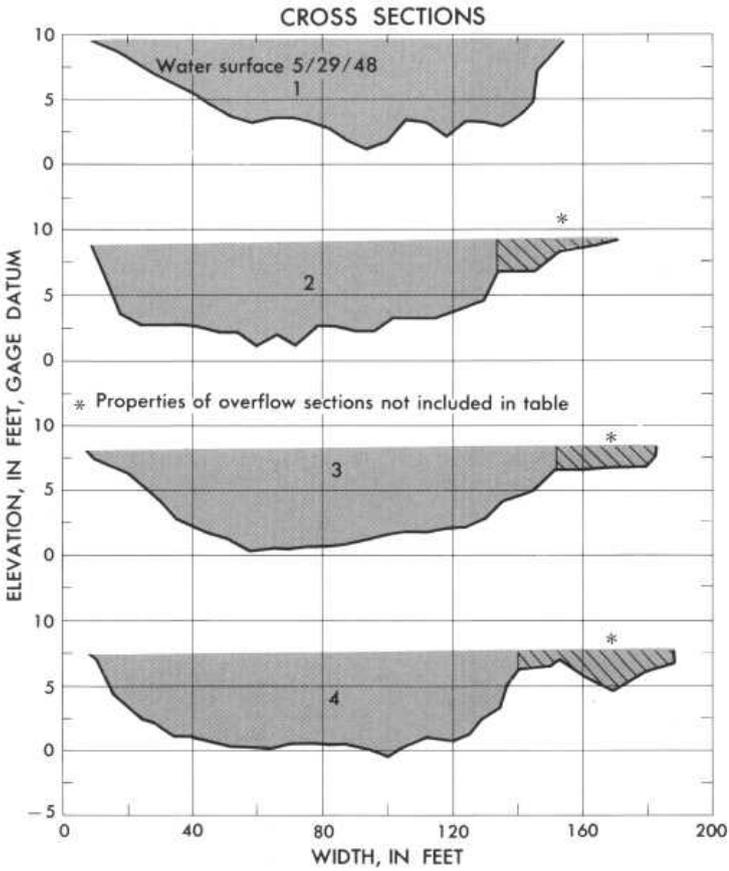
Plan sketch and cross sections, Chiwawa River near Plain, Wash.

Description of channel.—Bed generally extends to bedrock throughout reach with cover of boulders as much as $1\frac{1}{2}$ ft in diameter in some places. Banks are mildly sloped and have trees along the tops.

Section	Area (sq ft)	Top width (ft)	Mean depth (ft)	Hydraulic radius (ft)	Mean velocity (ft per sec)	Length (ft) between sections	Fall (ft) between sections
1.....	744	145	5.13	5.03	7.90
2.....	747	125	5.97	5.74	7.87	165	0.55
3.....	803	145	5.54	5.42	7.32	163	.80
4.....	770	131	5.89	5.75	7.64	145	.99

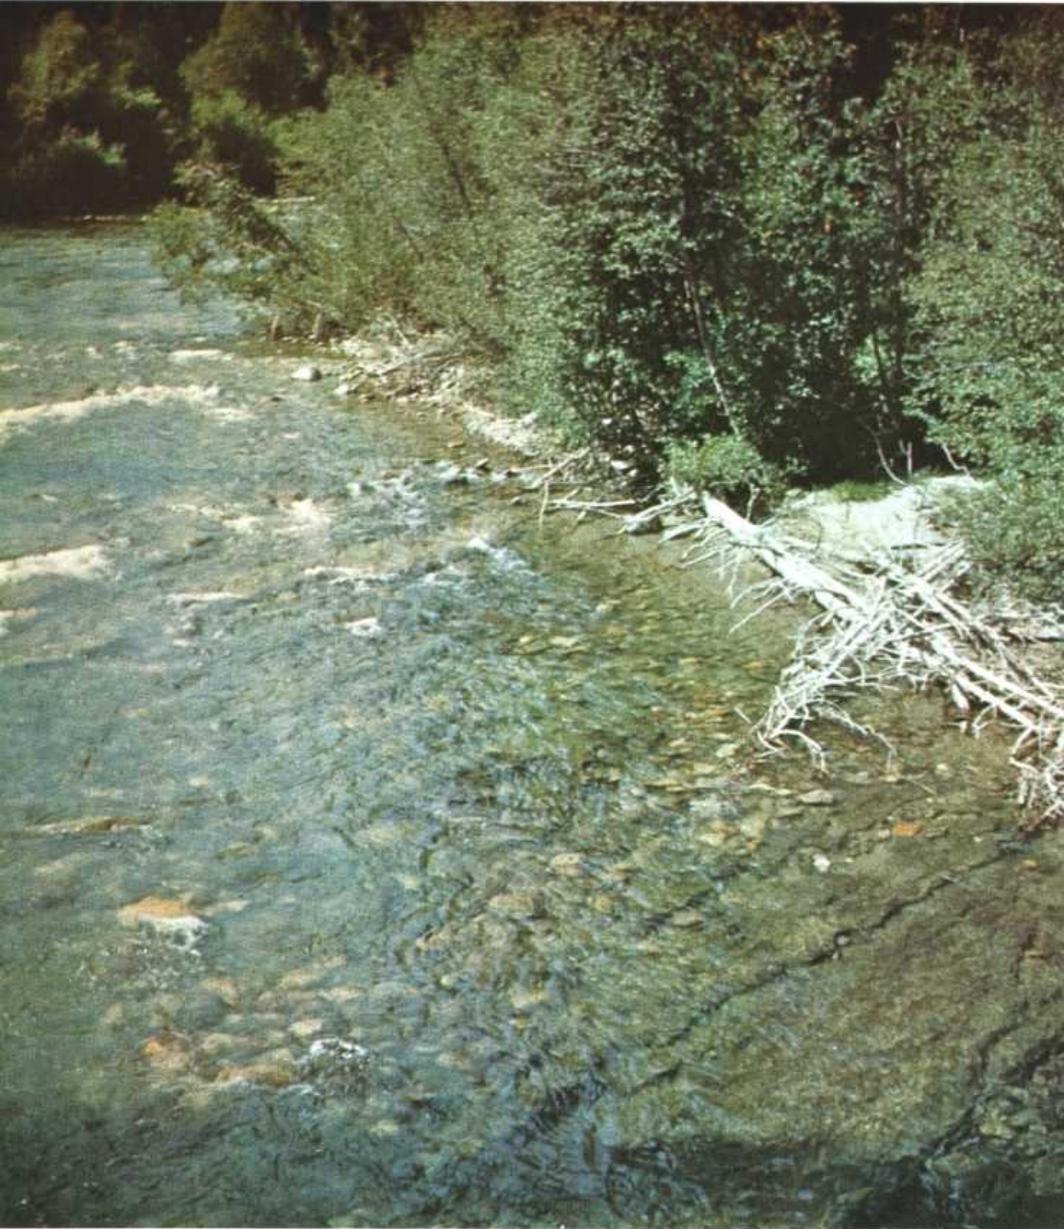
No. 13 upstream along left bank from section 2, Chiwawa River near Plain, Wash.

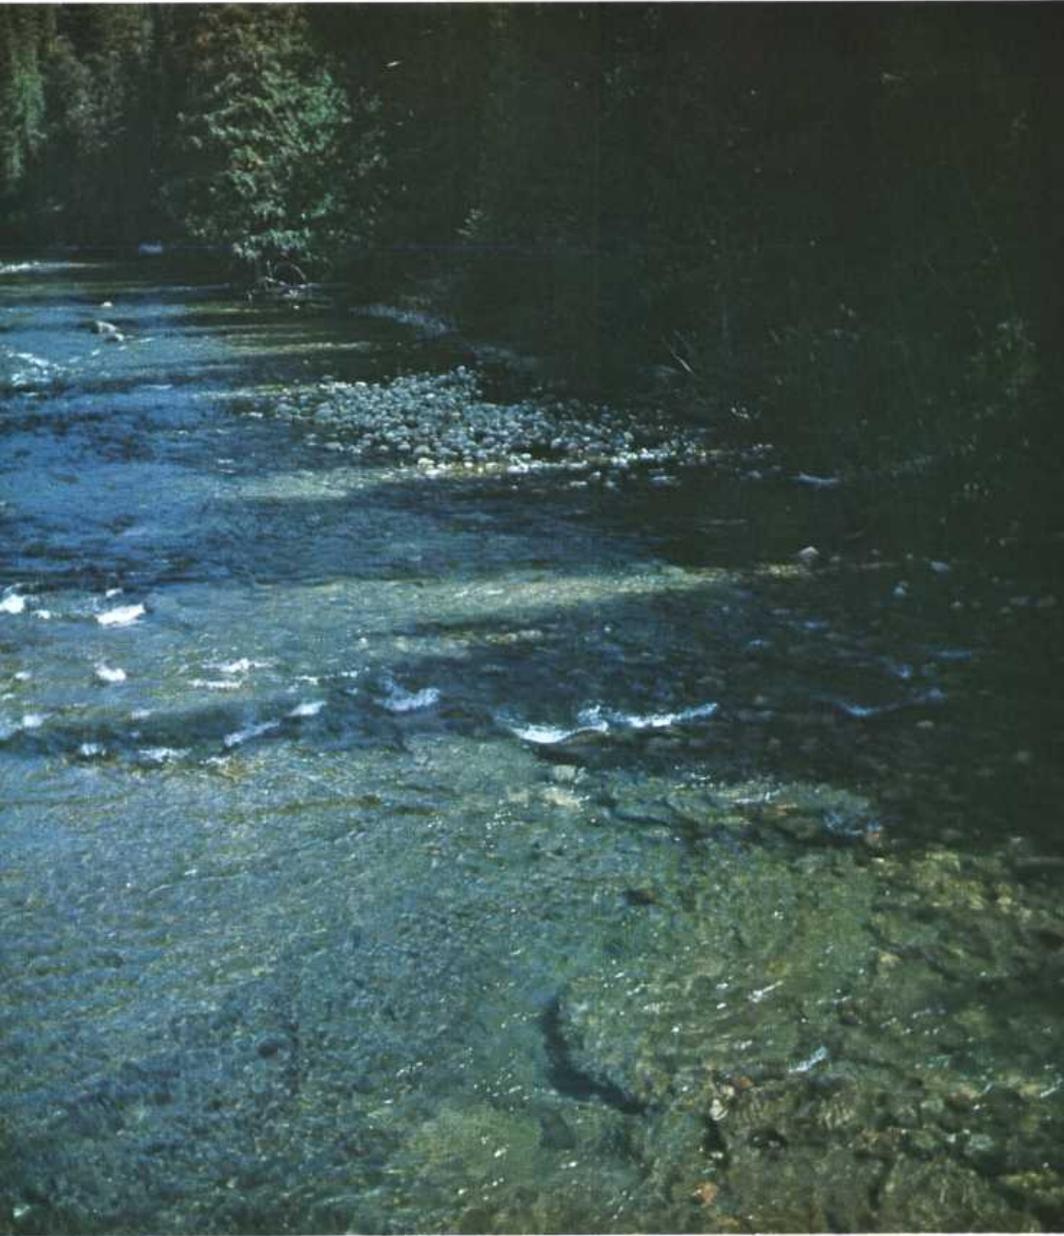
No. 15 downstream along right bank from section 2, Chiwawa River near Plain, Wash.

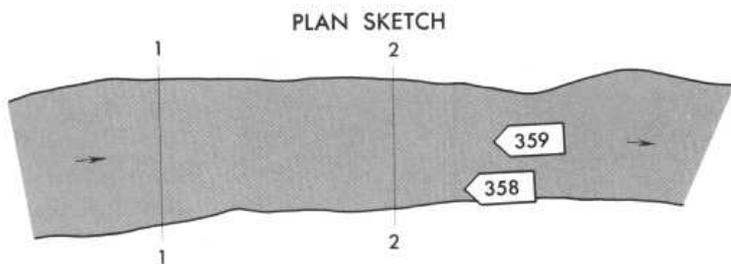
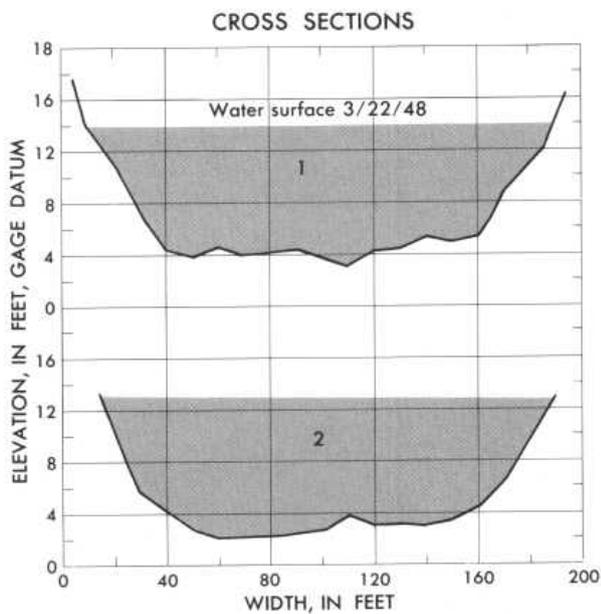
Plan sketch and cross sections, Esopus Creek at Coldbrook, N.Y.

Description of channel.—Bed material ranges from coarse gravel to a few large boulders. Banks are lined with boulders and scattered trees and brush.

Section	Area (sq ft)	Top width (ft)	Mean depth (ft)	Hydraulic radius (ft)	Mean velocity (ft per sec)	Length (ft) between sections	Fall (ft) between sections
1.....	1,460	181	8.1	7.97	9.48
2.....	1,470	175	8.4	8.28	9.45	258	1.15

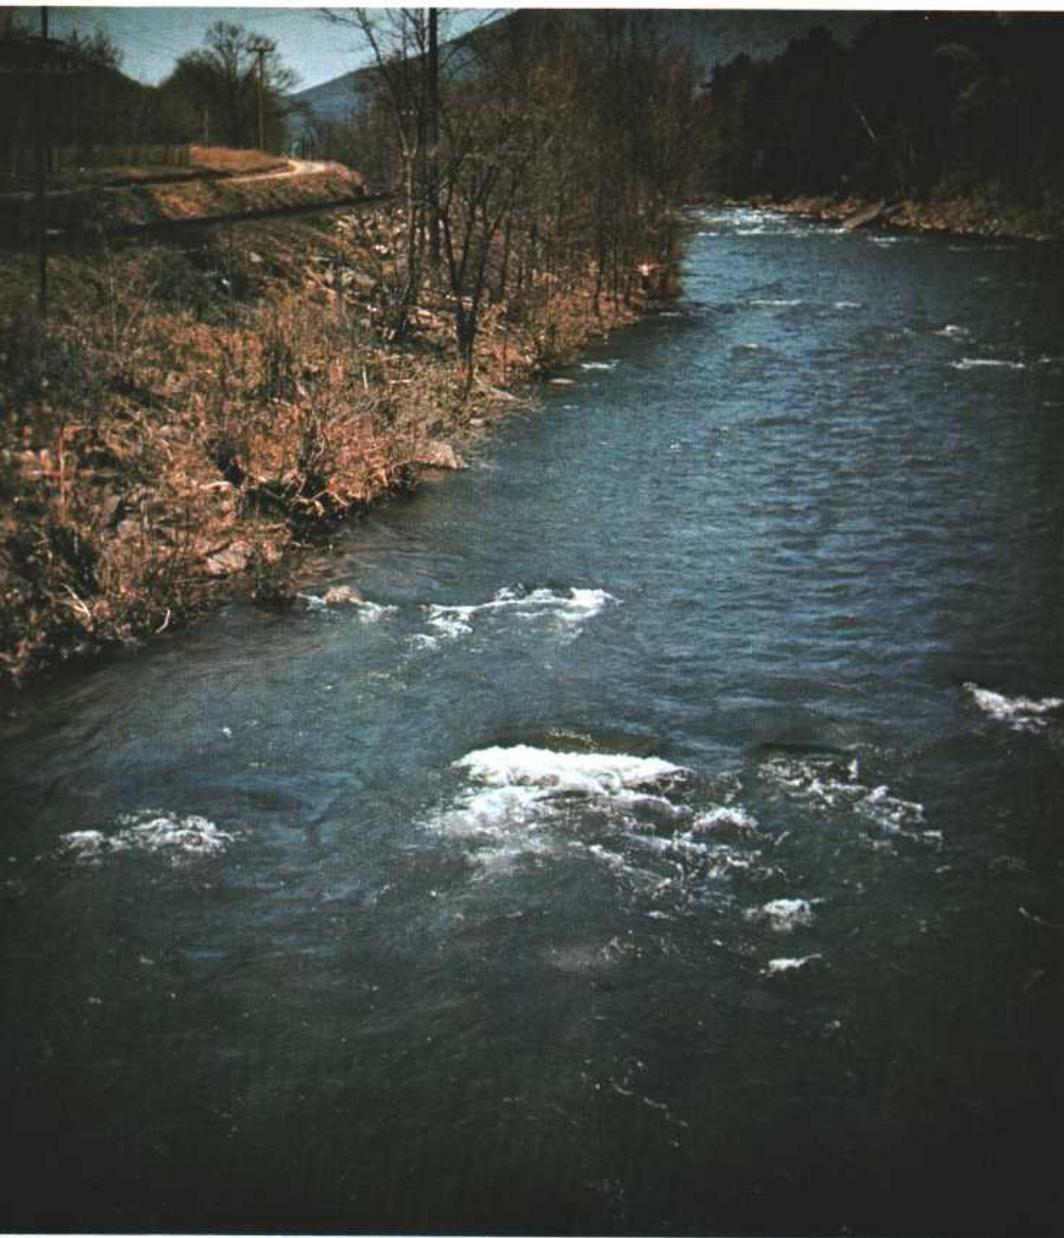
No. 358 upstream along right bank from below reach,
Esopus Creek at Coldbrook, N.Y.

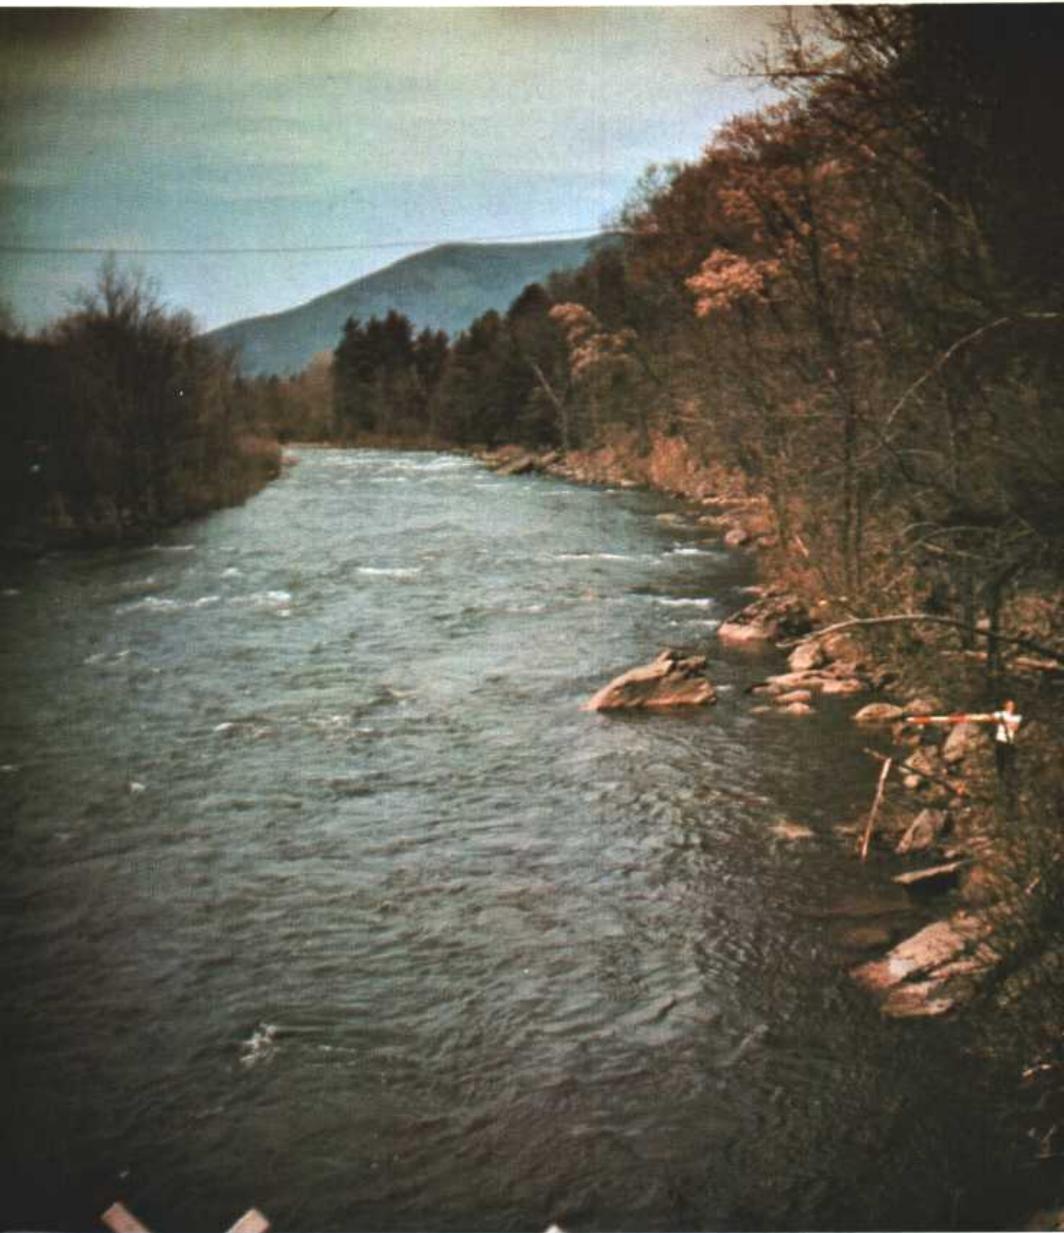
No. 359 upstream along left bank from below reach,
Esopus Creek at Coldbrook, N.Y.

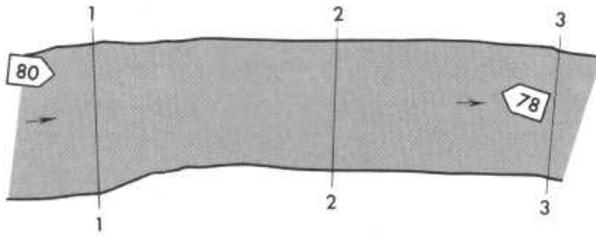
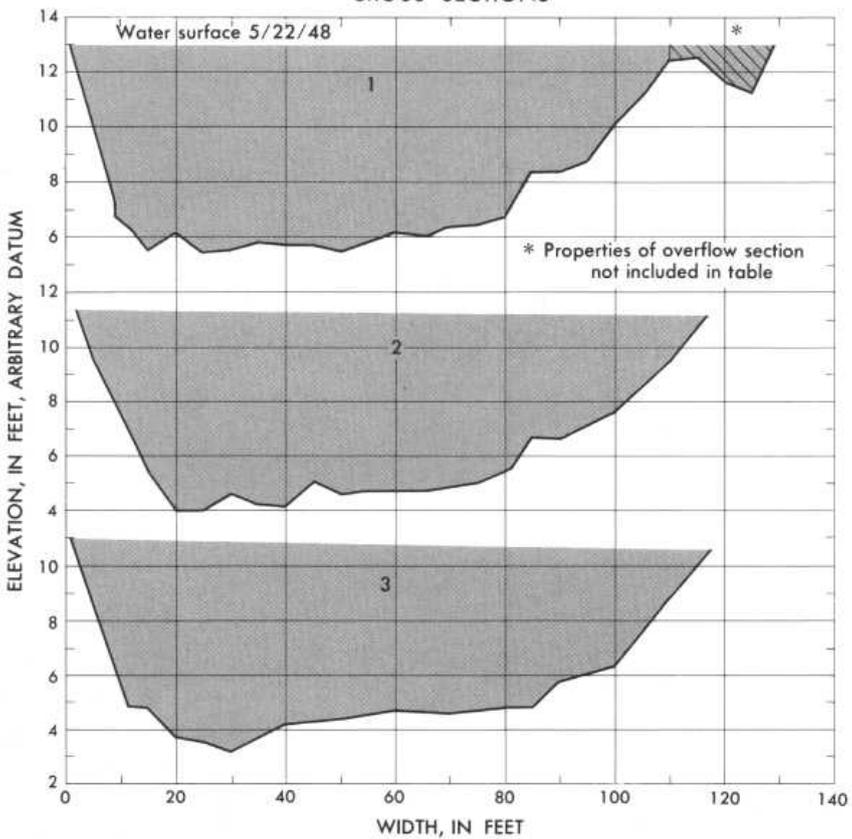
Plan sketch and cross sections, Grande Ronde River at La Grande, Oreg.

Description of channel.—Bed consists of boulders; $d_{50} = 93$ mm, $d_{84} = 157$ mm. Right bank is fairly steep and has dense overhanging bushes.

Section	Area (sq ft)	Top width (ft)	Mean depth (ft)	Hydraulic radius (ft)	Mean velocity (ft per sec)	Length (ft) between sections	Fall (ft) between sections
1.....	637	110	5.79	5.64	7.25
2.....	599	115	5.21	5.12	7.71	212	1.68
3.....	624	117	5.33	5.24	7.40	199	.48

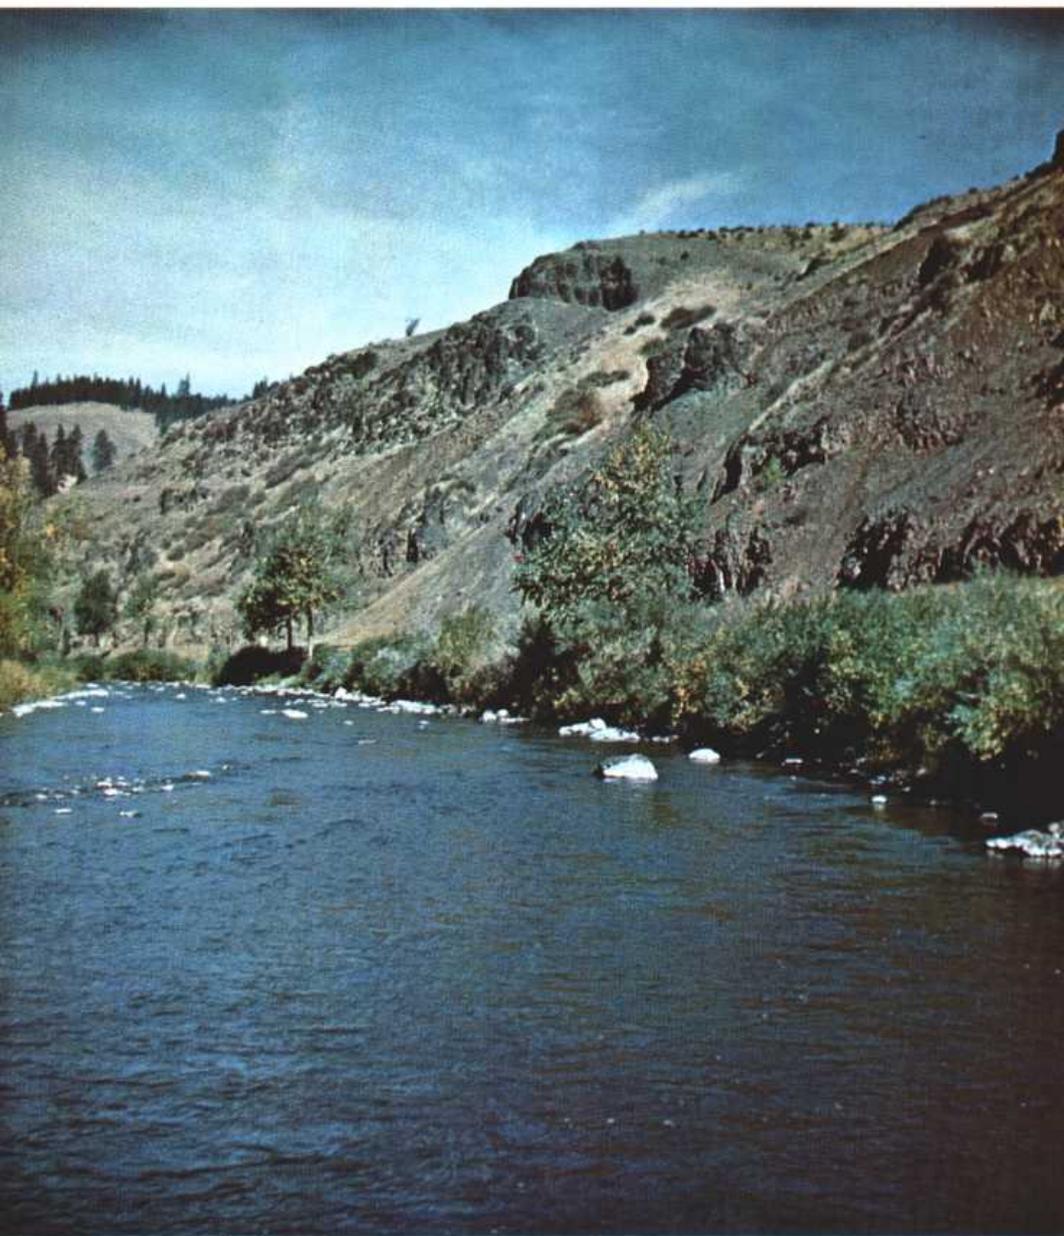
No. 78 upstream along left bank from channel below section 3,
Grande Ronde River at La Grande, Oreg.

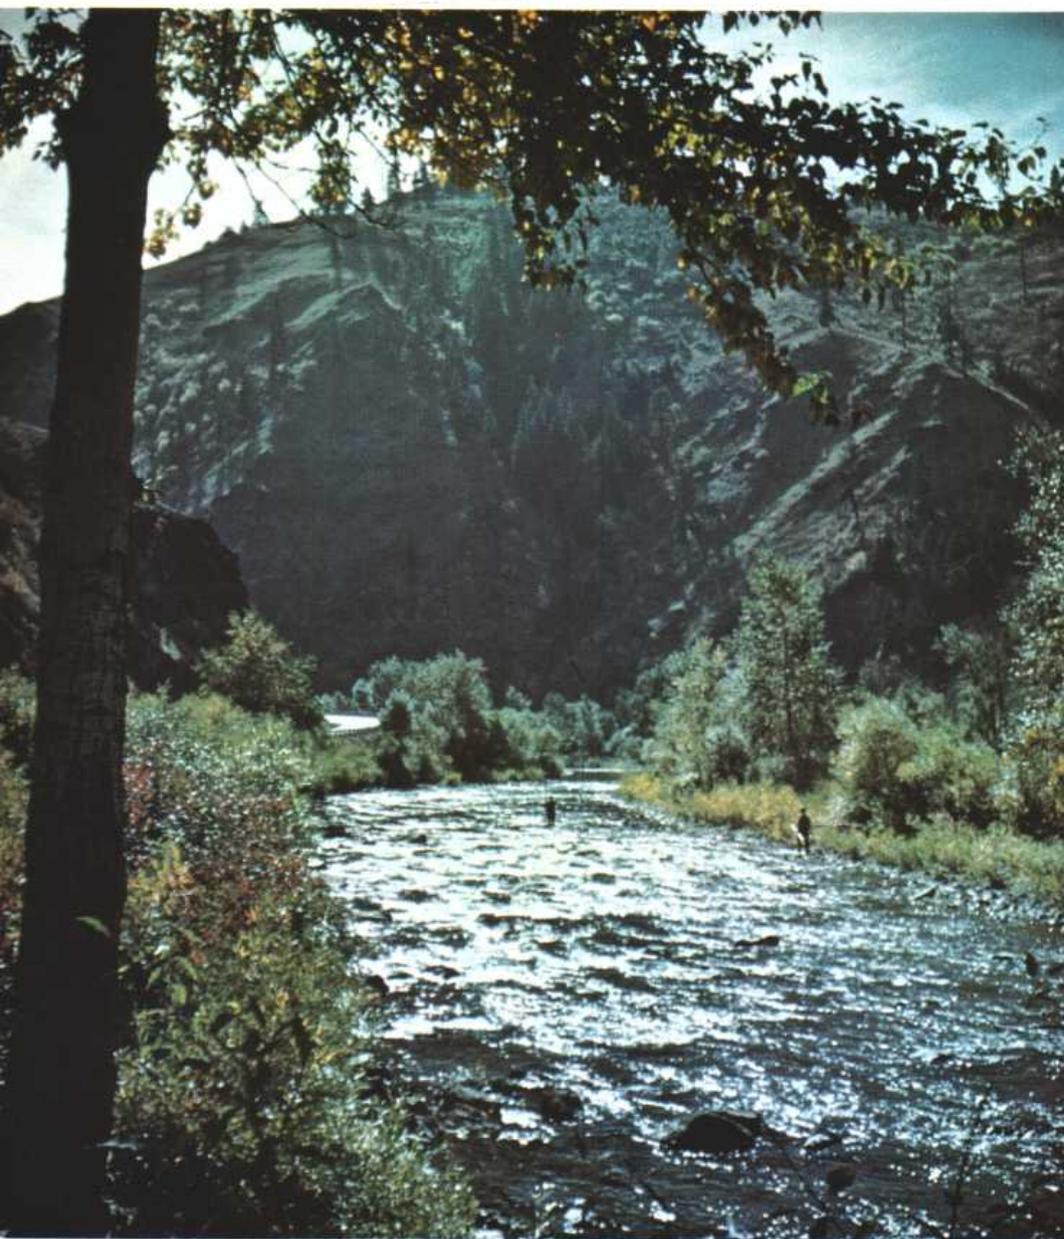
No. 80 downstream from left bank above section 1,
Grande Ronde River at La Grande, Oreg.

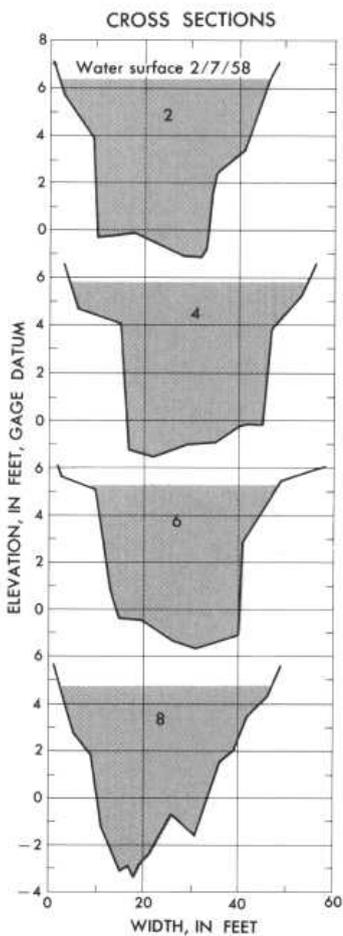
Plan sketch and cross sections, Murder Creek near Monticello, Ga.

Description of channel.—Bed consists of sand and gravel. Both banks are lined with trees above low waterline.

Section	Area (sq ft)	Top width (ft)	Mean depth (ft)	Hydraulic radius (ft)	Mean velocity (ft per sec)	Length (ft) between sections	Fall (ft) between sections
2.....	215	45	4.8	4.21	3.93
3.....	212	42	5.0	4.20	3.99	78	0.21
4.....	227	50	4.5	4.02	3.73	124	.35
5.....	202	43	4.7	4.02	4.19	92	.21
6.....	187	41	4.6	3.74	4.52	71	.35
7.....	200	48	4.2	3.64	4.23	88	.11
8.....	198	45	4.4	3.94	4.27	149	.38

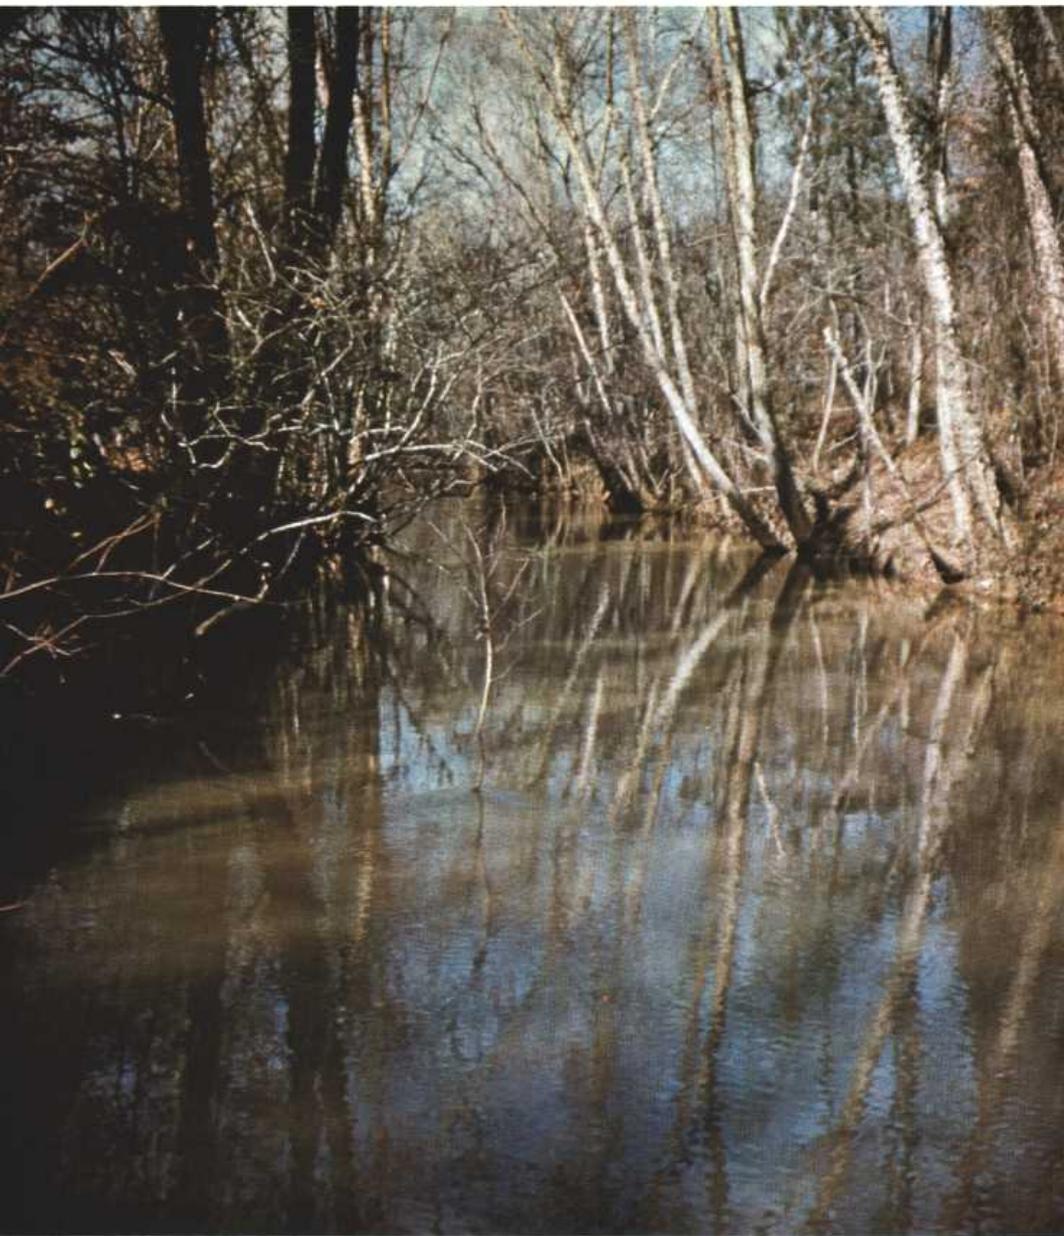
No. 1176 upstream from right bank at section 7,
Murder Creek near Monticello, Ga.

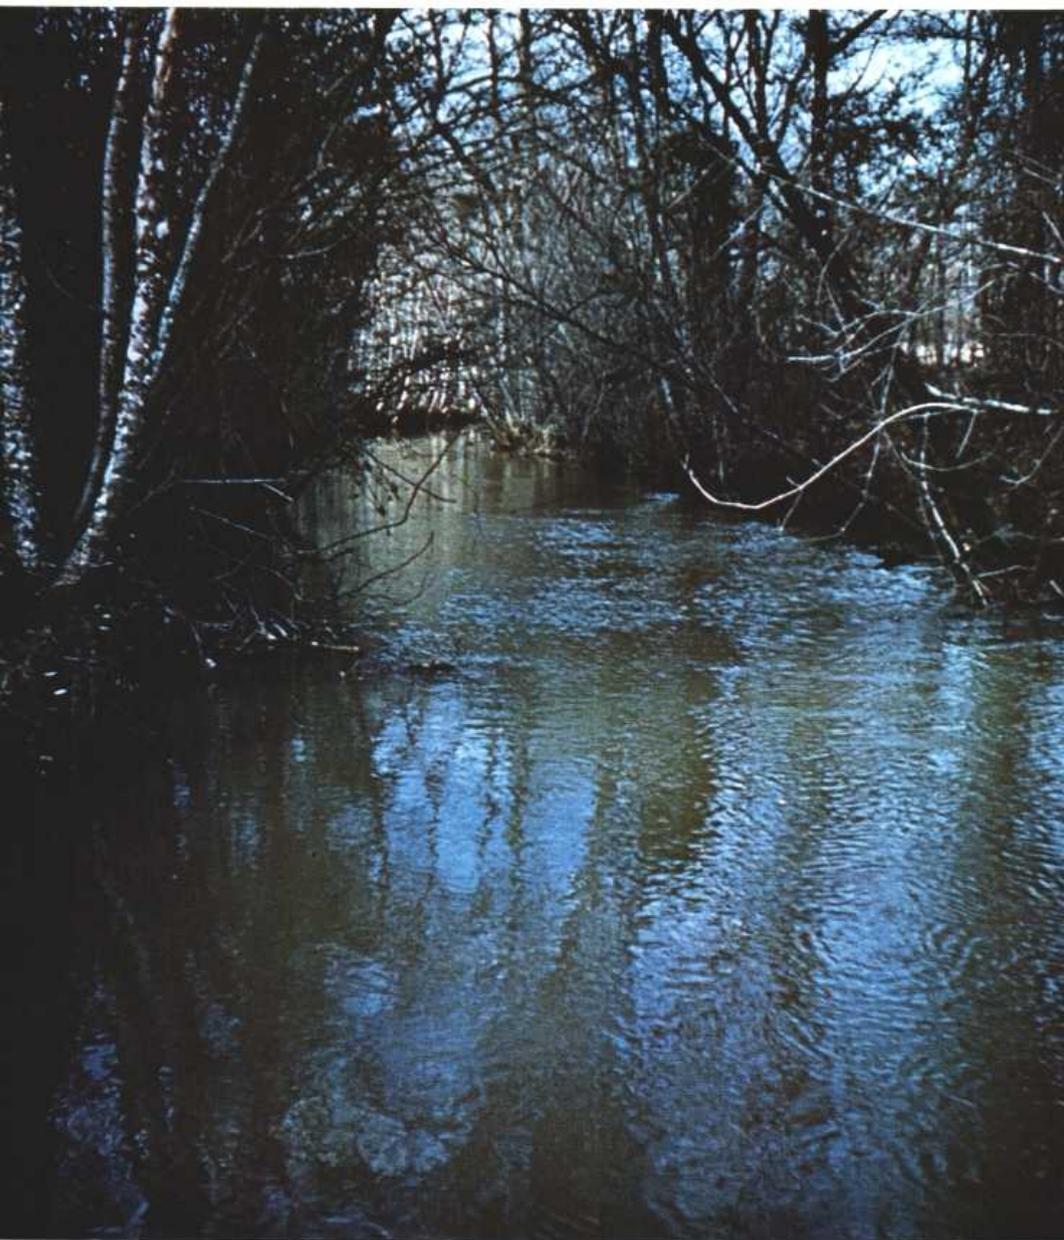
No. 1177 downstream from left bank at section 2,
Murder Creek near Monticello, Ga.

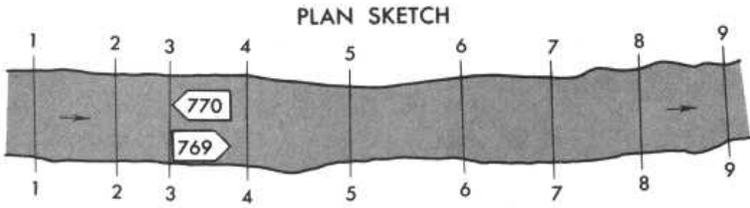
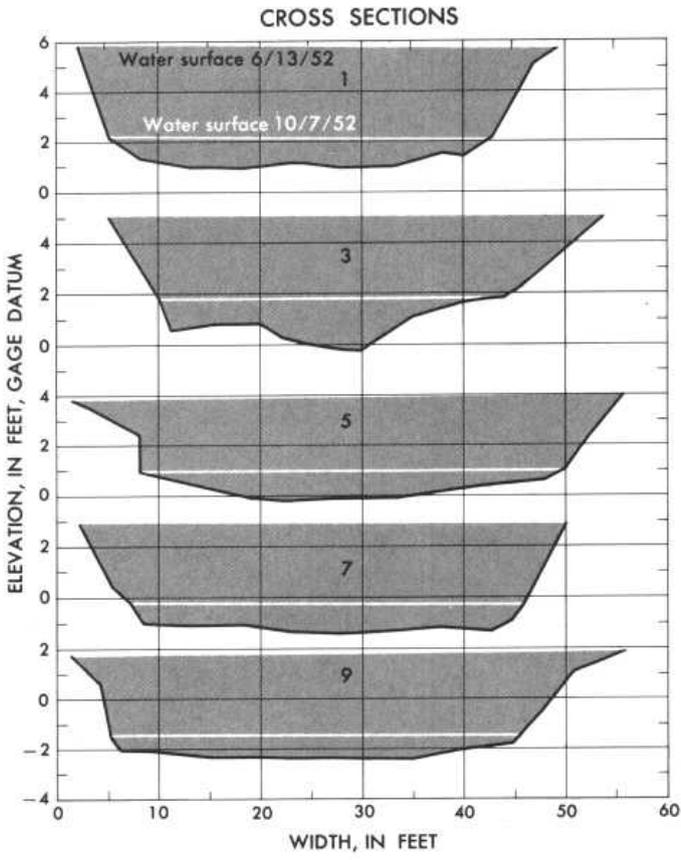
Plan sketch and cross sections, Provo River near Hailstone, Utah.

Description of channel.—Bed and banks consist of smooth rounded rocks as much as 1 ft in diameter. Some undergrowth is below water elevations of June 13.

Section	Area (sq ft)	Top width (ft)	Mean depth (ft)	Hydraulic radius (ft)	Mean velocity (ft per sec)	Length (ft) between sections	Fall (ft) between sections
June 13, 1952							
1	184	47	3.9	3.70	6.52
3	171	49	3.5	3.33	7.02	88	0.67
5	173	55	3.1	3.02	6.95	109	1.04
7	173	48	3.6	3.43	6.95	117	1.10
9	183	55	3.3	3.22	6.56	116	1.04
Oct. 7, 1952							
1	36	38	1.0	0.95	1.79
3	38	34	1.1	1.10	1.70	88	0.32
5	34	32	1.1	.82	1.90	109	.84
7	34	39	.9	.86	1.91	117	1.28
9	31	41	.8	.76	2.08	116	1.12

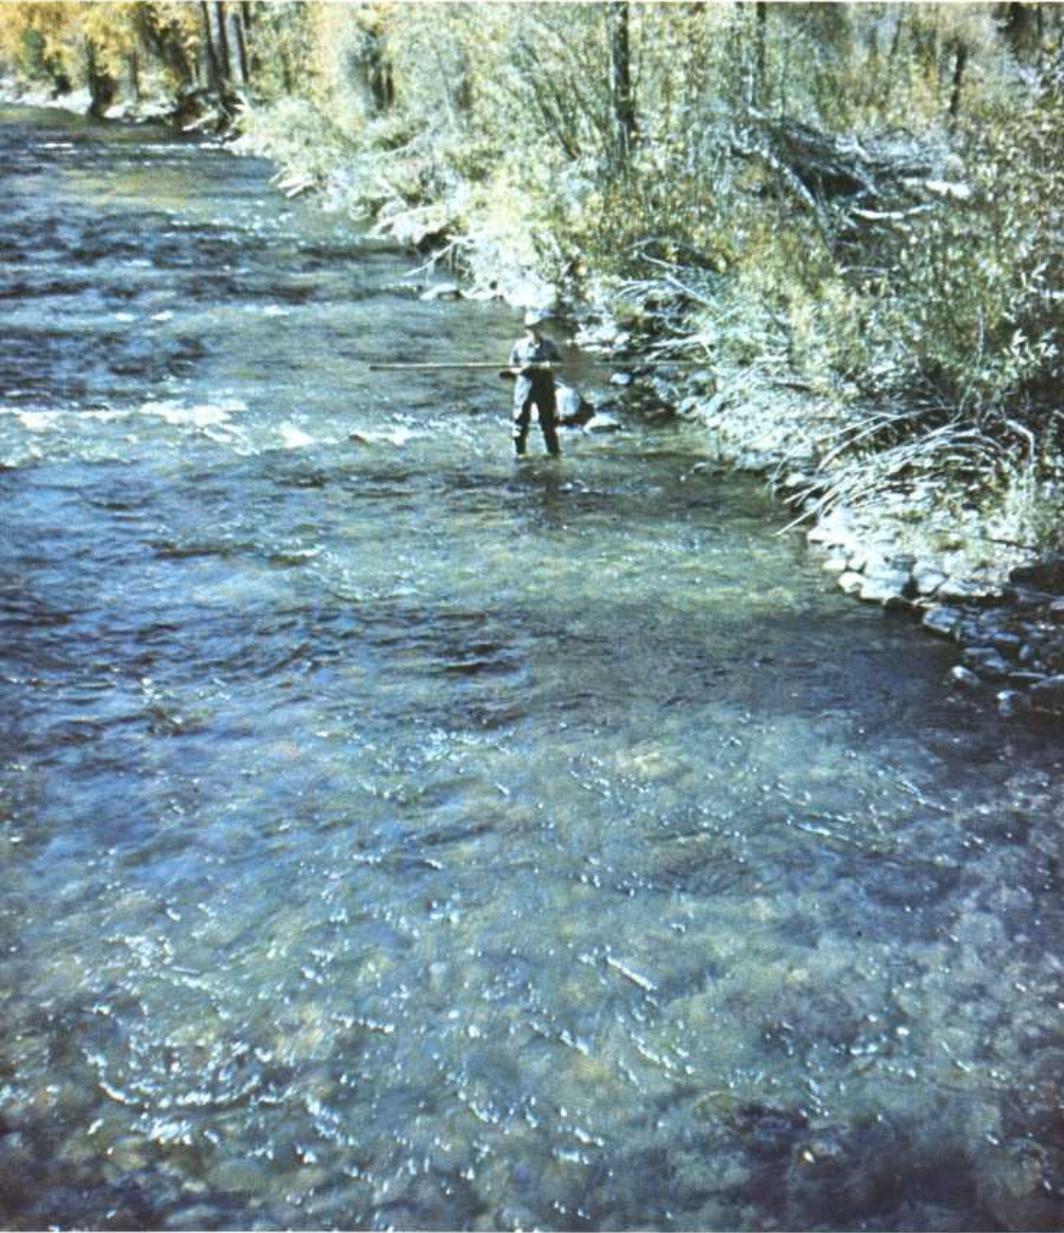
No. 769 downstream from section 3, Provo River near
Hailstone, Utah.

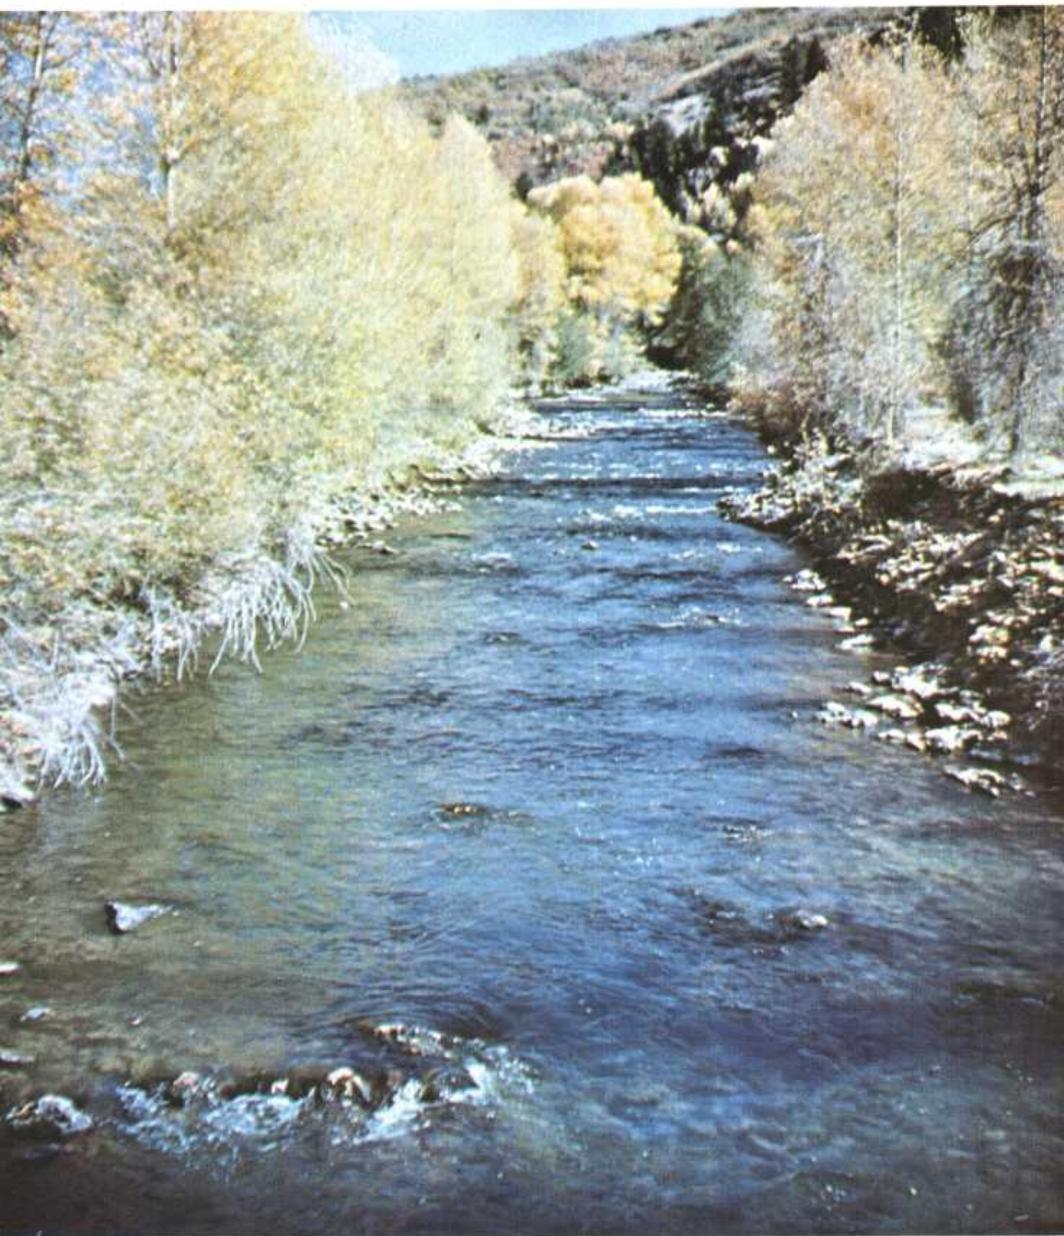
No. 770 upstream from section 3, Provo River near
Hailstone, Utah.

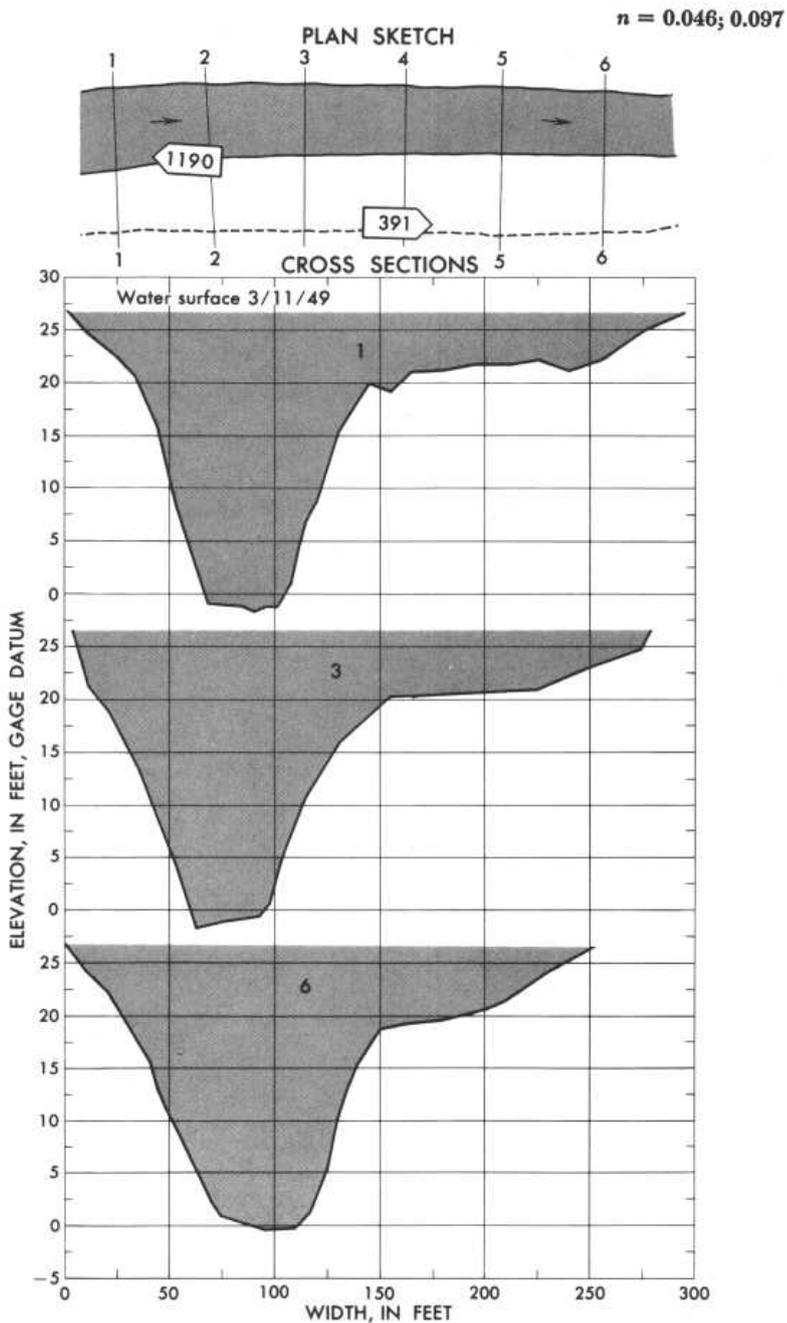
Plan sketch and cross sections, Rolling Fork near Boston, Ky.
Dashed line shows limit of overbank flooding.

Description of channel.—Main channel bed is clay and silt. Both banks are lined with overhanging trees. Right overflow channel is rather uniform with fairly dense stand of trees as much as 6 inches in diameter.

Section	Area (sq ft)	Top width (ft)	Mean depth (ft)	Hydraulic radius (ft)	Mean velocity (ft per sec)	Length (ft) between sections	Fall (ft) between sections
Main channel							
1	2,301	143	16.1	14.25	2.51
2	2,304	139	16.6	15.33	2.51	136	0.011
3	2,524	152	16.6	15.50	2.28	103	.028
4	2,416	140	17.2	15.95	2.39	127	.014
5	2,544	147	17.3	16.12	2.27	117	.004
6	2,483	150	16.6	15.52	2.32	86	.033
Right overflow channel							
1	668	150	4.4	4.44	0.48
2	643	138	4.7	4.63	.50	136	0.011
3	601	124	4.8	4.83	.54	103	.028
4	602	120	5.0	5.00	.54	127	.014
5	593	112	5.3	5.27	.55	117	.004
6	513	104	4.9	4.93	.63	86	.033
