Roughness Characteristics of Natural Channels

U.S. GEOLOGICAL SURVEY WATER-SUPPLY PAPER 1849

*Color photographs and descriptive
data for 50 stream channels for
which roughness coefficients have
been determined*

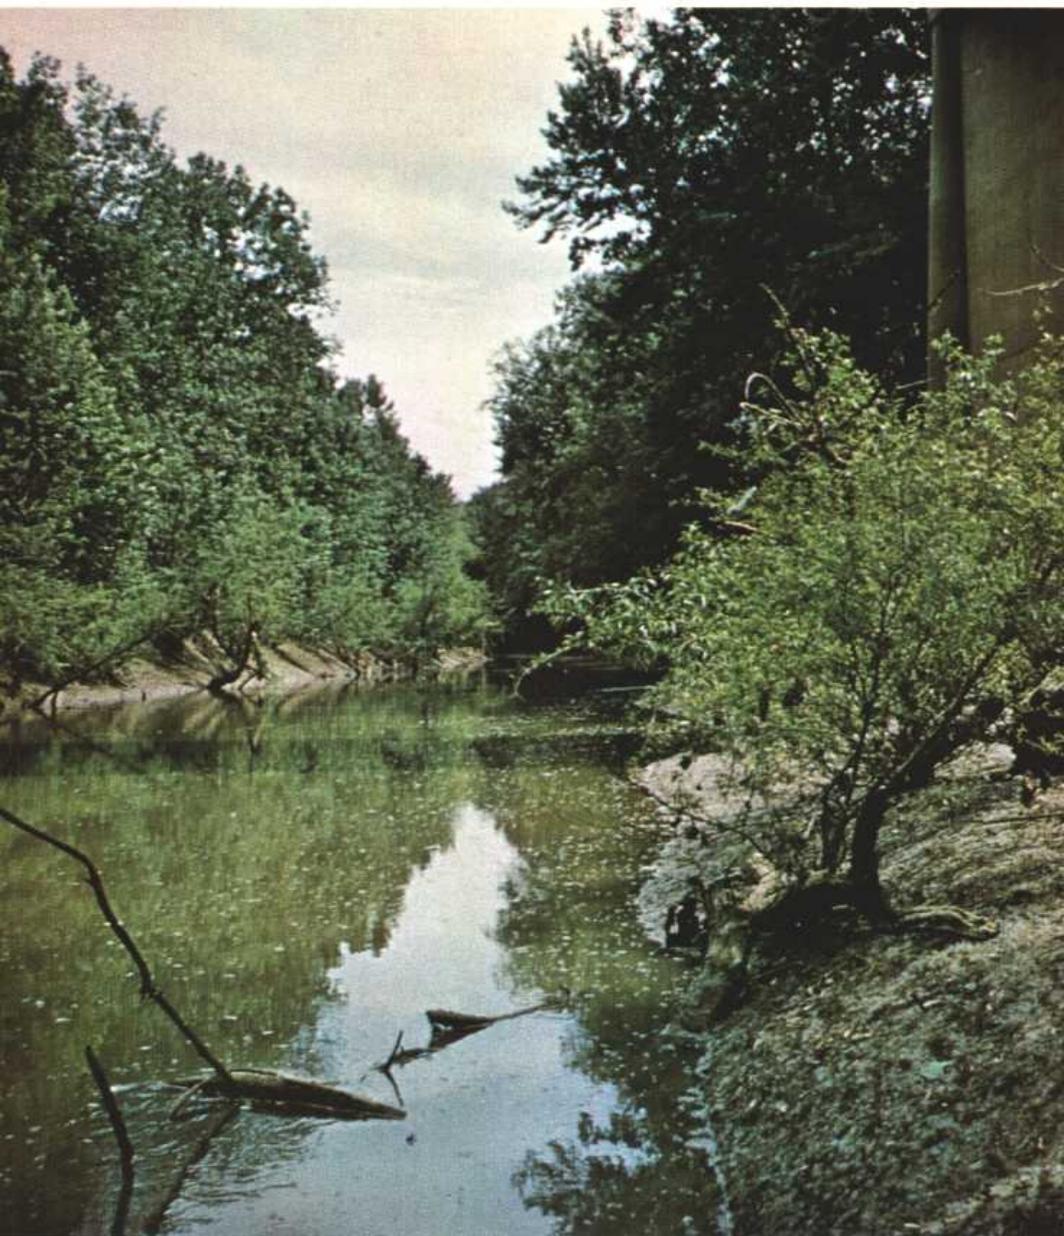
No. 1190 upstream from left bank below section 6,
Rolling Fork at Boston, Ky.

Description of channel.—Main channel bed is clay and silt. Both banks are lined with overhanging trees. Right overflow channel is rather uniform with fairly dense stand of trees as much as 6 inches in diameter.

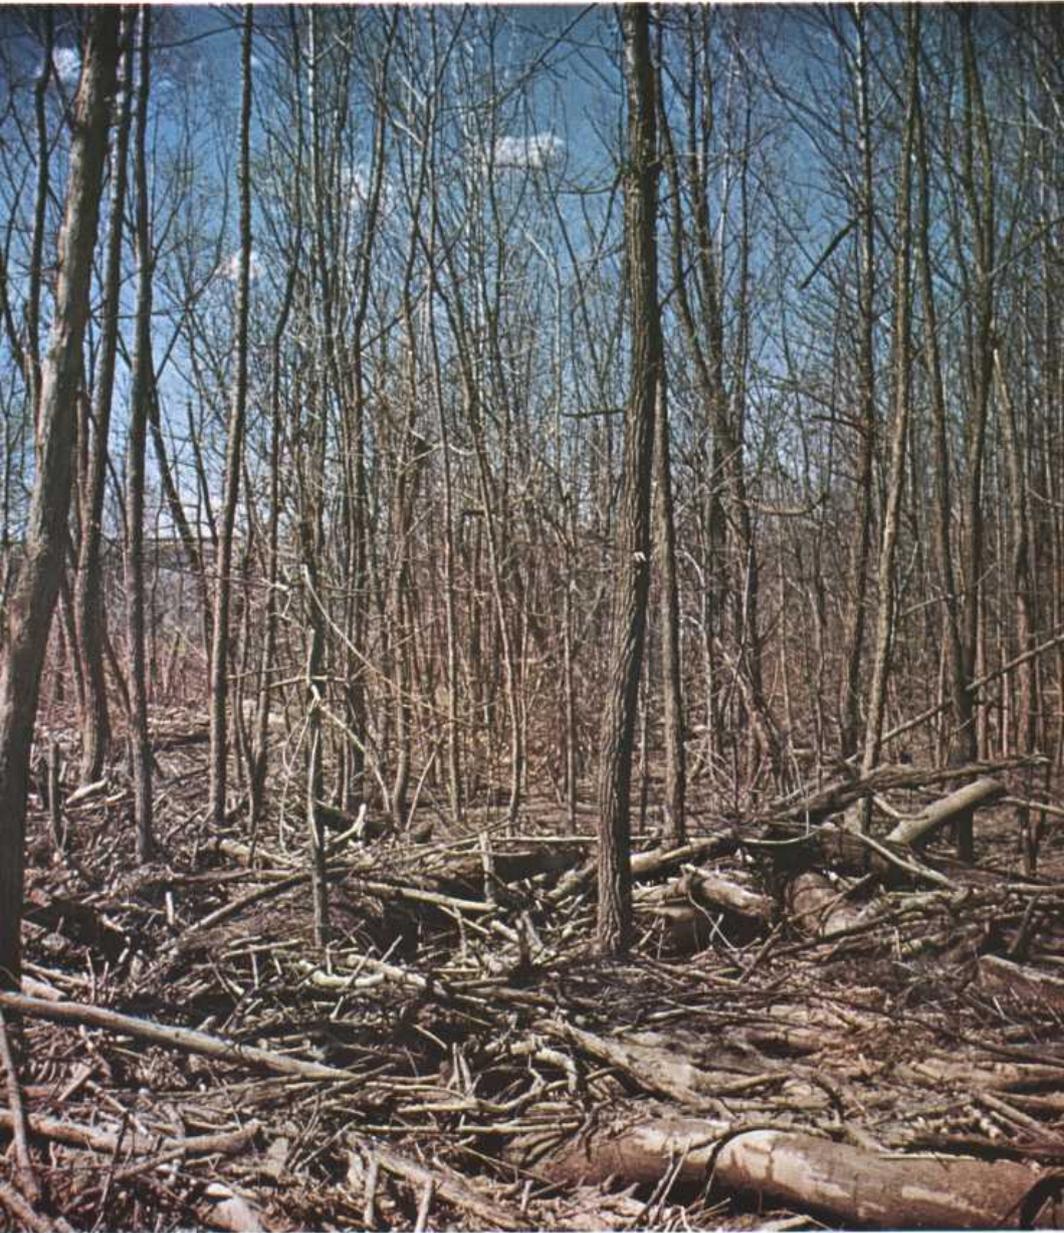
No. 391 downstream through right overflow from section 2,
Rolling Fork at Boston, Ky.
