Roughness Characteristics of Natural Channels

By HARRY H. BARNES, JR.

U.S. GEOLOGICAL SURVEY WATER-SUPPLY PAPER 1849

*Color photographs and descriptive
data for 50 stream channels for
which roughness coefficients have
been determined*

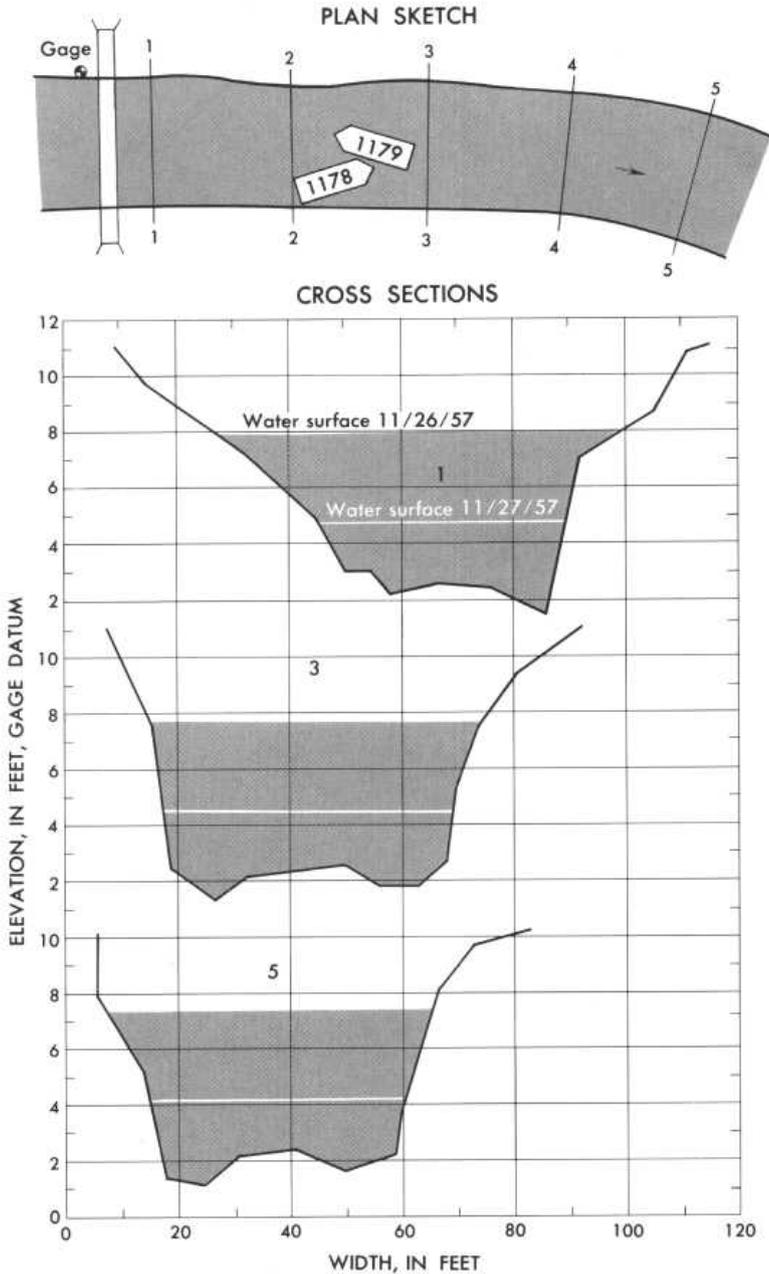
Plan sketch and cross sections, South Beaverdam Creek near Dewy Rose, Ga.

Description of channel.—Bed consists of sand about 1 ft deep over clay and rock. Banks are irregular with trees and bushes growing down to the low waterline.

Section	Area (sq ft)	Top width (ft)	Mean depth (ft)	Hydraulic radius (ft)	Mean velocity (ft per sec)	Length (ft) between sections	Fall (ft) between sections
Nov. 26, 1957							
1.....	268	71	3.8	3.62	3.06
2.....	288	56	5.1	4.97	2.85	71	0.14
3.....	278	59	4.7	4.34	2.95	66	.12
4.....	281	59	4.8	4.41	2.92	81	.13
5.....	260	58	4.5	4.13	3.15	64	.06
Nov. 27, 1957							
1.....	91	44	2.1	2.02	2.43
2.....	128	46	2.8	2.69	1.73	71	0.11
3.....	108	51	2.1	2.00	2.05	66	.10
4.....	108	54	2.0	1.98	2.05	81	.08
5.....	101	46	2.2	2.04	2.19	64	.14

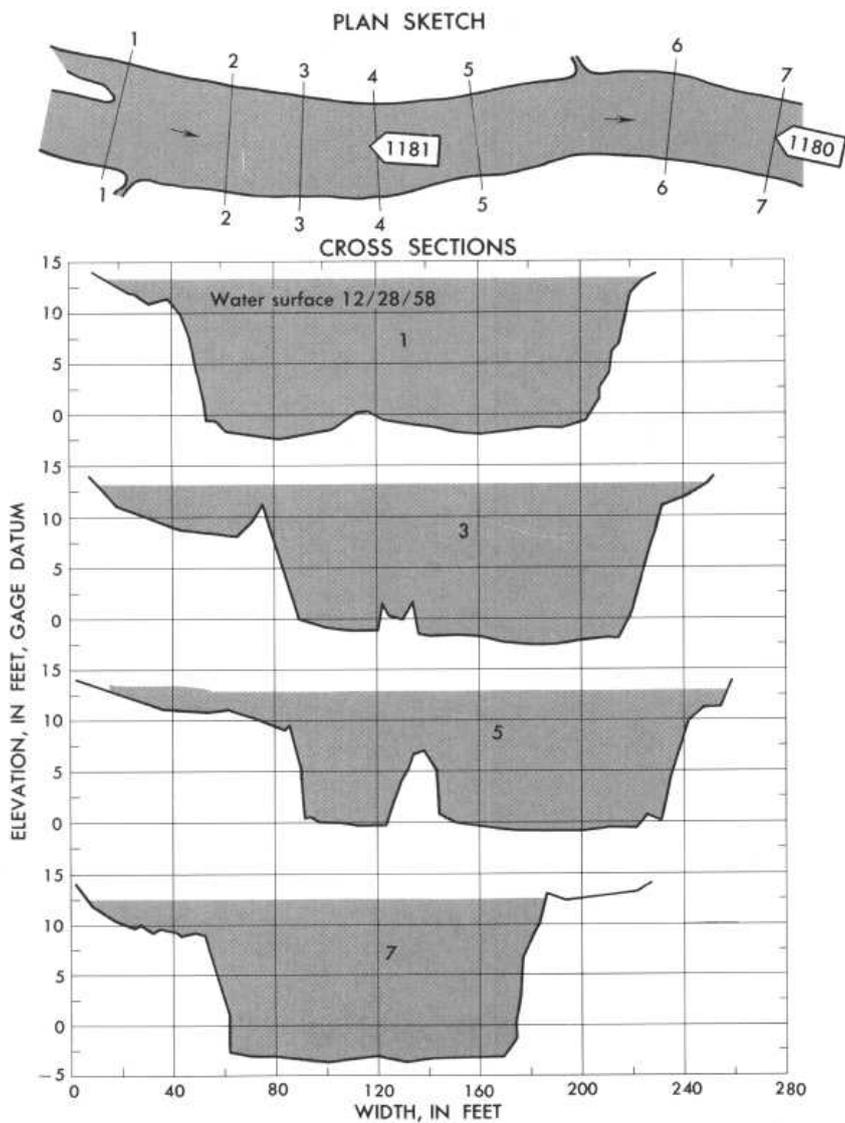
Plan sketch and cross sections, Deep River at Ramseur, N.C.

Description of channel.—Bed is mostly coarse sand and contains some gravel and one conspicuous outcrop. Three small islands in the reach have a dense stand of small birch trees. The banks are fairly steep and contain medium growths of underbrush and large trees.

Section	Area (sq ft)	Top width (ft)	Mean depth (ft)	Hydraulic radius (ft)	Mean velocity (ft per sec)	Length (ft) between sections	Fall (ft) between sections
1.....	2,474	215	11.5	10.8	3.36
2.....	2,135	198	10.8	10.4	3.89	219	0.17
3.....	2,137	240	9.8	9.34	3.88	218	.05
4.....	2,403	250	9.6	8.73	3.45	182	.12
5.....	2,061	244	8.4	7.94	4.03	185	.20
6.....	2,265	194	11.8	10.8	3.66	337	.30
7.....	2,026	189	10.7	10.4	4.10	265	.24

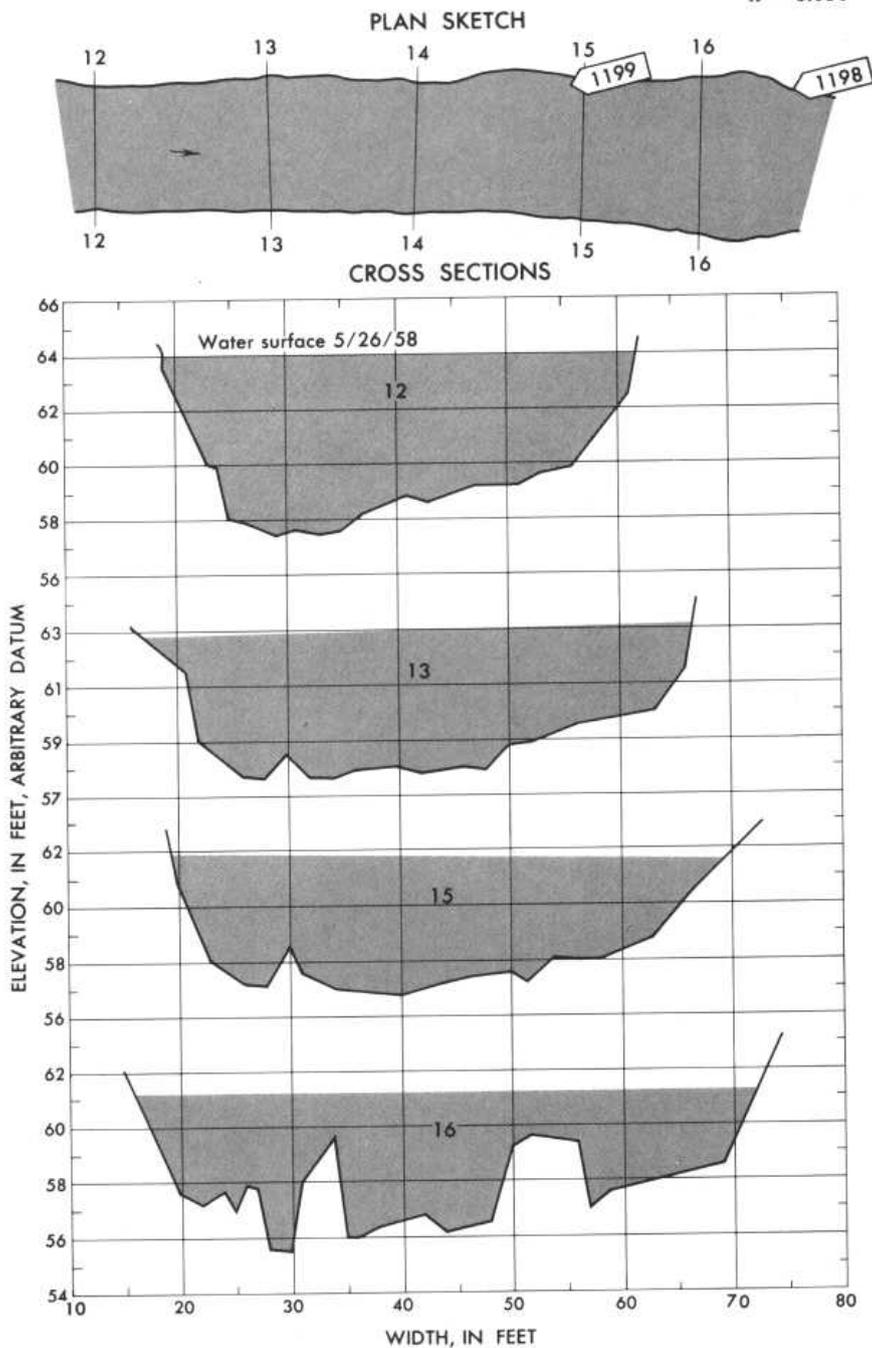
Plan sketch and cross sections, Clear Creek near Golden, Colo.

Description of channel.—Bed and banks are composed of angular boulders as much as 2 ft in diameter.

Section	Area (sq ft)	Top width (ft)	Mean depth (ft)	Hydraulic radius (ft)	Mean velocity (ft per sec)	Length (ft) between sections	Fall (ft) between sections
12.....	200	43	4.6	4.22	6.90
13.....	206	50	4.1	3.83	6.70	47	0.85
14.....	183	52	3.5	3.29	7.54	39	.65
15.....	184	51	3.6	3.36	7.50	46	.65
16.....	184	55	3.3	2.69	7.50	32	.60

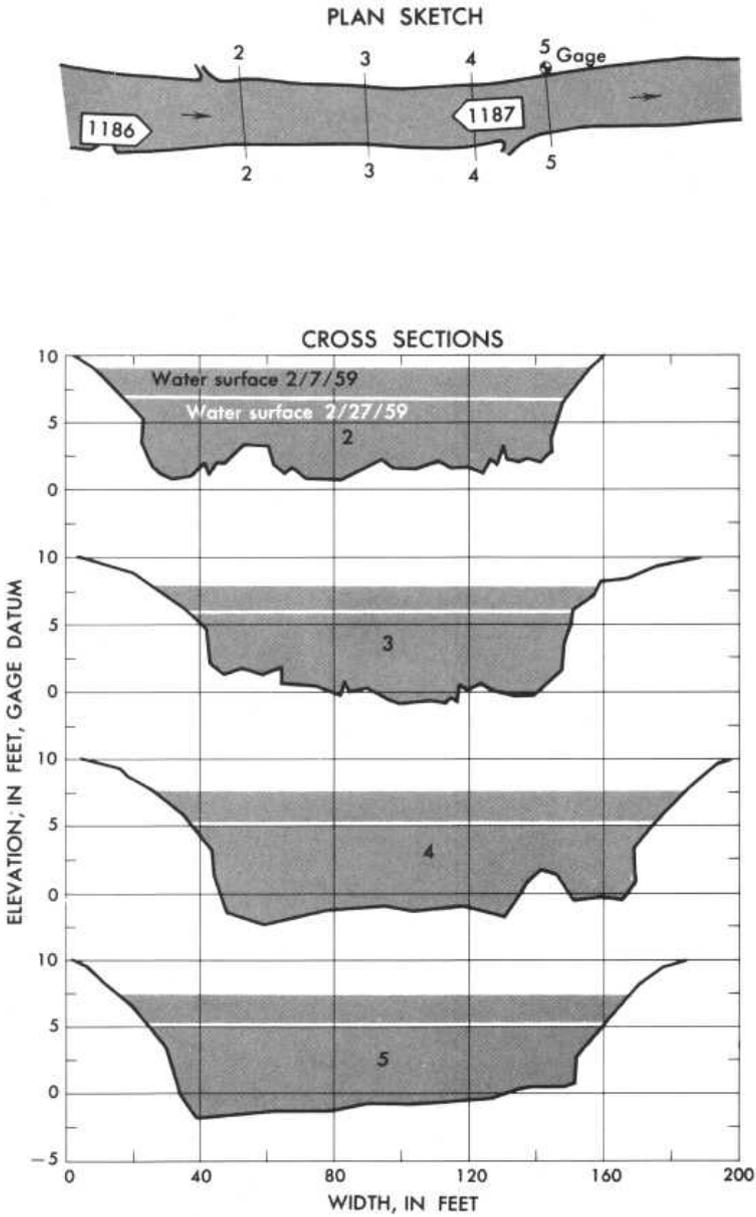
Plan sketch and cross sections, Chattahoochee River near Leaf, Ga.

Description of channel.—Bed is mostly rock and very irregular. Banks are covered with low thick rhododendron and small trees.

Section	Area (sq ft)	Top width (ft)	Mean depth (ft)	Hydraulic radius (ft)	Mean velocity (ft per sec)	Length (ft) between sections	Fall (ft) between sections
Feb. 7, 1959							
2.....	1,510	147	10.3	9.84	3.38
3.....	850	133	6.4	6.18	6.00	353	1.19
4.....	1,110	158	7.0	6.79	4.59	214	.35
5.....	1,070	151	7.1	6.84	4.77	125	.14
Feb. 27, 1959							
2.....	1,215	132	9.2	8.90	1.93
3.....	555	112	5.0	4.80	4.23	353	1.42
4.....	750	138	5.4	5.26	3.13	214	.37
5.....	720	134	5.4	5.18	3.26	125	.13

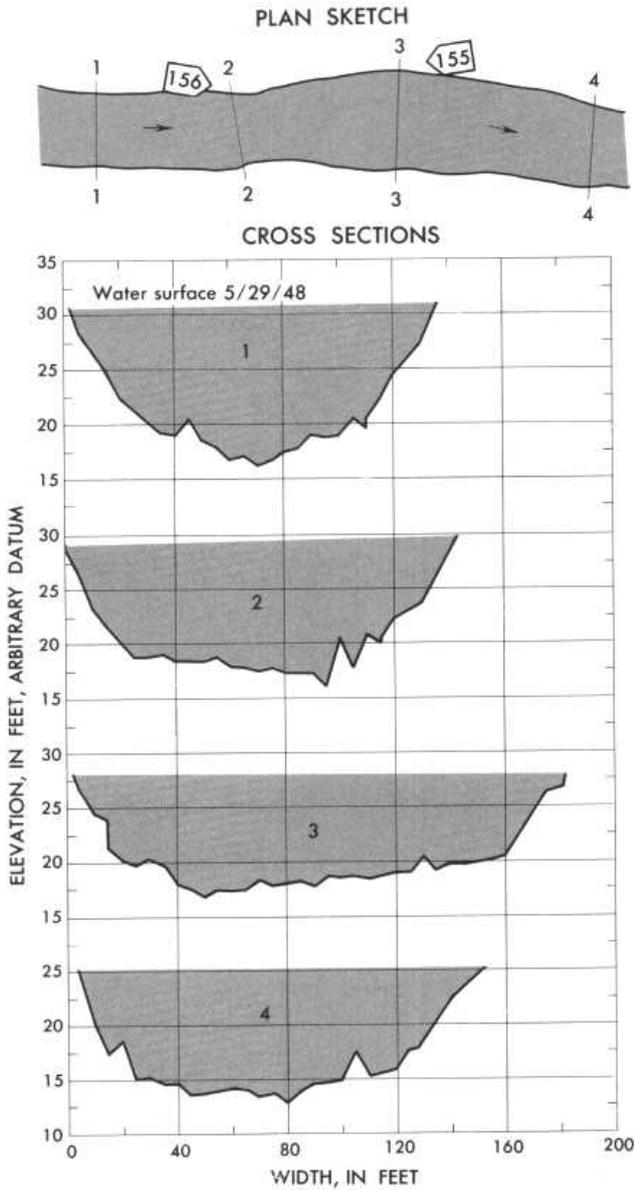
Plan sketch and cross sections, South Fork Clearwater River near Grangeville, Idaho.

Description of channel.—Bed consists of rock and boulders; $d_{50} = 250$ mm, $d_{84} = 440$ mm. Banks are mostly boulders and have trees and brush along tops.

Section	Area (sq ft)	Top width (ft)	Mean depth (ft)	Hydraulic radius (ft)	Mean velocity (ft per sec)	Length (ft) between sections	Fall (ft) between sections
1.....	1,326	134	9.90	9.40	9.50
2.....	1,310	143	9.16	8.68	9.62	255	1.40
3.....	1,434	181	7.92	7.71	8.79	295	1.45
4.....	1,267	148	8.56	8.23	9.94	357	2.85

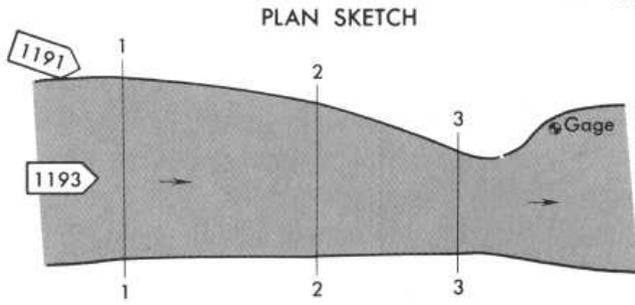
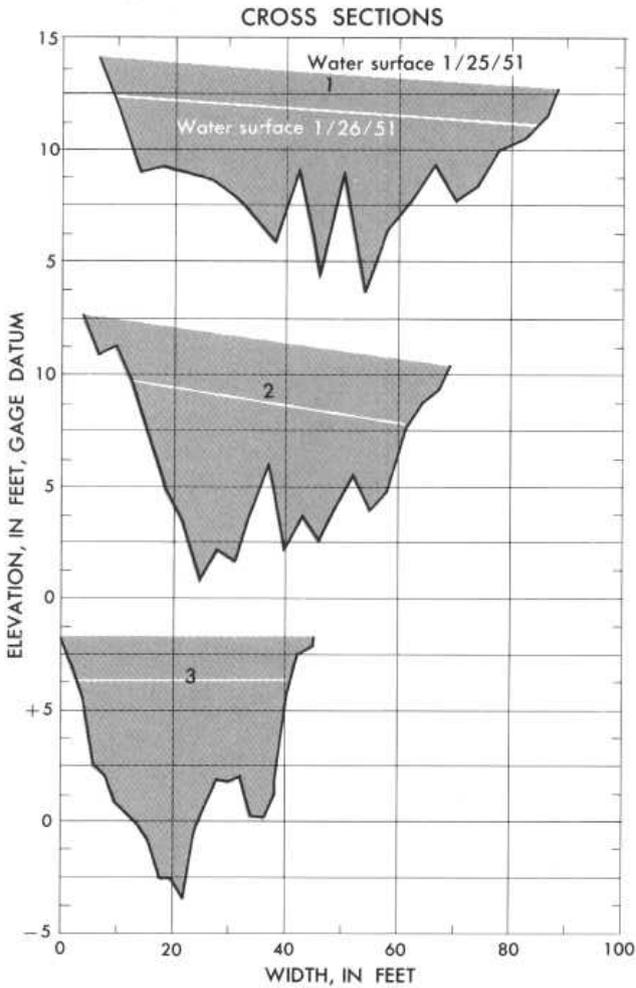
Plan sketch and cross sections, Cache Creek near Lower Lake, Calif.

Description of channel.—Bed is composed of large angular boulders. Banks consist of exposed rock, boulders, and some trees.

Section	Area (sq ft)	Top width (ft)	Mean depth (ft)	Hydraulic radius (ft)	Mean velocity (ft per sec)	Length (ft) between sections	Fall (ft) between sections
Jan. 25, 1951							
1.....	401	81	5.0	4.27	9.59
2.....	384	65	5.9	5.02	10.00	102	1.80
3.....	295	45	6.6	5.27	13.02	62	3.10
Jan. 24, 1951							
1.....	271	76	3.6	3.09	6.75
2.....	236	51	4.6	3.88	7.75	102	2.75
3.....	211	38	5.6	4.45	8.67	62	2.55

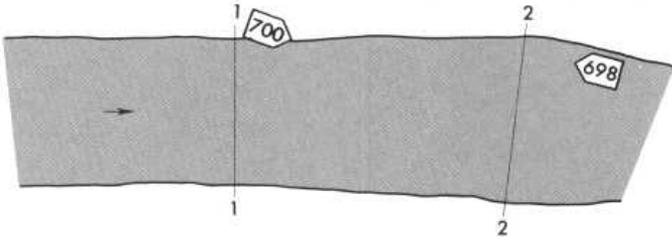
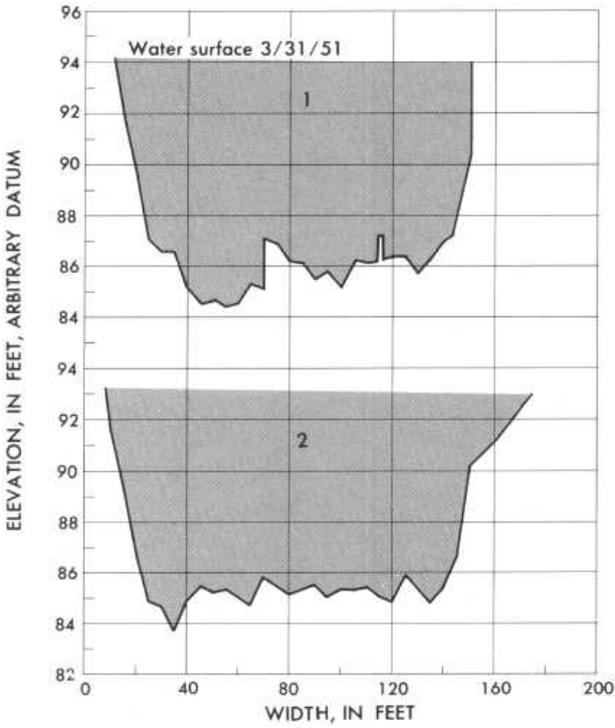
Plan sketch and cross sections, East Branch Ausable River at Au Sable Forks, N.Y.

Description of channel.—Bed consists of gravel, rock, and boulders as much as 5 ft in diameter. Banks are lined with boulders, small trees, and bushes.

Section	Area (sq ft)	Top width (ft)	Mean depth (ft)	Hydraulic radius (ft)	Mean velocity (ft per sec)	Length (ft) between sections	Fall (ft) between sections
1	1,050	139	7.6	7.01	7.40
2	1,090	166	6.6	6.42	7.13	178	1.00
