MAP AND LONGITUDINAL PROFILE OF ORE BODIES IN SCRANTON MINES, UTAH

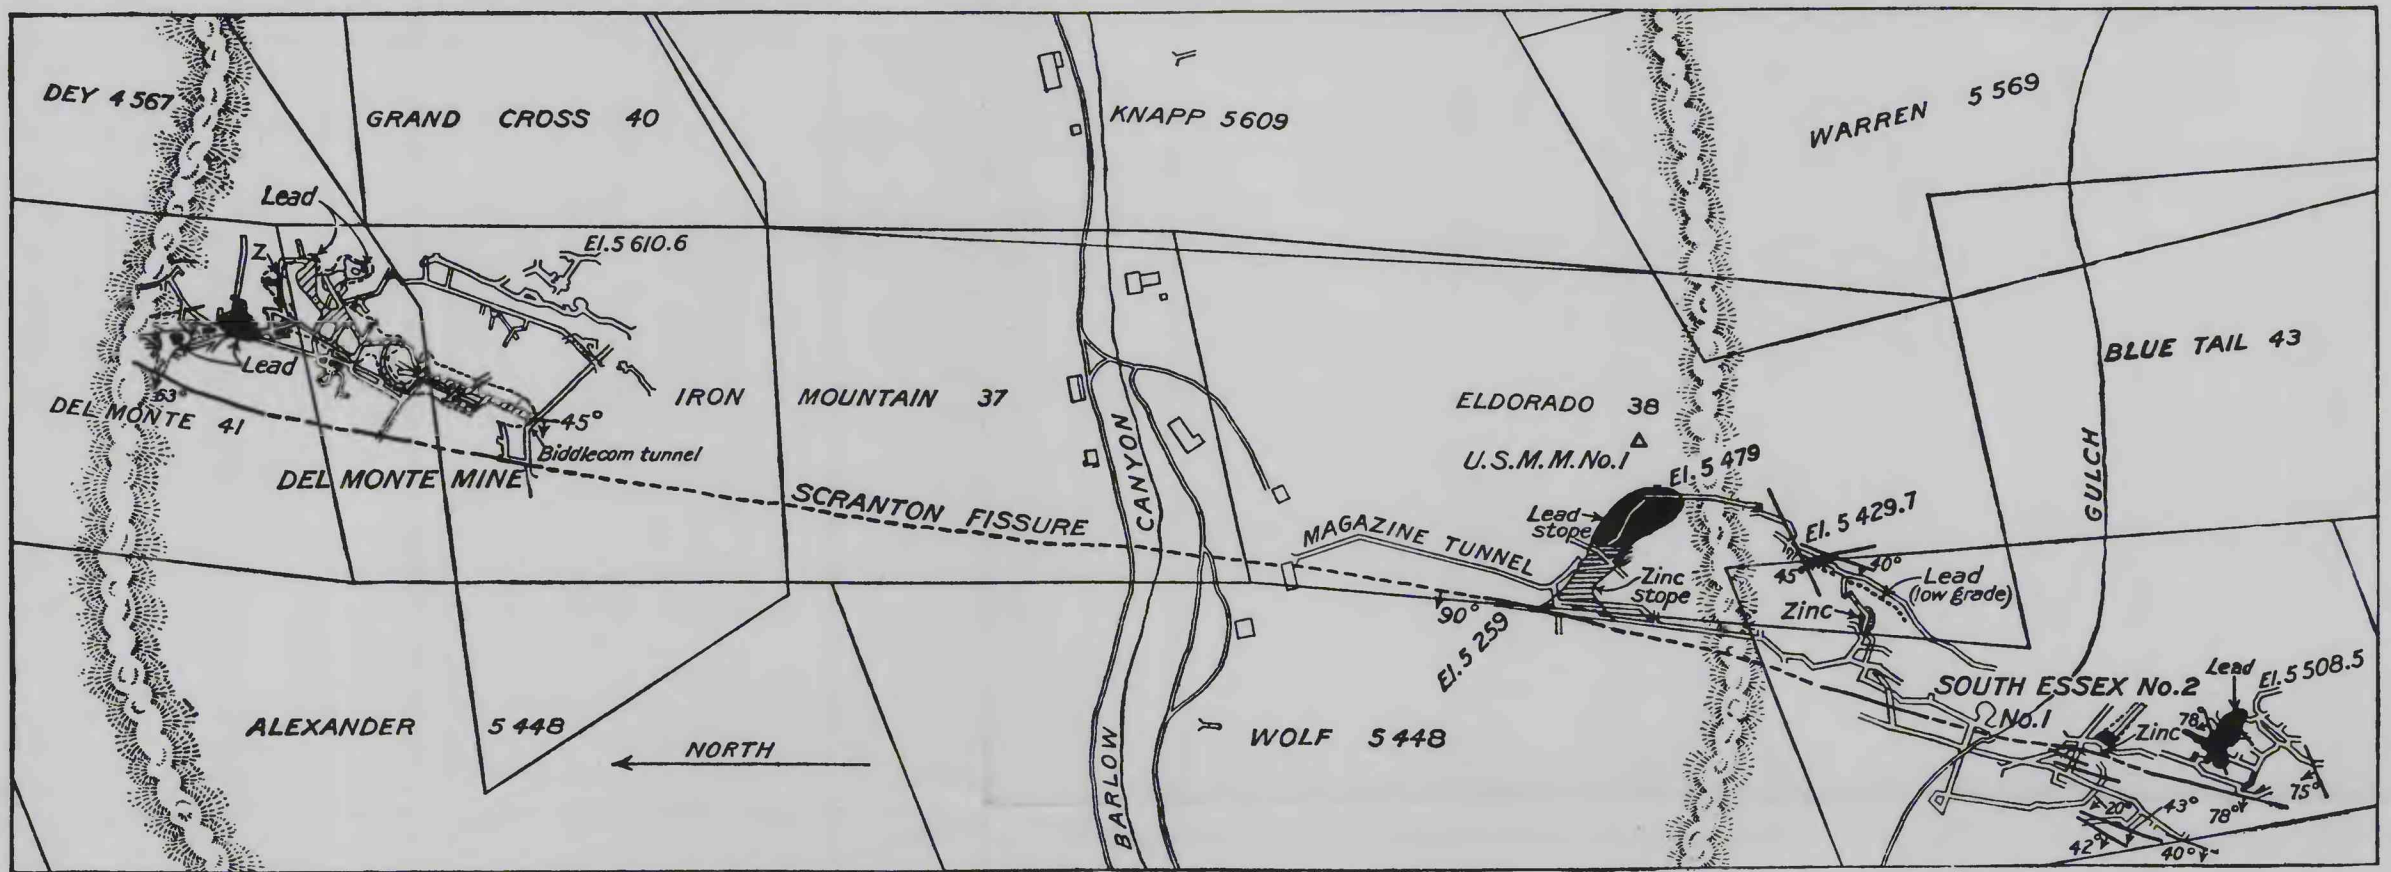
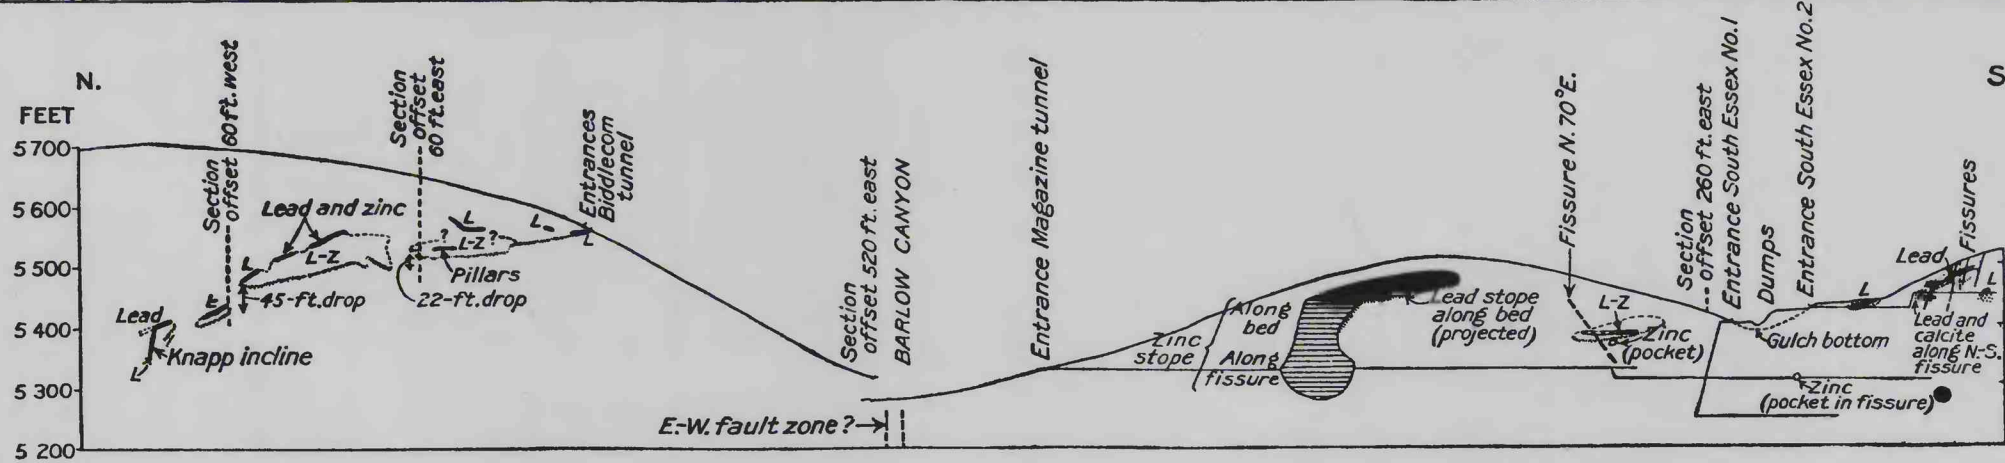
Reproduced from Lindgren and Loughlin (1919, pl 39)
