Debris Flow and Erosion Control Problems Caused by the Ash Eruptions of Irazú Volcano, Costa Rica

By HOWARD H. WALDRON

G E O L O G I C A L S U R V E Y B U L L E T I N 1 2 4 1 - I

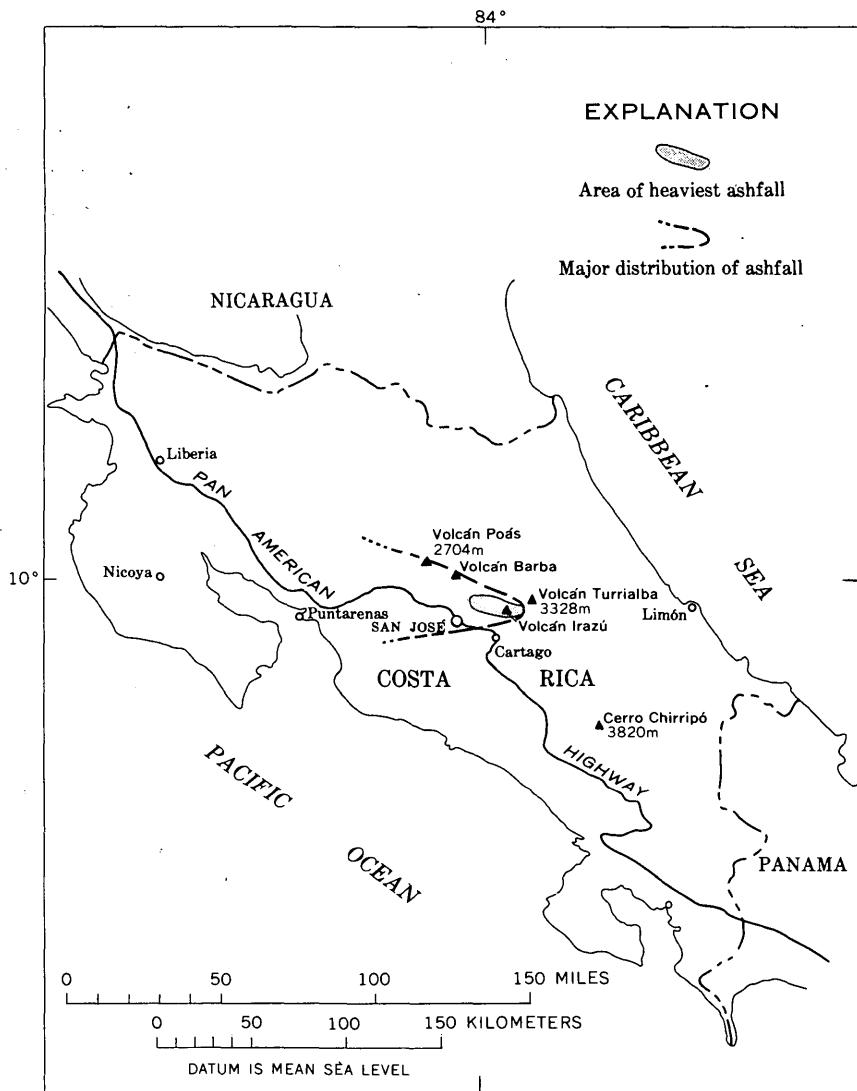
FIGURE 2.—Index map of Costa Rica, showing location of Irazú Volcano, major distribution of ashfall, and area of heaviest ashfall.

Irazú Volcano is the highest (3,432 meters) of several composite volcanic cones which make up the Cordillera Central in central Costa Rica and which are located near the population and economic centers of this small Republic (fig 2). The summit of Irazú lies only about 24 km (kilometers) east of San José, the largest city and capital of the Republic, and only about 15 km north-northeast of Cartago, the second largest city of the Republic and the capital of the Province of Cartago.

The prevailing southeast to east winds deposited the ash along a narrow zone that surrounded the summit crater and extended downwind for several tens of kilometers to the northwest and west (fig. 2).

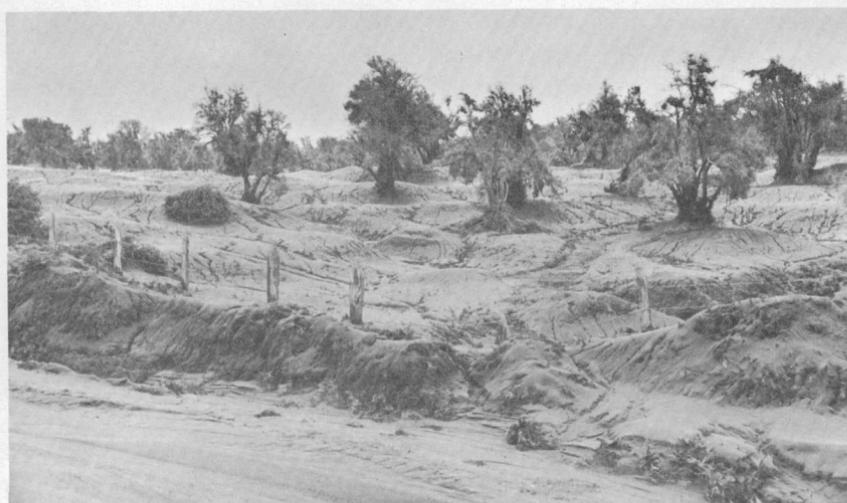
FIGURE 4.—Destruction of vegetation by ashfall. Upper: Along summit road near eastern summit crater. Lower: In Laguna area; in center foreground, beginnings of deep gully erosion by the Río Reventado.

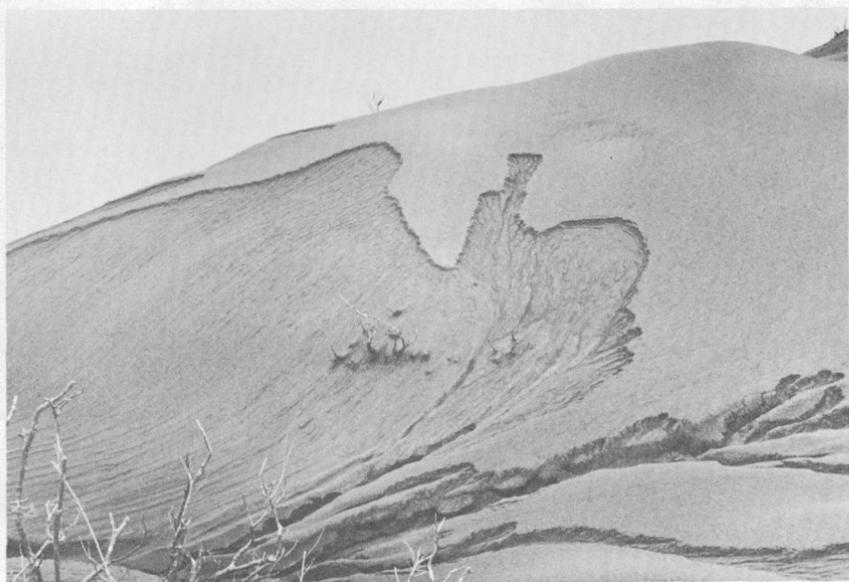
FIGURE 5.—Sheet and rill erosion of ash from upper slopes of Irazú Volcano.

During the 1964 rainy season most of the erosion of the fresh ash from the upper slopes of the volcano resulted from the headward and lateral growth of rills and gullies. Neither mass movement nor minor landslide failure of the new ash was observed. The stability of the new ash probably can be attributed to the high degree of internal friction and shearing resistance that is inherent in a mass composed almost entirely of fresh, angular, rock particles. From measurements made of ash removal and from a study of photographs taken periodically of the erosion features, it was estimated that one-third to one-half of the newly fallen ash had been removed from the upper slopes of the volcano by the end of the 1964 rainy season. Some of this material was redeposited on valley floors and other areas of low gradient, such as roadways and ditches; the remainder was carried on downstream.

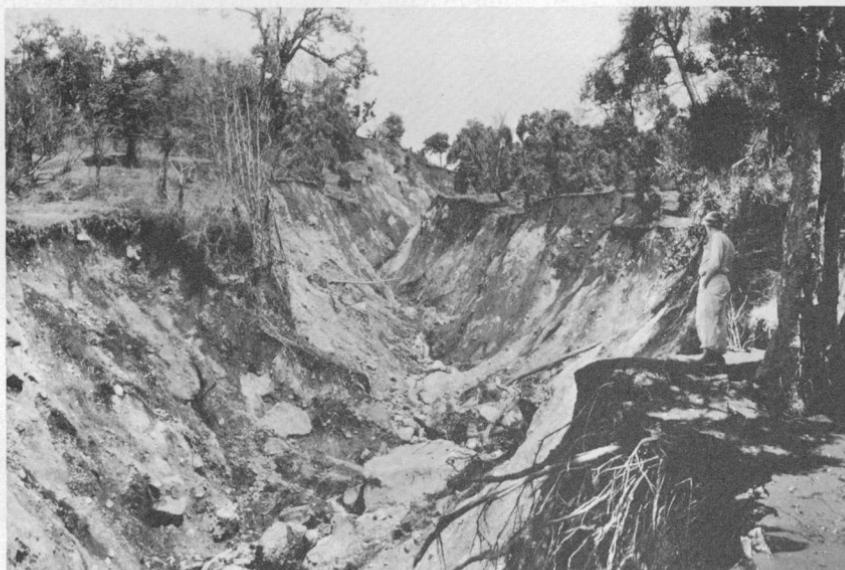
FIGURE 6.—Accelerated channel erosion in the upper Río Reventado valley. Much of the upper basin of the Río Reventado is underlain by soft, clayey lahar and ash deposits.

Channel erosion by streamflow (fig. 6) was many times more severe

than the sheet, rill, and gully erosion that occurred on the ash-covered slopes. The eroding capacity of streamflow depends largely on velocity and discharge of the stream. These factors are determined chiefly by the depth, width, and gradient of the channel, character and quantity of sediment load, and the material forming the channel. Much of the Río Reventado channel consists of poorly consolidated, altered and weathered, clayey lahar and ash deposits. Shear strength of these deposits is probably very low, particularly when saturated, owing to their high clay content; much of the original volcanic glass in the ash and lahar has been altered to a clay mineral. Thus, a combination of easily eroded channel material of low shear strength, high discharge, and high-velocity flow resulted in a very high eroding capacity for the Río Reventado and other streams draining the volcano.

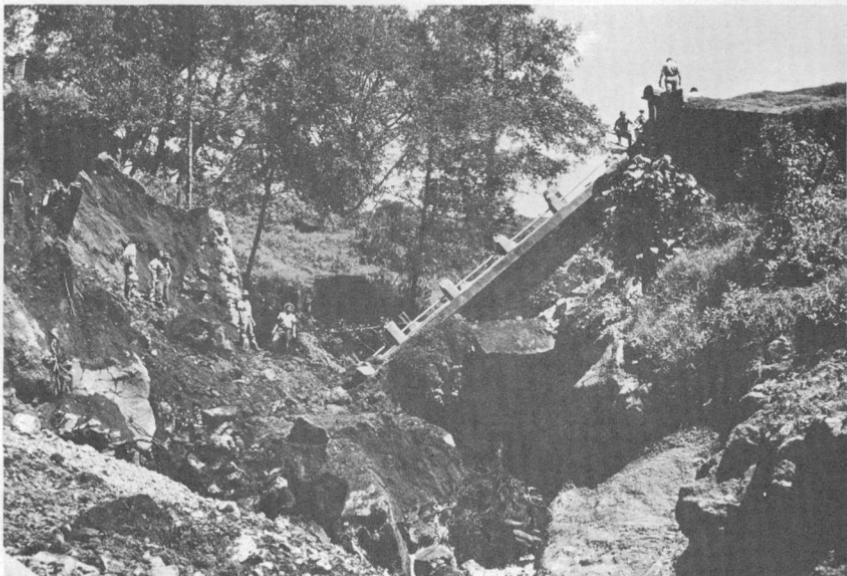
FIGURE 9.—Highway bridge destroyed by the Llano Grande landslide. View is looking upstream at observation post 2. Toe of the slide (on left) destroyed the abutment of the bridge.

The numerous landslides not only contributed large quantities of material to the debris flows but destroyed roads and bridges (fig. 9)
