Storm-Induced Slope Movements at East Brady, Northwestern Pennsylvania

U.S. GEOLOGICAL SURVEY BULLETIN 1618

By John S. Pomeroy

Description of the August 1980 debris
avalanching and other slope movements
and a discussion of the factors involved

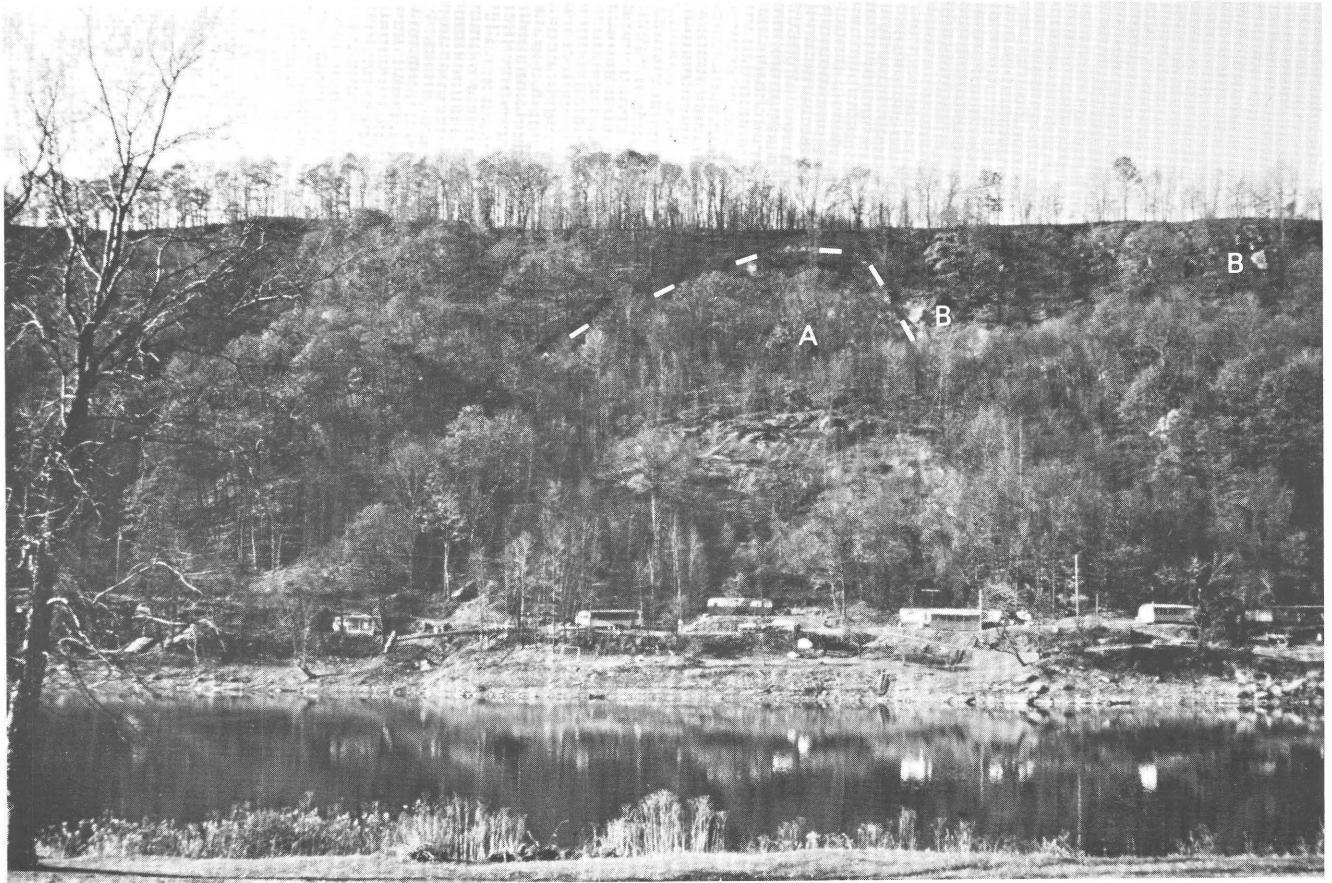
Figure 3. Large rock slump opposite East Brady, Pa., photographed in November 1976 (fig. 2, area A). Note indication of arcuate head scarp on pre-1938 rock slump. A is locale of figure 4. Subhorizontal bedrock adjacent to slump at B.

An inventory of slope stability features in western Pennsylvania revealed an apparent massive slope movement that had taken place opposite East Brady (figs. 2 and 3). Field inspection confirmed the presence of a rock slump. Slumped bedrock containing strata dipping moderately back toward the slope (fig. 4) could be differentiated among dislocated sandstone blocks on the very gently inclined bench (fig. 3, area A), in front of a bedrock-faced headwall. The width of the slump in the head area is approximately 60 m, increasing downslope to 137 m at the slump foot. Because the arcuate head scarp is easily recognized, the slope movement is probably historic. The movement probably occurred before 1920 because none of the older inhabitants of East Brady who were interviewed remembered the event. Furthermore, some trees as old as 60 years are rooted on the slump block. Slanted and curved tree trunks indicate that creep has occurred since the initial movement.

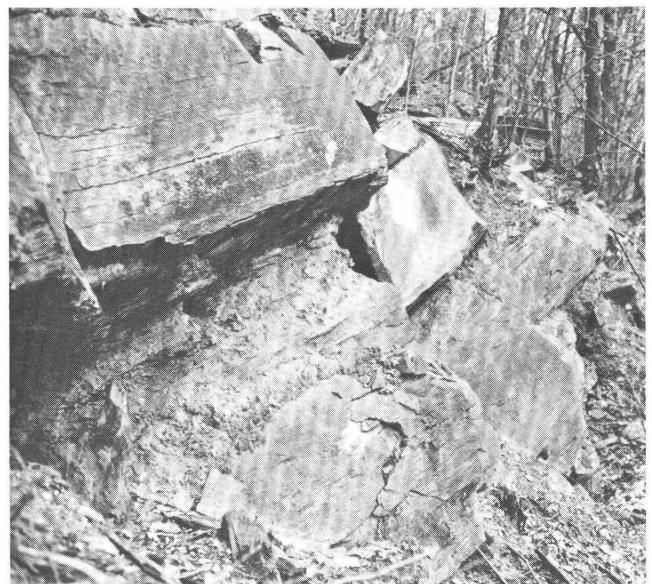
Figure 4. Slumped bedrock that lies within large historic rock slump (fig. 2, area A).

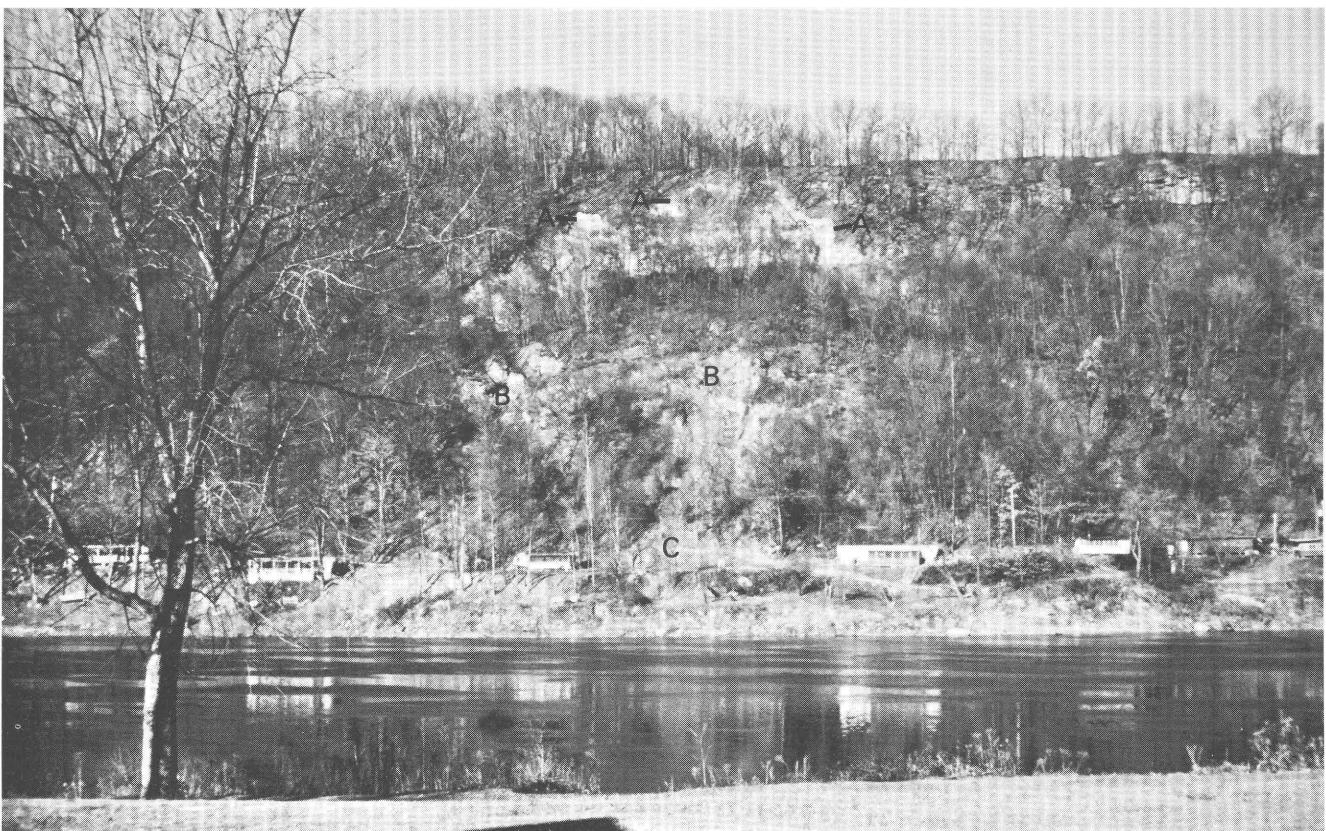
Figure 5. Large rock slump opposite East Brady, Pa., photographed in November 1980 (fig. 2, area A). Compare with figure 3. Scarring of headward margins at A. Slope movements (B) occurred during August storm. Site C (at foot of recent flow) is former location of trailer seen on figure 3.

No evidence points to any recent deep-seated reactivation of the slump block. However, the 1980 storm reactivated parts of the deposit below the bench (fig. 5) affecting about one-fifth to one-fourth of the entire slump block. The most recent slope movement was shallow and took place in colluvium where slippage was at, or close to, the bedrock-

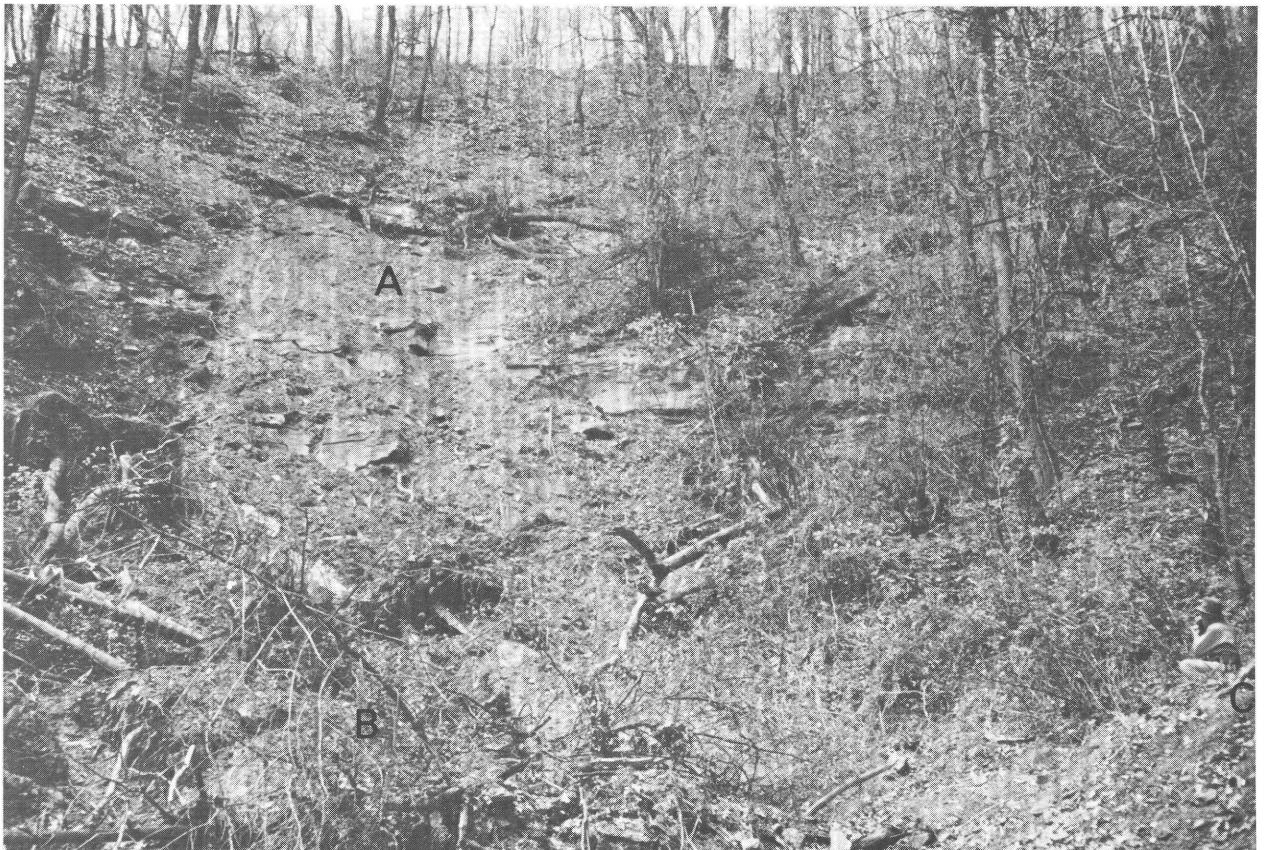
Figure 6. Head of longest debris avalanche (fig. 2, area C). Note thinness of removed regolith in head (A) and pileup of material at bench in foreground (B). The debris avalanche continued downslope from bench. Person (C) is at lateral margin of slope movement.

The longest (180 m) debris avalanche originated on the south side of a wide, steep, concave (sidewise) slope 10 m below the rim (fig. 6). The debris avalanche was 4.5 m wide at the head; sandy fragmental colluvium, 0.3 to 1.0 m thick, was exposed along its margin. The unusually steep (64°) bedrock-colluvium interface and a conspicuous north-south trending joint dipping 75° to the east were noted at the head of the slope movement.

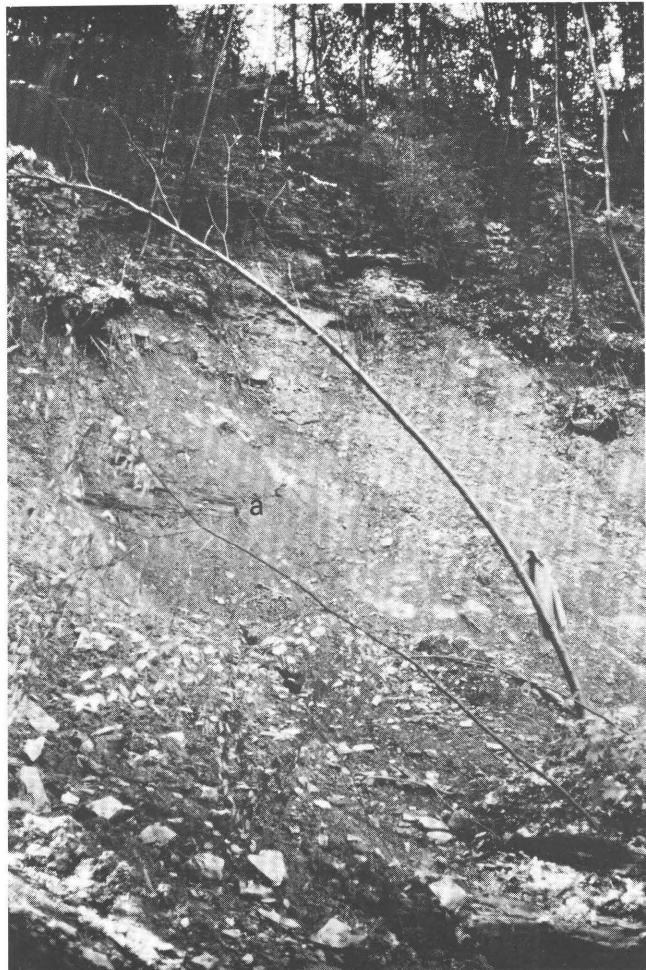
Figure 7. Amphitheater-shaped head scarp of debris avalanche (fig. 2, area D) with outcrop (a) in left center of photograph. Shirt hanging on tree indicates scale.

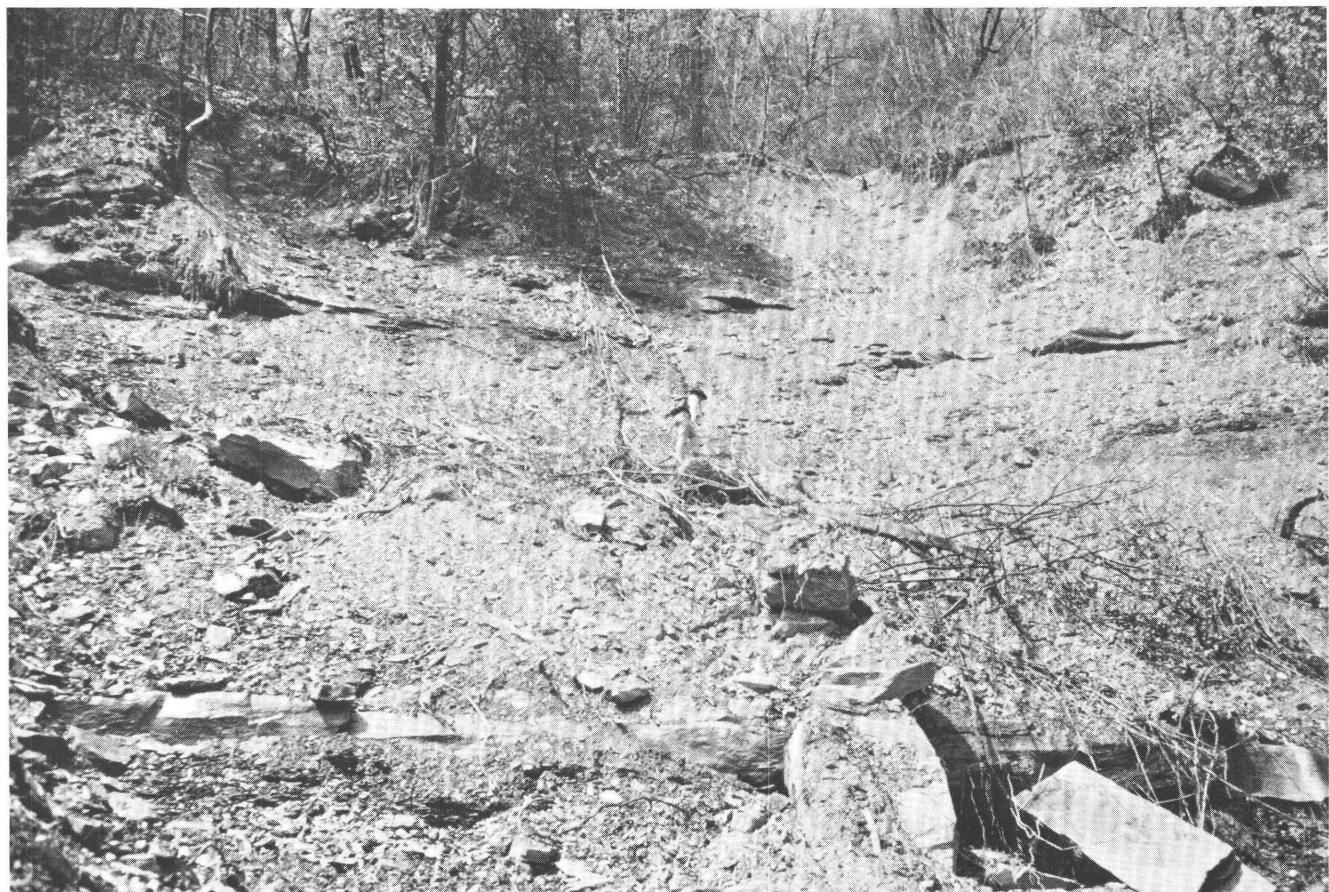
Figure 8. Part of 30-m-wide head of debris avalanche. Small seepages are common above person (center of photograph) where sandstone boulder colluvium and sandstone overlie thin coal and claystone. Gently sloping surface above scarp is part of head area of prehistoric rock slump (fig. 2, area D). Note person for scale.

A large debris avalanche (fig. 8) originated at about 1,050 feet altitude at the edge of the bench south of the previously mentioned movement. The main part flowed downslope until it stopped along the more gentle slope about 30 m from the river. In its lower extremity the flow bifurcated, and a 4.5- to 6.0-m-wide segment flowed to the river. The fact that the main path was cut below the level of the intersection of the fork indicated that the appendage represented an earlier event during the storm.

The head (fig. 8), nearly 30 m at its widest dimension, is part of a slightly larger concave (sidewise) slope. The adjacent slope measures 39°

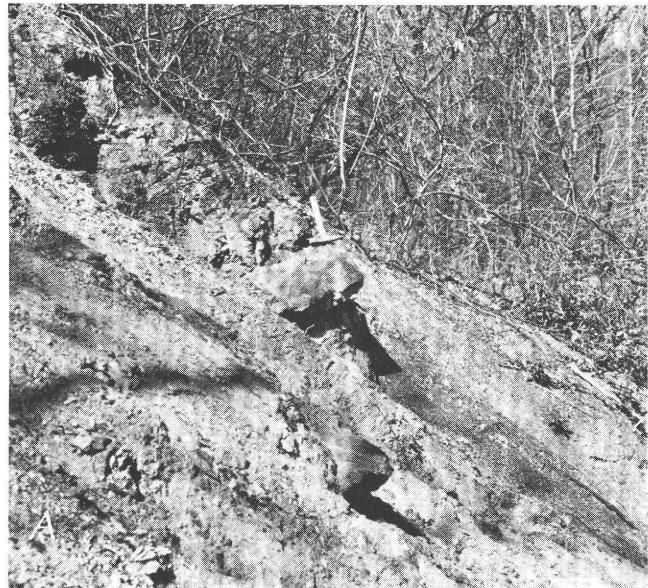
Figure 9. Slope movements in 1980. A. View across 1980 major slope movement (fig. 2, area D) in colluvium. Gently slumped bedrock is part of midsection of older (prehistoric) movement. B. Slumped bedrock in foreground dipping 39° back toward slope. Bedrock is in head area of same prehistoric rock slump as in 9A. 1980 slope movement (a) in background (fig. 2, area D).

The 4° to 5° westward dip of beds exposed in the present scarp (fig. 9A) indicates that the recent failure occurred in an older rock slump of probable prehistoric age. The carbonaceous shale and coal in the colluvium below the scarp are similar to the slope debris at locality A. The very gently sloping bench above the main scarp is hummocky with sandstone boulders to the base of the cliff and resembles the slope movement at locality A. Trees, at least 60 to 65 years old, are growing on massive

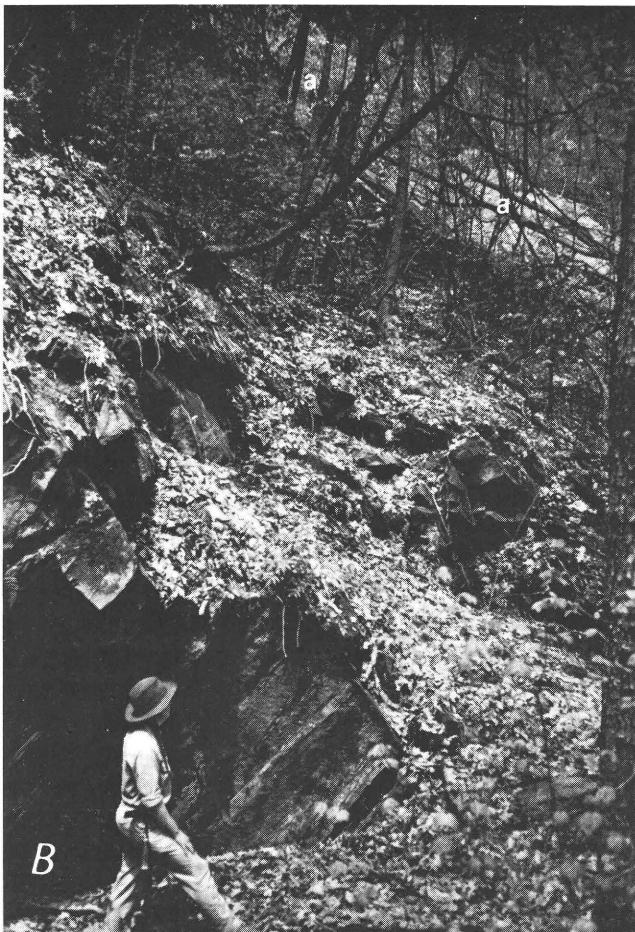
Figure 10. Slope movements east of East Brady.

An roughly equidimensional scar (B, fig. 10) is seen in the upper part of the slope. The width and length were 45 m and 48 m respectively along a 45° (100 percent) slope (fig. 11C). Thin soil and weathered rock, most not exceeding 0.3 m in thickness, were stripped off this large area, which is underlain by shale and sandstone. The terminus of the detritus was along a natural rock bench at the base of a 7.5-m-high sandstone cliff which was overridden by the debris. Well-developed joints, striking N. 80° W. and dipping 73° NE. paralleling the river, account for the loose, highly weathered regolith that contributed to the rock debris.

About 90 percent of the slope movements originated at or below the Lower Kittanning coal bed both east and west of East Brady (figs. 2, 10). Though seeps were seen at other horizons, the most pronounced springs emanated from the contact of the coal (densely jointed) and underclay below a dominantly sandstone section. In the absence of coal, seepages were common at the base of a
