Geologic Relationships Of Slope Movement in Northern Alabama

U.S. GEOLOGICAL SURVEY BULLETIN 1649

By JOHN S. POMEROY and ROGER E. THOMAS

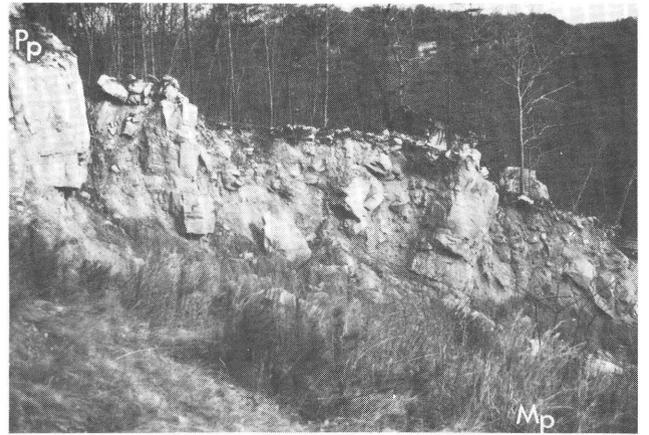
- B.** Prehistoric(?) toppled blocks of Pottsville Formation downslope from outcrop at far left of figure 2A. Unstable colluvium and weathered rock of Pennington Formation in foreground was recently active (see locality B on fig. 3A). Alabama 227, 18 km northeast of Guntersville. Columbia City 7 1/2-minute quadrangle.

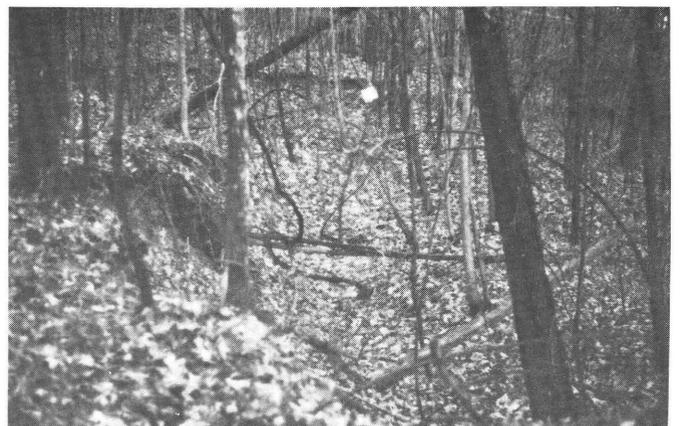
F

- F.** Head of translational (planar) slide in woodland above road. Weathered mudstone from Bangor Limestone underlies head. Cumberland Plateau escarpment 38 km south-southwest of Huntsville. Center Grove 7 1/2-minute quadrangle.

Most of the slope movements are 9–15 m wide. One of the larger debris slides (figs. 1, locality F; 2F) is more than 30 m wide, has well-defined lateral borders, and is at least 10 years old based on vegetation. The debris slide originated along a 22° (41 percent) wet slope a few meters below the contact of Bangor Limestone and Pottsville Formation and shows translational (planar) movement.

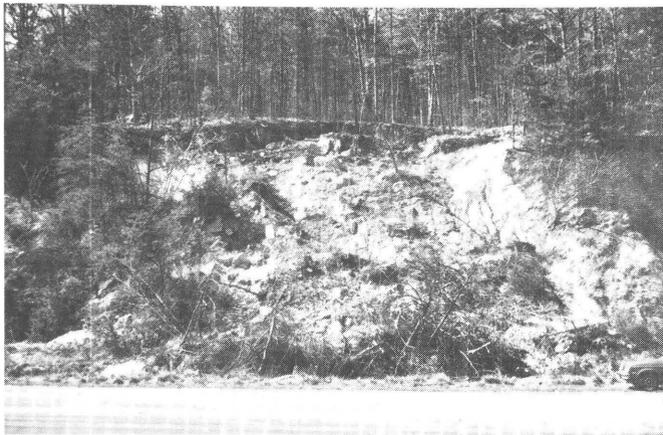
- G.** Colluvial slope failure above U.S. 43. Grayish-green weathered shale and soil of Pride Mountain Formation. Little Mountain section 13 km northeast of Russellville. Russellville 7 1/2-minute quadrangle.

All observed slope movements in the Highland Rim have taken place in areas underlain by the Pride Mountain Formation (table 1). The Pride Mountain Formation consists of thick shale units including mudstone interbedded with thin beds of limestone and sandstone. Recent sliding and flowage have taken place in highly plastic when wetted soil derived from mostly grayish-green shale. Major localities include slopes along U.S. 43 between Russellville and Tuscumbia (figs. 2*G*, 3*F*) and Alabama 247 west and southwest of Tuscumbia.
