# Landslides and Debris Flows in Ephraim Canyon, Central Utah

U.S. GEOLOGICAL SURVEY BULLETIN 1842-C

By REX L. BAUM and ROBERT W. FLEMING

Geologic mapping of landslides in bedrock, landslides in  
unconsolidated materials, and debris flows occurring in  
1983–1986, on the west side of the Wasatch Plateau

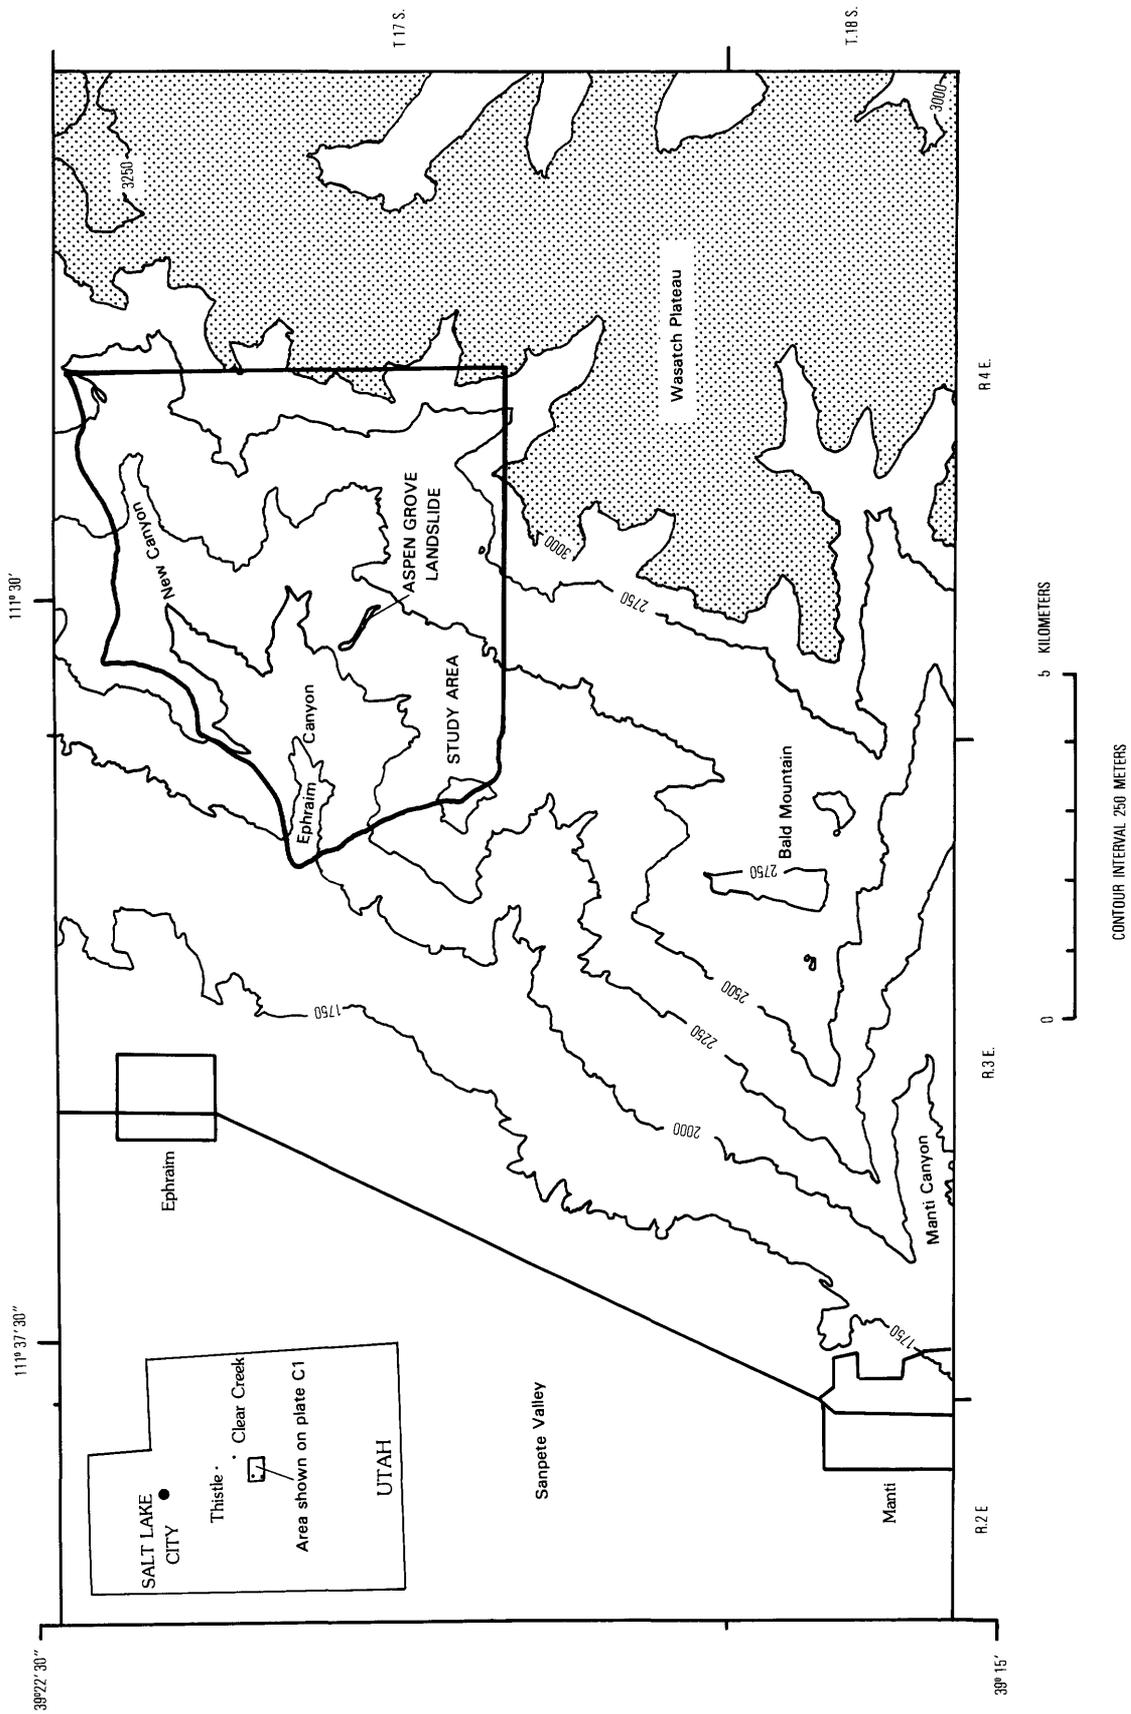
Figure C1. Map showing location of the study area.

The mouth of Ephraim Canyon is at about 1,850 m elevation and is about 3 km southeast of the town of Ephraim (fig. C1). The canyon is about 5 km long and heads in the Wasatch Plateau, which is a slightly dissected, nearly horizontal surface between 3,050 and 3,200 m in altitude.

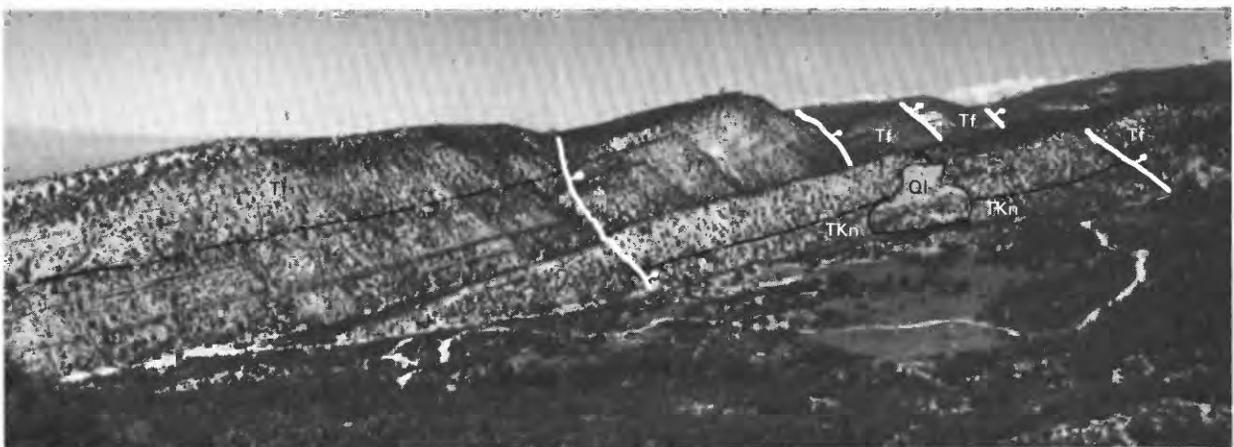
**Figure C2.** Photograph showing exposures of the North Horn Formation (TKn) and the Flagstaff Limestone (Tf) on the north side of Ephraim Canyon (looking north from Bald Mountain, fig. C1). A rockslide (Ql<sub>2</sub>) on the north side of Ephraim Creek is shown near the right-hand edge of the photograph. Ball and bar on downthrown side of fault.

Bedrock crops out on steep slopes and in cliffs. In the map area, bedrock is exposed primarily in south-facing slopes of New Canyon and Cottonwood Creek, in cliffs along the edge of the plateau at White Ledge and the Great Basin Experiment Station, in the area between Maple Creek and Cottonwood Creek, and in the rims of the hogbacks (pl. C1; fig. C2).

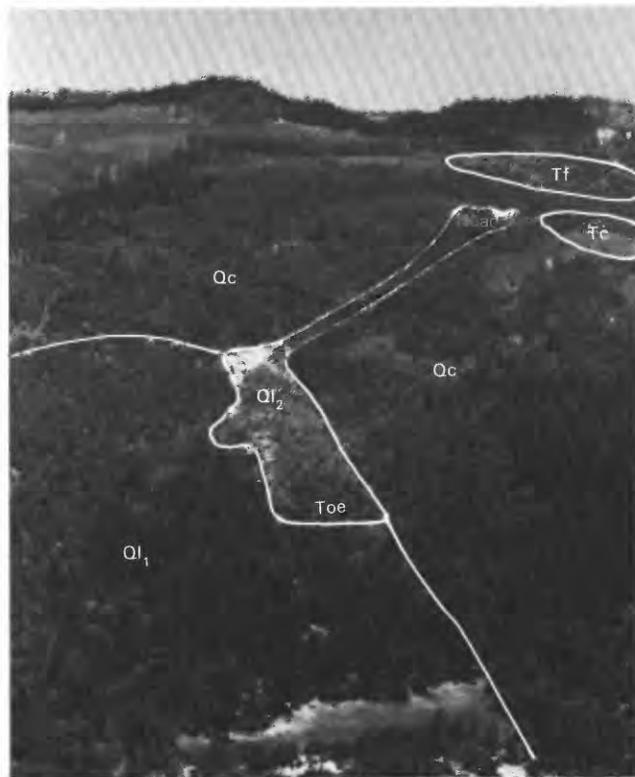
**Figure C3.** Photograph of the Dusterburgs Hill landslide, looking east from the northwest rim of New Canyon.  $Ql_2$ , Dusterburgs Hill landslide;  $Ql_1$ , pre-1983 landslide deposit;  $Qc$ , slope deposits;  $Tf$ , Flagstaff Limestone;  $Tc$ , Colton Formation. All contacts approximately located.

The geometry of the Dusterburgs Hill landslide differs in some details from that of the Aspen Grove landslide. An arcuate head scarp, from 2 to 3 m high, defines the proximal boundary of the landslide. The surface of the upper half of the landslide is slightly lower than neighboring ground. Well-developed shear zones mark the lateral boundaries, and a steep toe, from 1.5 to 2.0 m high, marks the distal boundary. The surface of the landslide was strongly deformed and is broken by many cracks. Most trees and shrubs growing on the landslide were uprooted by its movement (fig. C3).

The sharp bend in the landslide is a unique feature. Most landslide debris slid out of the bend, leaving a bowl-like depression 3–4 m deep (fig. C3). Red shale, probably of the Colton Formation, is exposed in the bottom of the depression. During the summer of 1985, two small springs were observed near the margins of the depression.

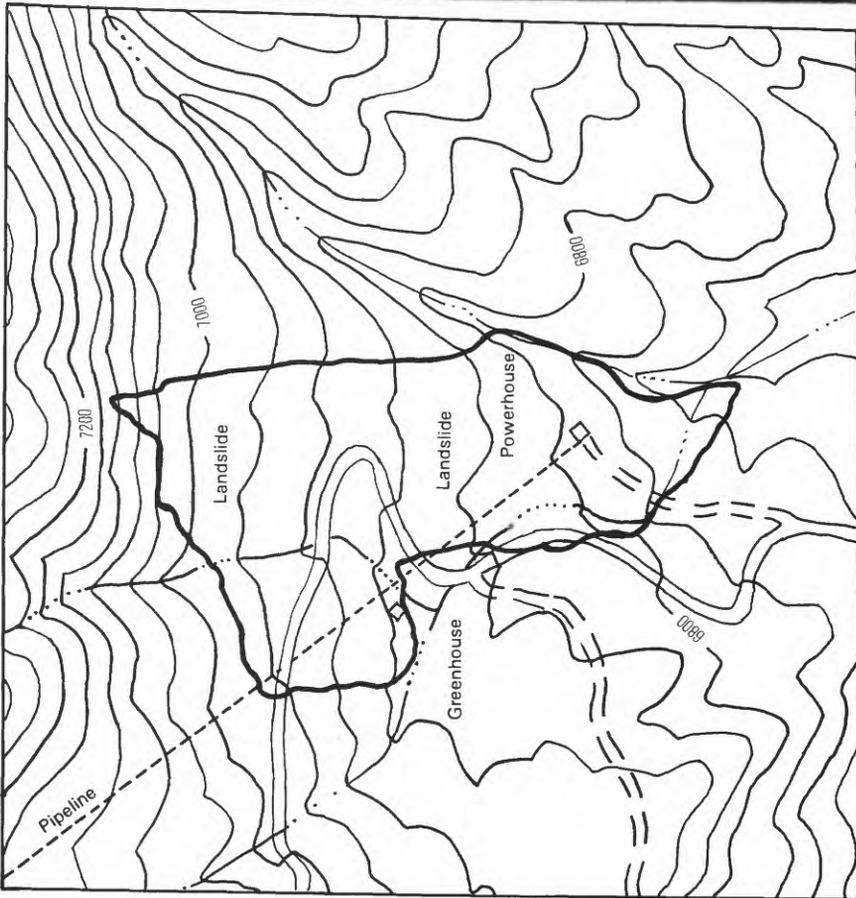
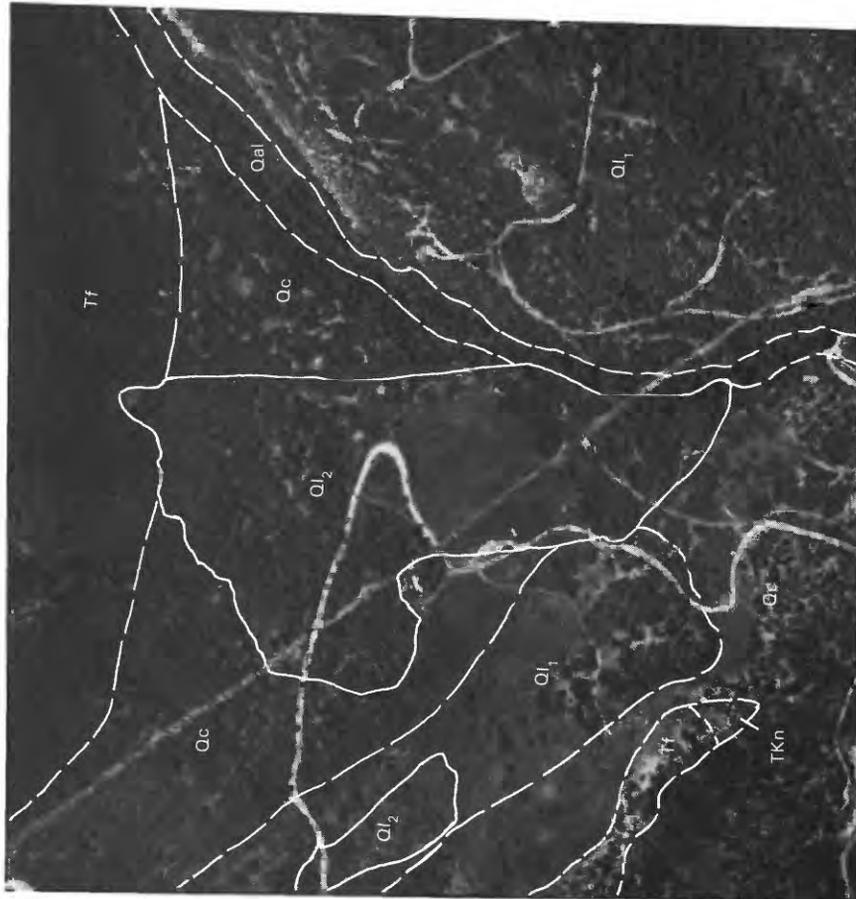
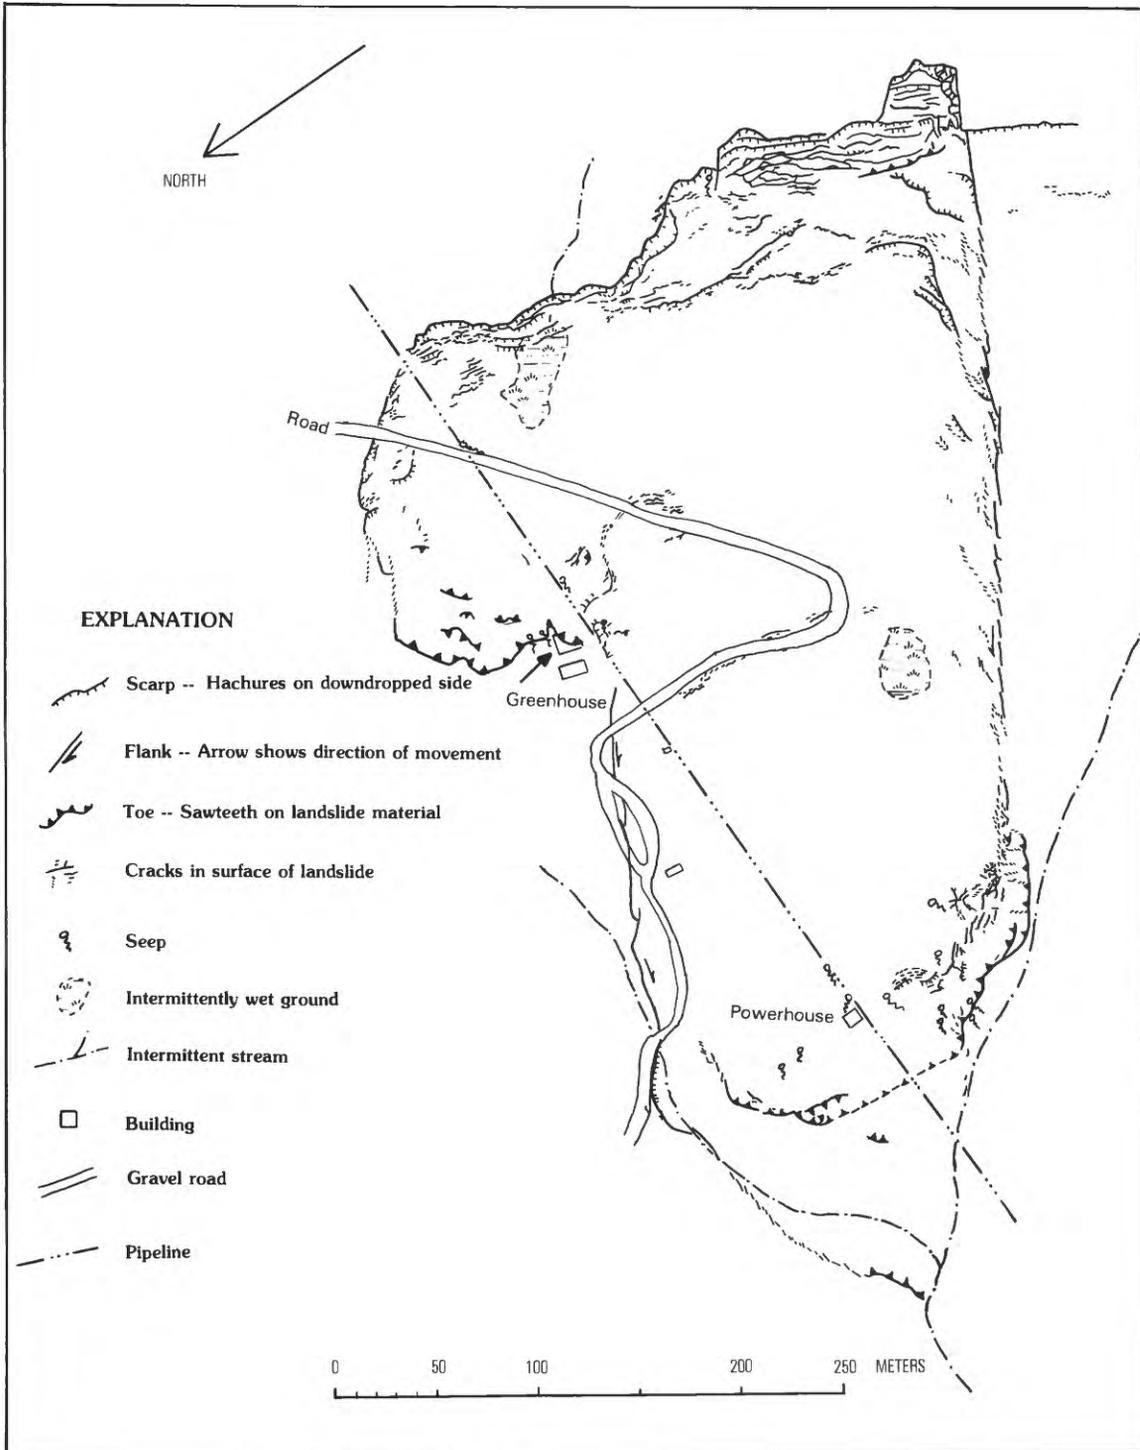
**Figure C4** (above and facing page). Majors Flat landslide. *A*, Pre-landslide topographic map redrafted from Ephraim 7½-minute quadrangle (USGS). *B*, vertical aerial photograph. Map units on photograph correspond to map units on geologic map (pl. C1). *C*, map showing features at the surface of the landslide.

m<sup>3</sup>. The average slope of the landslide surface is from 10° to 11° (fig. C4A). In plan view, the landslide is shaped about like Africa, with the head of the landslide corresponding to the north coast of Africa, and the toe of the landslide to the Cape of Good Hope (figs. C4B, C4C).

Deformation due to movement occurred mainly around the edges of the landslide; the central part is relatively uncracked and undeformed (fig. C4C). The head scarp of the landslide is rough and irregular, and stands from 1 to 3 m high. A region immediately below the head scarp, 30–60 m long and extending the full width of the landslide, is broken into long blocks, from 1 to 4 m wide, that are bounded by transverse cracks and scarps. En echelon cracks and segmented faults (fig. C4C) define the flanks of the landslide. A slightly sinuous toe, 1–2 m high, connects the right flank of the wide upper half of the landslide to the right flank of the narrower, lower half of the landslide (fig. C4C). Imbricated thrust sheets occur in the foot of the landslide; the edges of the thrust sheets are defined by steep, sinuous ridges from 0.5 to 1.5 m high.

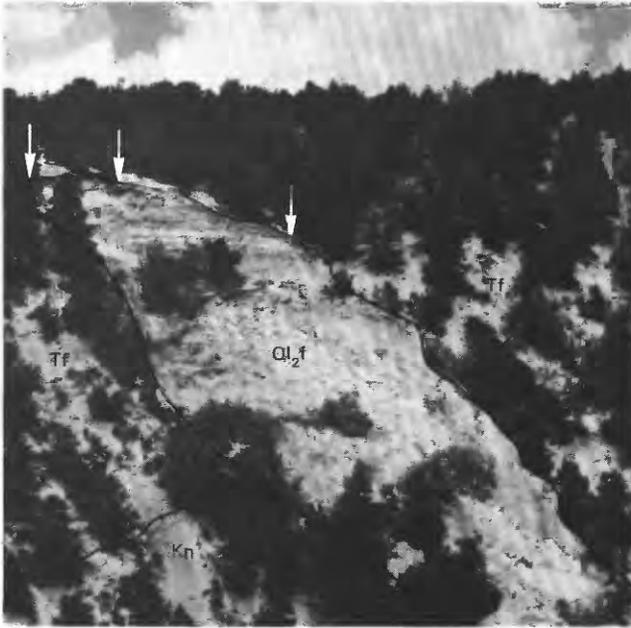
**Figure C5.** Photograph showing a rockslide near Cottonwood Spring. Faulted, thickly bedded limestone of the Flagstaff Limestone is exposed in the head scarp. Arrows indicate locations of three different faults. Tf, Flagstaff Limestone; TKn, North Horn Formation; Ql<sub>2f</sub>, 1983–1986 rockslide.

Many distinguishing features of bedrock landslides are illustrated by a rockslide in the fault zone upslope from Cottonwood Spring, SE¼ sec. 7, T. 17 S., R. 4 E. (fig. C5). The rockslide is about 170 m long, its head is about 45 m wide, but the landslide tapers gradually so that the toe is about 5 m wide. The thickness ranges from 1 to 8 m and the average is about 4 m. The volume of the landslide is approximately  $1.8 \times 10^4$  m<sup>3</sup>. The slope of the ground surface, where the landslide occurred, was about 30°.

The head scarp exposes fractured limestone bedrock of the Cove Mountain Member of the Flagstaff Limestone. The head of the slide slopes a few degrees toward the south. It is covered with porous, white, limestone blocks. The body and toe of the landslide consist of an unsorted mixture of silty clay with angular fragments and blocks of limestone. Dead trees lying in various positions dot the surface of the slide (fig. C5).

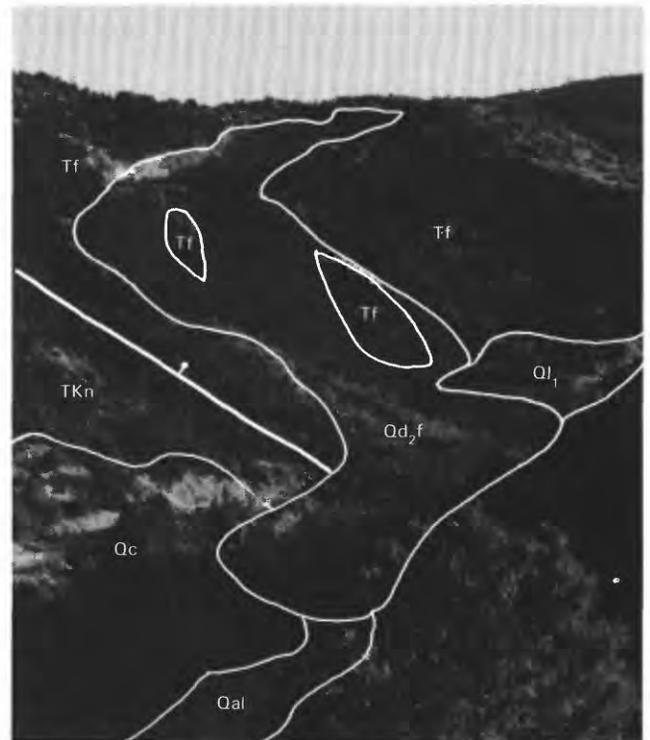
**Figure C6.** Photograph showing the Cottonwood Spring debris flow of 1986. Tf, Flagstaff Limestone; TKn, North Horn Formation; Qc, colluvium and slope wash; Ql<sub>1</sub>, Pre-1983 landslide deposit; Qal, alluvium; Qd<sub>2f</sub>, debris flow of 1986. All contacts approximately located. (Photograph by Arvid Johnson).

The debris flow that occurred in 1986 at Cottonwood Spring (fig. C6) was notably different from debris flows that occurred at other localities in Ephraim Canyon during 1983–1985. The 1986 debris flow began as a landslide in bedrock on a dip slope. We observed a few widely spaced cracks on the upper part of the dip slope in 1984 or 1985, but a slope failure was unexpected because many of the landslides that had been active in 1983 or

1984 had stopped by 1985. However, sliding and debris-flow movement started on about April 15, 1986 and continued for several days. Material slid down the dip slope, gradually being remolded until it began flowing, and then cascaded over steep slopes toward Ephraim Creek. In the bottom of the canyon, the flow moved a few meters per hour (Roger Johnson, oral commun., 1986). The flow partially dammed and diverted the creek, and covered an intake structure for a power plant at the mouth of Ephraim Canyon.

The Cottonwood Spring debris flow differed from typical debris flows in Ephraim Canyon in that it developed slowly for one or two years before it failed abruptly in 1986. It moved more slowly than other debris flows, was active for several days, and was mobilized from a layer of weathered bedrock several meters thick rather than from colluvium.
