Geomorphic Studies of the Storm and Flood of  
November 3–5, 1985, in the Upper Potomac  
and Cheat River Basins in West Virginia and  
Virginia

U.S. GEOLOGICAL SURVEY BULLETIN 1981

ROBERT B. JACOBSON, Editor

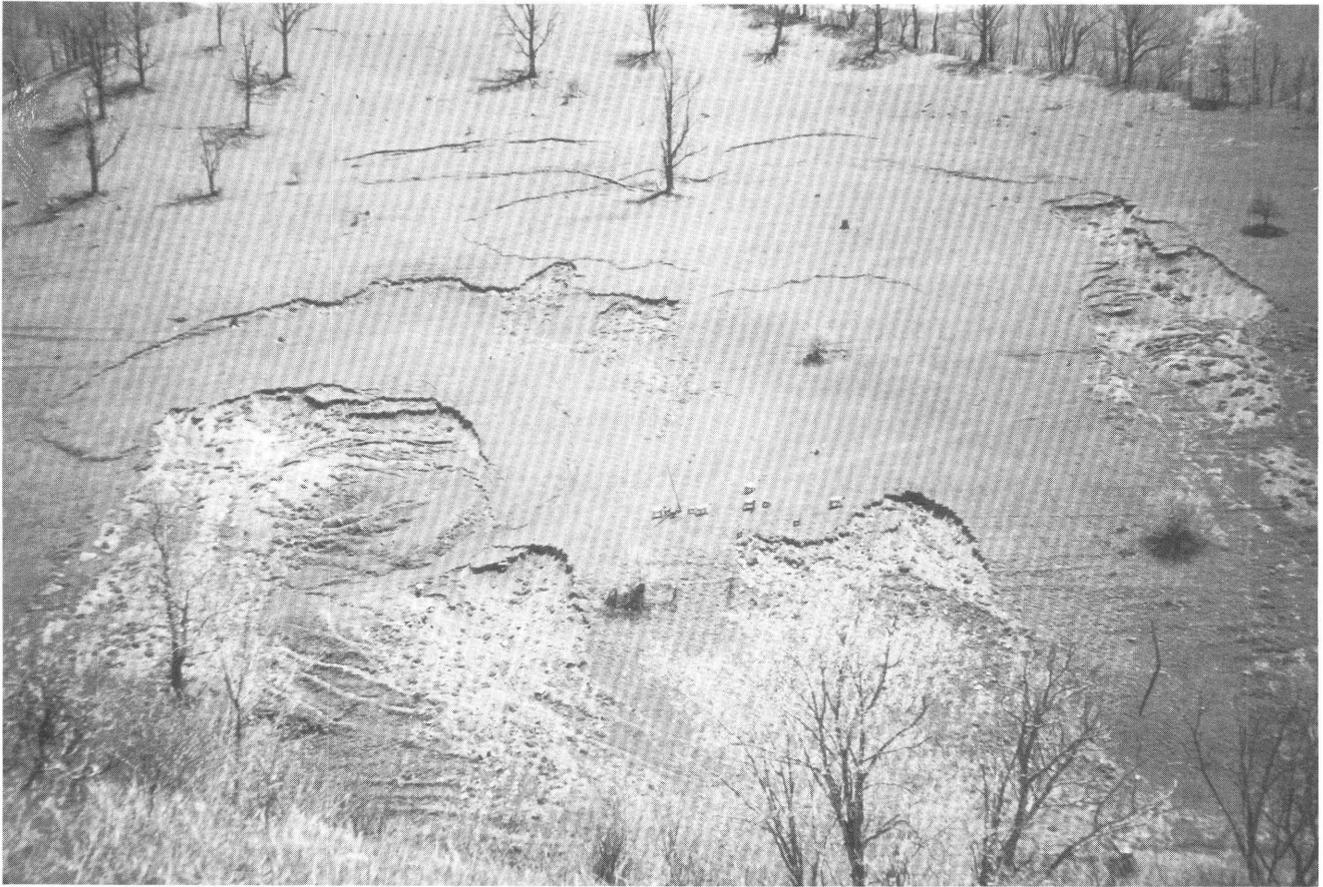
**Figure 3.** Shallow slides and slide flows in residuum derived from the Reedsville Shale. (Photograph taken June 1987. Note sheep for scale.)

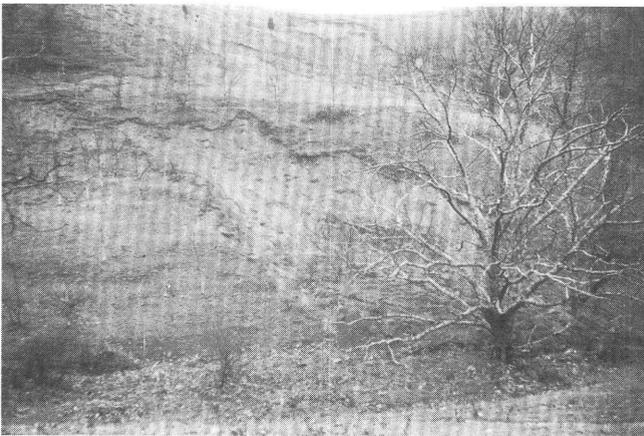
**Figure 4.** Large slump in toeslope colluvium derived from Reedsville Shale. Slump dammed stream at base of slope, causing several cubic meters of deposition upstream. Slump is approximately 5 m across.

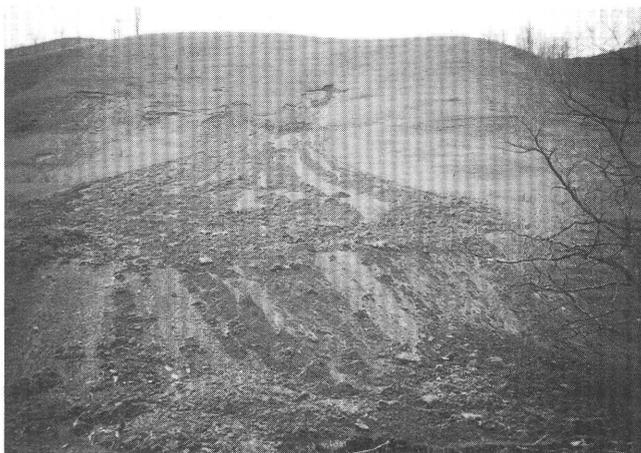
**Figure 6.** Typical slide flow on Reedsville Shale. Slide flow initiated in thin colluvium and residuum and flowed over turf on toeslope colluvium. Part of the flow was delivered to the stream channel at the base of slope. Flow track is 6 m across.

Slides and slide flows on the Reedsville Shale were approximately 90 percent shallow, planar failures in thin colluvium and residuum and 10 percent rotational failures in toeslope colluvium. Landslides in clayey residuum and thin colluvium of the Tonoloway, Wills Creek, and Williamsport Formations, Trenton Group shaley limestone, and the Mauch Chunk Group were all shallow, planar slides, most of which transformed into muddy debris flows. Regolith on these bedrock units is generally thin (less than 1 m), and slopes are relatively steep (20°–40°).

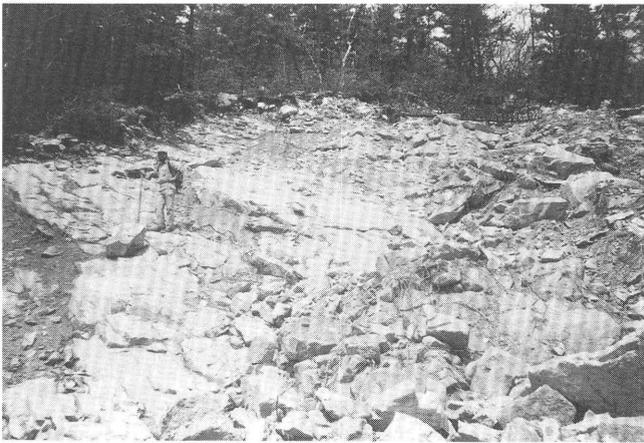
**Figure 7.** Debris avalanche scar at Twin Run. From 25 to 100 cm of fractured sandstone slid along bedding planes at left; diamicton colluvium at right was mostly stable.

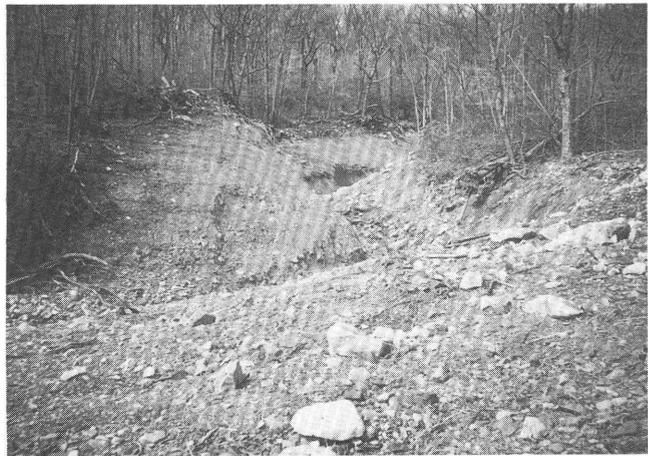
**Figure 8.** Track of debris flow from Twin Run debris avalanche. Note super-elevation around curve.

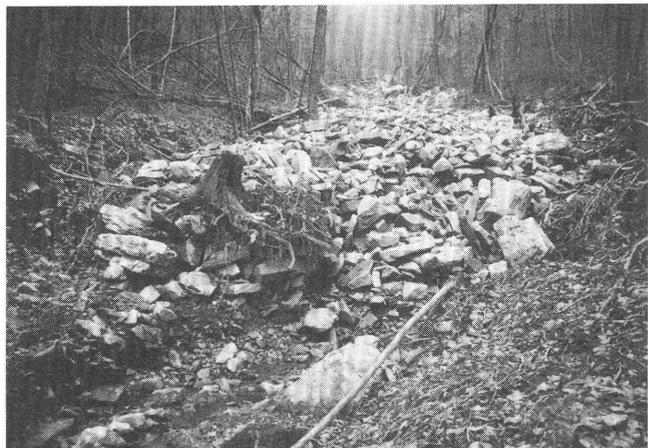
**Figure 9.** Snout of deposit of debris flow at Hartman's farm, southeast of North Fork Mountain. Snout is approximately 4 m wide, and deposit is about 1.5 m thick.

tracks were characterized by variable scour and deposition, common formation of lateral levees, super-elevated flow around bends (fig. 8), and large snoutlike deposits of debris and logs (fig. 9). Substantial fluvial reworking of the original deposits took place subsequent to debris flow deposition.

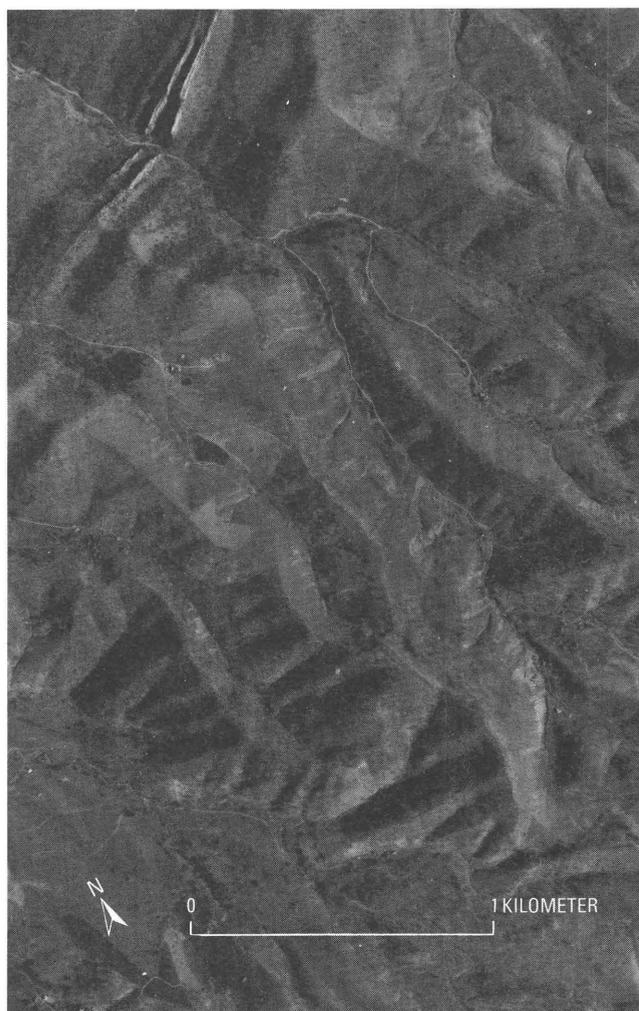
**Figure 16.** Aerial photograph showing association of landslides with cleared, northeast-facing slopes on Reedsville Shale in the center of the Wills Mountain anticline.

The interrelations among slope aspect, land cover, and landslide occurrence were investigated in the Germany Valley study area (Cron, 1990). Cron used a computer-assisted geographic information system (GIS) with 100-m by 100-m grid cells over 75 km<sup>2</sup> to compare topography, land cover, bedrock geology, and surficial geology for both stable and unstable slopes. She concluded the following:

- For all slopes, 9 percent of cleared cells had one or more landslides, whereas only 3 percent of the forested cells had one or more landslides.
- For north-facing slope cells, 6 percent had one or more landslides, and for south-facing slope cells, 5 percent had one or more landslides.
- For north-facing cleared slopes 10 percent of the cells had one or more landslides, compared with 2 percent for wooded cells; for south-facing cleared slopes, 7 percent had one or more landslides compared with 3 percent for wooded cells (table 5).

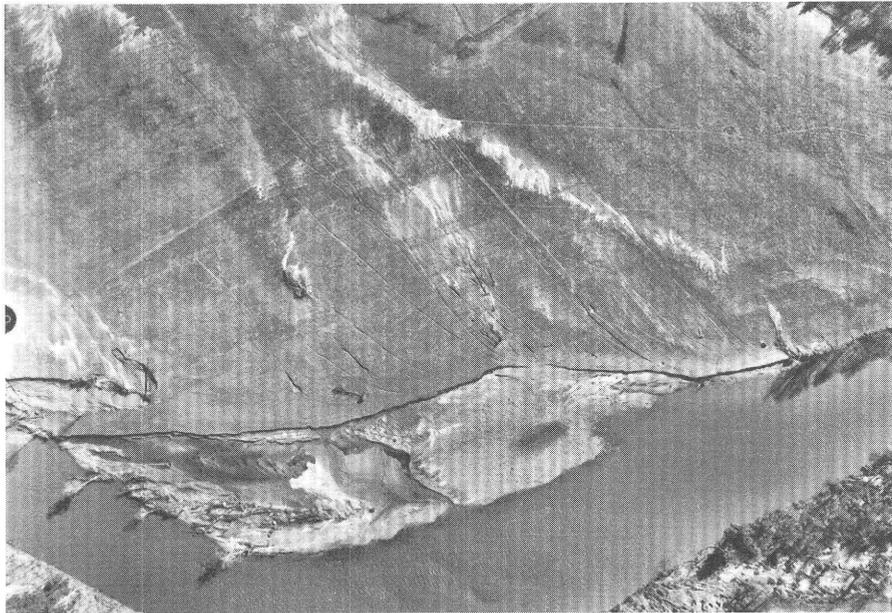
**Figure 5.** Aerial photograph of Cheat River flood plain near St. George, W. Va. Note evidence of bank retreat (bottom), incision of long narrow grooves (right and center), and deep scour around a standing tree (left). Deposits include sand dunes, sand ribbons, and flood-rafted trees. Normal flow in the river is from right to left (northwestward), but the grooves and tree alignment show flow was diverted northward across the flood plain during the flood (West Virginia Department of Highways photograph).

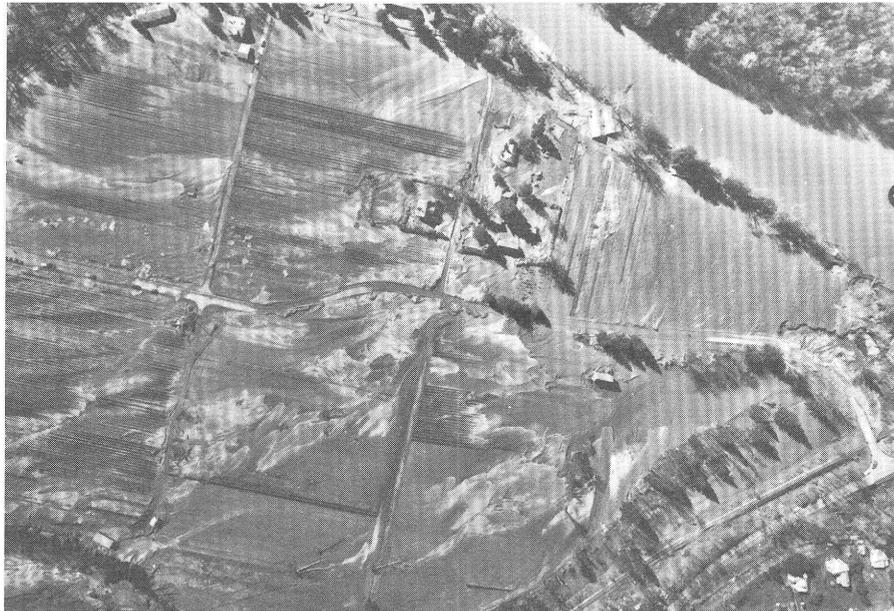
**Figure 6.** Aerial photograph showing parabolic and complex dunes on Black Fork flood plain at the Parsons Tree Nursery. Note buildings and automobiles for scale. Dunes occur just downstream from gravel splay and gravel stripes shown in figure 9. Transported asphalt slabs occur at left (south); dune sediments have been bulldozed from the roads (center) (West Virginia Department of Highways photograph).

Sand dunes formed at many sites in the study area. The best developed dune fields occurred at the Parsons Tree Nursery (fig. 6) and the Preston County Country Club, 4 km south of Albright (fig. 7). Dunes are composed of sand and a minor amount of granules. The largest dunes occurred at Parsons and were up to 1.3 m high, 40 m wide, and 70 m long. Dune shape varied. Larger dunes tended to have

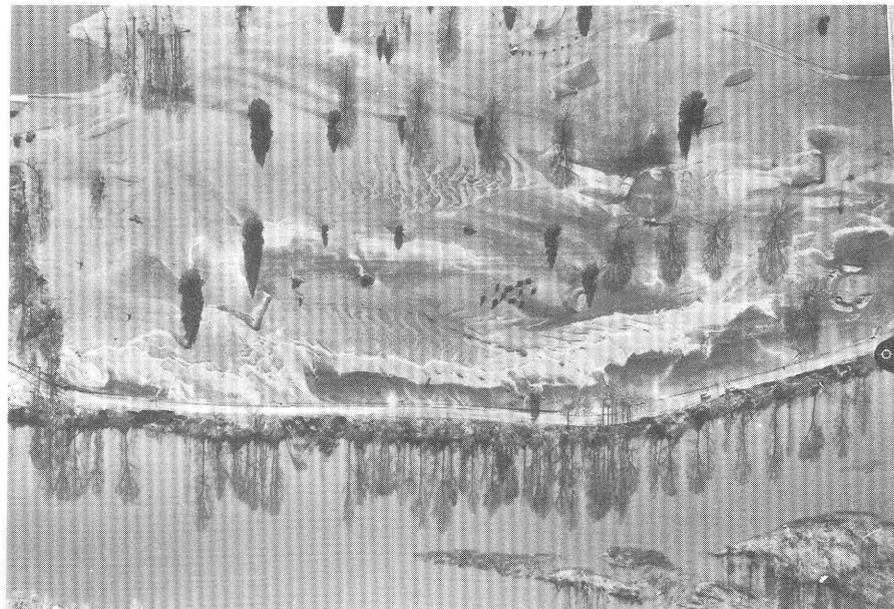
**Figure 7.** Aerial photograph showing sand deposits at the Preston County Country Club, south of Albright. Normal streamflow is from right to left (northward). Complex and parabolic dunes near Cheat River indicate flow at a 45° angle to the channel. Barchan-shaped dunes and sand "shadows" in the lee of trees near the top of the photograph indicate that flow over the flood plain was nearly parallel to the channel. Much of the sand at this site was derived from sand traps on the golf course. Tree shadows are more obvious than trees in this vertical aerial photograph (West Virginia Department of Highways photograph).

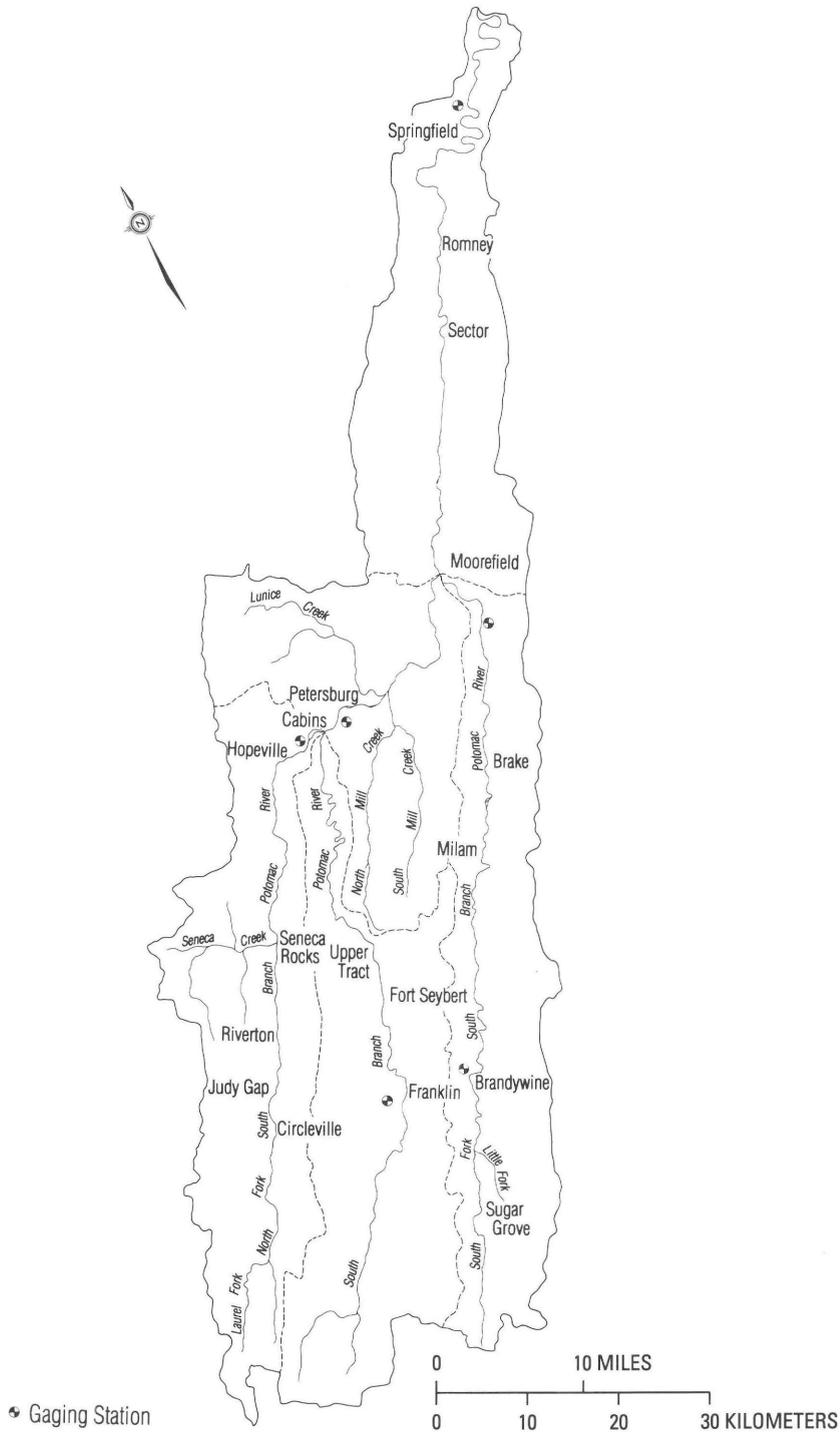
**Figure 1.** Major streams, drainage divides, and gaging stations in the South Branch Potomac River basin. Drainage divides within the basin are represented by dashed lines.

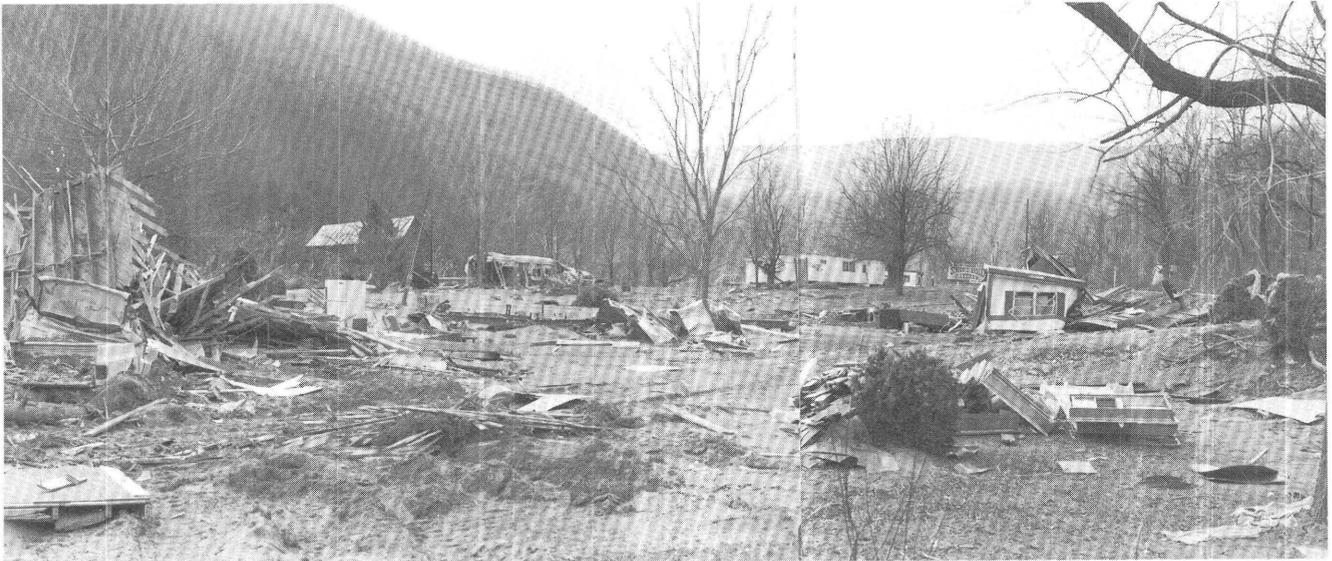
**Figure 3.** Property damage on flood plain, looking upstream along valley of North Fork South Branch Potomac River immediately upstream of North Fork Gap. The river is located to the left of the field of view. Photograph by F.N. Scatena.

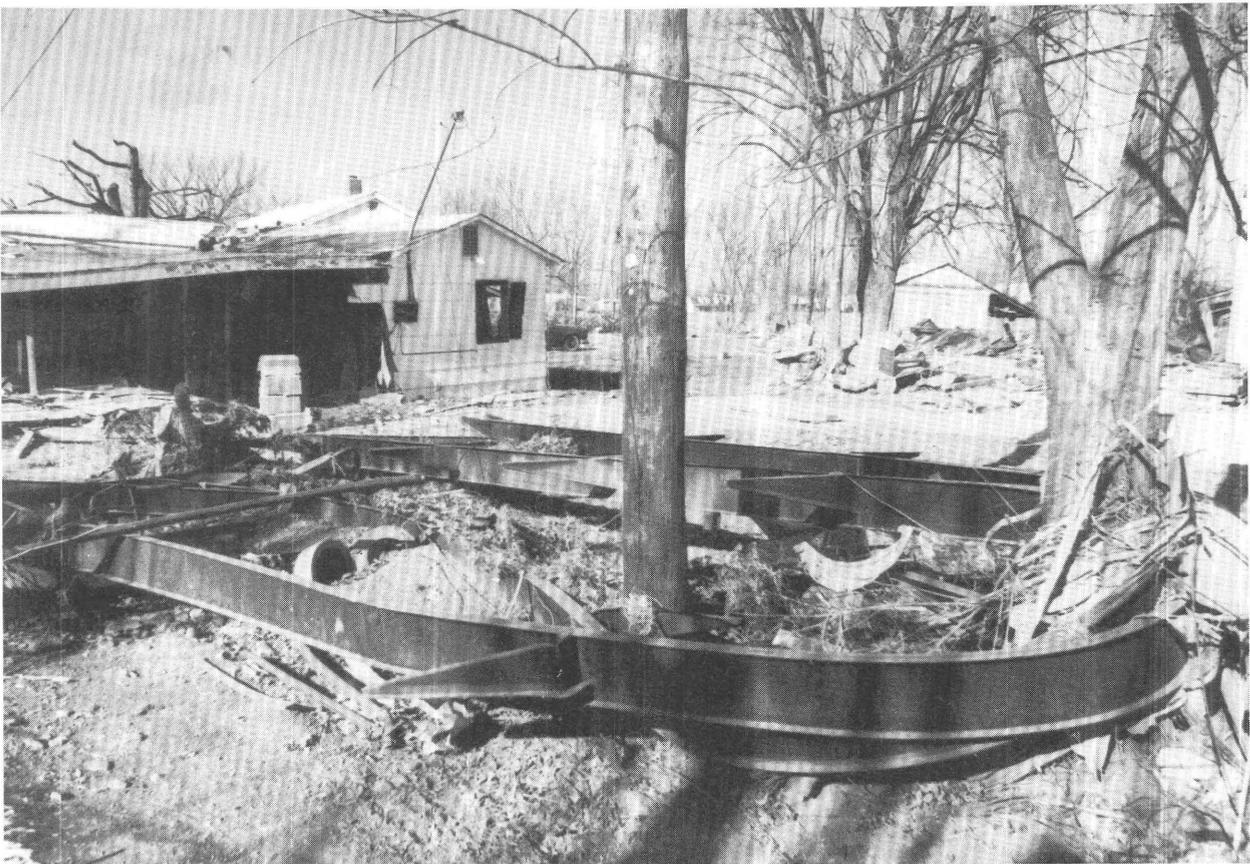
**Figure 4.** Trailer frame wrapped around tree by floodwaters. Note severely damaged house in background. Photograph by D. Lafon, U.S. Army Corps of Engineers.

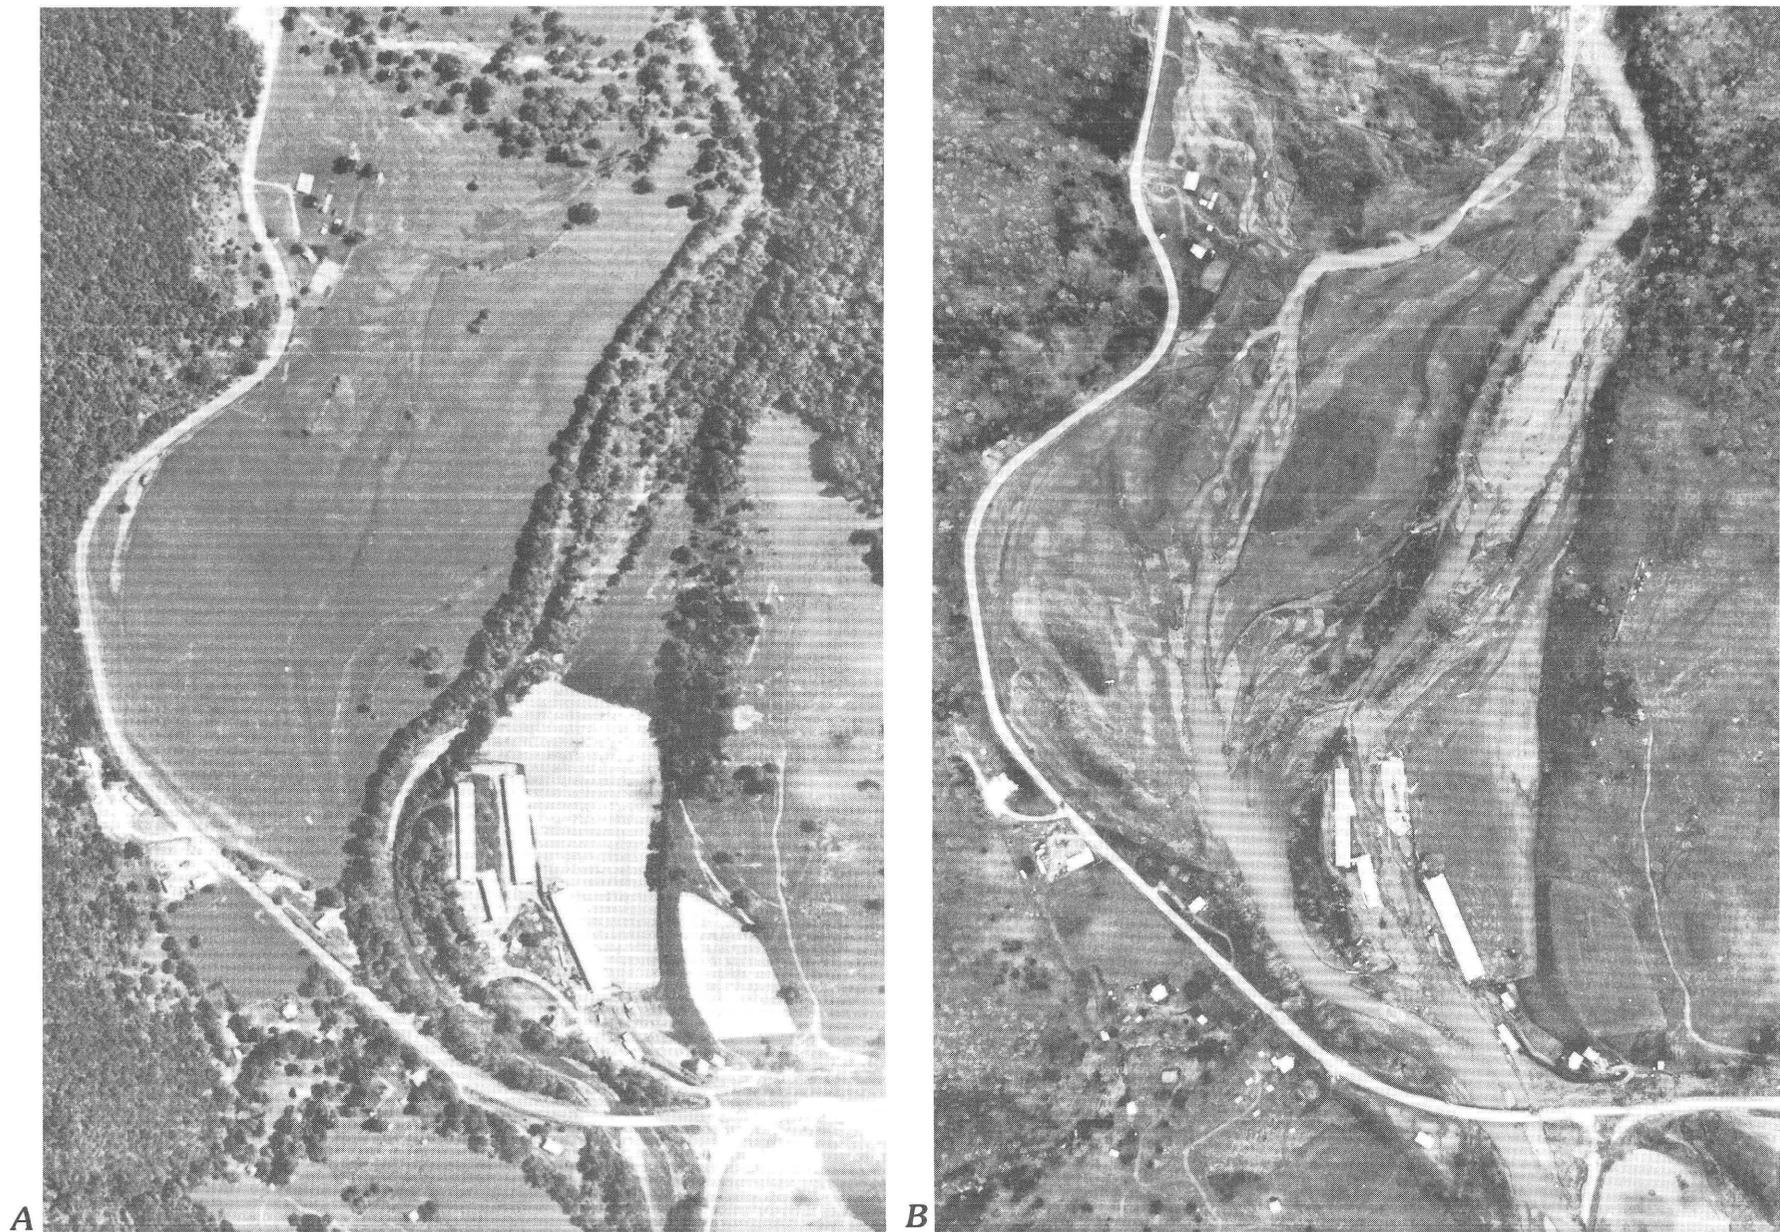
**Figure 9.** Aerial photographs illustrating reoccupation and incision of old flood-plain channels: (A and B) North Fork South Branch Potomac River at Judy Gap, May 1980 and November 1985; flow is from bottom to top. Field of view is 780 m wide. (C and D) South Fork South Branch Potomac River near Milam, May 1980 and November 1985; flow is from bottom to top. Field of view is 780 m wide.

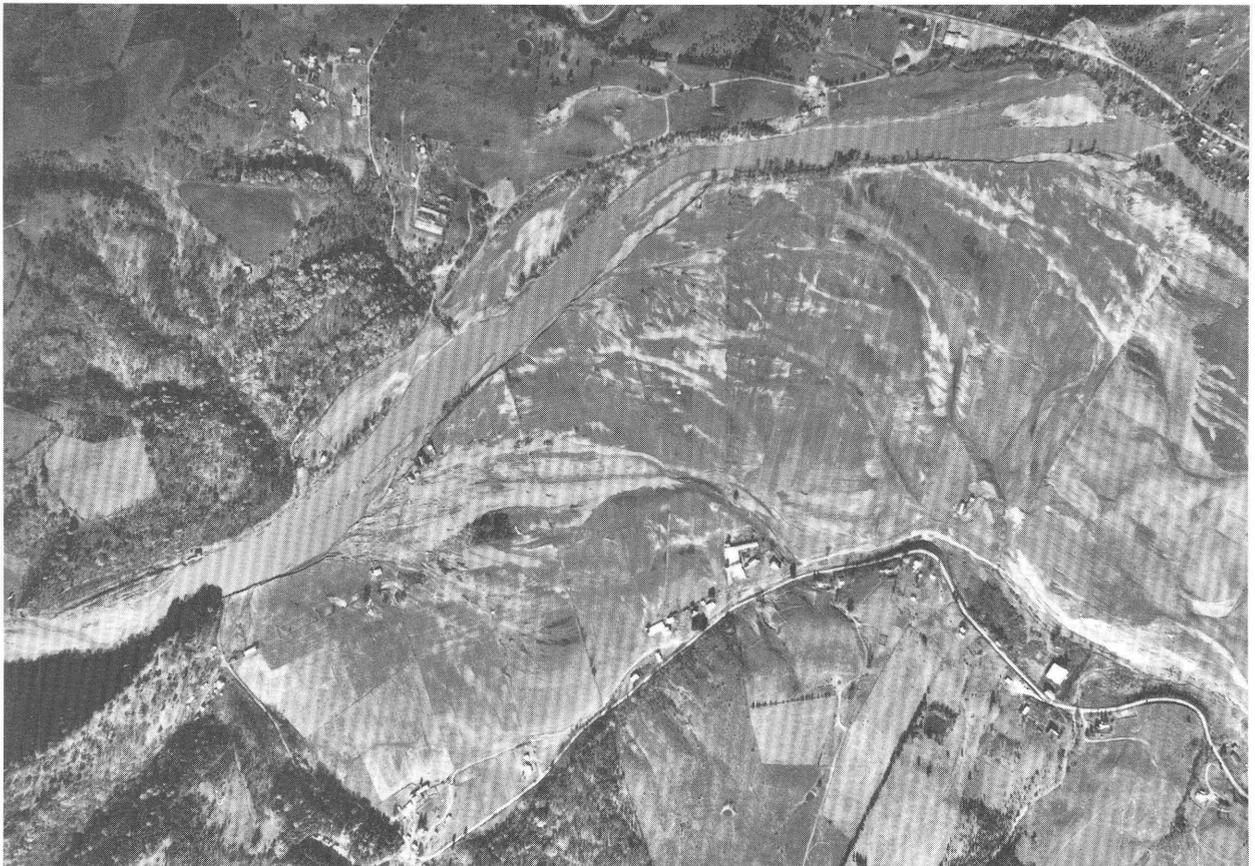
**Figure 18.** Valley floor upstream of Petersburg at the site where flood flow emerged from an unnamed gap (at left). This is the site where the Petersburg gage on the South Branch was destroyed, along with several houses. Note the erosional trough just left of center that carried flow across the flood plain toward Johnson

Run, on the south side of the valley. Other flow paths visible in the photograph also indicate diversion of a significant component of the flood flow away from the South Branch channel and convergence toward the south side of the valley. Field of view is 3,000 m wide.

The sequence of events at Petersburg is a case in point. Residents stated that a sudden surge caused a rapid increase in water level some time after the river overflowed its banks. Furthermore, the surge that inundated most of the valley floor was described as spreading from the South Petersburg flood plain rather than from the channel of the South Branch itself. This account is consistent with the geomorphic evidence. Flow emerging from the gap upstream eroded the channel banks, causing the channel to widen by a factor of 2 or 3 and destroying the Petersburg gage and several houses. After the river overflowed its banks, a major component of flow headed southeast, away from the channel, and scoured a broad, shallow trough leading toward the south side of the valley (fig. 18). Flow

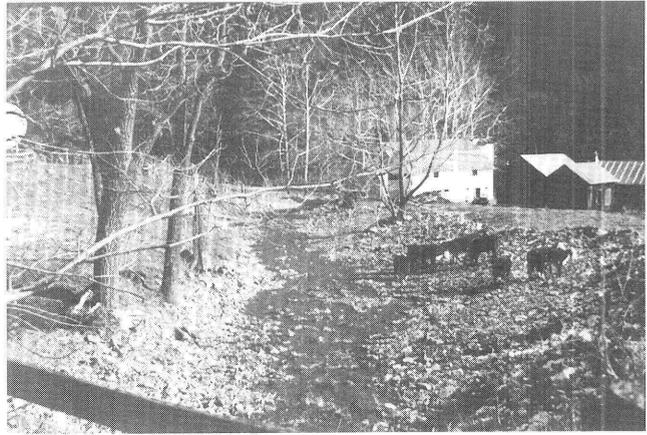
**Figure 20.** Scouring and widening of small tributary to the North Fork South Branch Potomac River between Judy Gap and Riverton.

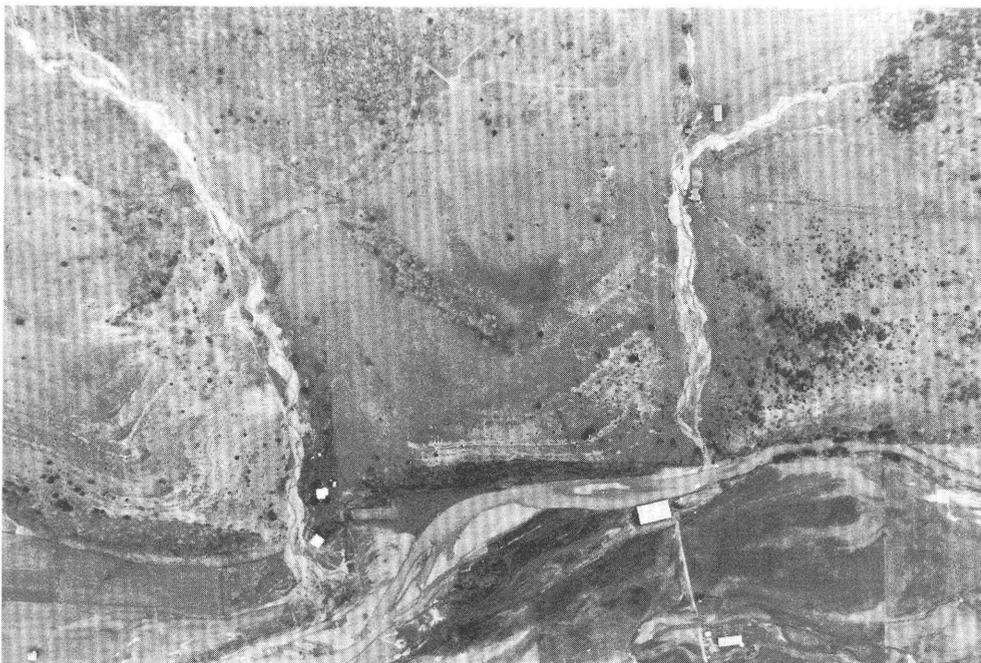
◀ **Figure 23.** Valleys of two unnamed tributaries to the South Branch Potomac River near the Virginia–West Virginia border. Reworking of bottomland deposits by stripping and deposition of coarse sediment occurred along most of the meander belt in both valleys; valley walls were undercut at several locations. Both tributaries delivered sediment directly to South Branch. Flow along South Branch is from right to left. Field of view is 660 m wide.

Tributaries subject to differing amounts of disturbance delivered varying amounts of sediment to the main valley. In some cases a tributary incised its bed but the zone affected by channel erosion was quite narrow, and much of the sediment mobilized by the stream was deposited at its mouth (fig. 22). Other, higher order tributaries exhibited more extensive scouring and reworking and appear to have delivered more sediment to the main channel (fig. 23).

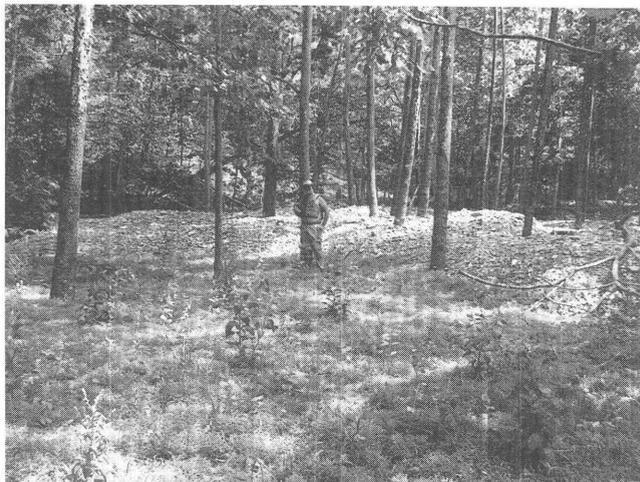
**Figure 24.** Delta formed at mouth of unnamed tributary to the South Branch Potomac River at Blue Rock in Smoke Hole canyon. Poorly sorted deposits bury trees to depths of approximately 1 m.

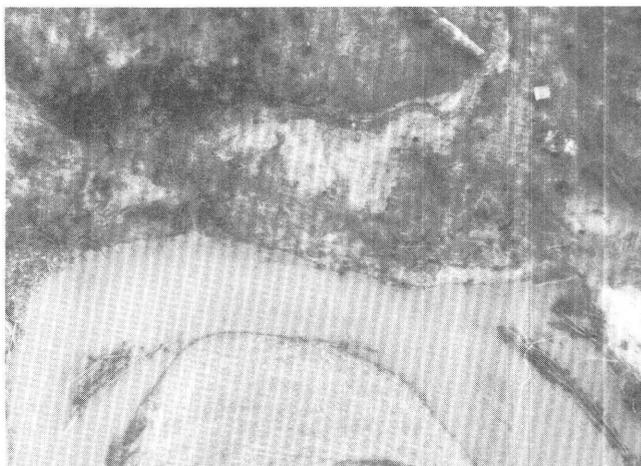
**Figure 25.** Aerial view of delta shown in figure 24 (see top center). Flow along South Branch is from right to left. Note that the point bar along the left bank (bottom center) was stripped of vegetation, whereas vegetation along the right bank was left intact. Field of view is 250 m wide.

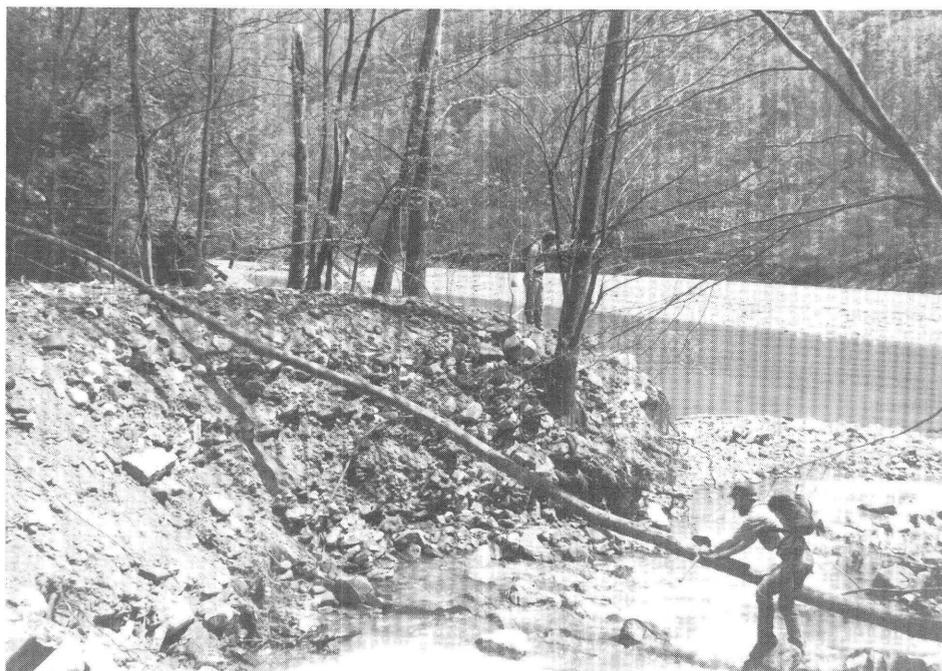
**Figure 26.** Delta at the mouth of Redman Run, tributary to South Branch Potomac River in Smoke Hole canyon. Sediment up to 1 m thick buries bases of trees growing on the pre-1985 surface. The approximate elevation of this surface is indicated by the tree on the edge of the center of the deposit, just right of the center of the photograph. Much of the underlying material probably was delivered by a debris avalanche that occurred in June 1949. Flow along South Branch is from right to left.

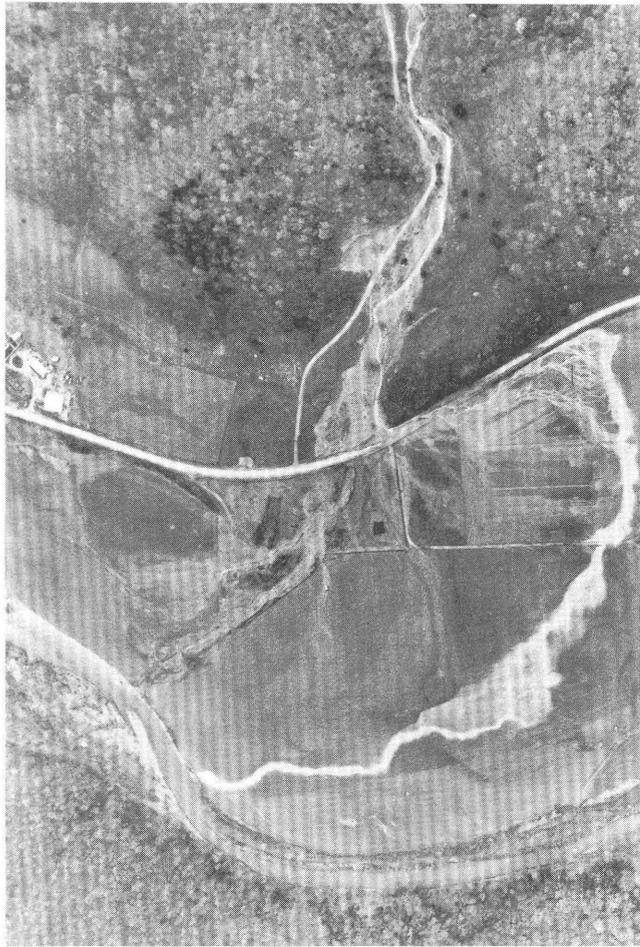
**Figure 27.** Erosion and deposition on fan at the mouth of Nelson Run, tributary to North Fork South Branch Potomac River, between Circleville and Judy Gap. Flow along North Fork is from right to left. Field of view is 750 m wide.

and incision occurred on some fan surfaces during the flood, especially where tributaries were subjected to intensive scour and widening. A prominent example is Nelson Run, a tributary of the North Fork between Circleville and Judy Gap (fig. 27). Some of the flow emanating from Nelson Run evidently moved down the steepest part of the fan (to the right along the base of the mountain slope in the figure) and then crossed the flood plain along the base of the fan. On this fan, as on others in the South Branch basin, some sediment clearly reached the main channel, but a substantial amount of the sediment coming out of the tributary appears to have been deposited on the fan or on the flood plain at the base of the fan.

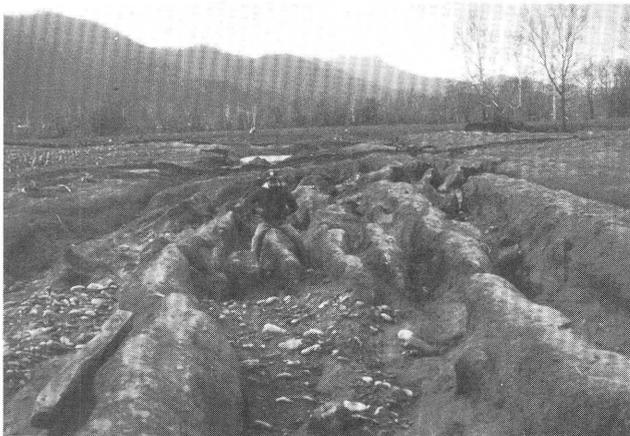
C

**Figure 29.** Longitudinal grooves (A) formed by the limbs of a tree dragged across valley floor, North Fork South Branch Potomac River about 0.6 km upstream of Seneca Rocks; (B) oriented along direction of flow, unrelated to crop patterns. Ruler is 15 cm long. North Fork South Branch Potomac River near Zeke Run, about 10 km upstream of Hopeville; (C) incised along crop rows, South Branch Potomac River near Fisher, several kilometers upstream of Moorefield. Photograph by R. Gray, U.S. Soil Conservation Service.

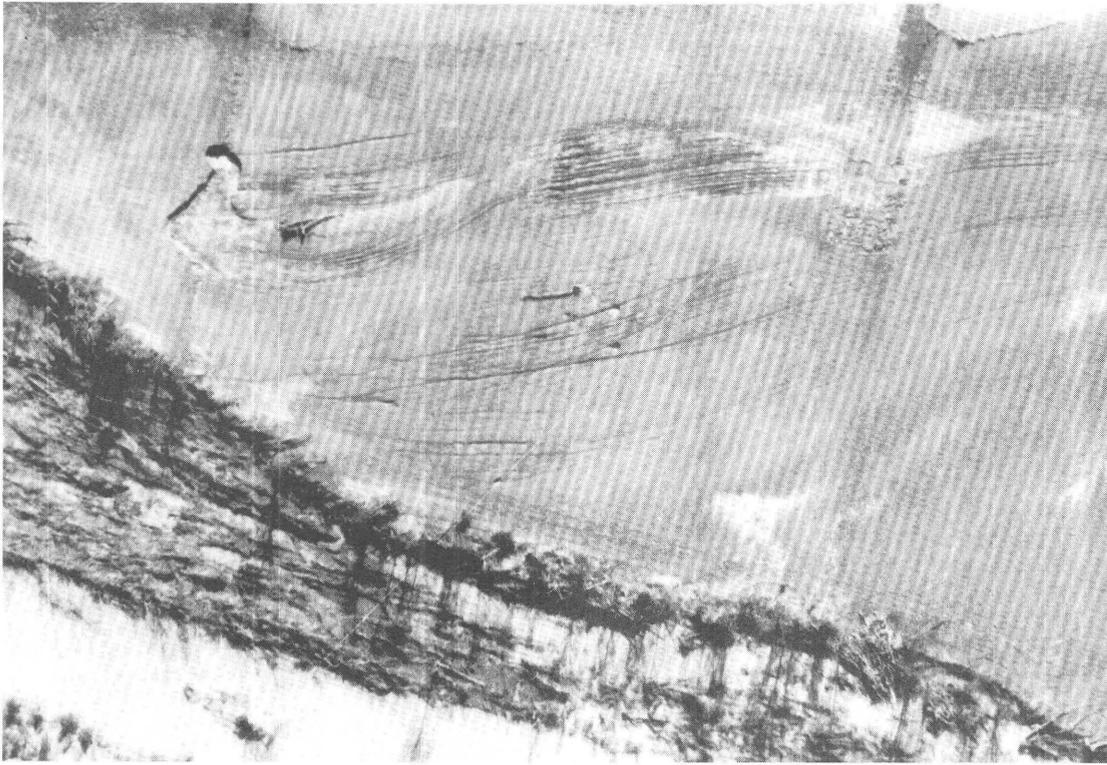
**Figure 30.** Grooves formed as drag marks by trees entrained in flood flow. South Fork South Branch Potomac River, 2 km upstream of Milam; flow along South Fork is from left to right. Field of view is 460 m wide.

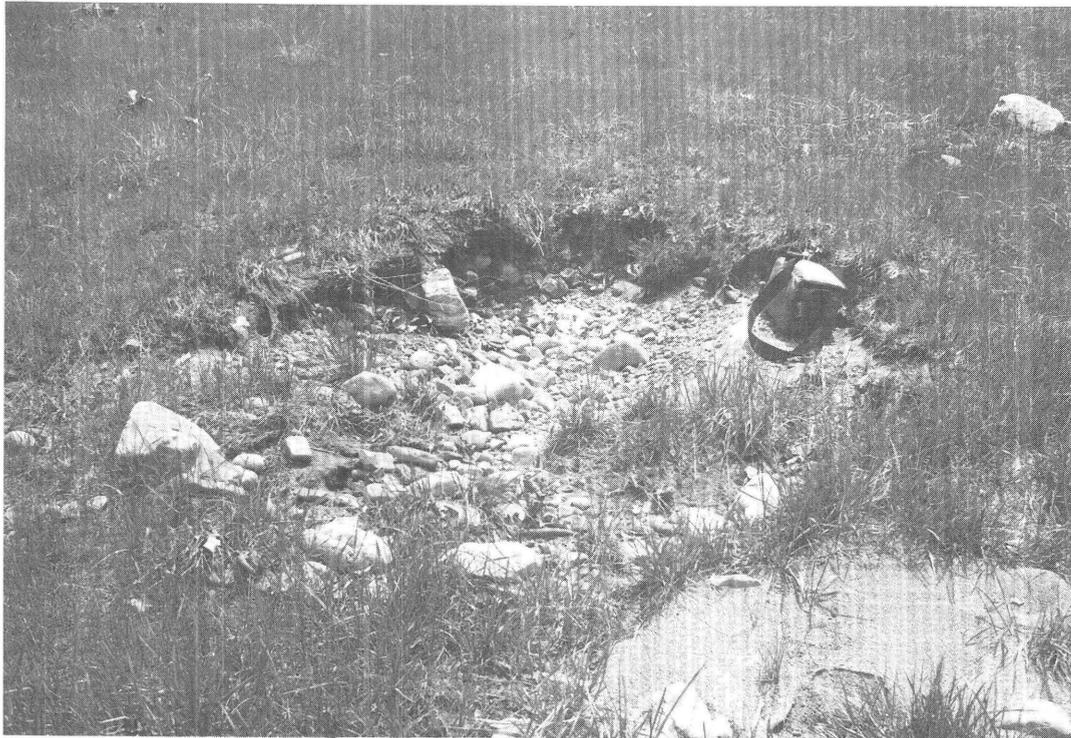
A

**Figure 34.** (A) Small elliptical scour on valley floor along South Branch Potomac River between Redman Run and Austin Run, 5 km upstream of confluence with North Fork. Flow was from upper right to lower left. (B) Elliptical (see right edge) and elongate or spindle-shaped (see center) scour marks on the Cheat River flood plain, about 2 km upstream of Rowlesburg. Flow was from right to left. Note longitudinal grooves incised along crop rows; also note sand dunes at top and bottom of photograph. White lines running from top center to lower right are power transmission lines. Field of view is 100 m wide.

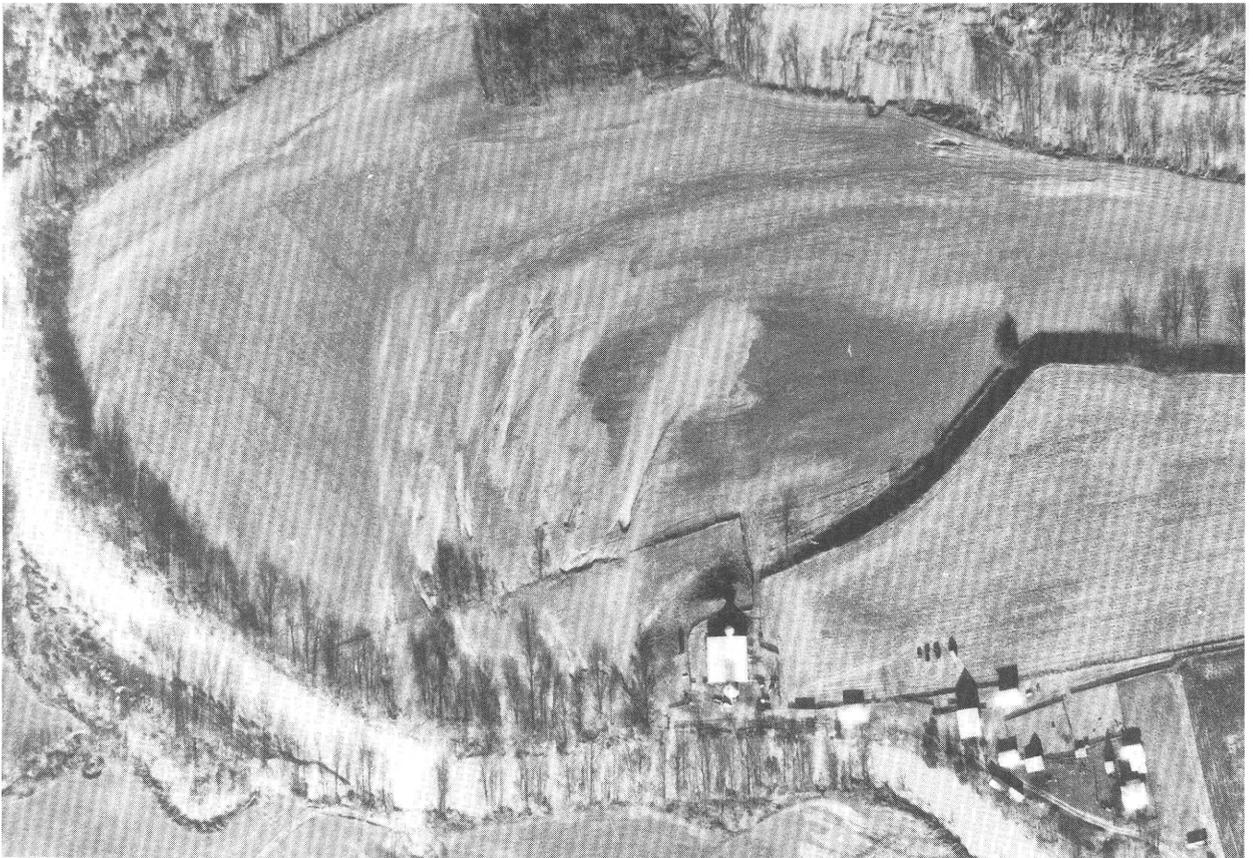
**Figure 35.** Elongate scour marks along South Fork South Branch Potomac River, 7 km downstream of Brandywine. Note that the heads of the scour marks are located just downstream of a fence line, which may have been a site for initiation of separated flow. Flow

in channel enters at lower right and follows meander clockwise to upper right, but overbank flow during the flood cut across the valley floor from bottom center. Field of view is 760 m wide.

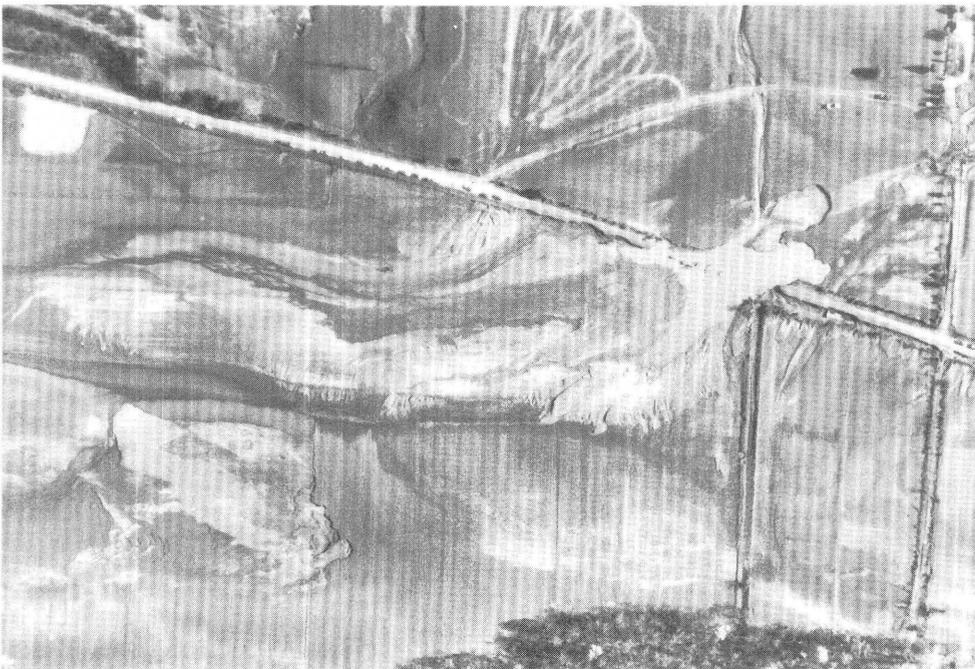
B

**Figure 36.** (A) Headward branching scour on North Fork flood plain, about 2 km downstream of Circleville. The two headcuts diverge at the location of a fence line, which may have been a site of initiation of flow separation before the scour retreated headward. Field of view is 390 m wide. (B) Several scour features in this photograph appear to have retreated headward from linear flow obstructions. Flow was from upper right to lower left; the river channel is out of view at the bottom of the picture. South Fork flood plain, 13 km upstream of confluence with South Branch at Moorefield. The road is elevated 2–3 m above the flood plain and served to block floodwaters until it was overtopped and breached; the resulting scour, at right center, then retreated headward and formed two prominent headcuts. Another, broader headcut is visible at lower left and appears to have started at a fence line oriented perpendicular to the flow, which was from right to left on this portion of the flood plain. Splay deposits also are clearly visible. Field of view is 620 m wide.

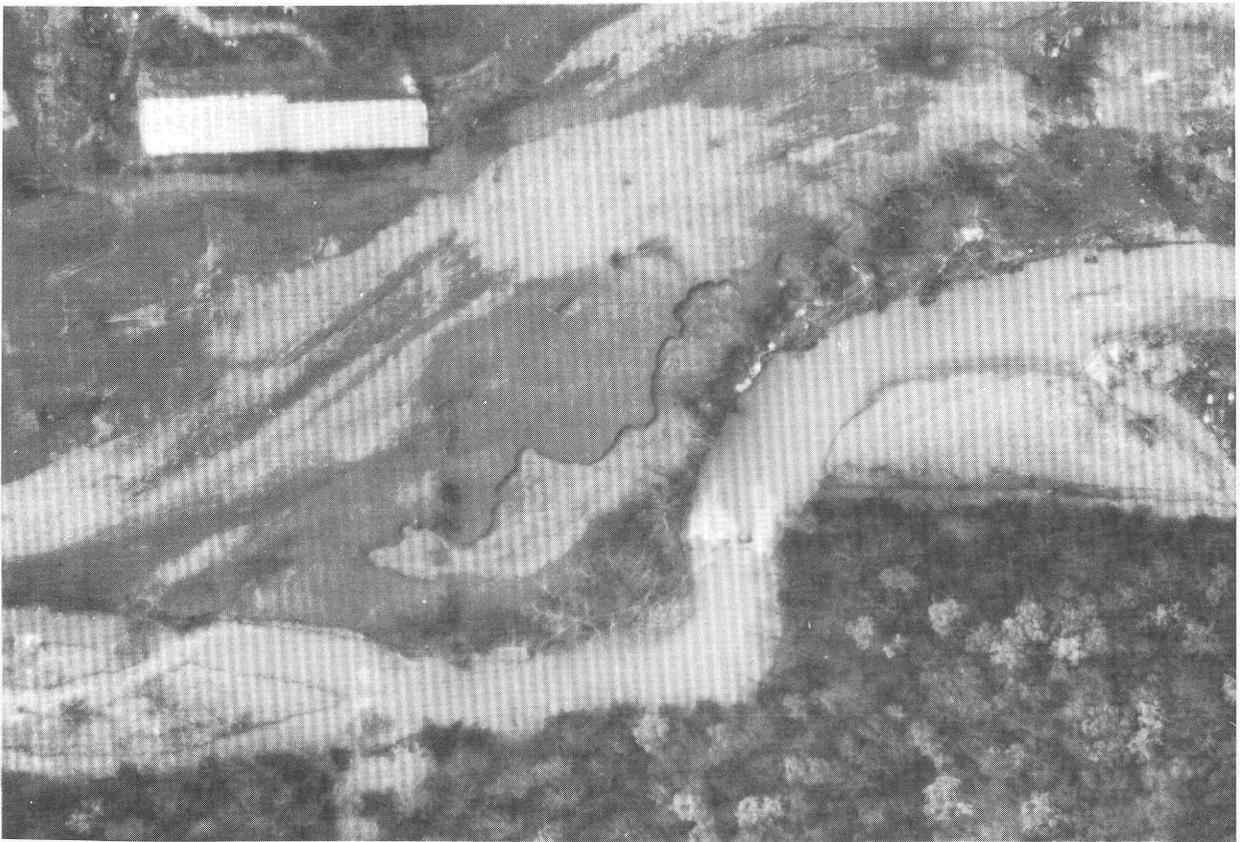
**Figure 37.** Headward-eroding scour formed where overbank flow drained back into the river channel (center of picture). Flow is from left to right. North Fork at Bennett Gap, 1.5 km downstream of Riverton. Field of view is 380 m wide.
