Geomorphic Studies of the Storm and Flood of  
November 3–5, 1985, in the Upper Potomac  
and Cheat River Basins in West Virginia and  
Virginia

U.S. GEOLOGICAL SURVEY BULLETIN 1981

ROBERT B. JACOBSON, Editor

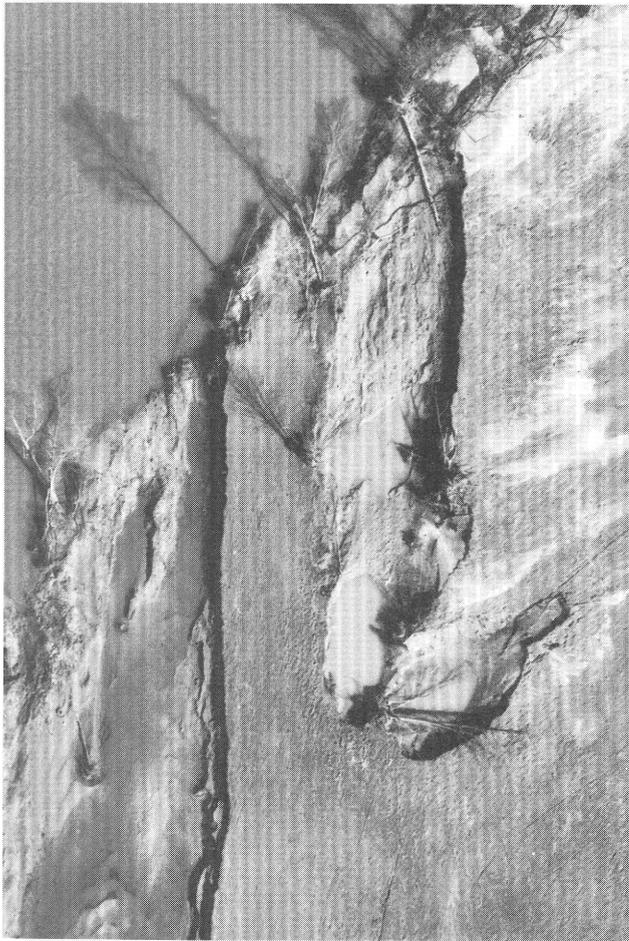
◀ Figure 40. Fallen tree flanked by a pair of elliptical scour marks, Cheat River about 8 km downstream of Parsons. The scours appear to make up the limbs of a horseshoe, but they do not quite meet on the upstream side of the tree, and the scour on the left side leads into an elongate erosional trough that extends downstream. Note cutbank on left side of photograph where channel widening occurred in the flood. Flow along Cheat is toward the top. Field of view is 100 m wide.

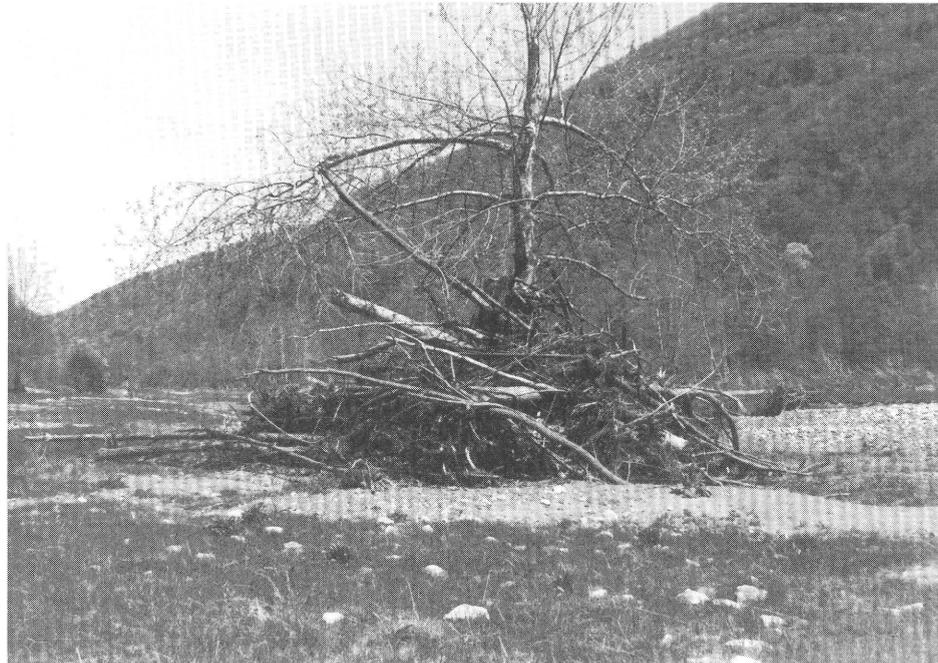
Figure 41. Debris jam formed on upstream side of tree during the flood. South Branch Potomac River between Redman Run and Austin Run, about 5.4 km upstream of confluence with the North Fork.

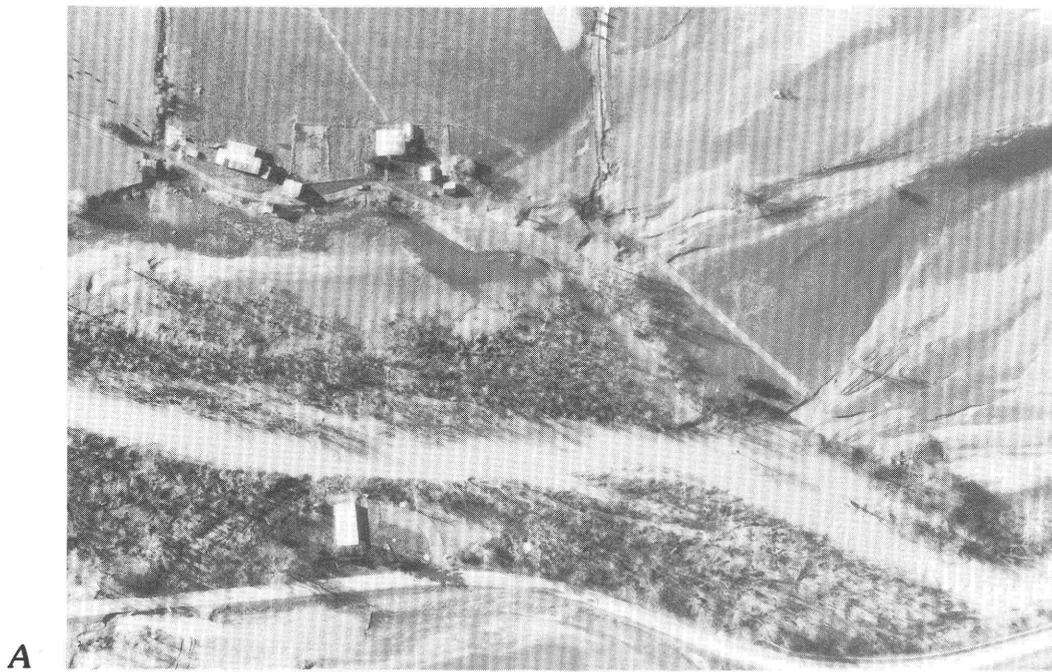
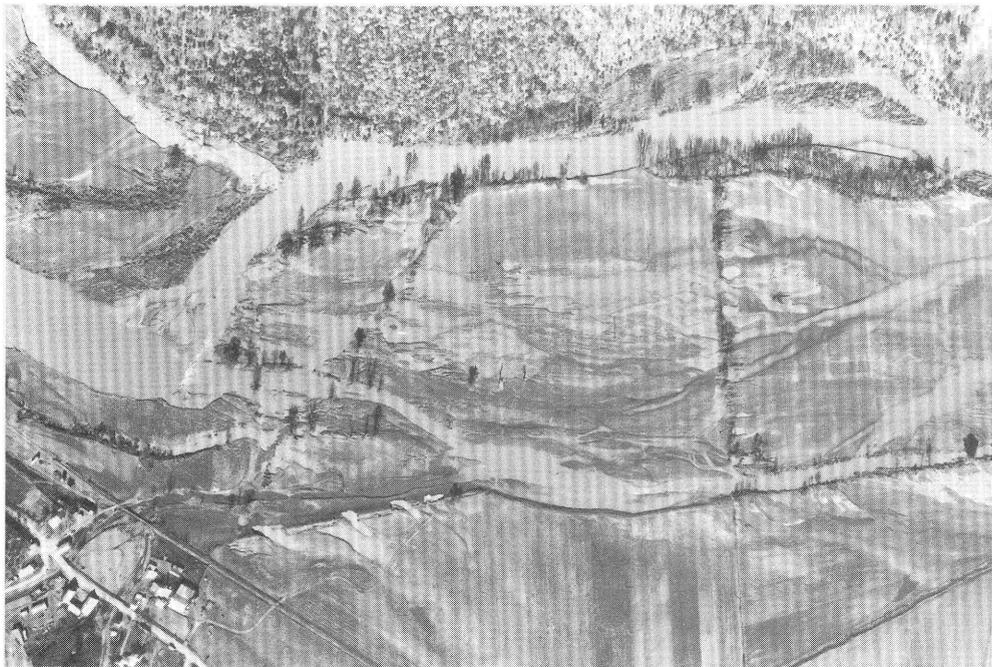
**Figure 43.** Scour marks associated with flow obstructions: (A) South Fork South Branch Potomac River at Brandywine; flow is from left to right. Note elongate scours initiated where flood flow crossed over the road just right of the center of the photograph and also where the road approaches the river channel at lower right. Field of view is 640 m wide. (B) South Branch Potomac River near Durgon, 9 km downstream of Petersburg; flow is from left to right. Complex pattern of channel widening and flood-plain erosion, with elliptical and elongate scours formed downstream of fence lines, rows of trees, and topographic steps. Note area marked by both scour marks and longitudinal grooves in cultivated field at the center of the photograph. Several larger channels incised along the flood-plain margins also are visible. Field of view is 1,400 m wide.

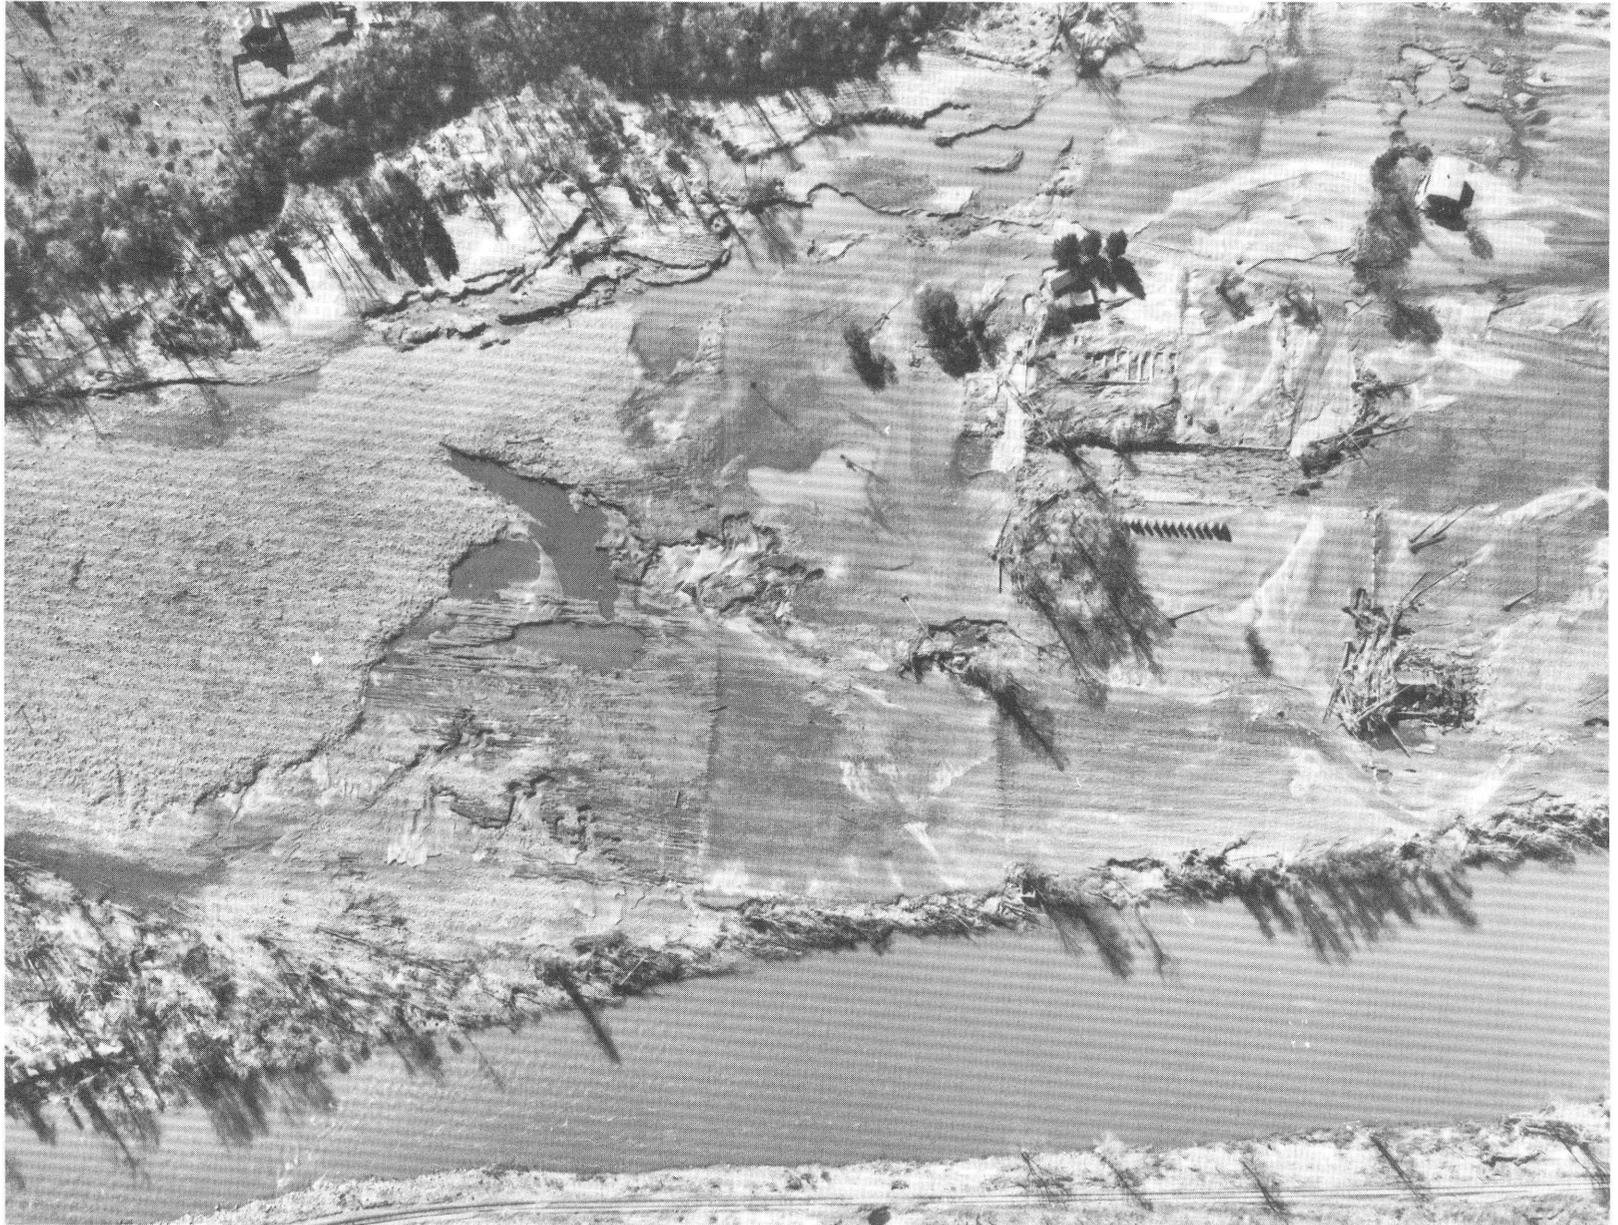
**Figure 45.** Complex pattern of scour and incision, flood plain of Black Fork River at Hendricks (tributary to Cheat River). Lobe of coarse sediment at left is derived from a stripped area just upstream (see Kite and Linton, chapter D, this volume, fig. 8). Enlarged view of debris jam around house at lower right is shown in Kite and Linton (chapter D, this volume, fig. 11). Flow is from left to right. Field of view is 600 m wide.

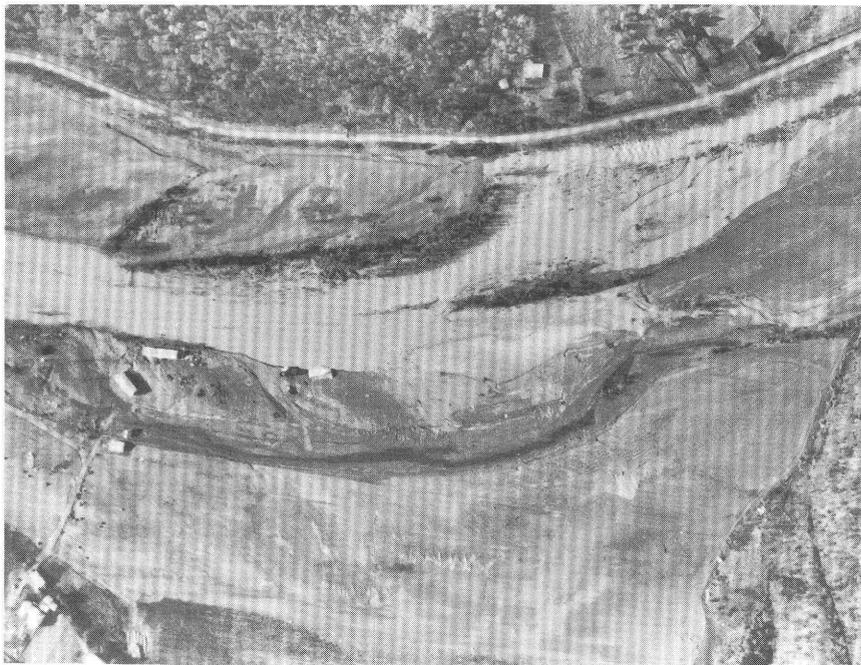
D

Figure 46. Continued.

The positions of preflood banks are sometimes marked in the aerial photographs by a line of trees or organic debris in the water (figs. 46A, B). Often a cutbank is flanked by an area along the channel margin where alluvium has been partially stripped away. Downstream, the stripped areas commonly grade into sandy to gravelly splay deposits (figs. 47, 48). In some instances an example of radical channel widening is associated with multiple chutes or erosion channels on the valley floor or with formation of bars and remnant islands in the channel belt (figs. 47, 49).

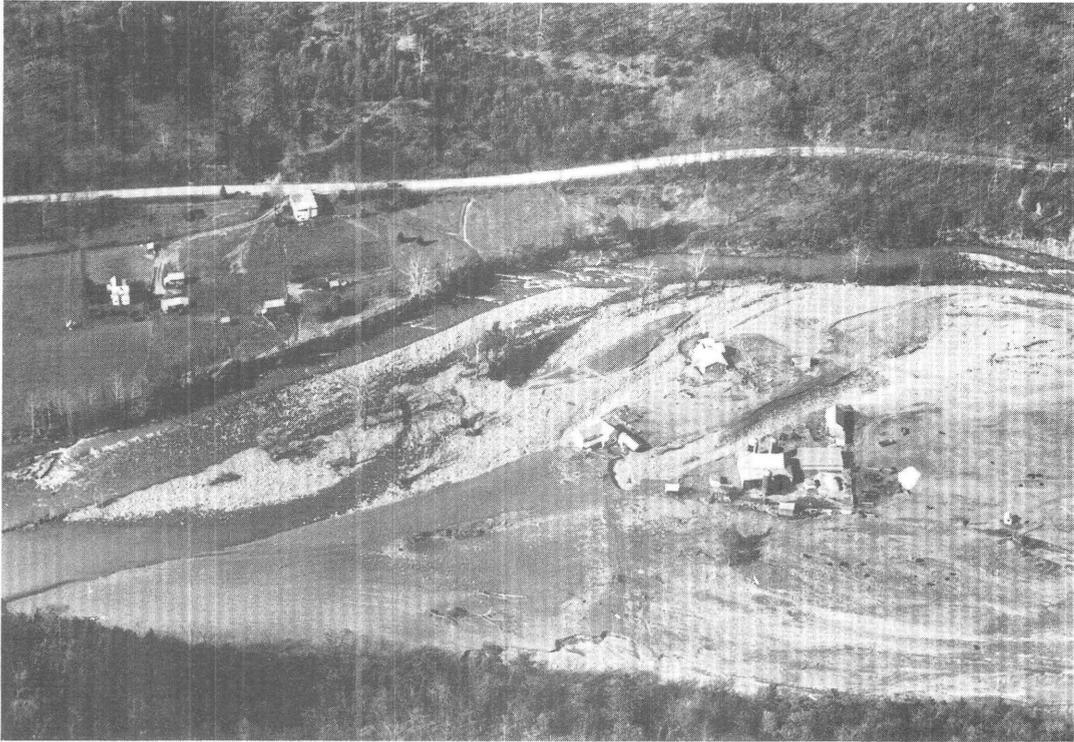
**Figure 47.** Oblique aerial photograph showing channel widening along the North Fork at Macksville, 4.7 km upstream of Seneca Rocks. Note the surviving trees standing on stripped flood-plain remnants in the widened channel. A scour channel with amphitheater-shaped headcut extends headward between two buildings at right center. Photograph by E. Propst, Clarksburg Publishing Company.

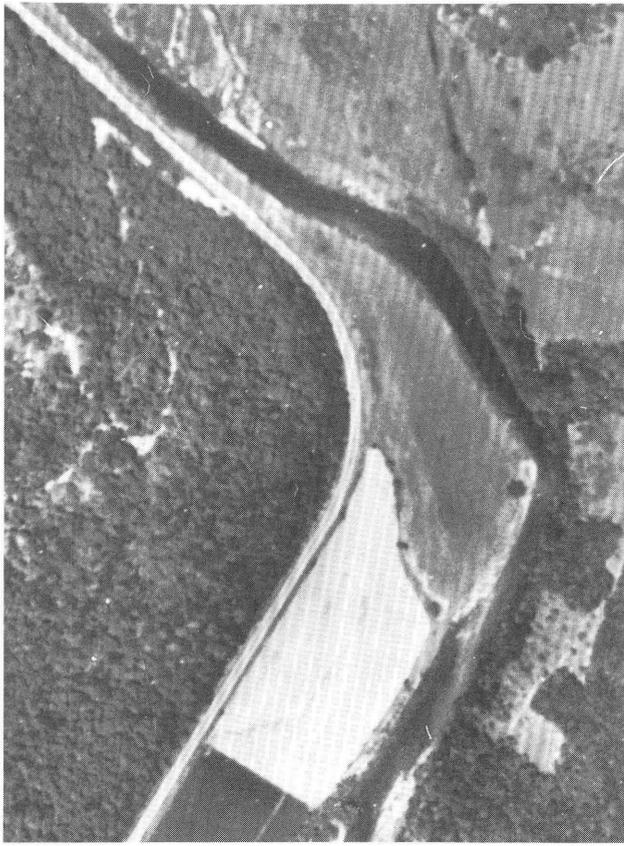
**A**

**Figure 49.** North Fork near Tool Run, 8.4 km upstream of Hopeville (A) before and (B) after the flood. Flow is from bottom center to top left. Channel widening has left a broad stripped remnant in the channel at the apex of the bend. The pre-flood view in (A) suggests that this remnant

Some of the sediment deposited in channel bars may have been derived from tributary contributions, but most of the gravel bars visible in the channel were at locations where substantial channel widening and bottomland erosion occurred. At these sites, gravel bars were difficult to distinguish from stripped flood-plain remnants (figs. 49, 77–79).

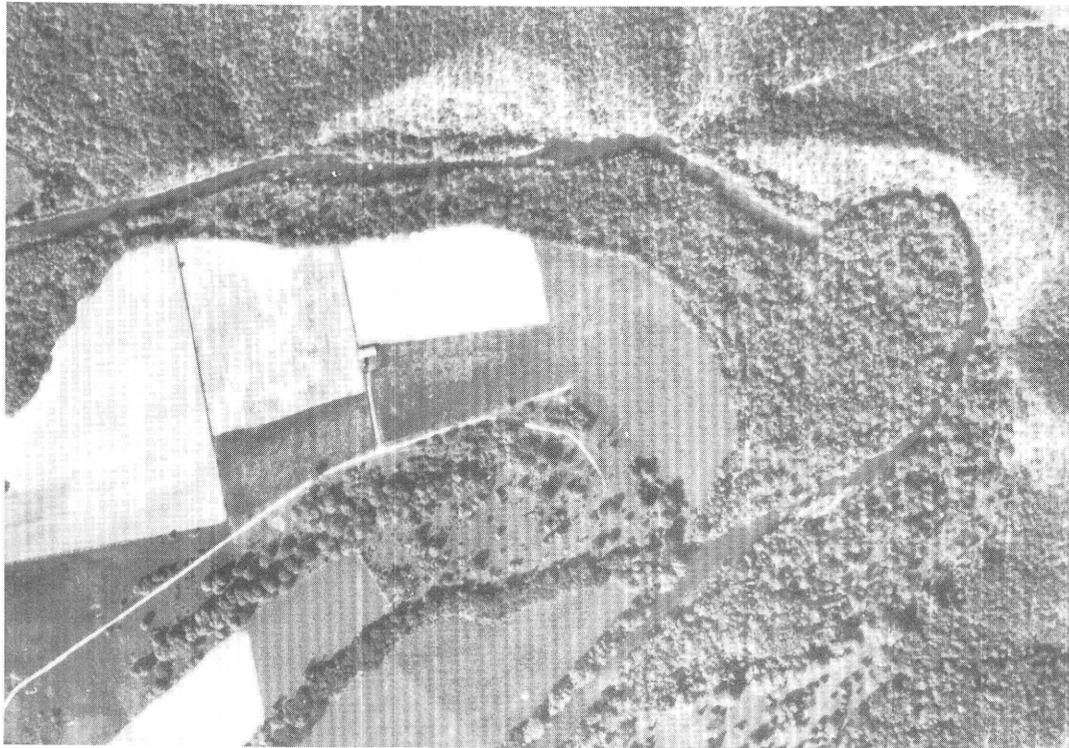
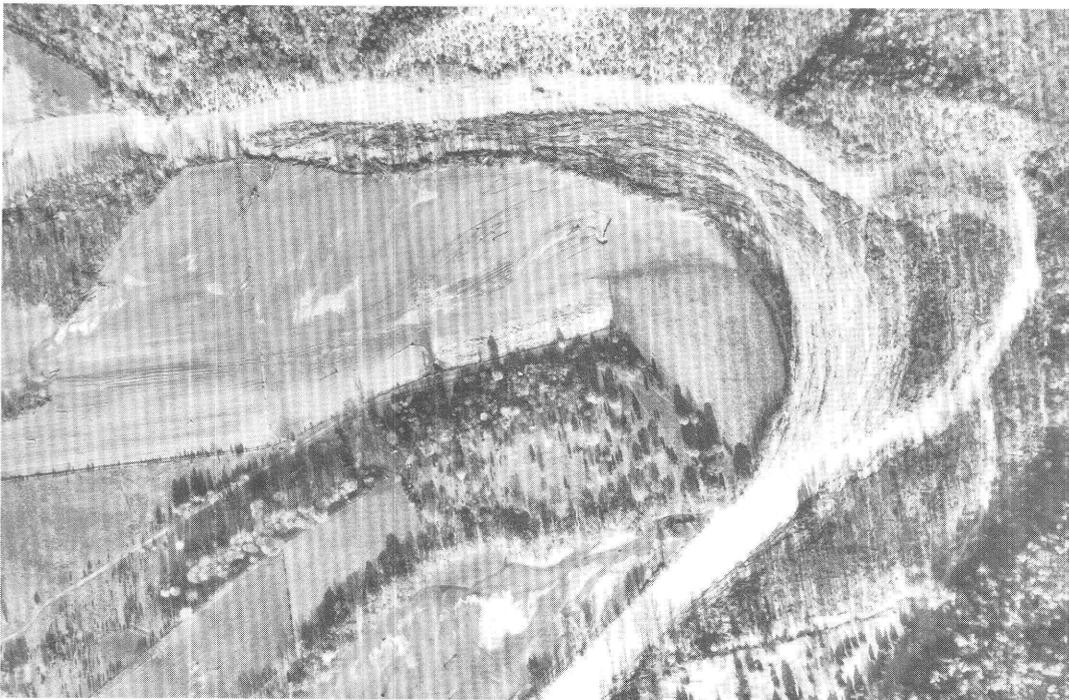
**Figure 50.** (A) Before and (B) after views showing scour of forested channel margins and low flood plain along South Fork, 2 km upstream of Milam. Flow is from bottom center. Several shallow channels were cut across the forested area at right center, and a large portion of the valley floor was stripped. The upper flood-plain surface was affected primarily by formation of scattered longitudinal grooves and scour marks. Field of view is 1,100 m wide.

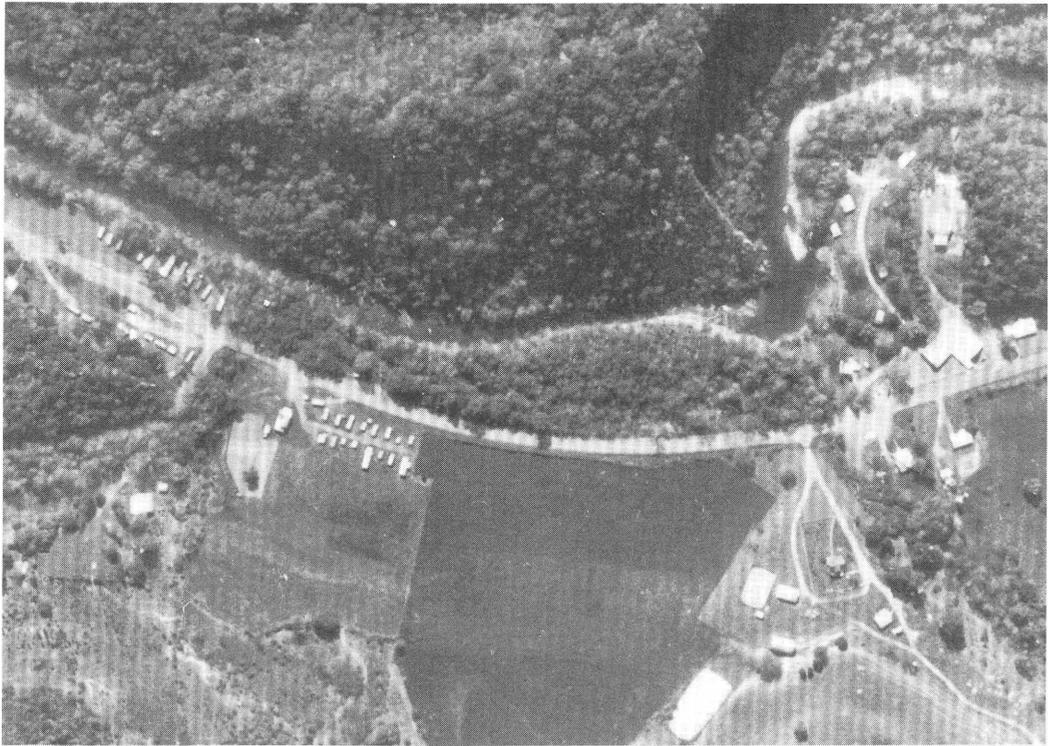
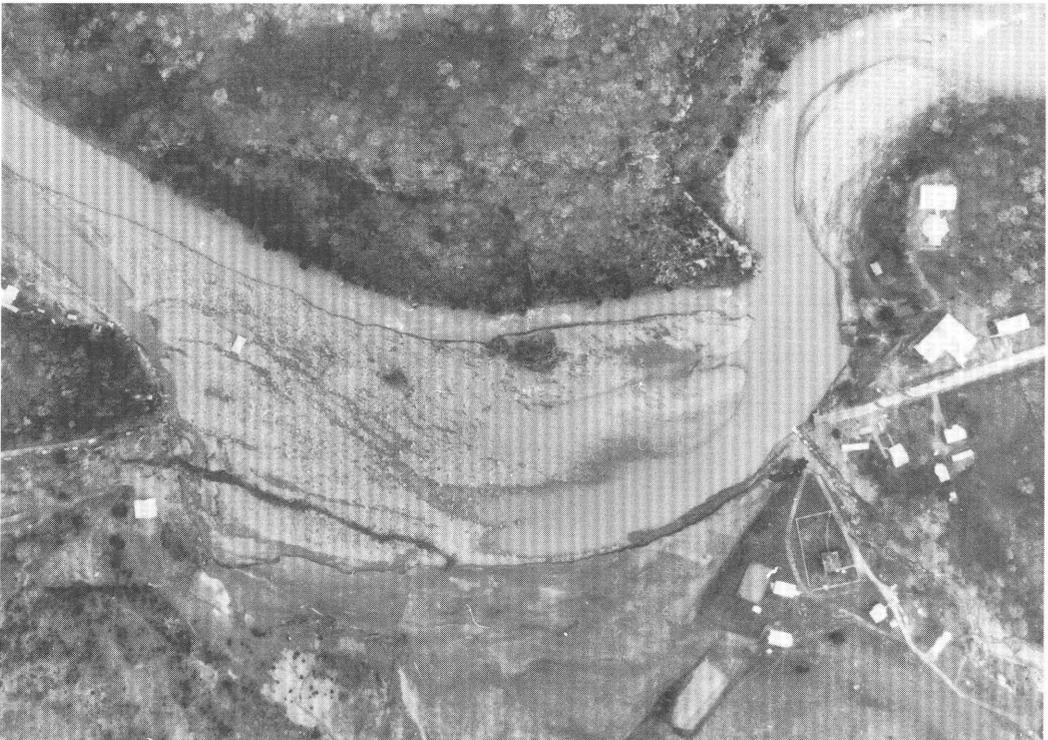
**Figure 51.** (A) Before and (B) after views of the North Fork at Hopeville. Flow is from upper right to upper left. The bedrock constriction at the exit of Hopeville canyon is about 60 m wide, and flow emerging from this constriction stripped away a large grove of trees and the underlying flood plain. Eleven lives were lost at the site of the house and trailer park seen at left center of (A). This surface is about 6–7 m above the low-water channel, and local residents noted that it had not been reached by floodwaters in the previous record flood of June 1949. Field of view is 770 m wide.

bottomland surface at those sites where stresses imposed by flood flows were most intense (fig. 51).

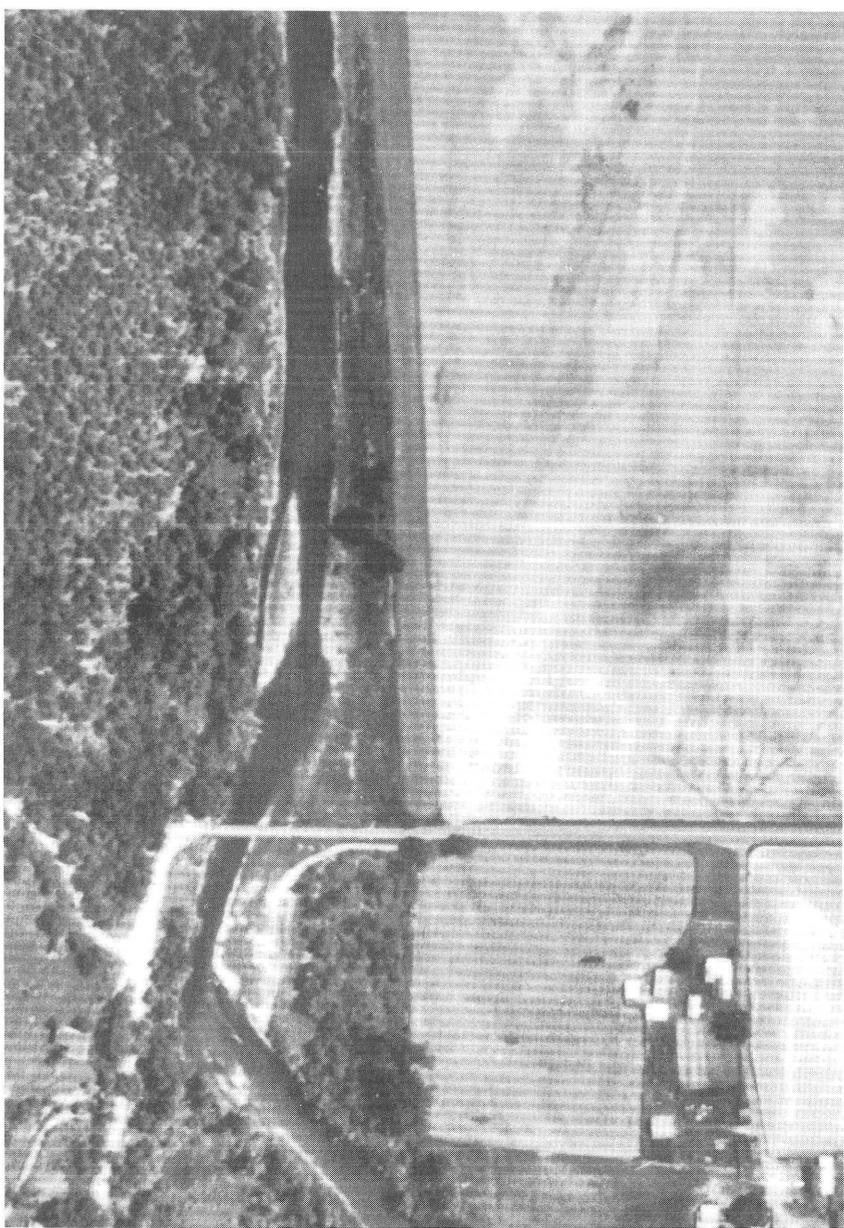
**Figure 52.** (A) Before and (B) after views showing channel widening downstream of a bridge crossing the South Fork at Fort Seybert, 14 km downstream of Brandywine. Flow is from bottom to top. Channel widening affected the lower topographic surface; note that the scarp separating the lower surface from the upper flood plain in (A) coincides with the position of the channel

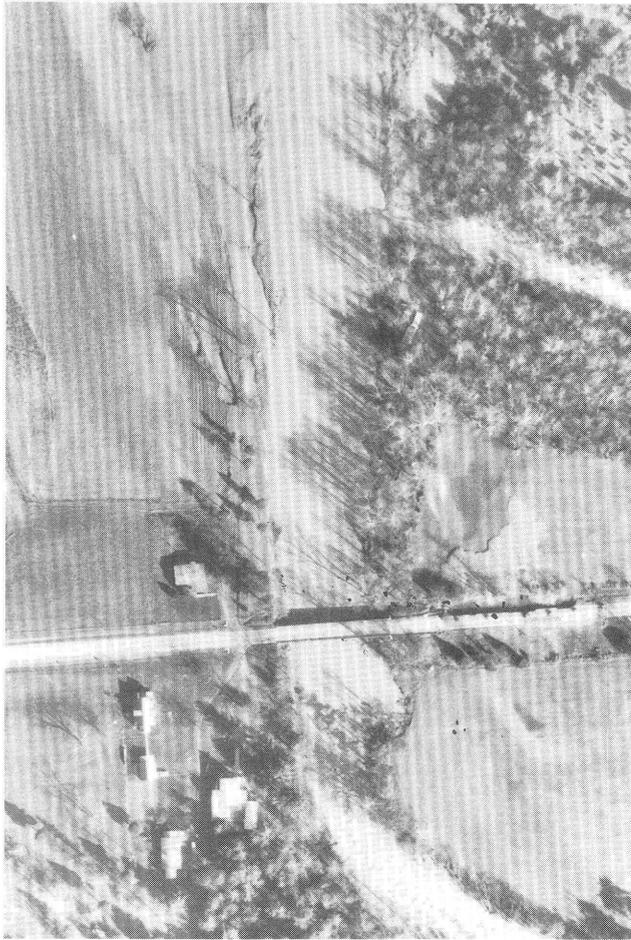
**Figure 53.** Channel widening and flood-plain scour, South Fork at Brandywine gaging station. Flow is toward the top. Field of view is 300 m wide.

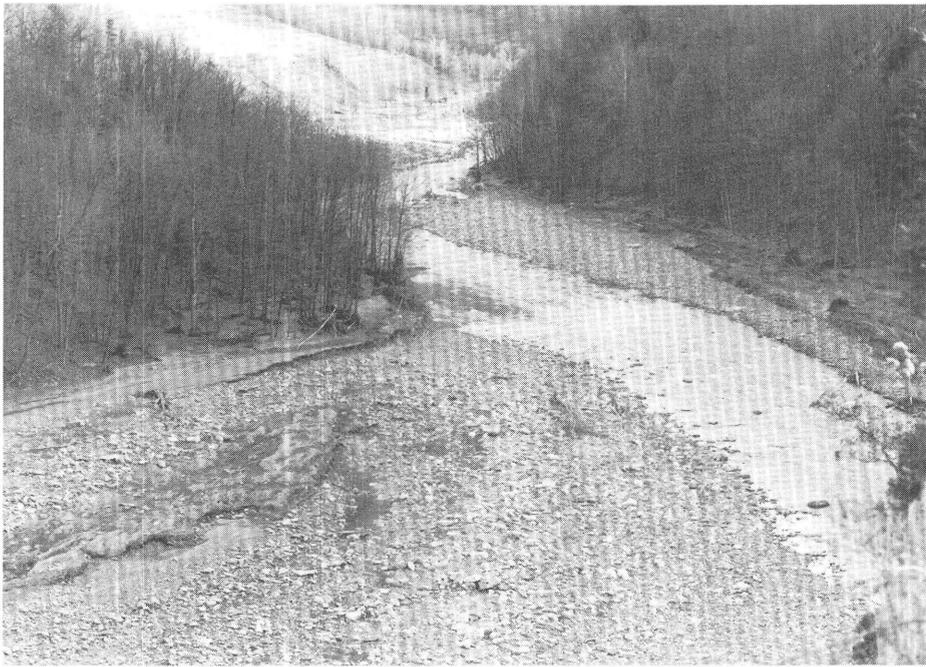
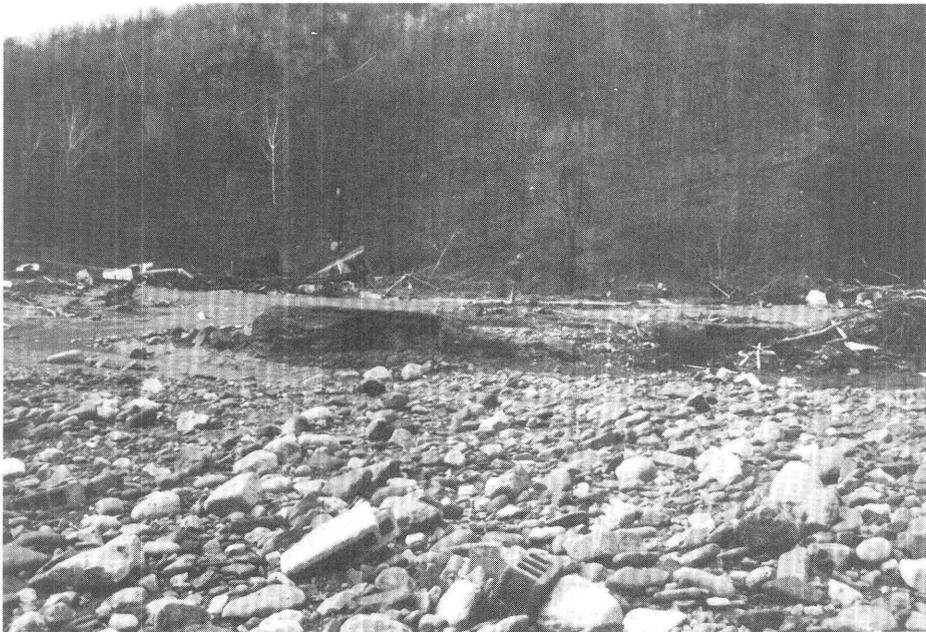
**Figure 54.** Three examples of flood-plain stripping: (A) North Fork in Hopeville canyon, 0.9 km upstream of Hopeville (photograph by F.N. Scatena). The view is looking upstream. The channel is about 40 m wide. The point bar in the foreground was a pasture before the flood. As much as a meter of alluvium was stripped away; erosion scarps are visible on the remnants of the original surface. Figures 55 and 56 show the area upstream and around the bend from this location. (B) North Fork near North Fork Gap. The remnant of flood-plain alluvium is virtually all that remains of the original surface at this location. (C) South Branch, 0.8 km downstream of the Trough. Flow is from right to left. Photograph by W.E. Duliere, West Virginia Advocate.

General scouring and removal of vegetation and fine-grained alluvium from the valley floor that is not restricted to a well-defined scour mark or erosion channel is here referred to as "stripping." Stripping usually involved removal of a veneer of silty to sandy overbank deposits to reveal an underlying pavement of cobbles and boulders (figs. 54A–C, 55). At some locations, tree trunks were

The coarse pavement presumably represents a channel lag deposit such as is normally found at the base of the alluvial sequence underneath a flood plain. Imbrication of cobbles and boulders exposed on the postflood surface, with some clasts resting against remnant clumps of vegetation (fig. 55), indicates that considerable reworking of this layer often occurred at sites where it was exposed by stripping of the surface layer. At some sites in the study area, cobbles and boulders were deposited on top of soil without stripping, leaving a continuous carpet of imbricated clasts that looks virtually identical to the layer exposed at other sites by stripping. Positive evidence for stripping is provided by erosional remnants of fine-grained cohesive material adjacent to the stripped surface (figs. 54A, B).

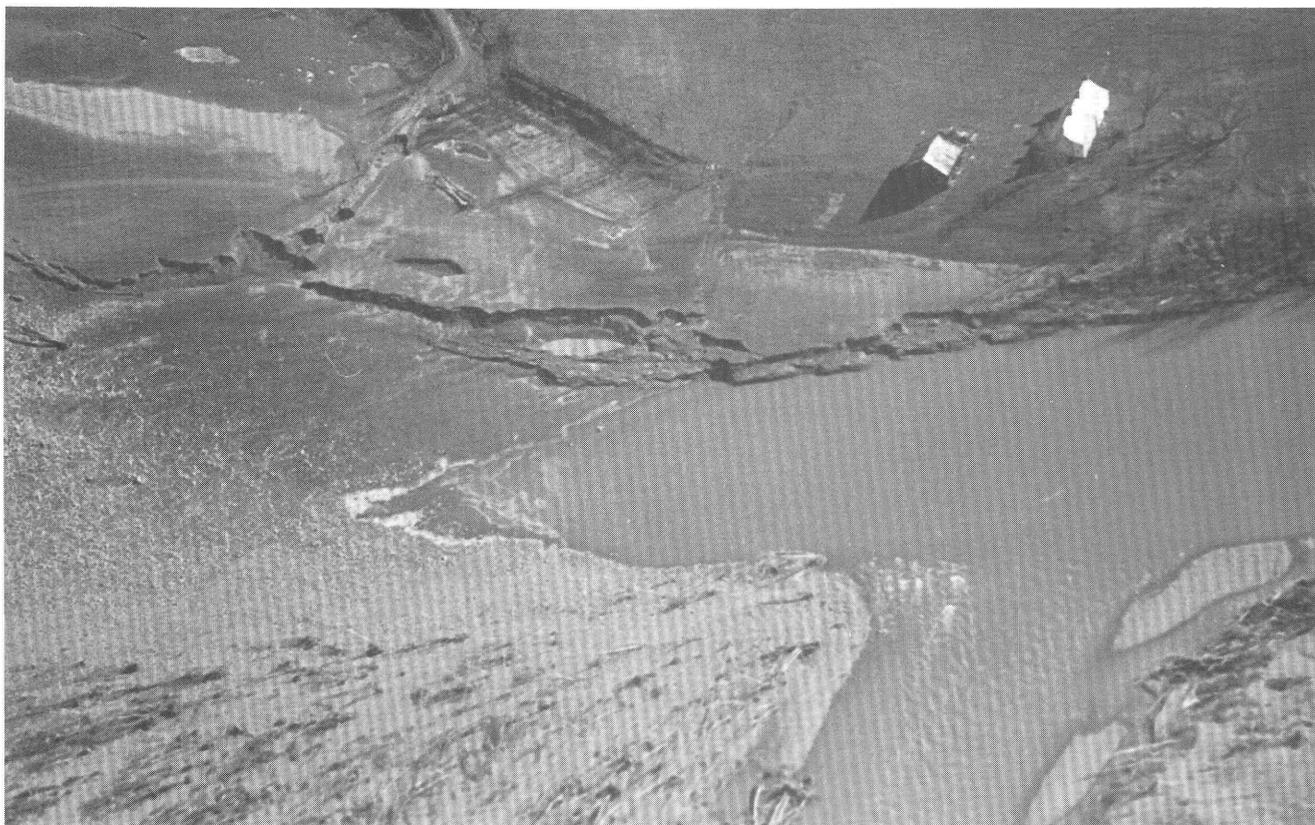
C

Figure 54. Continued.

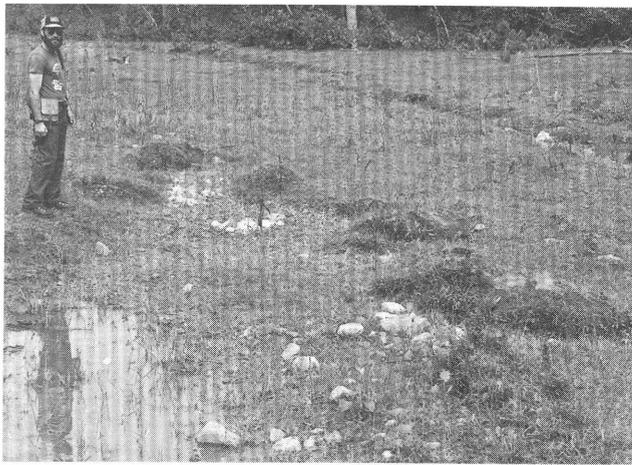
**Figure 58.** Mounds of rolled-up turf located around margins of an elongate scour mark. This photograph was taken about 18 months after the flood, and the margins of the scoured area were covered by grass. South Branch flood plain between Redman Run and Austin Run, 5.1 km upstream of confluence with North Fork.

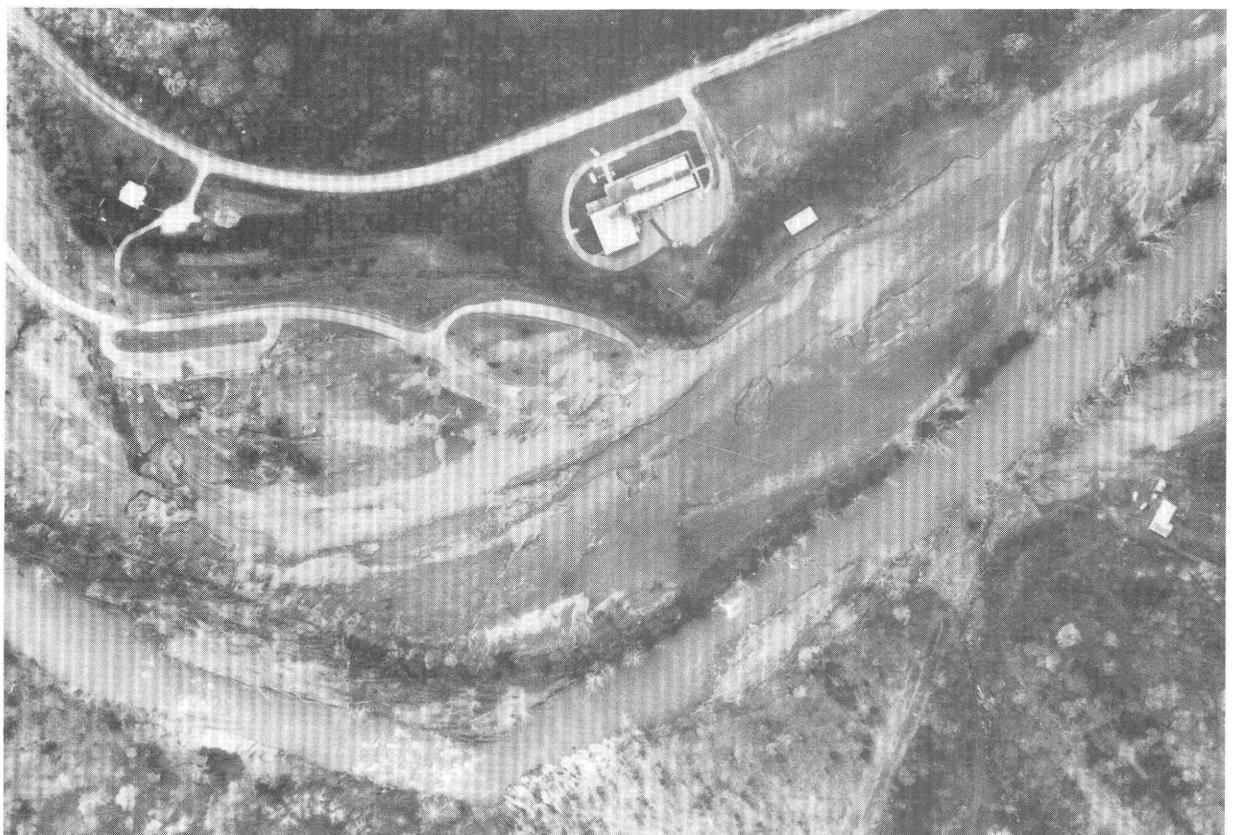
◀ **Figure 62.** Chute on flood plain of North Fork at Seneca Rocks Visitor Center, 0.6 km downstream of Seneca Rocks. Flow is from left to right. Seneca Creek joins the North Fork just to the left of the area shown in this picture; the headcut oriented toward the upper left corner of the photograph evidently was exploited by flow coming from Seneca Creek. The cross section shown in figure 59 extends across the flood plain at this site from a point about halfway between the two parking loops at top left center to a point on the right bank of the North Fork just upstream of the bend in the channel. Field of view is 650 m wide.

intersecting the river channel at one or both ends (fig. 60), but there were also well-developed examples with upstream or downstream termini that did not intersect the channel (fig. 62).

**Figure 59.** Postflood cross section of North Fork valley at Seneca Rocks Visitor Center. Chute formed in the flood is comparable in width to the pre-flood river channel. Figure 62 is an aerial photograph of this chute (after McKoy, 1987).

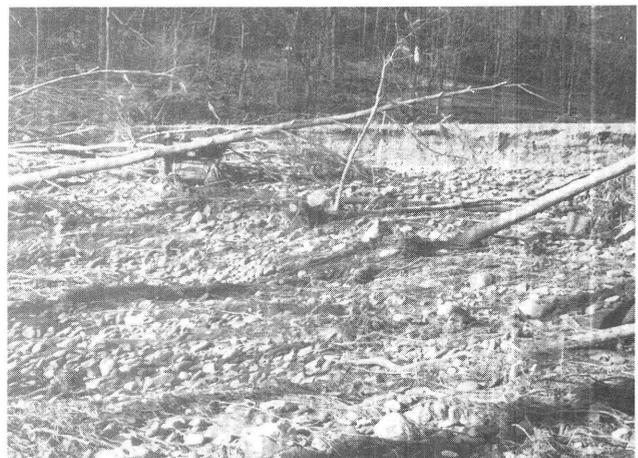
**Figure 64.** Ground view of upstream end of chute illustrated in figure 63. Tilted and uprooted trees indicate current direction and indicate that erosion of the channel proceeded from upstream to downstream rather than by upstream migration of headcuts.

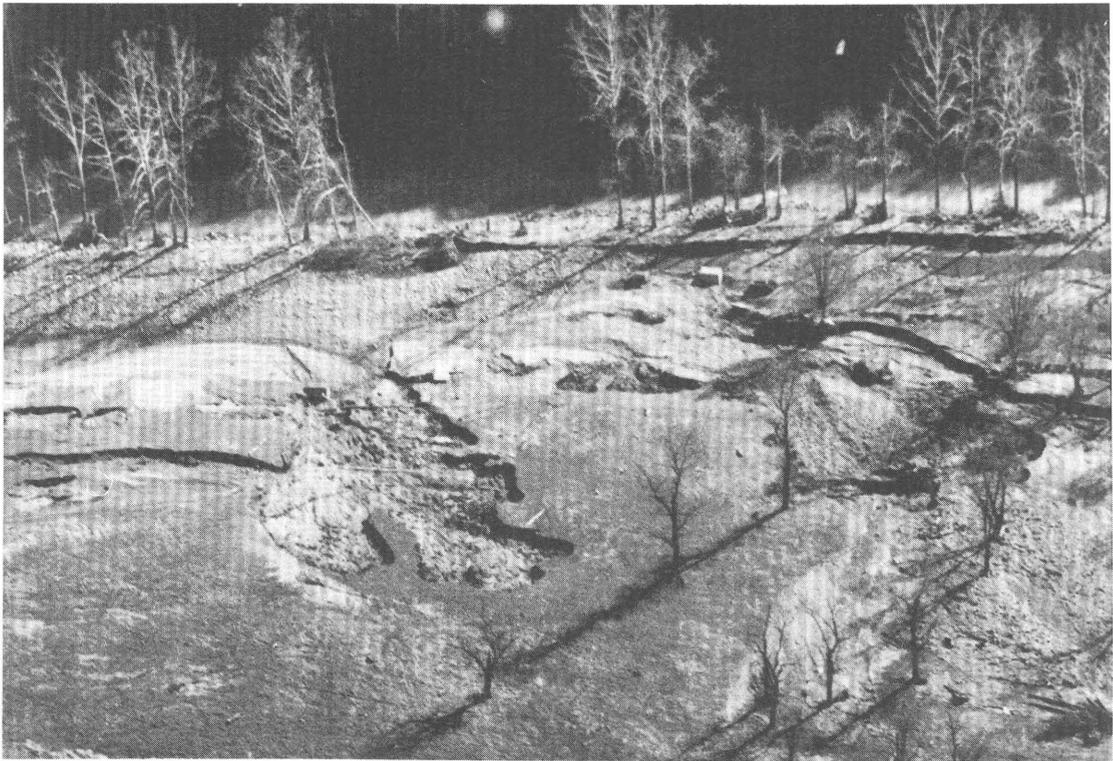
**Figure 65.** Chute with branching headcuts, South Branch at Smith Creek, about 3.5 km upstream of Franklin. Flow along the South Branch is from right to left. Prominent headcuts in the foreground were created by flow emerging from Smith Creek. Photograph by E. Propst, Clarksburg Publishing Company.

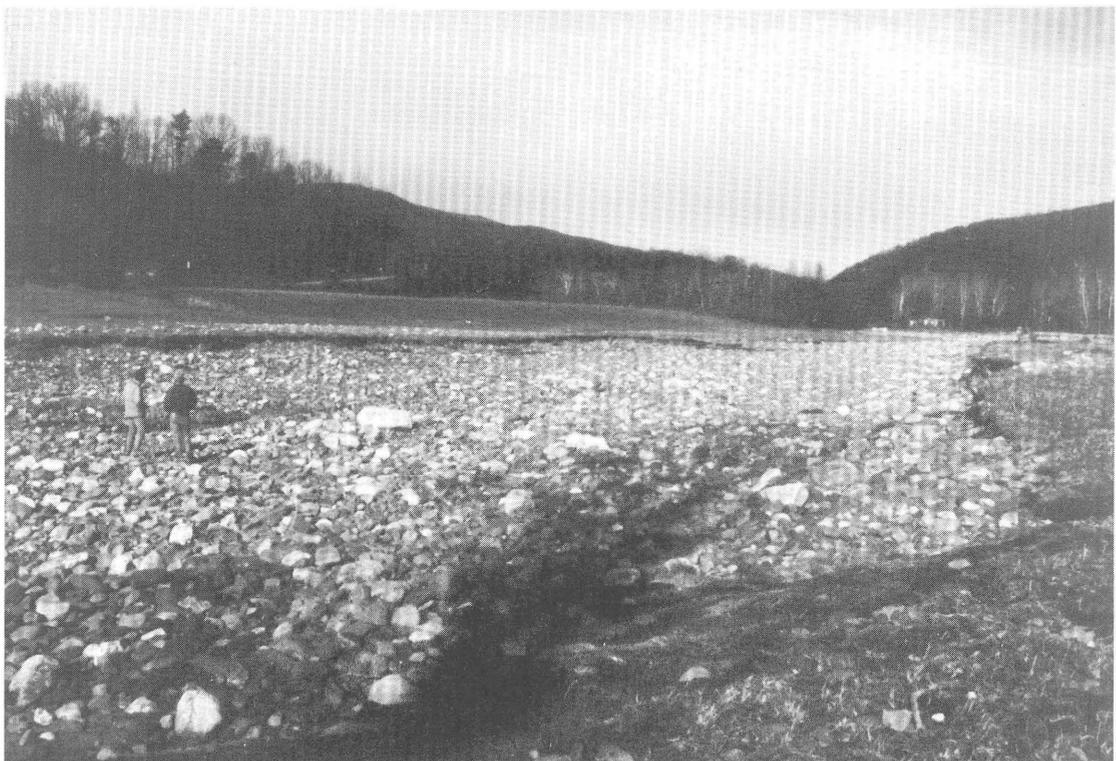
**Figure 66.** Chute in figures 63 and 64, shown looking downstream. This chute was about 40 m wide, 1.5 m deep, and 500 m long.

Chutes inspected in the field generally had steep banks. Those that did not intersect the river channel at the downstream end gradually shallowed downstream until they merged with the surrounding undisturbed valley floor; sometimes the transition was obscured by splays deposited at the downstream end of the chute. Chute floors usually were flat (fig. 66), but some had uneven or stepped bed topography with inner and outer channels (fig. 59).

Most chutes were floored by imbricated cobbles and boulders (fig. 66). Although many of the cobbles and boulders appeared to have moved during the flood, the fact that cobble splays observed following the flood generally were contiguous to areas of channel or flood-plain scour (from which they presumably were excavated) suggests that most probably did not move further than a few hundred meters. Much of the floor material may have been composed of slightly reworked lag deposits: older sediments exposed in some chute walls were composed of rounded cobbles, gravel, and small boulders in a sandy matrix (fig. 67) and were similar in texture to the fresh deposits on the adjacent valley floor. Along one 126-m section of chute (figs. 66 and 67), 63 percent of the bank length contained imbricated gravel, cobbles, and boulders; gravel lenses at this site were up to 14 m long and 1 m thick (Scatena, 1986). That such coarse material should be found at such shallow depth beneath the flood-plain surface suggests that large floods may have played an important role in shaping

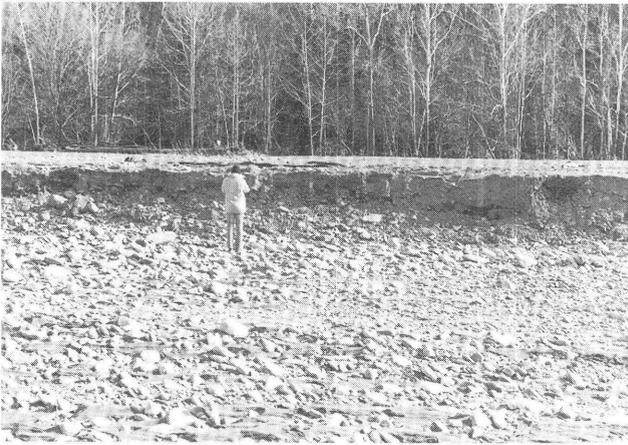
**A**

**Figure 67.** Two views of the right bank of the chute seen in figure 66. (A) A flat bed of imbricated cobbles and a bank about 1.5 m high; the trees in the background are standing on a lower surface, and the North Fork is on the other

side of the trees. (B) A closer view of the bank section, indicating that the flood plain is underlain by a sequence of cobbles and gravel that generally resembles the material exposed on the floor of the chute.

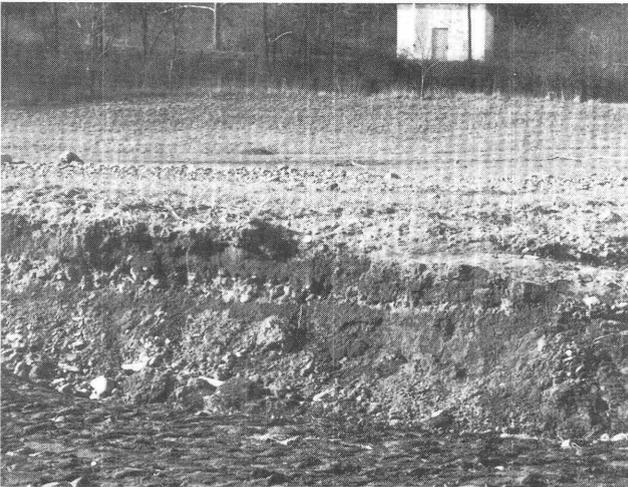
**Figure 68.** The left bank of the chute illustrated in figures 66 and 67 exposes a sequence of fine-grained alluvium with interbedded gravel lenses resembling those described by Ritter (1975). The gravel lens exposed in cross section presumably was deposited by a past flood in much the same way as the gravel lens on the surface was deposited by the November 1985 flood.

the present form of the flood plain. However, cobbles and boulders are not equally important components of the subsurface at all locations. In some chute walls and river bank exposures a vertical section of fine-grained alluvium with interbedded gravel lenses was observed (figs. 68, 69). Similar alluvial sequences were observed by Costa (1974) and by Ritter (1975) and were interpreted as evidence for large rare floods in an environment otherwise characterized by long-term accumulation of sandy or silty lateral and vertical accretion deposits.

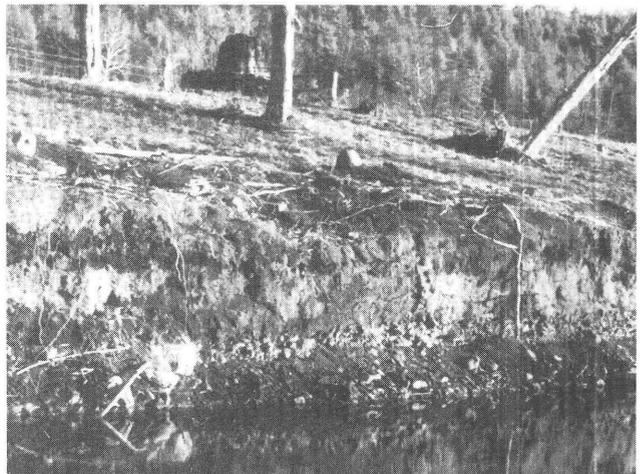
**Figure 69.** The left bank of the South Fork at Brandywine exposes a gravel lens (near the base) that resembles the lenses shown in figure 68. Such deposits may be common in the flood plains of the three forks of the South Branch. The bank is about 2–2.5 m high.

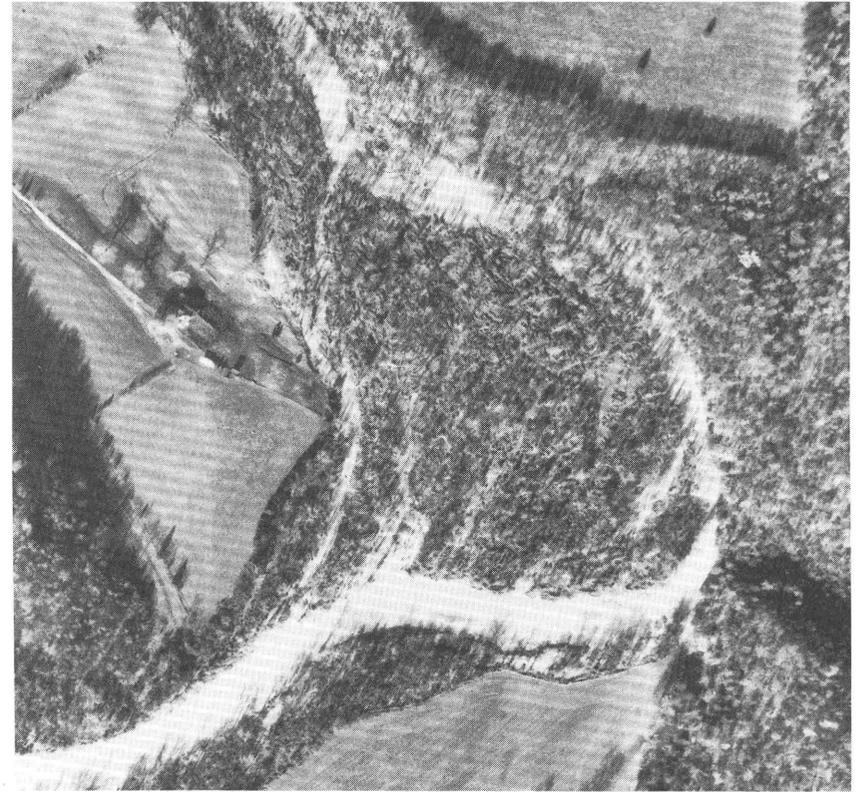
**B**

**Figure 70.** South Fork, 1.9 km downstream of Brandywine gaging station, seen (A) before and (B) after the flood. Flow is from bottom left to top center. Chutes running across this forested bottomland (actually the lower of the two surfaces described previously) are generally narrower than, and not as well defined as, chutes running across cleared fields. The examples shown here were enlarged by the flood, but their existence predates the flood. Field of view is 630 m wide.

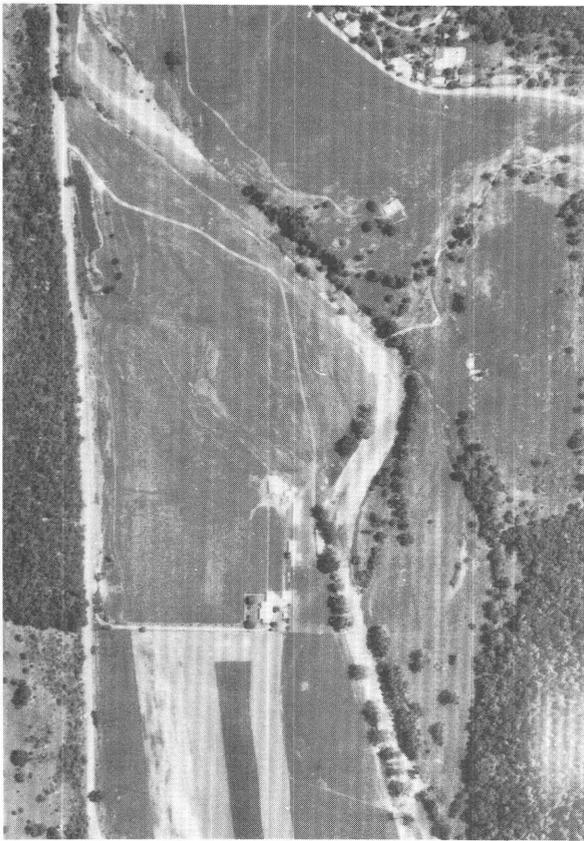
**A**

**Figure 71.** South Branch flood plain, about 3 km upstream of Franklin. Flow is from bottom to top. Channel widening and dissection of the flood plain left several large remnant islands separated by a set of
