Geomorphic Studies of the Storm and Flood of  
November 3–5, 1985, in the Upper Potomac  
and Cheat River Basins in West Virginia and  
Virginia

U.S. GEOLOGICAL SURVEY BULLETIN 1981

ROBERT B. JACOBSON, Editor

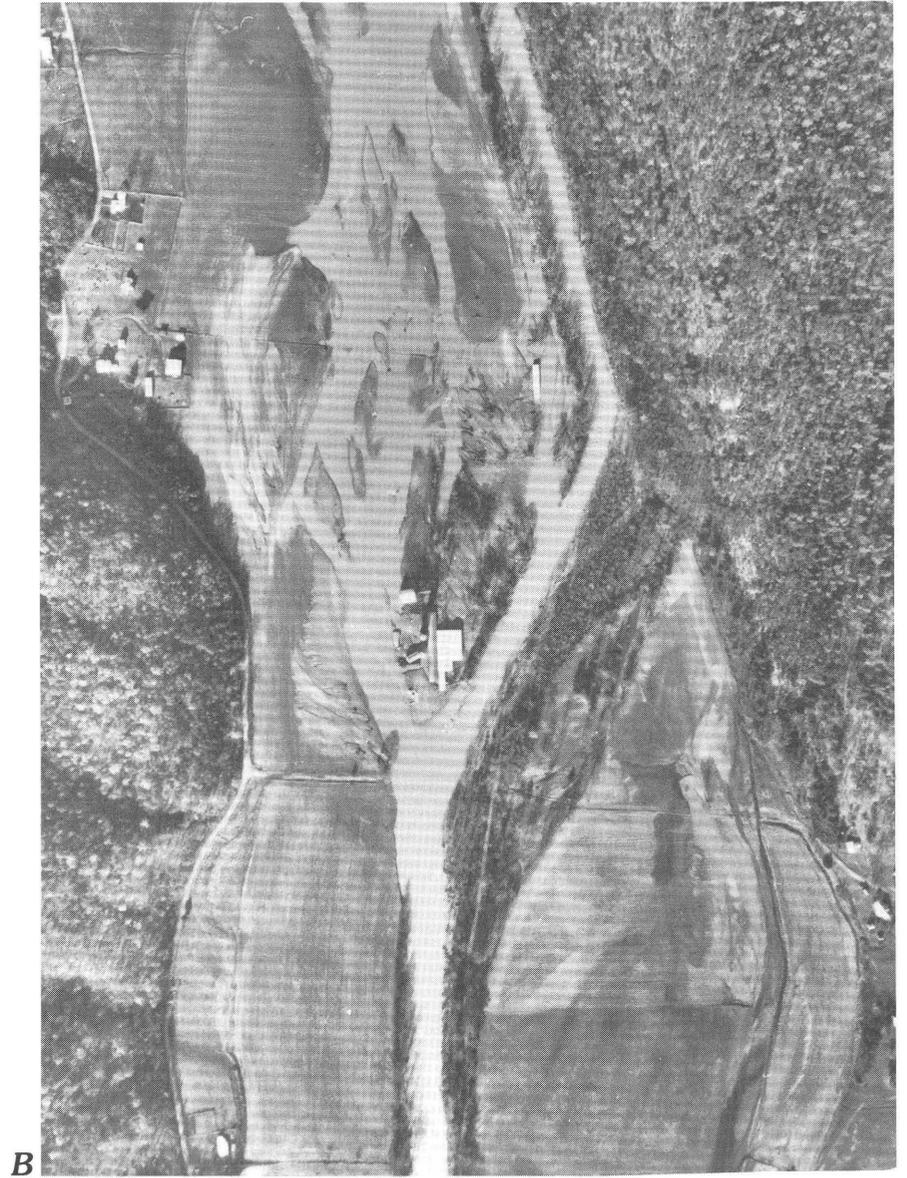
**Figure 72.** Examples of valley floors extensively dissected by anastomosing erosion channels. (A) Before and (B) after views of the Adamson dairy farm on the South Fork flood plain at Fame, 6 km downstream of Fort Seybert. Flow is from bottom to top. The South Fork emerges from a bedrock constriction about 3 km upstream of the dairy, but the channel follows a straight path from the constriction until it reaches the location shown here. Field of view is 870 m

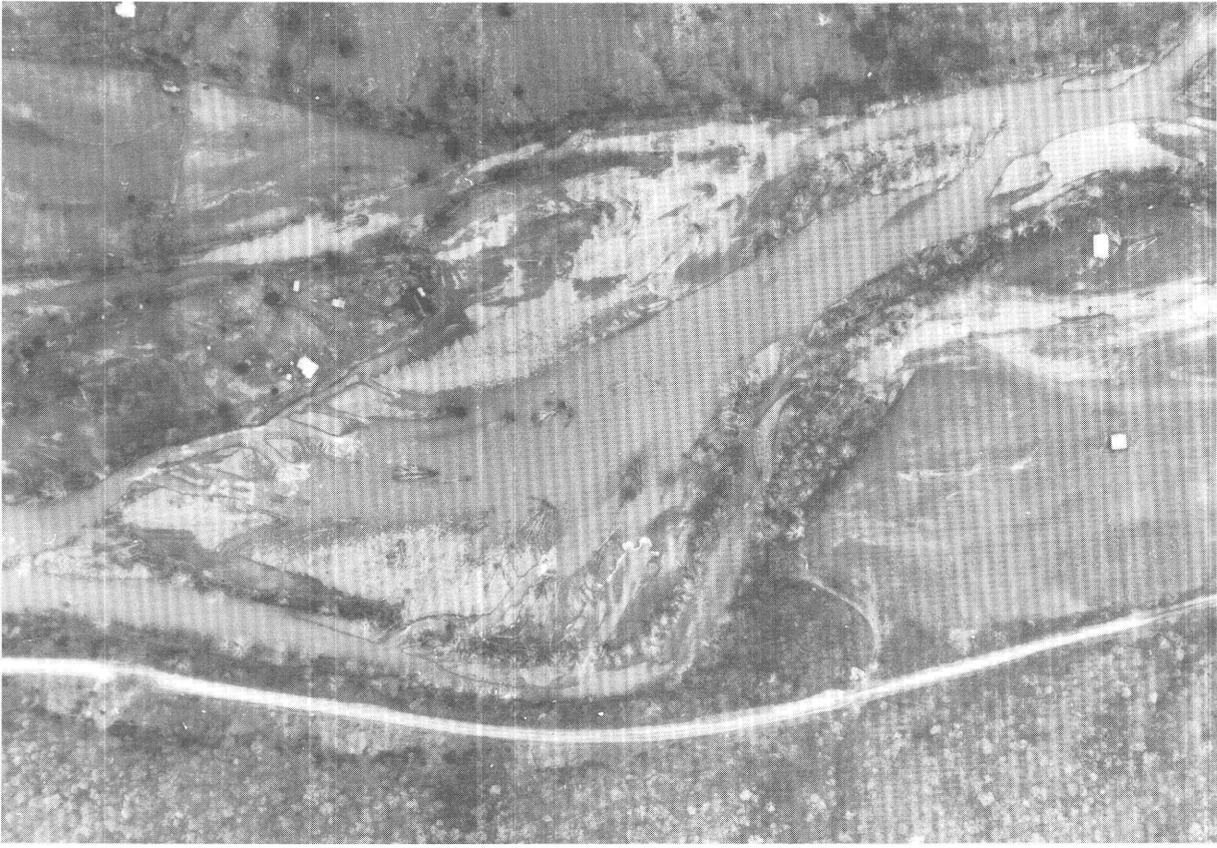
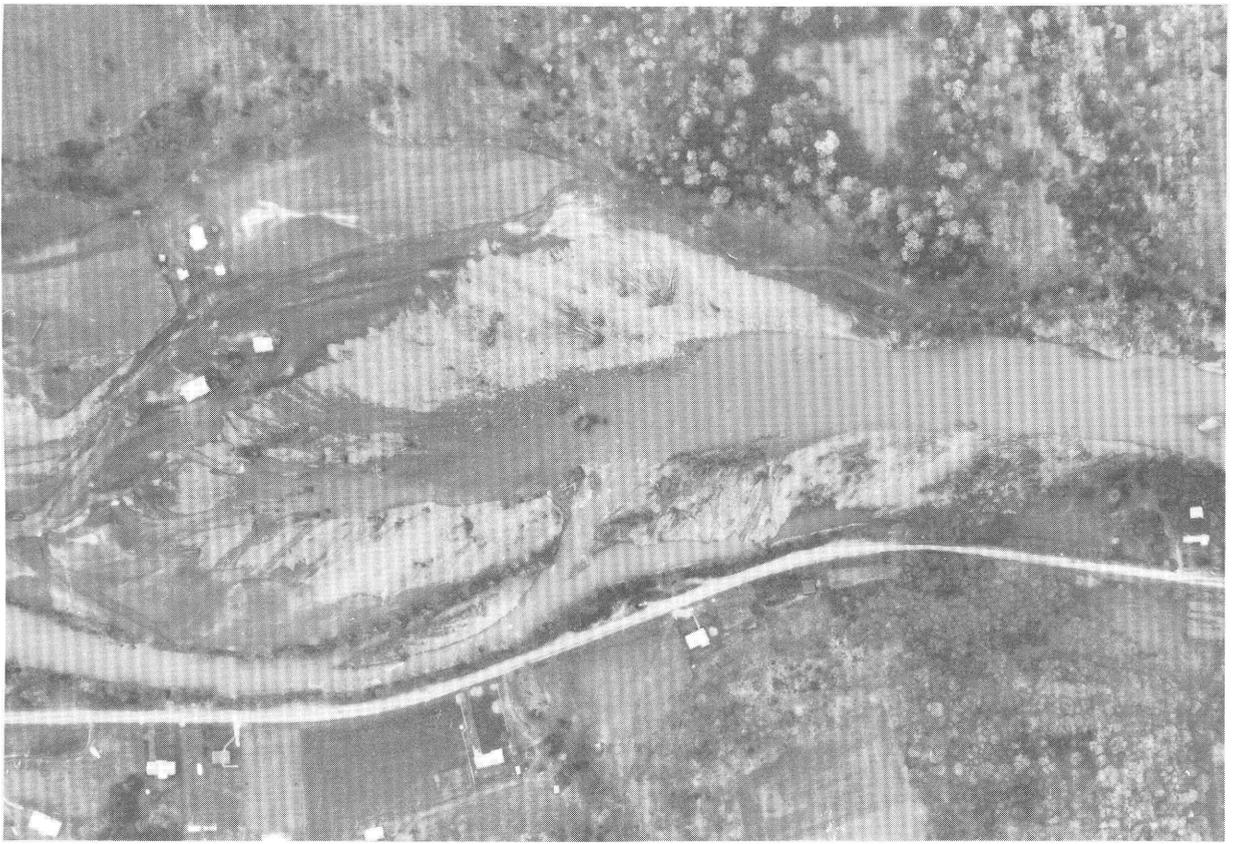
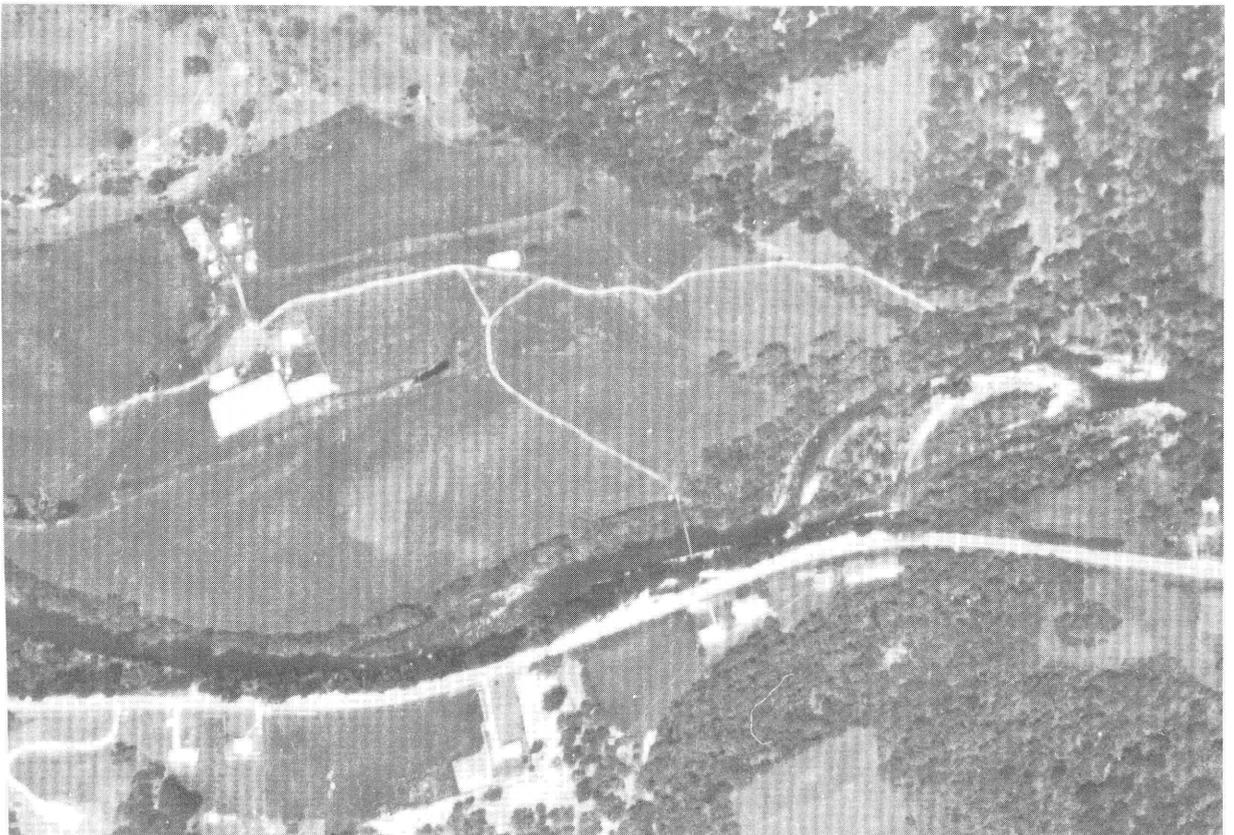
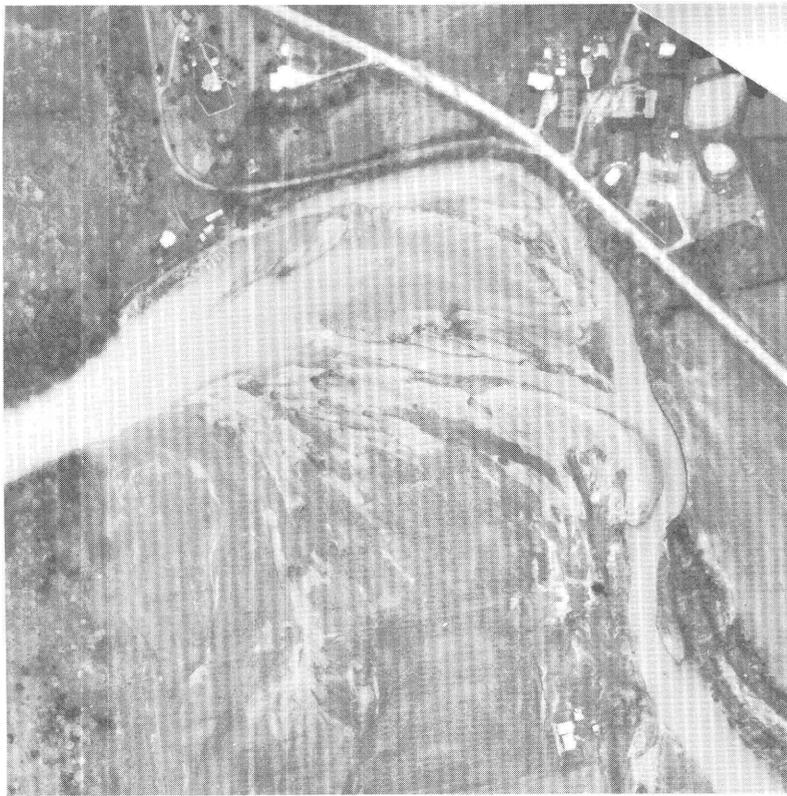
**Figure 73.** Examples of jet-shaped erosion forms. (A) Before and (B) after views of the South Fork South Branch Potomac River valley at a site about 3 km downstream of Brake. Flow is from bottom to top. The preflood photograph shows a complex valley form with multiple abandoned or inactive overflow channels and several forested bars or channel islands. Field of view is 690 m wide. (C) Before and (D) after views of the North Fork South Branch Potomac River valley at a site 3 km downstream of Seneca Rocks. Flow is from bottom to

top. Field of view is 640 m wide. (E) Before and (F) after views of the North Fork South Branch Potomac River valley about 8 km downstream of Seneca Rocks and 14 km upstream of Hopeville. Flow is from bottom to top. Field of view is 670 m wide. (G) Before and (H) after views of the South Branch Potomac River valley about 5 km downstream of Franklin. Flow is from top to bottom. Field of view is 700 m wide.

Another form of catastrophic erosion observed at several locations in the study area resembled a plane jet formed by an expanding stream of fluid emerging from an orifice or constriction (figs. 73A-H). This type of erosion typically occurred in expanding reaches downstream of valley constrictions. At sites where the river channel below the constriction flowed along the left or right valley wall rather than down the center of the valley floor, the high-velocity core of flow emerging from the constriction left the channel and followed a trajectory directed downvalley. The resulting erosion channel typically was several times as wide as the preflood river channel and expanded slightly with increasing distance downstream, with coarse splays and debris flaring outward in all directions. As the flow

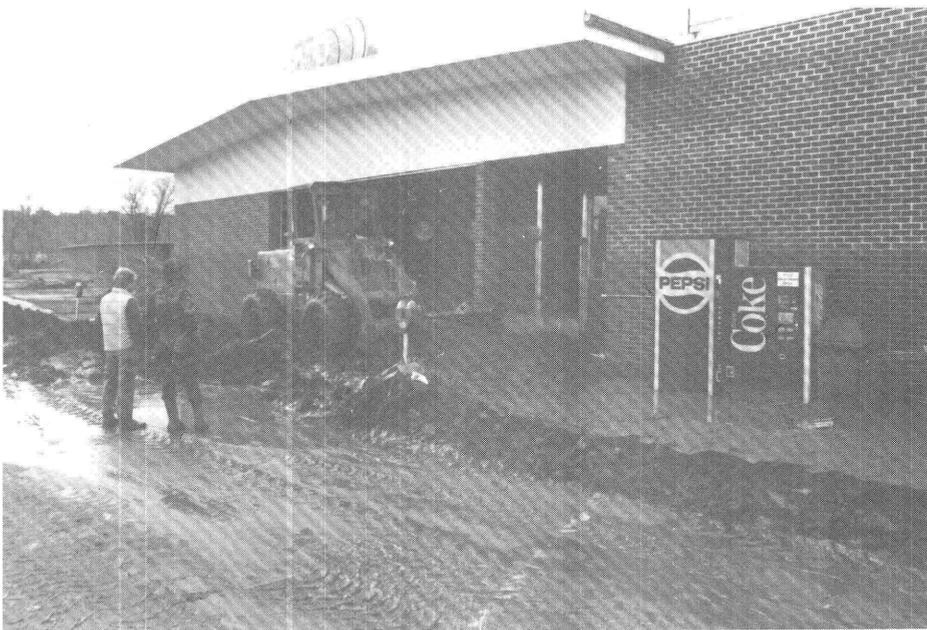
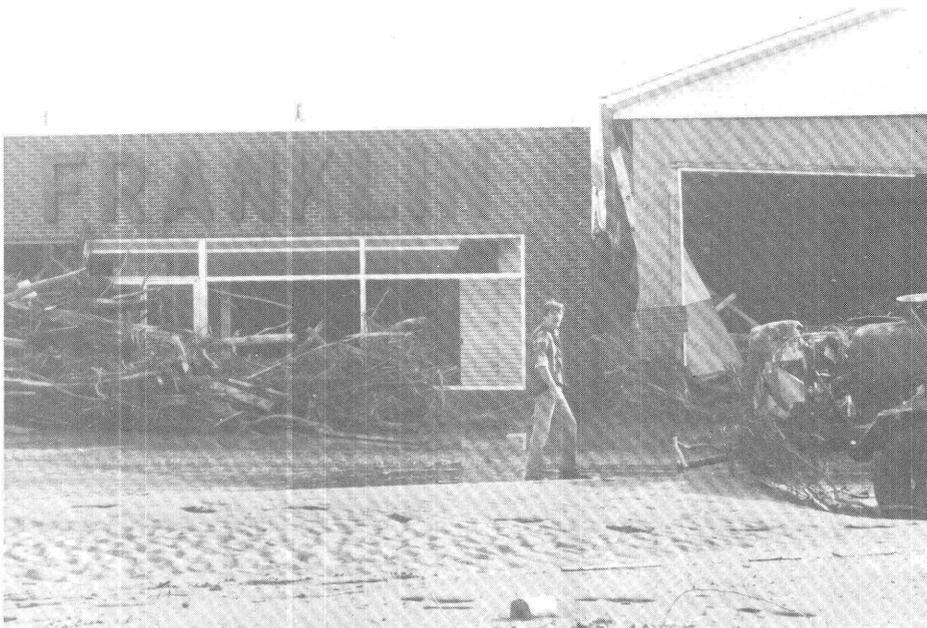
**Figure 74.** Two views of sediment deposited in the streets of Petersburg, W. Va. (A) Mud deposits about 30 cm deep. (B) Ripple marks in sand. Note also organic debris piled up in front of the store entrance. Photographs by Paul Porter.

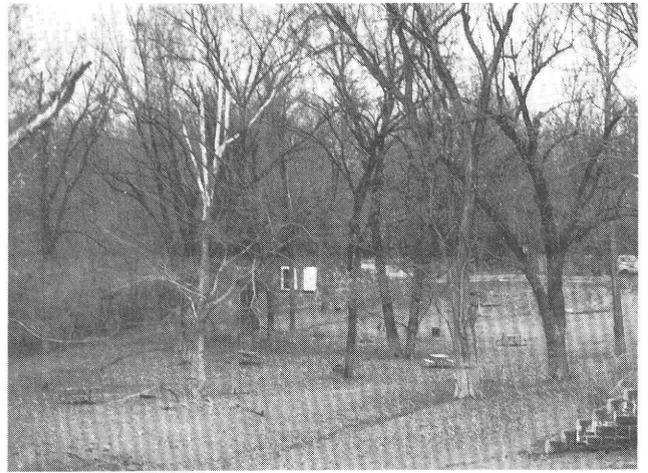
**Figure 76.** Mud deposited on flood plain and "bathtub ring" formed by silt marks on vegetation (note light gray color in bottom half of photograph), indicating elevation of high water during the November 1985 flood. Photograph taken from Monocacy Aqueduct, junction of Monocacy River with Potomac River.

Along the main stem Potomac River, downstream from the South and North Branches, little erosion occurred on flood plains, and the impact of the flood was primarily depositional. No gravel deposits were observed on the valley floor. A 250-m transect across the left flood plain at a site near Hancock, Md., showed an average of 3.6 cm of silt deposited by the 1985 flood (fig. 75). Far downstream, at the mouth of the Monocacy River, mud coatings were left behind on the trees, and 2–5 cm of mud were deposited in the picnic area near the Monocacy aqueduct (fig. 76).

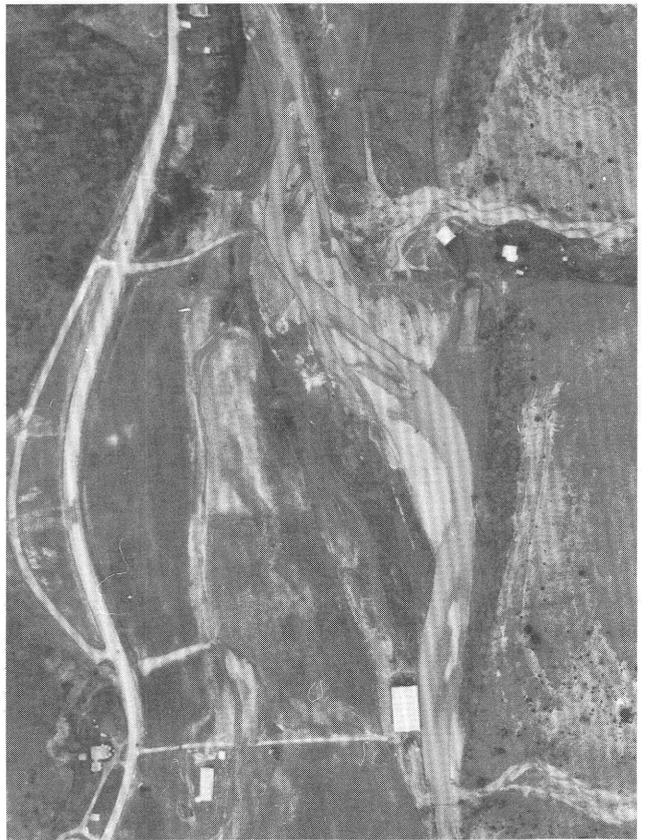
**B**

**Figure 77.** (A) Before and (B) after views of South Branch Potomac River near the Virginia–West Virginia boundary. Flow in South Branch is from bottom to top. Although some of the coarse material visible in the channel may have been delivered from heavily reworked tributary val-

Some of the sediment deposited in channel bars may have been derived from tributary contributions, but most of the gravel bars visible in the channel were at locations where substantial channel widening and bottomland erosion occurred. At these sites, gravel bars were difficult to distinguish from stripped flood-plain remnants (figs. 49, 77–79).

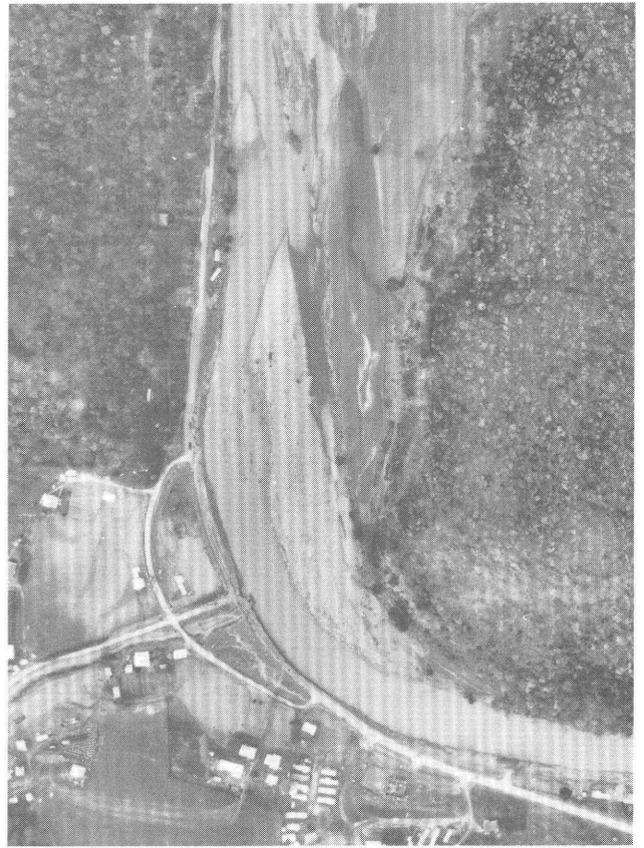
A

**Figure 78.** (A) Before and (B) after views of South Branch Potomac River at Ruddle. Flow is from lower right. Note erosion of valley floor along left bank of river and formation of large bar along right bank and smaller bar along left bank downstream. Field of view is 650 m wide.

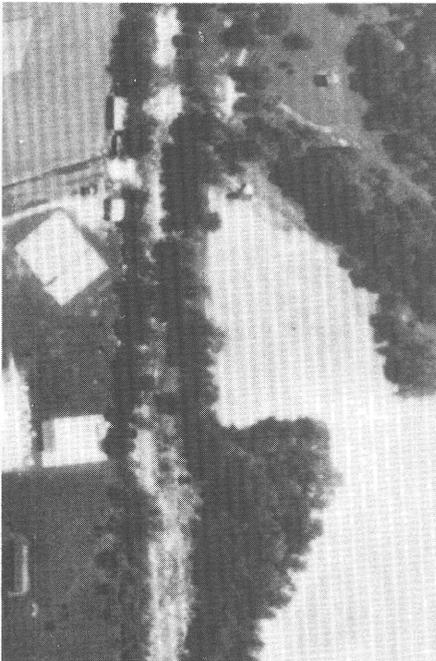
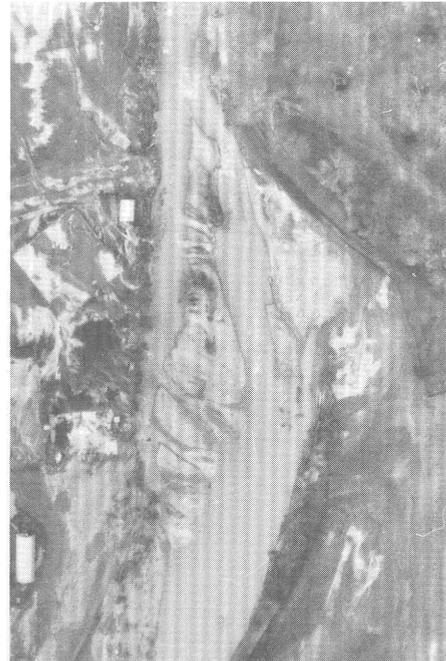
**Figure 79.** (A) Before and (B) after views of South Branch Potomac River at Franklin. Flow is from bottom to top. Channel islands visible in (B) look like gravel bars in a braided river but probably are stripped and dissected remnants of the valley floor. Field of view is 270 m wide.

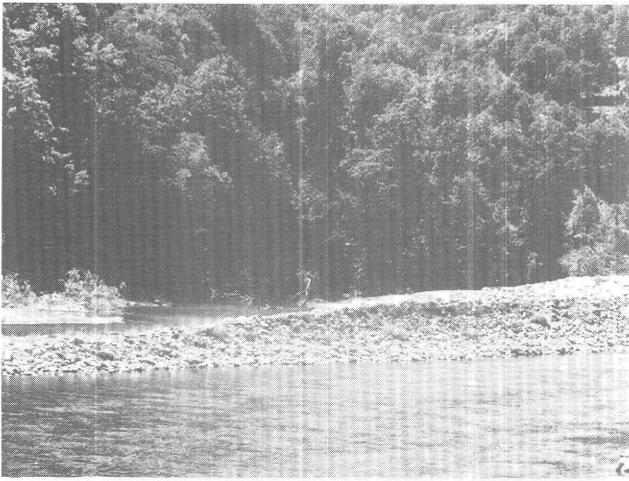
**Figure 80.** Gravel bar in South Branch channel, 1 km downstream of confluence between South Branch and North Fork. Highest point on bar is about 4 m above low water. Flow is from right to left. Steep side profile of this bar appears to result from scour following peak flood discharge; this process probably continued during subsequent high flows.

Church and Jones (1982) point out that gravel bars typically occur in a limited range of settings, the principal categories being (1) areas of channel widening, (2) channel junctions where backwater from the main river ponds a tributary, and (3) apices of channel bends, where resistance to flow increases and slack water may occur along the convex bank. Bars in these settings are associated with diverging flow, succeeded immediately downstream by converging flow and increased shear stress. For the most part this statement is sufficient to characterize sites of bar formation in the channels of the three forks of the South Branch Potomac River in the 1985 flood. Most bars observed in the postflood river channel are oriented along the direction of flow with a streamlined form that tapers to a point. Depending on position and shape, gravel bars may be classified following the nomenclature adapted by Church and Jones (1982) after Smith (1974) and Krigstrom (1962). However, as Ashmore (1982) points out, most bar forms reflect the influence of postdeposition modification (fig. 80).

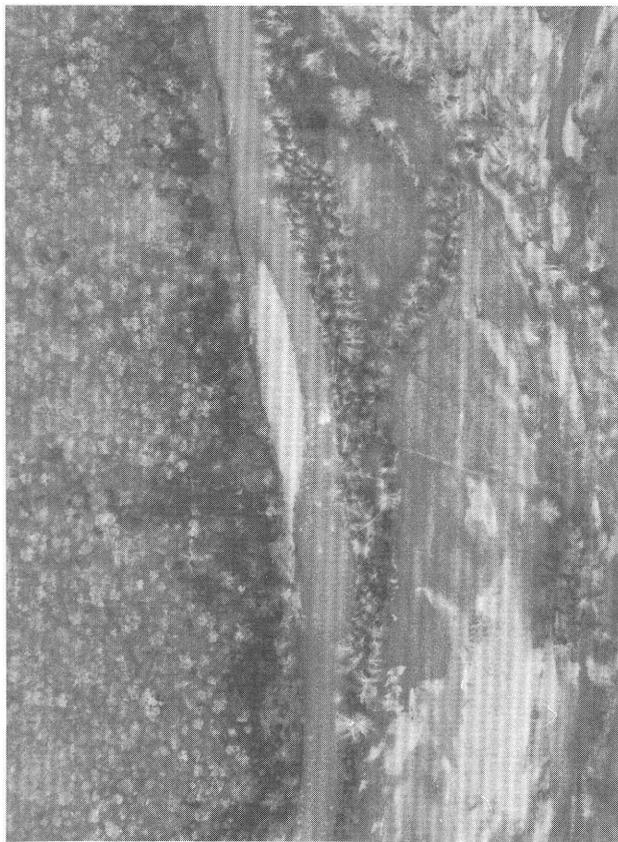
**Figure 81.** (A) Before and (B) after views of South Branch Potomac River at the mouth of Redman Run, about 6 km upstream of the confluence with the North Fork. Flow is from the lower right. Note that the bottomland along the left bank was completely eroded by the November 1985 flood and that the bar along the right bank was formed in

the same event. The section of bottomland removed in 1985 was not present in 1945; it was replaced by a debris avalanche emerging from the mouth of Redman Run during the flood of June 1949 and remained in place for 36 yr until the 1985 flood removed it. Field of view is 390 m wide.

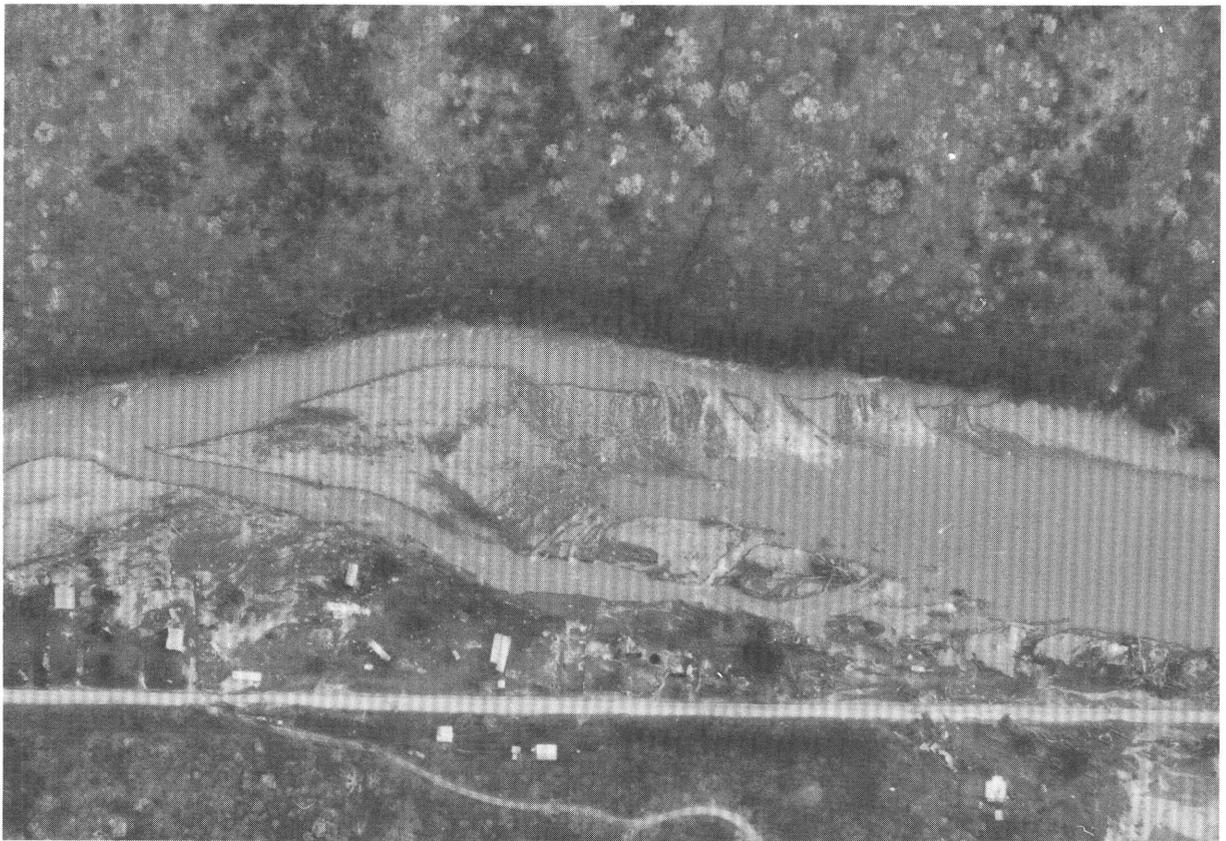
**Figure 84.** Compound bar formed from dissected flood-plain remnants and freshly deposited gravels. North Fork, about 1 km upstream of the Cabins gage site and 5 km downstream of Hopeville. Flow is from right to left. Note the area of diverging flow through

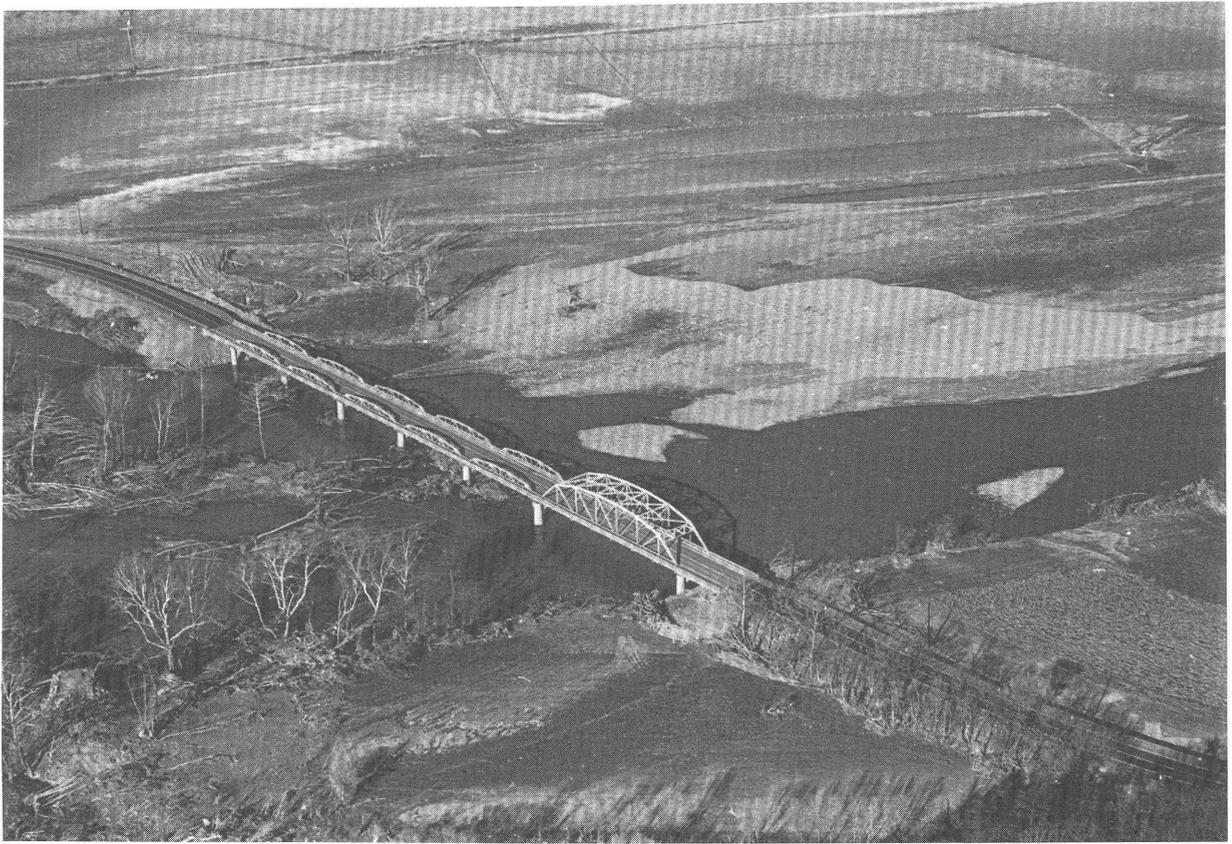
**Figure 86.** Gravel splays derived from bottomland erosion downstream of bridge, South Branch Potomac River, 1 km upstream of Romney. Flow is from left to right. Photograph by W.E. Duliere, West Virginia Advocate.

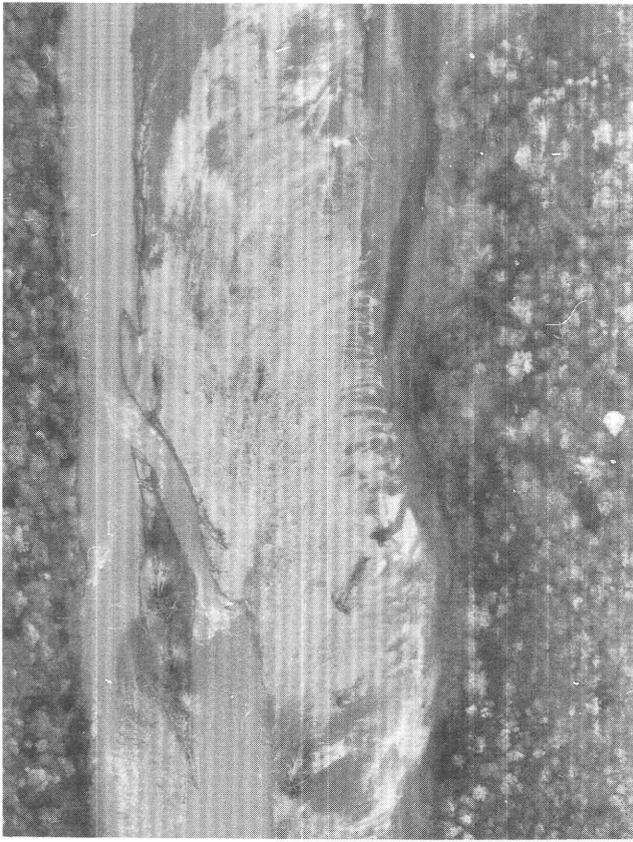
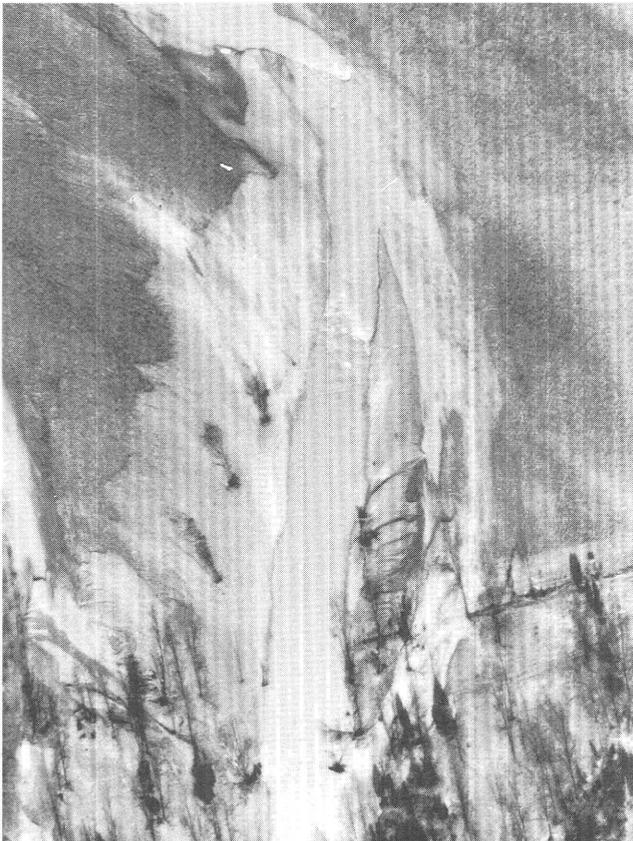
**Figure 87.** Gravel splays with dentate outer margins. Scrolled ridges and troughs curve outward and appear to be sculpted by flow that drained away from the channel. (A) South Branch Potomac River, about 4 km upstream of confluence with North Fork. Flow is from bottom to top. Field of view is 360 m wide. (B) North Fork South Branch Potomac River, 10 km downstream of Seneca Rocks and 12 km upstream of Hopeville. Flow is from bottom left. The area immediately to the right of the channel has been stripped; lateral transition from an area of net erosion to an area of net deposition is poorly defined. Field of view is 380 m wide. (C) South Fork South Branch Potomac River near Fort Seybert. Flow is from bottom to top. The channel shown here is a chute incised into the valley floor during the flood (see fig. 60). The fallen trees on the surface of the splay deposit at left center provide flow vectors. Field of view is 260 m wide.

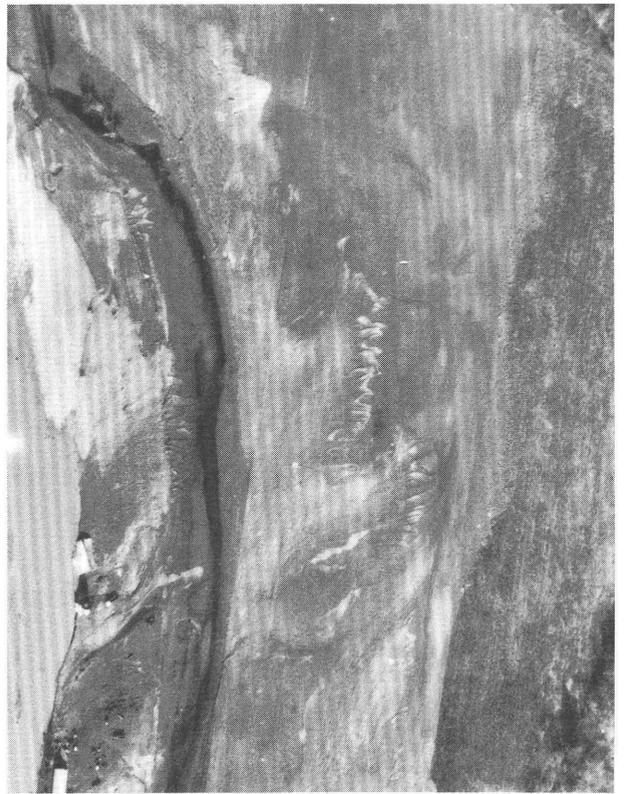
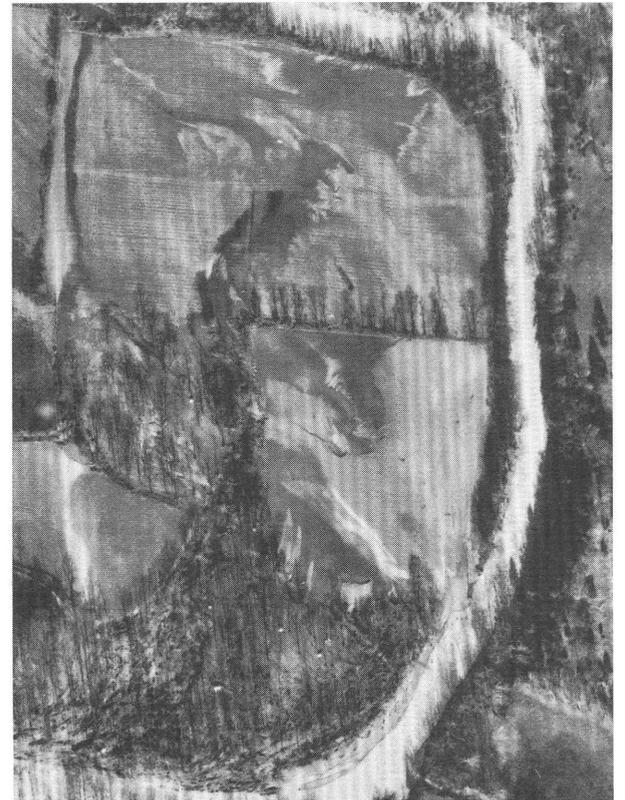
◀ **Figure 91.** Feathered or dentate sand deposits on the valley floor; flow in each case is from bottom to top. (A) South Fork South Branch Potomac River, 2 km upstream of Milam. Note sand deposits at left center. Field of view is 500 m wide. (B) South Fork South Branch Potomac River, 6 km downstream of Milam. Note dentate sand deposits to the right of the channel, at the center of the photograph. Field of view is 360 m wide. (C) North Fork South Branch Potomac River, 9 km downstream of Seneca Rocks. Note the sand deposits to the left of the road. Field of view is 400 m wide. (D) South Fork South Branch Potomac River, 8.5 km downstream of Brandywine. Field of view is 460 m wide.

sediment source by an area lacking significant deposition (fig. 90). In many cases the sand deposit has a feathered or dentate outline (figs. 90, 91A–D). This shape resembles the furrowed margins at the edges of some gravel splays and reflects either a pattern of outward-draining flow, which became less competent and deposited sand as it spread out, or a swash mark left behind as the water reversed direction and drained back toward the channel following the flood crest.

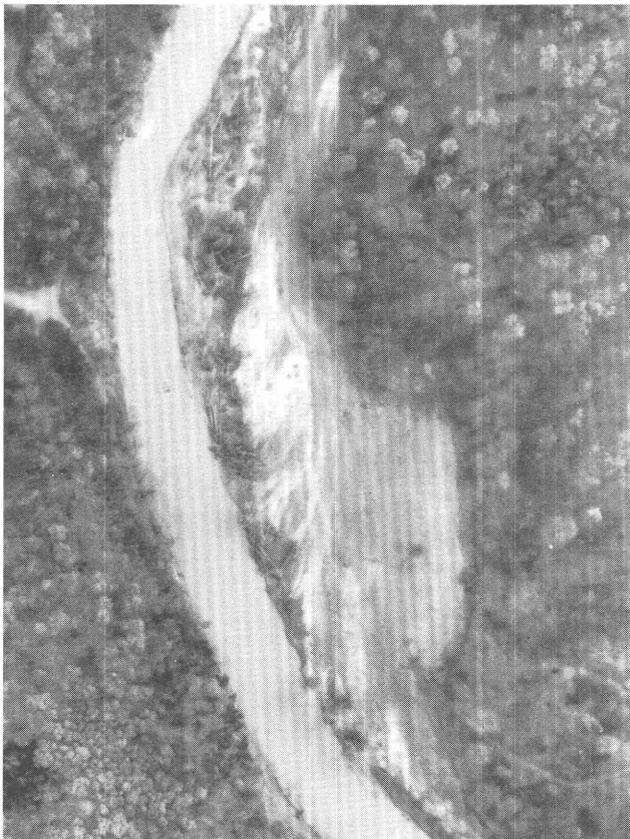
**A**  
**Figure 93.** Sand levees formed as wake deposits associated with flow obstruction by trees bordering the channel. Flow is from bottom to top in each case. (A) South Branch Potomac River, about 20 km upstream of the confluence with the North Fork. Field of view is 420 m wide. (B) South

**B**  
Fork South Branch Potomac River at Fort Seybert. Note the discrete lobes of sand emerging from between the trees and oriented almost perpendicular to the channel. Field of view is 150 m wide.

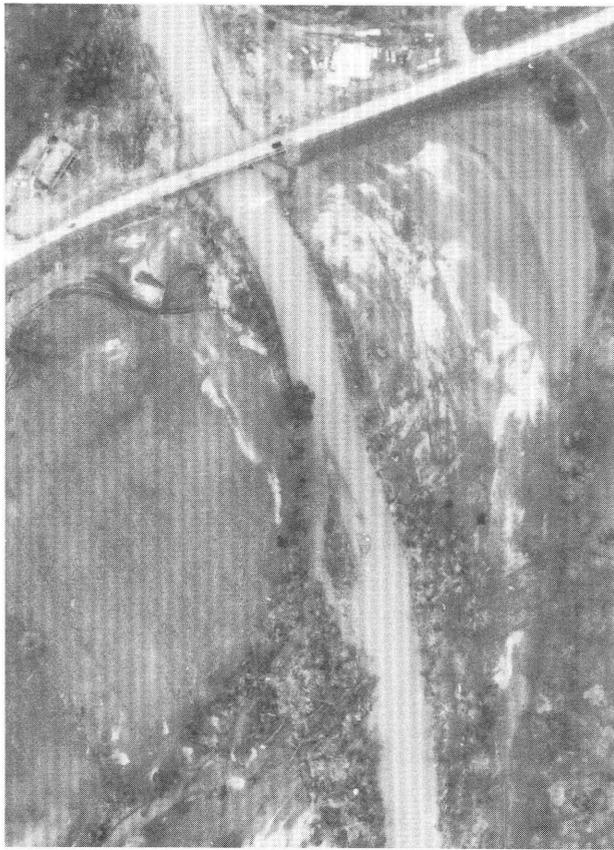
**Figure 94.** Backwater deposits upstream of a road embankment at the entrance to a bedrock gorge; South Branch Potomac River, about 2 km downstream of Franklin. Flow is from bottom to top. Field of view is 290 m wide.

94. Backwater deposits upstream of a road embankment at the entrance to a bedrock gorge, South Branch 2 km downstream of Franklin **E84**
95. Sand sheet on right bank of South Branch at the site shown in figure 94 **E84**

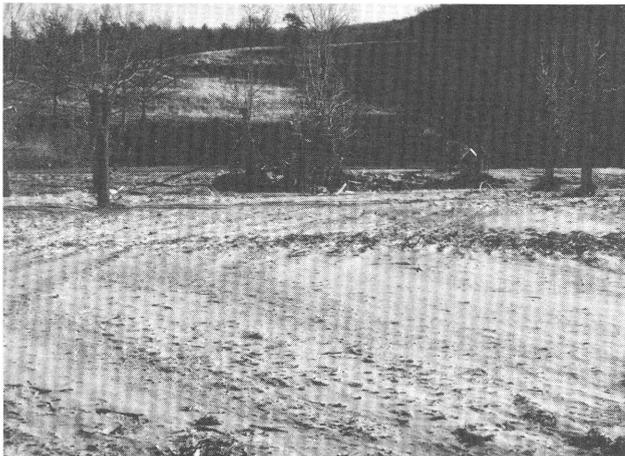
**Figure 95.** Sand sheet on right bank of South Branch Potomac River at the site shown in figure 94. View is toward the right valley wall.

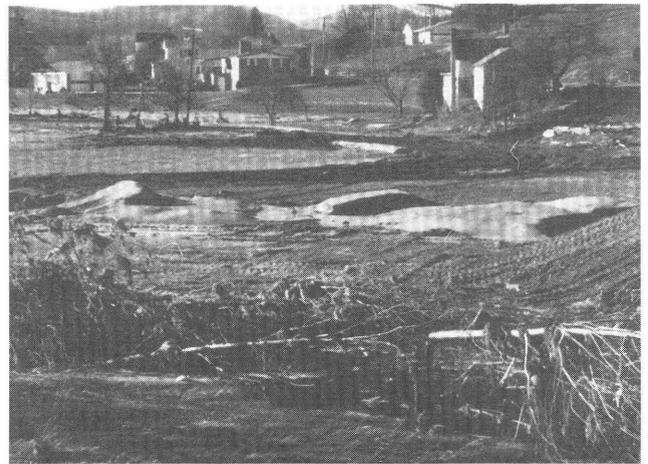
**Figure 96.** Sand dunes near left bank of South Branch Potomac River at the site shown in figure 94.

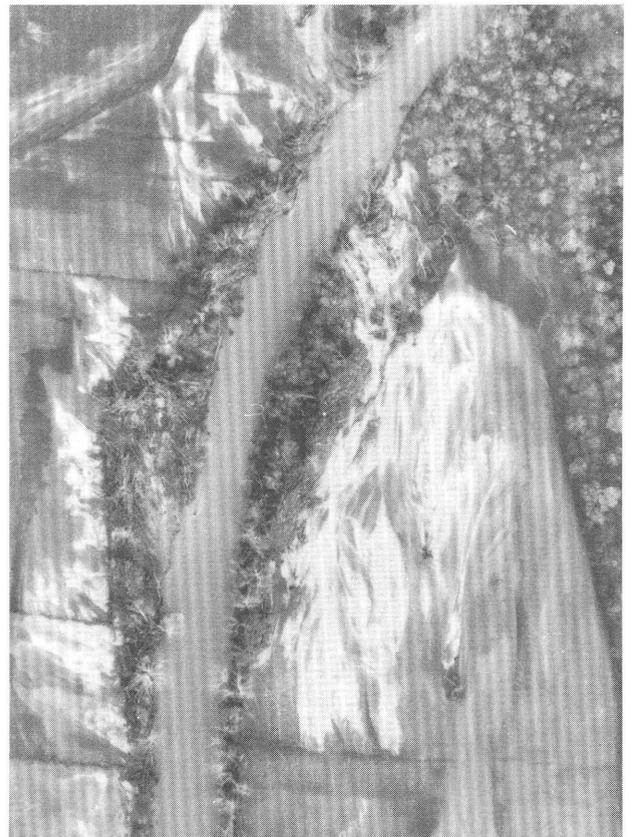
**Figure 97.** Sand deposits on right and left banks of South Branch Potomac River, 0.8 km upstream of the confluence with the North Fork. Flow is from bottom to top. Backwater deposits formed on the valley floor to the right of the channel, where flow was blocked by trees and by a debris jam lodged against the trees at the downstream end of the open field. Note headcut on gully formed at breach in tree line just right of center. Wake deposits formed on the left side of the channel where trees retarded overbank flow. Field of view is 370 m wide.

The second example (fig. 97) is a site where a thick grove of trees accumulated a large amount of floating organic debris that formed a barrier to flow crossing the flood plain. A broad, nearly continuous blanket of sand was deposited just upstream of this barrier; note that the barrier
