Rockfalls and Debris Avalanches in the Smugglers Notch Area, Vermont

U.S. GEOLOGICAL SURVEY BULLETIN 2075

**ROCKFALLS AND DEBRIS AVALANCHES IN THE
SMUGGLERS NOTCH AREA, VERMONT**

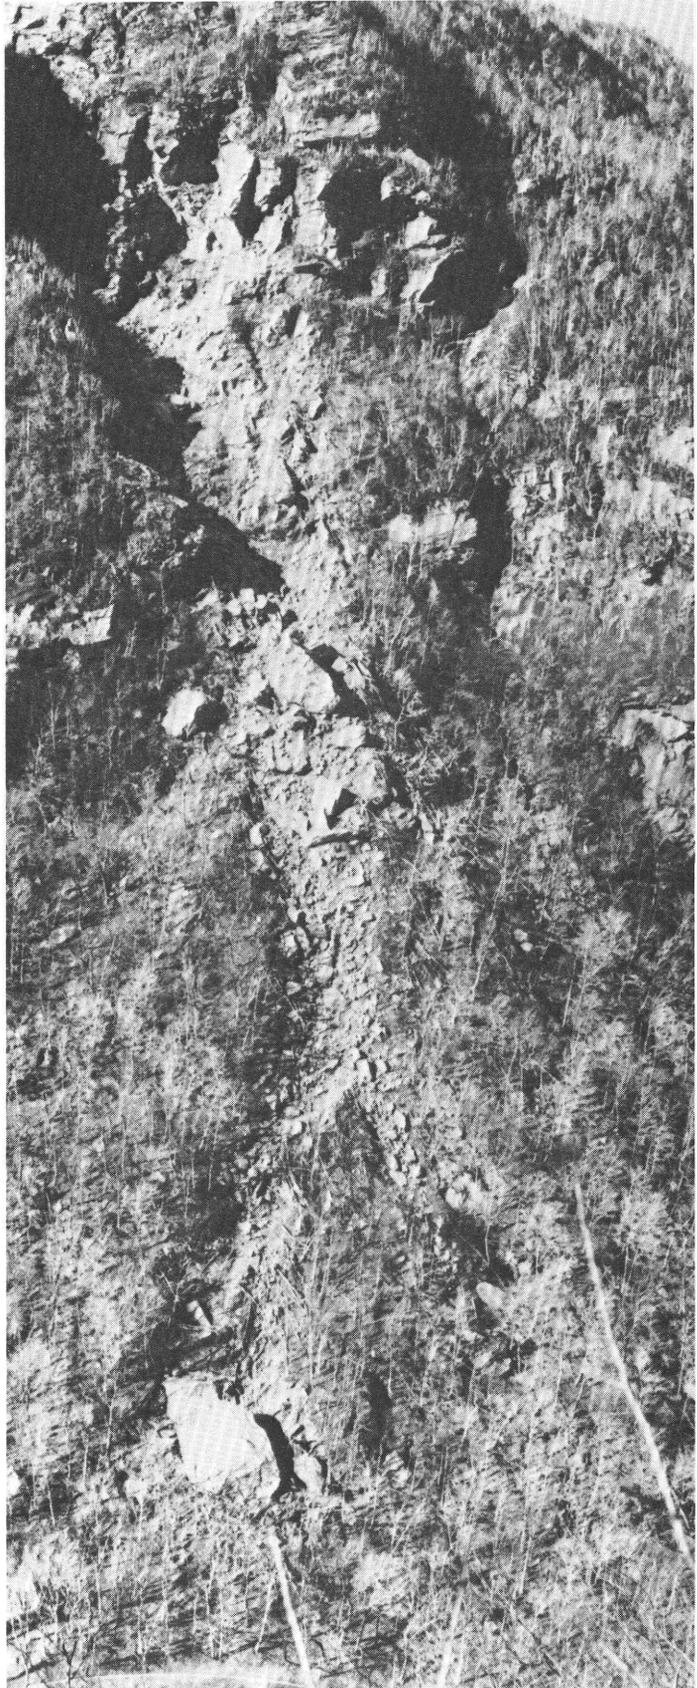
Scar and debris from the July 13, 1983, rockfall and debris slide on the west (east-facing) wall of Smugglers Notch. This path (chute) has also been the site of earlier slope failures. Vermont Route 108 is at the bottom of the photograph. Photograph by C.A. Ratté, October 1987.

broke into smaller pieces and scoured soil, trees, and other vegetation in their paths. Some large and small blocks crossed the road at an altitude of 665 m (frontispiece). This failure was unusual in that it was not closely preceded by heavy rain; however, the failed block was partly bounded by weathered joint surfaces, and, because of its unstable, overhanging position, a slight disturbance, such as expansion and contraction produced by diurnal temperature changes, might have triggered the failure. An examination of blocks, ranging in length from 1 to 23 m, that came from the original block showed that the foliation surfaces were well bonded and would not have split apart easily. Joint spacings in this part of the valley wall range from 1 to more than 10 m. These factors may explain why such large blocks survive the intense pounding that they receive during their downslope travel.

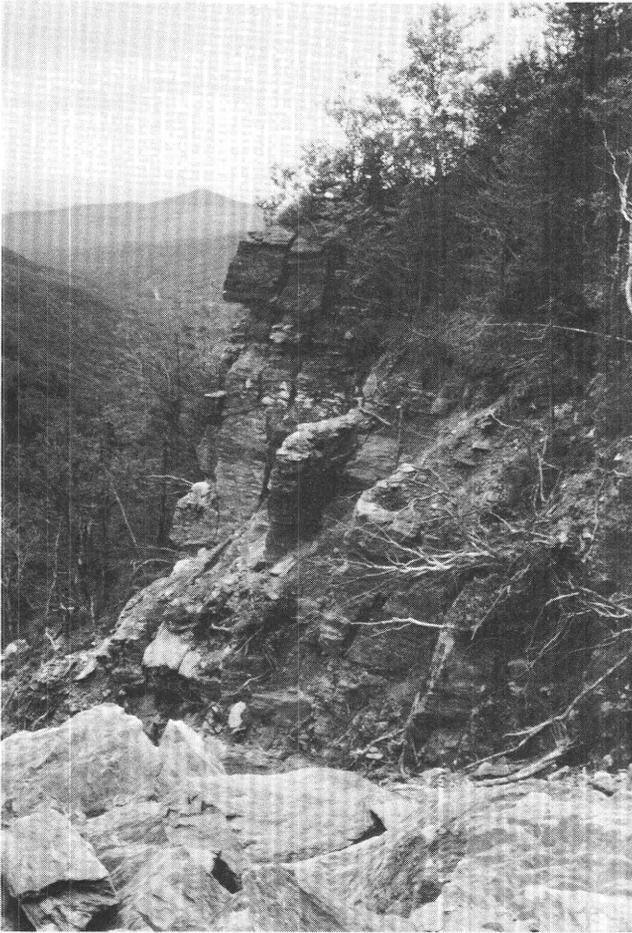
Figure 2. Unstable, loosened blocks in west-facing cliff at Smugglers Notch. Recent debris-avalanche blocks are in foreground.

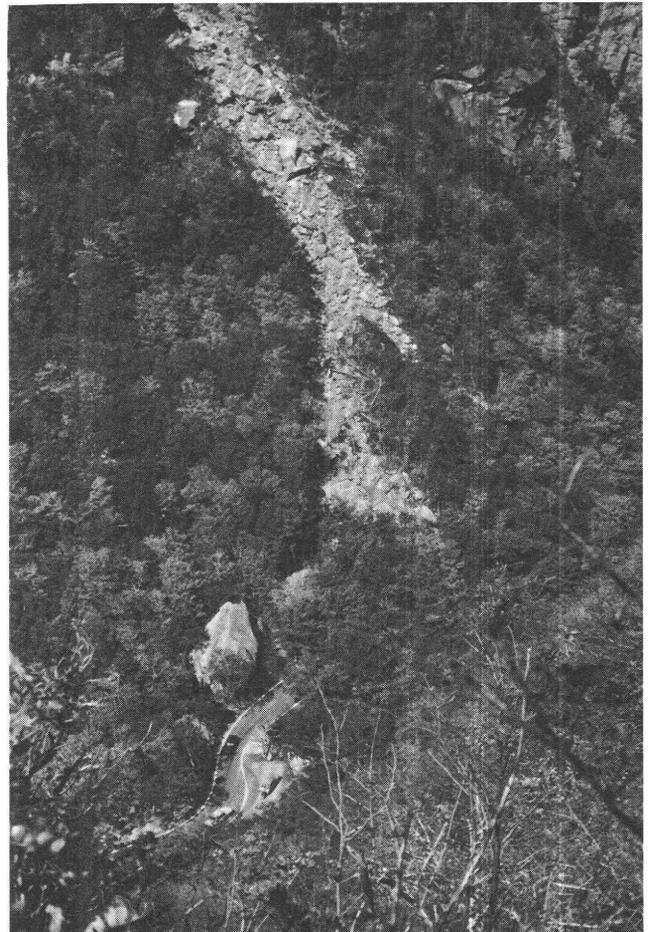
Figure 3. View of part of west wall, Smugglers Notch; single-lane section of Vermont Route 108 is at base of slope. Most of the fresh rock-debris was created by the rockfall and debris avalanche of July 13, 1983.

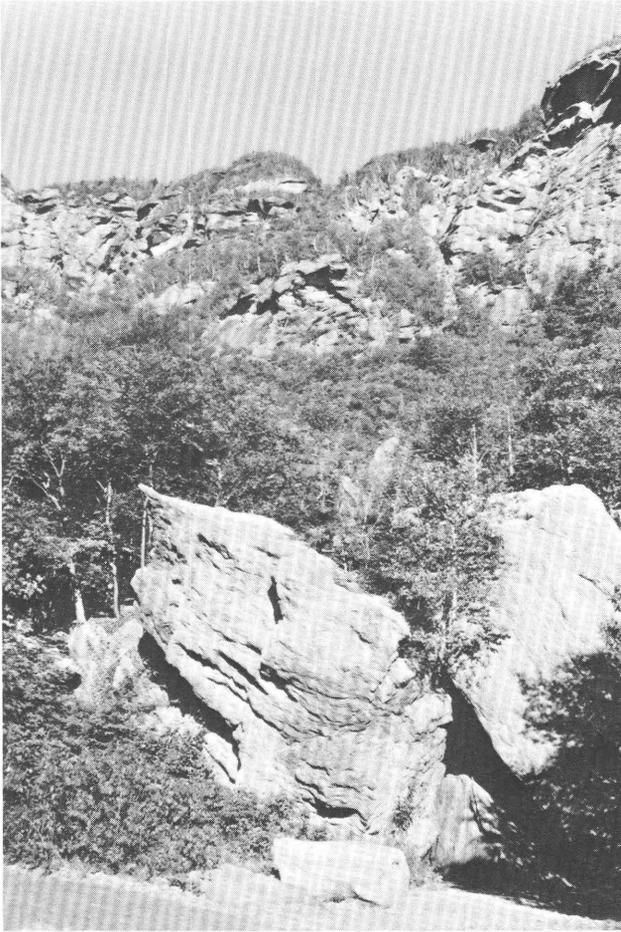
Figure 4. Large joint blocks of quartzitic schist of the type that forms the “caves” at Smugglers Notch.

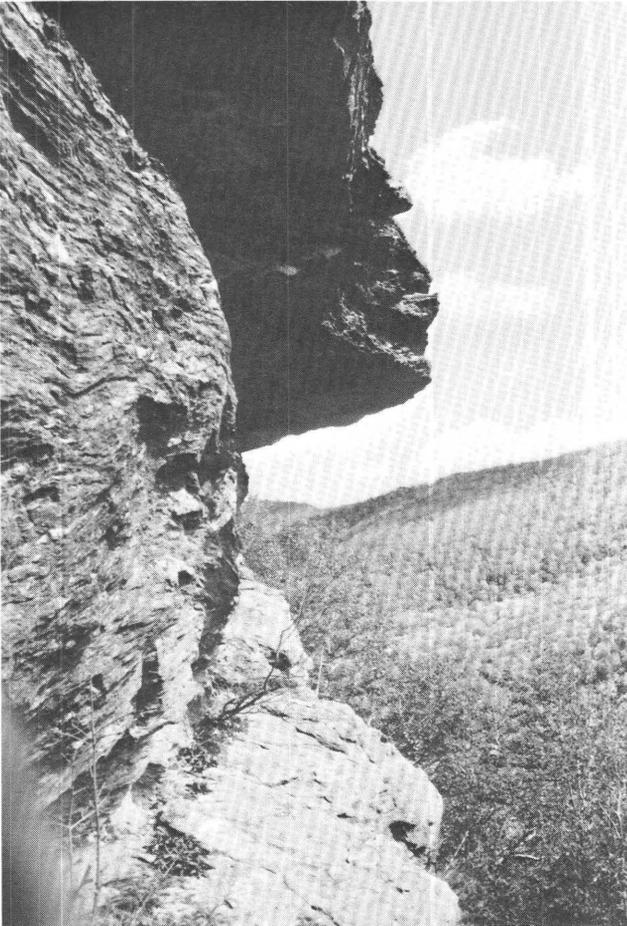
Figure 5. “Old Man of the Mountain,” Smugglers Notch, one of the numerous fanciful profiles visible in the notch, produced by physical and chemical weathering of the jointed and unevenly foliated metamorphic rocks.

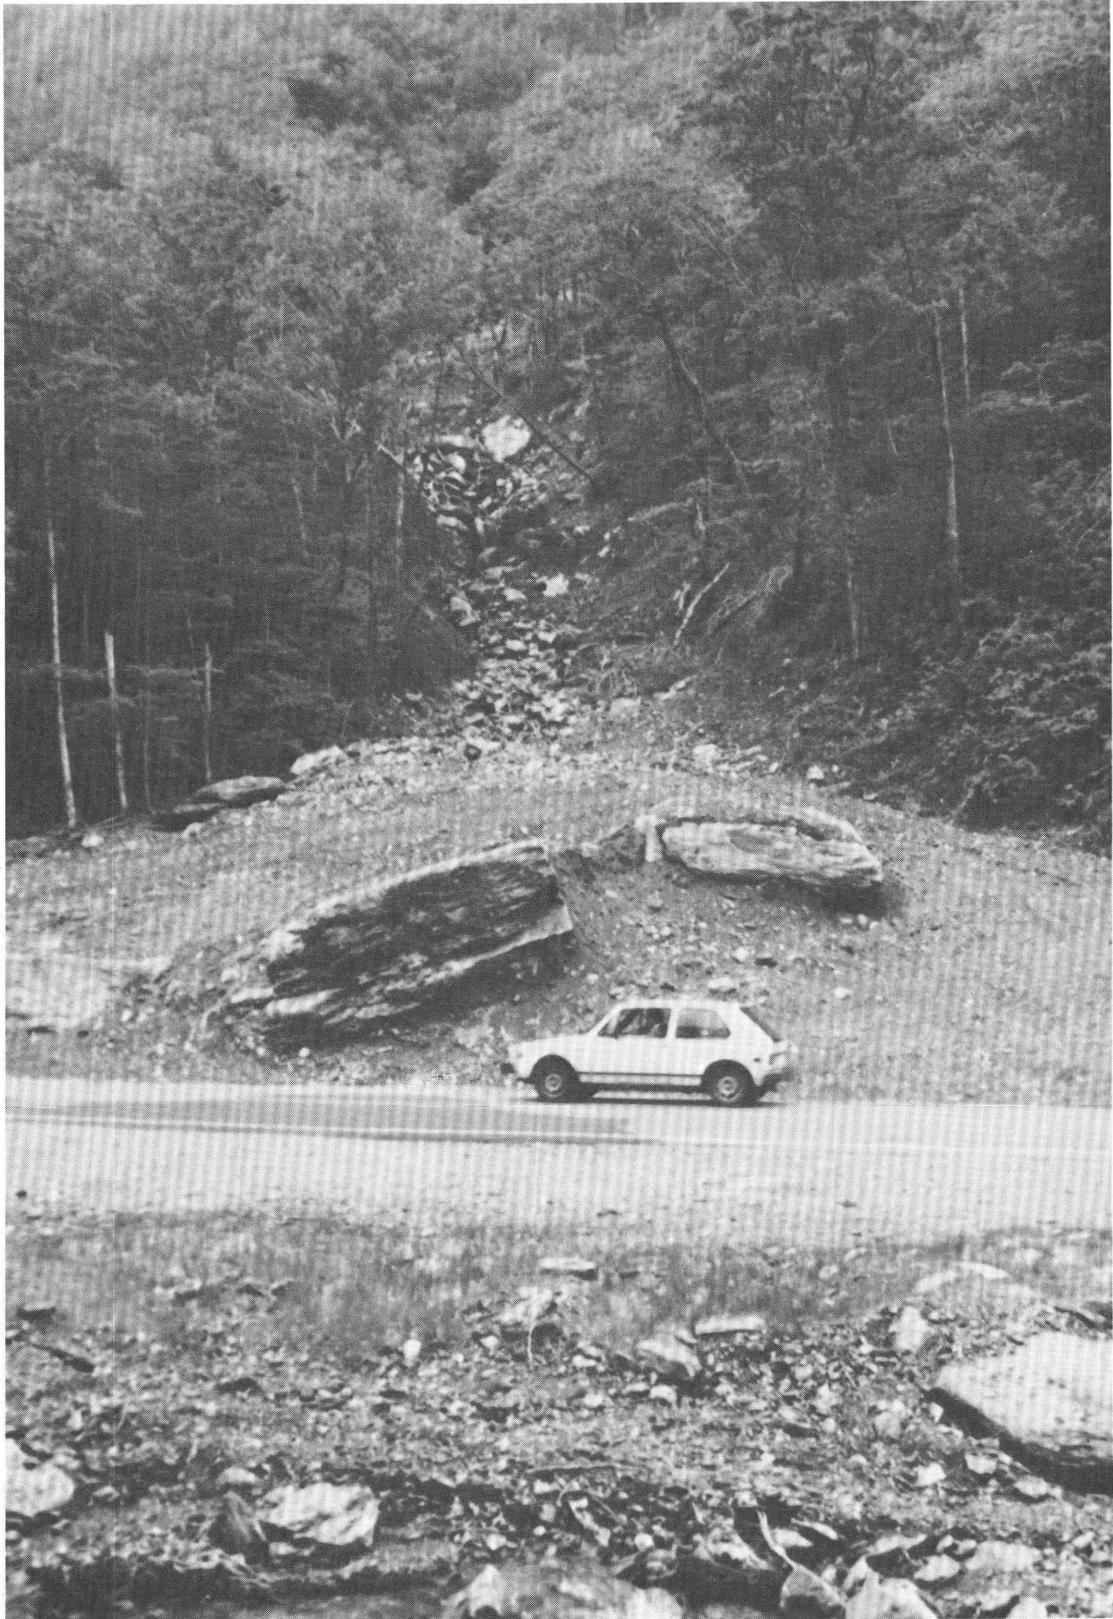
Figure 6. Lower part of rockfall-debris avalanche that occurred on May 22, 1986, Smugglers Notch. This slope failure, which occurred in an old chute, originated as a rockfall in the southeast wall approximately 320 m above road level. The mass incorporated increasing amounts of soil, loose rock, and trees as it moved to flatter slopes, finally crossing Vermont Route 108 and the West Branch Little River in the foreground.

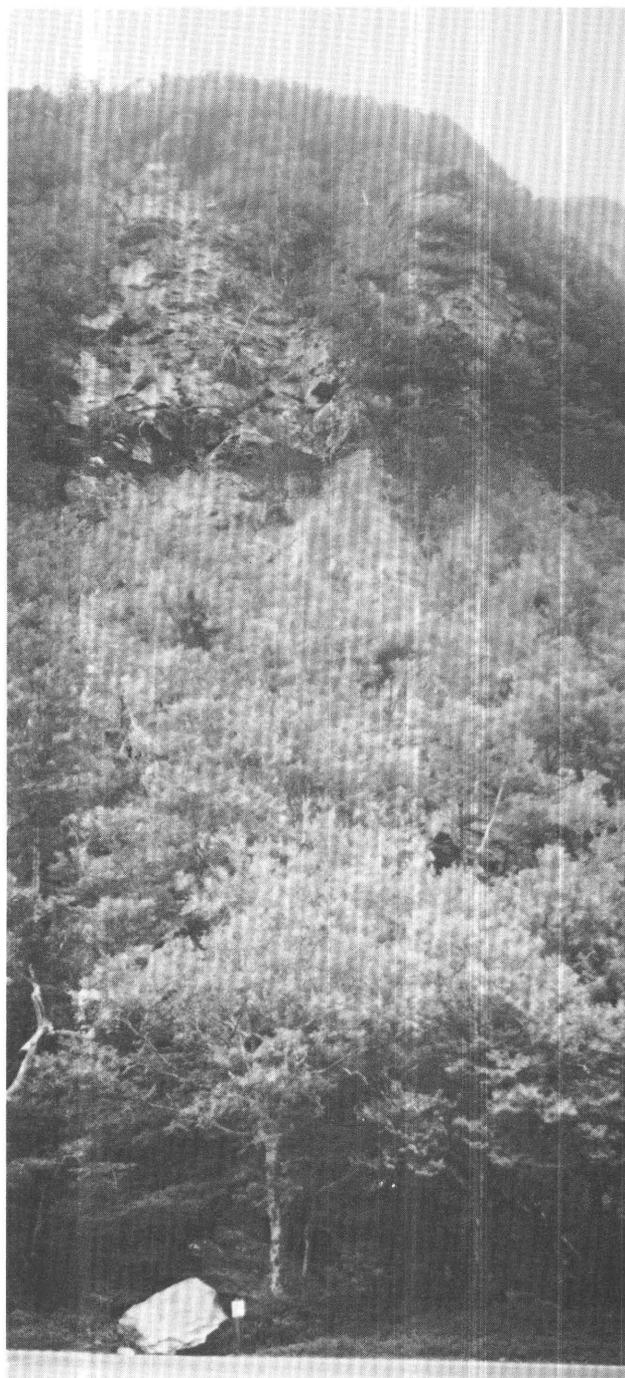
Figure 7. Rockfall that occurred on July 4, 1989, near Elephants Head on the east wall of Smugglers Notch. Trees slowed the velocity of the blocks and distributed them along several paths, although several reached the highway. Photograph by C.A. Ratté.

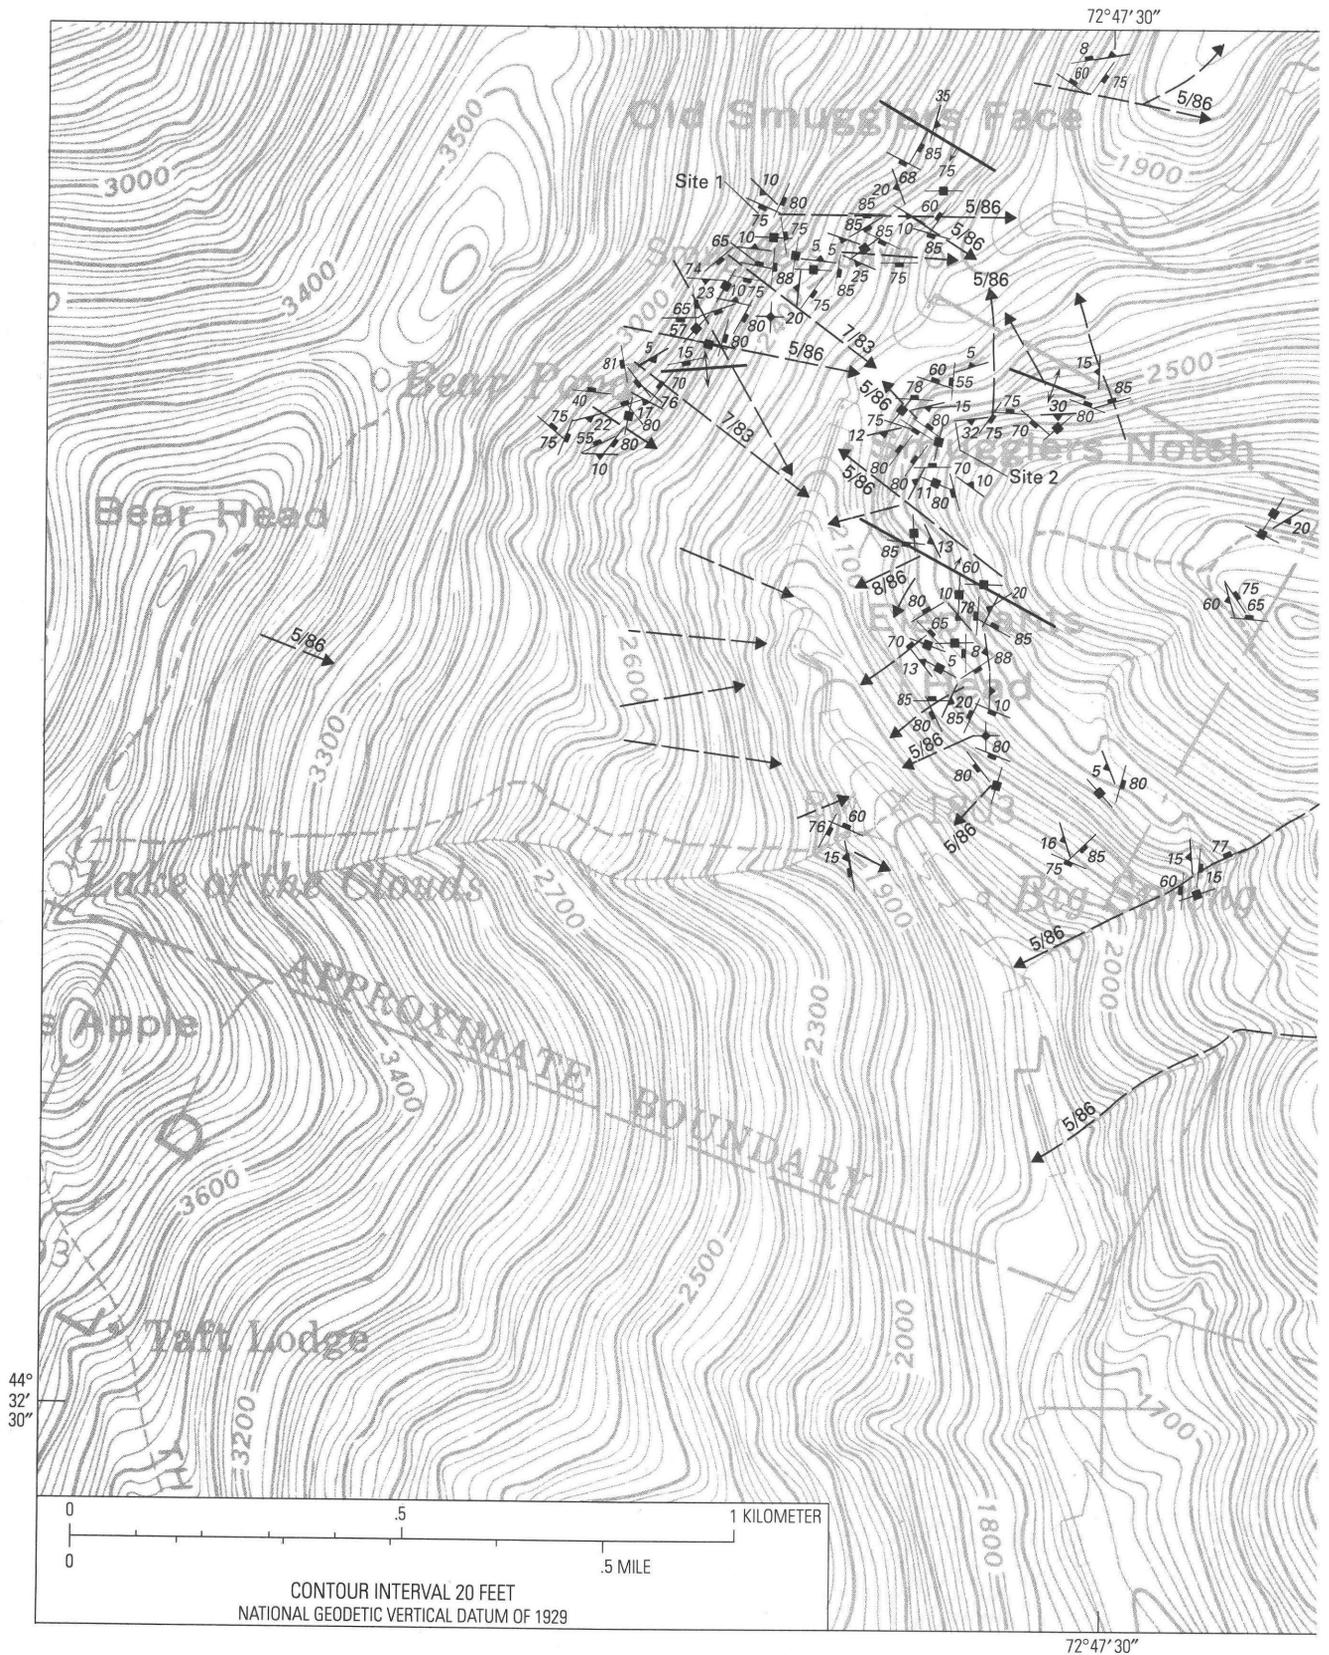
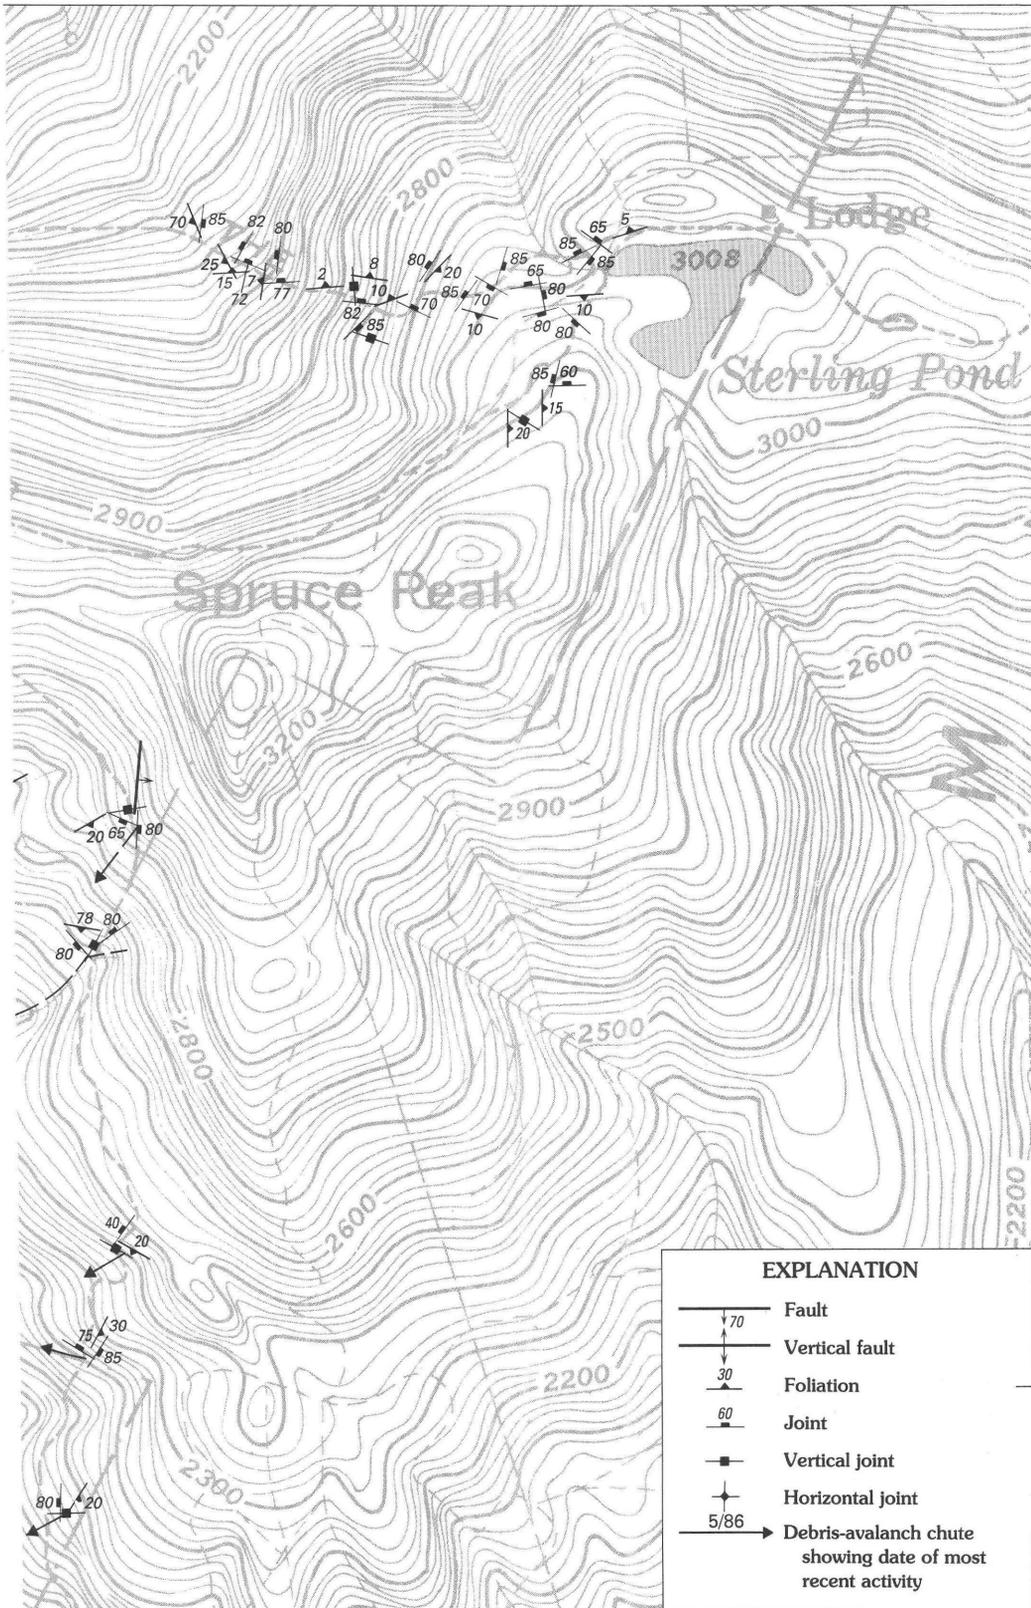
Figure 8 (above and facing page). Map showing major debris-avalanche chutes, joints, faults, and foliation mapped in the study area, Smugglers Notch, Vermont. Slope failures typically originated as a rockfall of joint blocks at the head of a chute. The mass incorporated smaller and smaller fragments of material as it moved downslope. Base from U.S. Geological Survey, Mount Mansfield, 1:24,000.

Aerial photographs show three well-developed lineament sets in the area. The most extensive of these sets strikes N. 70° W. and extends across and beyond both valley walls. A second lineament set is best developed on the west wall and strikes N. 30° E. The third set strikes north-south, is visible in the east valley wall, and extends north and south of the study area. Figure 9 is a 1974 aerial photograph of the Smugglers Notch area in which the three sets of lineaments are visible. These features were studied in the field and found to be related to mapped geologic structures. The high-angle faults and joints discussed below are represented by the N. 70° W. lineaments, and foliation and a strong joint set correspond to the N. 30° E. lineaments. Although the third set of lineaments is not as well defined as the other two, it may represent the high-angle north-striking joints mapped near Spruce Peak (fig. 8).

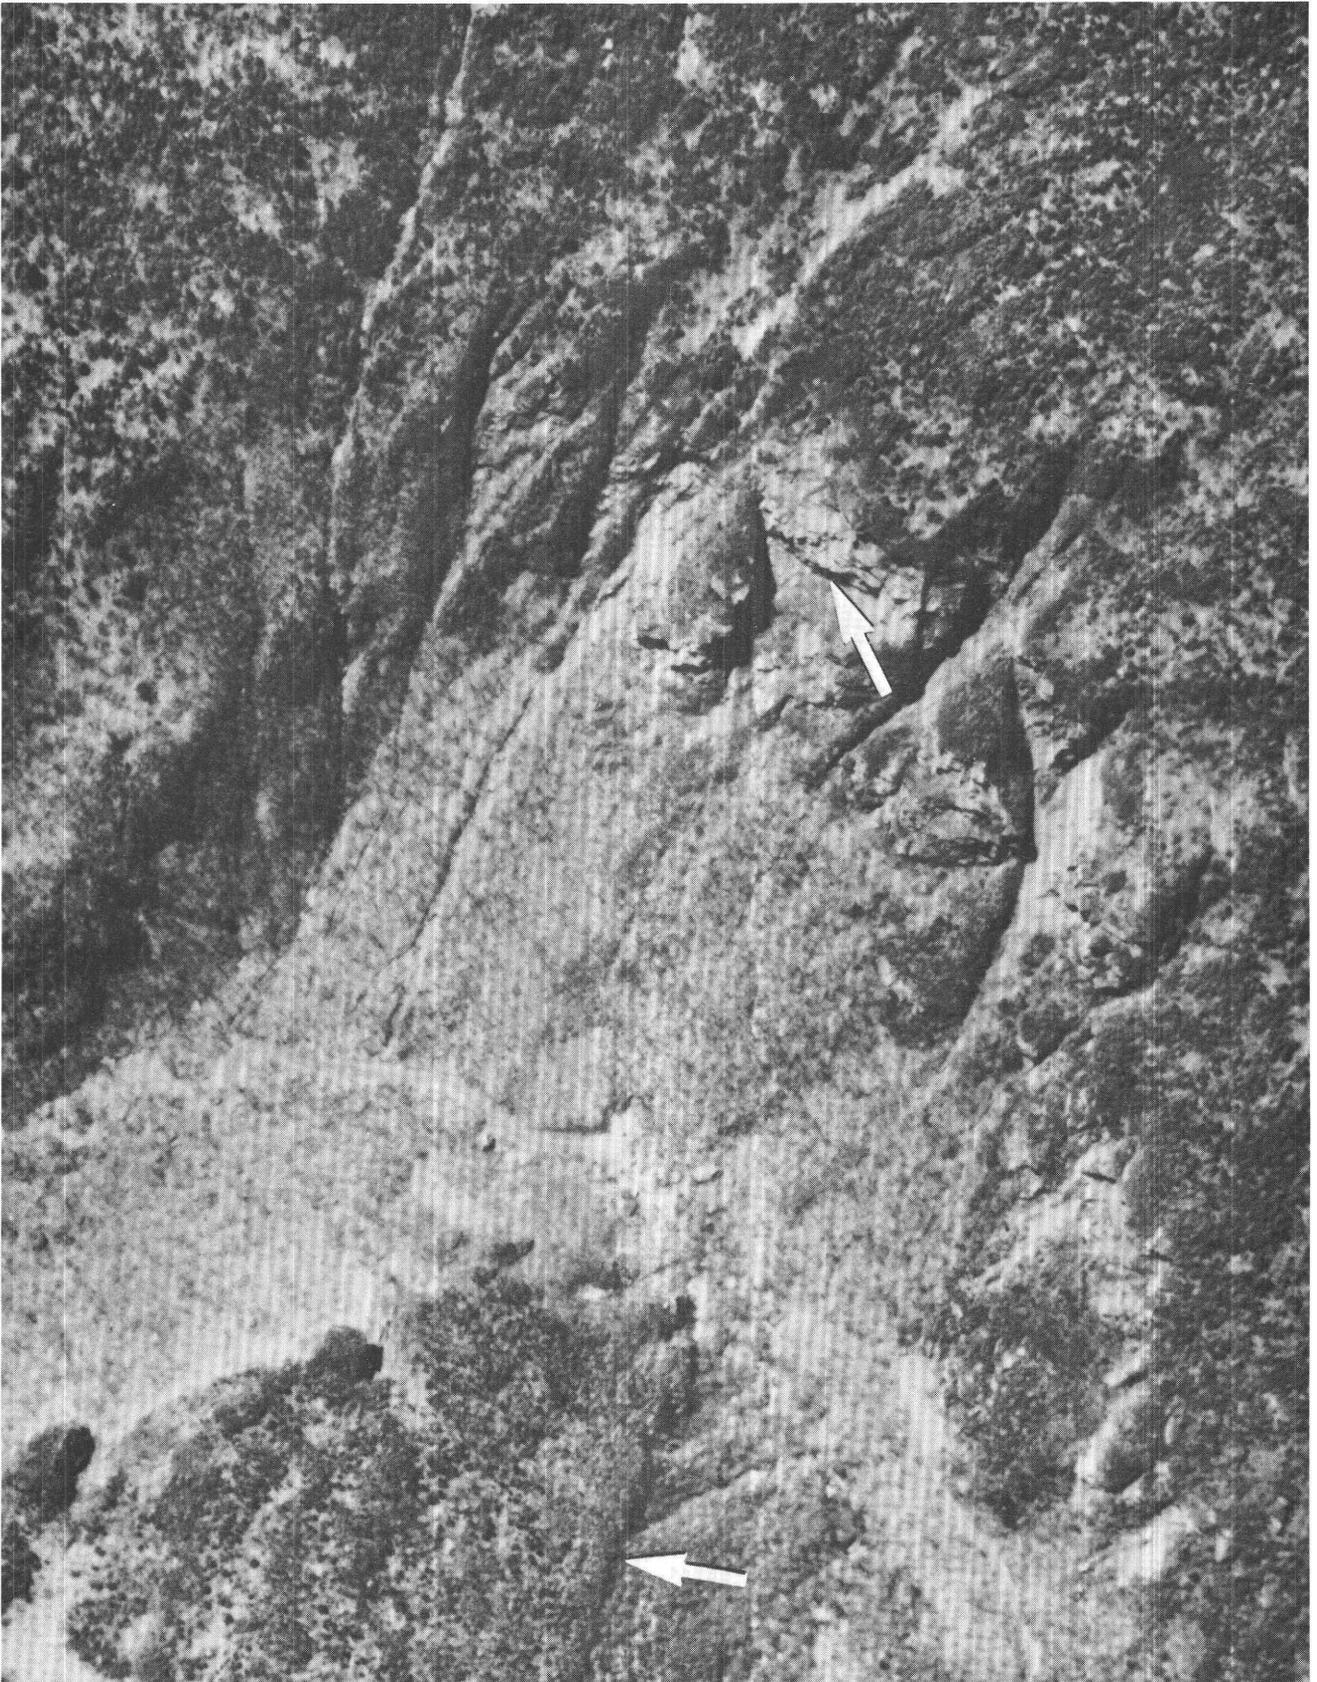
Figure 9. Section of aerial photograph, taken in May 1974, enlarged to show several prominent lineaments (arrows) in the Smugglers Notch area.

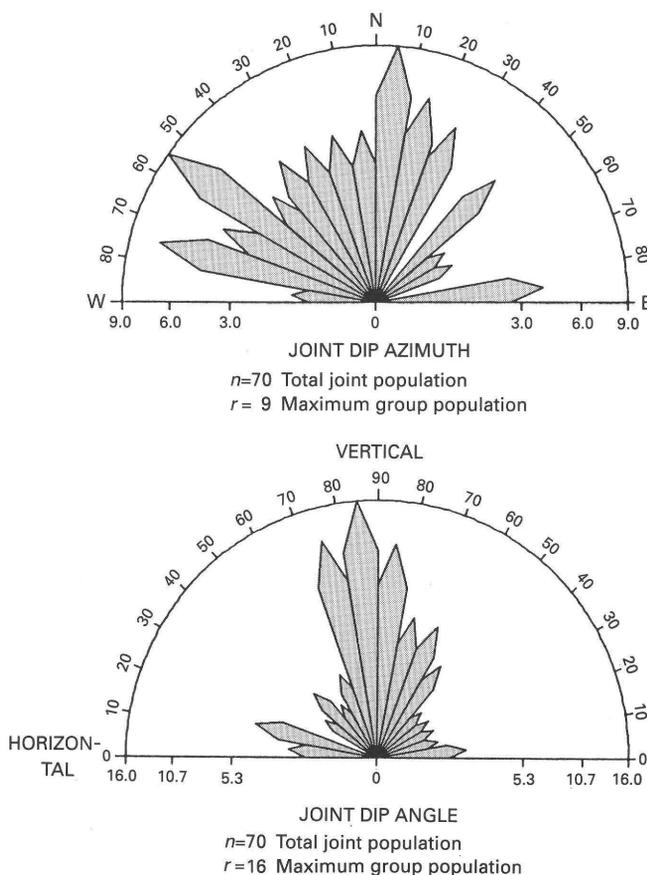
Figures 10 and 11 are azimuthal (strike) and dip-angle diagrams for joints recorded on the opposite walls of Smugglers Notch. They show that the joints exposed in both walls have similar attitudes, with strike maxima of N. 55° W. and N. 5°–25° E. Dip angles are primarily vertical with secondary low or horizontal angles, reflecting the dominant rectangular joint structure. Near ridge tops, open northeasterly trending joints are parallel to and behind the free face. Most of these joints were observed on the west wall; their presence on the east wall was concealed by heavy vegetation.

Figure 10. Azimuthal and dip-angle diagrams for joints on the northwest valley wall at Smugglers Notch.

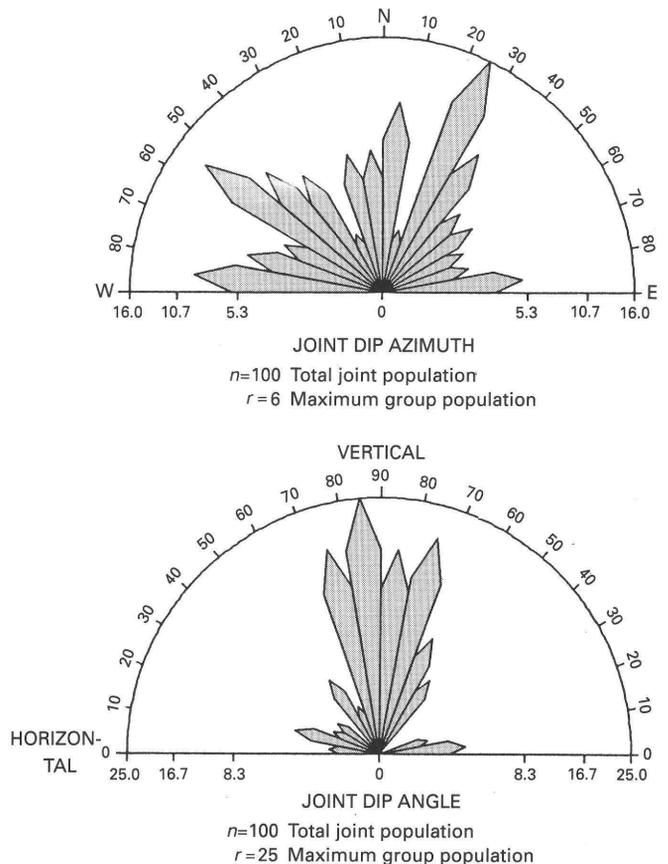
Figure 11. Azimuthal and dip-angle diagrams for joints on the southeast valley wall at Smugglers Notch.

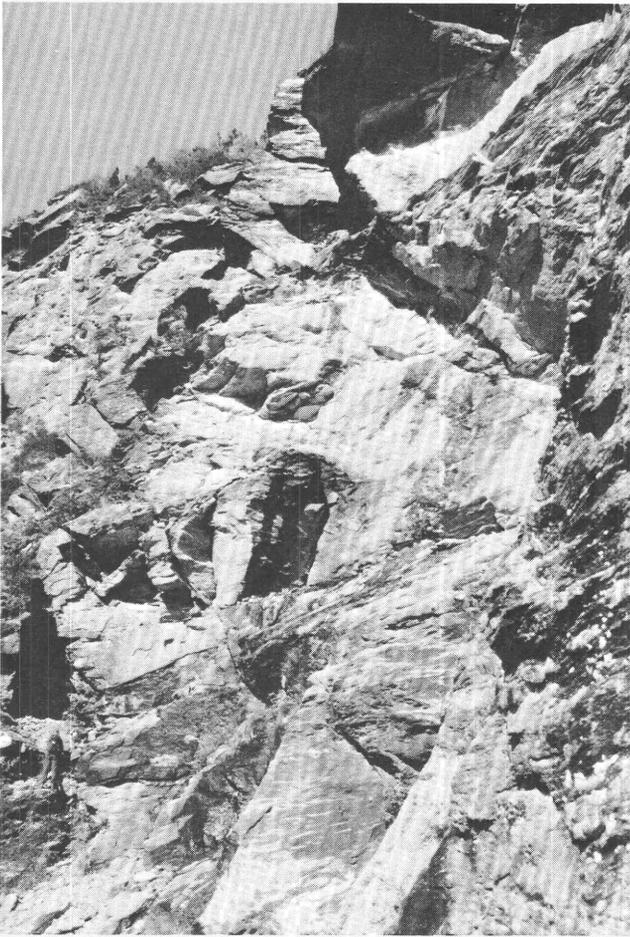
All rock exposures that we observed were foliated, and, because these surfaces are typically well bonded, the rock is generally massive (fig. 12). Weakly bonded surfaces may separate and form blocks by virtue of their intersection with joints. Figures 13 and 14 are azimuthal and dip-angle diagrams showing the major foliation attitudes in Smugglers Notch. On both walls of the notch, dip angles are low. Foliation strike maxima are N. 15° E. and N. 85° W. on the west wall and N. 15° W. and N. 85° W. on the east wall.

Figure 12. Well-bonded foliation in schist at Smugglers Notch.

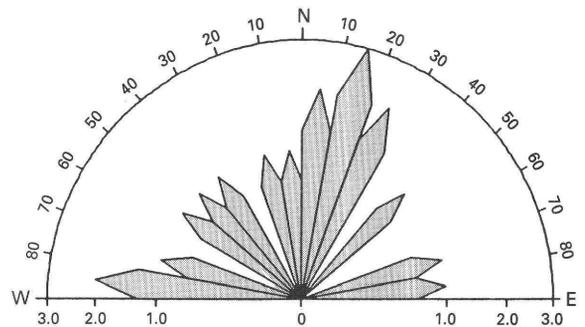
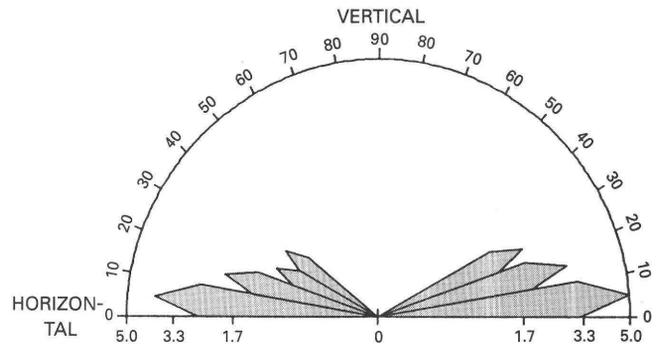
Figure 13. Azimuthal and dip-angle diagrams for foliation on the northwest valley wall at Smugglers Notch.

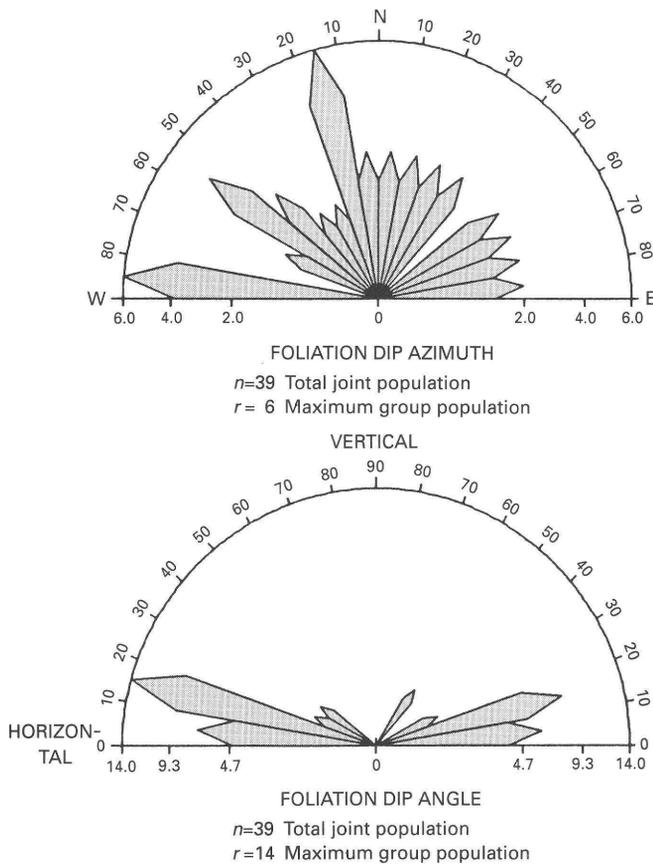
Figure 14. Azimuthal and dip-angle diagrams for foliation on the southeast valley wall at Smugglers Notch.

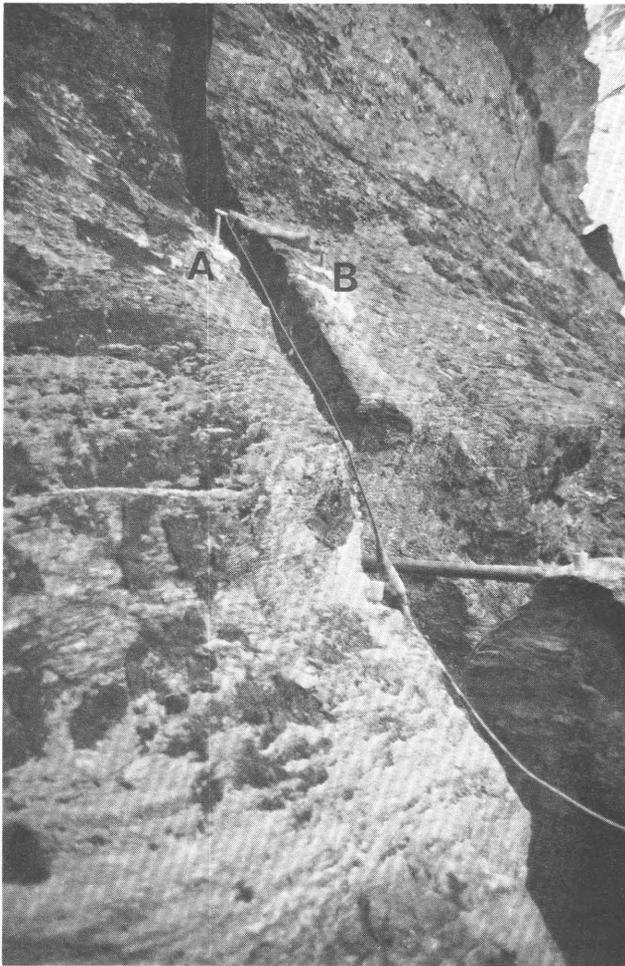
Figure 15. Photograph showing jointmeter installation. Anchors are shown at A and B.

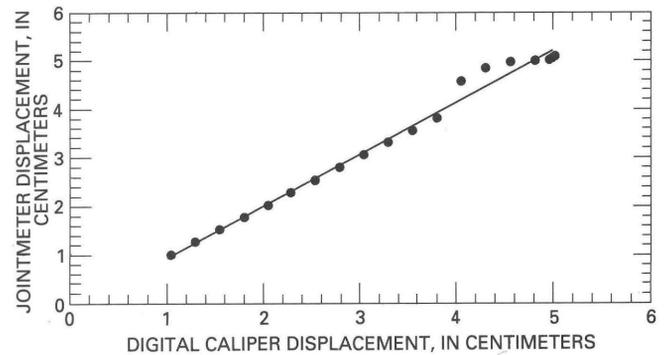
Figure 16 shows a typical calibration curve that compares jointmeter measurement precision with a digital caliper (resolution 0.013 mm) at a constant temperature of 25°C. The excellent agreement is expressed by the correlation coefficient of 0.9999, which indicates a precision of approximately twice that claimed by the manufacturer (Geokon, written commun., 1988). Temperature changes have no measurable effect on the indicated displacement of an unattached jointmeter, as shown in the graph in figure 17. Our concern here was that, if gage materials were dissimilar, there could have been differential and unequal expansion of components.

Figure 16. Typical calibration curve comparing jointmeter and digital caliper precision; this curve yields a correlation coefficient of 0.9999.

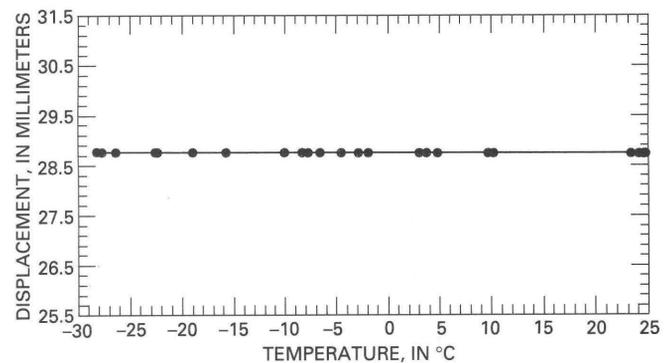
Figure 17. Graph showing results of temperature-change test of jointmeter. The instrument was placed unattached on block of styrofoam in freezer. As is indicated, temperature had no effect on displacement measured by the jointmeter.

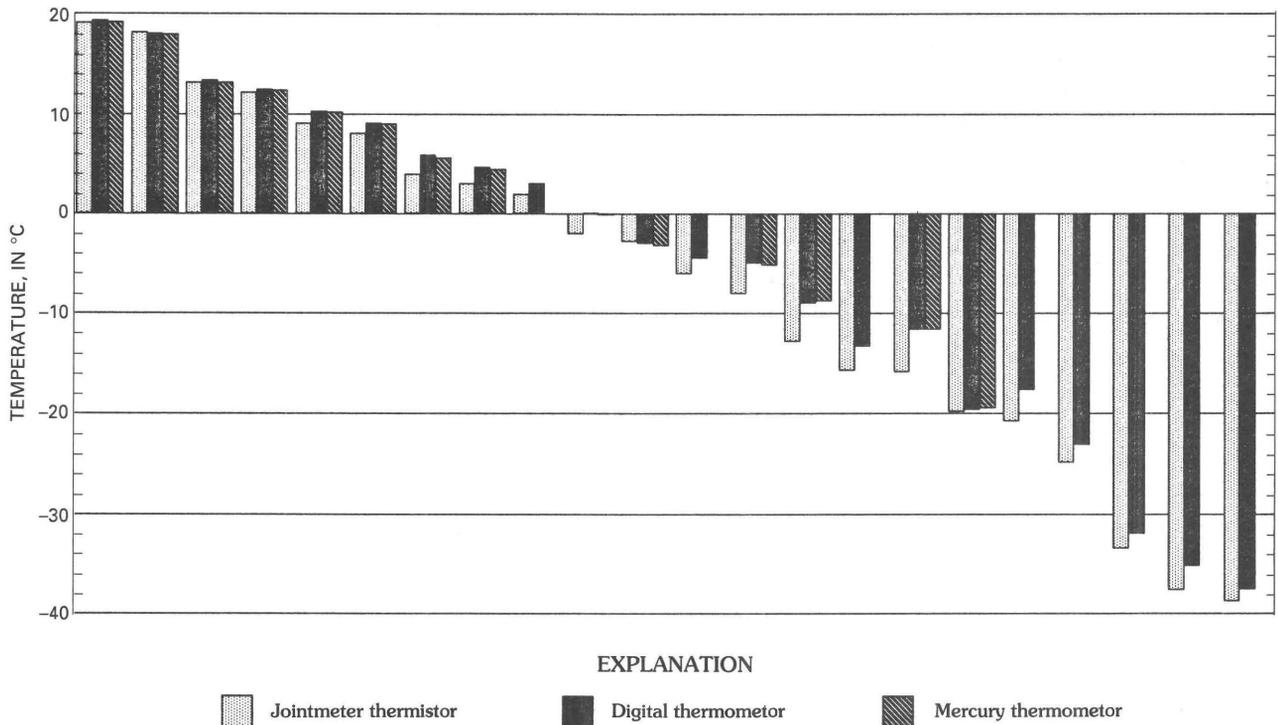
Figure 18. Temperature-response curve of jointmeter thermistor over range of -38°C to 19°C .

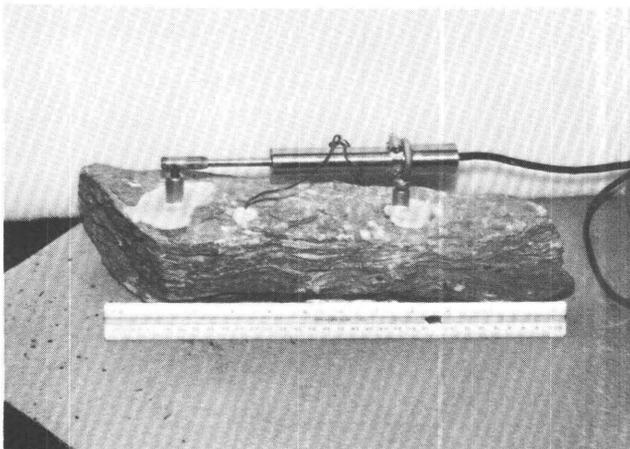
Figure 19. Block of schist from Smugglers Notch used for testing reaction of jointmeter to temperature-induced expansion.

In addition to calibrating jointmeters and thermistors, we monitored in the laboratory the freeze-thaw behavior of a block of schist from the field site. Because the jointmeters span joint openings in the field, we tested an instrumented solid rock block parallel to foliation in the laboratory to differentiate the expansion and contraction of the solid rock from changes in joint openings. The test block is shown in figure 19. The jointmeter was set at midrange and mounted so that it moved freely with thermal expansion and contraction of the block. A thermocouple was cemented in a shallow drilled hole in the top surface. The block was placed in a freezer and subjected to temperatures ranging from -27.6°C to 24.0°C in slowly changing increments so that the entire block equilibrated to each increment of temperature change. The test duration was 13 hrs.

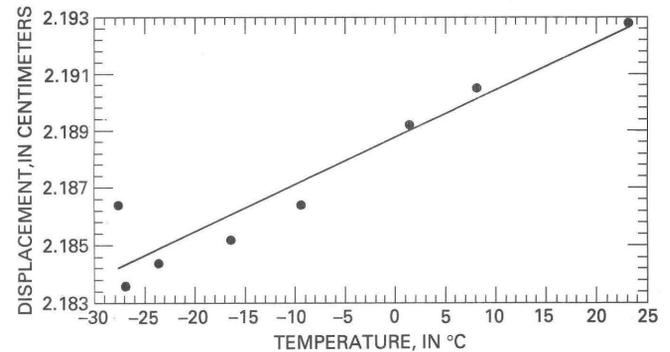
Figure 20. Temperature-change test of block of schist from Smugglers Notch.

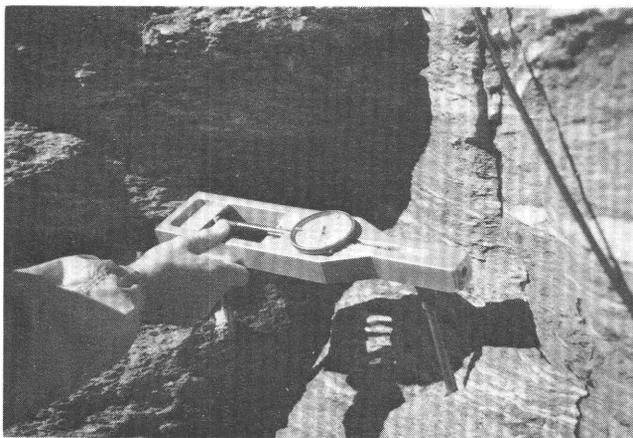
Figure 21. Dial-gage extensometer used for manually recording rock displacement caused by temperature-induced expansion. This instrument was calibrated between measurements with an Invar rod.

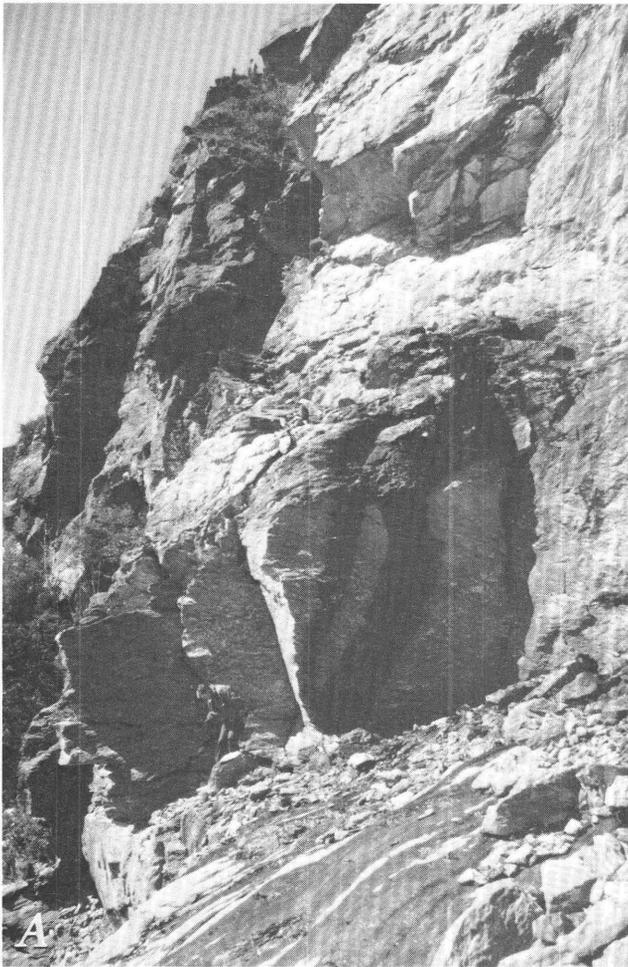
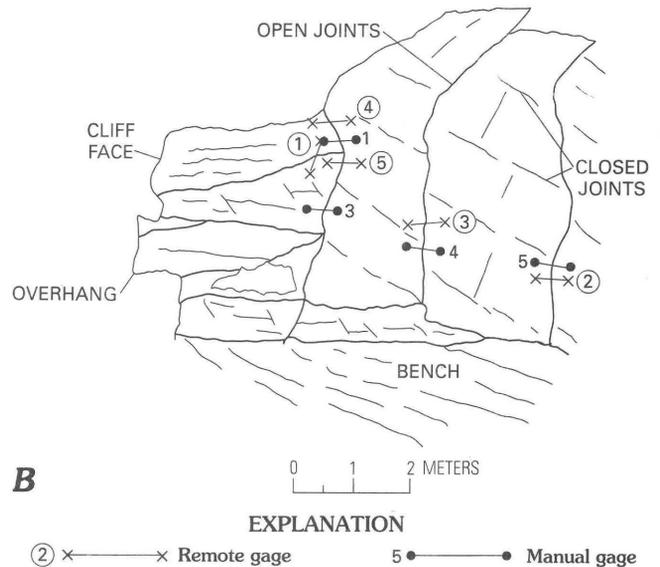
Figure 22 (above and facing column). Site 1, Smugglers Notch. Location of site 1 is shown in figure 8. *A*, Photograph of site after a summer rain. View is to southwest. Water is draining from the vertical fractures to subhorizontal fracture surfaces at base of cliff. *B*, Sketch of vertical section of cliff (in center of photograph shown in *A*) showing major blocks and gage locations. Numbers correspond to gage numbers in table 1. Manual gage 2 is not shown because no readings were obtained.

Site 1 is on the northwest (east-facing) slope of Smugglers Notch at an altitude of approximately 900 m in a zone

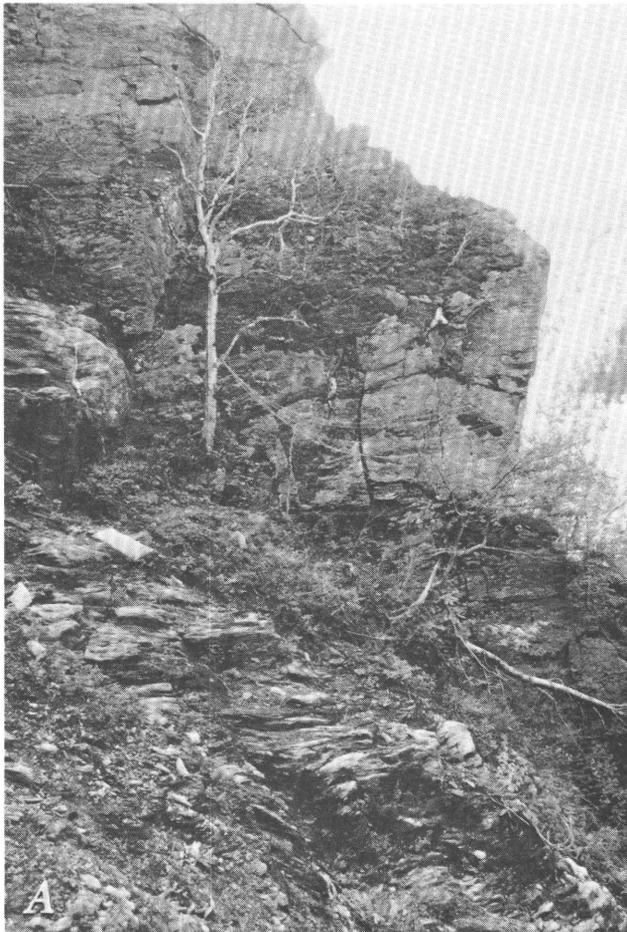
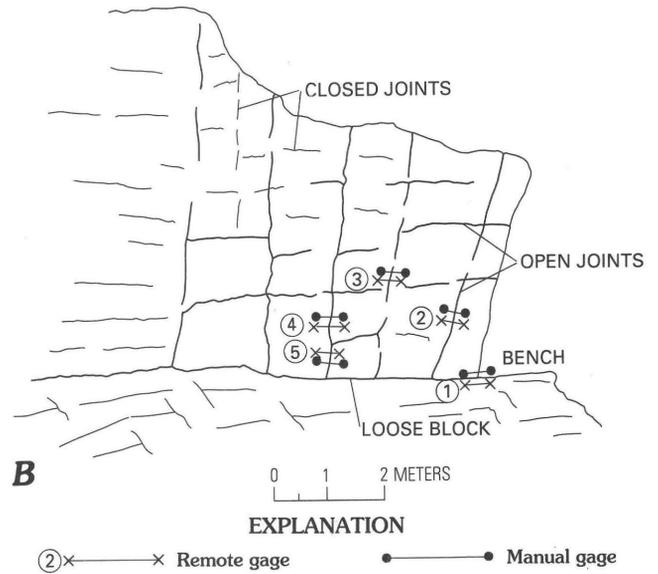
Figure 23 (above and facing column). Site 2, Smugglers Notch. Location of site 2 is shown in figure 8. *A*, Photograph of site. The cliff faces north-northwest and receives no direct sunlight for most of the year. *B*, Sketch of vertical section of cliff showing major blocks and gage locations. Numbers correspond to gage numbers in table 1. Gage 1 is mounted on horizontal bench. Manual and remote numbers are same. View is to southwest.

Site 2 is on the east (west-facing) slope of Smugglers Notch at an altitude of approximately 740 m (fig. 8). The cliff is vertical to overhanging and is somewhat steeper than at site 1. Block movement and cliff breakup are less rapid, based on the more weathered condition of rock surfaces and the absence of recently fallen rock blocks. The rock is a greenish-gray, medium- to fine-grained schist containing numerous 0.1- to 5-cm-thick quartz lenses parallel to the schistosity. The schistosity surfaces are strongly bonded, similar to those at site 1, and form widely spaced benches on the cliff front. Joints are spaced from 1 to 6 m and average approximately 2 m. Principal joints are oriented N. 47° E., vertical (parallel to the valley wall); N. 45° W., vertical; and N. 70° W., horizontal to 20° SW. (parallel to foliation). At this site, we did not observe deep, open joints striking parallel to the ridge, and benches were somewhat flatter than at site 1. Joint opening due to toppling may not be a factor here; rather, our observations suggest that basal sliding is more likely. Figure 23A is a photograph of the cliff at site 2 showing the joint blocks that were

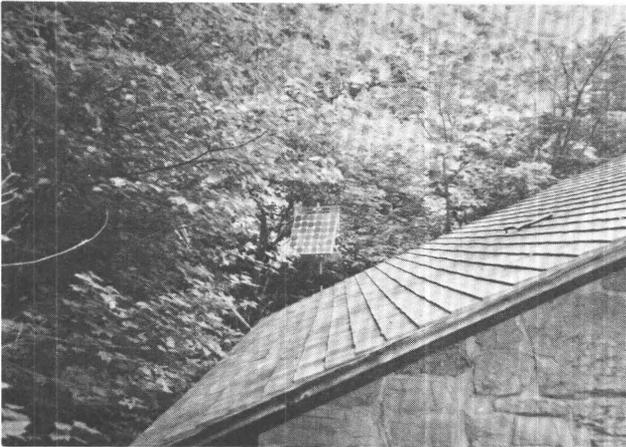
Figure 25. Solar panel and cable entry at monitoring site, Smugglers Notch. The panel faces south and receives sufficient sunlight to recharge recorder battery, even with leaves on trees.
