Rockfalls and Debris Avalanches in the Smugglers Notch Area, Vermont

U.S. GEOLOGICAL SURVEY BULLETIN 2075

**ROCKFALLS AND DEBRIS AVALANCHES IN THE
SMUGGLERS NOTCH AREA, VERMONT**

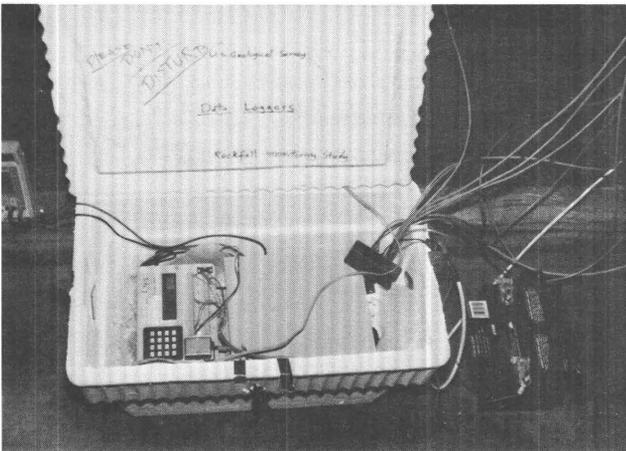
Figure 26. Data logger and batteries in building at Smugglers Notch.

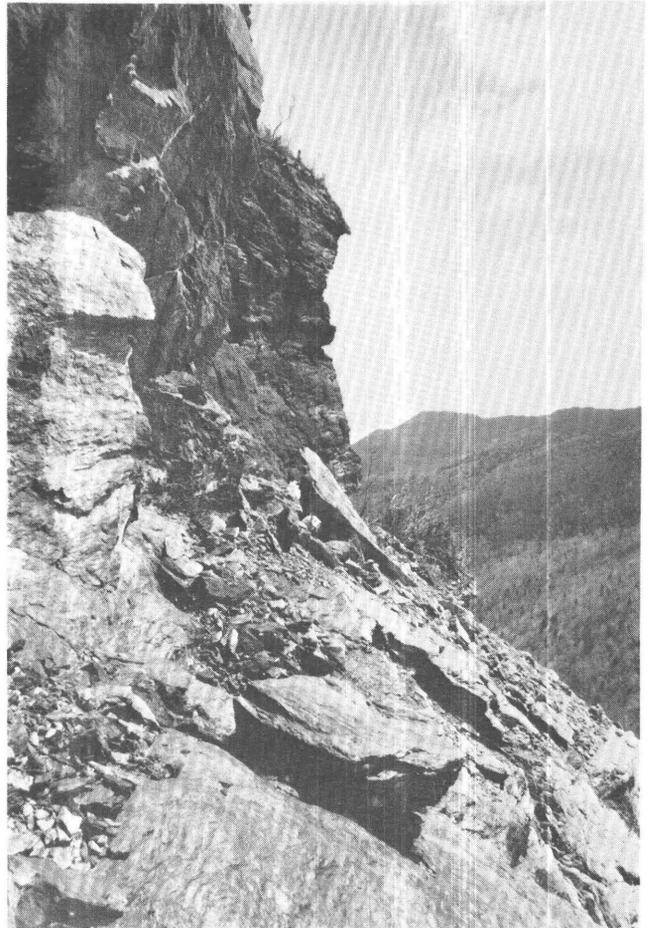
Figure 27. View to northeast of cliff at site 1, Smugglers Notch. The slabby blocks at this location are more stable than equidimensional blocks would be on such a steep slope.

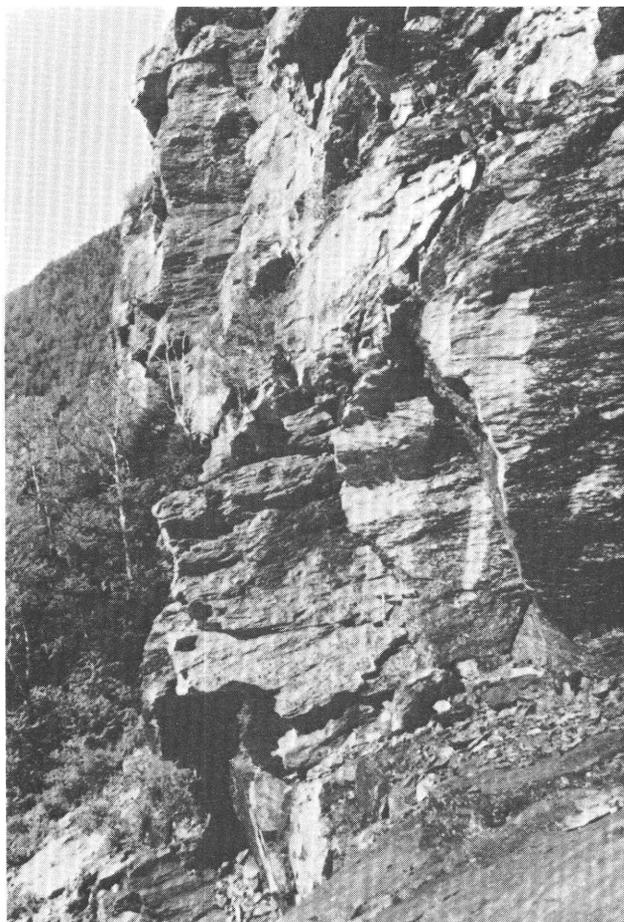
Figure 28. Rock blocks on bench at base of cliff at site 1, Smugglers Notch. The east-southeast-facing exposure produces greater temperature extremes than the northwest-facing exposure at site 2.

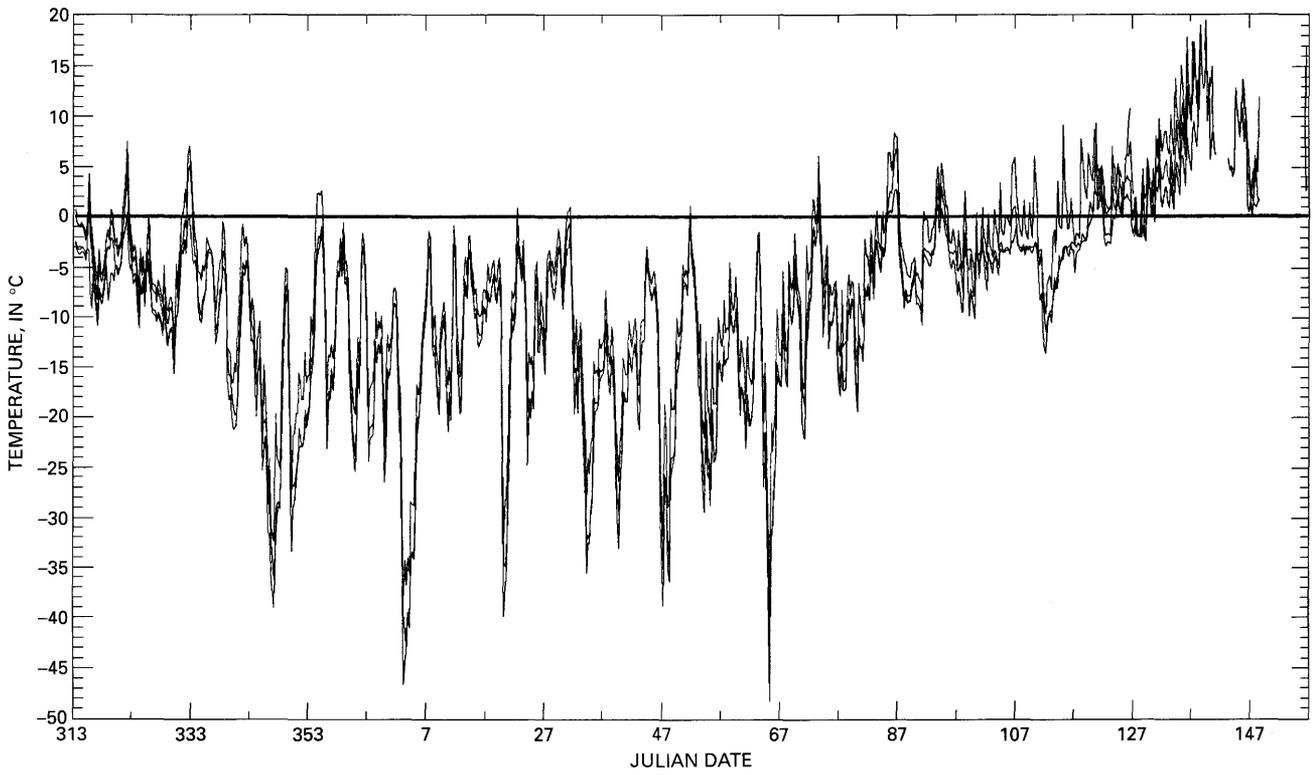
Figure 29. Temperature records for three monitoring points at site 1, Smugglers Notch.

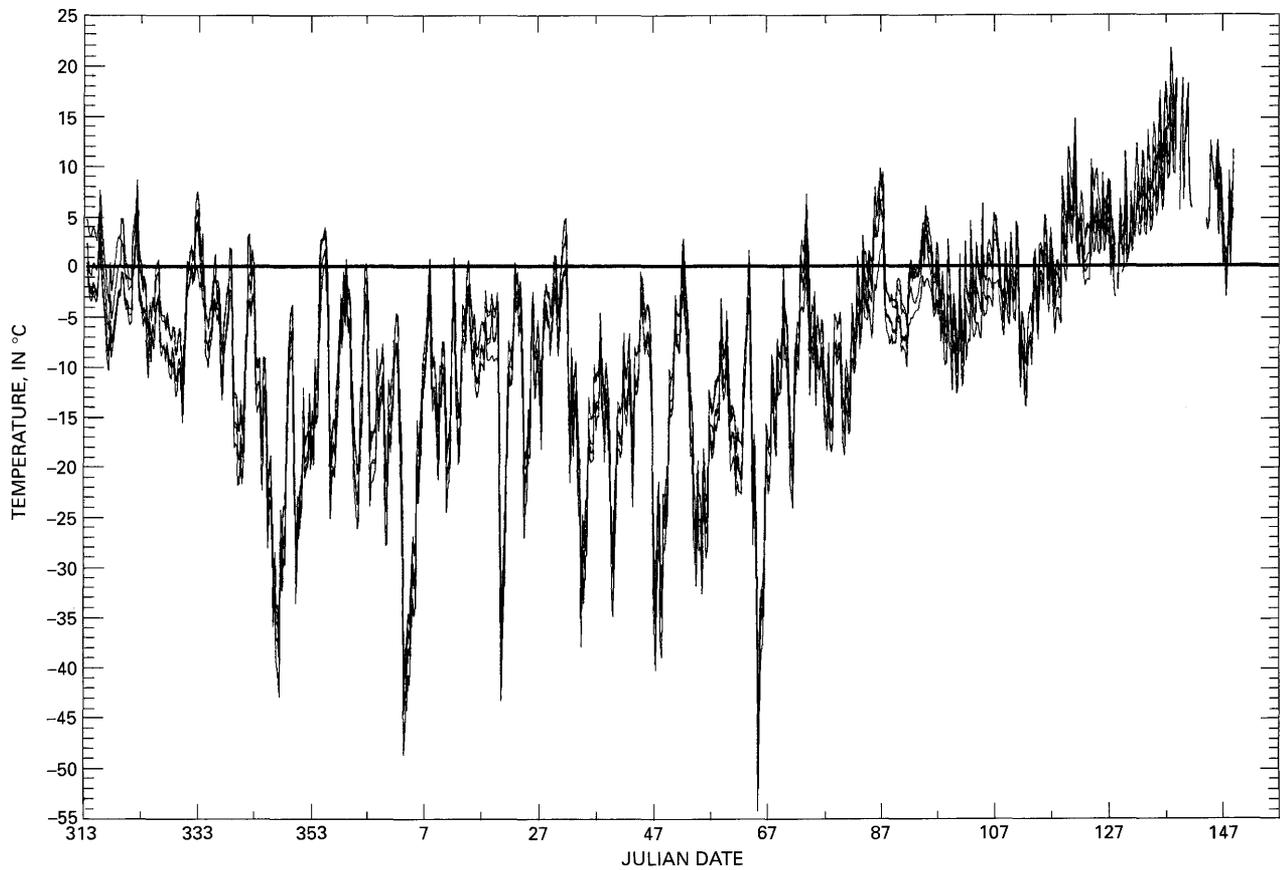
Figure 30. Temperature records for five monitoring points at site 2, Smugglers Notch.

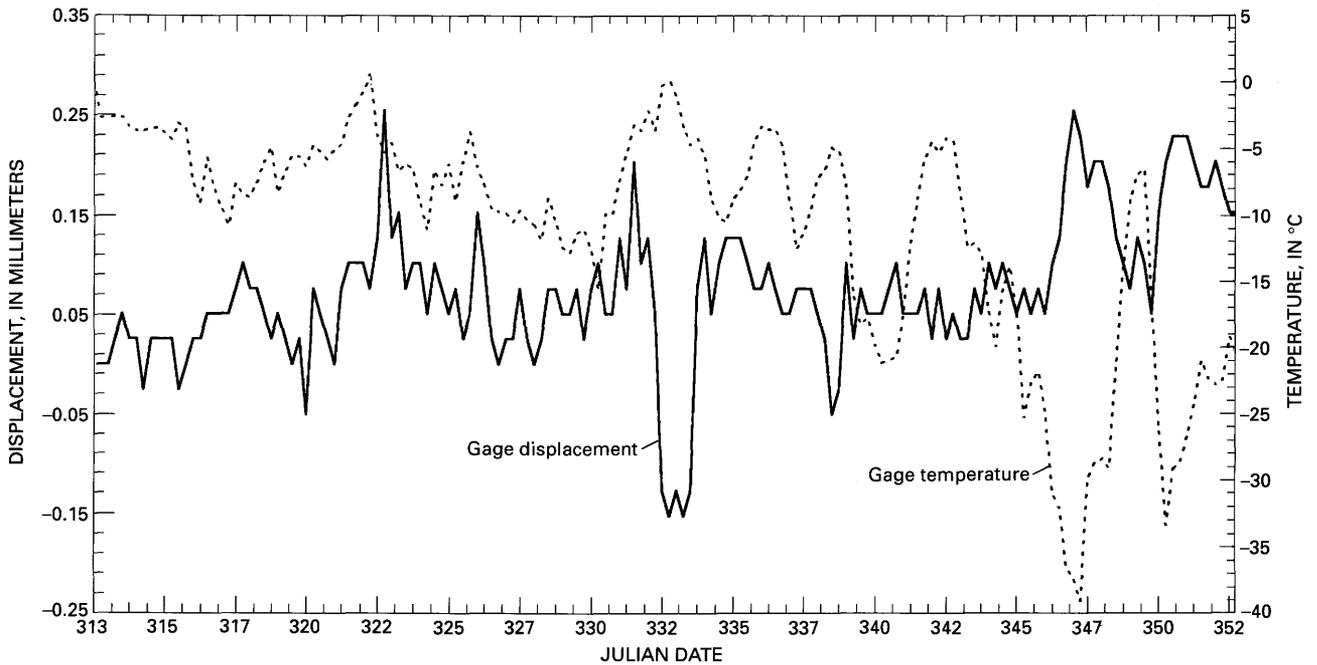
Figure 31. Plot of displacement and temperature versus time for gage 5 at site 1, Smugglers Notch, during the period November 8–December 16, 1988.

Figures 31 and 32 show typical examples of temperature-induced displacements of jointmeters at the two sites. Displacements are greatest in the late fall and early spring, as shown on later records. Displacements in the winter are smaller, probably impeded by ice buildup and almost constantly freezing temperatures. Most gages recorded a small net positive displacement over the monitored period (table 1). They have both daily and seasonal cyclicity and both elastic and permanent components. The permanent displacements were smaller than the elastic cyclic displacements. For example, gage 3 at site 1 had cyclic displacements of more than 2.5 mm but a net positive displacement of only 0.427 mm. Other gages had a net permanent displacement of from 0.102 to 1.605 mm. This compares with

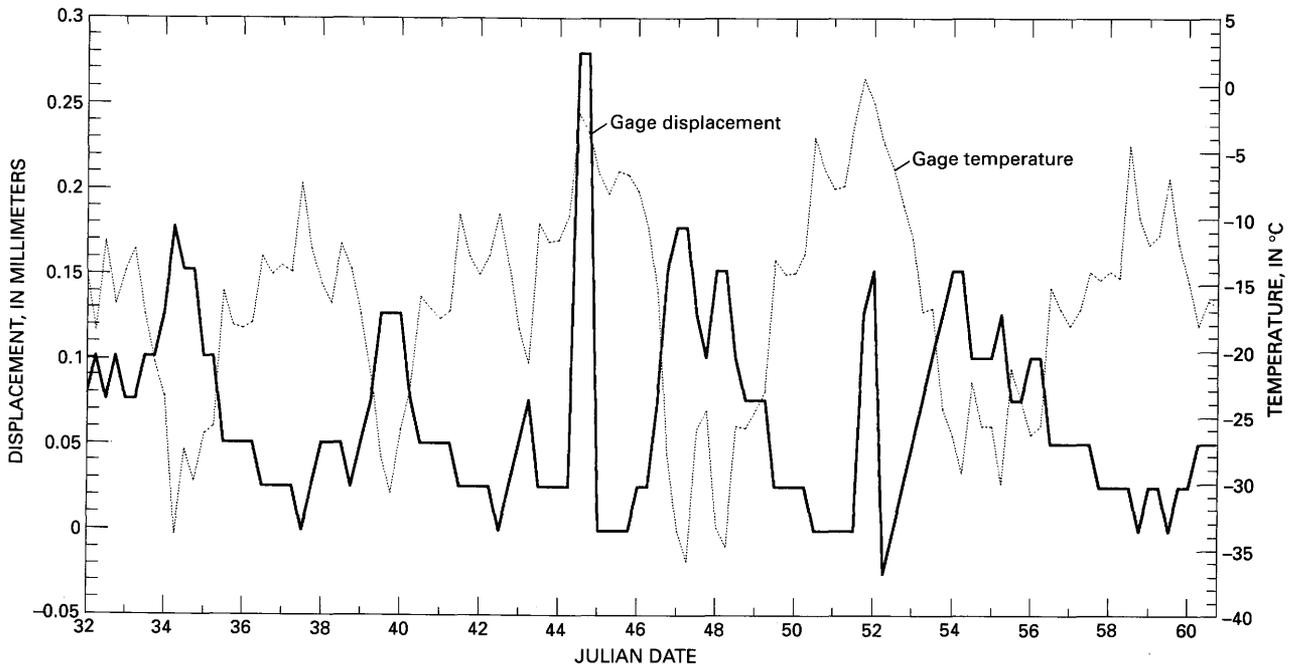
Figure 32. Plot of displacement and temperature versus time for gage 3 at site 2, Smugglers Notch, during the period February 1–28, 1989.

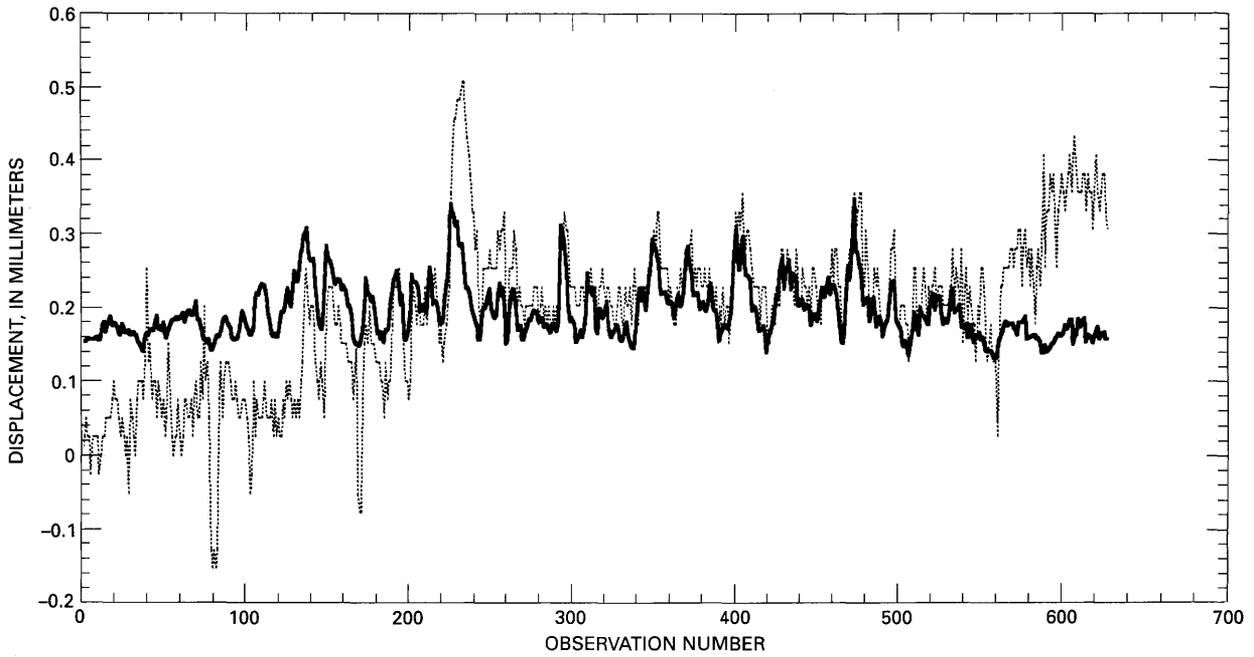
Figure 33. Graph showing observed displacement (dashed line) and predicted displacement as a function of temperature (solid line). $\text{Displacement} = f(\text{temp})$ (text equation 1). The gages listed in table 2 were used in this analysis. Observations cover the period November 8, 1988, through May 3, 1989. One observation interval is 6 hr.

The predictions shown in figures 33, 34, and 35 were generated using a least-squares estimate of the parameters in equations 1, 2, and 3. These parameters were then

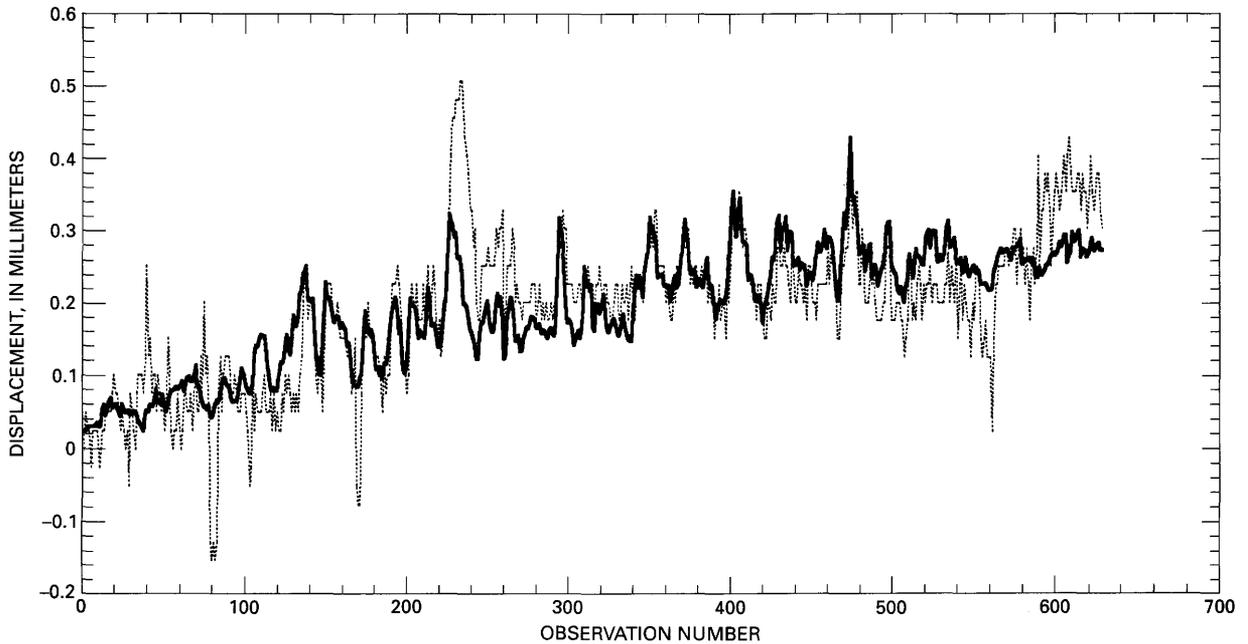
Figure 34. Graph showing observed displacement (dashed line) and predicted displacement as a function of temperature and time (solid line). $\text{Displacement} = f(\text{temp}, \text{time})$ (text equation 2). The gages listed in table 2 were used in this analysis. Observations cover the period November 8, 1988, through May 3, 1989. One observation interval is 6 hr.

the predictions are based on a discrete, point-by-point linear relationship between temperature and rock displacement. The predicted displacements shown in figure 34 are based on a slightly more complex calculation. In addition to the effects of temperature (fig. 33), the predicted displacements shown in figure 34 include an estimate of rock

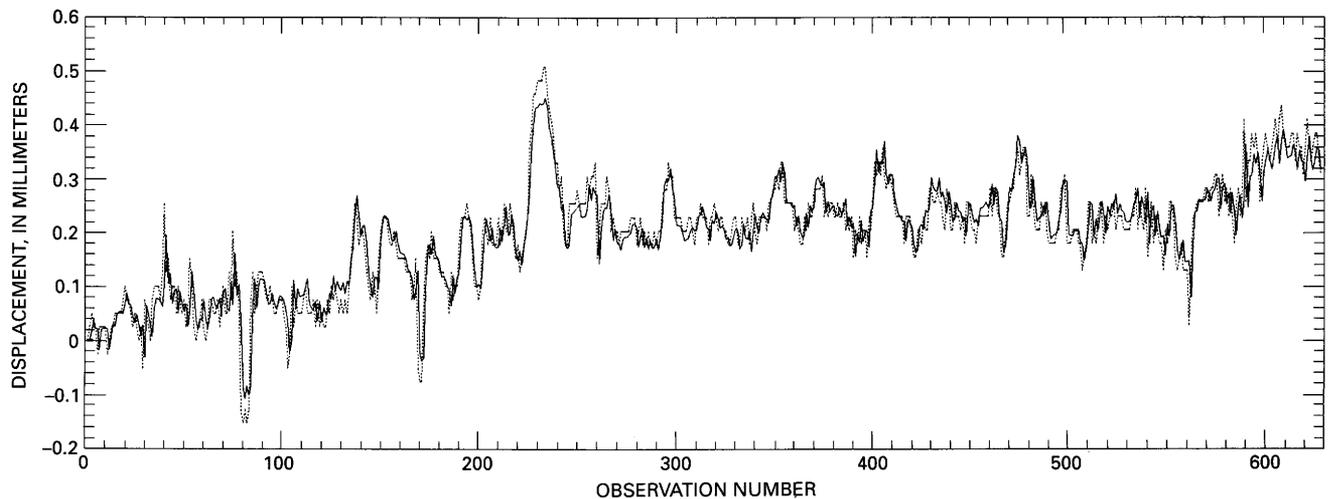
Figure 35. Graph showing observed displacement (dashed line) and predicted displacement as a function of temperature, time, and the previous value of displacement between time and temperature (solid line). Displacement= $f(\text{temp}, \text{time}, \text{displ}(t-1))$ (text equation 3). The gages listed in table 2 were used in this analysis. Observations cover the period November 8, 1988, through May 3, 1989. One observation interval is 6 hr.

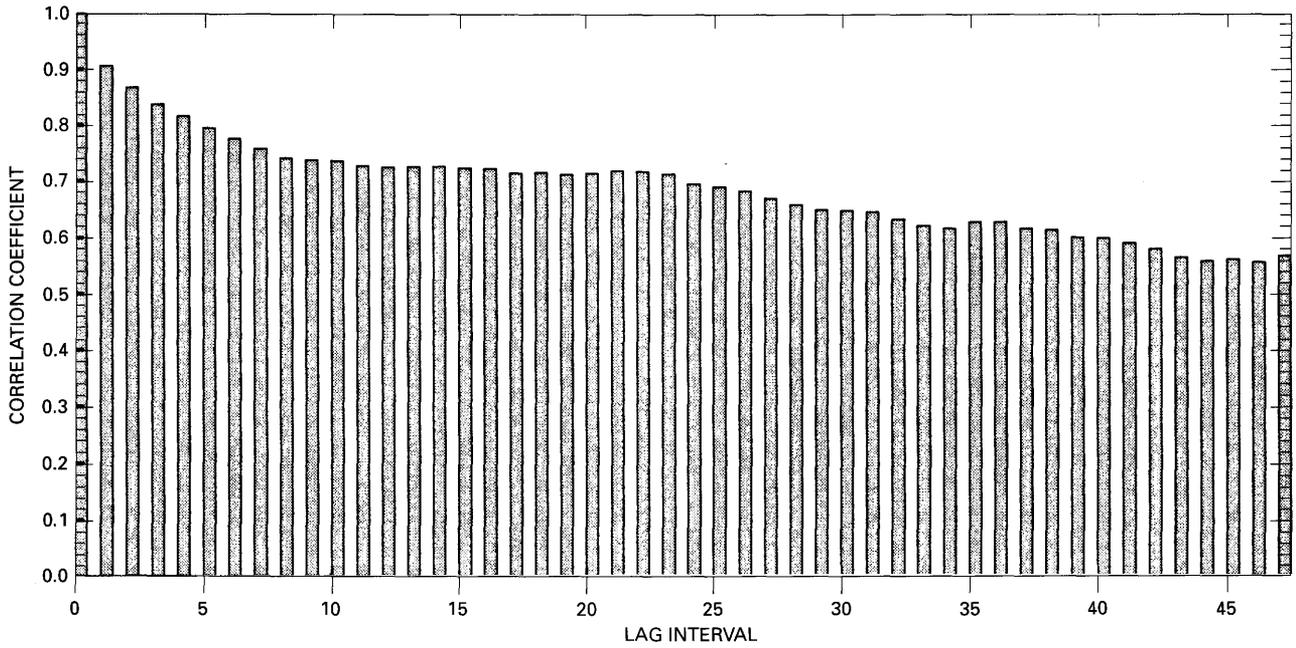
Figure 36. Graph of the 1st through 40th autocorrelations for the residuals of equation 2 for gage 5, site 1, Smugglers Notch. One lag interval (t)=6 hr.

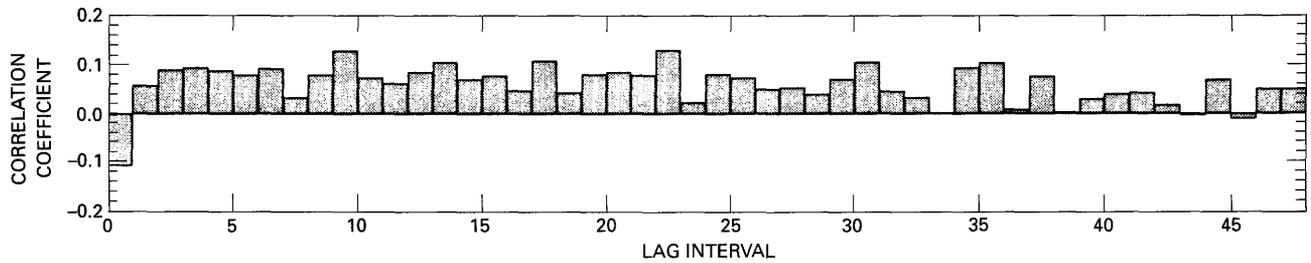
Figure 37. Graph of the 1st through 40th autocorrelations for the residuals of equation 3 for gage 5, site 1, Smugglers Notch. One lag interval (t)=6 hr.

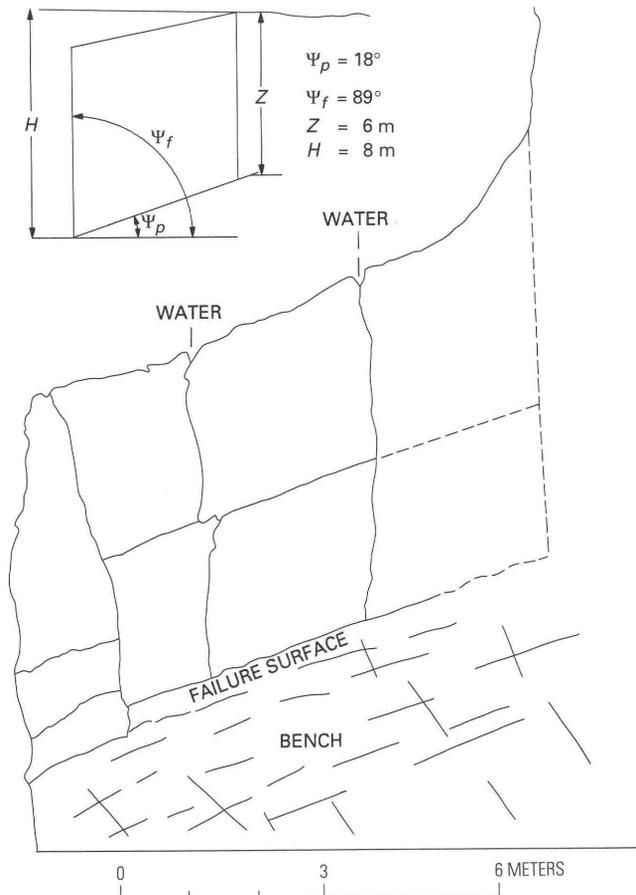
Figure 38. Sketch of cliff at site 1, Smugglers Notch, showing open vertical fractures and the parameters used for the stability analysis. This is a simplified representation of the blocks shown in figure 22. View is to the southwest.

P , Q , R , and S are dimensionless ratios that depend on the geometry, but not the size, of a slope and are taken from

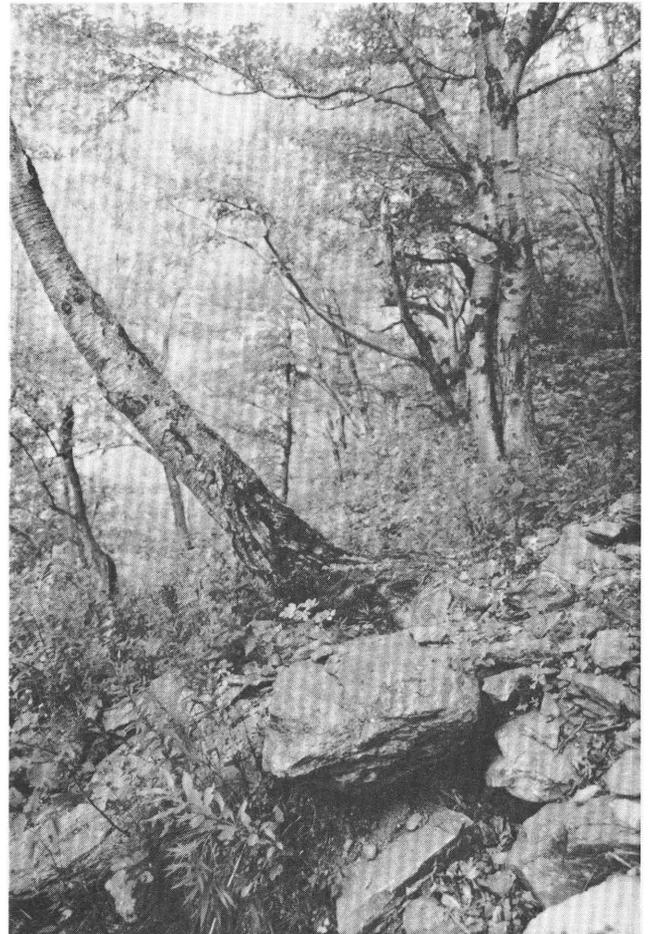
Figure 39. A chute that has been the site of many debris avalanches, Smugglers Notch. Rings in cores from these birch trees show several episodes of scarring and healing.

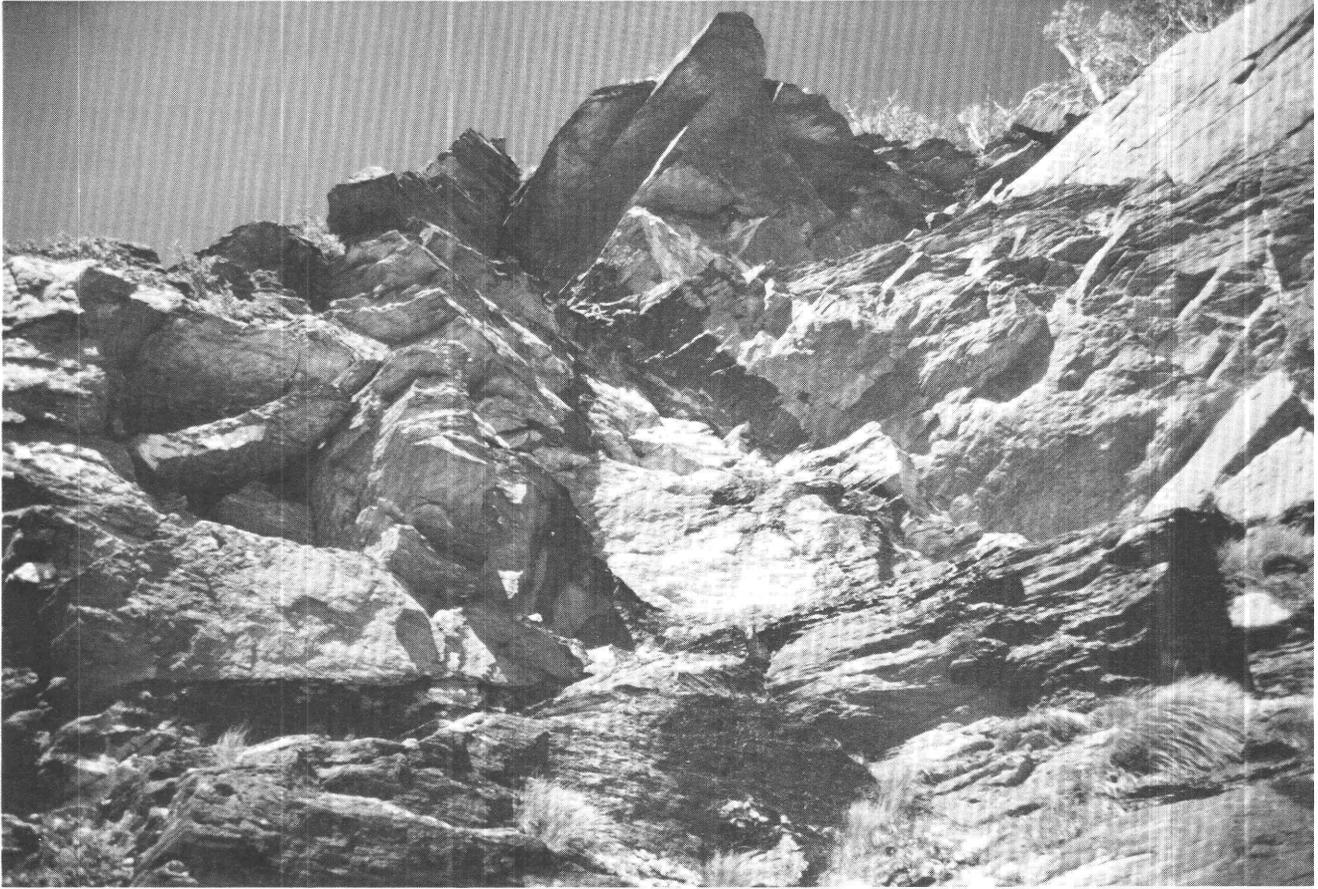
Figure 40. Overhanging blocks on the northwest wall at the top of Smugglers Notch.
