Environmental Impact of Hurricane Katrina on Lake Pontchartrain

By P. Thomas Heitmuller and Brian C. Perez

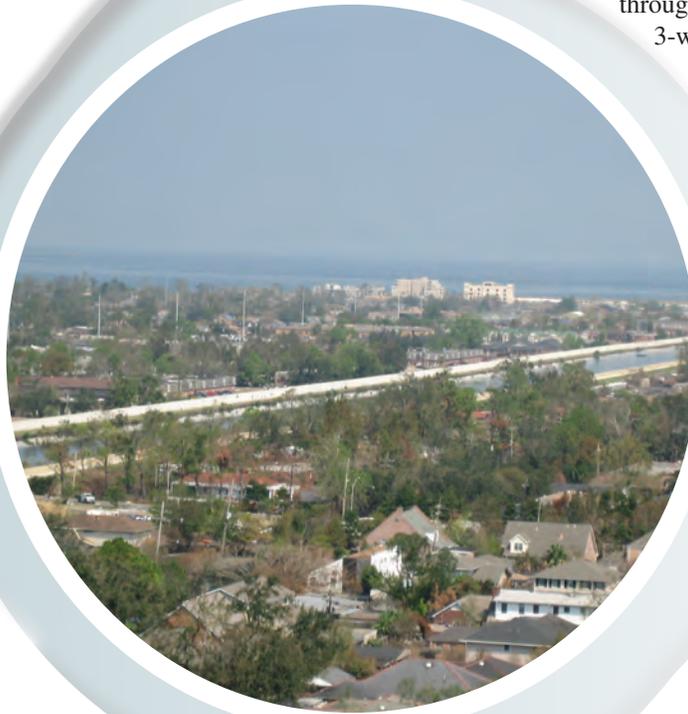
Figure 1. Lake Pontchartrain and Greater New Orleans, La. Gray-shaded area denotes areas of New Orleans that flooded because of the effects of Hurricane Katrina in 2005.

Lake Pontchartrain (fig. 1) is a 630-mi² (1,632-km²) shallow, brackish lagoon with New Orleans, La., located along its southern shore. The lake suffered dual assaults from devastating Hurricane Katrina, a category 3 storm that roared in from the Gulf of Mexico on August 29, 2005, with the eyewall passing along the eastern edge of the lake. Not only was Lake Pontchartrain's delicate ecosystem subjected to nature's fury—Katrina packed 135-mi/hour (217-km/hour) winds and a 20–30-ft (6–9-m) storm surge—the lake also faced an additional challenge by becoming

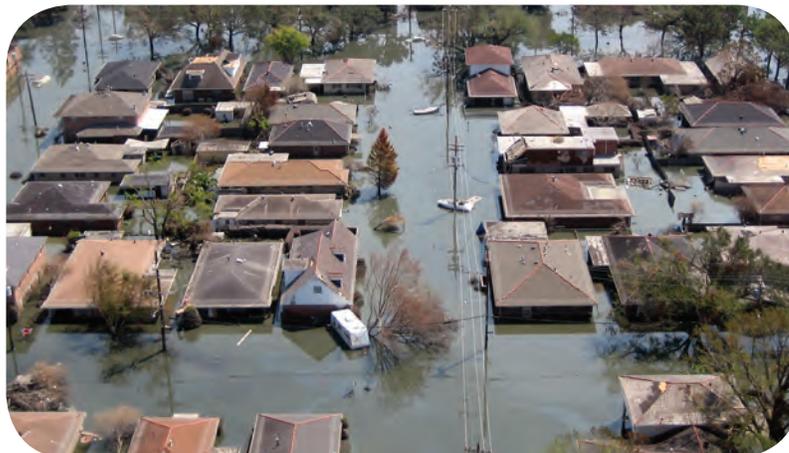
Figure 2. Neighborhoods in New Orleans, La., inundated following levee breaches after Hurricane Katrina in 2005.

the primary dumping ground for the flood waters that lingered throughout New Orleans during the 3-week period following Katrina. New Orleans and the surrounding area are situated in a bowl-like depression that lies typically 4–12 ft (1.3–3.7 m) below sea level. A network of levees and seawalls protect the city from nominal flooding, and an intricate system of large pumps evacuates accumulated rainfall from even normal storm events. The protective levees held during the initial landfall of Katrina; however, after 12–24 hours of continuous stress from the elevated water level, breaches occurred at several locations, most dramatically at the Metairie Outfall Canal (popularly known as the 17th Street Canal) and the Inner Harbor Navigation Canal (popularly known as the Industrial Canal). The storm-driven water rapidly poured through the breaches, filling the natural basin of Orleans Parish and adjacent St. Bernard Parish with resultant flood waters that reached heights of 4–12 ft (1.2–3.7 m) (fig. 2). While the pumping system was being

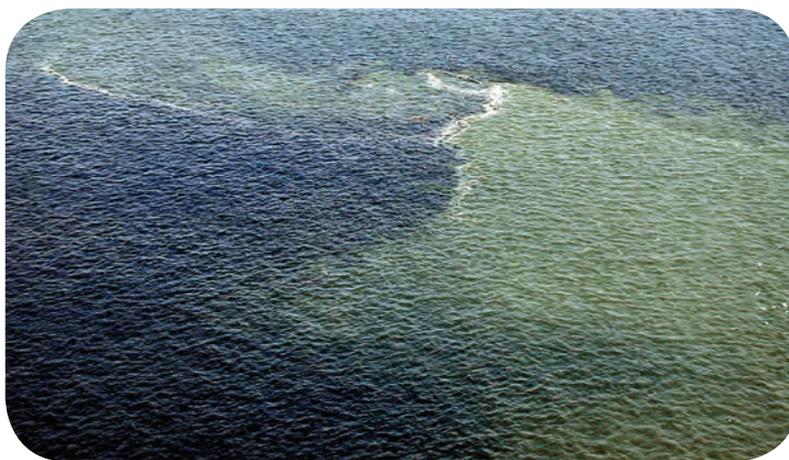
Figure 3. Plume from New Orleans, La., floodwater effluent pumped into Lake Pontchartrain, La., as a result of the flooding of the city by Hurricane Katrina.

When the pumps were finally reactivated, the bulk of contaminated water from the city was jettisoned for many days directly into the southern portion of Lake Pontchartrain with a discharge estimated at 2–3 percent of the volume of the lake, or approximately 30–50 billion gallons (100–200 billion liters) (fig. 3).

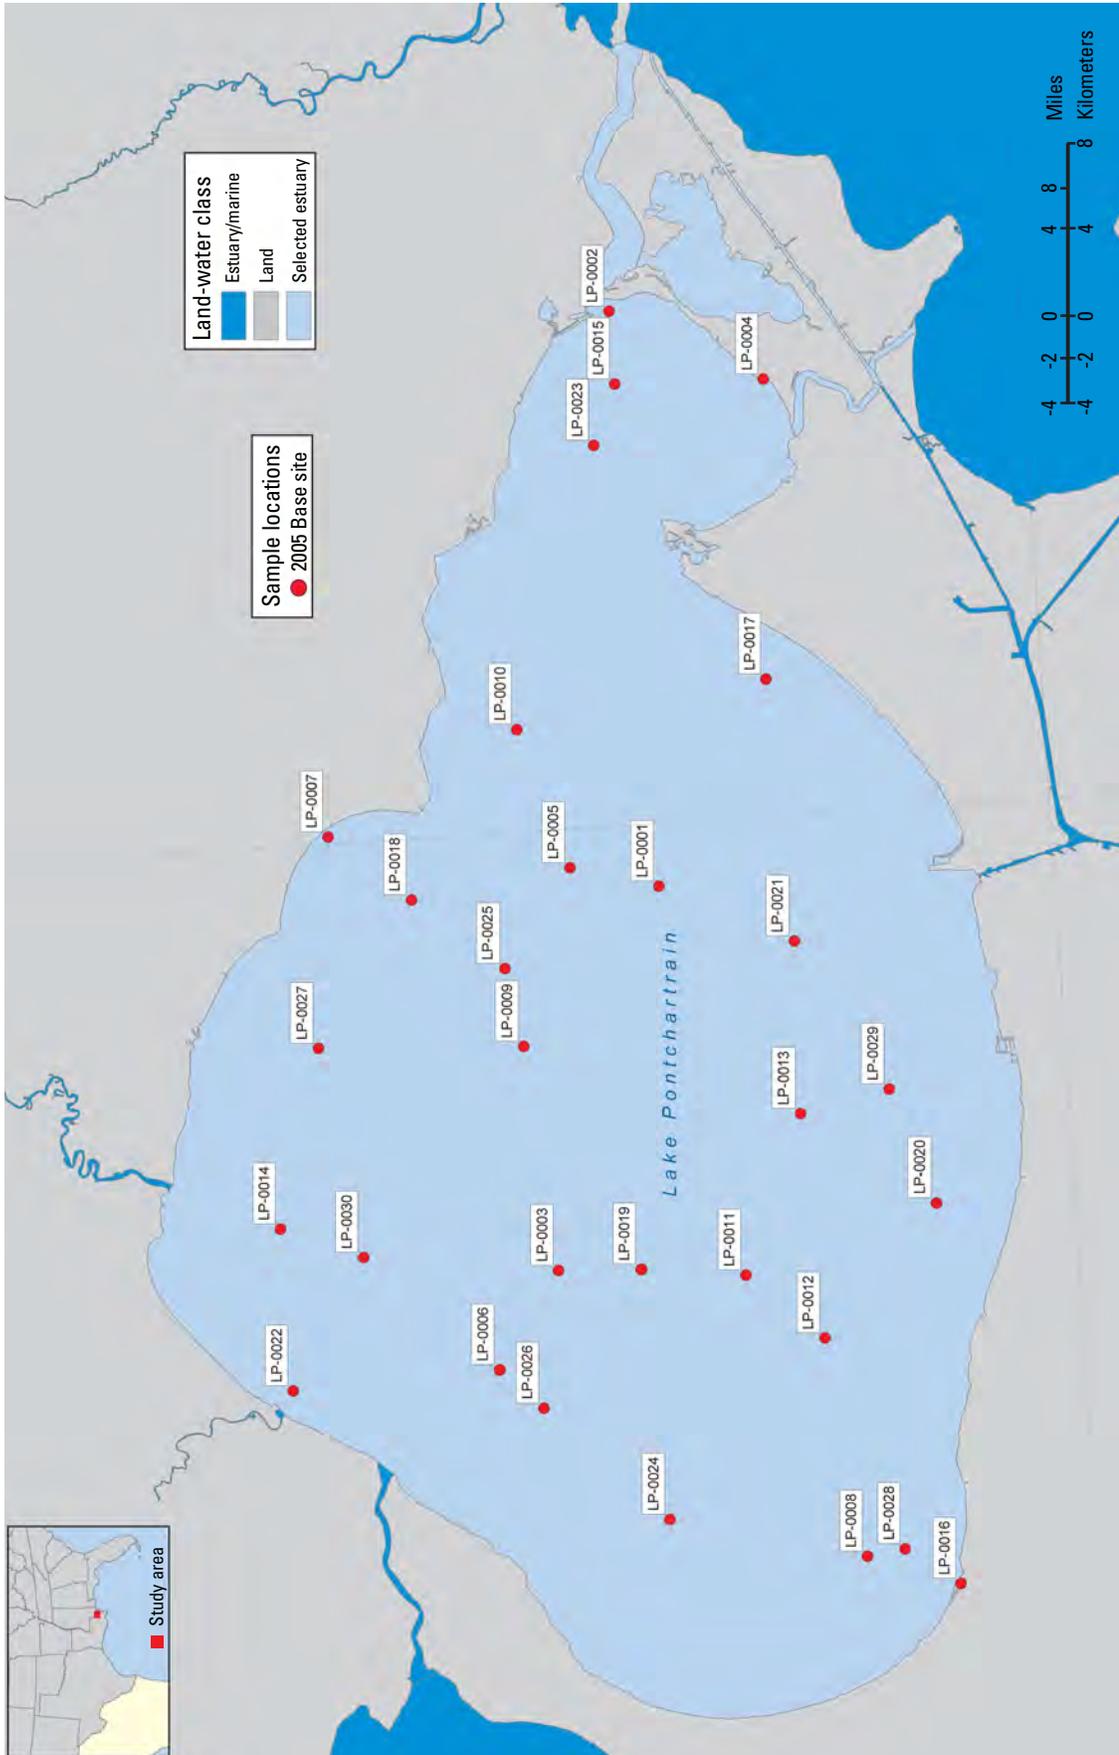
Figure 4. Map of the 30 base sites in Lake Pontchartrain, La., randomly selected for the post-Hurricane Katrina survey.

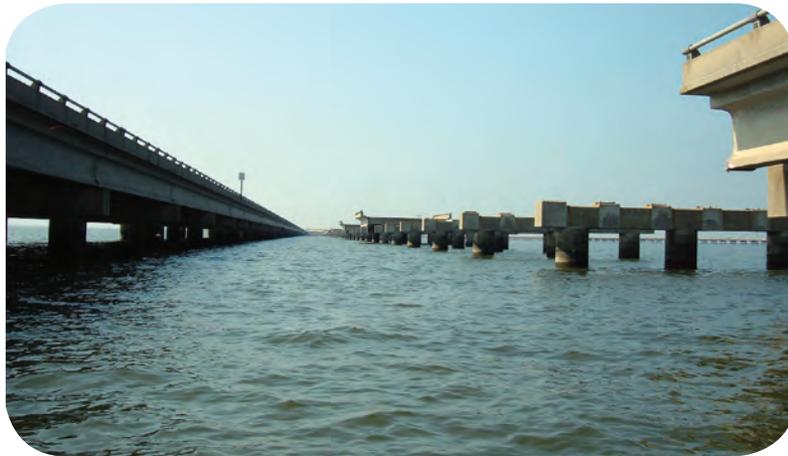
Figure 6. Sections of the Interstate 10 Twin Span Bridge, La., displaced by Hurricane Katrina's storm surge.

Even though (just several weeks prior to the survey) Lake Pontchartrain had experienced natural forces of such magnitude that the Interstate 10 Twin Span Bridge connecting Slidell, La., to New Orleans was severely fractured (fig. 6) and that an estimated 40 billion gallons (151.4 billion liters) (equivalency of approximately one million backyard swimming pools) of flood water were pumped from the New Orleans area directly into the lake, no immediate signs of ecological damage, other than floating debris, were evident to the field crew at the time of sampling (mid-October 2005). The lake water had a green, translucent appearance and was fairly clear as indicated by Secchi depth readings (fig. 7), typically about 3 ft (1 m).

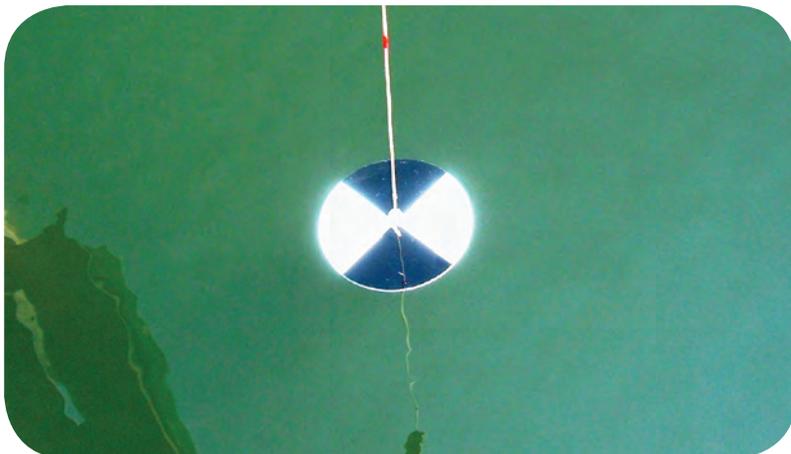
Figure 7. A Secchi disk is deployed to determine Secchi depth, an indicator of water clarity. The 8-inch (20.5-cm) disk is lowered through the water column to the point where it disappears from sight; it is then slowly retrieved to the point at which it just reappears to mark the Secchi depth.

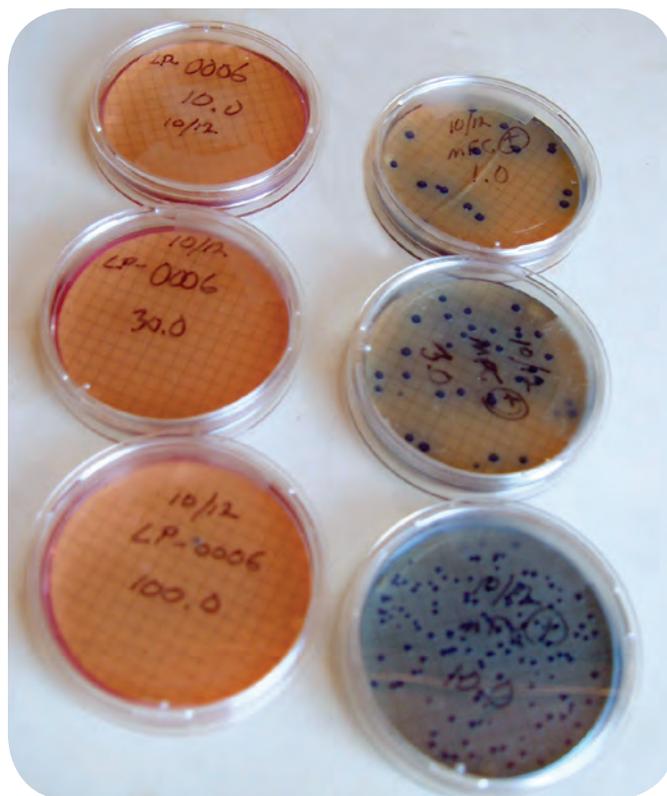
Figure 9. Microbial activity in water samples collected during the Lake Pontchartrain, La., survey was very low. Note the lack of colonies for fecal coliforms in cultures from a lake water sample (left row) compared to those for a fecal coliform positive control sample (right row).
