Rosen, M.R., Turner, K., Goodbred, S.L., and Miller, J.M., eds., 2012, A synthesis of aquatic science for management of Lakes Mead and Mohave

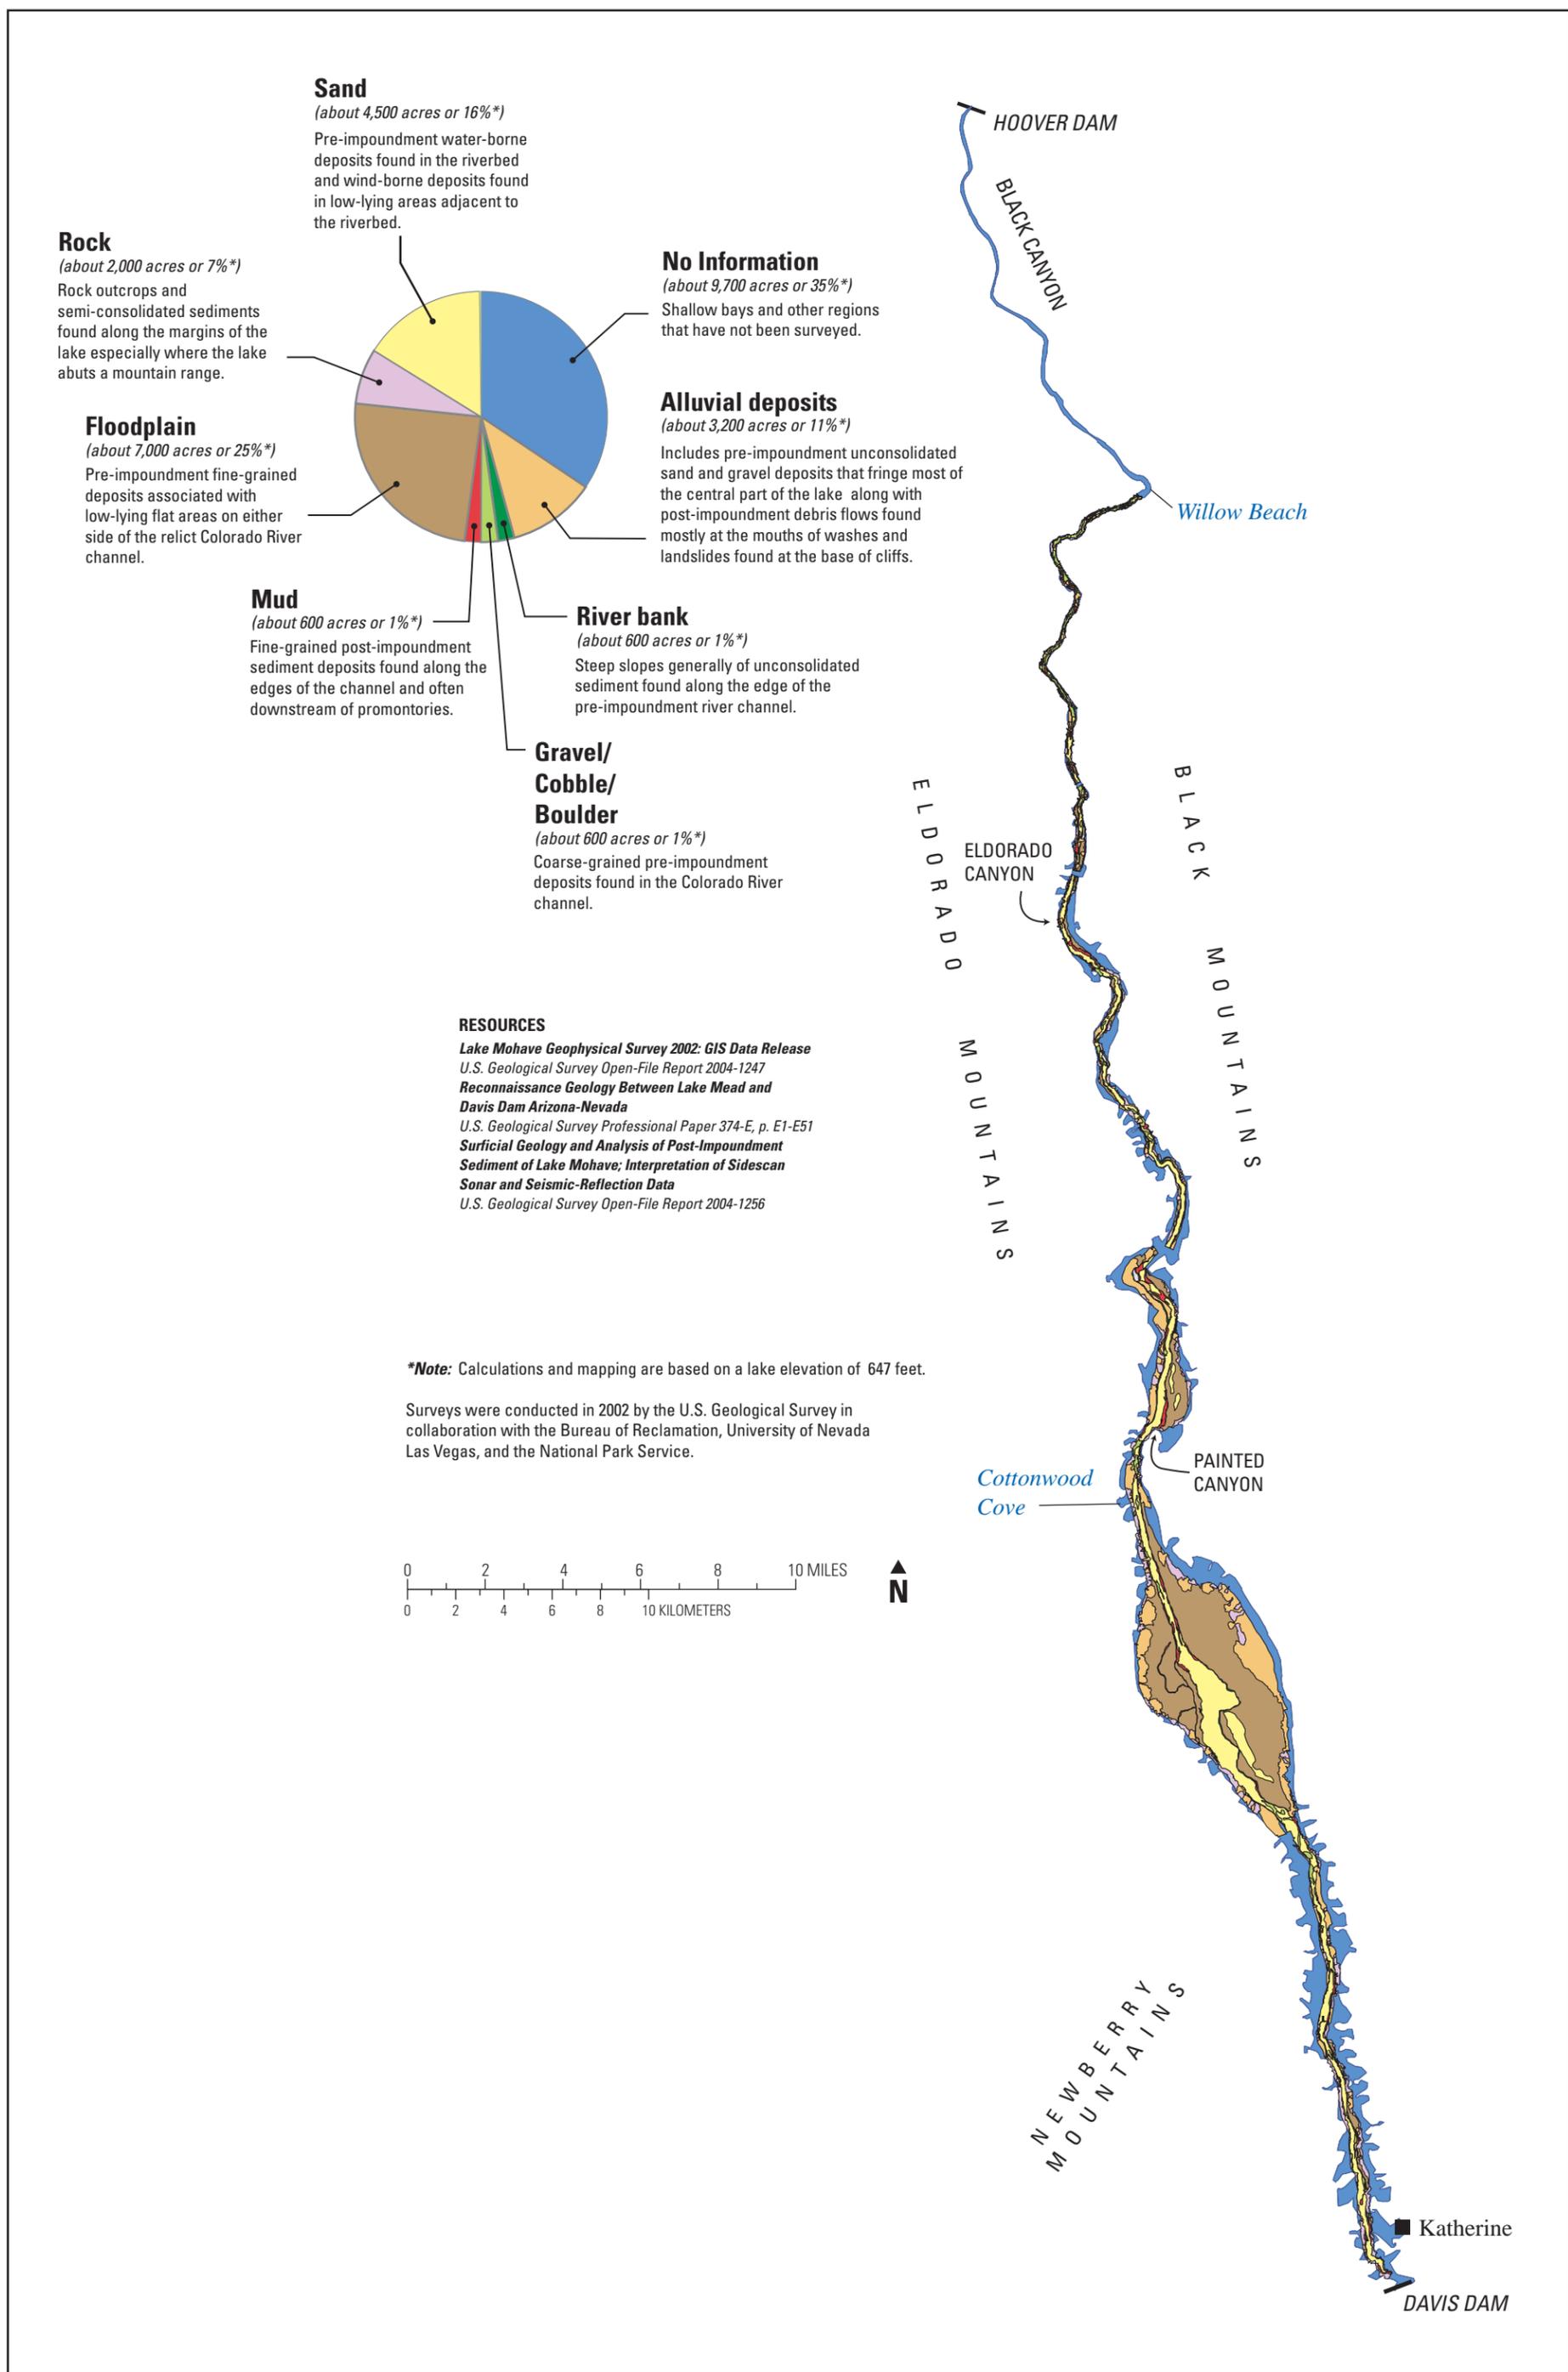
FIGURE 2.6—Little sediment has accumulated in Lake Mohave due to upstream dams and reservoirs such as Lake Powell and Lake Mead. Post-impoundment lake muds cover only 1 percent of the lake floor.
